**University of Strathclyde**  
**Department of Pure and Applied**  
**Chemistry**  
**Centre for Forensic Science**

**Developing a reliable systematic**  
**analysis for arc fault mapping**

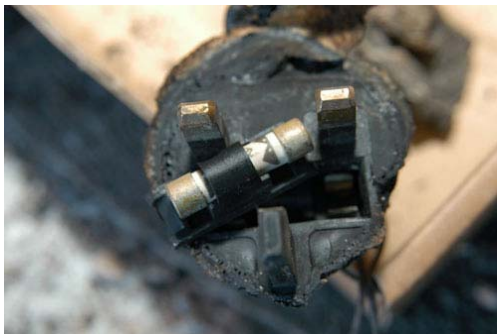
Figure 6 – 5 A cartridge fuse from a UK plug [14]

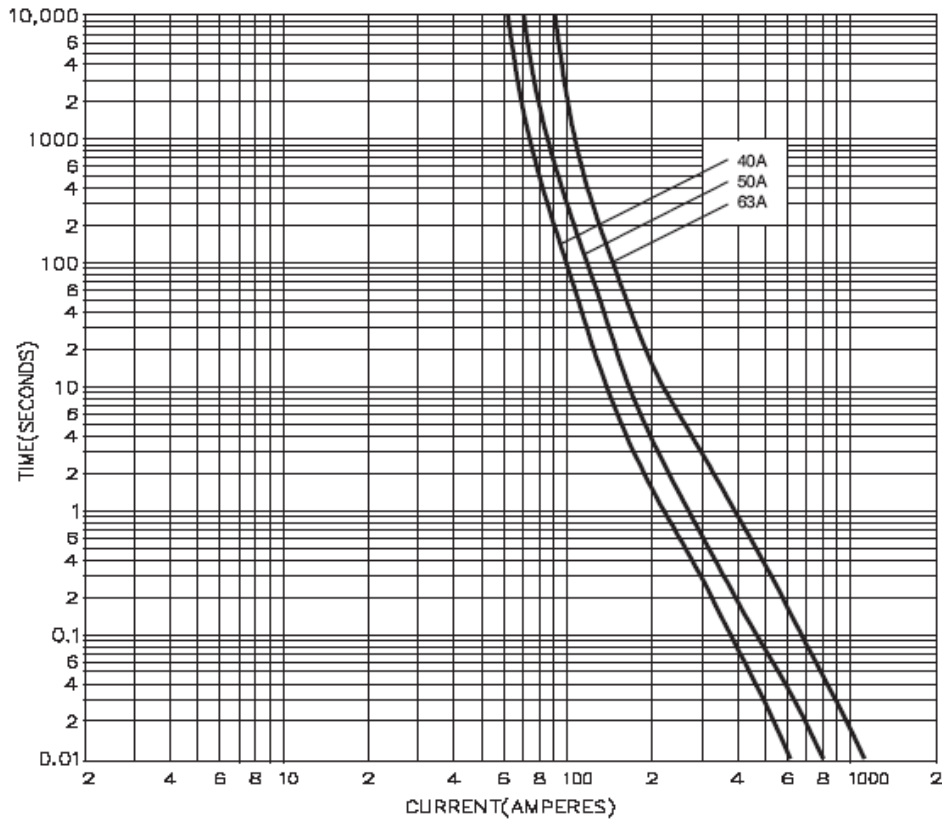
Figure 8 – Time current characteristics of 3 different ratings of BS88 cartridge fuse [16].

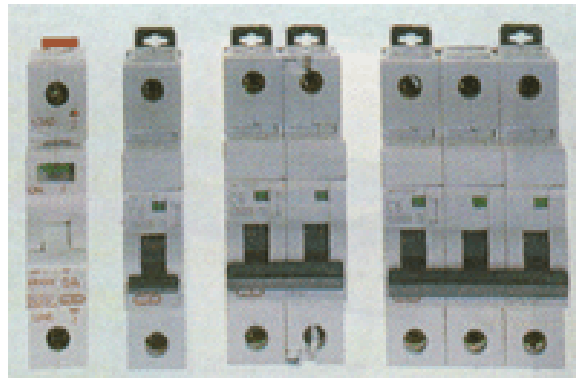
Figure 9 – Some examples of European miniature circuit breakers [19].

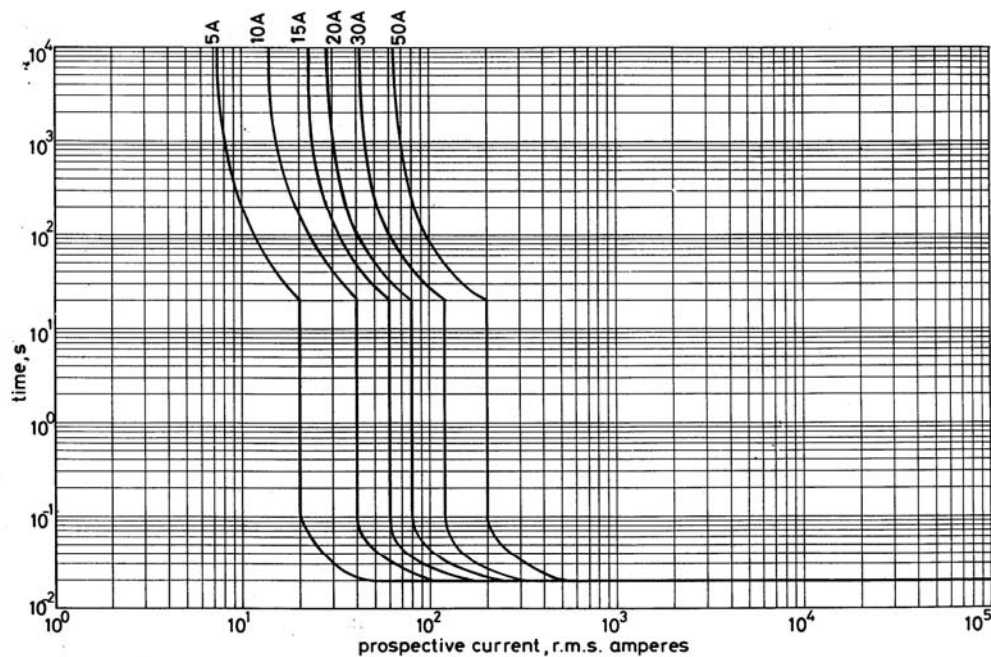
Figure 10 – Time / current curves for miniature circuits breakers [20]

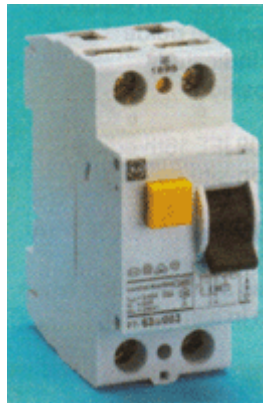
Figure 11 – Typical RCD found in residential and commercial electrical installations [19].

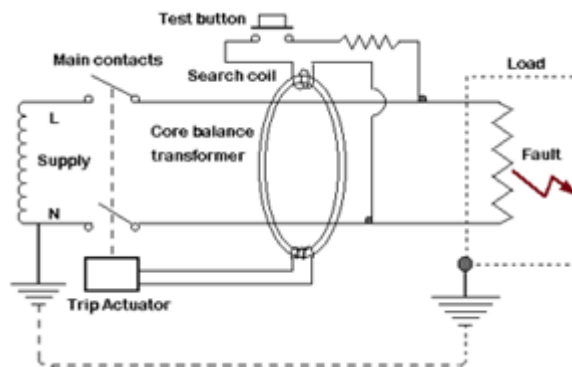
Figure 12 – Circuit diagram of an RCD [19]

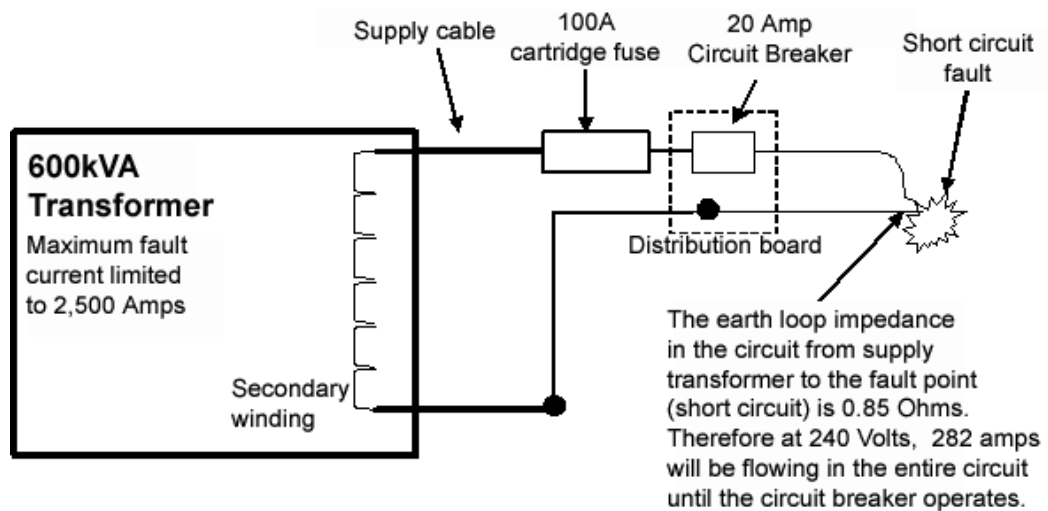
Figure 13 – A circuit detailing the electricity supplier’s (sub-station) transformer to a point in a final circuit with a short circuit fault.

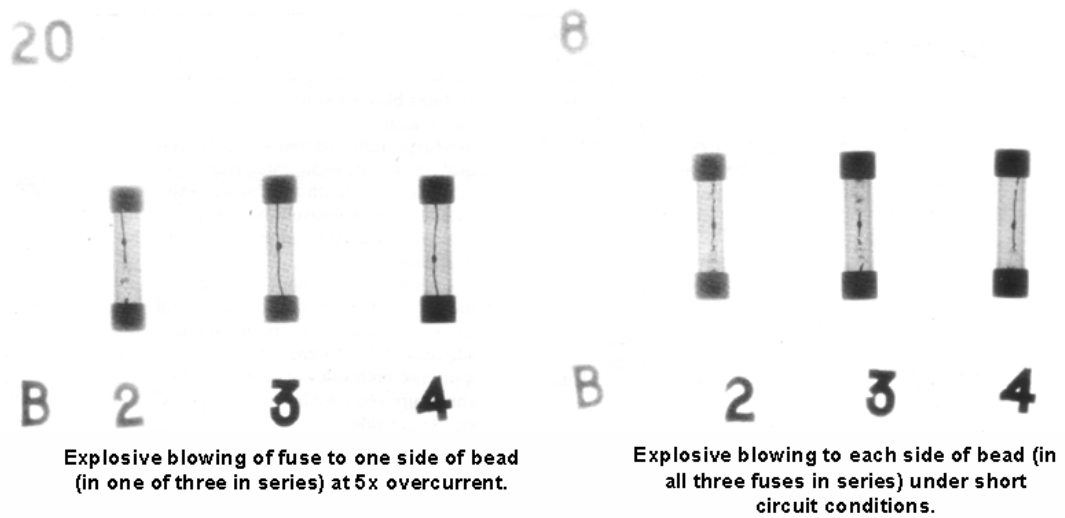
Figure 14 – overload and short circuit evidence revealed with x-ray images [13].

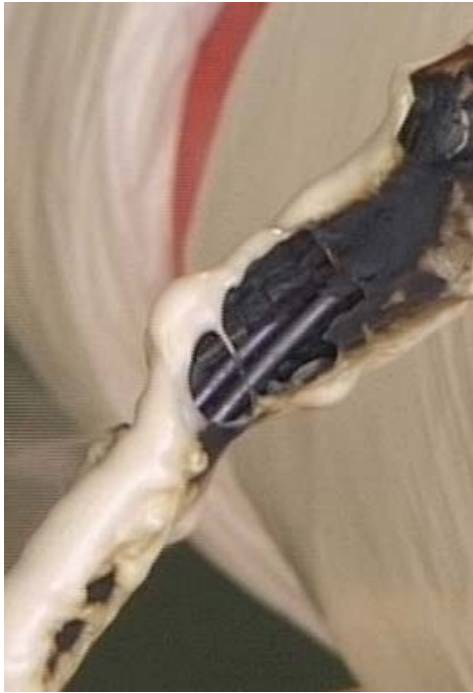
Figure 15 – Current overloaded PVC insulated cable [45].

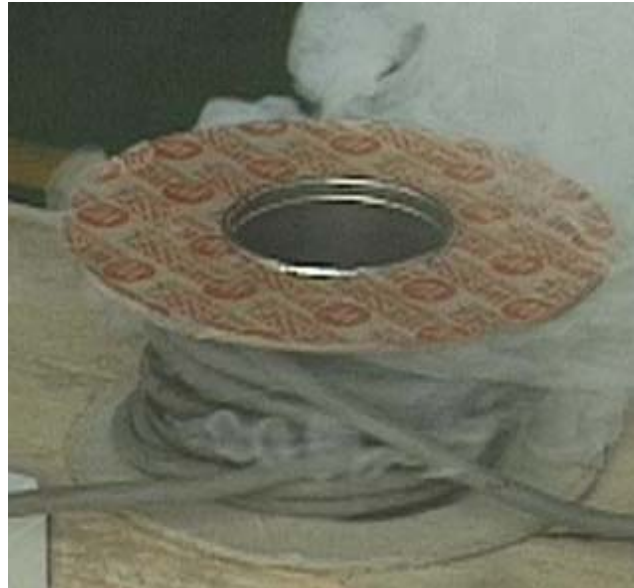
Figure 16 – Overloaded drum of cable with two heaters connected to the circuit [45].

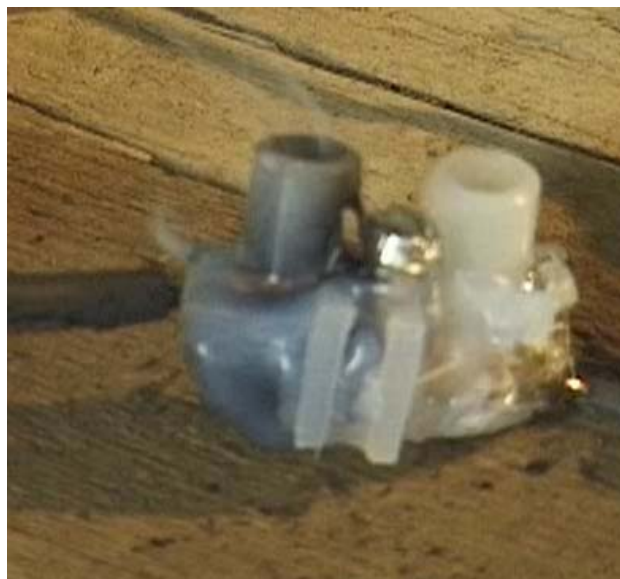
Figure 17 – Resistance heating of a terminal connection [45].

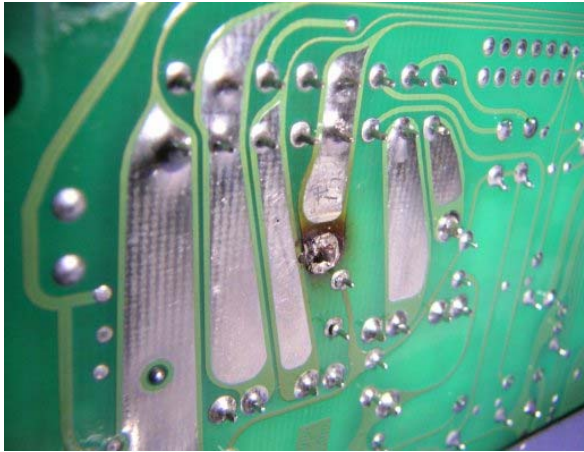
Figure 18 – Example of a dry solder joint with localised overheating to the printed circuit board [46].

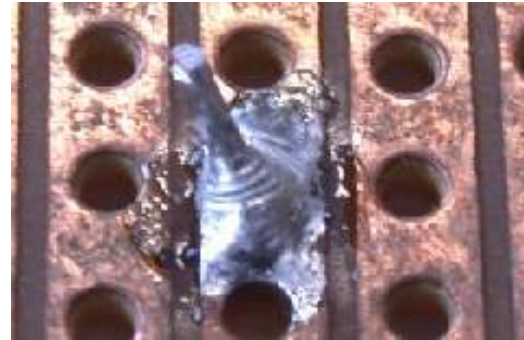
Figure 19 – The solder is dull in colour indicating a dry brittle solder connection [47].

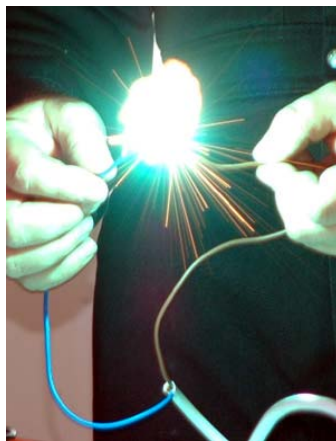
Figure 20 – The author demonstrating an arc [59].

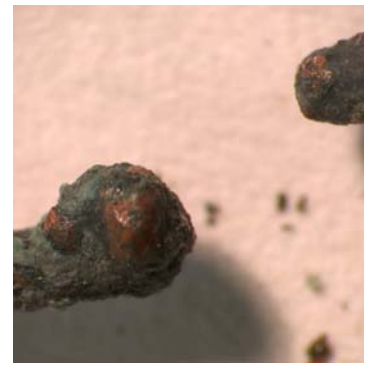
Figure 23 – A severed conductor at 20x magnification.

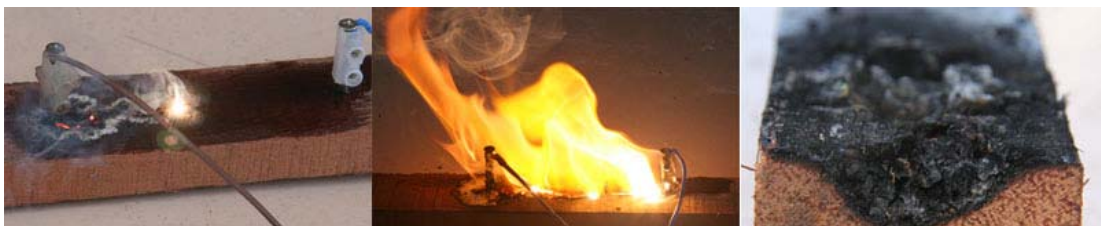
Figure 24 – demonstration of arcing through char [65].

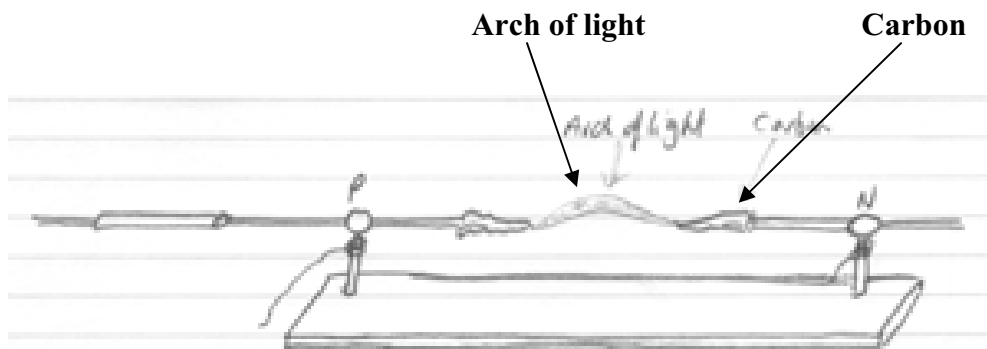
Figure 26 – A reproduced diagram of the “arch of light” observed by Davy when the cells were connected [73].

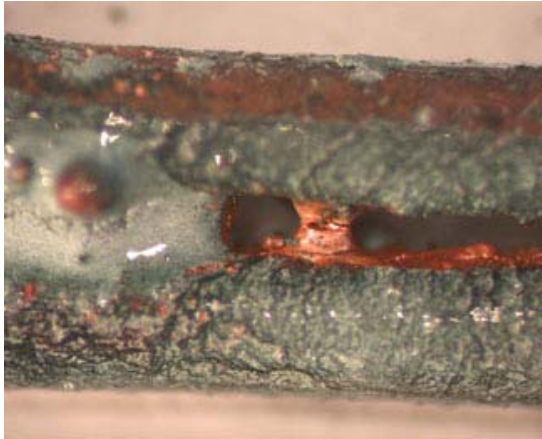
Figure 27 – Two conductors welded together.

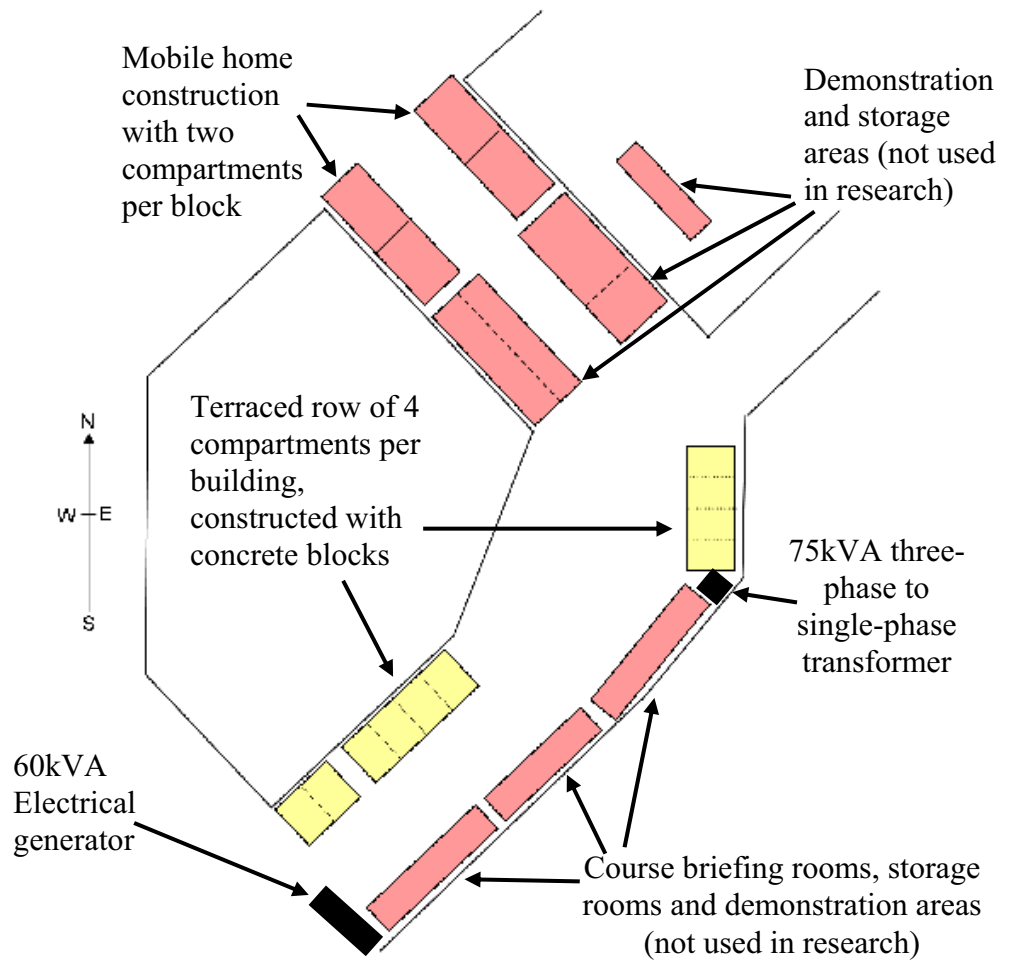
Figure 37 – Overview of the Wethersfield site [136].

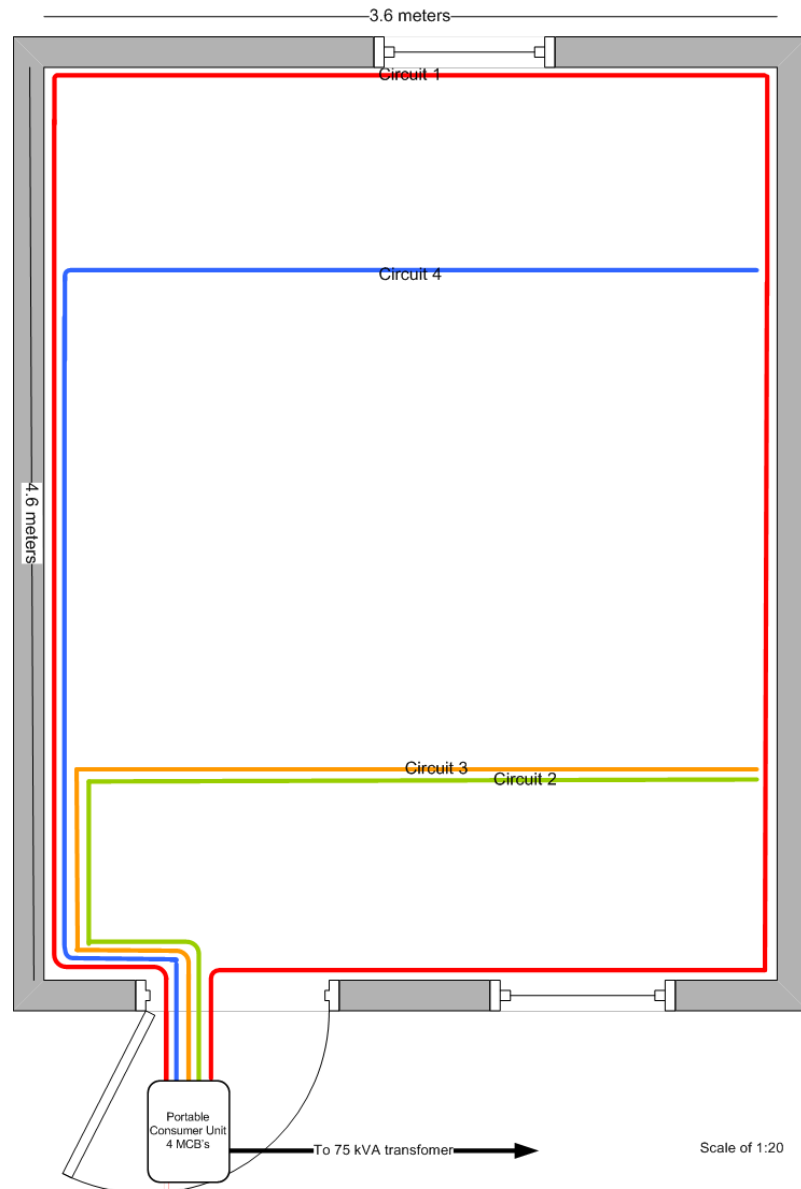
Figure 42 – The typical routes of the electrical circuits installed within the compartments fires used in the research.

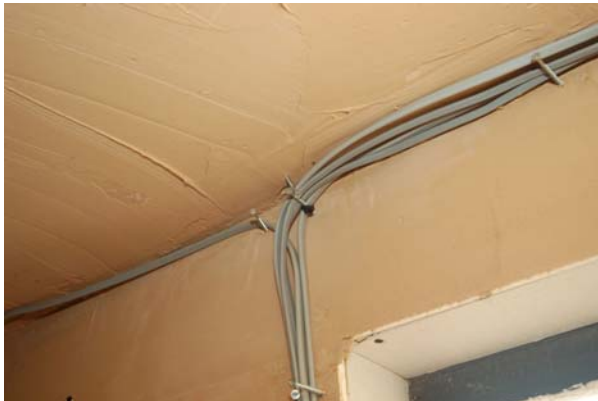
Figure 43 – Cables fixed with screws and cable ties above and to the side of the compartment's entrance doorway.

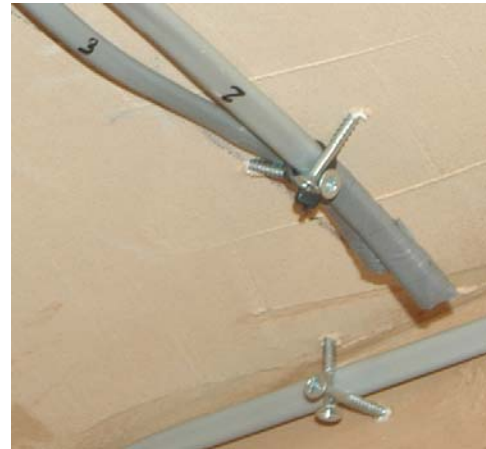
Figure 44 – The method of crossing two screws into an 'X' shape to support the cables during the fire and its suppression by fire crews.

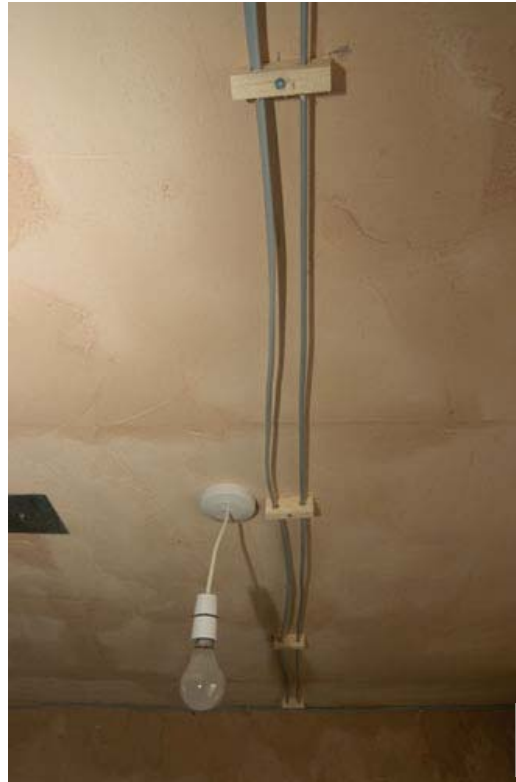
Figure 45 –Timber blocks simulating floor joists used to support the cables.

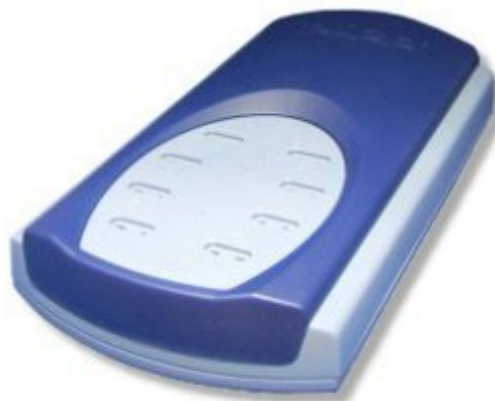
Figure 52 – The Pico Technology TC-08 temperature data logger [141].

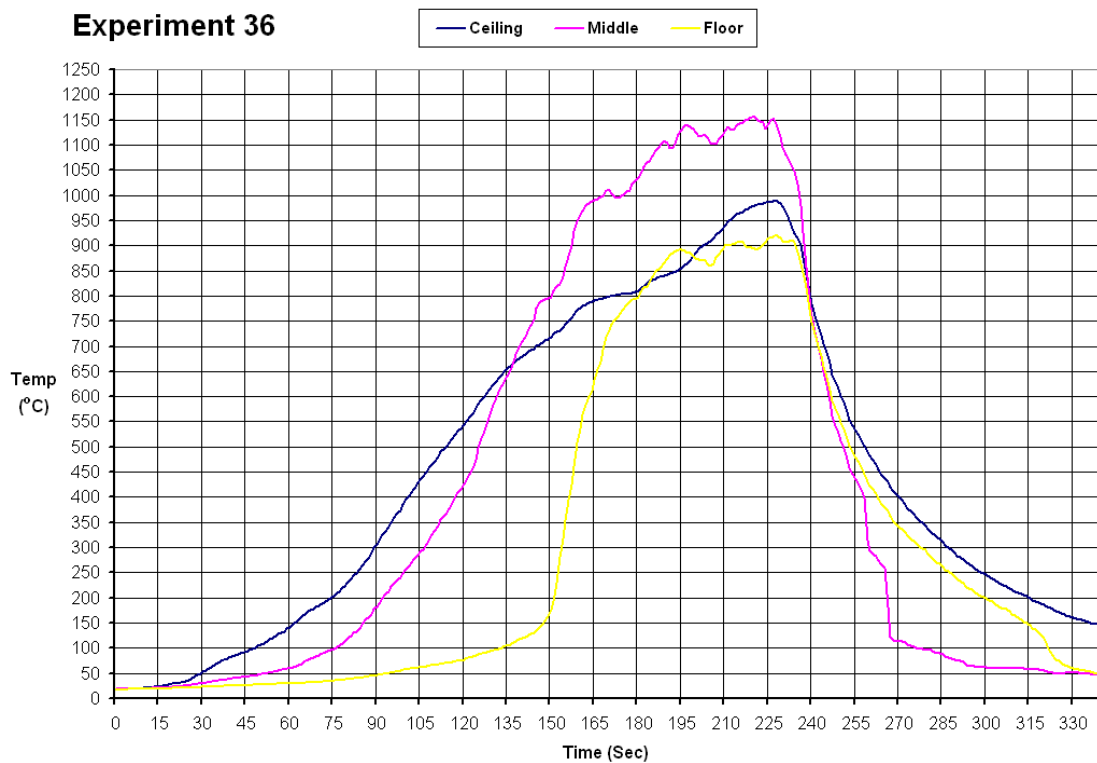
Figure 53 – Example of a time temperature graph from experiment 36 [142].

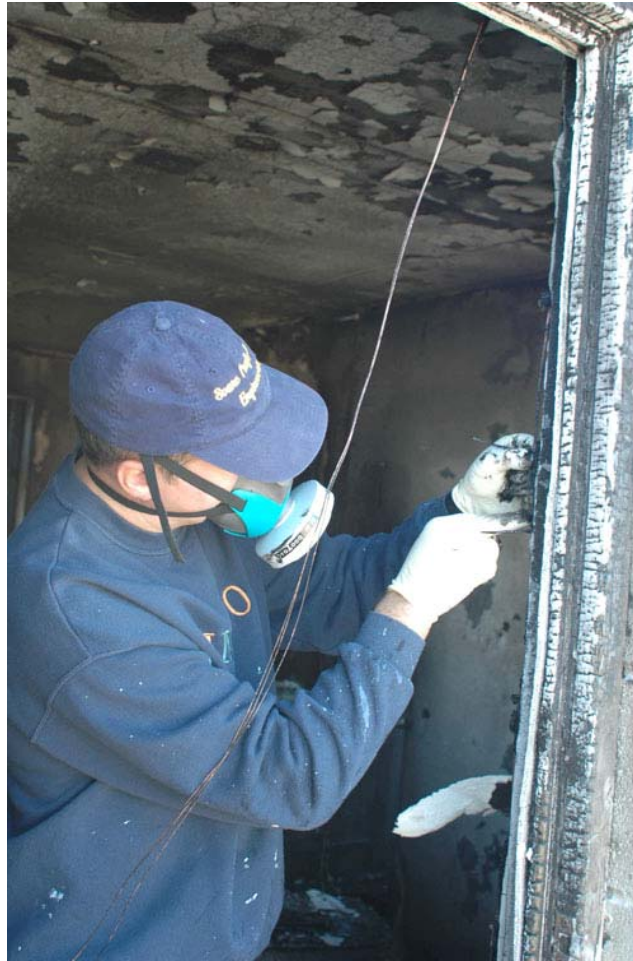
Figure 57 – Examination of the copper conductors post-compartment fire [146].

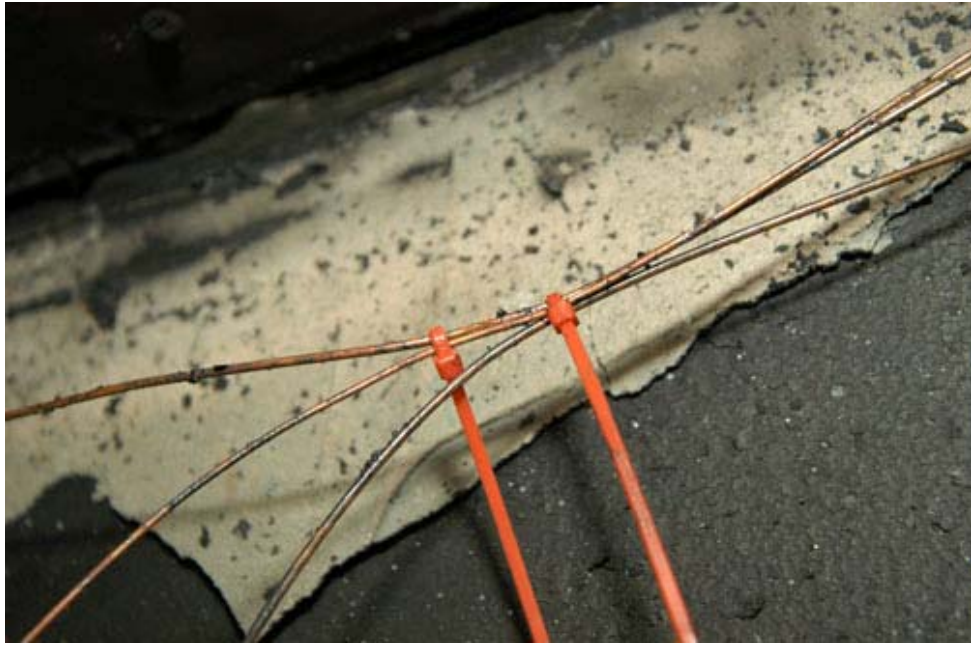
Figure 58 – Cable-ties used to identify arcing damage.

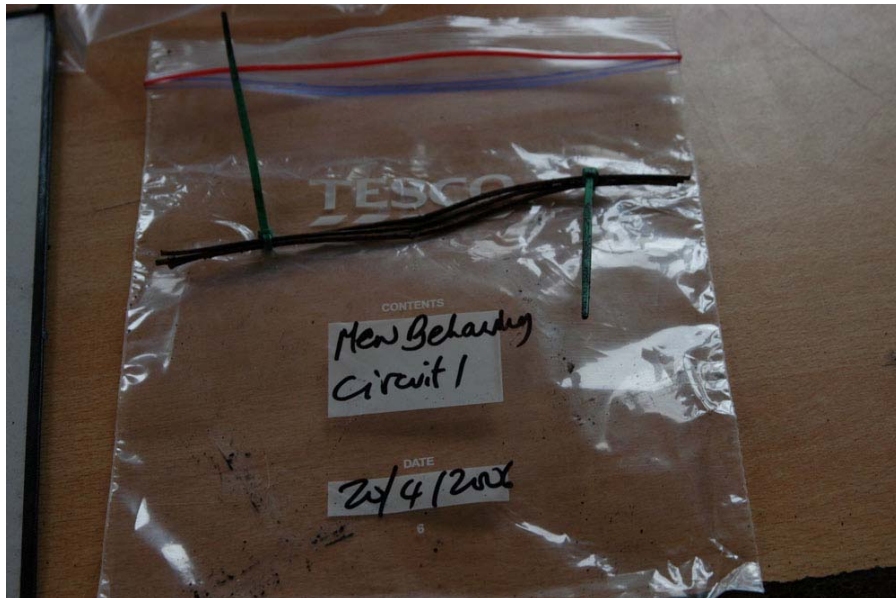
Figure 59 – A clear re-sealable polythene bag containing an exhibit.

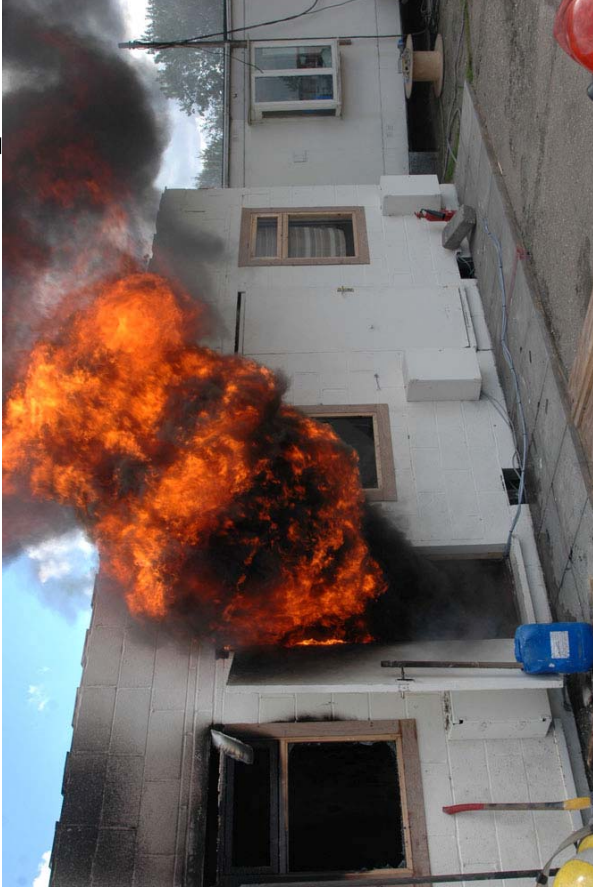
Figure 60 - “Scenario B”, 7 September 2006 [147]

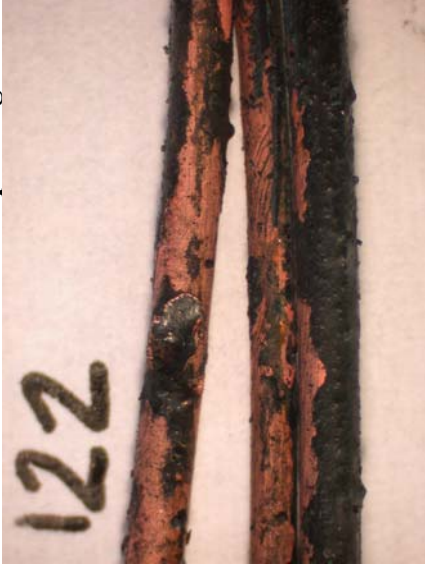
Figure 72 - One of the three conductors had arcing damage in the pattern of a notch. This circuit (2) may have faulted with circuit 3

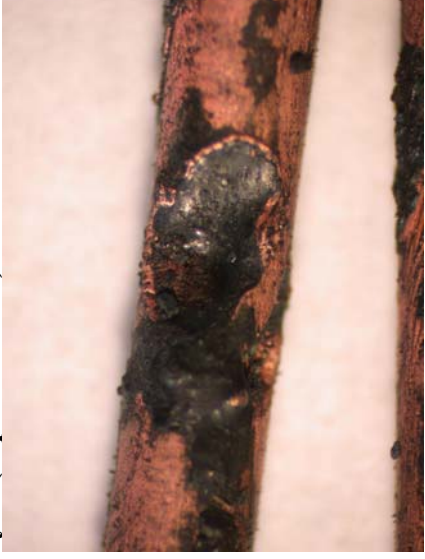
Figure 73 - 15x magnification of the notch with a small bead at the notch left edge.

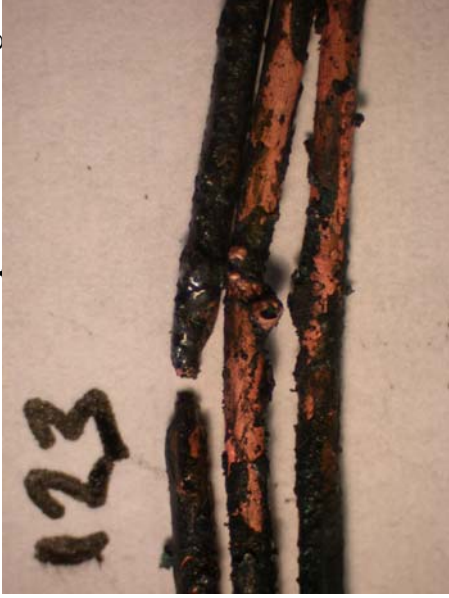
Figure 76 - Microscope image of exhibit 123. Two conductors had arcing damage. The lower conductor has a bead with a large hole.

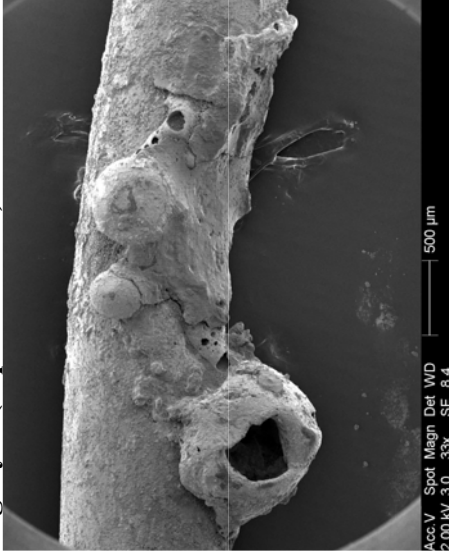
Figure 77 - SEM image of the lower conductor. The demarcation is clearly defined at the notch edge.

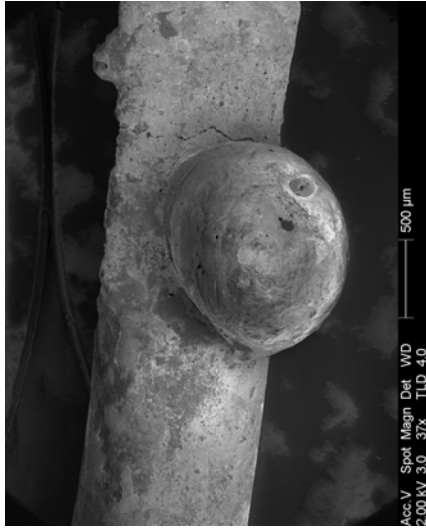
Figure 85 - SEM image of the notch with a bead on the surface. There was a crack in the conductor surface to the right of the bead.

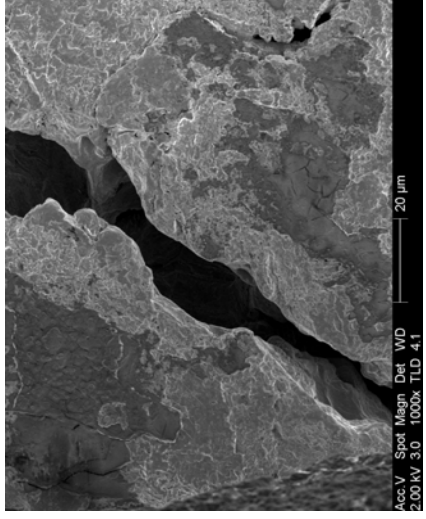
Figure 86 - SEM image at 1000x magnification documenting the crack in the conductor surface.

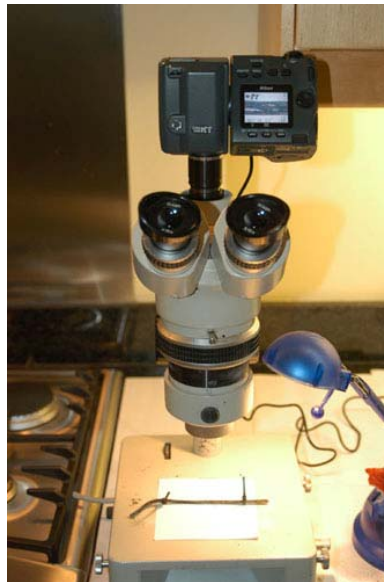
Figure 90 – Nikon microscope in use to document the exhibits.

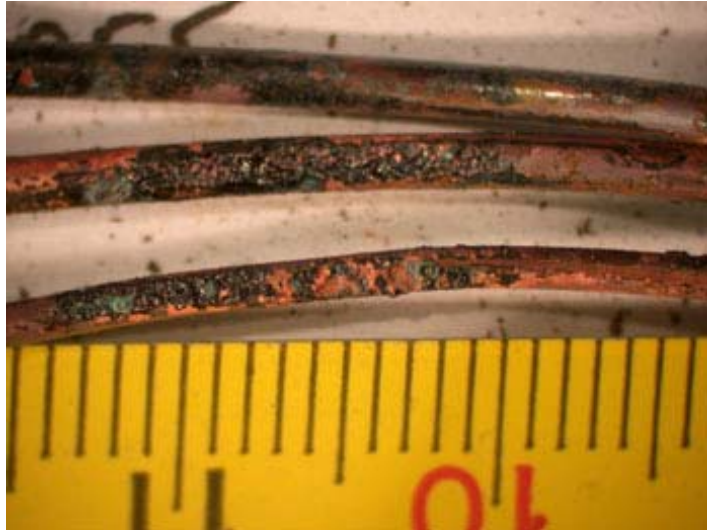
Figure 91 – Category A: Arcing through charred plastic PVC insulation (exhibit 055). The metallic damage is very shallow and there are numerous small beads and notches over a wide lateral area of the conductor surface.

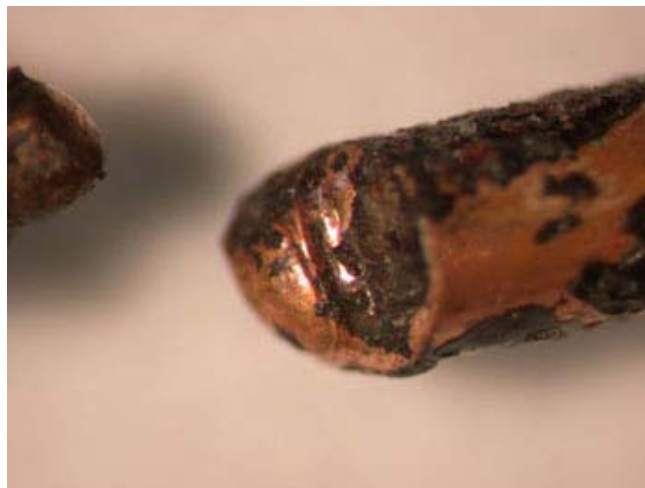
Figure 92 – Category B: Severed conductor ends (exhibit 067). The conductors were severed during the arcing event. Localised damage observed at each end often had a clear demarcation line between the localised metallic damage and un-damaged conductor.

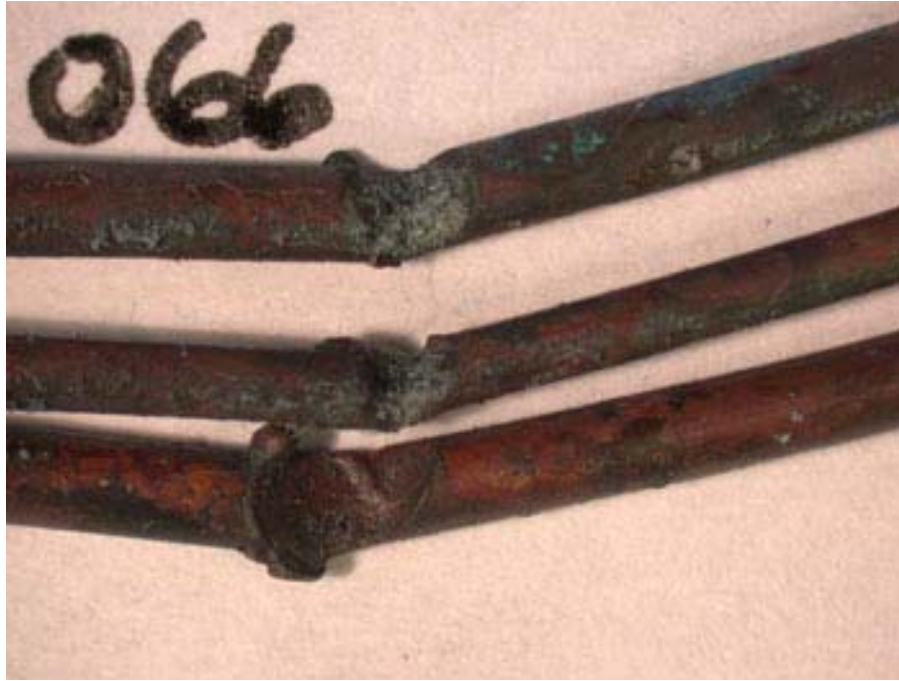
Figure 93 - Category C: Bead and notch conductor damage (exhibit 066). A large notch and a smaller bead were found on the same conductor. Often the bead was located at the edge of the notch. The metallic damage is very localised with clear demarcation between damaged and undamaged conductor.

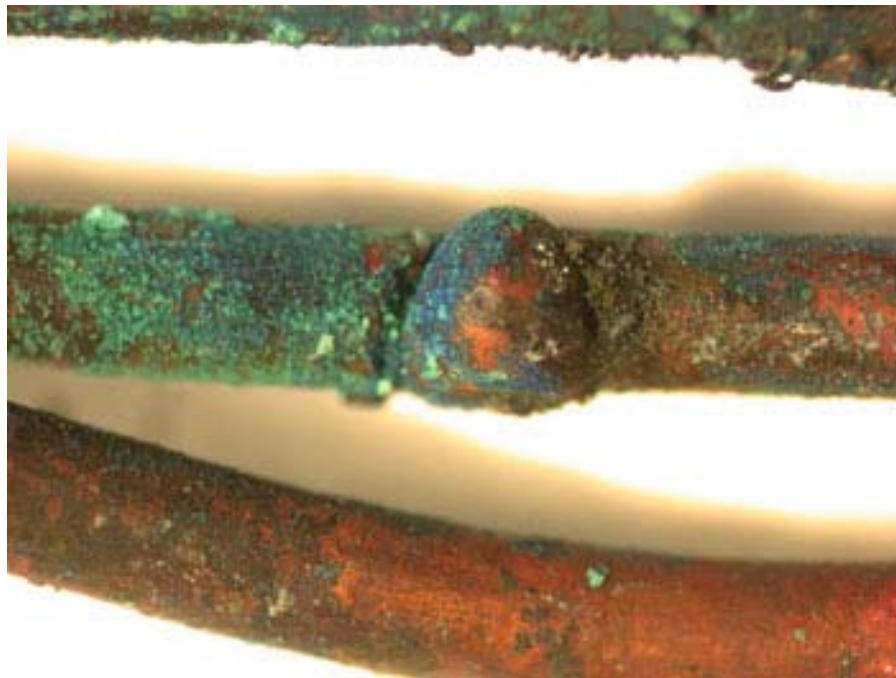
Figure 94 – Category D: Bead within notch (exhibit 068). A large bead was located within the notch on the conductor. The metallic damage is localised with a clear demarcation area at the edge of the notch and the undamaged conductor.

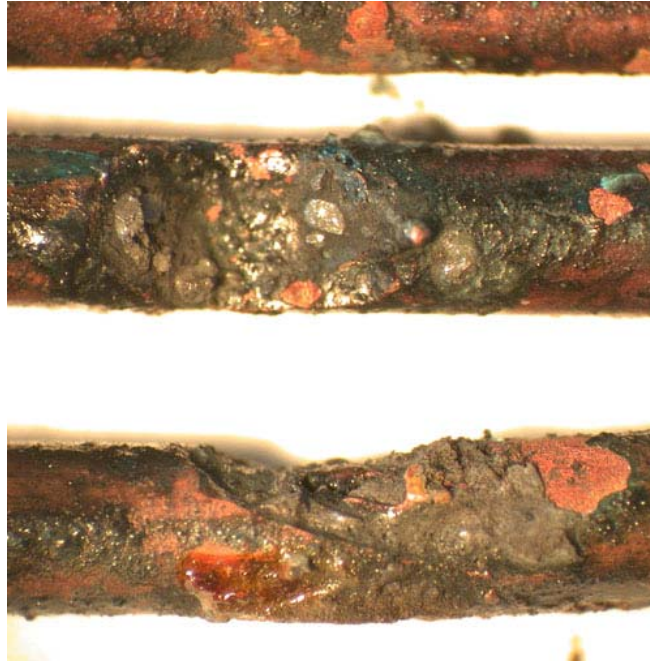
Figure 95 – Category E: Two notches (exhibit 009). A notch was found on each adjacent conductor of this exhibit that have faulted together. There was a clear demarcation area between the damaged and undamaged conductor with the metallic damage very localised.

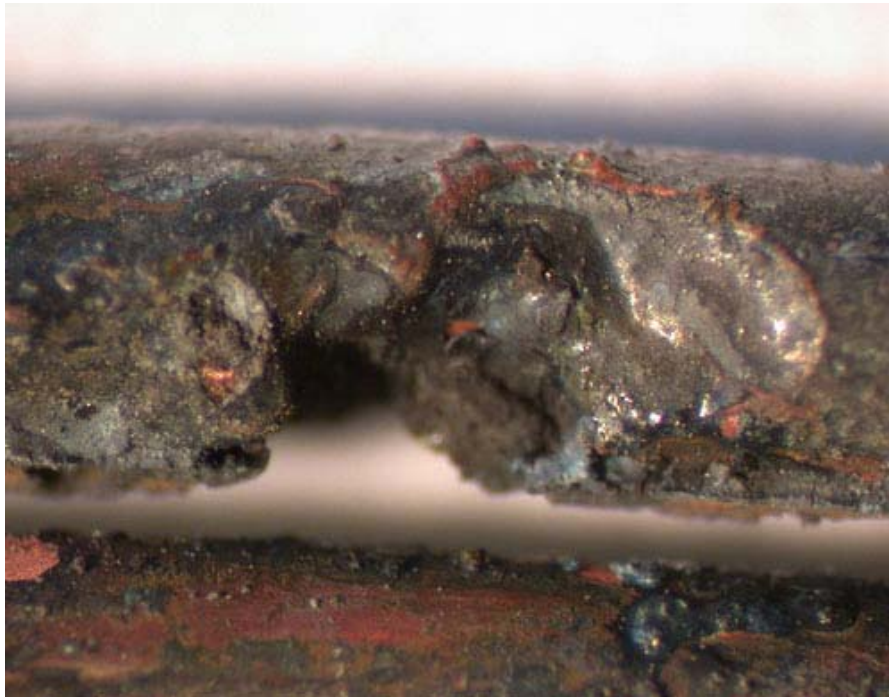
Figure 96 – Category F: One notch (exhibit 063). The damage on this exhibit was in the form of a large notch affecting only one conductor in the cable. This suggests that electron flow was established through another route (possibly via a fixing screw and an adjacent circuit).

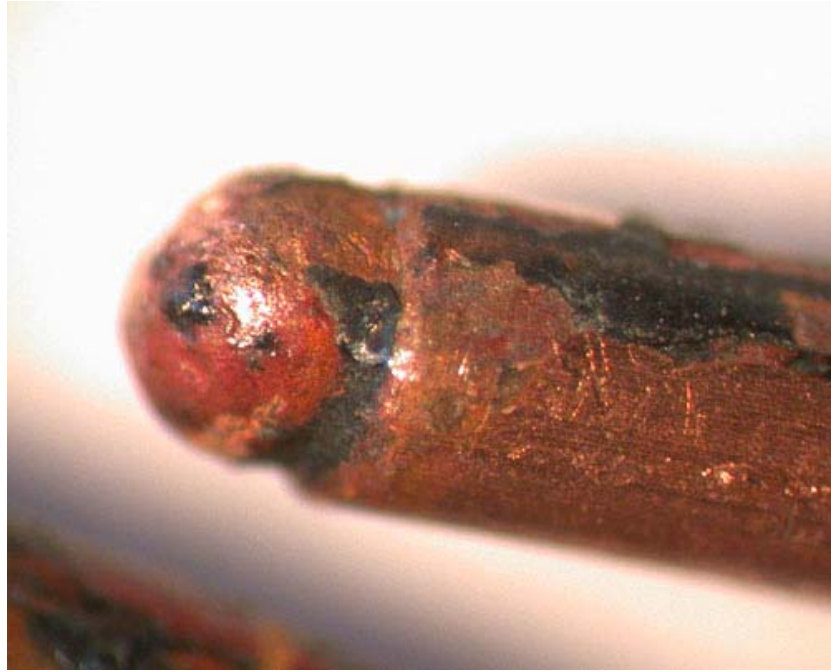
Figure 97 – Category G: Bead(s) at the conductor end (exhibit 012). This example was a bead at the end of a severed conductor with a clear demarcation area between the localised metallic damage and the undamaged conductor.

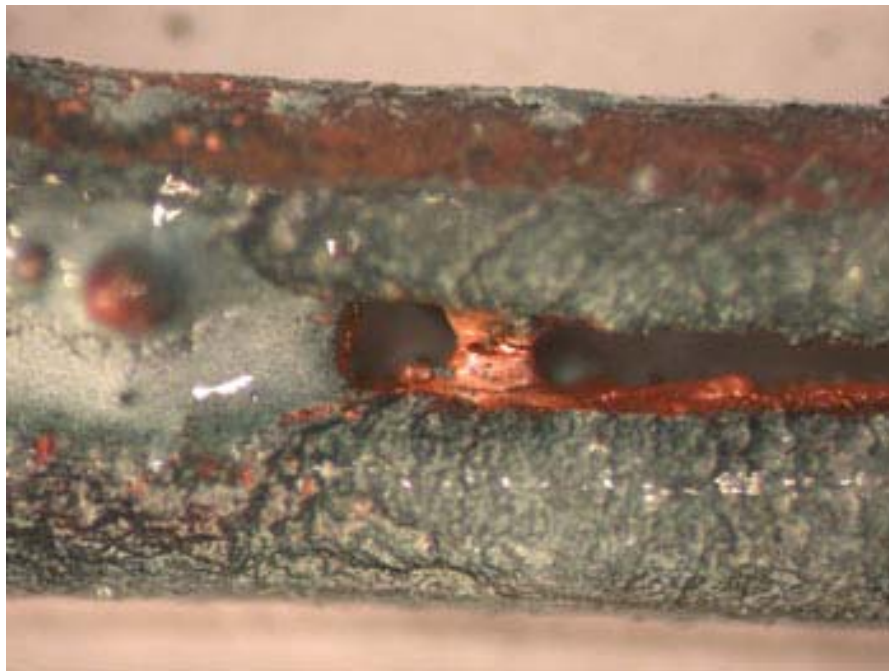
Figure 98 – Category H: Two conductors welded together (exhibit 054). In this example the conductors have welded themselves together during the arcing event in the short period of time that the copper metal was molten. The damage was localised and copper splatter from the arcing event was often observed adjacent to the weld.

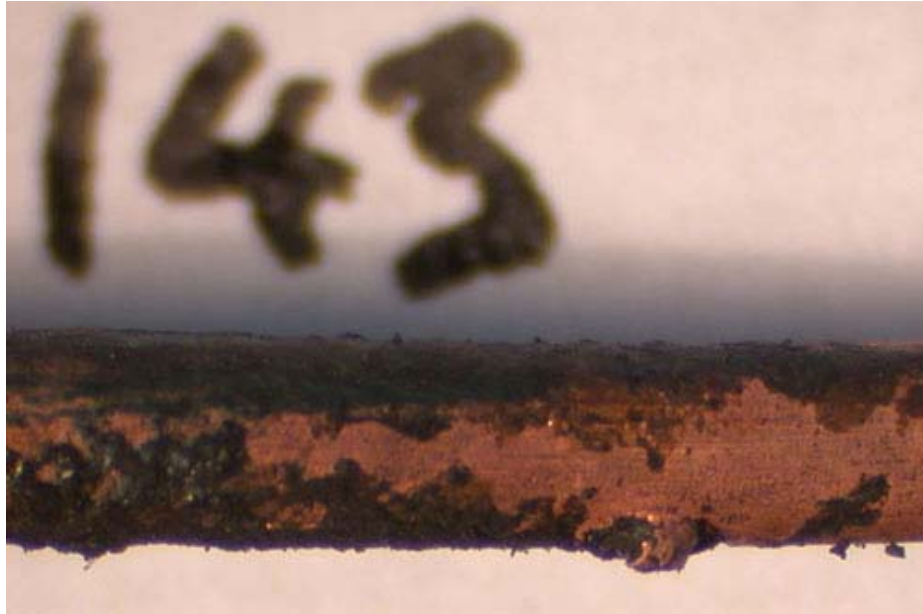
Figure 99 – Category I: Bead on conductor surface (exhibit 143). This example was the smallest surface bead observed in the series of experiments. The example of this category detailed in figure 109 is a bead that was substantially larger.

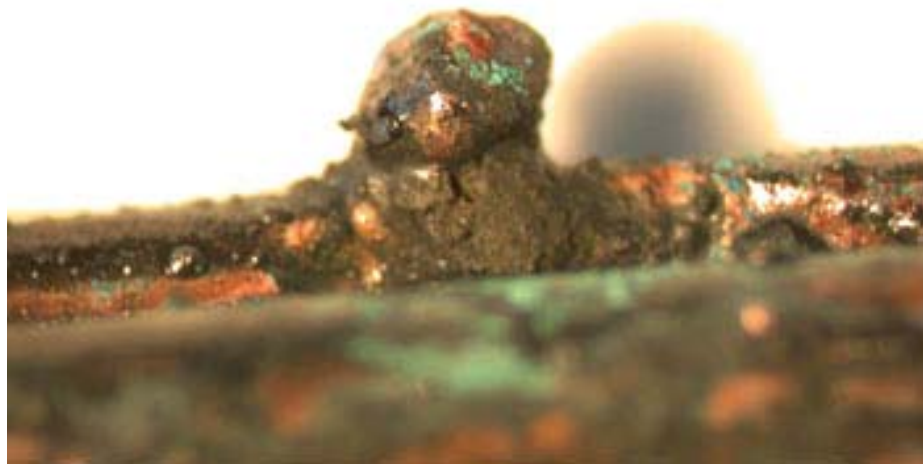
Figure 100 – A second example of Category I (exhibit 125) bead on conductor surface.

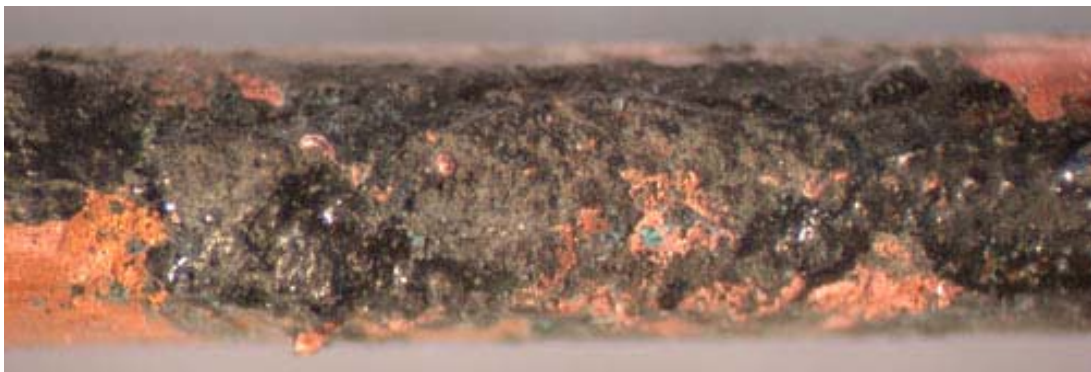
Figure 101 – An optical microscope image of arcing through char conductor damage (exhibit 088).

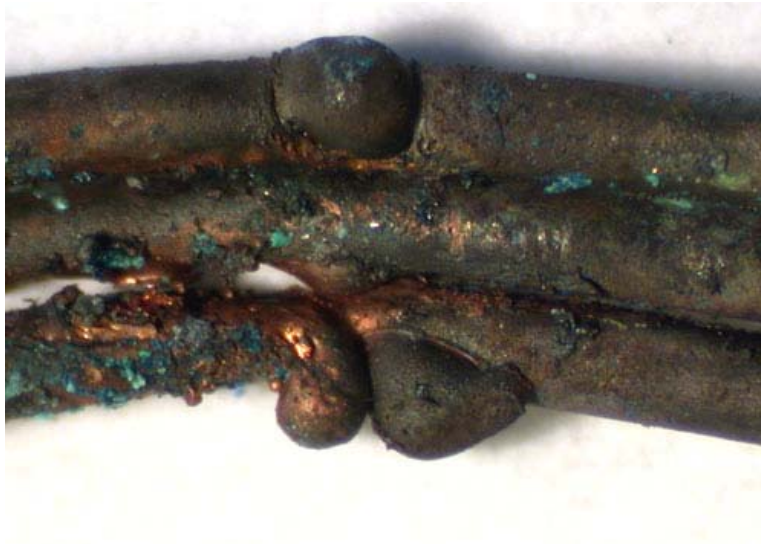
Figure 102 – An optical microscope image detailing the ‘short circuit’ fault at a fixing screw location (exhibit 081 – arcing category E).

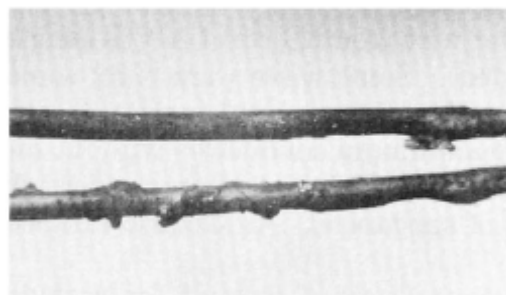
Figure 103 – Gross melting damage to electrical conductors caused by exposure to high overall temperatures [35]

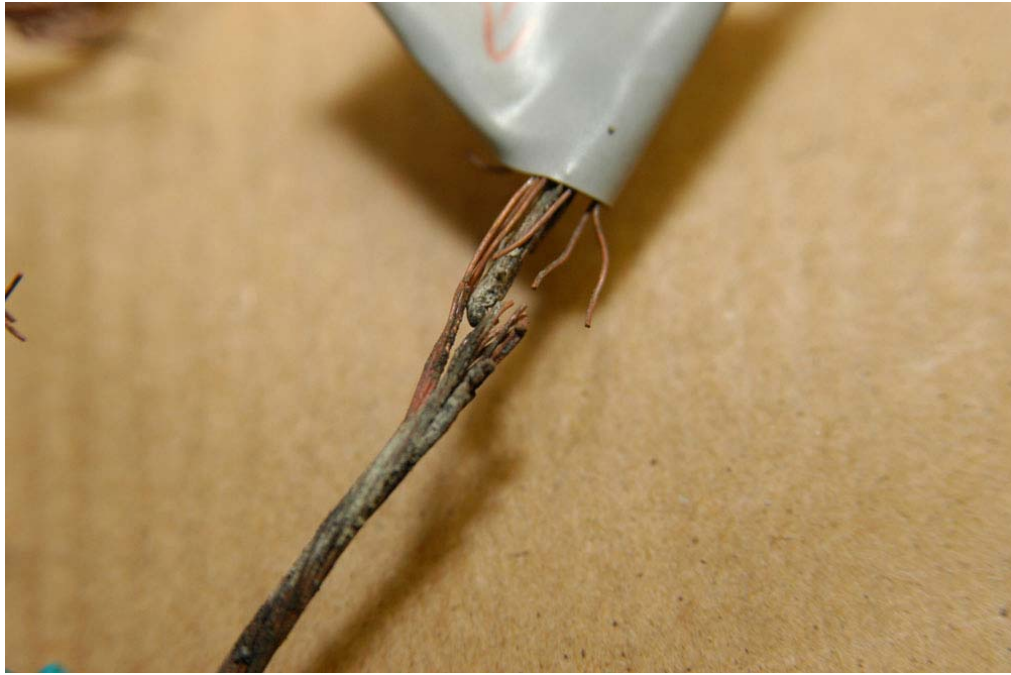
Figure 104 – Gross melting to electrical conductors caused by exposure to high overall temperatures [155]

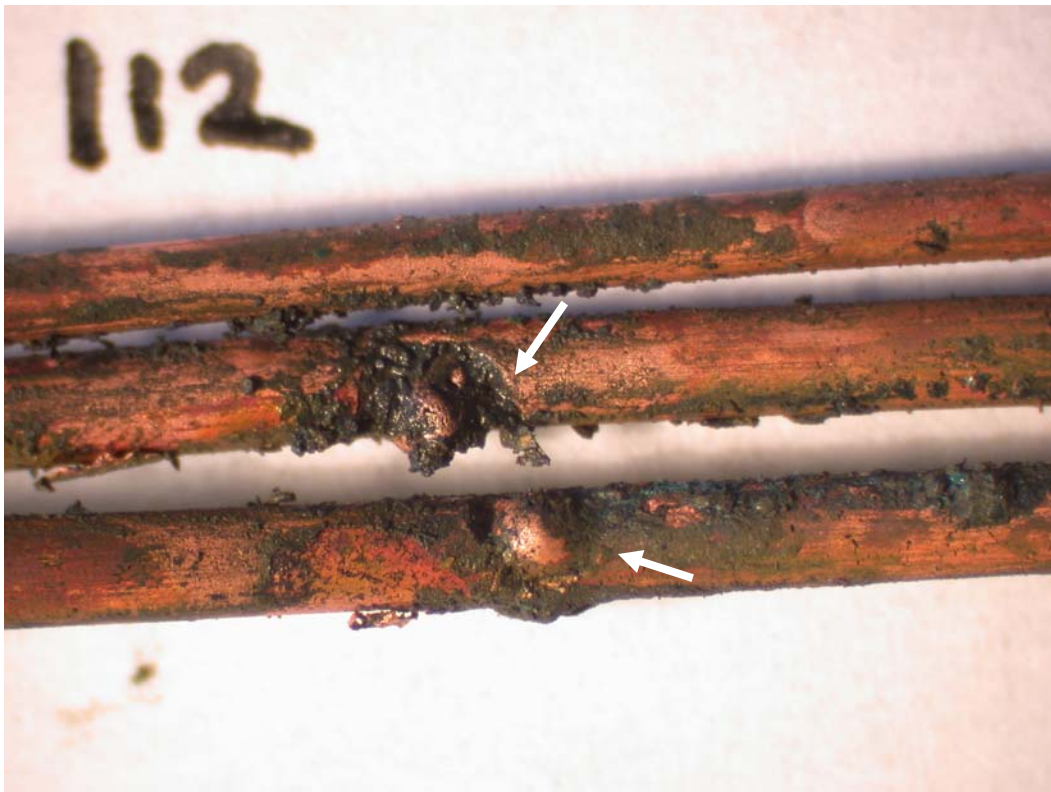
Figure 105 – microscope image of exhibit 112 that details the demarcation area between the highly localised arcing damage and the undamaged conductor
