**University of Strathclyde**  
**Department of Pure and Applied**  
**Chemistry**  
**Centre for Forensic Science**

**Developing a reliable systematic**  
**analysis for arc fault mapping**

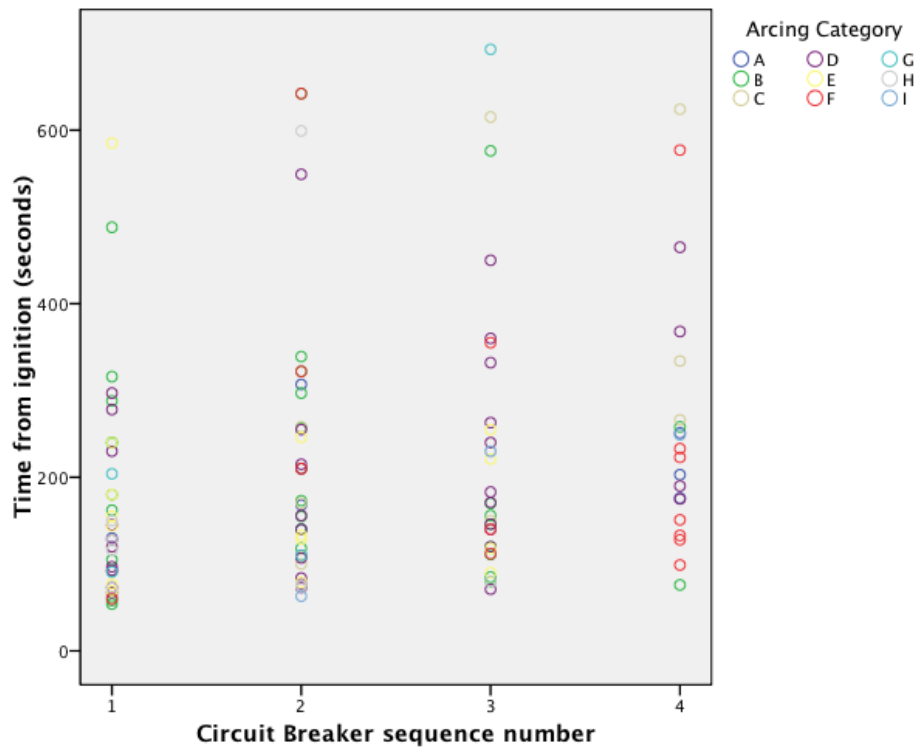
Figure 107 - Linear scatter plot chart detailing the correlation between the time from ignition and “circuit breaker sequence.”

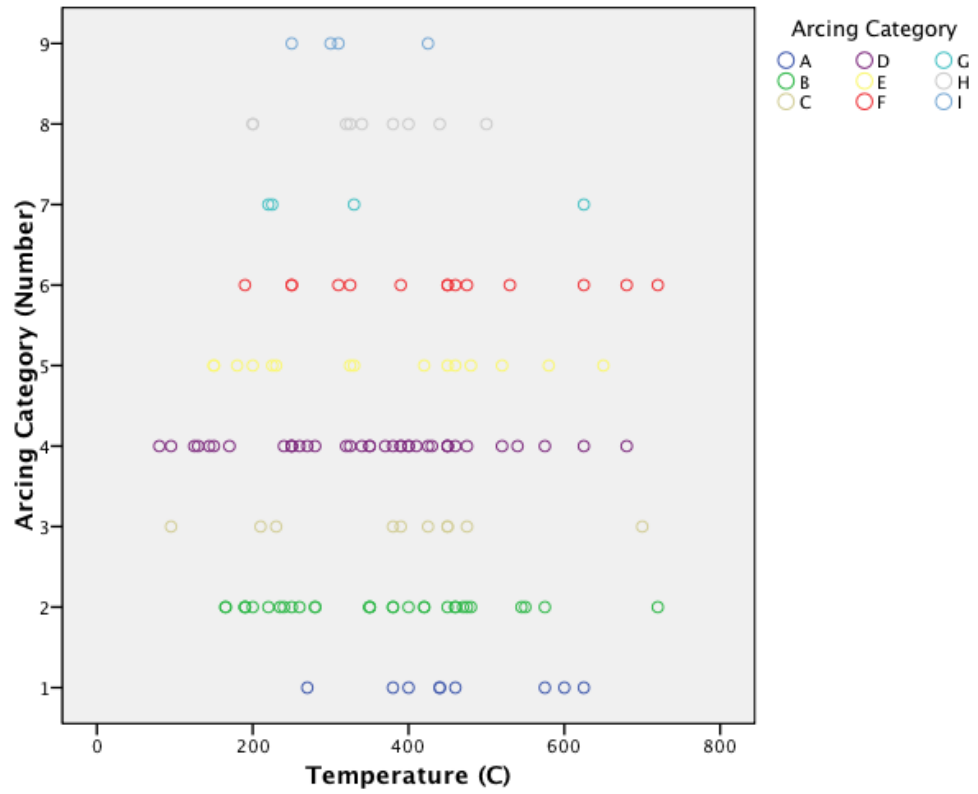
Figure 108 – Comparison of the temperature and arcing categories

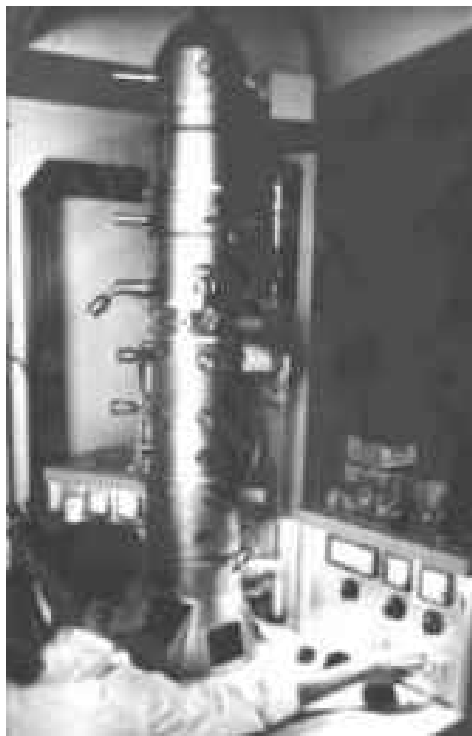
Figure 113 – the original electron microscope [164].

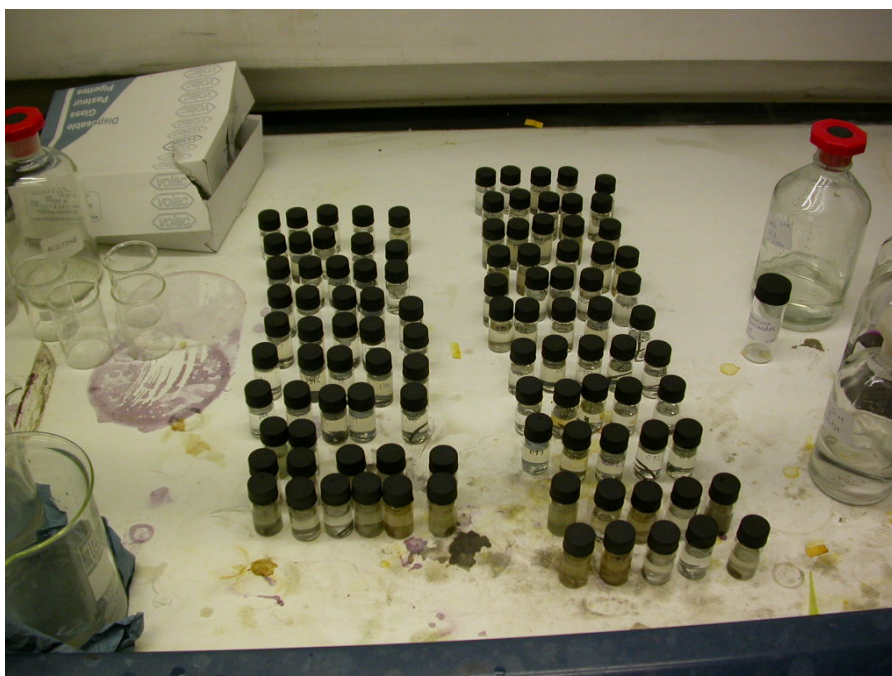
Figure 114 – Glass vials with individual exhibits and acetone in the fume cupboard at in University of Strathclyde laboratory [167].

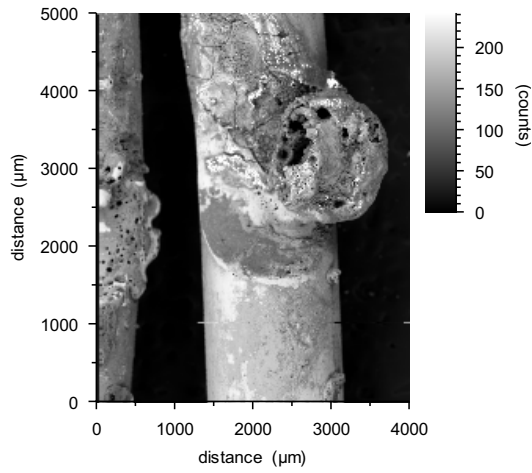
Figure 119 - Exhibit 133 Back Scatter Electron scan

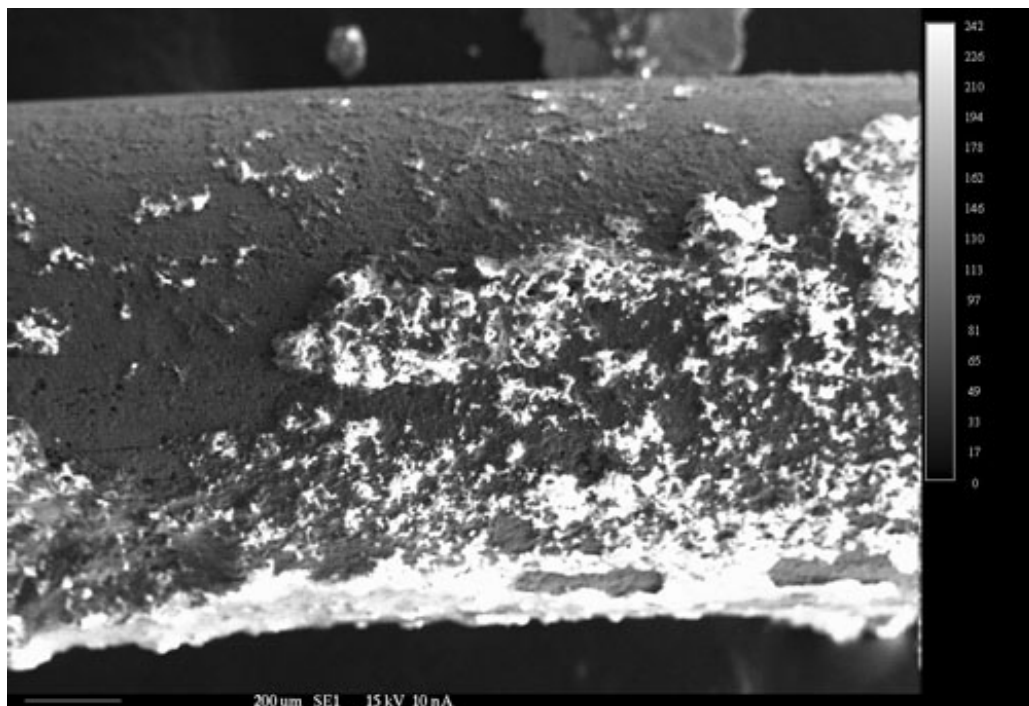
Figure 129 – Cameca SX100 SEM image of exhibit 145

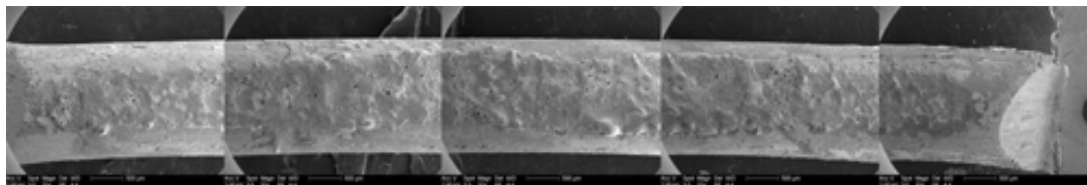
Figure 131 – Five SEM images stitched together (category A arcing damage)

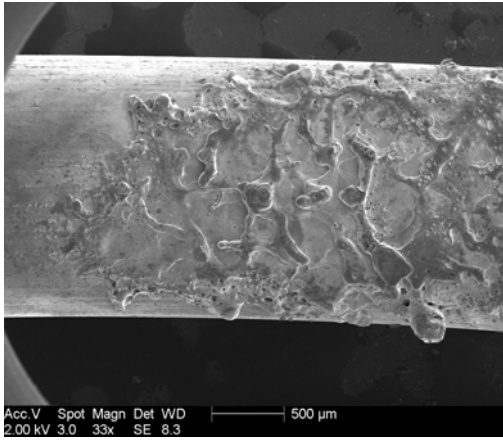
Figure 132 – left side of pre-fire exhibit (pre-fire 9 neutral)

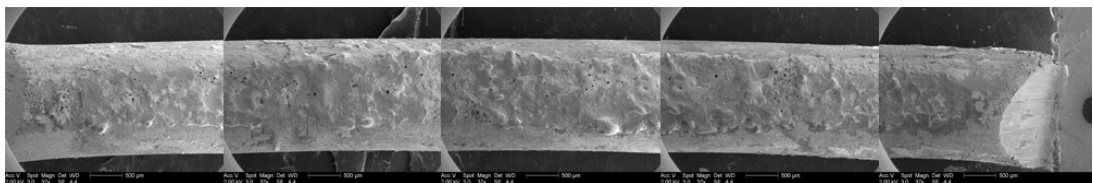
Figure 140 – Five SEM images stitched together to detail the extent of the arcing through char damage, exhibit 055 – arcing category A

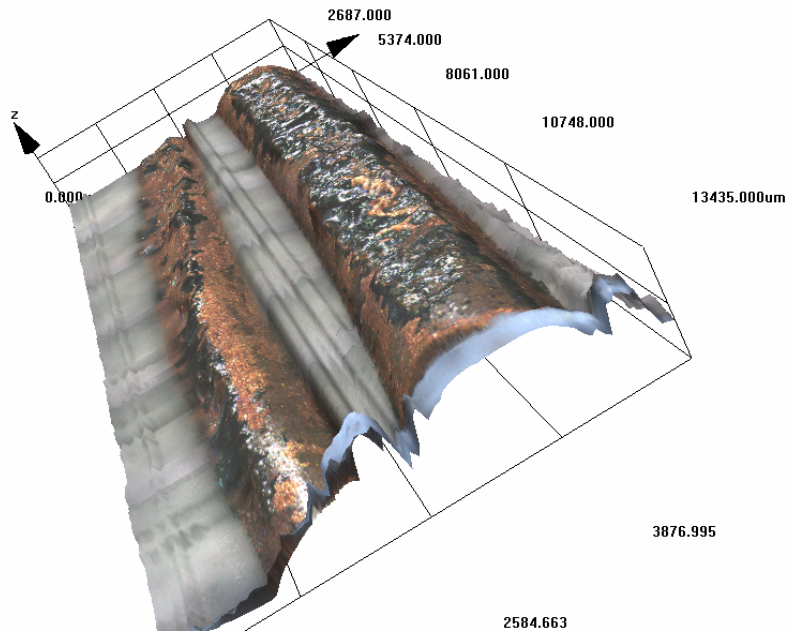
Figure 141 - A capture from the confocal laser scanning microscope of exhibit 055 – arcing category A.

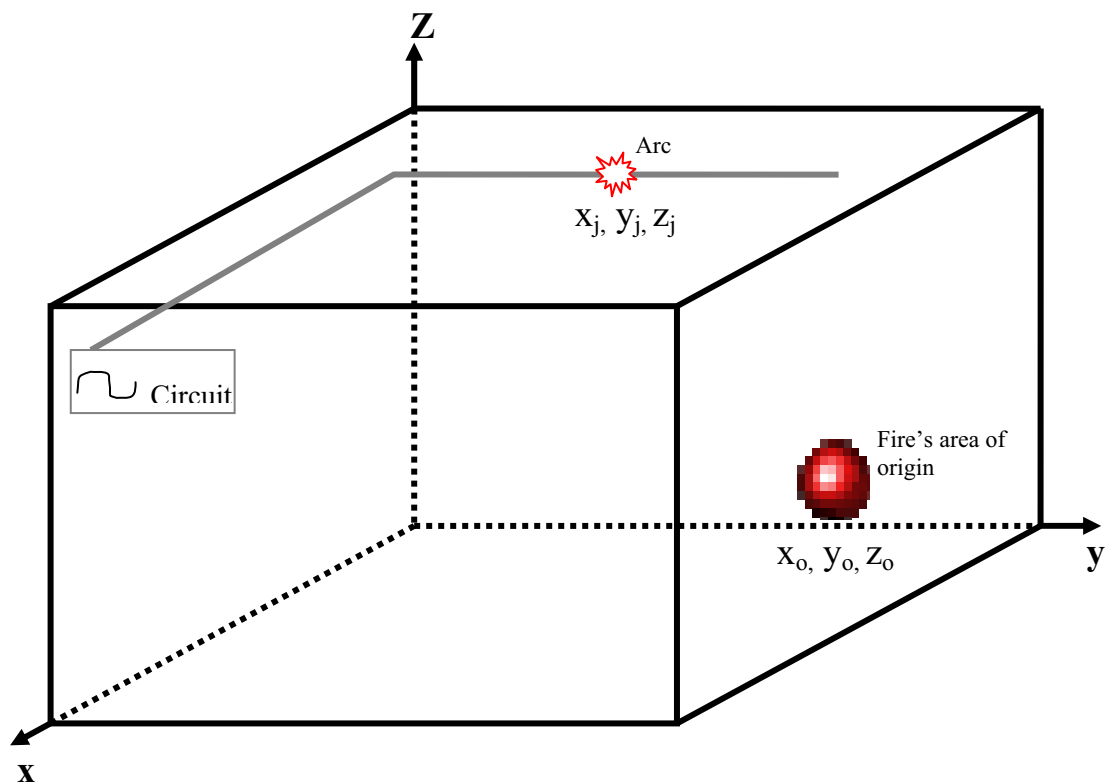
Figure 142 – Three-dimensional diagram showing the relationship between the fire's area of origin and the arcing damage on one circuit.

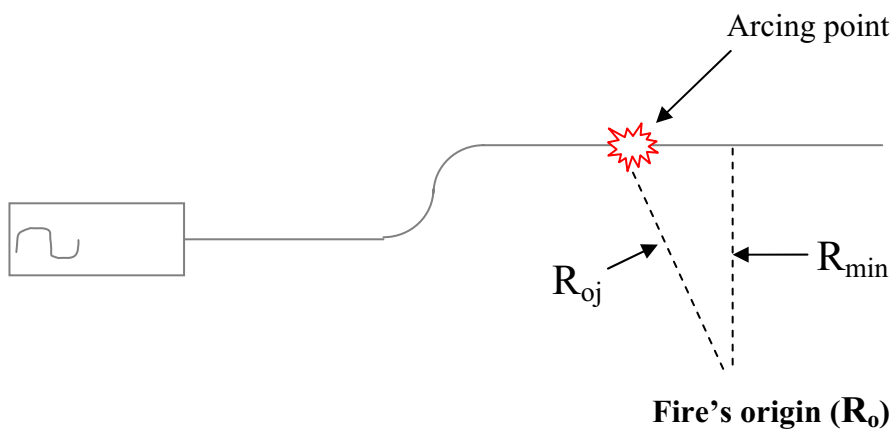
Figure 143 – A cross sectional view showing the two different distances from the fire's area of origin to the circuit's arcing point and the minimum possible distance.

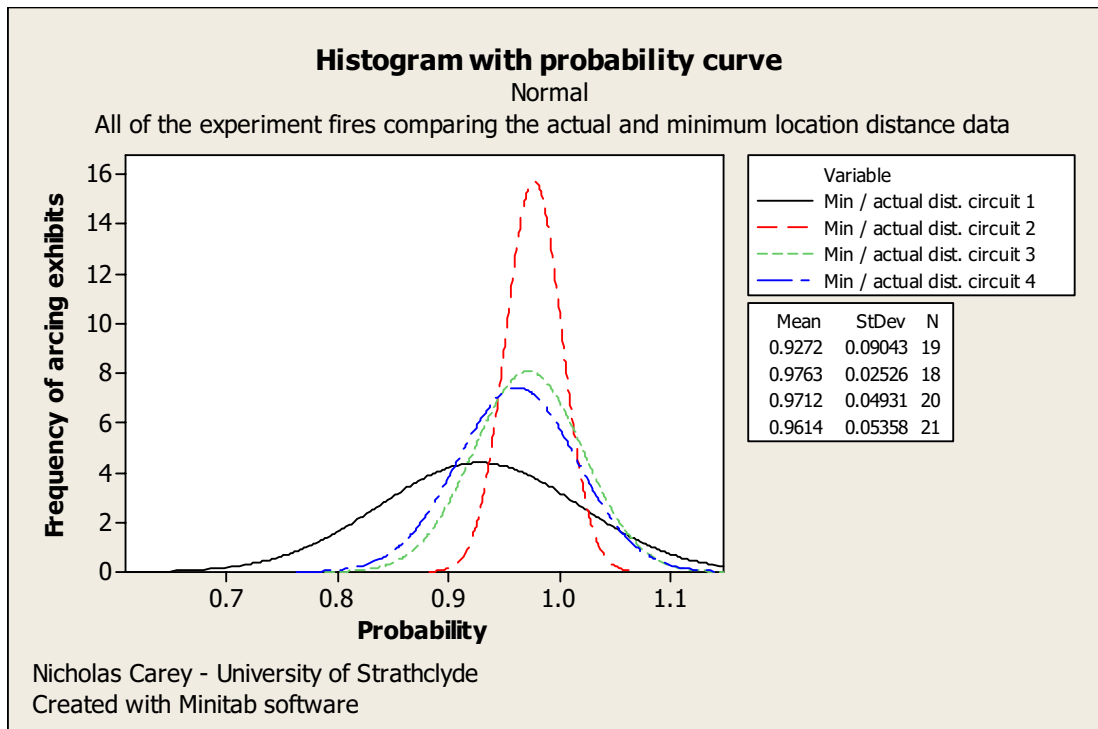
Figure 144 – Histogram detailing the probability of the arcing damage compared to the closest point on a circuit.

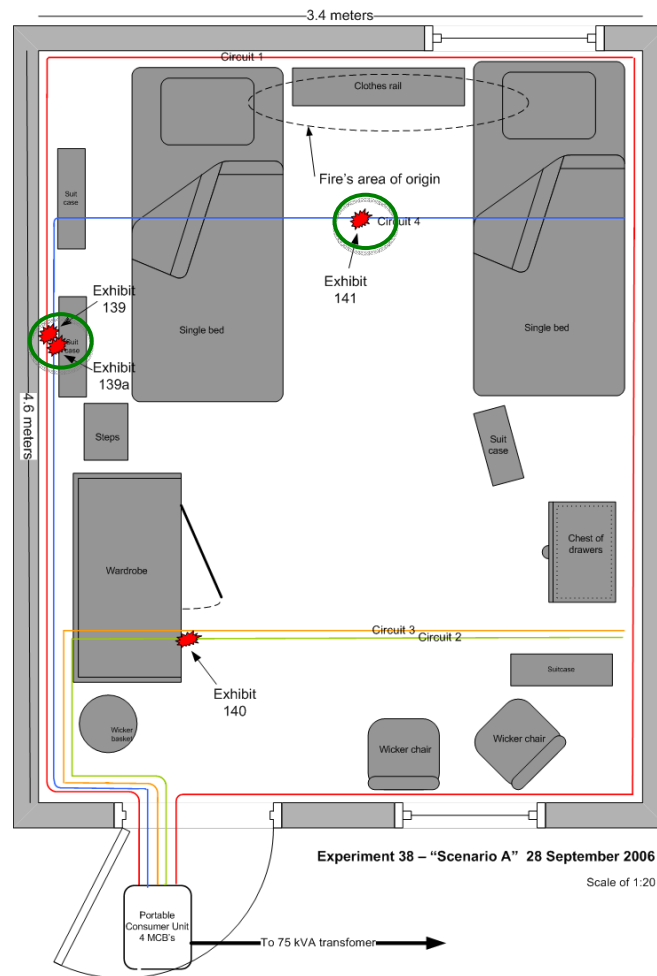
Figure 145 – Diagram of experiment 38 detailing two separate areas of localised metallic (arcing) damage on circuit 4.

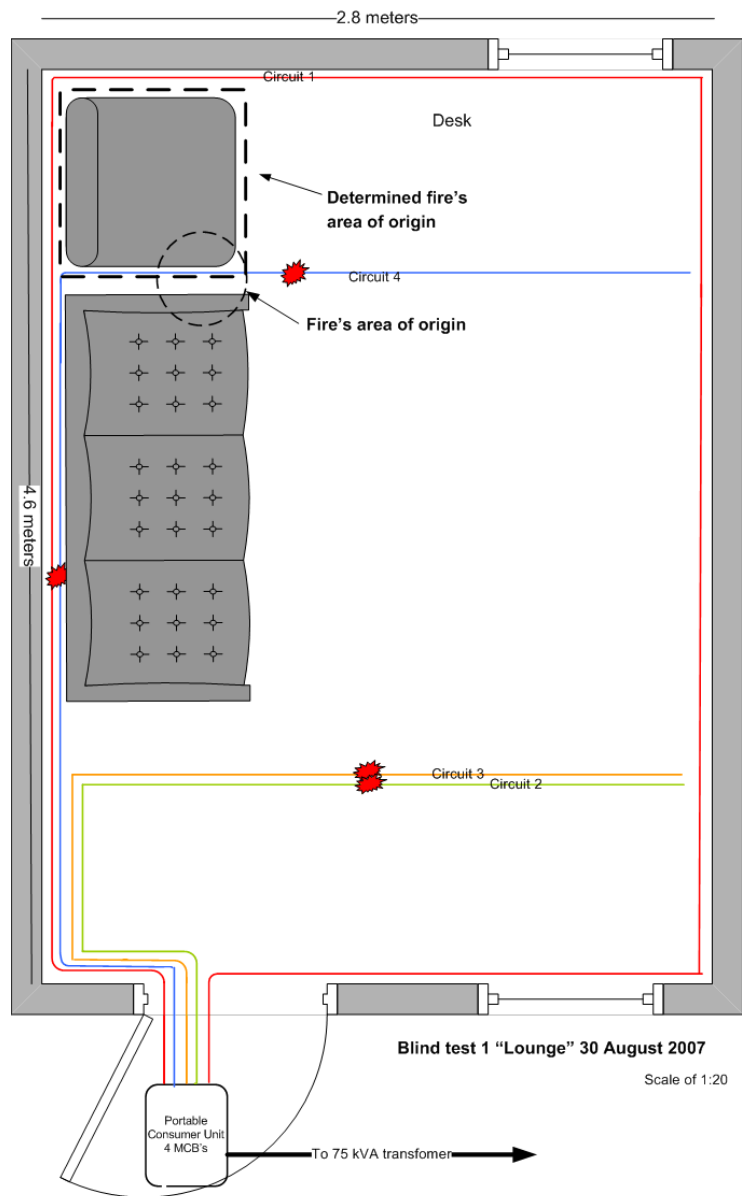
Figure 146 – Room plan for blind test 1 (furniture mainly omitted for clarity)

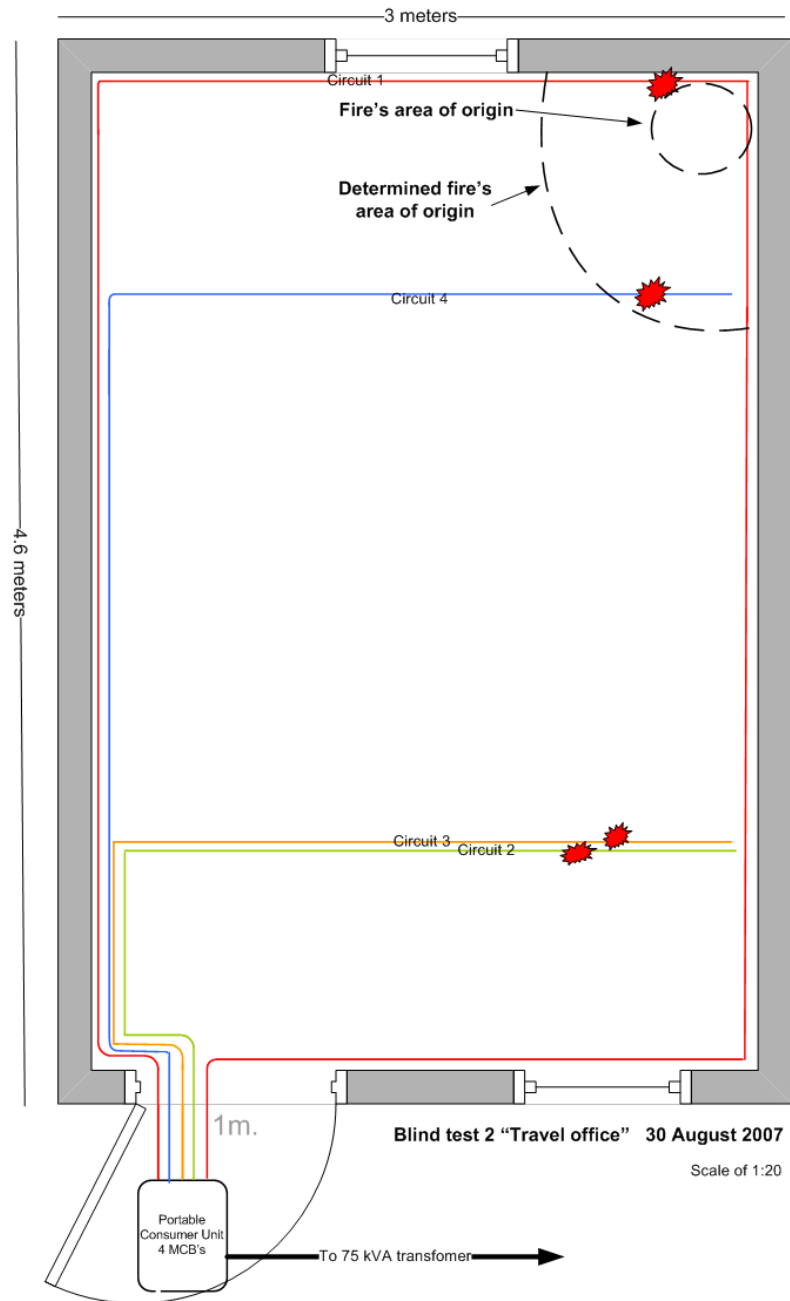
Figure 147 – Room plan for blind test 2 (furniture mainly omitted for clarity)

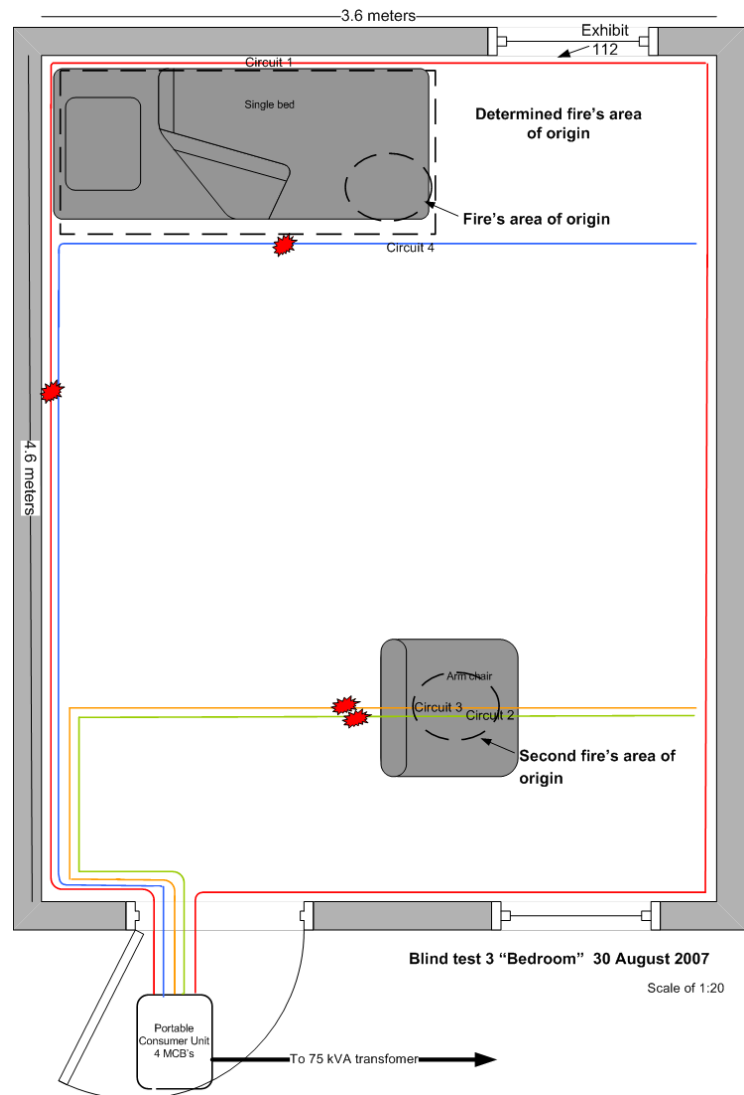
Figure 148 – Room plan for blind test 3 (furniture mainly omitted for clarity)

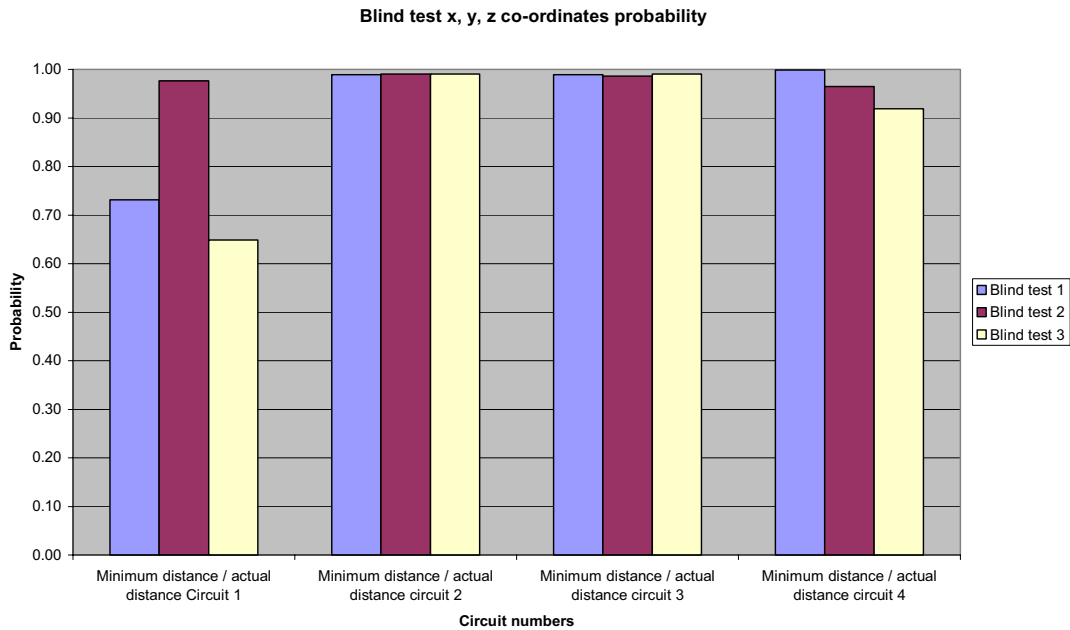
Figure 149 – Chart detailing the co-ordinates data analysis (series 1 represents blind test 1 etc.). The closer the value is to 1 the closer proximity of the arc to the part of the conductor which was closest to the fire’s area of origin.

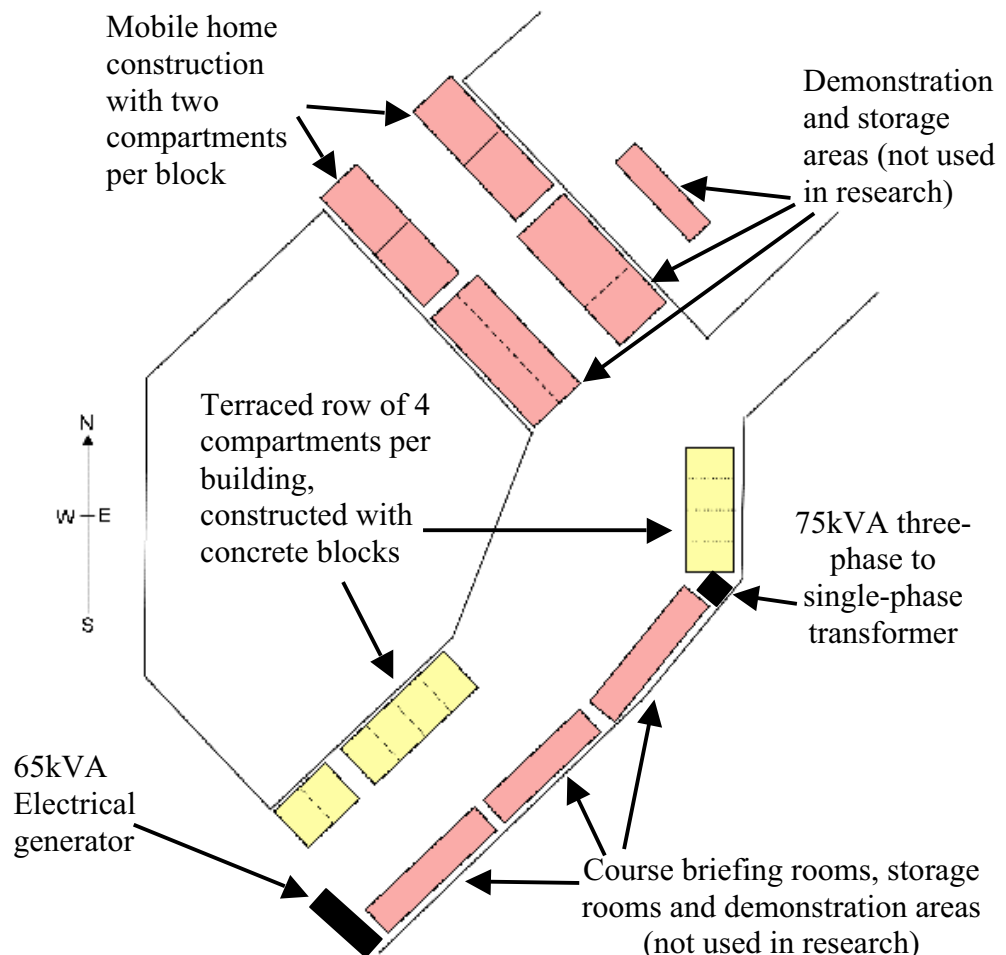
Figure 1 – Overview of the facility used for the experiments

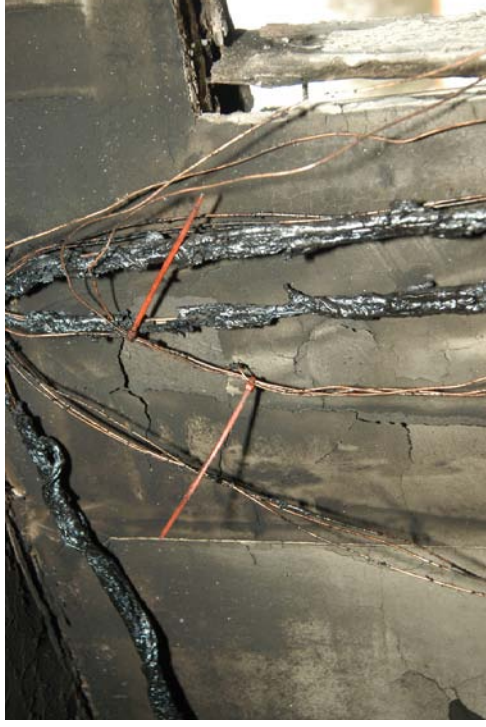
Figure 6 - Post-fire photograph indicating the arcing damage to circuit 3 above the doorway.

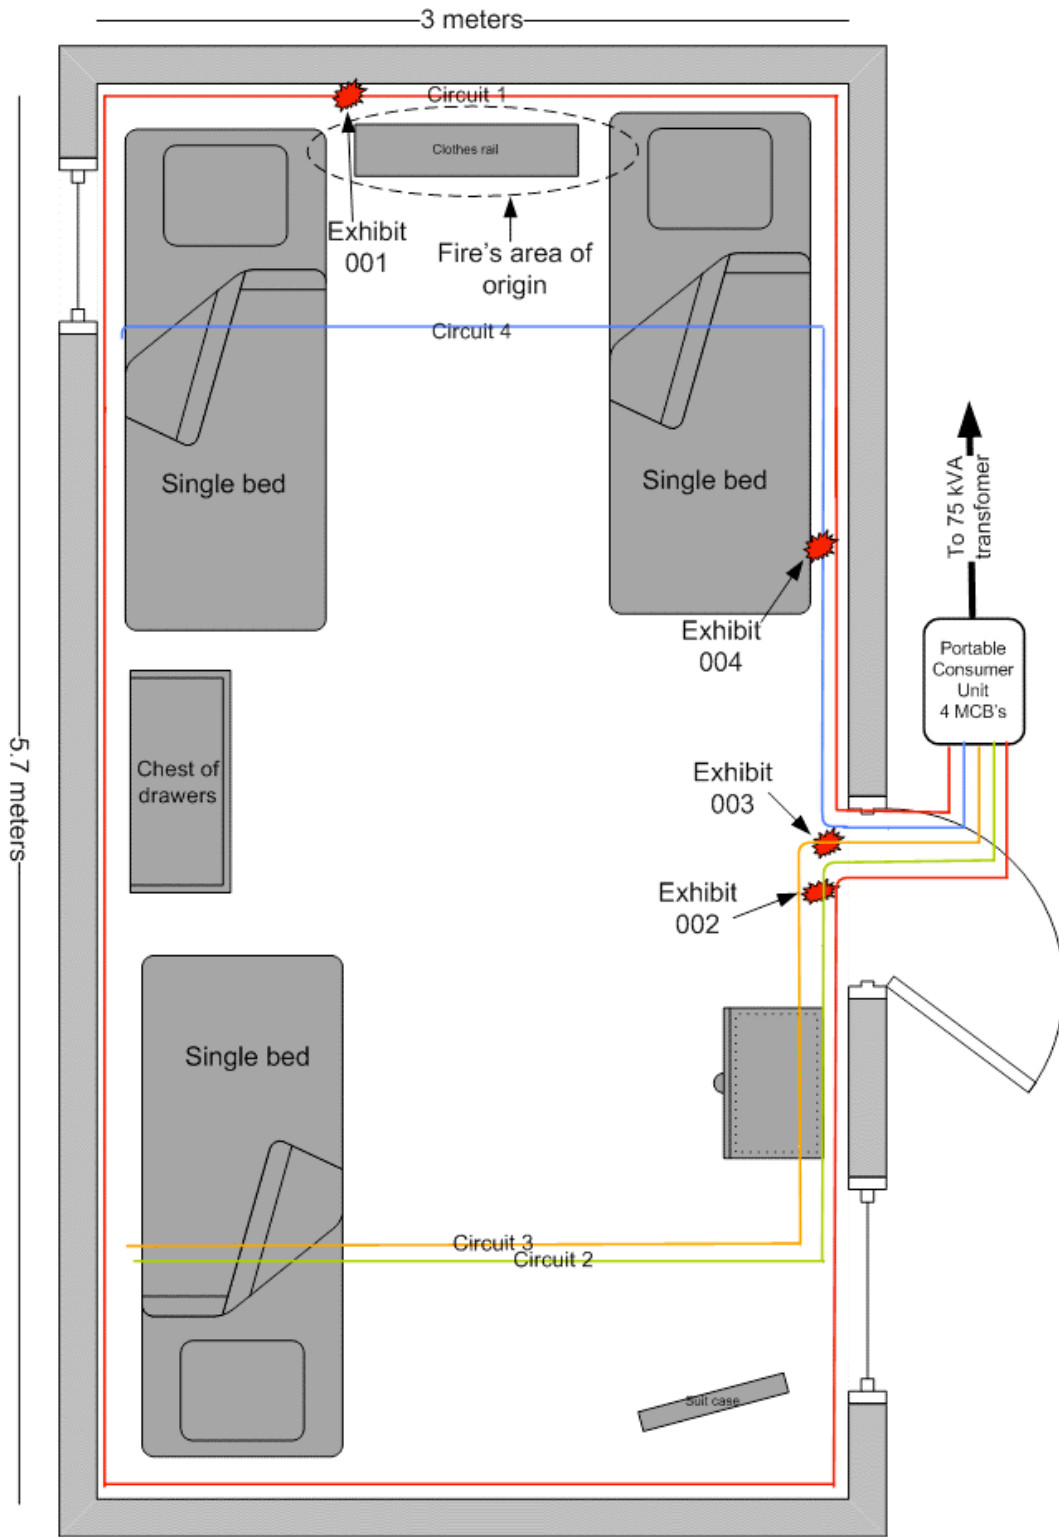
Figure 7 - Experiment 1 – “Scenario A” 10 March 2005

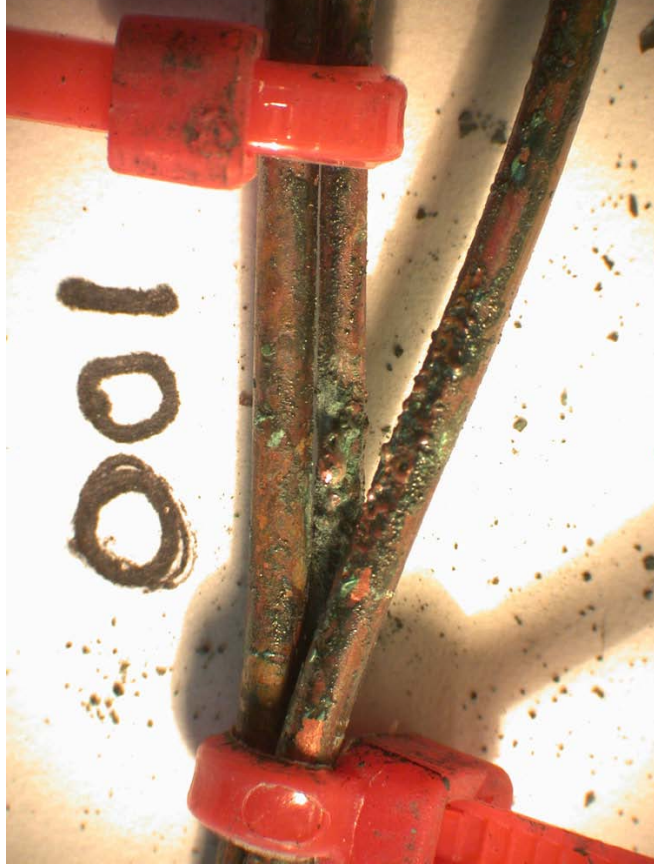
**Figure 8 - Microscope image of exhibit 001 with localised metallic damage affecting two of the three conductors**

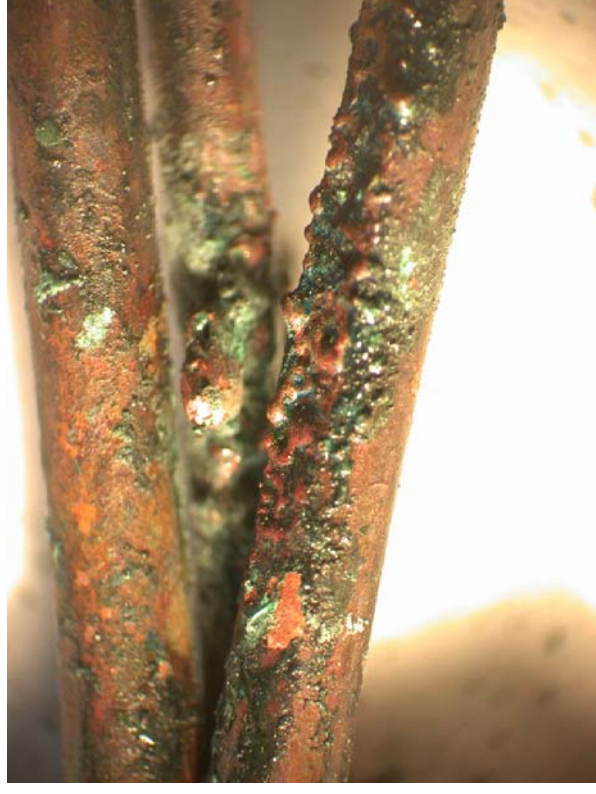
**Figure 9 - Microscope image of exhibit 001 at 20x magnification, detailing the wide area of lateral metallic damage.**

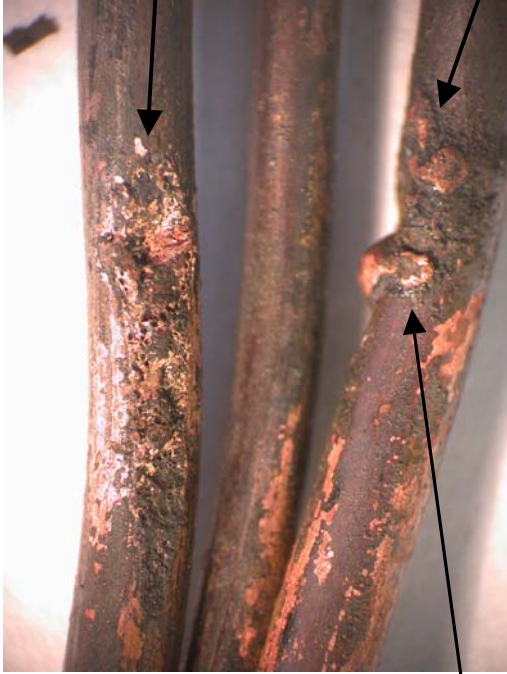
Figure 10 – Microscope image of exhibit 002.

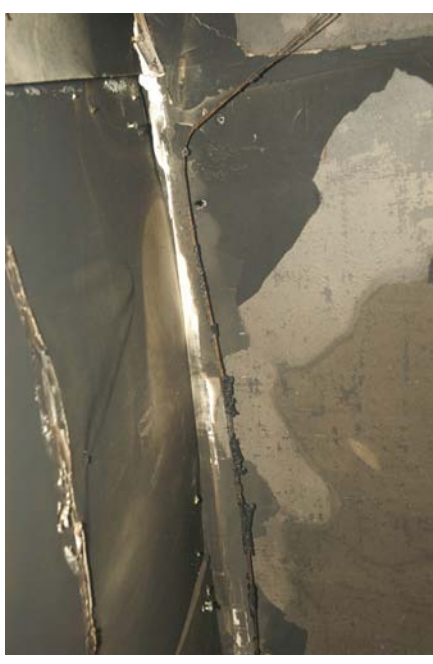
Figure 31 - Post-fire photograph detailing post fire damage to the cables.

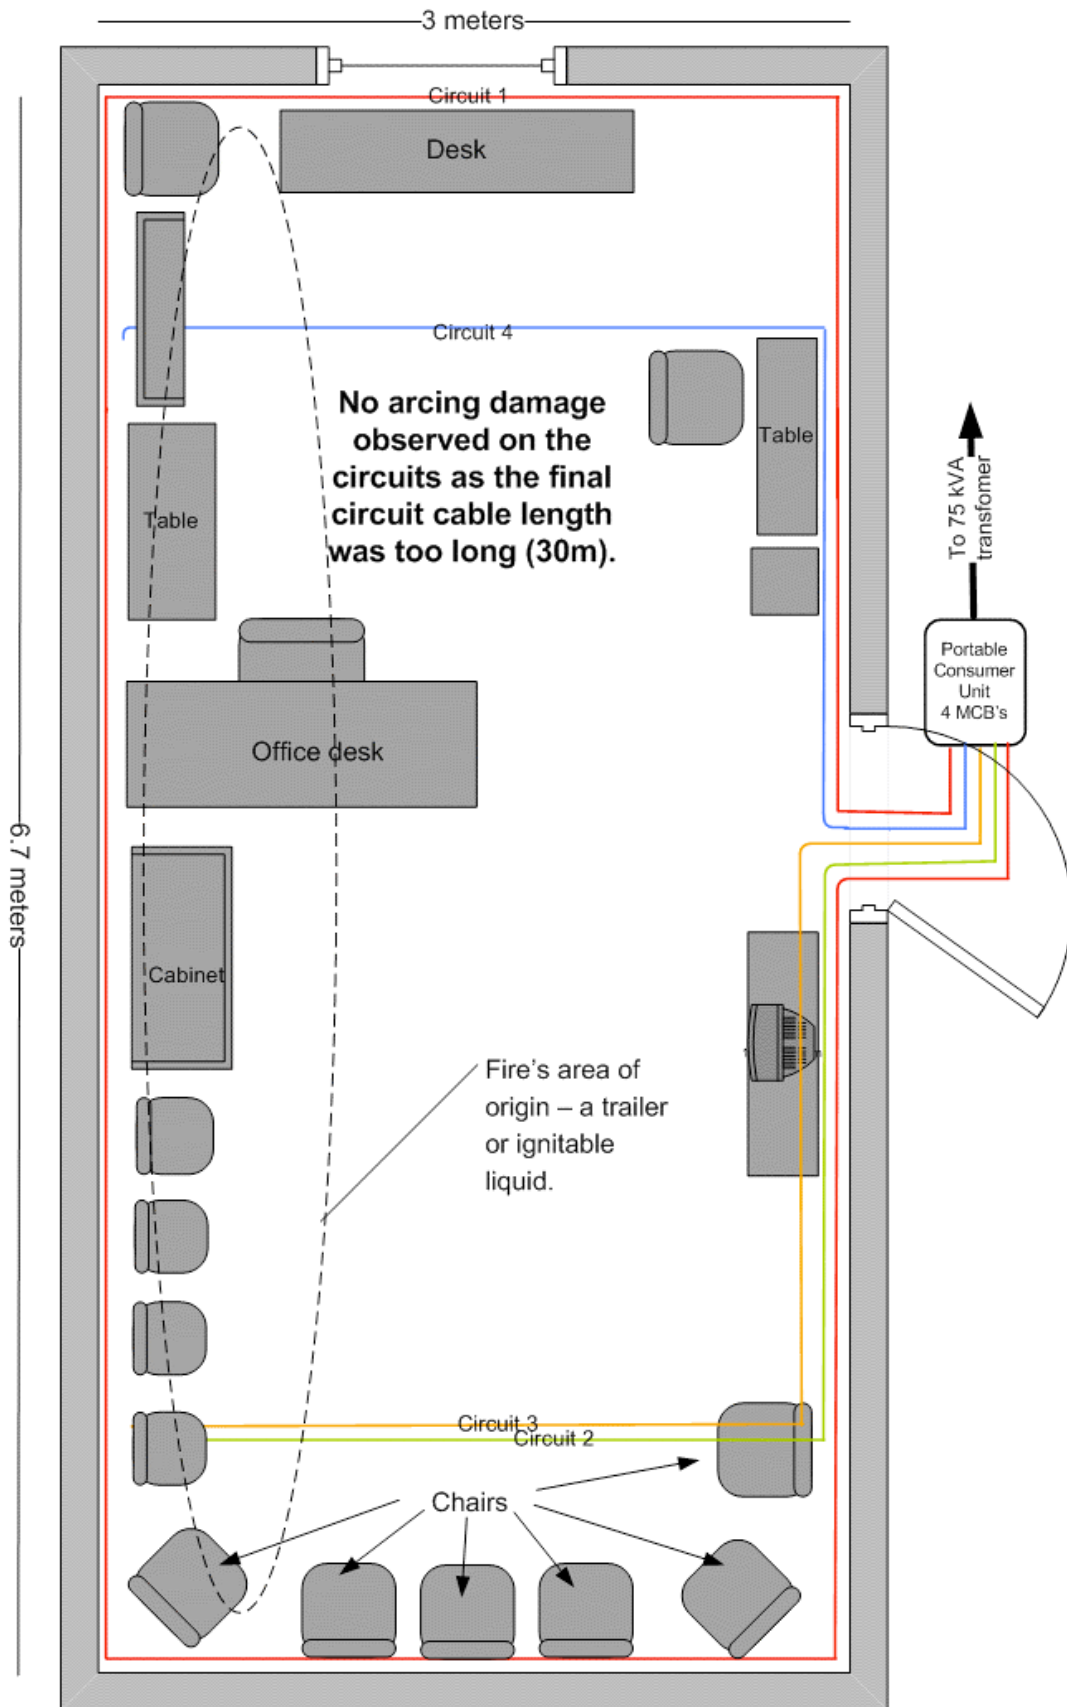
Figure 32 Experiment 2 – “Scenario B” 14 April 2005 Scale of 1:25

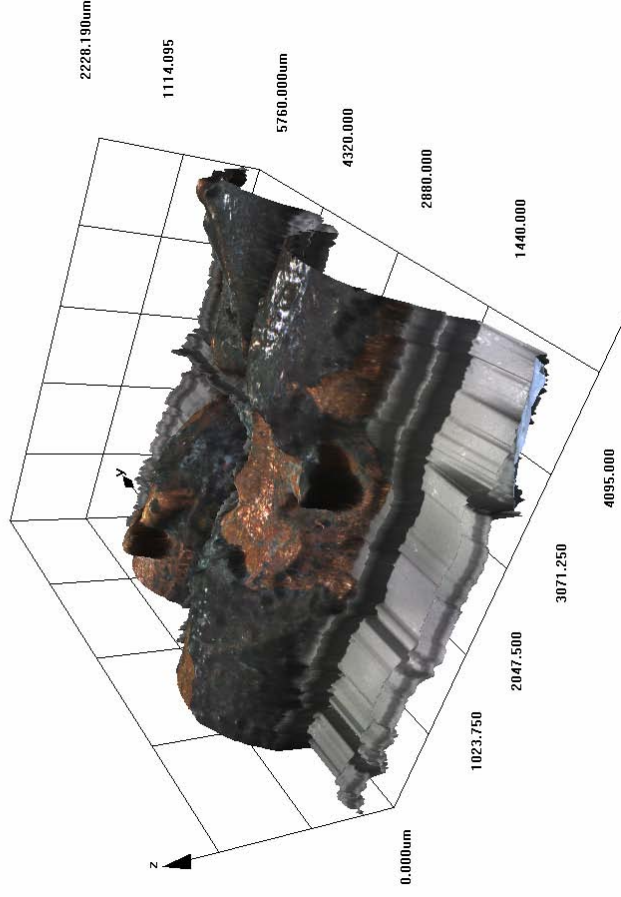
Figure 45 - LEXT overview image. The brown colour rendering was used initially with the Confocal laser scanning microscope during the initial scans to find the preferred settings. The brown render was found to be less effective than the “real colour” setting.

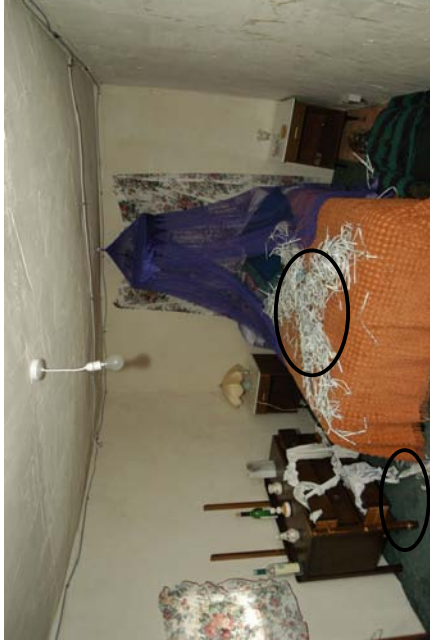
Figure 61 - Pre-fire photograph, view from the doorway. The black ovals indicate the fire's areas of origin.

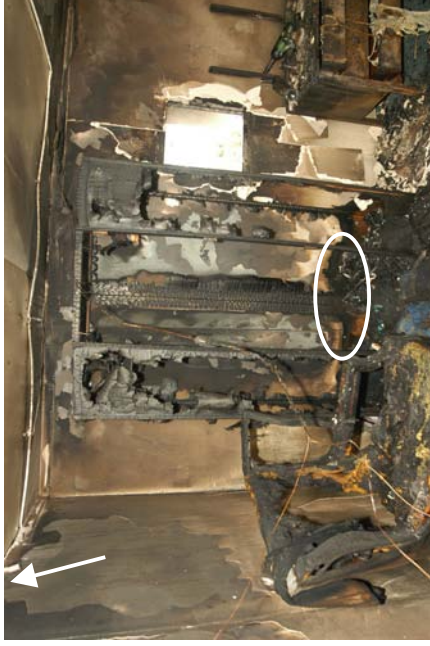
Figure 64 - Post-fire photograph detailing the damage to the wardrobe. The white arrow is the location of exhibit 005.

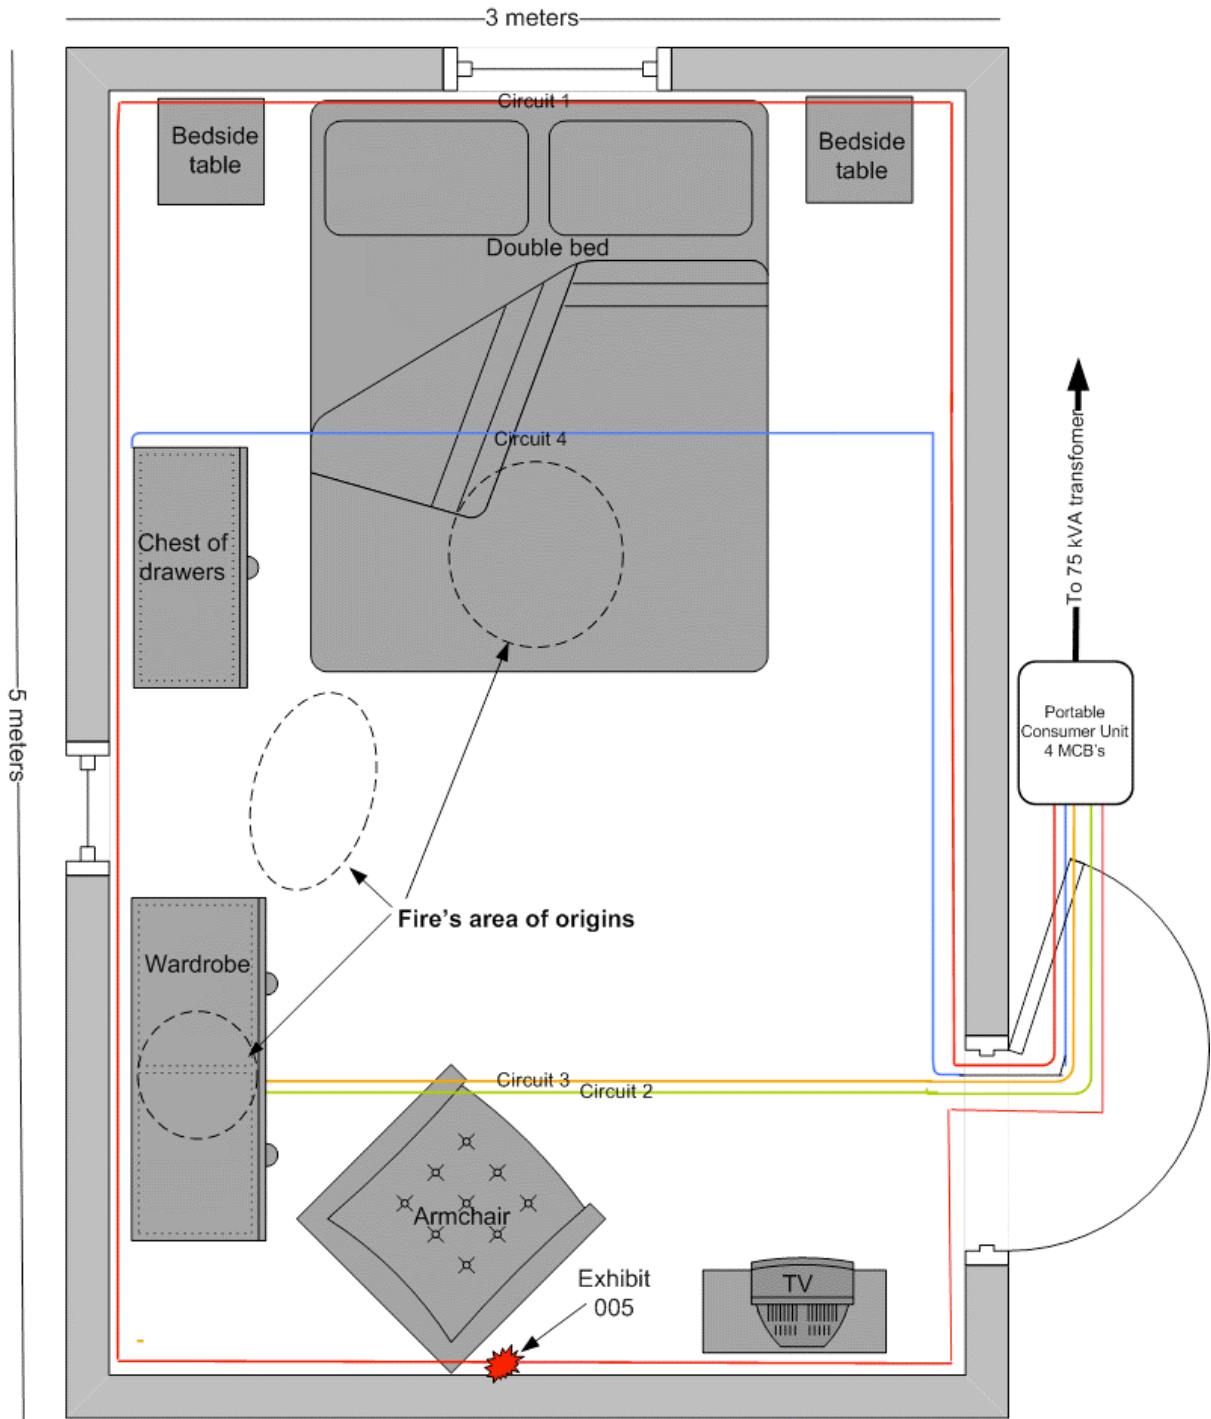
Figure 65 -  
Experiment 4 – “Scenario E” 10 March 2005

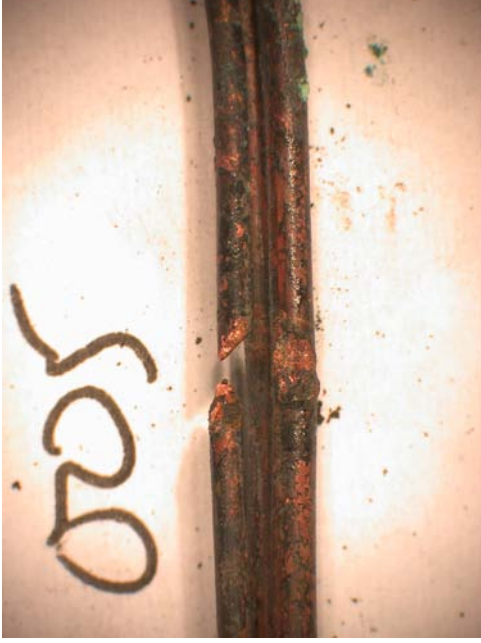
Figure 66 - Microscope image of exhibit 005. Two of the three conductors have localized metallic (arcing) damage.

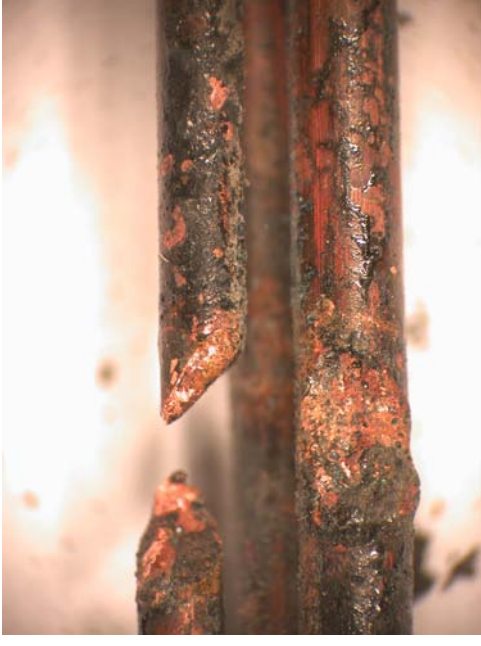
Figure 67 - Microscope image at 20x magnification detailing the bottom conductor notch in figure 66.

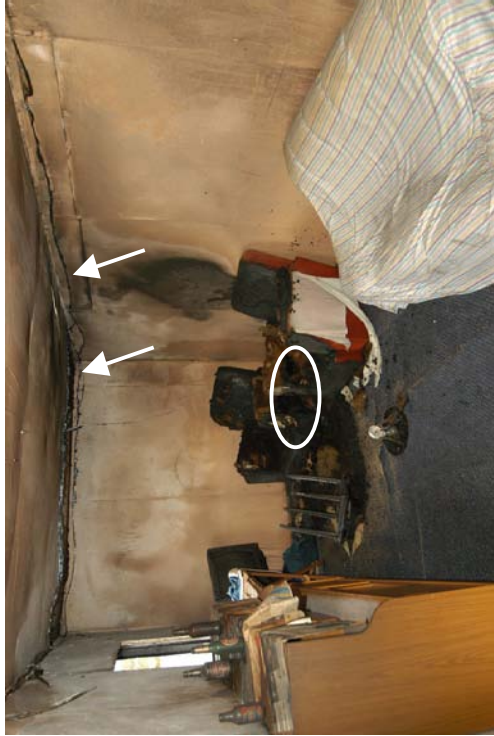
Figure 74 - Post-fire photograph of the view above showing the area of origin. The arrows indicate arcing damage locations.

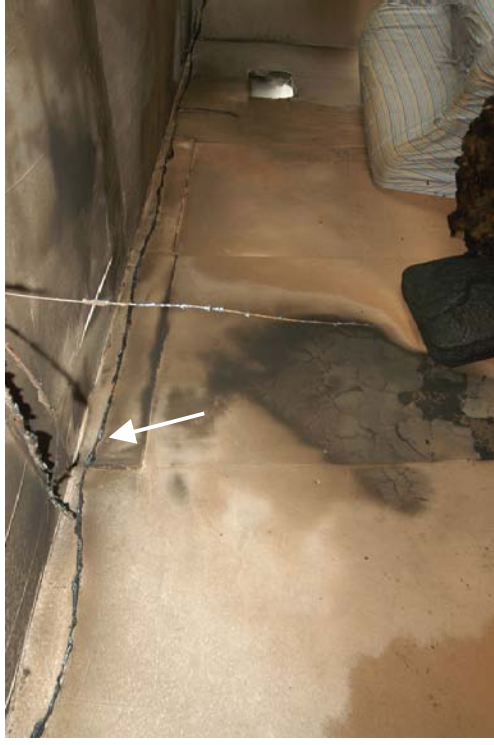
Figure 75 - Post-fire photograph detailing the location of exhibit 009 indicated by the white arrow.

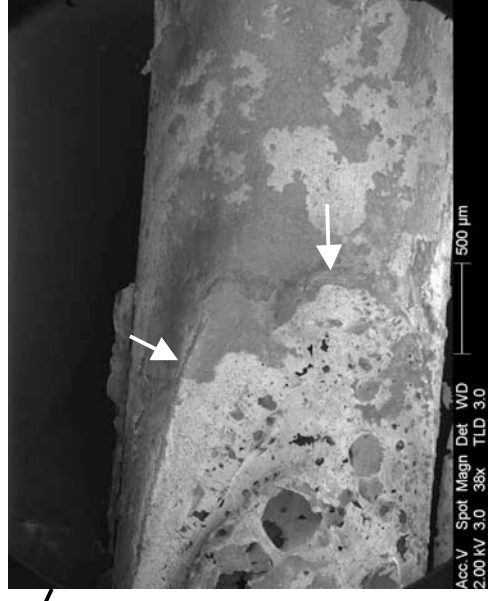
Figure 80 - SEM image of the right edge of the bottom conductor notch. Note the demarcation of the arcing damage when compared to the undamaged conductor area.

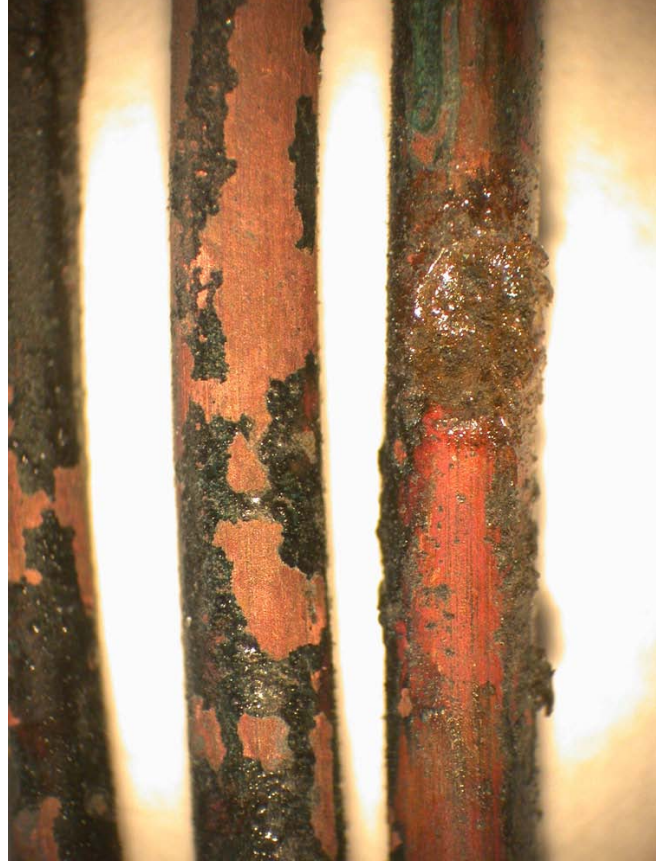
Figure 81 - Microscope image of exhibit 010. There is a notch affecting one of the three conductors.
