**University of Strathclyde**  
**Department of Pure and Applied**  
**Chemistry**  
**Centre for Forensic Science**

**Developing a reliable systematic**  
**analysis for arc fault mapping**

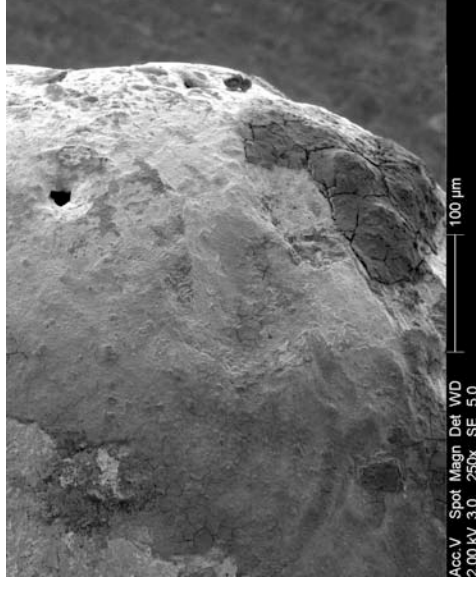
Figure 93 - SEM image at 250x magnification of the bead surface. Note the holes in the melted copper surface resulting from arcing damage.

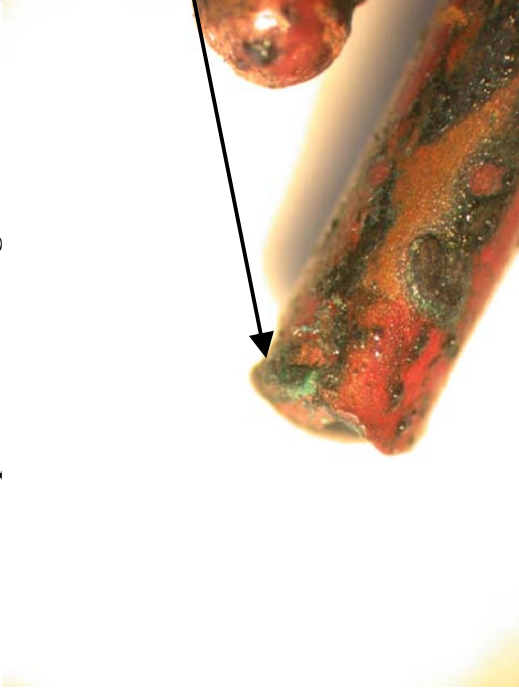
Figure 94 - Microscope image of the middle severed conductor.

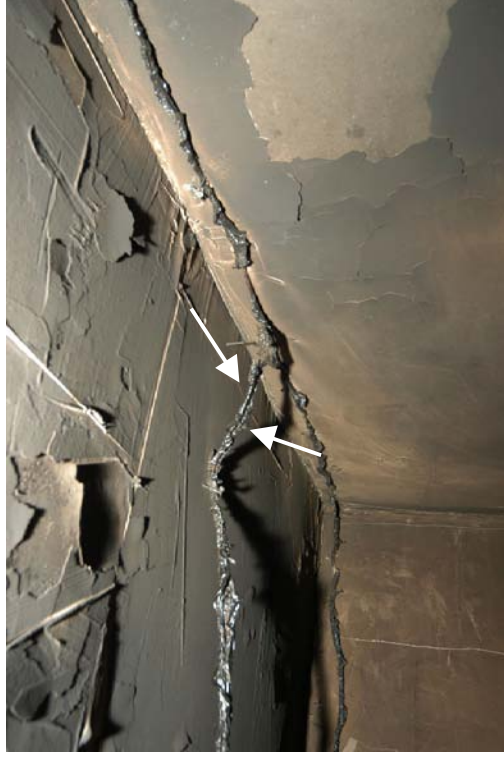
Figure 111 - Post-fire photograph detailing with arrows the arcing damage locations of circuits 2 and 3.

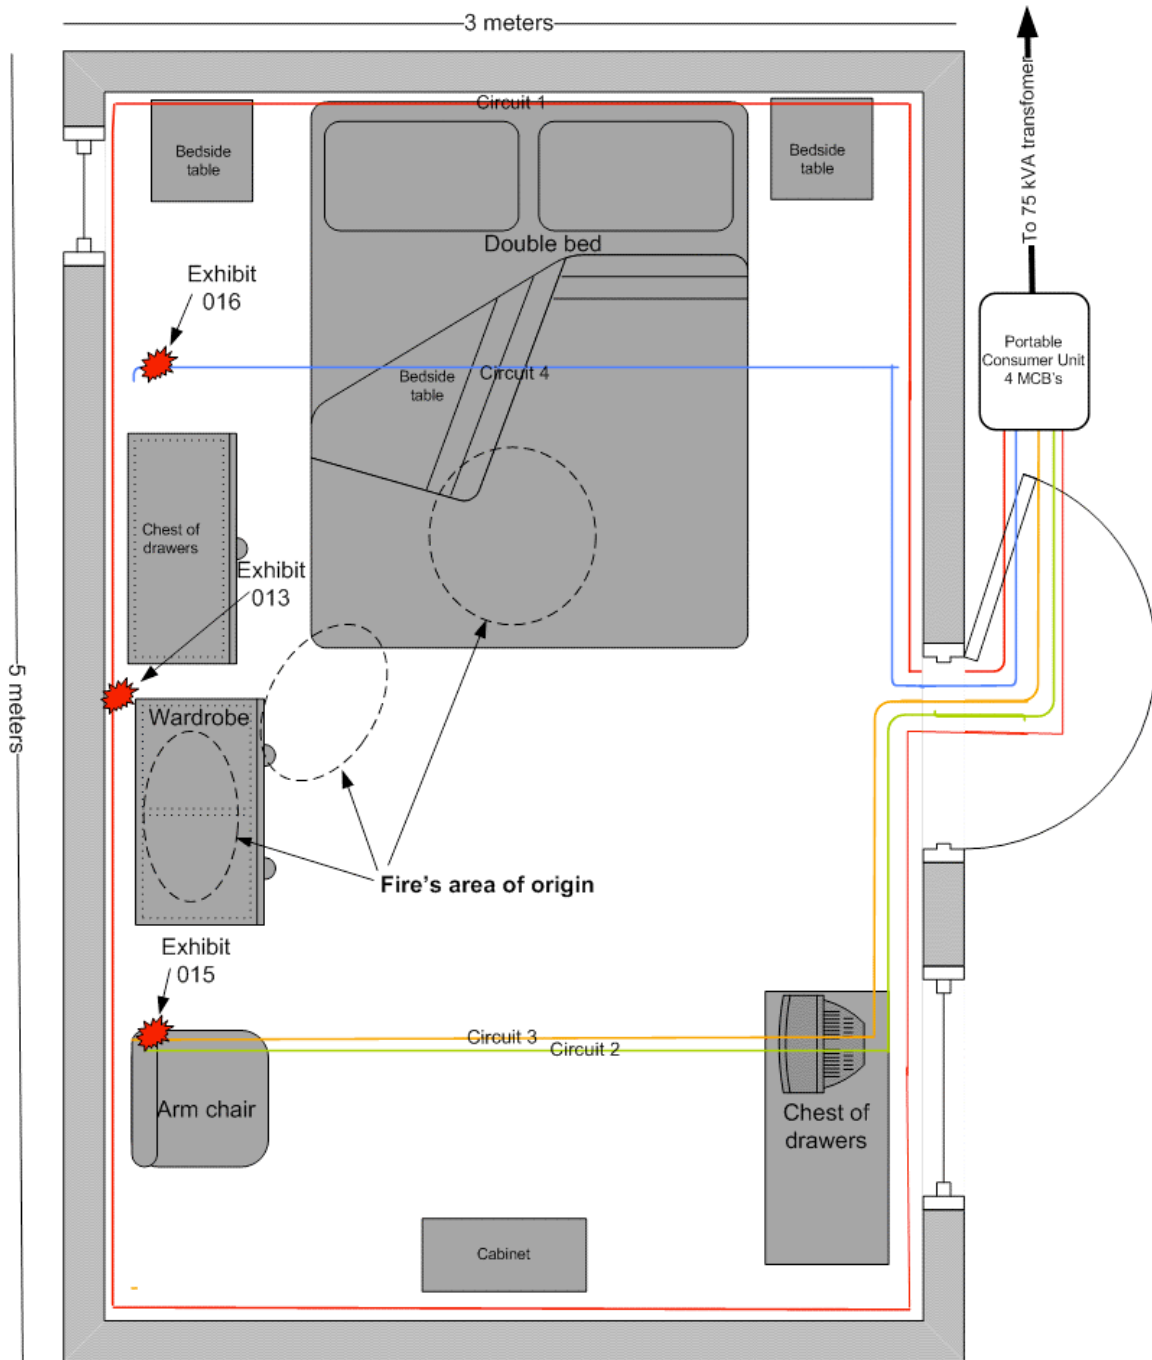
Figure 112 -  
Experiment 6 – “Scenario E” 14 April 2005

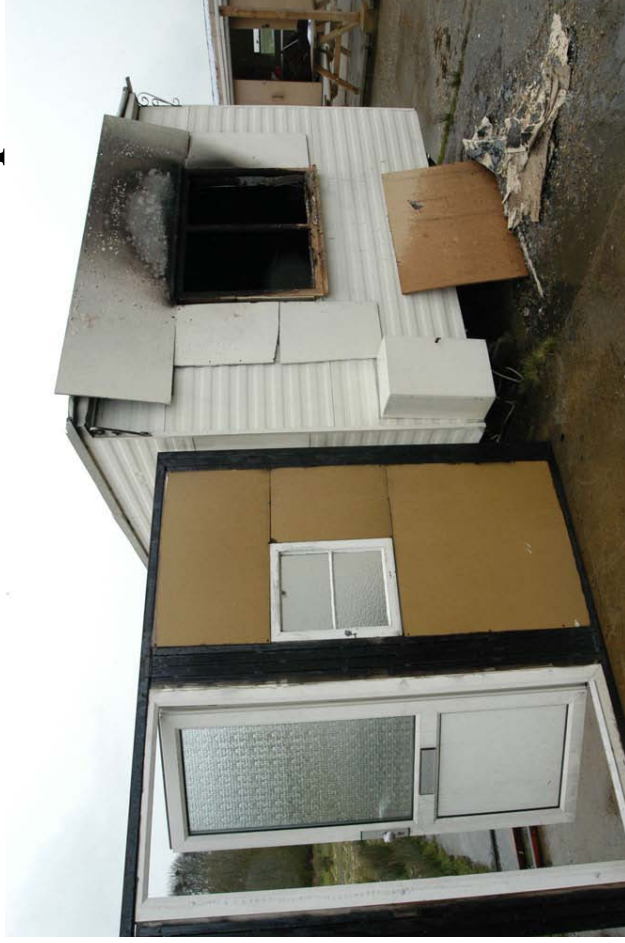
Figure 133 – “Scenario C” 14 April 2005

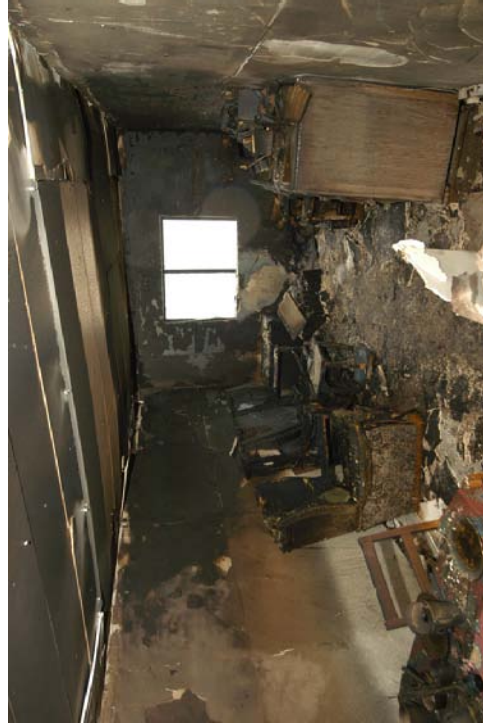
Figure 136 - Post fire photograph of experiment 7, burn patterns show protected areas at low level.

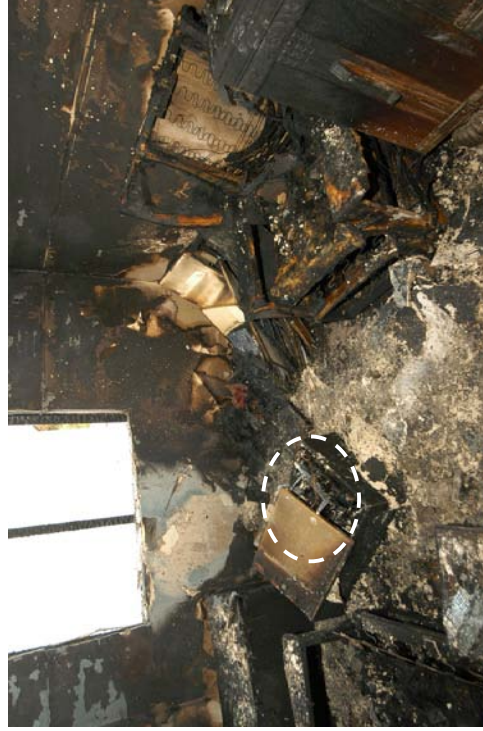
Figure 137 - Post-fire photograph of the area of origin that is indicated with a white oval. Note the TV that fell into this area.

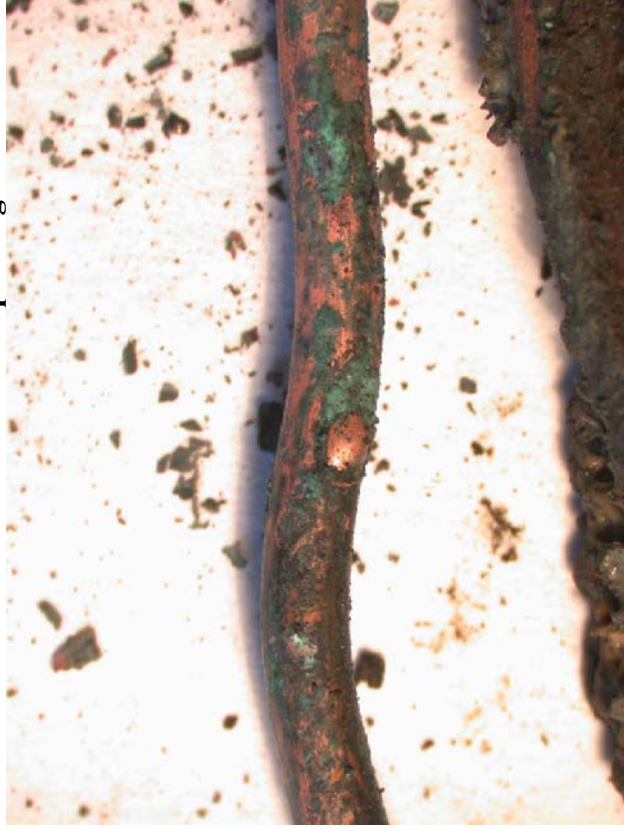
Figure 139 - Microscope image for exhibit 018 detailing the arcing damage to one conductor with a bead located within a notch.

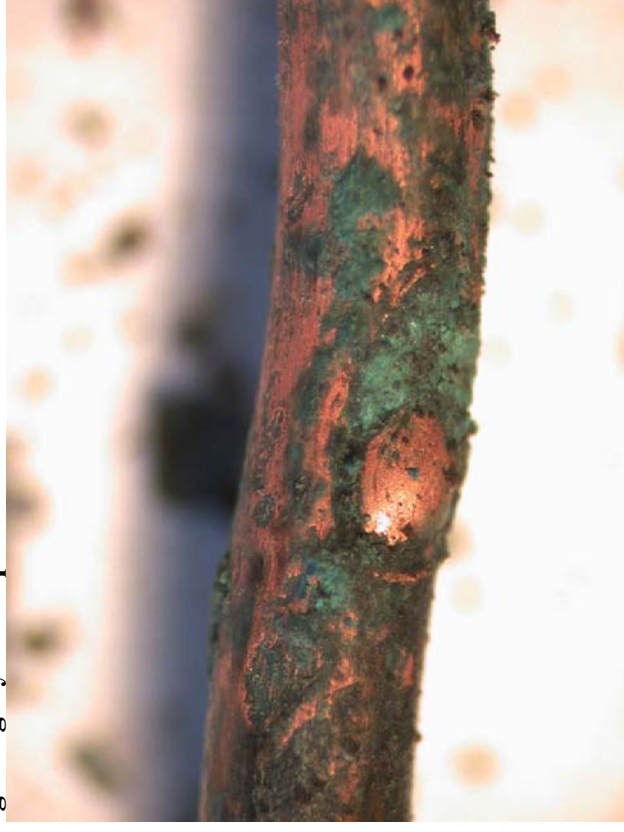
Figure 140 - Microscope image at 20x magnification.

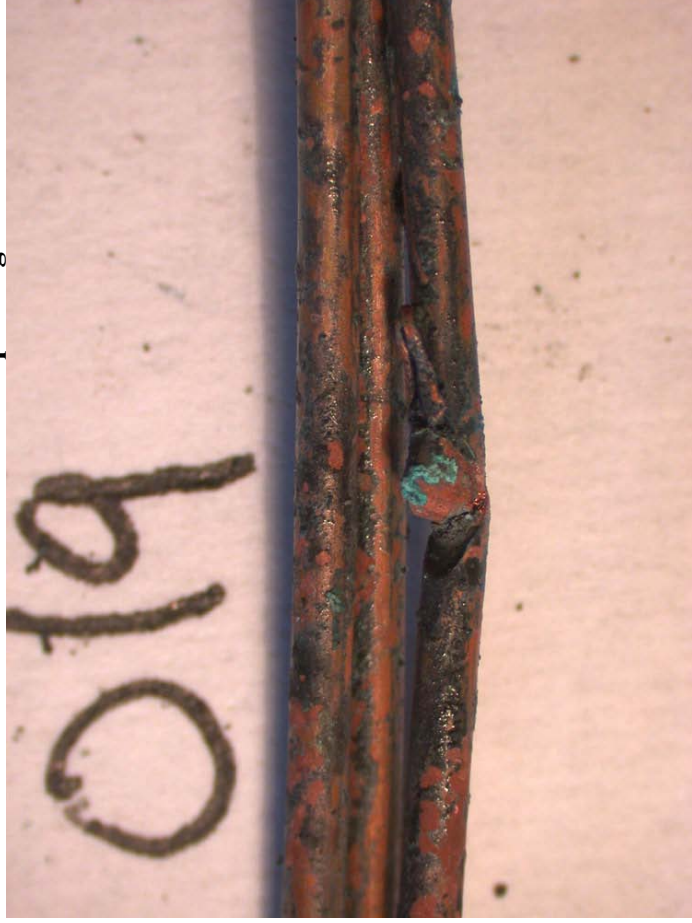
Figure 141 - Microscope image of exhibit 019 detailing the arcing damage to the bottom conductor.

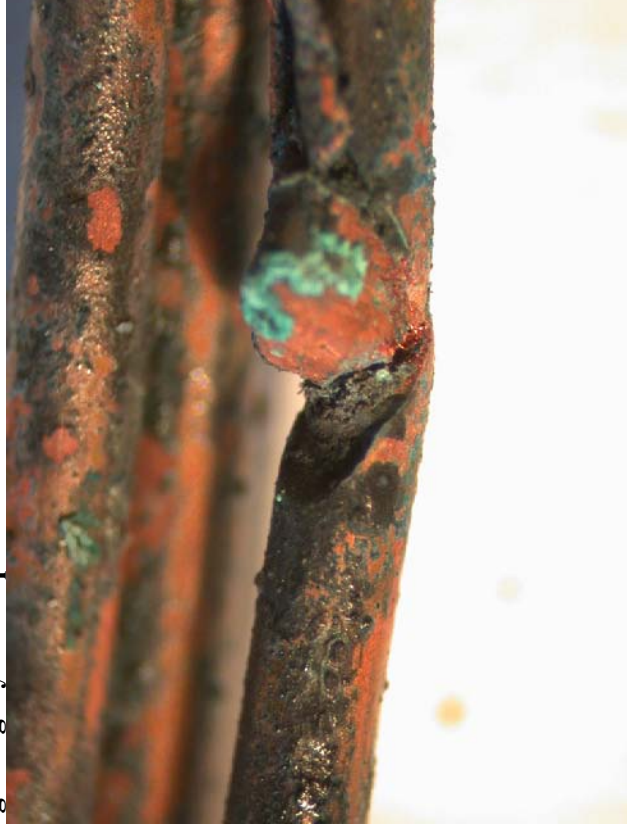
Figure 142 - Microscope image of at 20 magnification detailing the deep notch and bead within.

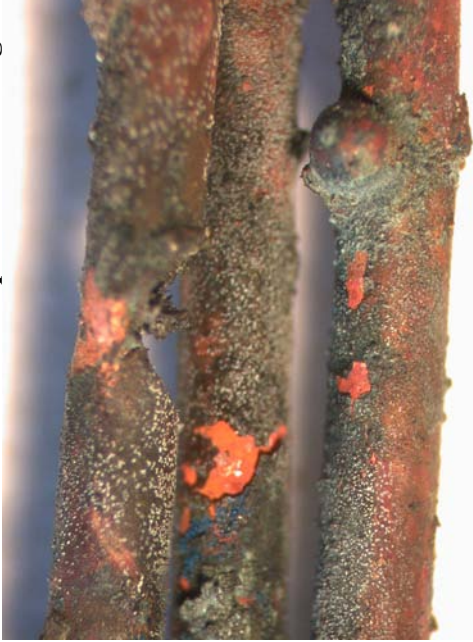
Figure 143 - Optical microscopic image of exhibit 020, two conductors with localised metallic damage.

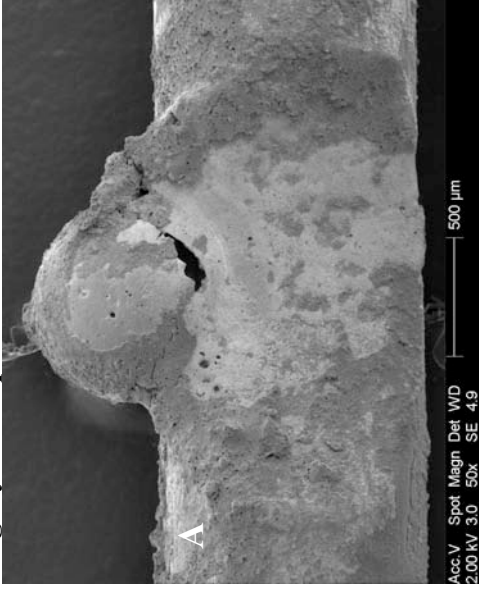
Figure 144 - SEM image of the bottom conductor in figure 143, a notch with a bead on the notch edge.

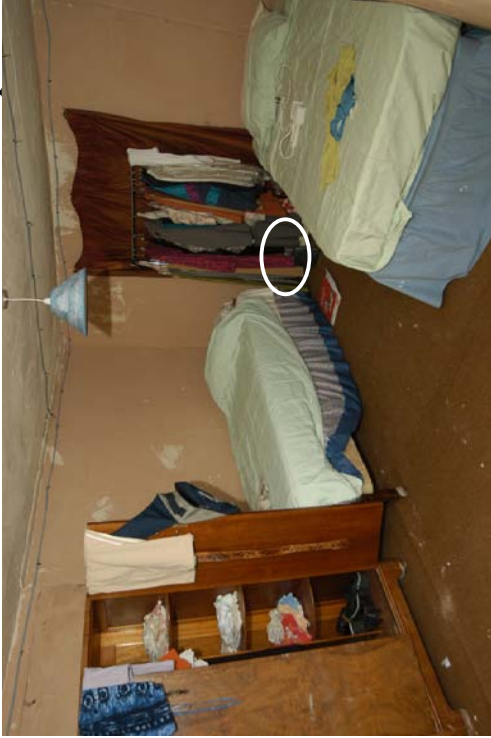
Figure 152 - Pre-fire photograph of experiment 8 detailing the fire's area of origin with the white circle.

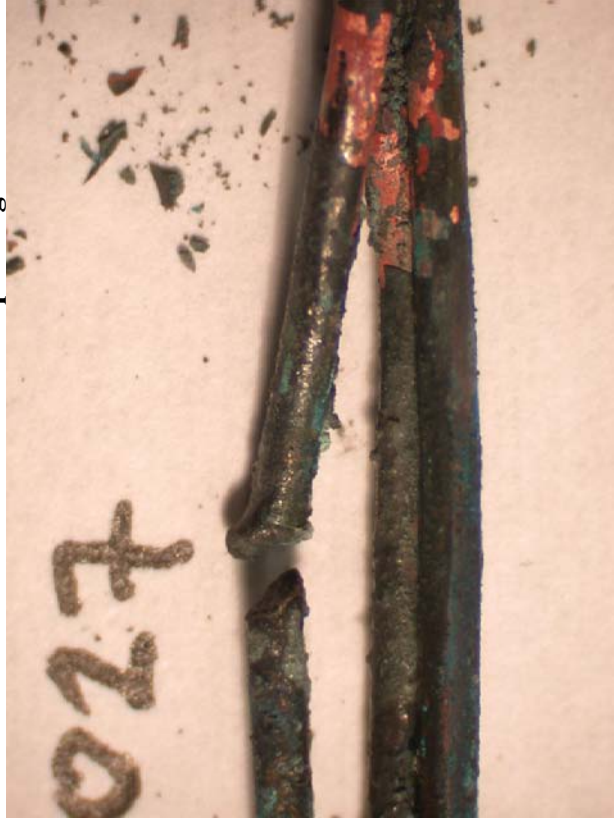
Figure 185 - Microscope image of exhibit 027. This localised metallic damage has severed one of the three conductors.

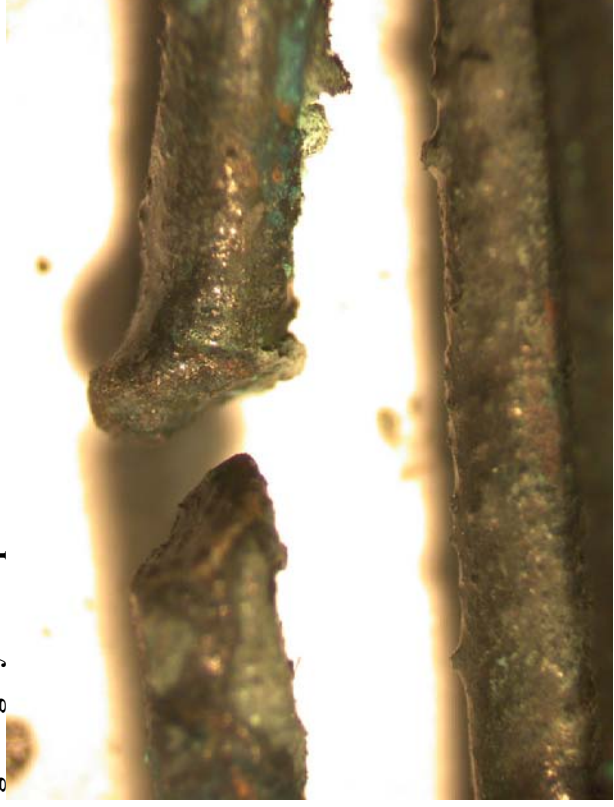
Figure 186 - Microscope image of exhibit of the severed ends at 20x magnification. The depth of field limits the area of the image in focus.

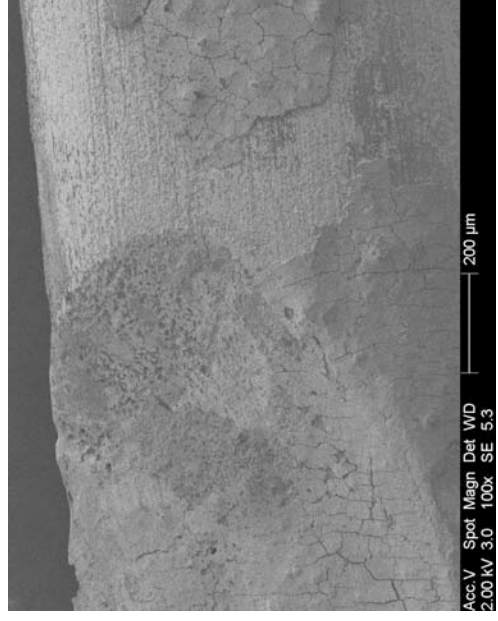
Figure 190 - SEM image of the right side of the notch showing a clear demarcation between the arcing damage and the undamaged area of the conductor.

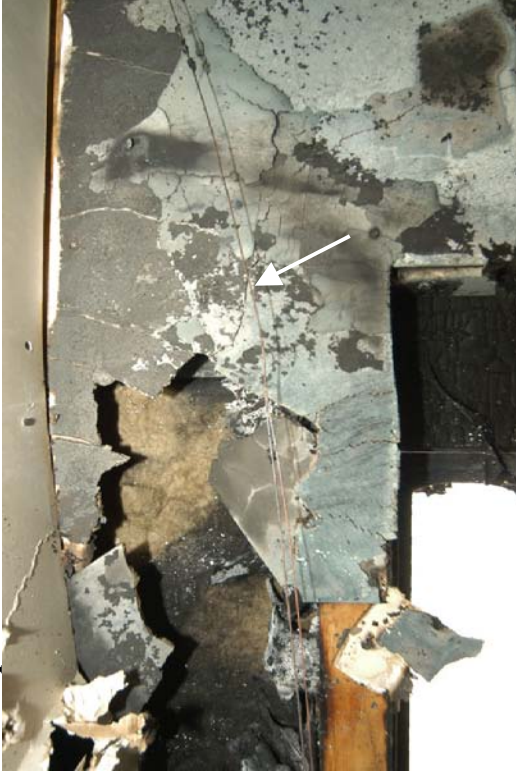
Figure 198 - Arcing damage to exhibit 029 on circuit 1.

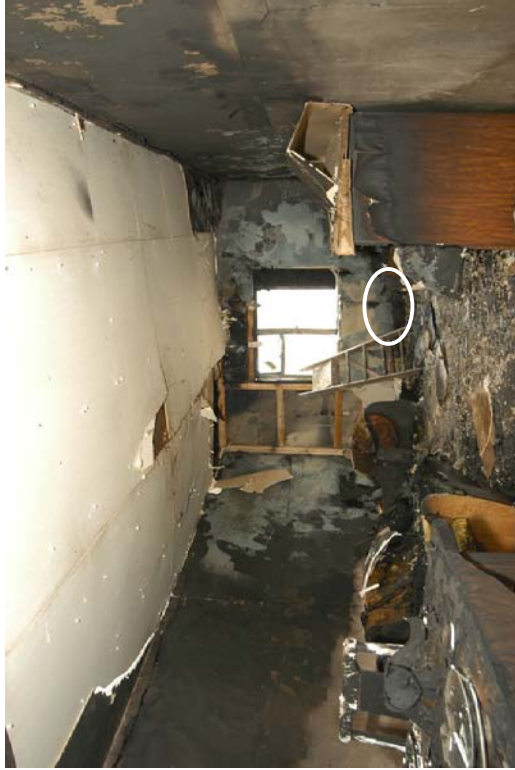
Figure 199 - Post-fire photograph of the scene.

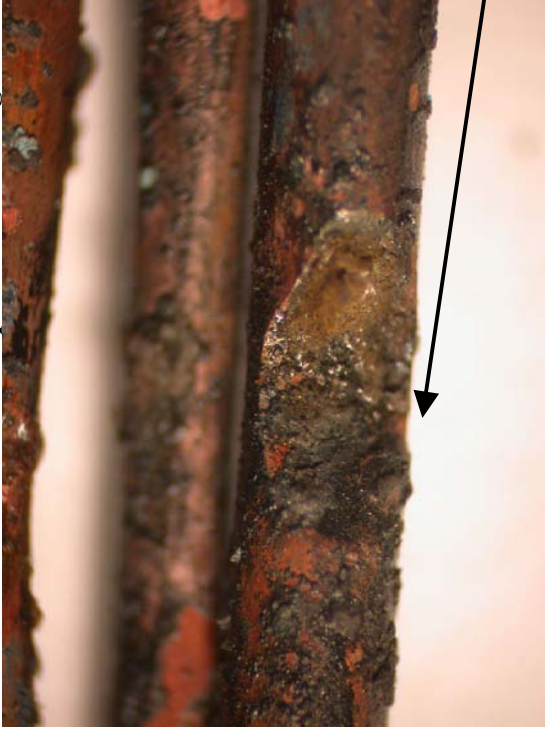
Figure 220 - Microscope image of the notch damage to one conductor.

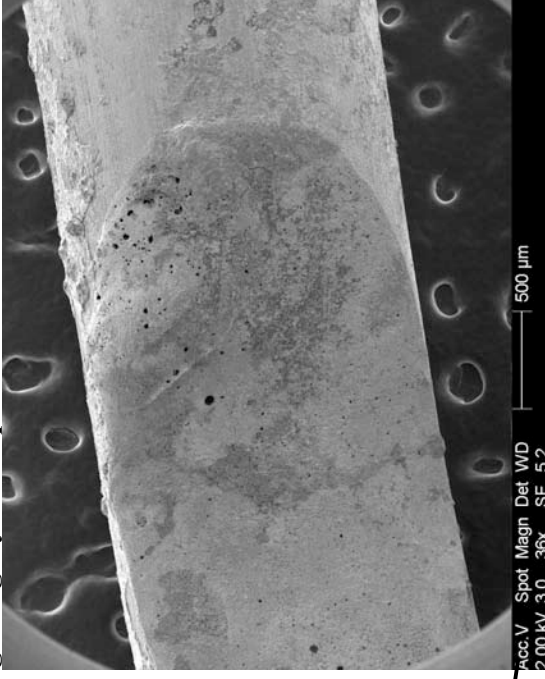
Figure 221 - SEM image of the right edge of the notch.

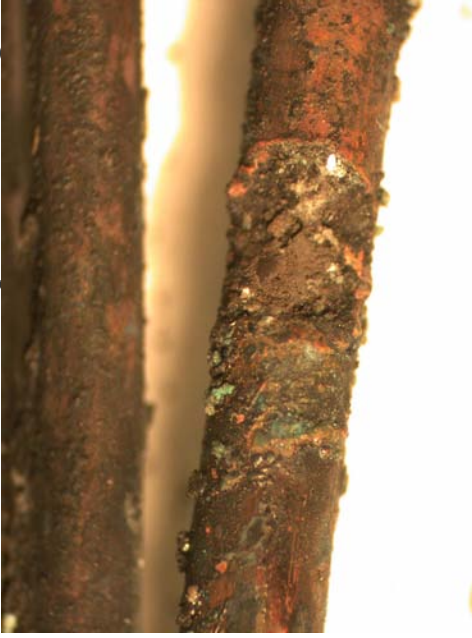
Figure 227 - Microscope image of first conductor (of two) forming exhibit 033. The damage pattern is a notch in the conductor surface.

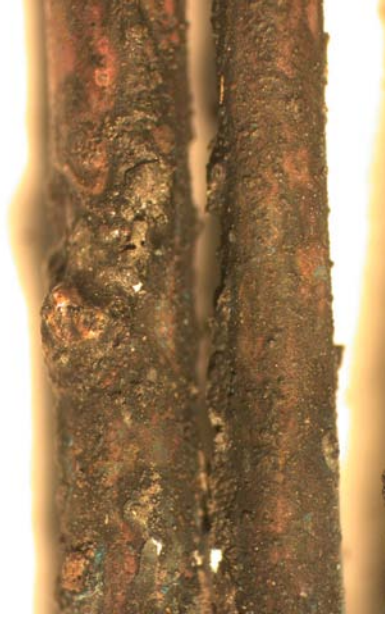
Figure 229 - Microscope image of the second conductor of exhibit 033. The metallic damage is a notch with a bead within it.

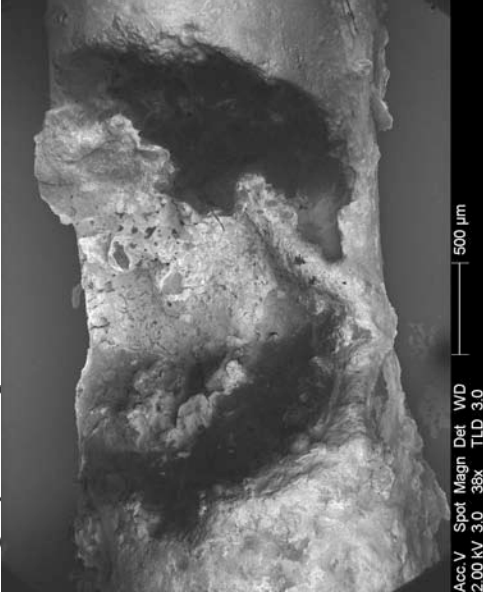
Figure 228 - SEM image of the conductor detailed in figure 227. The demarcation of the right edge is clear.

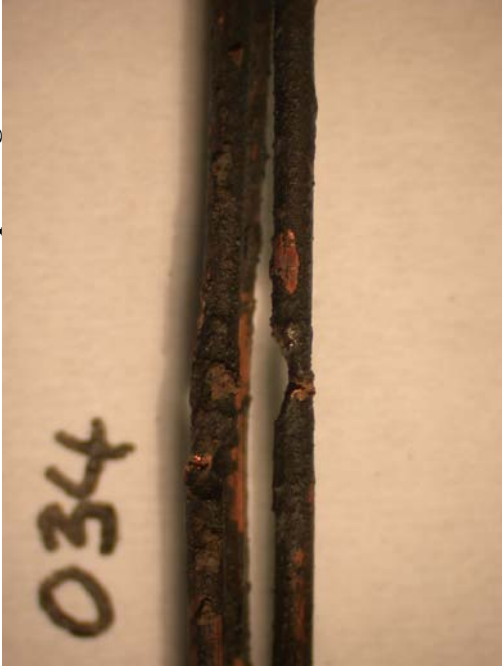
Figure 235 - Microscope image of exhibit 034. The metallic damage involves two conductors. Each one had a large notch.

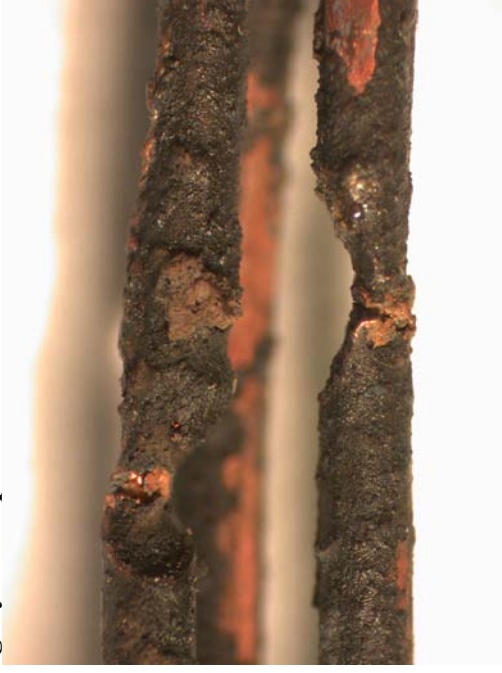
Figure 236 – 20x magnification of the top and bottom conductors detailed in figure 235. Note the cracks in the metal surface below the notches.

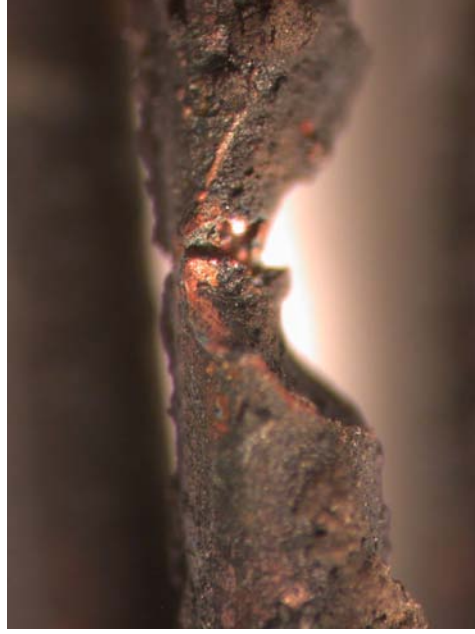
Figure 237 - Microscope image at 40x magnification of the bottom conductor detailed in figures 235 and 236.

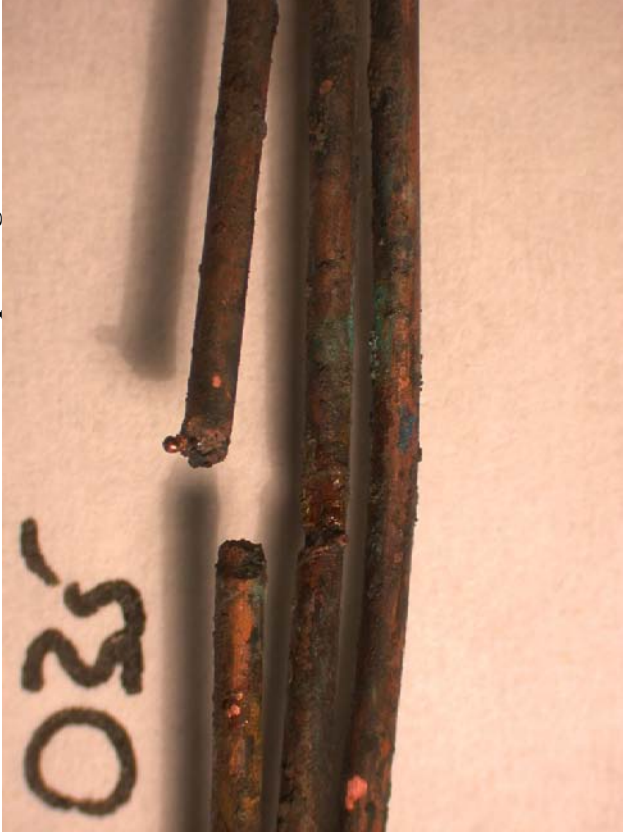
Figure 238 - Microscope image of exhibit 035. The metallic damage has affected two conductors. The top conductor is severed and the bottom conductor has a notch.

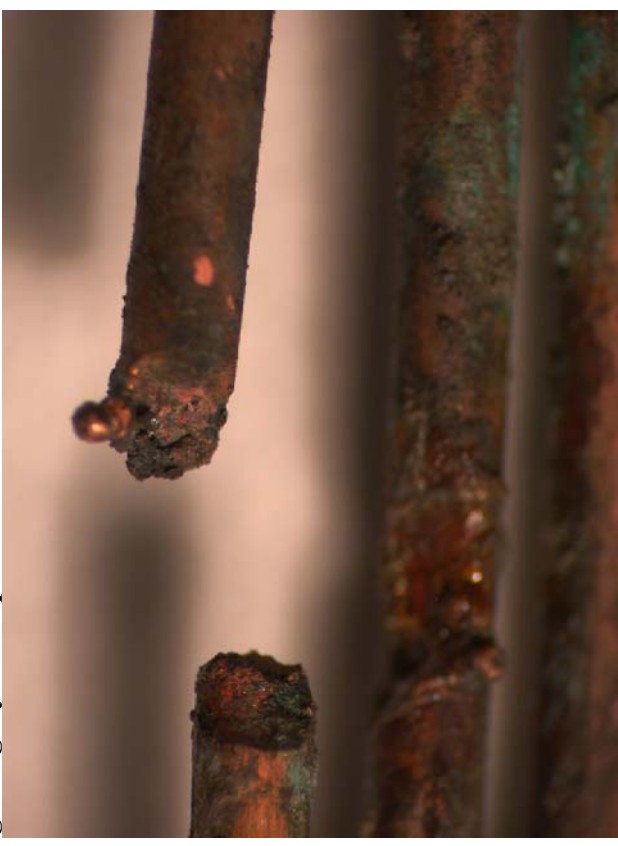
Figure 239 - Microscope image at 20x magnification detailing the severed ends of the top conductor. The demarcation area of the left severed end is very clear.

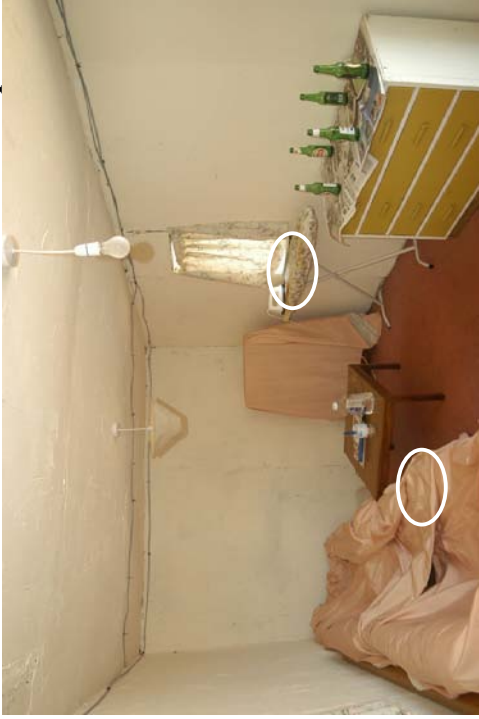
Figure 243 - Pre-fire photograph of experiment 12. The white ovals indicate the fire's areas of origin.

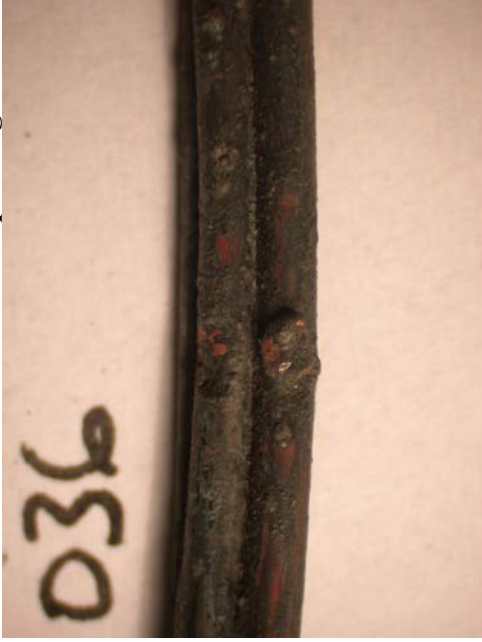
Figure 248 - Microscope image of exhibit 036. The localised metallic damage involved two conductors. One with a notch and the other with a bead within a notch.

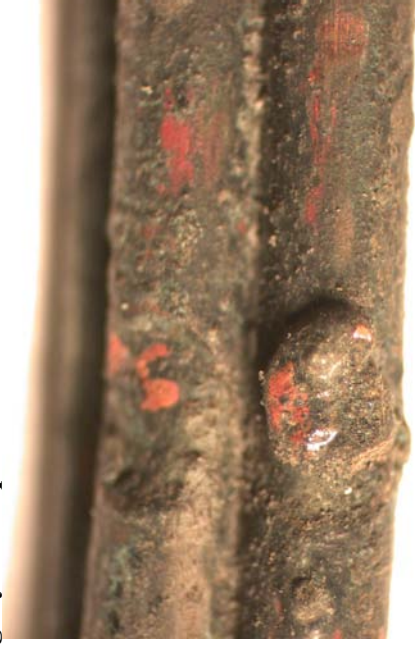
Figure 249 – Microscope image at 20x magnification detailing the damage to the two conductors.

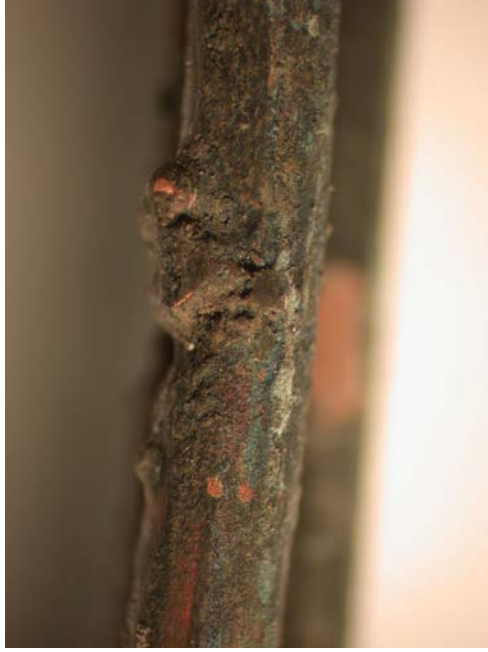
Figure 250 – A side view taken at 20x magnification of the lower conductor detailed in figure 249.

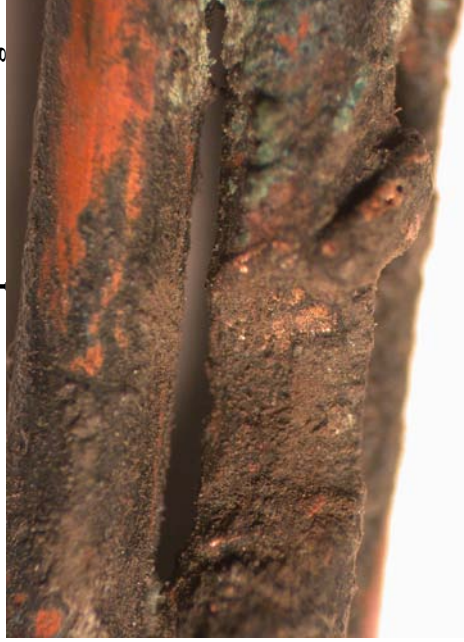
Figure 251 - Microscope image of exhibit 037. The metallic damage was limited to one conductor with a notch and a large bead to side of the notch edge.

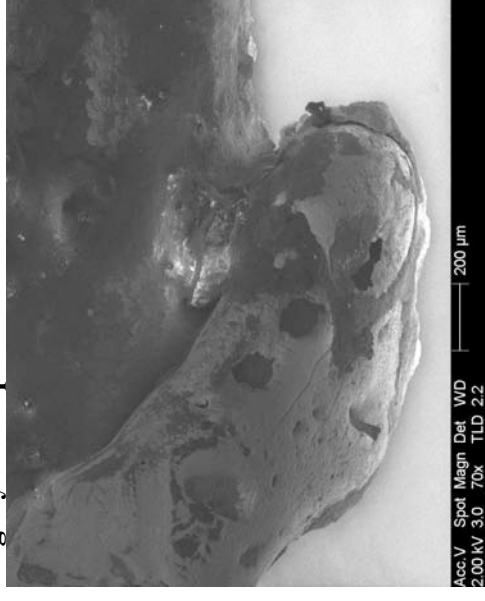
Figure 252 - SEM image of the bead at 70x magnification.

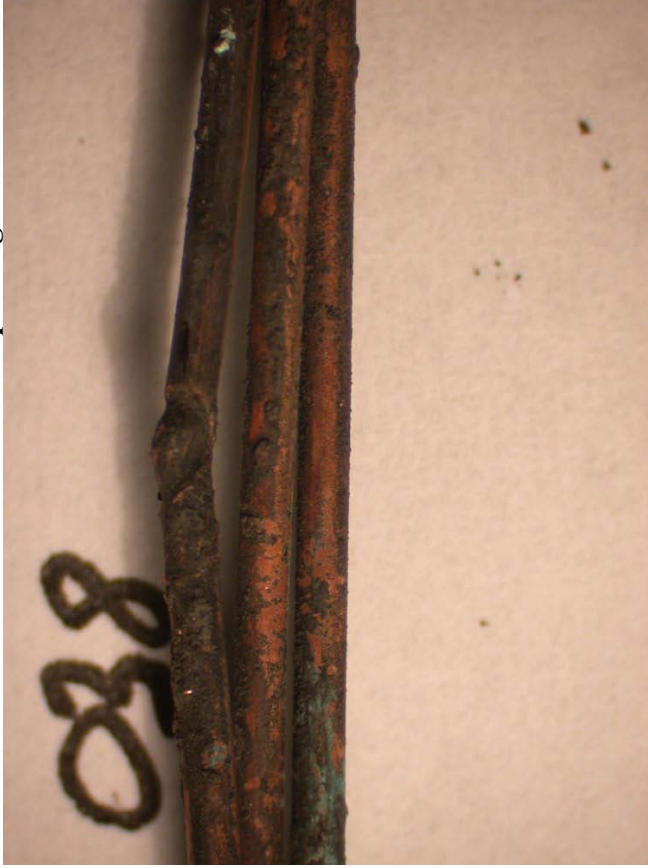
Figure 257 - Microscope image of exhibit 038. The localised metallic damage has affected one conductor consisting of a notch with a bead within it.

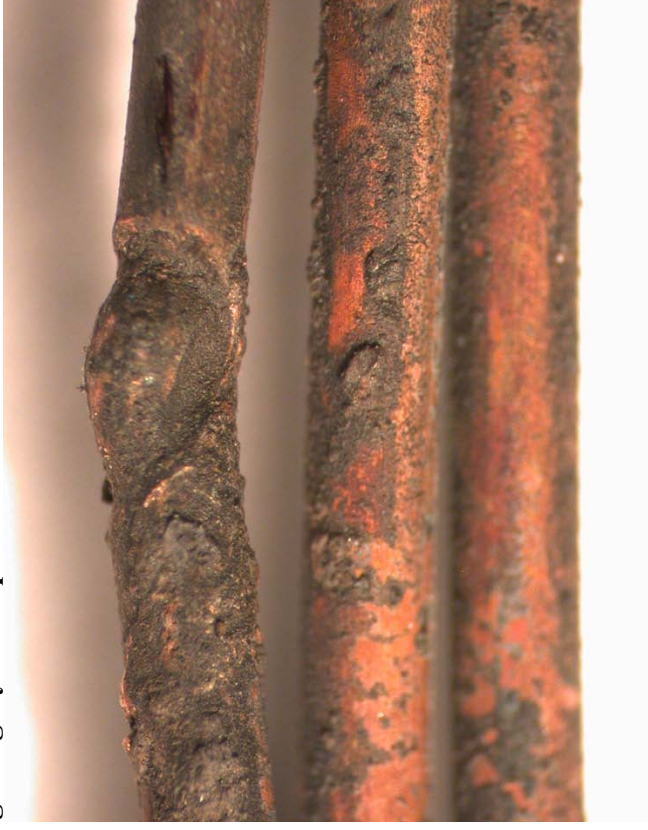
Figure 258 - Microscope image at 20x magnification detailing the bead within a notch. The demarcation between the arcing damage and the undamaged conductor surface is clear to the left and right edges of the notch.

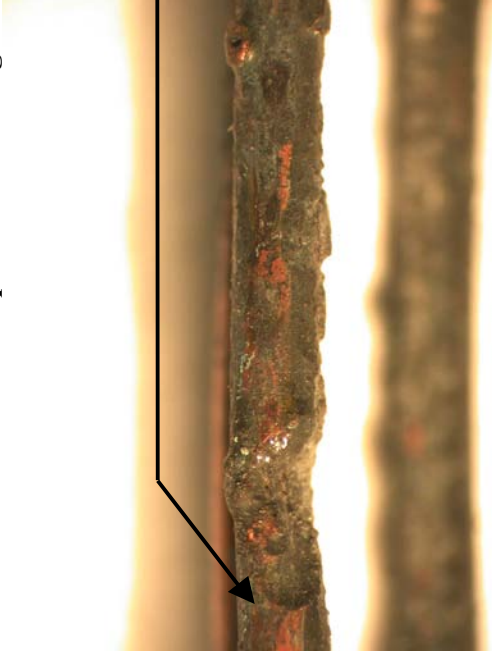
Figure 259 - Microscope image of exhibit 039. The damage is limited to one conductor with a notch.

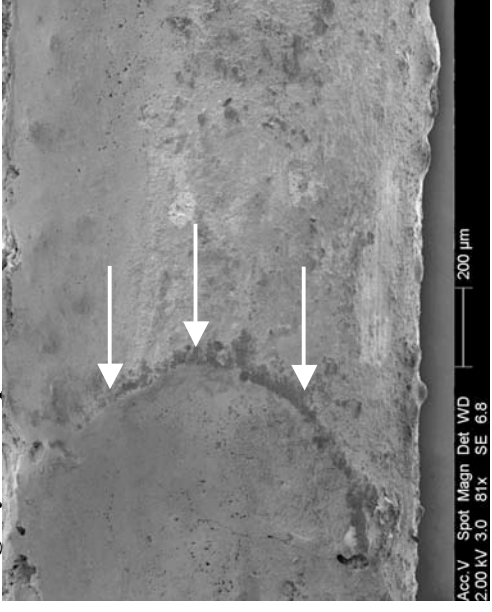
Figure 260 - SEM image of the left notch edge. The white arrows indicate the demarcation between the notch and the undamaged section of conductor.

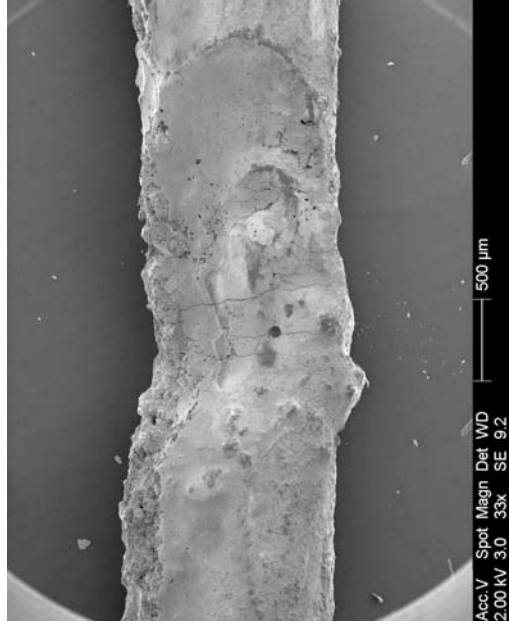
Figure 261 - SEM overview image of the notch damage.

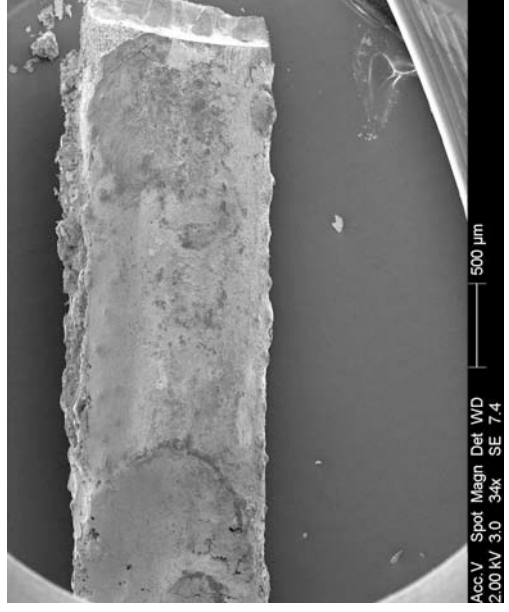
Figure 262 - SEM image of the left side of the notch.

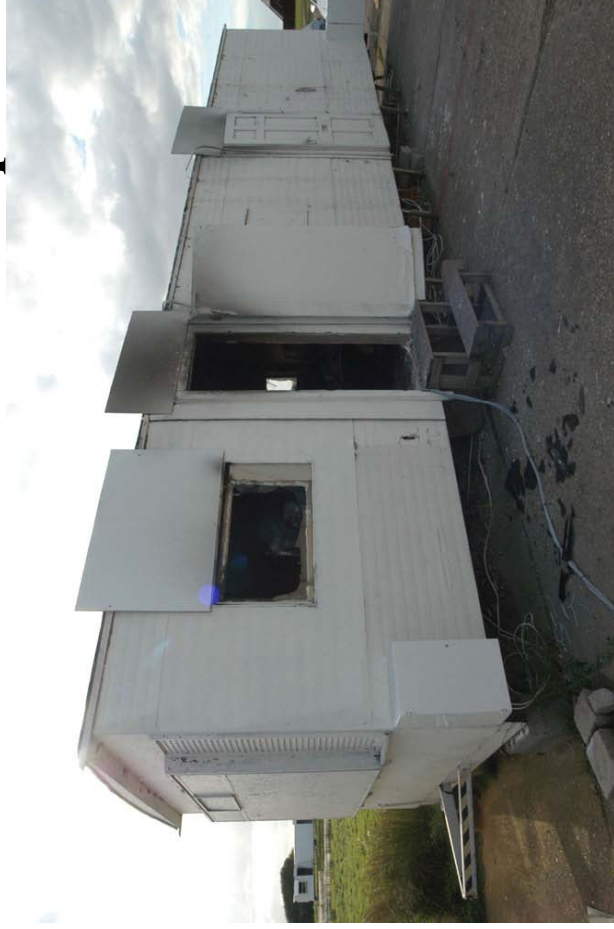
Figure 268 – “Scenario E” 29 September 2005

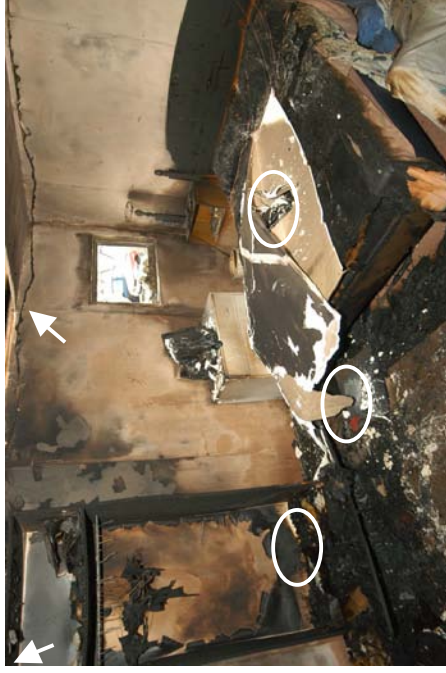
Figure 272 - Post-fire over-view detailing the fire's area of origin. The arrows detail the arcing damage locations to circuit 1 (left of wardrobe) and circuit 4 (above the bed)

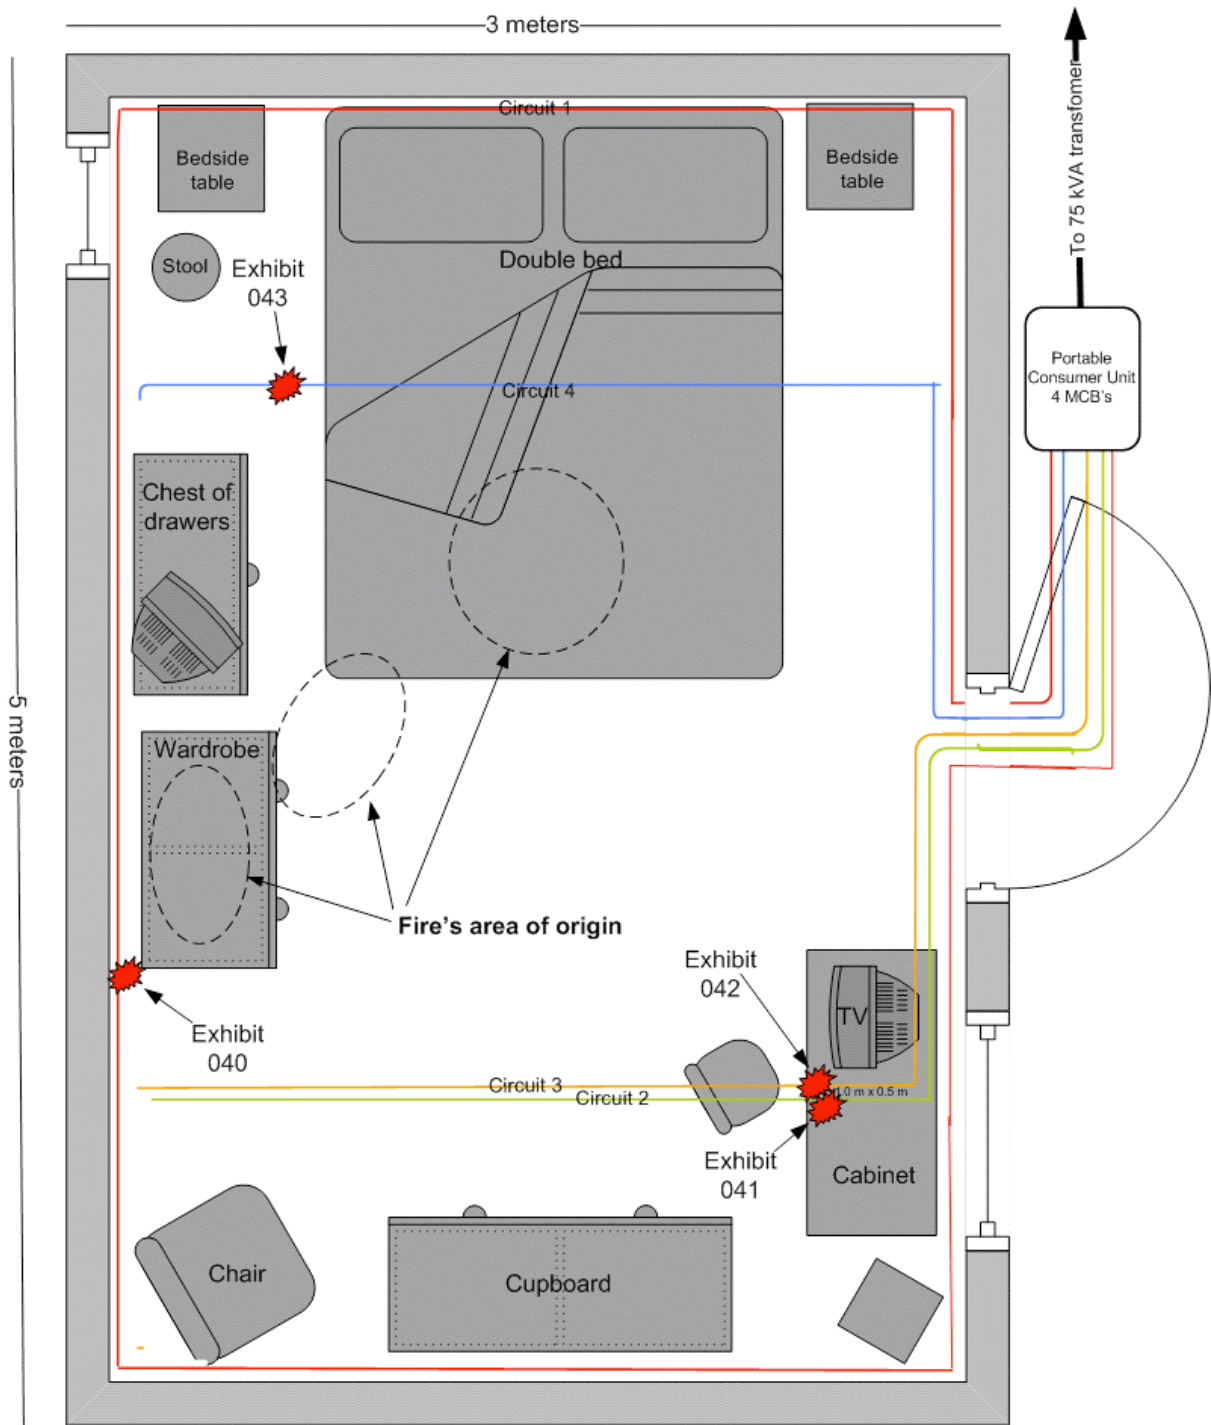
Figure 273 - Experiment 13 – “Scenario E” 29 September 2005

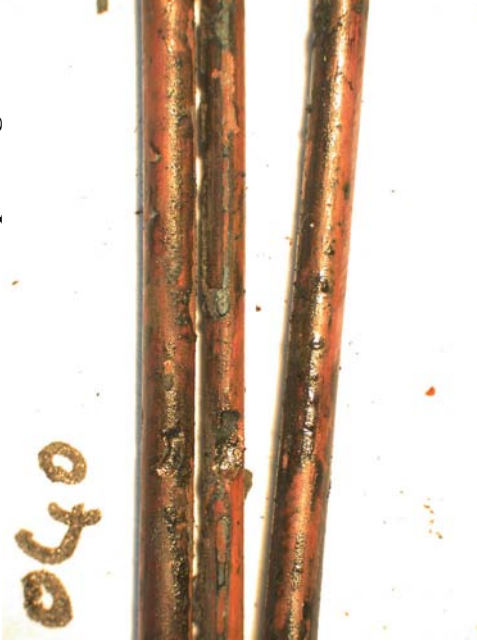
Figure 274 - Microscope image of exhibit 040 at 6x magnification. Two conductors have arcing damage. Each one has a notch.

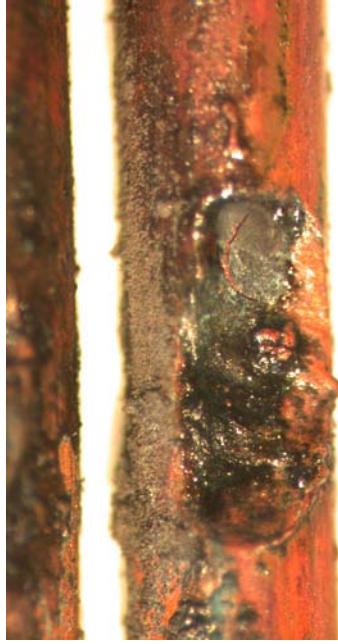
Figure 276 - View of the middle 1.5mm<sup>2</sup> protective earth conductor notch at 40x magnification.

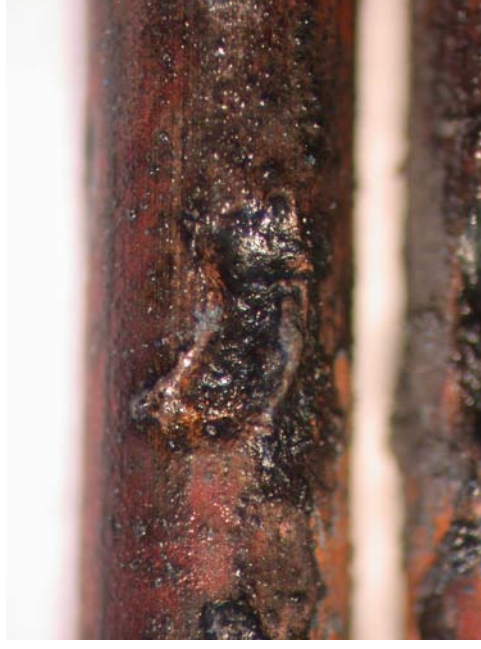
Figure 277 - View of the notch damage to the 2.5mm<sup>2</sup> conductor at 40x magnification.

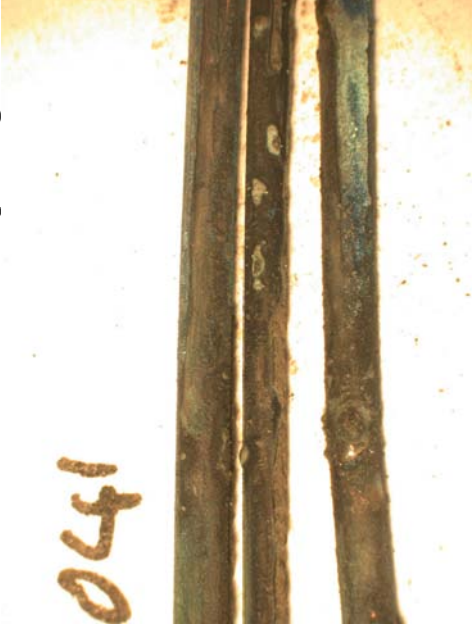
Figure 278 - Microscope image of exhibit 041. One of the three conductors has arcing damage that is a notch with a bead within it.

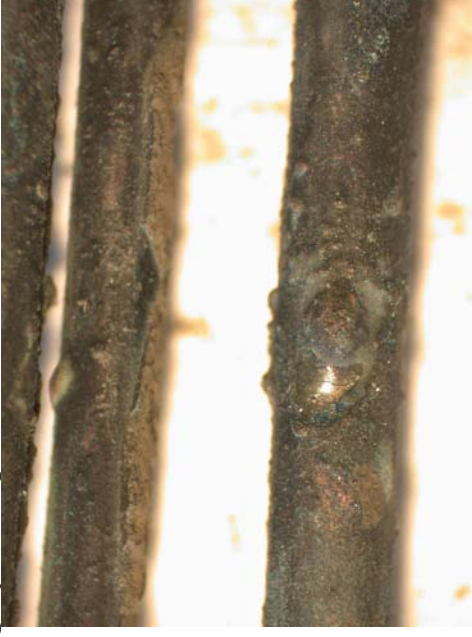
Figure 279 - View at 20x magnification of the bottom conductor damage. Figures 278 – 280 are all over-exposed.

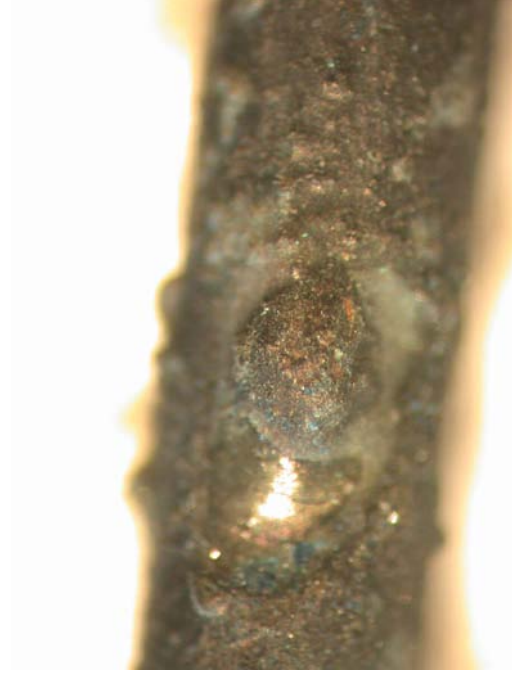
Figure 280 – 40x microscope image of the notch with a bead within.
