**University of Strathclyde**  
**Department of Pure and Applied**  
**Chemistry**  
**Centre for Forensic Science**

**Developing a reliable systematic**  
**analysis for arc fault mapping**

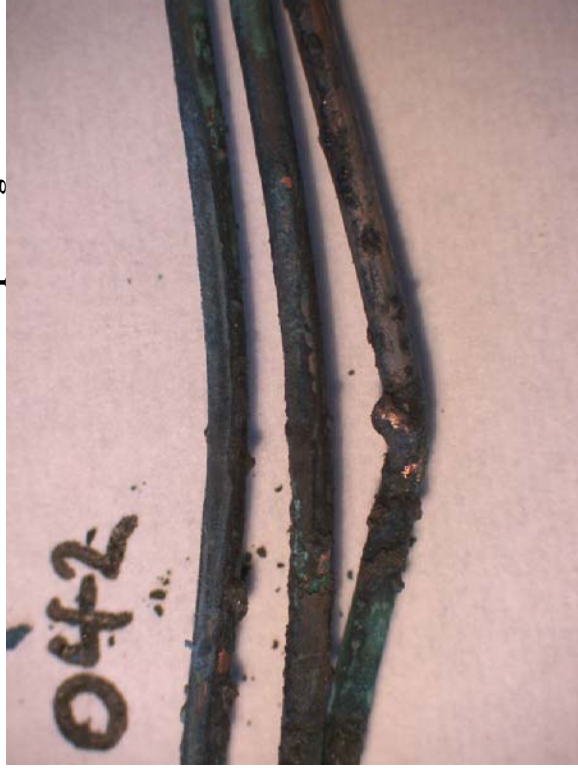
Figure 281 - Microscope image of exhibit 042. One conductor has localised metallic damage with a wide notch and a bead at the edge of the notch.

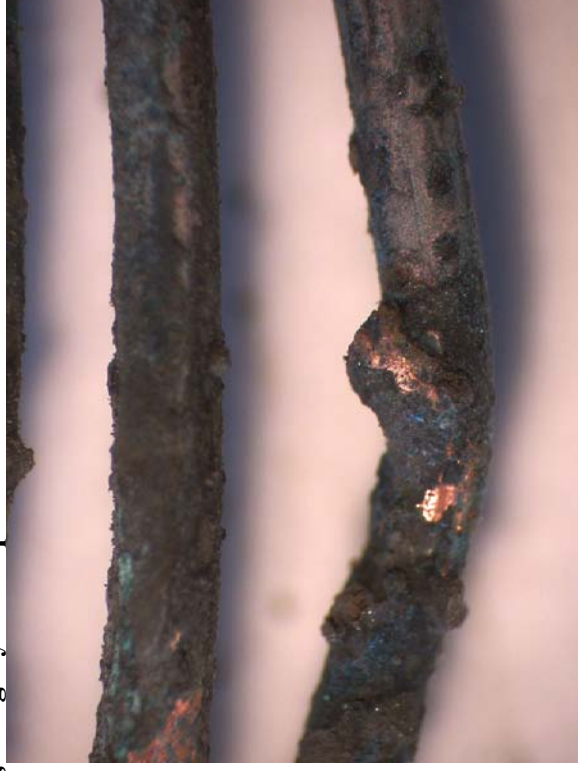
Figure 282 – Microscope image at 20x magnification detailing the arcing damage to the bottom conductor in figure 281.

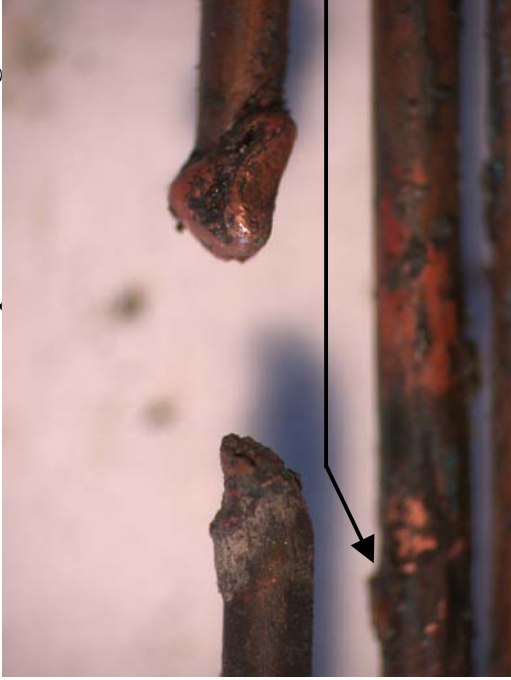
Figure 283 - Microscope image of exhibit 043 with damage to two conductors. The bottom conductor is out of focus.

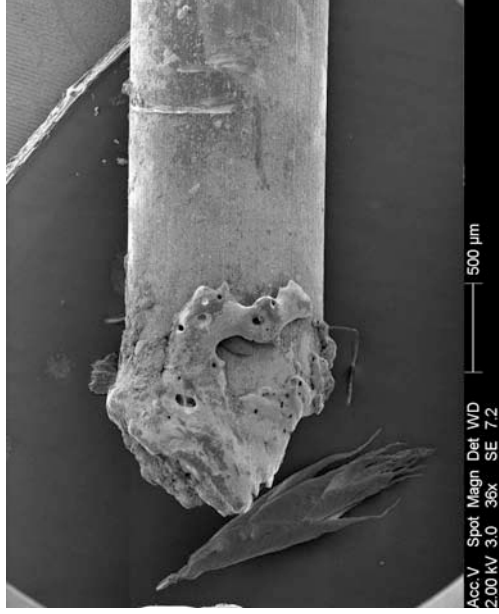
Figure 285 - SEM image of the left severed end in figure 283 at 38x magnification.

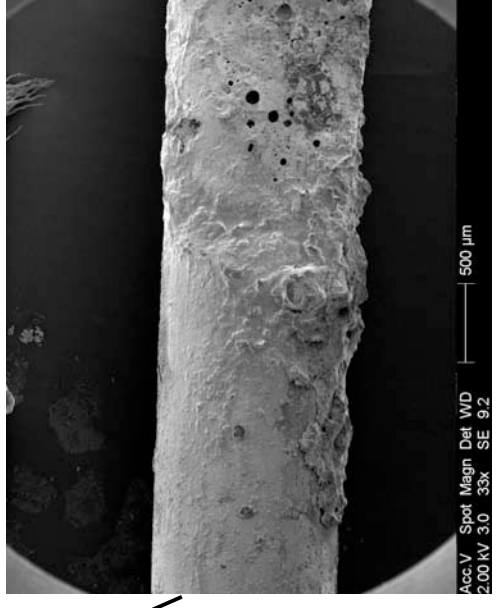
Figure 286 - SEM image of the notch damage to the bottom conductor in figure 283.

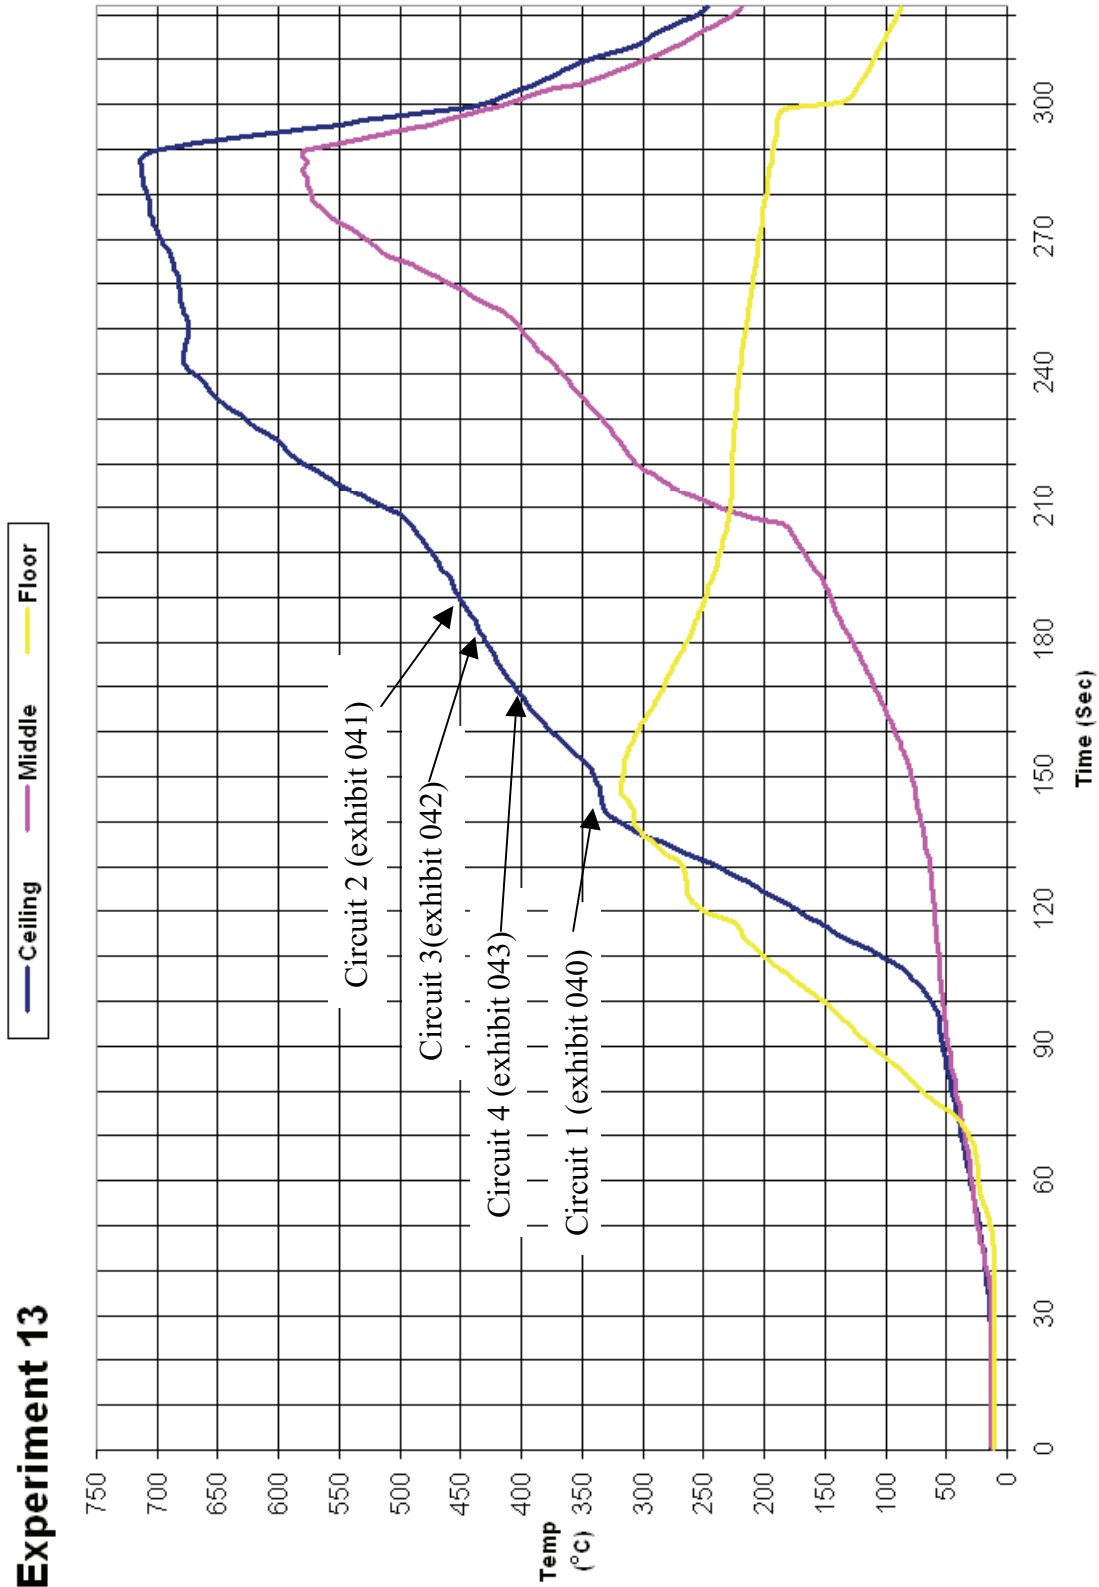
Figure 287 - Time temperature graph for experiment 13

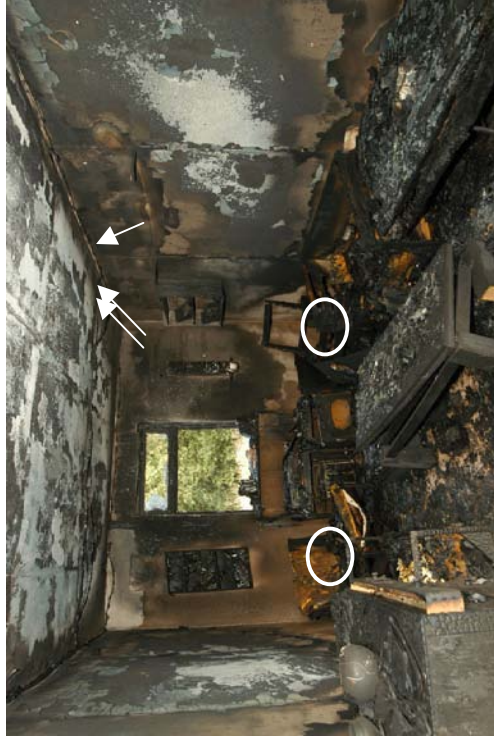
Figure 292 - Post-fire photograph of experiment 14. The white ovals detail the fire's two areas of origin. The white arrows indicate the arcing damage locations to circuits 1 (right), 2 (left) and 3 (centre).

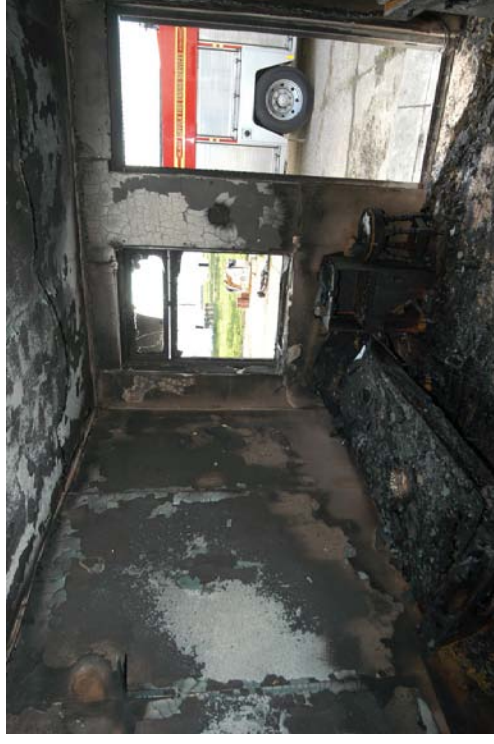
Figure 293 - Post-fire image of the compartment viewing the entrance door.

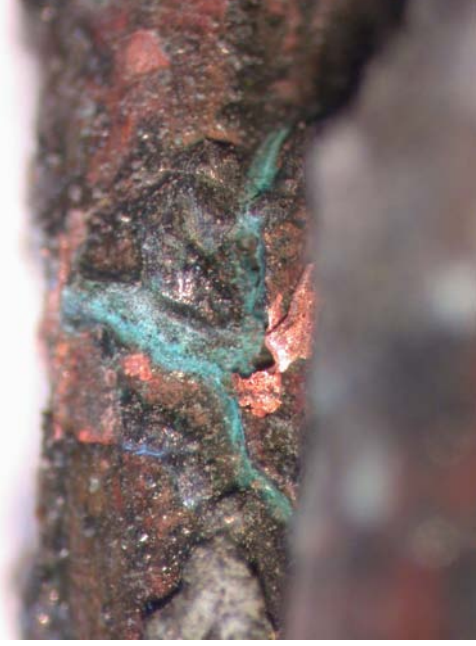
Figure 298 - 40x magnification of the bottom conductor damage detailed in figure 295.

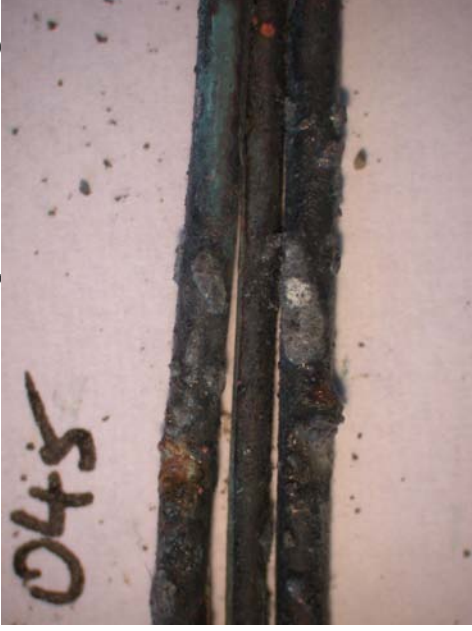
Figure 299 - Microscope image of exhibit 045, two of the conductors have notch damage.

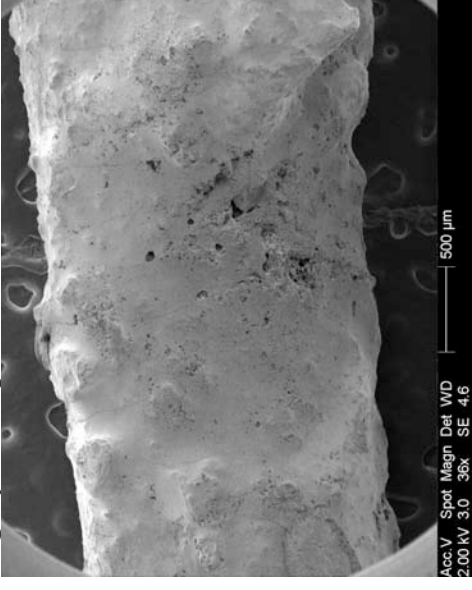
Figure 300 - SEM image of the top conductor notch detailed in figure 299.

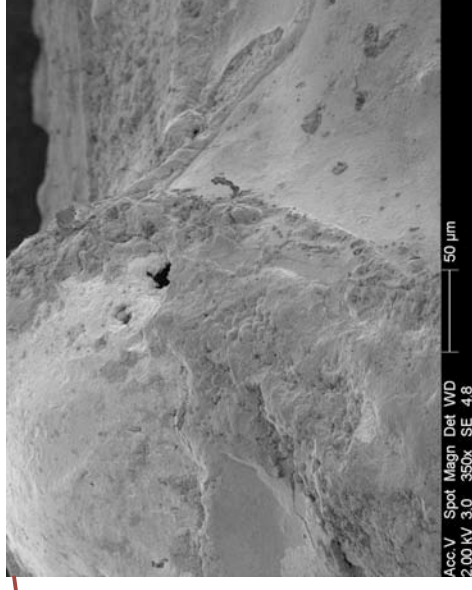
Figure 302 - SEM image at 350x magnification detailing the demarcation area between the arcing damage and the undamaged conductor detailed in figure 301.

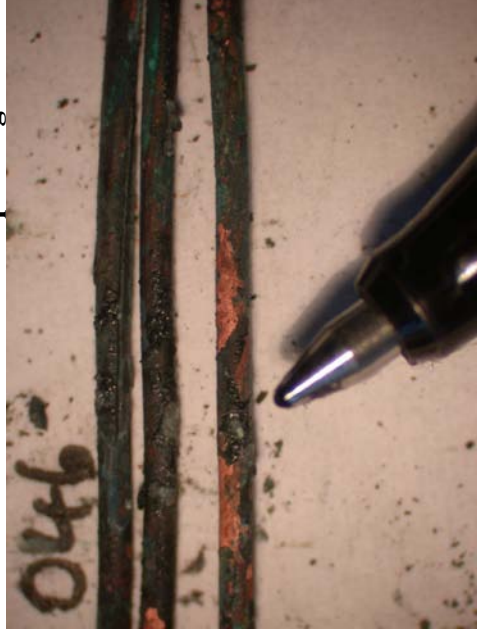
Figure 305 - Microscope image of exhibit 046 at 6x magnification with the arcing damage indicated with the pen ballpoint tip.

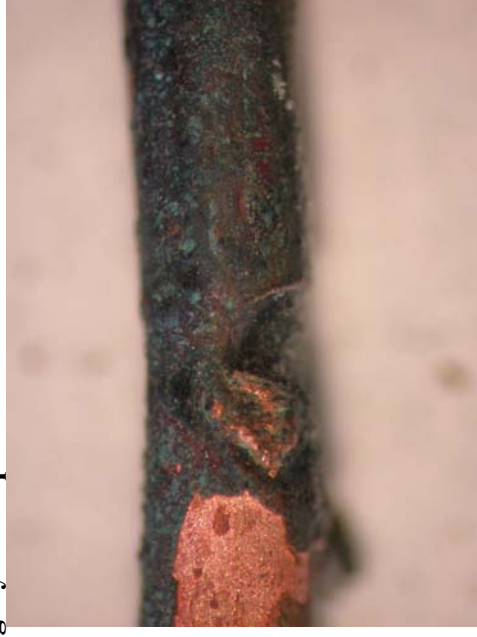
Figure 306 - Microscope image of the notched area of the conductor indicated in figure 305 at 40x magnification.

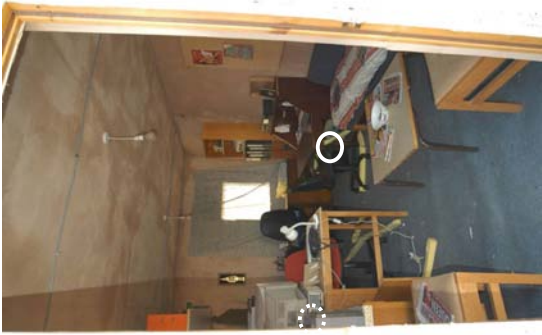
Figure 311 - Pre-fire view of experiment 15 taken from the door.

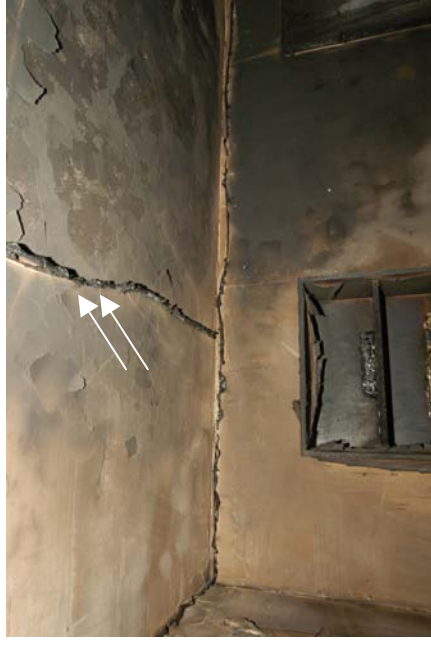
Figure 314 - Post-fire view of the fire damaged wiring above the dominant area of origin, the shelf unit. The arrows indicate the arcing damage to circuits 2 and 3.

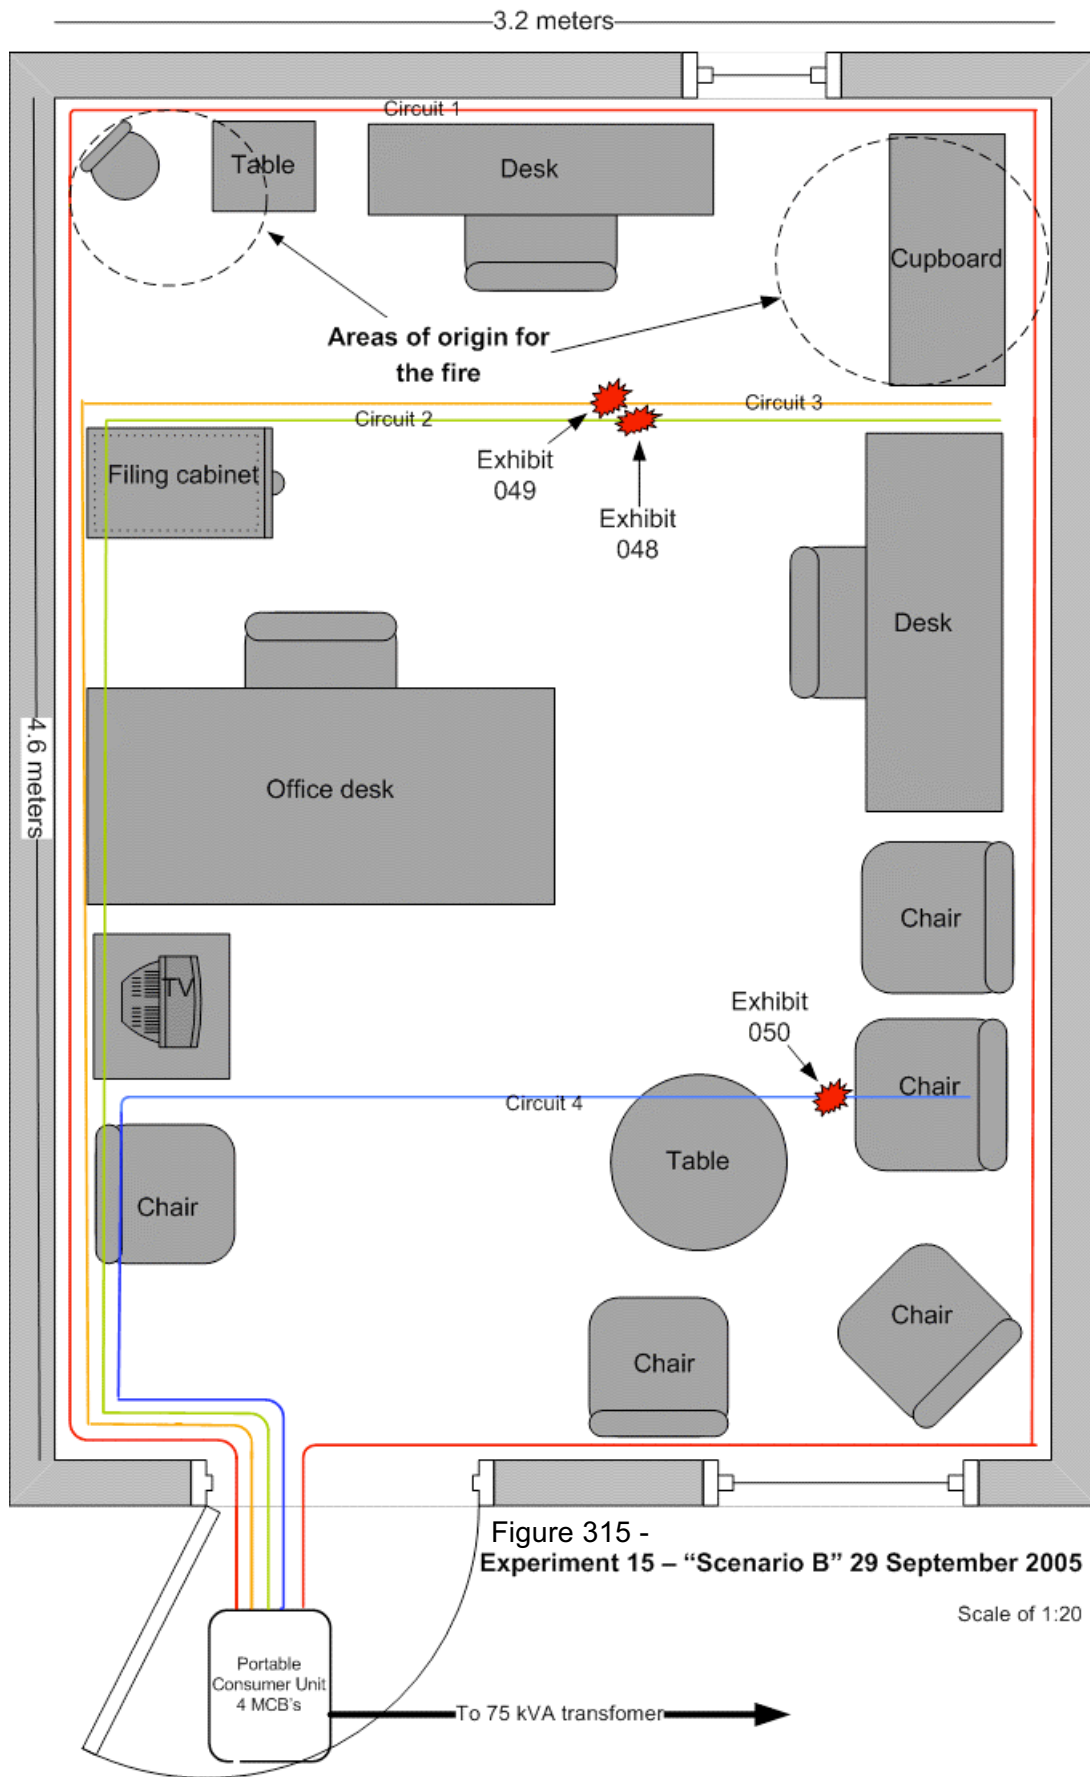
Microscope images for exhibit 048 arcing category D – experiment 15

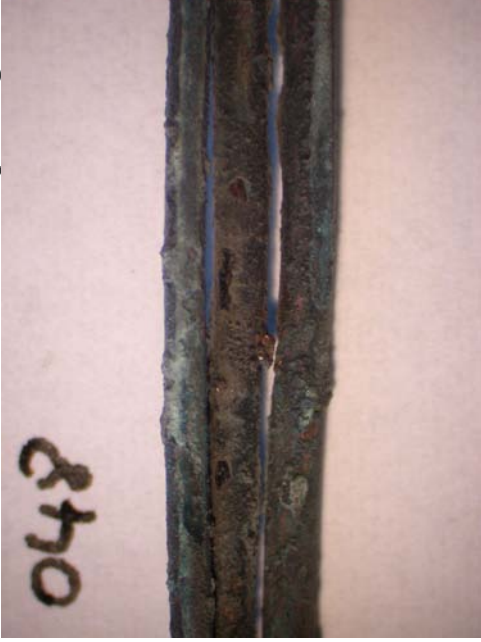
Figure 316 - Microscope image of exhibit 048 at 6x magnification. Two of the conductors were damaged with notches and beads.

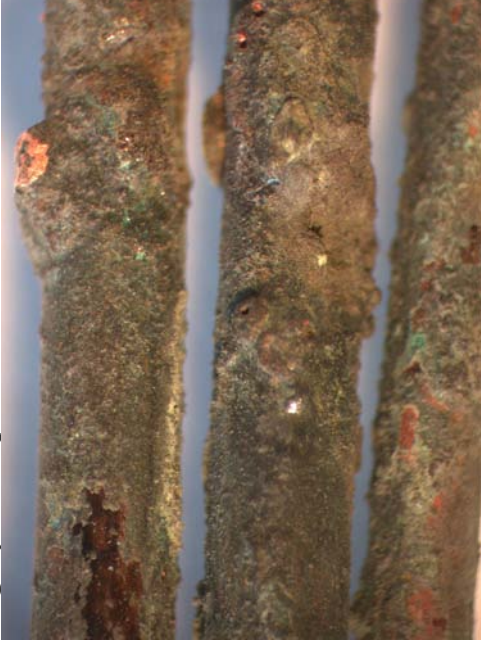
Figure 317 - Microscope image of the two conductors at 20x magnification.

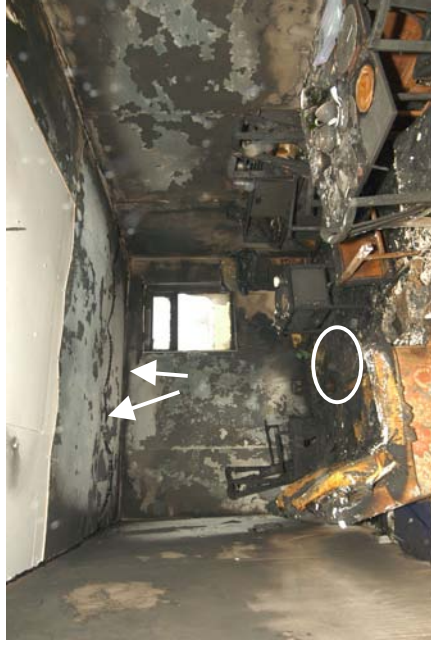
Figure 335 - Pre-fire photograph of experiment 16. The white oval indicates the fire's area of origin. The white arrows indicate arcing damage to circuit 4 (left) and circuit 1 (right).

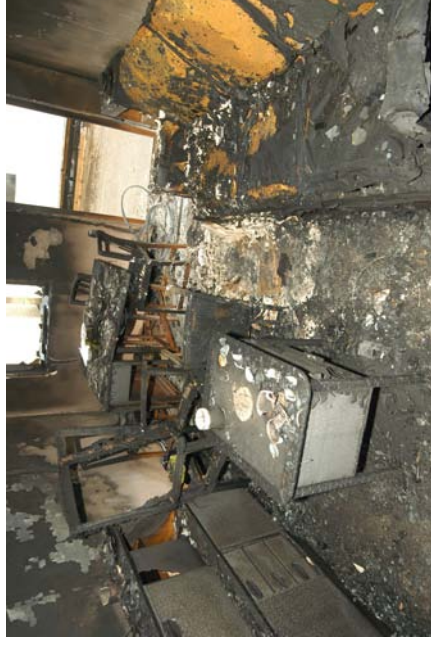
Figure 336 - Post-fire photograph of the view shown above in figure 334.

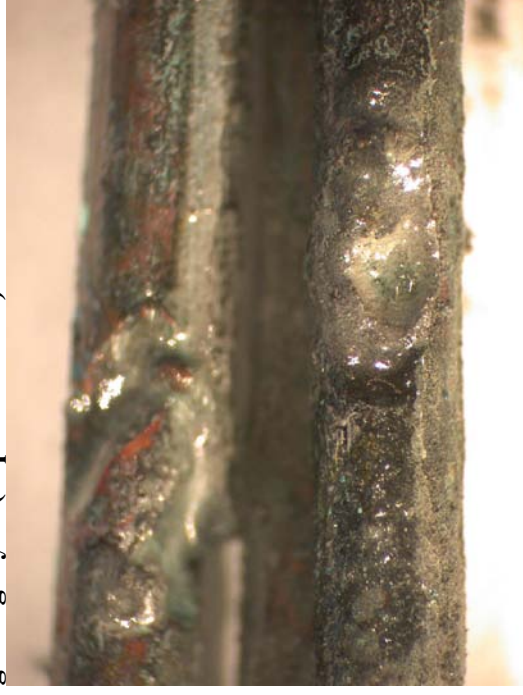
Figure 339 - 20x magnification of arcing damage of the two notches.

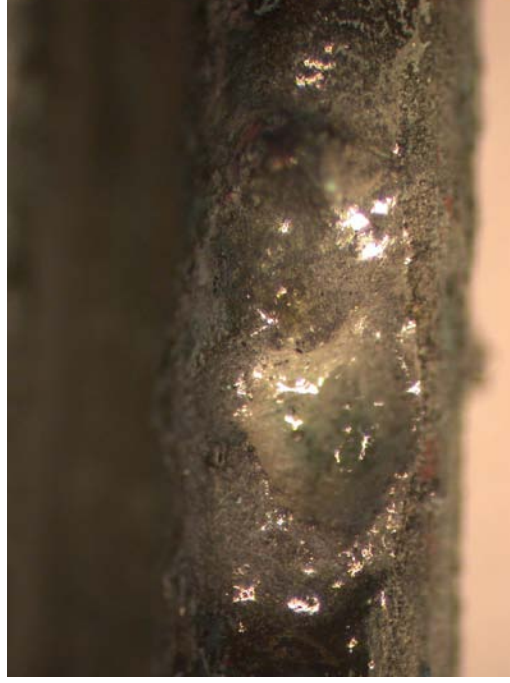
Figure 340 - 40x magnification of lower conductor notch.

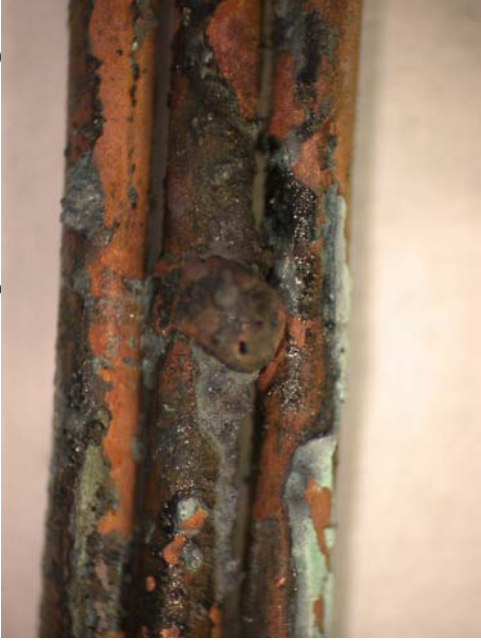
Figure 346 - Microscope image of exhibit 053. Two conductors have localised melting (arcing) damage.

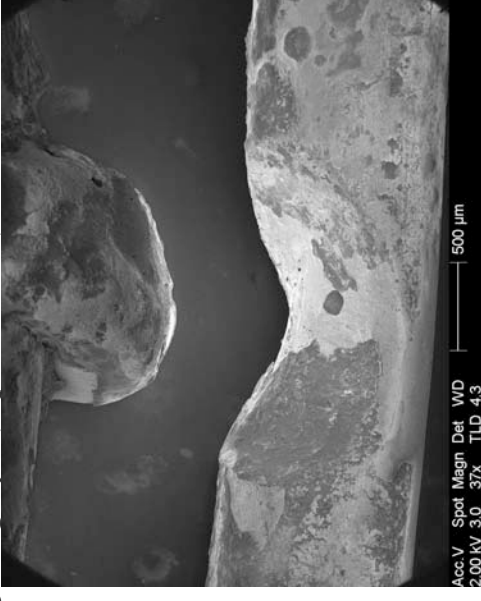
Figure 347 - SEM image of both conductors. The bead and the notch were adjacent to each other at the scene.

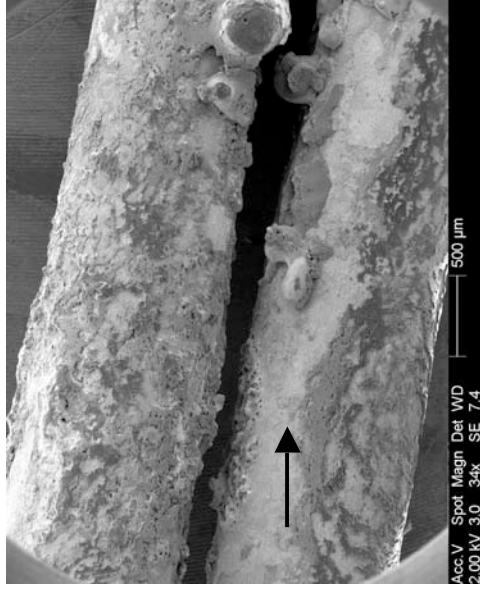
Figure 356 - The left edge of the lower conductor's arcing damage - a notch with a clear demarcation area.

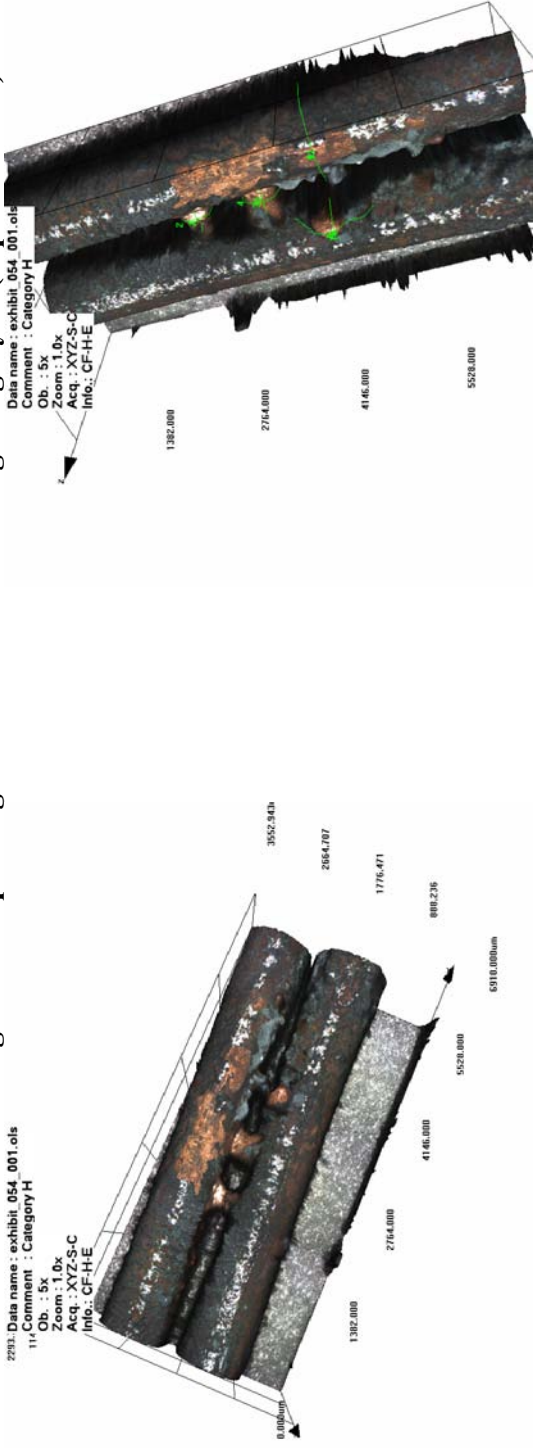
Figure 357 - LEXT overview image of exhibit 054 detailing the entire exhibit.

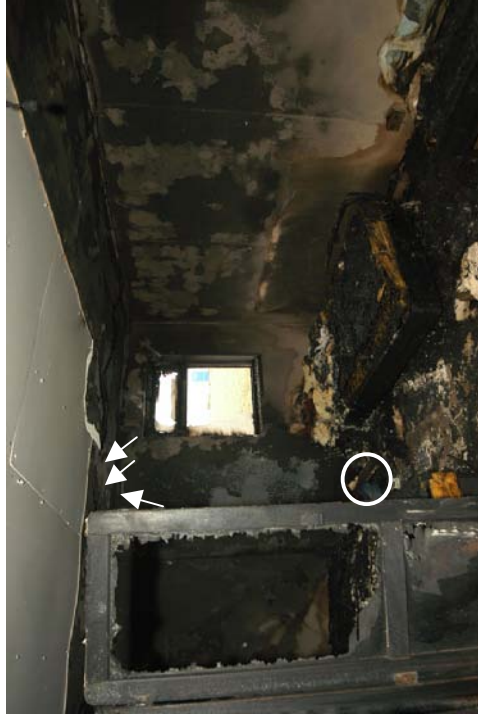
Figure 365 - Post-fire photograph with a white circle indicating the area of origin. The left arrow is the arcing damage to circuit 1. The middle and right arrows are the arcing damage to circuit 4.

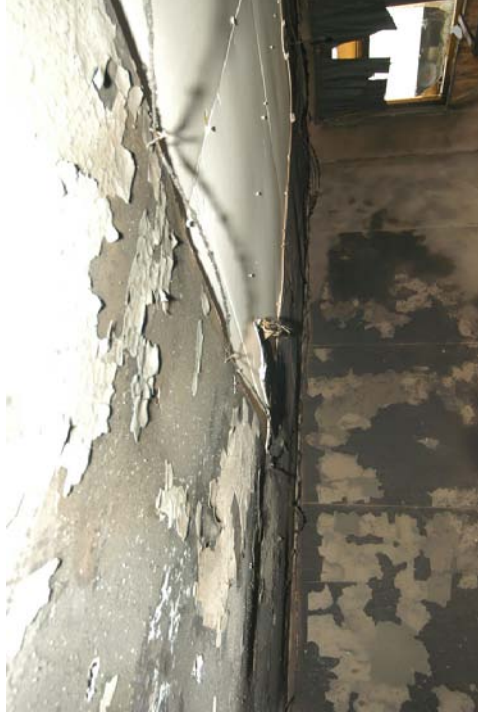
Figure 366 - Post-fire photograph the ceiling area of the front of the compartment. This details circuits 1 (wall edge), 2 and 3 (routed across the ceiling).

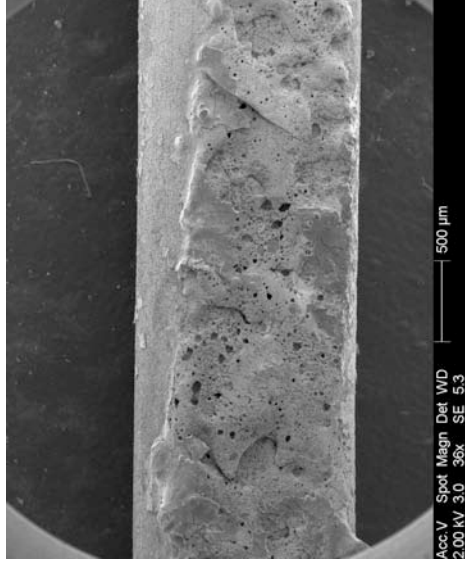
Figure 370 - SEM image detailing the central area of the arcing damage to the bottom conductor.

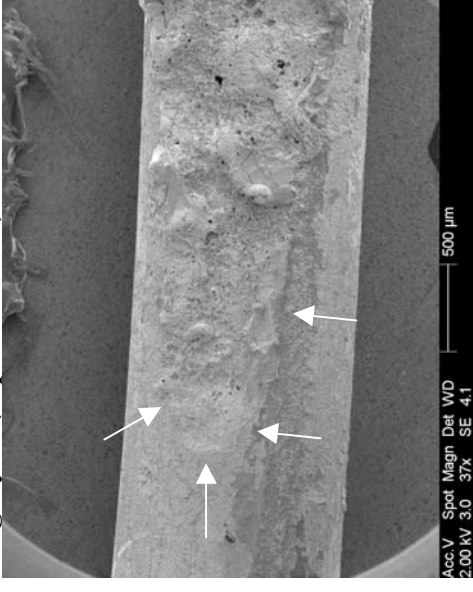
Figure 369 - SEM image of the left side of the bottom conductor. Detailing the demarcation between the arcing damaged surface and the undamaged metallic surface.

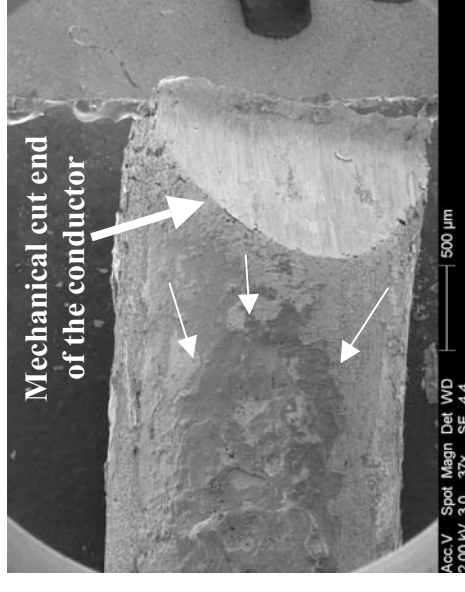
Figure 371 - SEM image of the right edge of the arcing damage to the top conductor. A mechanical cut edge of the conductor is also detailed with this image.

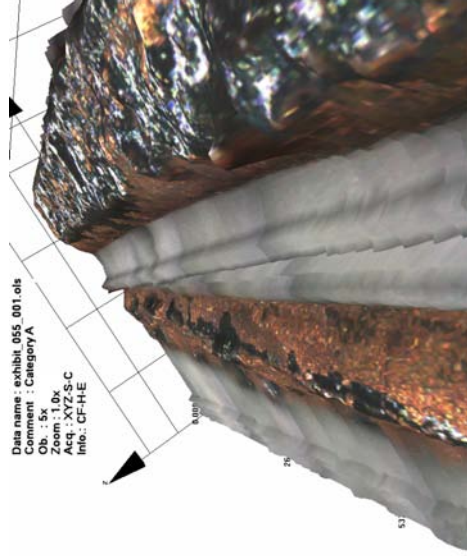
Figure 374 - LEXT image capture of a close-up view in the software, highlighting the surface detail of the conductor damage.

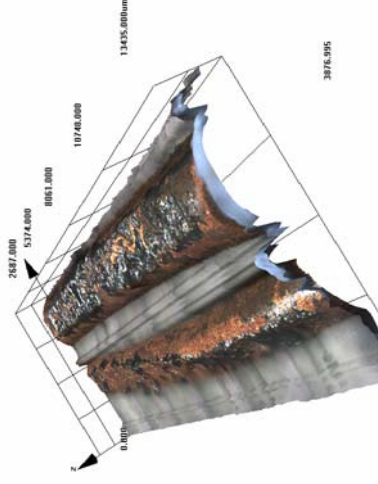
Figure 373 - LEXT image of an end profile detailing the shallow depth of the scans forming this image.

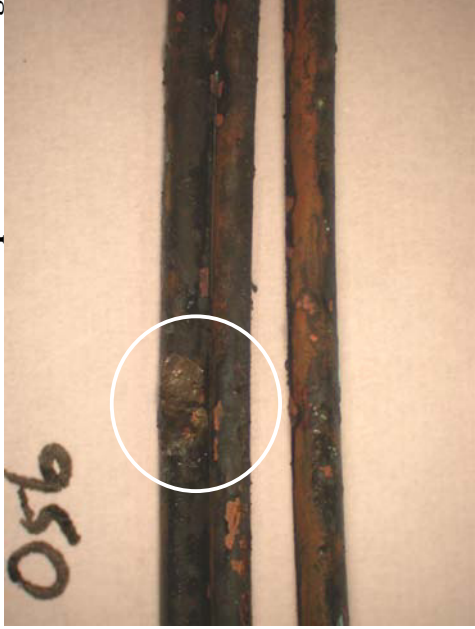
Figure 377 – A microscope image of exhibit 56. The arcing damage is limited to the top conductor.

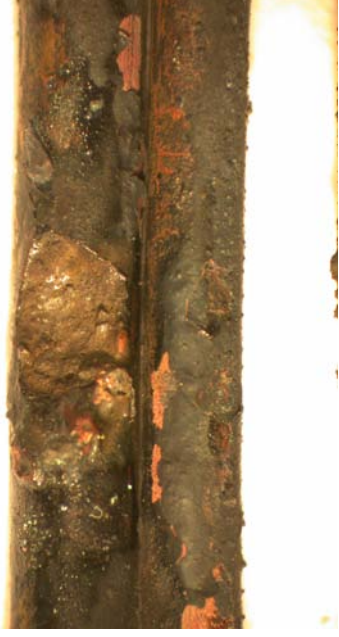
Figure 378 - A notch on one conductor with a bead to the side.

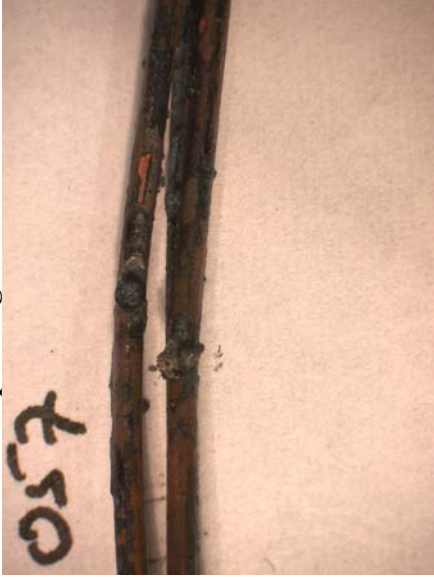
Figure 383 - Microscope image of exhibit 57. This was furthest from the electrical source and closer to the origin of the fire than exhibit 57a (below). This metallic damage did not operate the circuit breaker

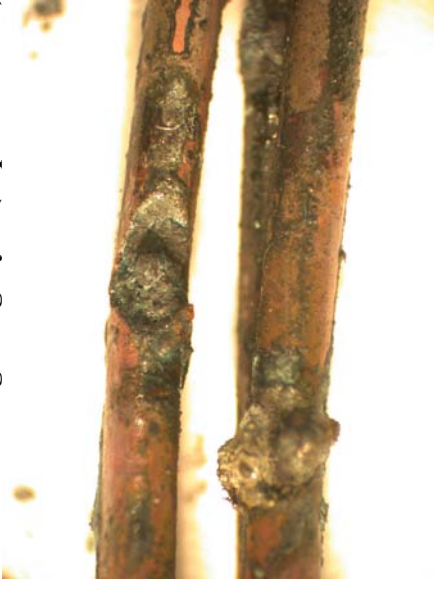
Figure 384 - 20x magnification of the exhibit detailing the bead on one conductor and the notch on the other conductor.

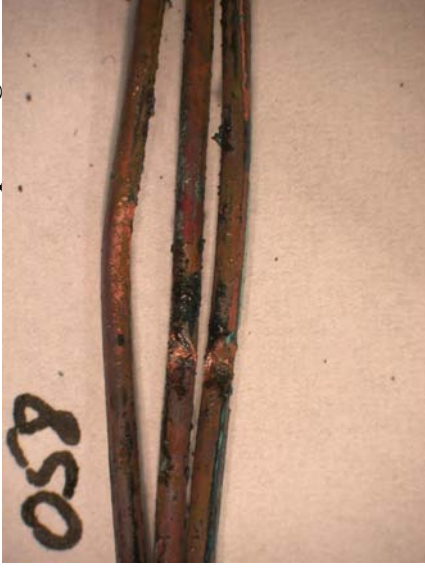
Figure 387 - Microscope image of exhibit 058 with a notch on two adjacent conductors. Circuit 4 was subject of two separate areas of arcing damage and this was the first arcing event - furthest area from the electrical source.

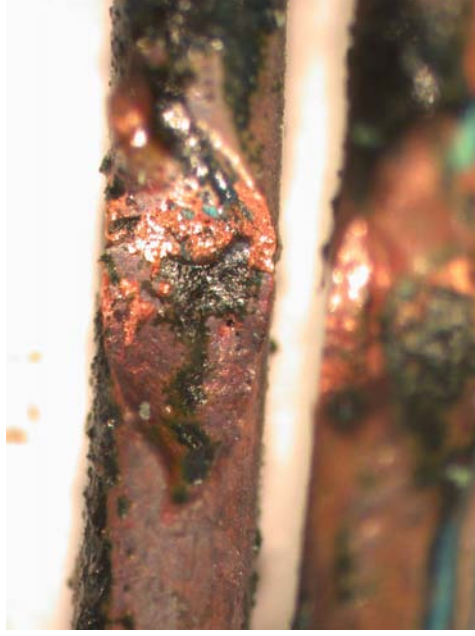
Figure 389 - Microscope image of the top notch at 40x magnification. The bottom notch is out of focus due to the limited field of view.

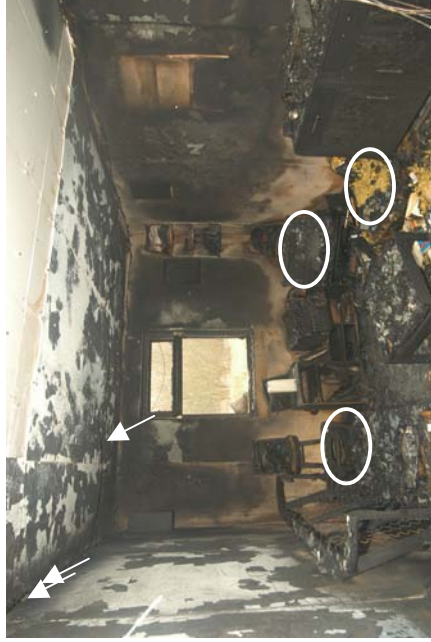
Figure 404 - Post-fire photograph with white ovals indicating the three points of origin. The right arrow locates the arcing damage to circuit 4. The middle arrow indicates the second area of arcing to circuit 4, the left arrow indicates the arcing damage to circuit 1.

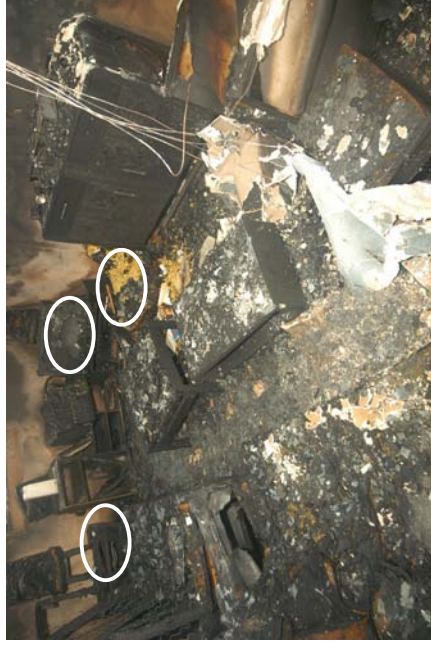
Figure 405 - A post-fire photograph showing the three points of origin close to the rear wall. The points of origin in order were the sofa end, the television and the upholstered stool.

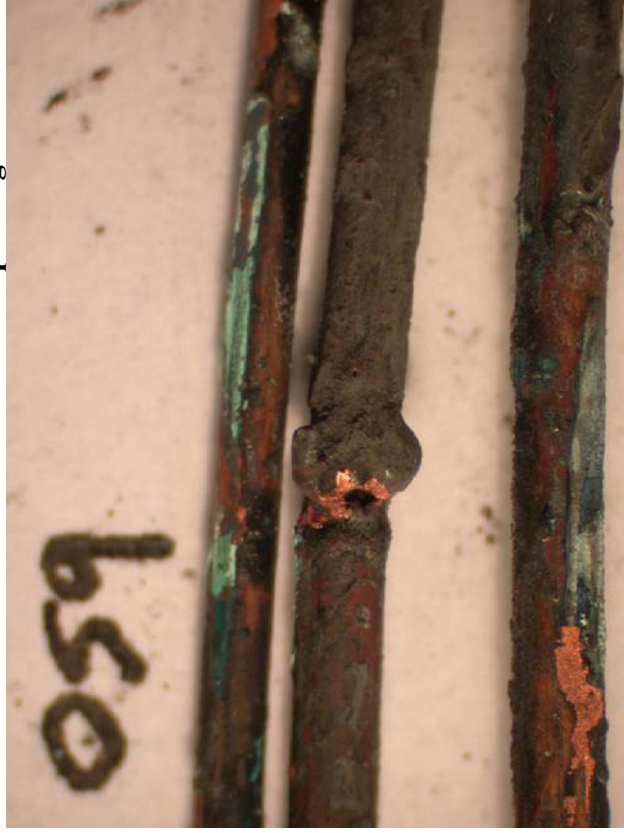
Figure 407 - Microscope image of exhibit 059 at 6x magnification. The localised metallic damage is limited to one conductor with a surface bead.

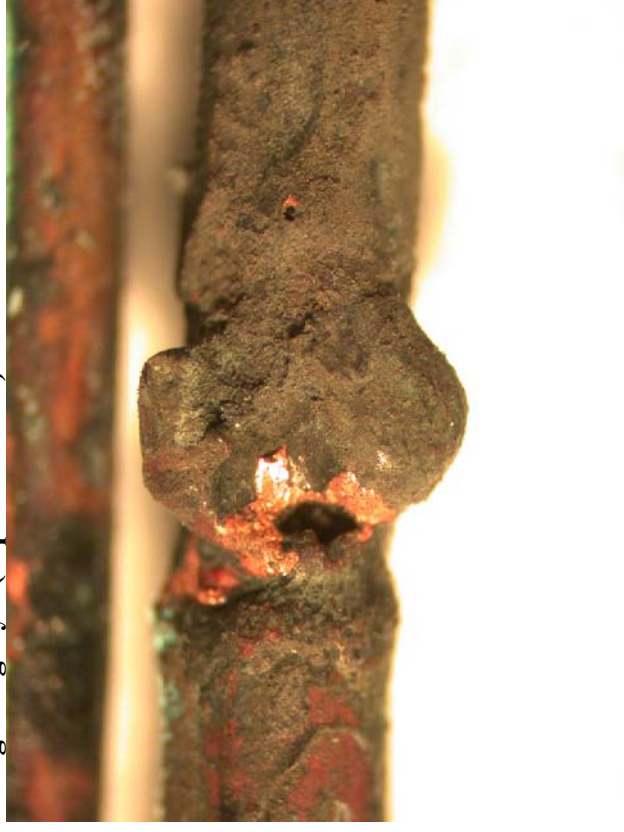
Figure 408 - Microscope image at 20x magnification of the area indicated in figure 407.

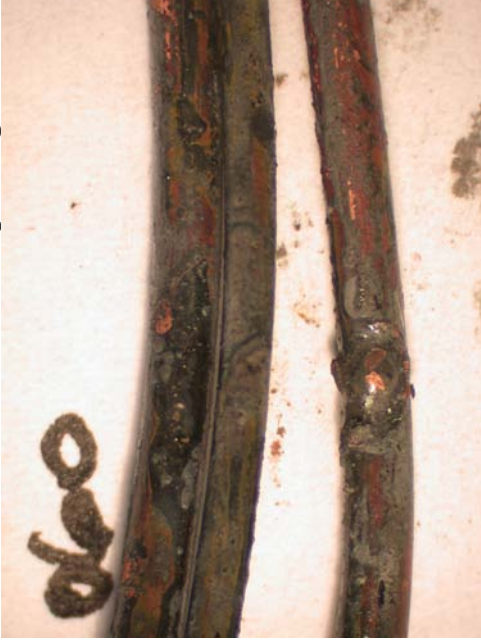
Figure 409 - Microscope image of exhibit 060. The arcing damage affects one of the three conductors with a bead within a notch.

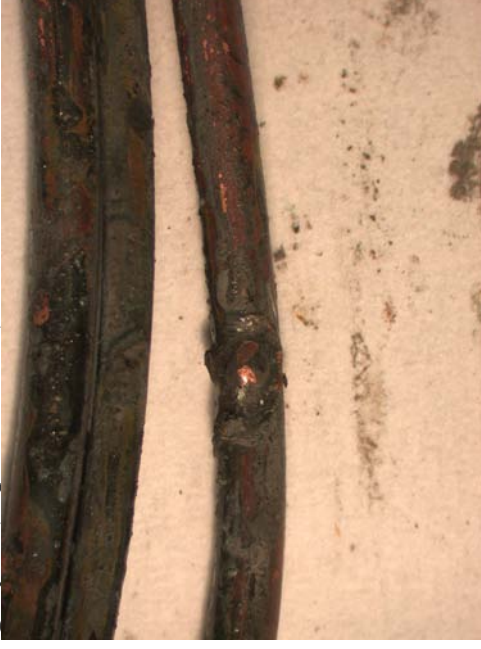
Figure 410 - Microscope image at 6x magnification of the area indicated in figure 409.

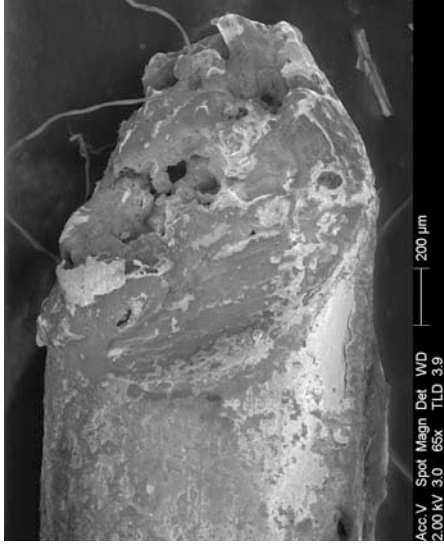
Figure 414 - SEM image at 65x magnification of the left end. The demarcation between the arcing damage and the undamaged conductor is clear in this image.

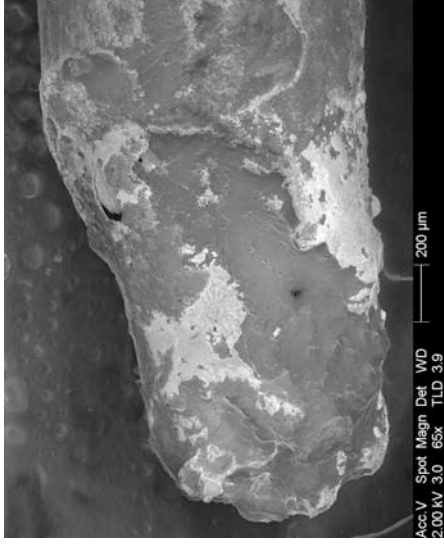
Figure 415 - SEM image of the right severed end at 65x magnification.

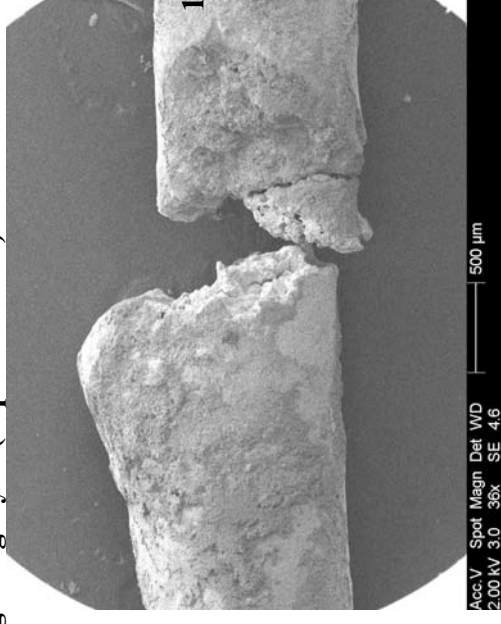
Figure 417 - SEM image of the two fractured ends. The left end has a bead at the top.

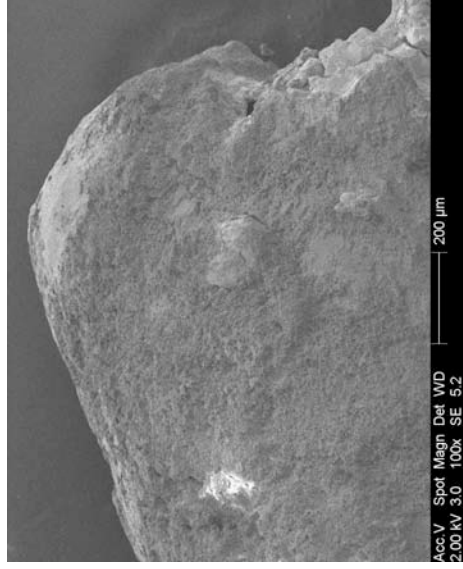
Figure 418 - SEM image at 100x magnification of the bead at the edge of the notch detailed in figure 417.

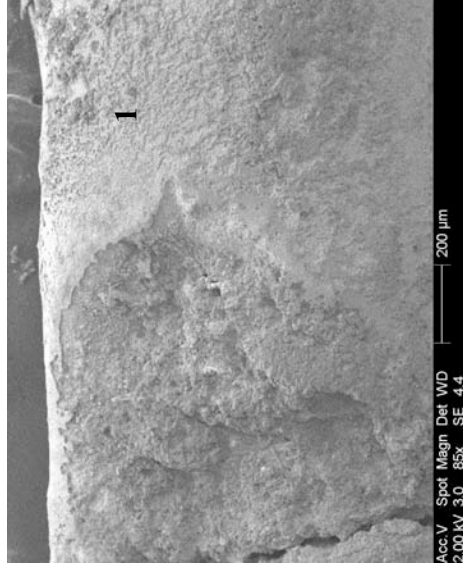
Figure 418 - The right edge of the notch indicating the demarcation of the edge of the arcing damage.

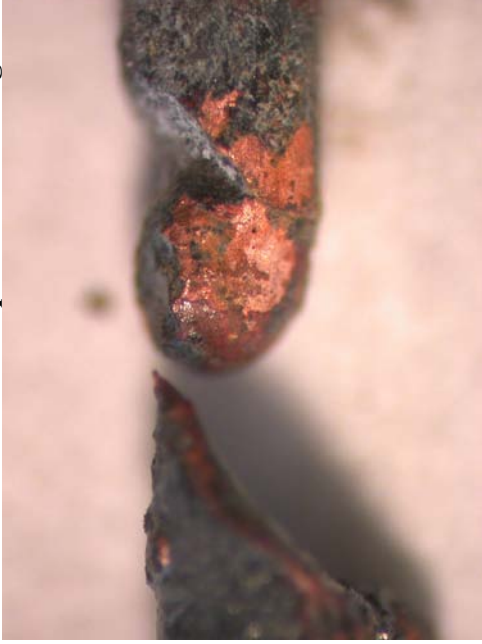
Figure 420 - A microscope image of exhibit 062a, the second area of arcing on circuit 4. This event operated the circuit breaker.

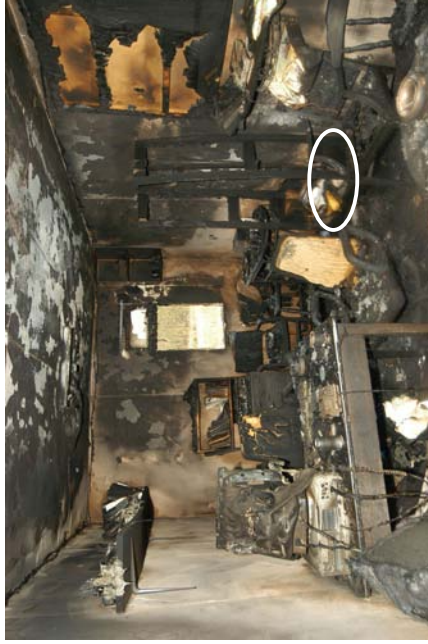
Figure 433 - Post-fire photograph of the compartment. The white arrow indicates the dominant area of origin for this fire. Burn patterns on the right wall detailed a large "U" pattern with its base either side of the wardrobe.

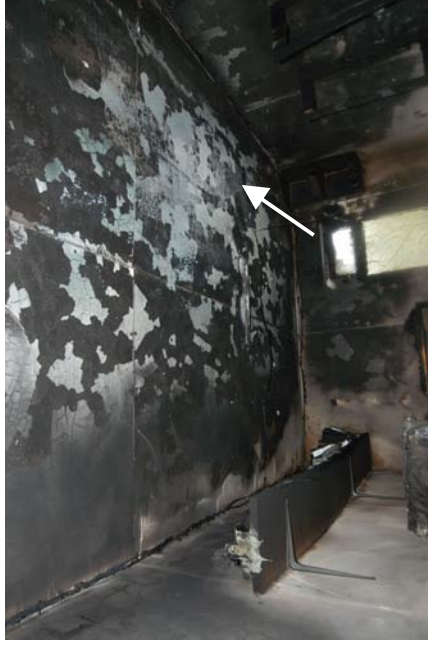
Figure 434 - Post-fire photograph of the compartment with a white arrow indicating the arcing damage location on circuit 4 that was within 0.5m of the wardrobe edge.
