**University of Strathclyde**  
**Department of Pure and Applied**  
**Chemistry**  
**Centre for Forensic Science**

**Developing a reliable systematic**  
**analysis for arc fault mapping**

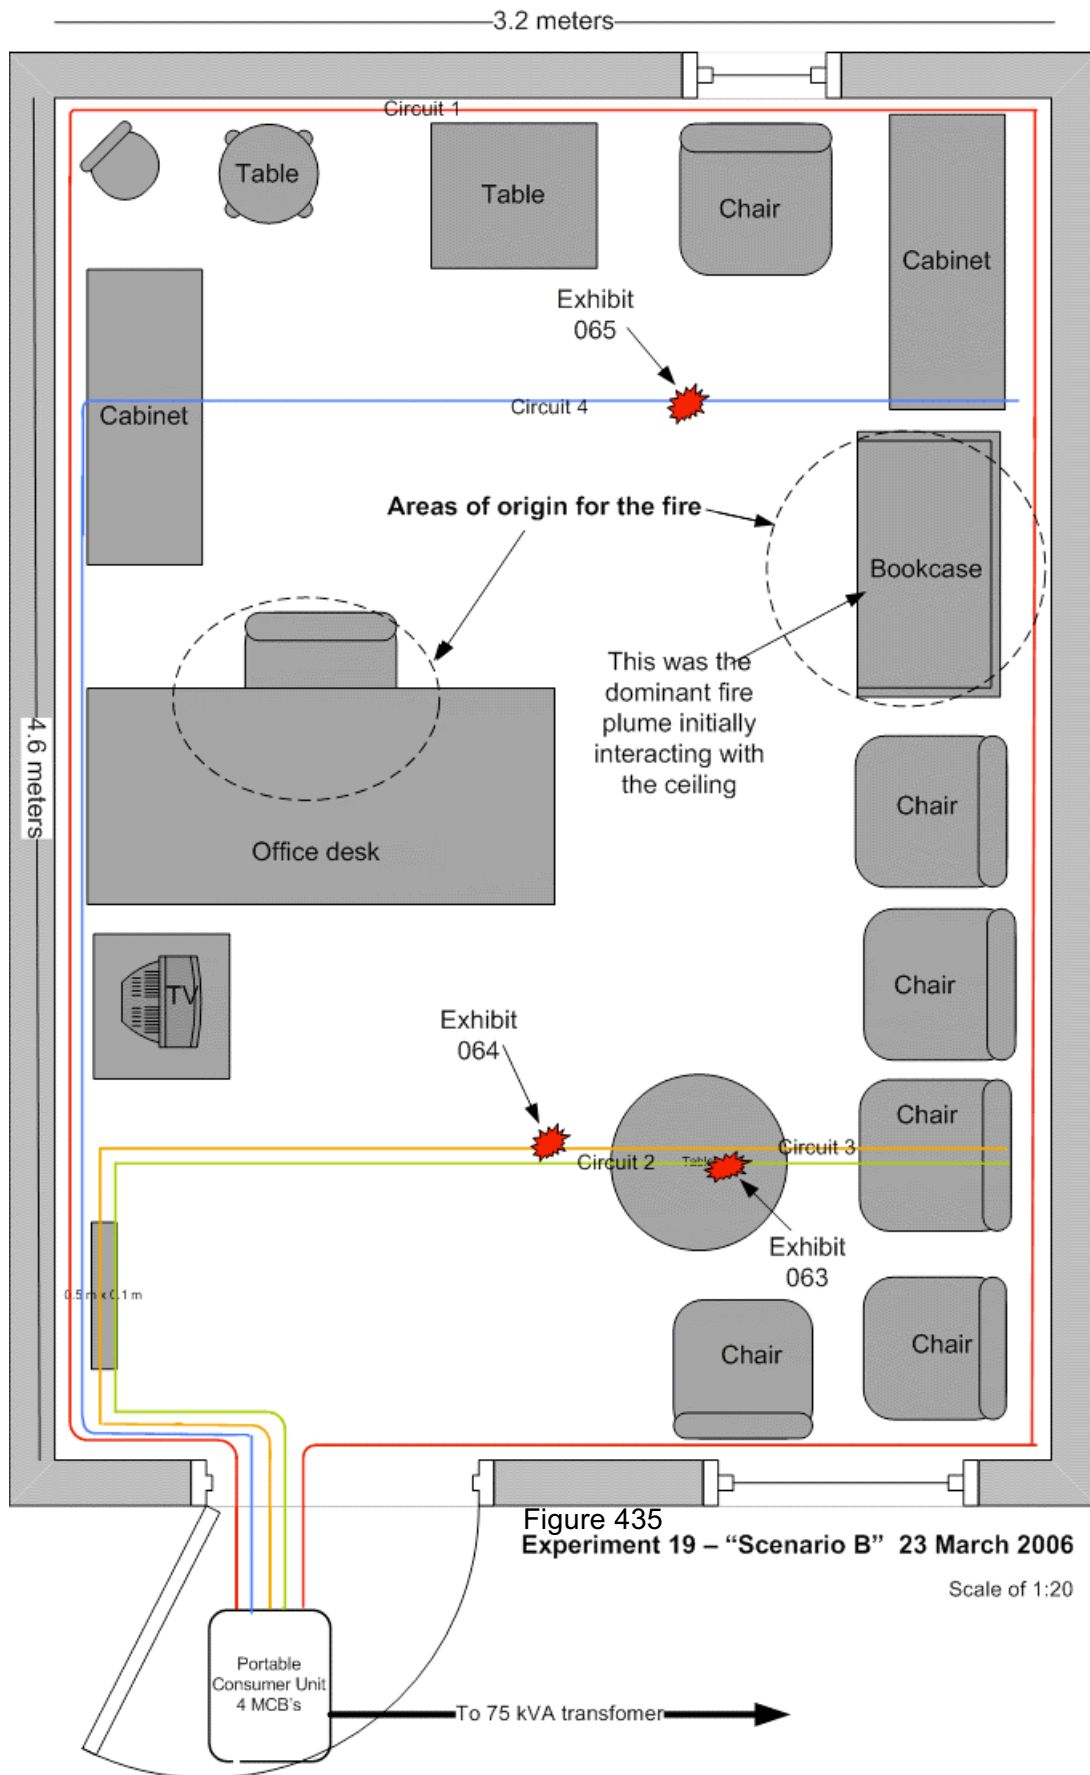
**Microscope and SEM images for exhibit 063 - arcing category F (experiment 19)**

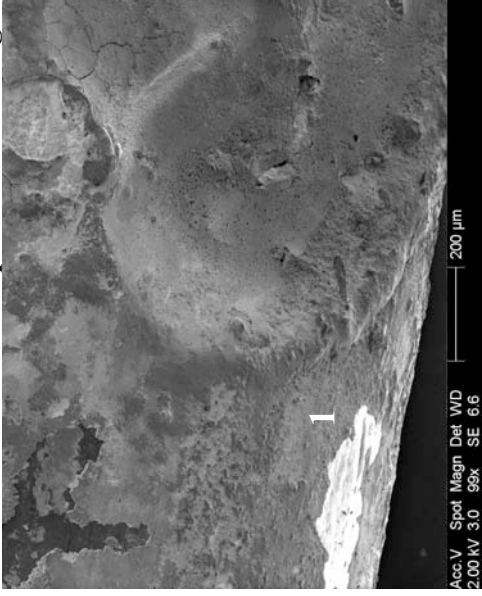
Figure 436 - SEM image at 99x magnification detailing the demarcation area between the arcing damage and the undamaged conductor on the left edge of figure 437.

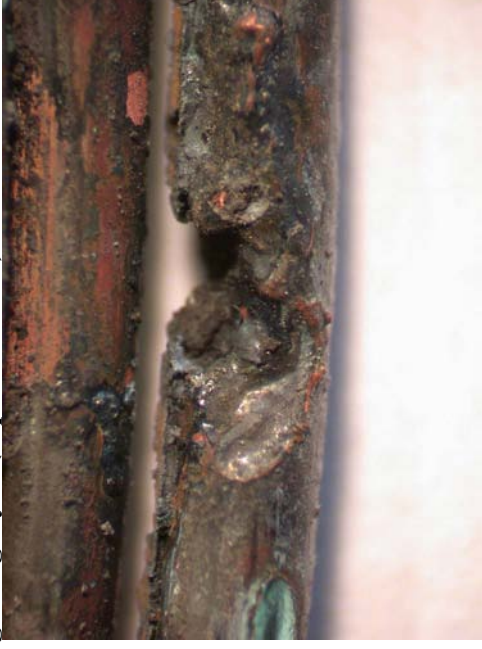
Figure 437 - Microscope image of exhibit 063. One of the three conductors had arcing damage consisting of a large notch.

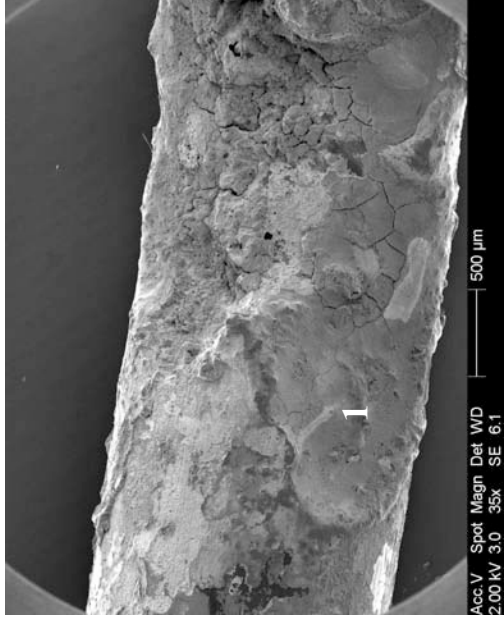
Figure 438 - SEM image of left side of the large notch in figure 437.

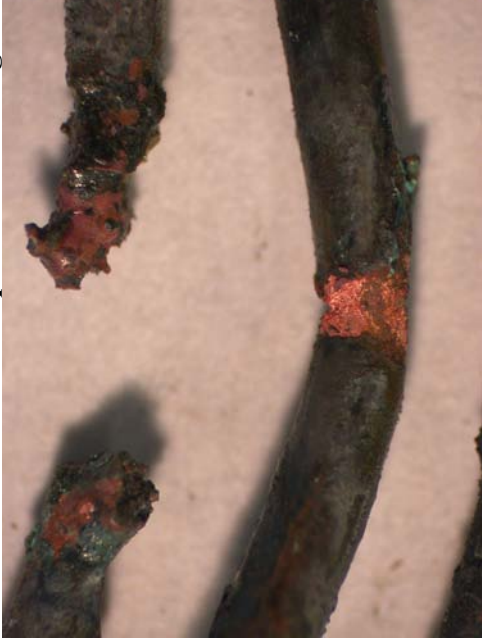
Figure 443 - Microscope image of exhibit 064. The top conductor is severed and there was a notch in the bottom conductor.

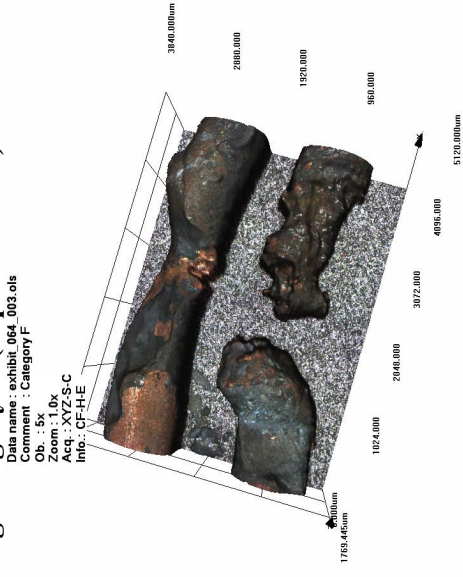
Figure 447 - LEXT image of the two conductors of exhibit 064.

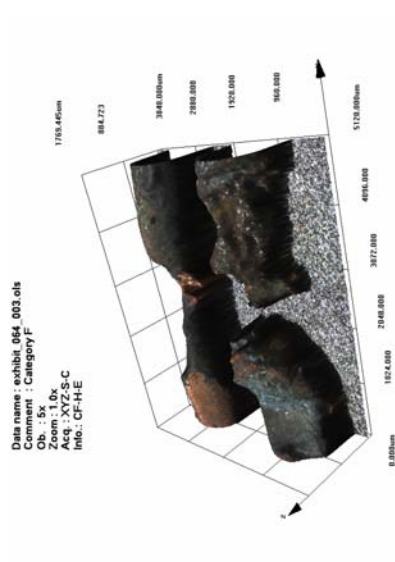
Figure 449 – Capture of 3-D image from the LEXT software package.

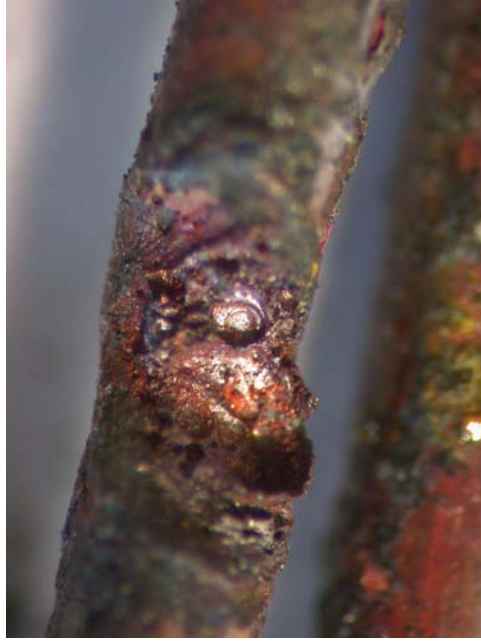
Figure 453 - Microscope image of the notch arcing damage on the middle conductor of figure 451. Depth of field limitations rendered both edges of the notch out of focus.

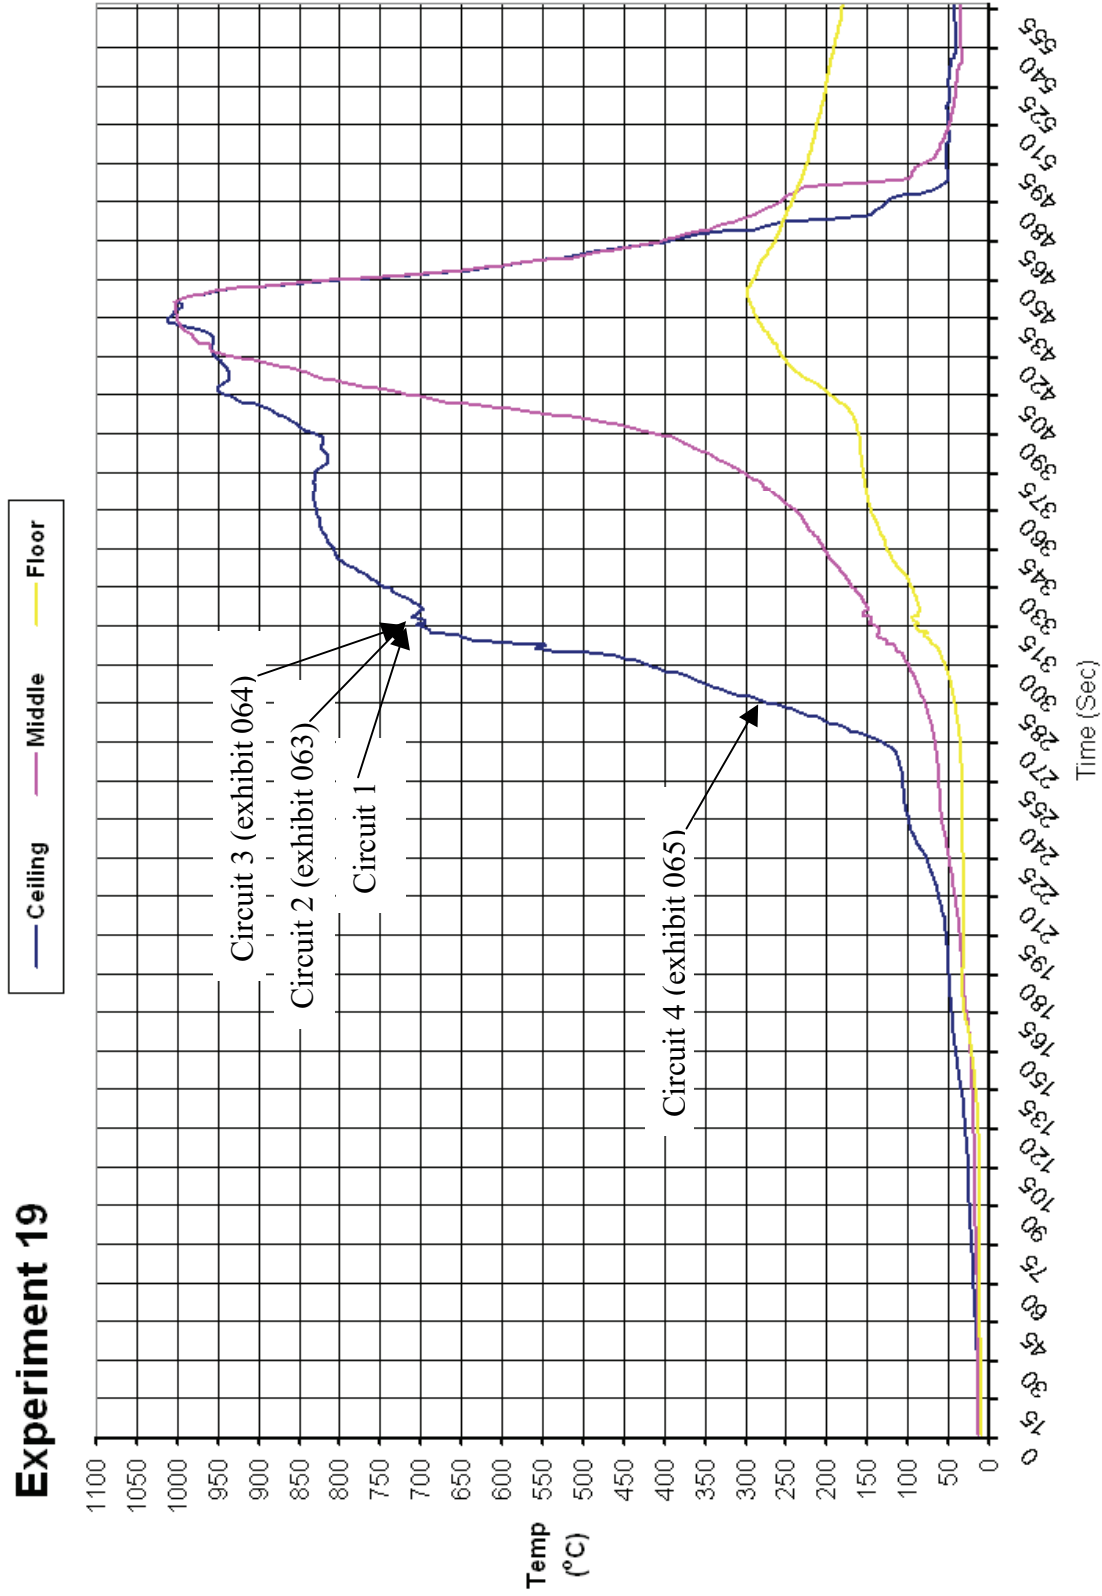
Figure 454 - Time temperature graph for experiment 19

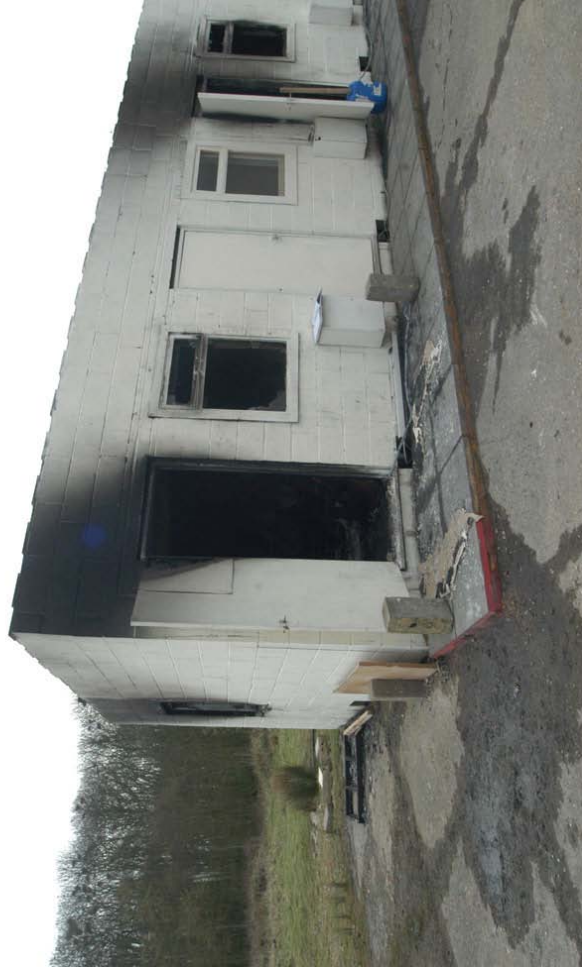
Figure 456 – “Scenario D” 20 April 2006

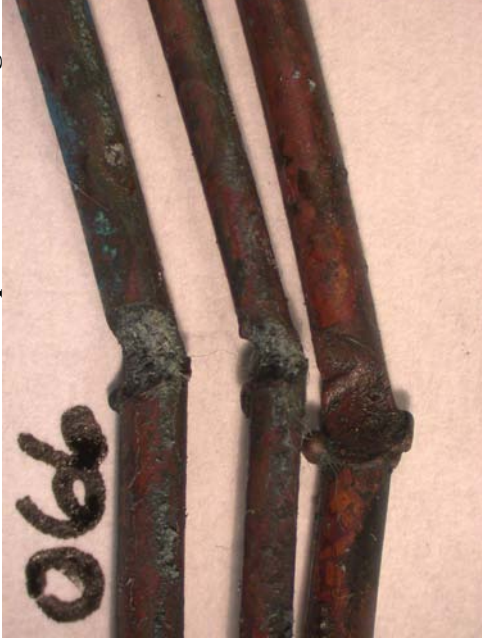
Figure 462 - Microscope image of exhibit 066 with notch damage to all three conductors.

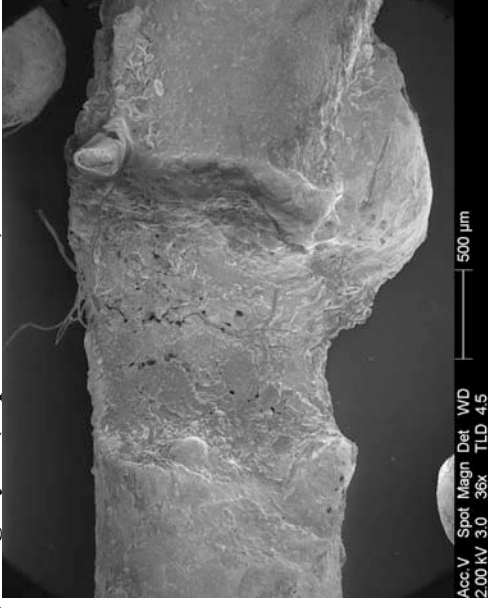
Figure 463 - SEM image of the centre conductor detailed in figure 462.

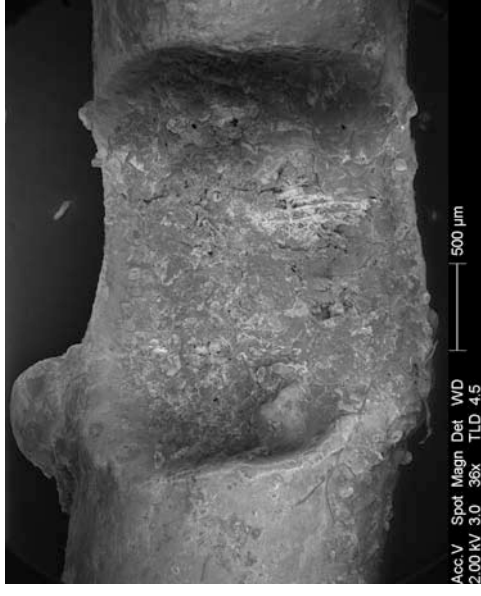
Figure 465 - SEM image of the top conductor in figure 462, this image details the clear demarcation between the arcing damage and the undamaged conductor.

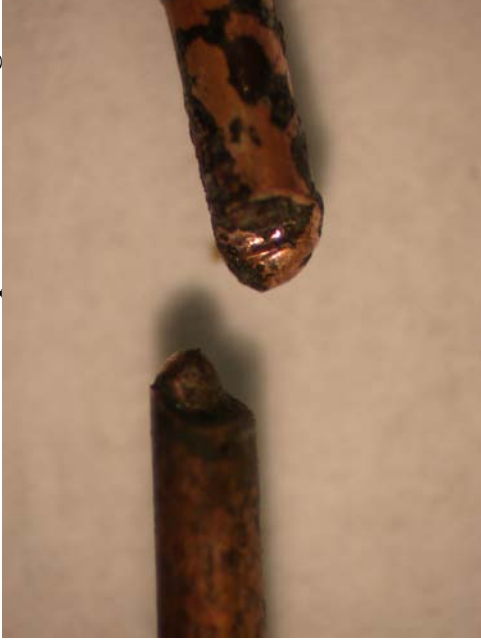
Figure 466 - Microscope image of exhibit 067 detailing the two severed ends of the one conductor with metallic damage.

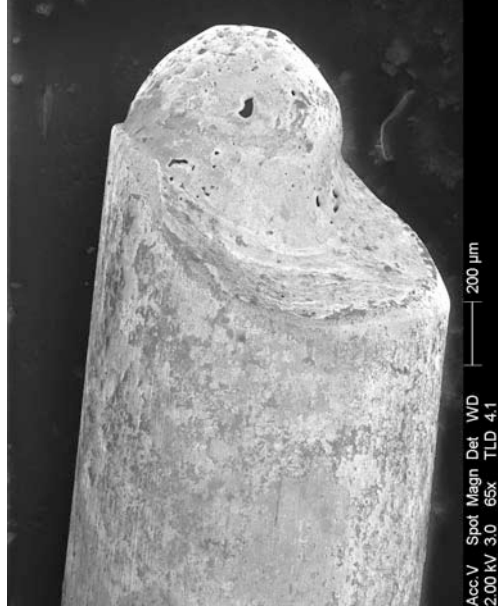
Figure 467 - SEM image of the left severed end at 65x magnification detailed in figure 466.

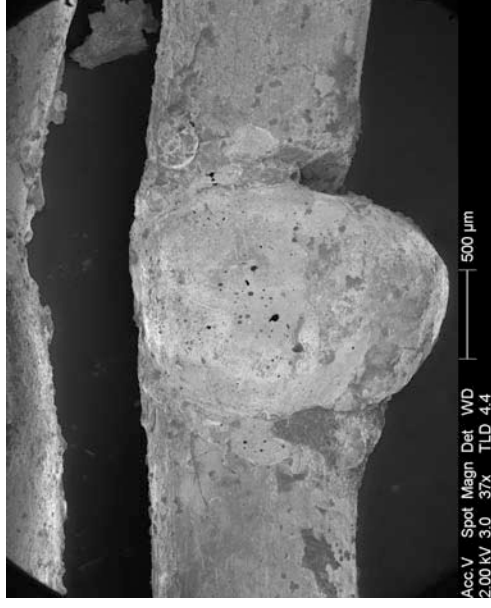
Figure 476 - SEM image detailing the bottom conductor's arcing damage detailed in figure 474.

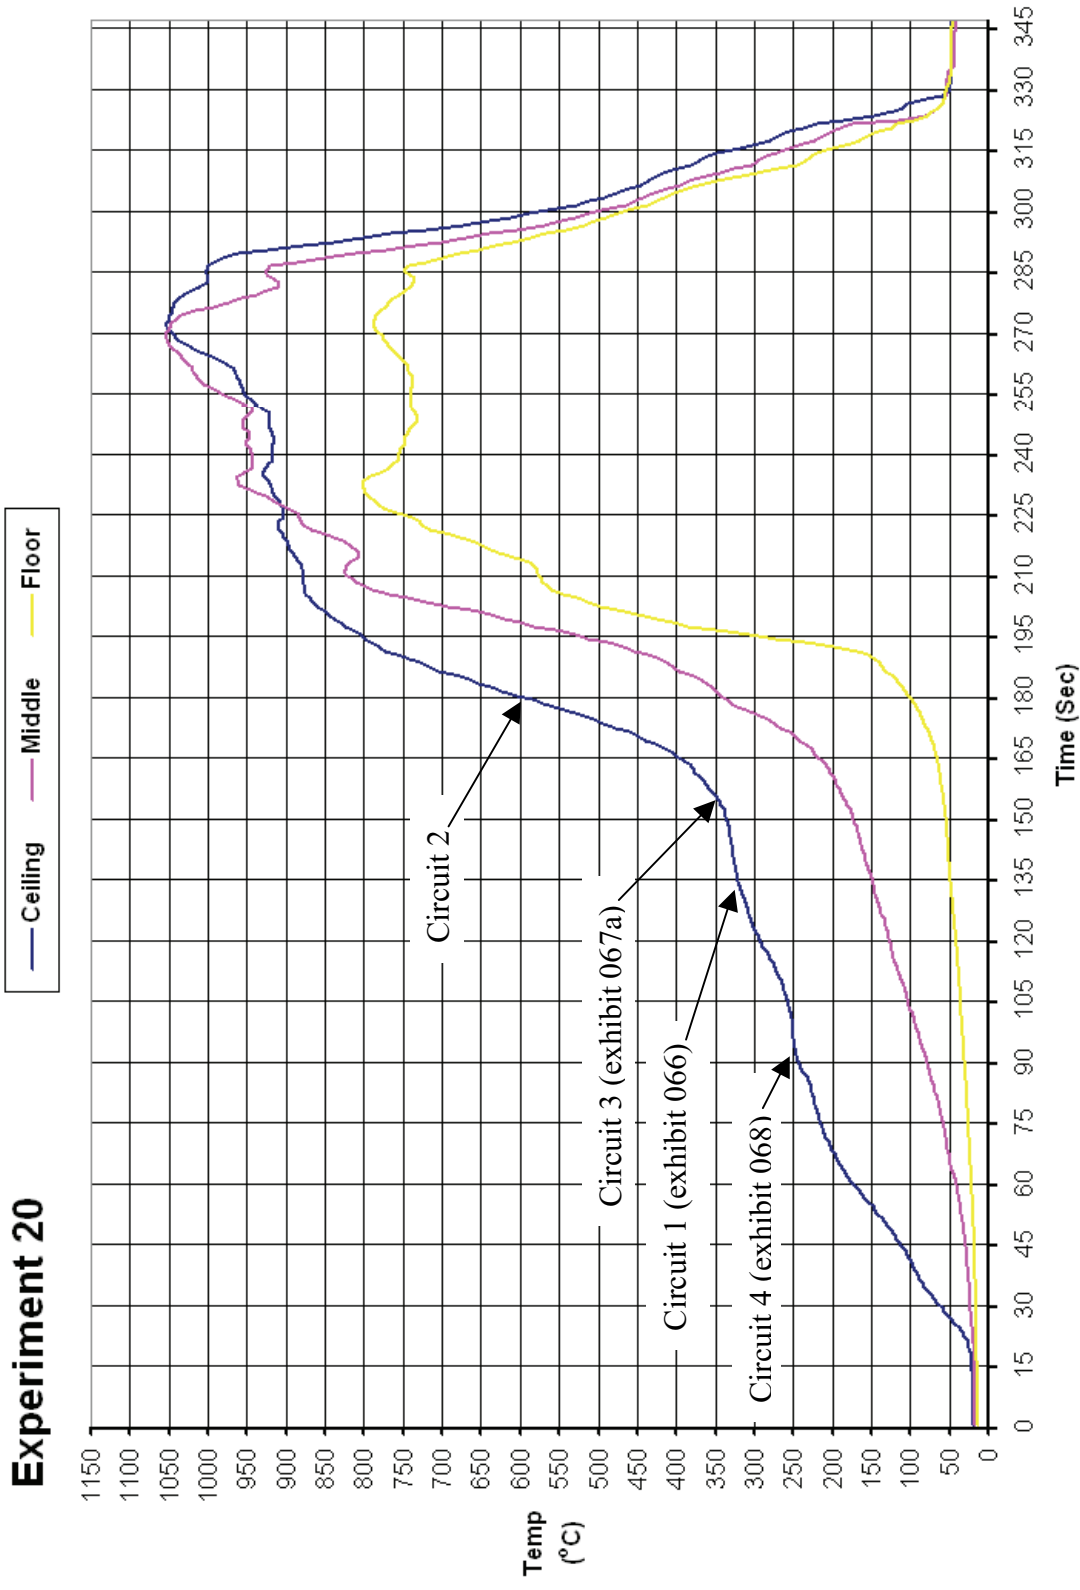
Figure 477 - Time temperature graph of experiment 20

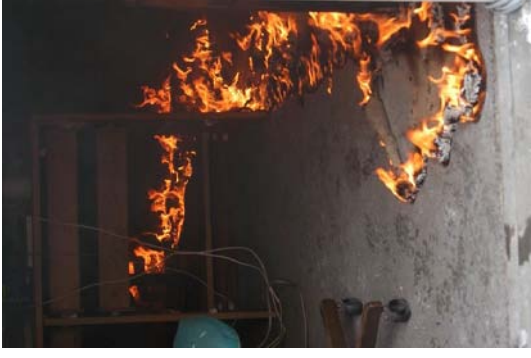
Figure 481 - A view of the trailer of the burning PU foam trailer soaked with ignitable liquid, taken from the doorway.

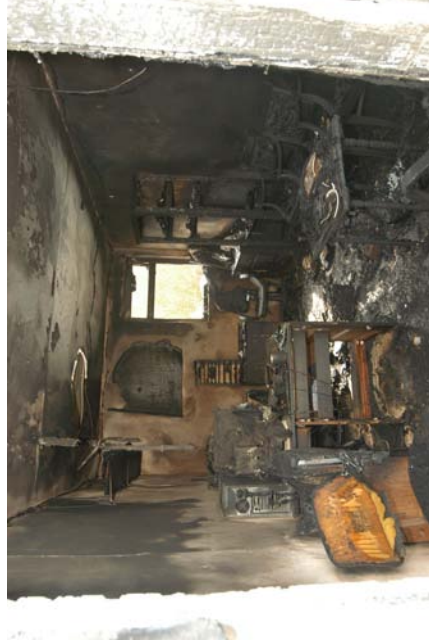
Figure 482 - Post-fire photograph of the compartment.

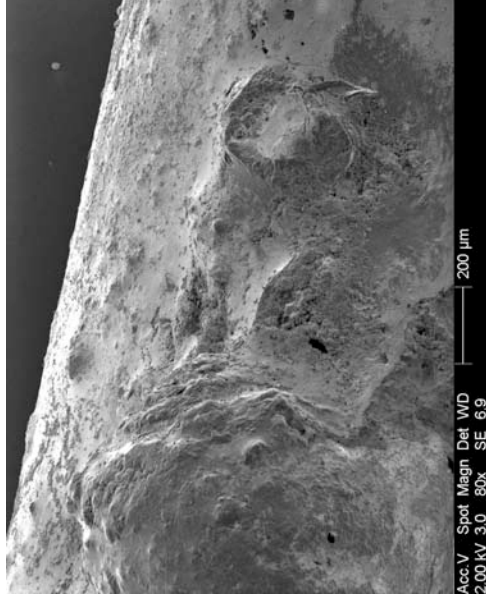
Figure 488 - SEM image at 80x magnification detailing the edge and demarcation of the arcing damage.

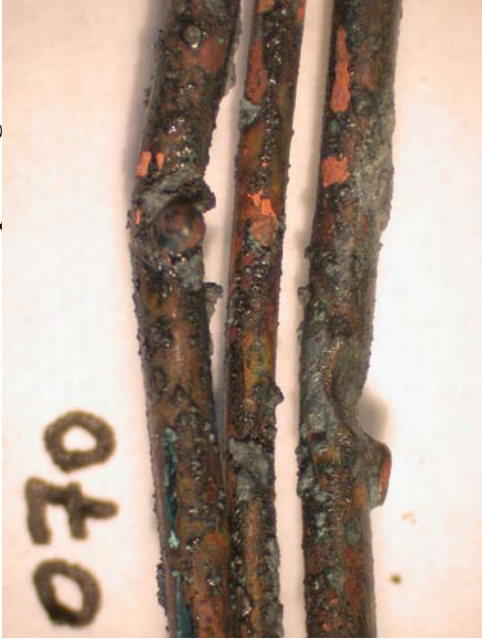
Figure 489 - Microscope image of exhibit 070 with all three conductors for this circuit detailed.

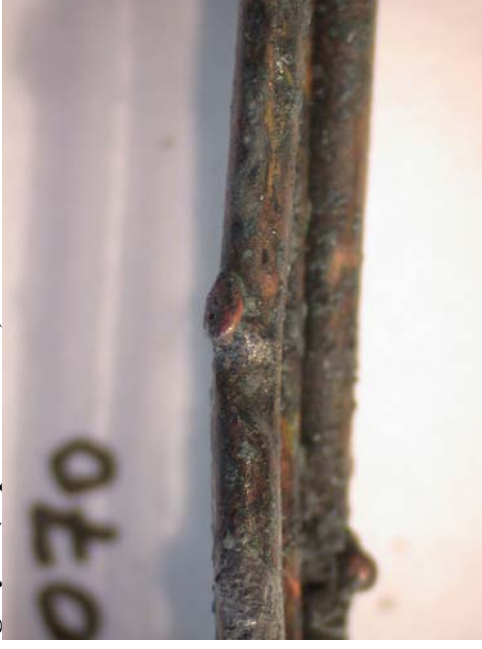
Figure 490 - Image of the two conductors with arcing damage. Depth of field issues renders one conductor out of focus in this image.

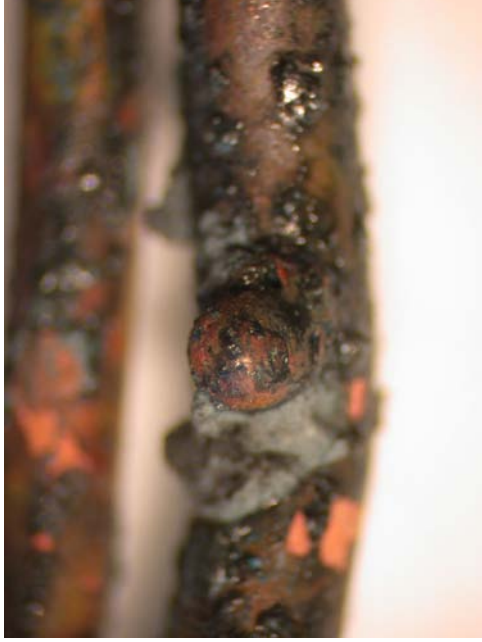
Figure 491 - Close-up view of the bead for the top conductor in figure 489.

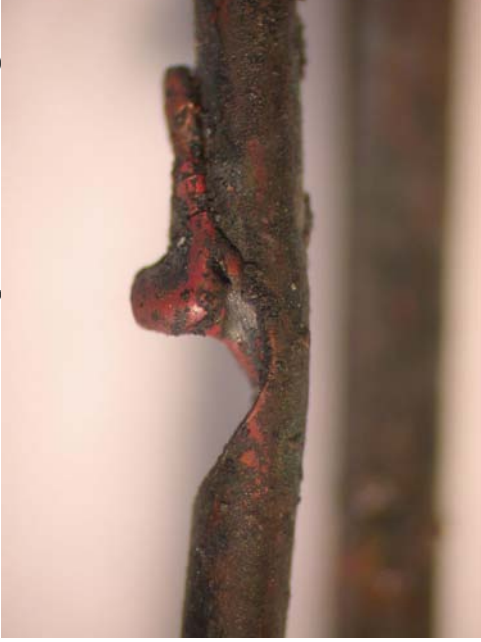
Figure 493 - Microscope image of one of the two conductors with arcing damage for circuit 3.

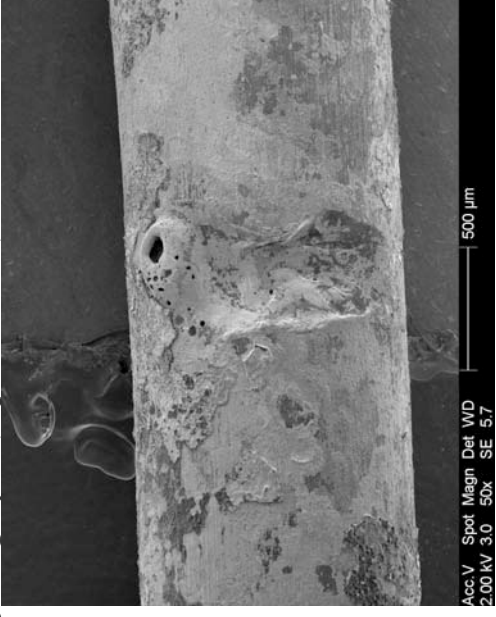
Figure 494 - SEM image of the bottom conductor (out of focus in figure 493) with a small notch.

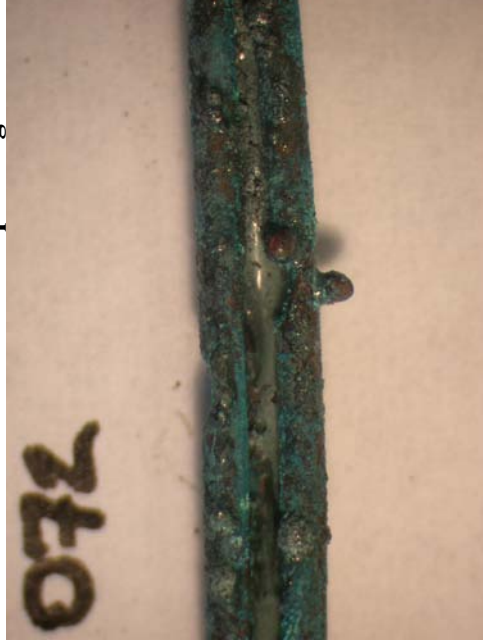
Figure 499 - Microscope image of exhibit 072 with arcing damage to two of the three conductors.

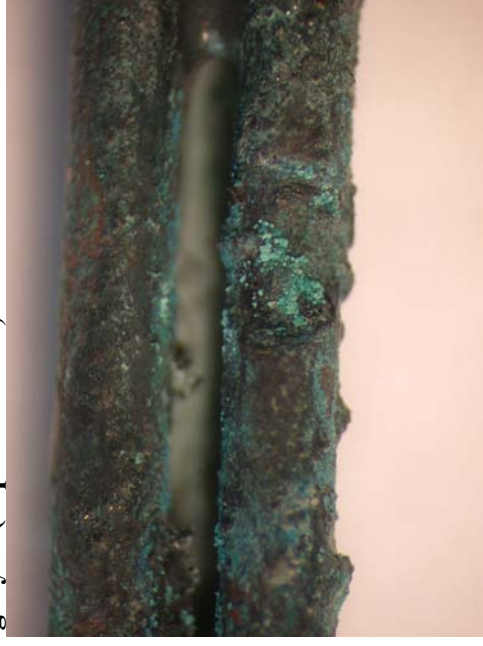
Figure 500 - 20x magnification of the bead within the notch of the top conductor.

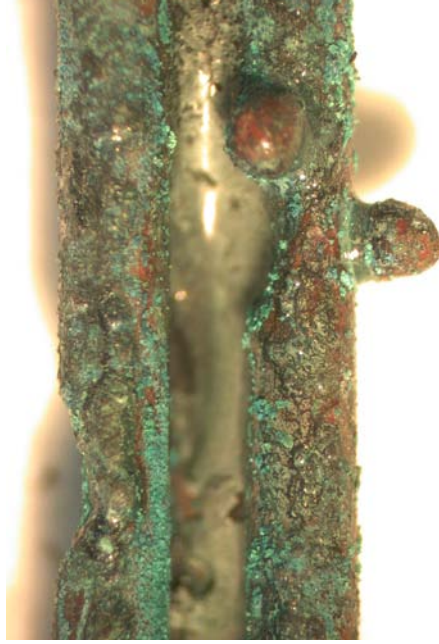
Figure 501 - 20x magnification of the notch with an adjacent bead. There is a lot of oxide corrosion on the surface of this exhibit.

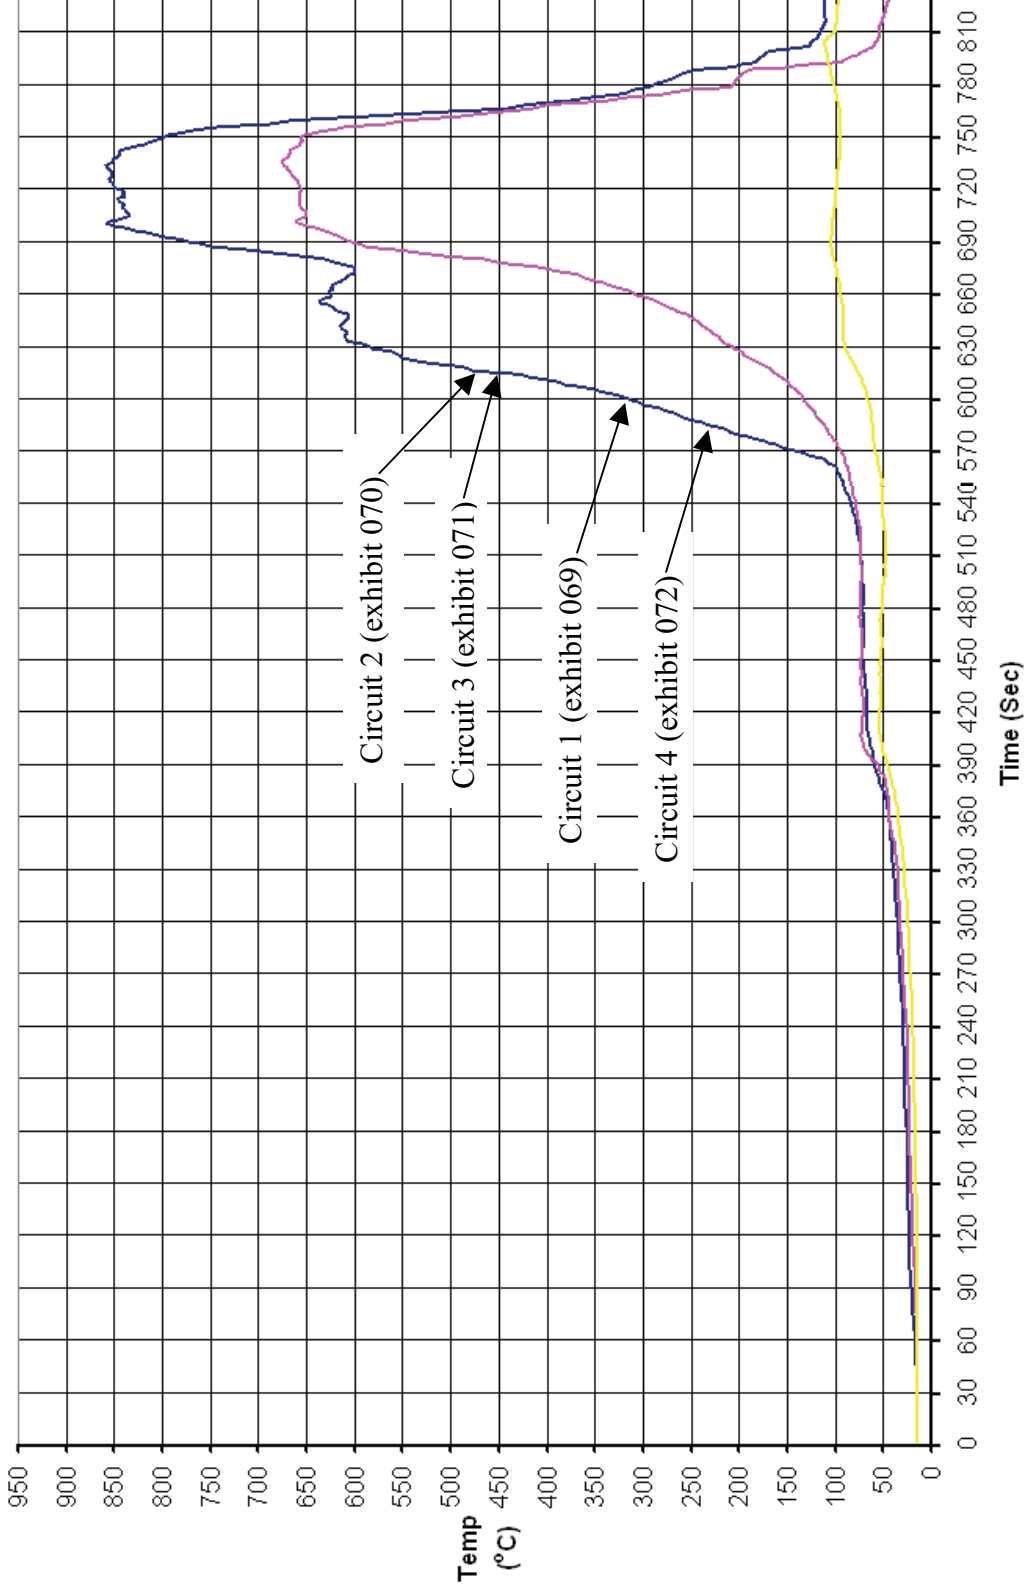
Figure 502 - Time temperature graph for experiment 21

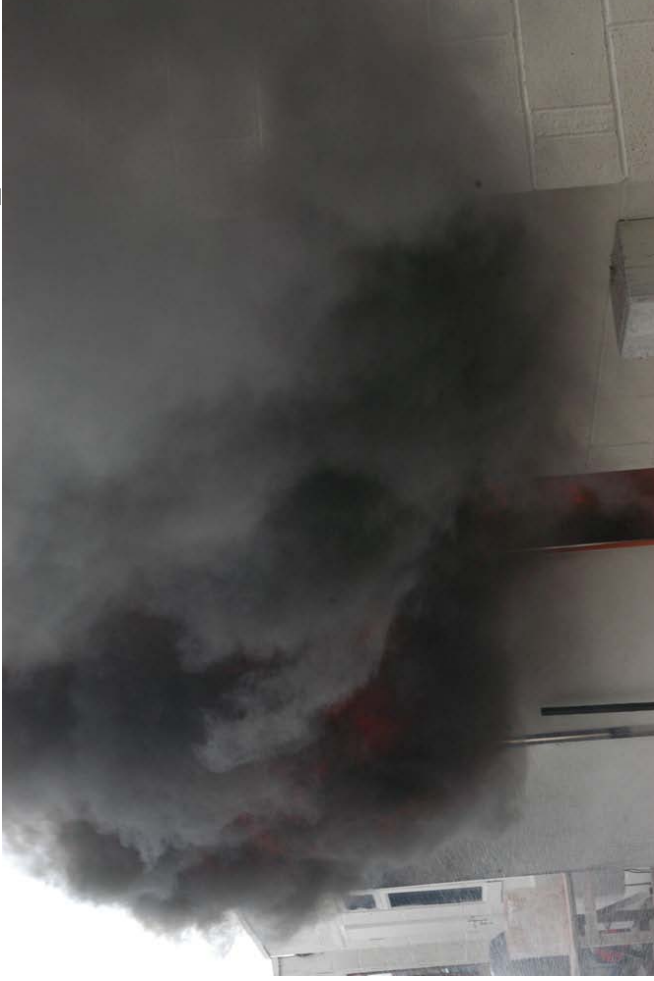
The fire in experiment 22 (scenario A) originated on a clothing rail and the side of each adjacent bed at the far end of the room.

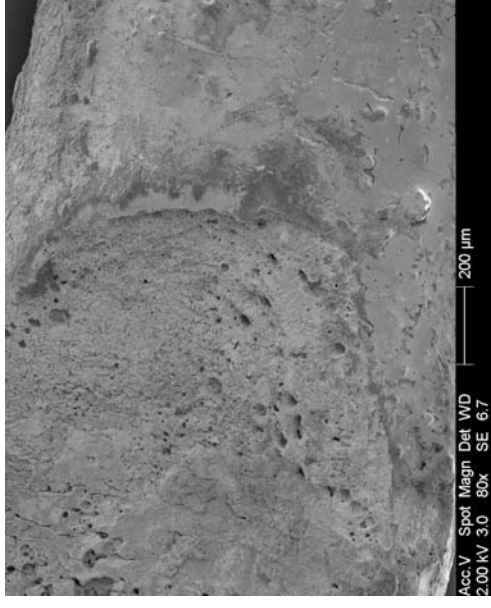
Figure 513 - SEM image of the right side of the notch for the bottom conductor in figure 512, detailing the clear demarcation between the arcing damage and the undamaged conductor.

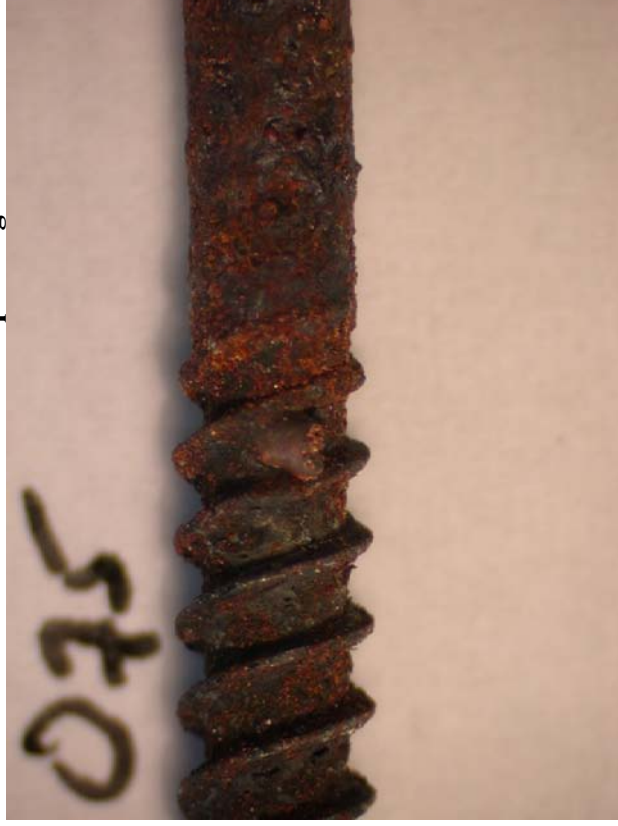
Figure 520 - Microscope image of exhibit 075. This is the fixing screw for circuits 2 and 3. It has a copper conductor welded to its surface. The conductor fractured during the recovery process.

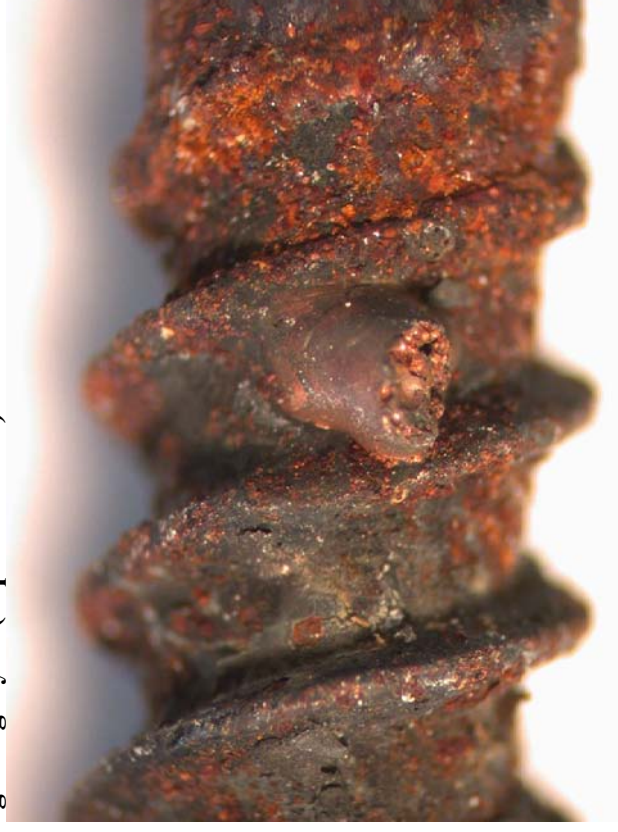
Figure 521 - Close-up microscope image at 40x magnification of the copper conductor welded to the surface of the fixing screw.

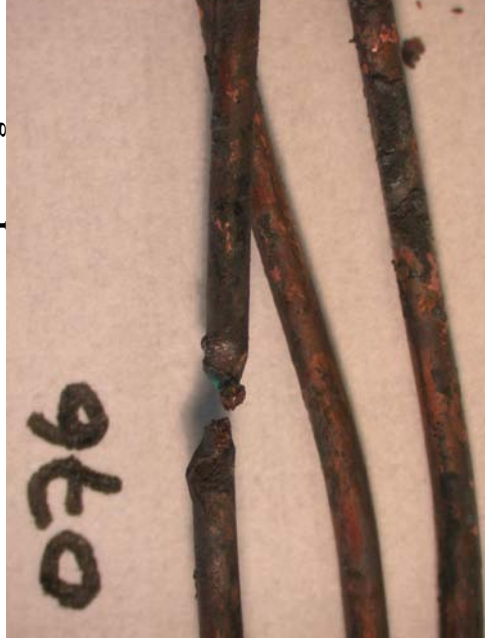
Figure 522 - Microscope image of exhibit 076. This comprises of two severed ends. The left end appears to be fractured and is linked to exhibit 075.

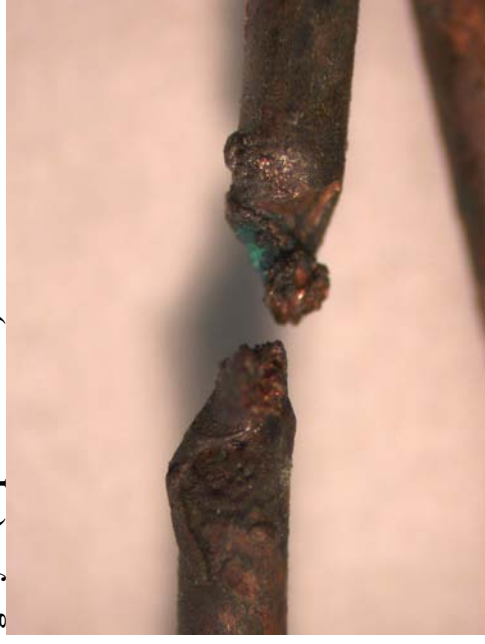
Figure 523 - Close-up microscope image at 20x magnification of the two severed ends.

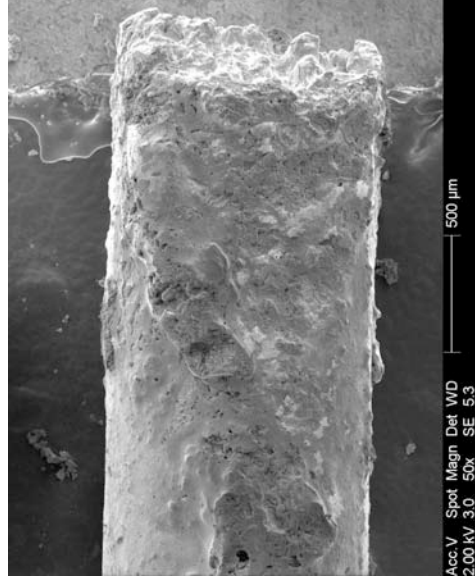
Figure 527 - SEM image of the right severed end detailed in figure 525. The demarcation is observed at the edge of the notch.

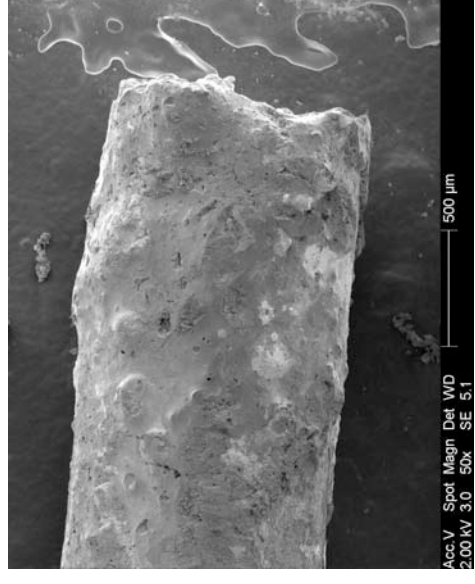
Figure 528 - SEM image of the left severed end in the microscope of figure 526.

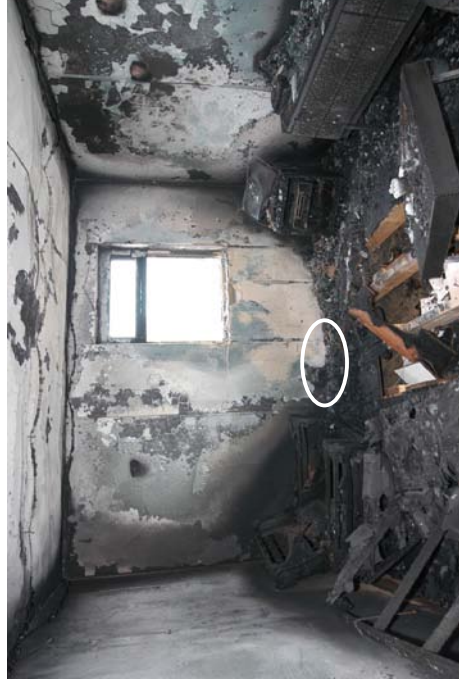
Figure 537 - Post fire photograph detailing the fire's area of origin. The floor has failed just in front of the remains of the Christmas tree.

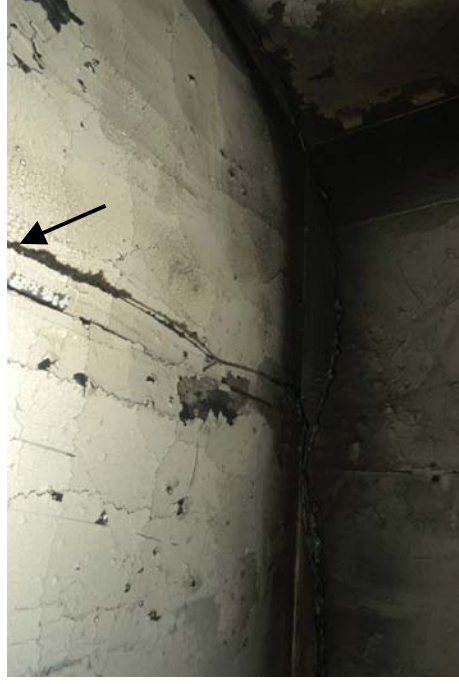
Figure 538 - Post-fire photograph of the rear left corner of the ceiling above the fire's area of origin. The arrow indicates circuit 4 that was routed across the ceiling.

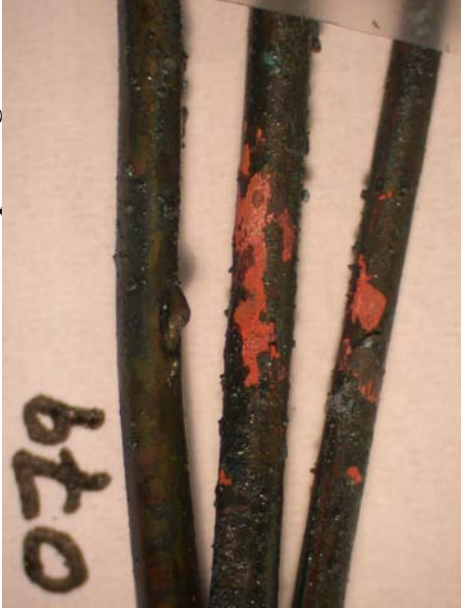
Figure 547 - Microscope images of exhibit 079. Overview of exhibit with damage to one of the three conductors, at 6x magnification.

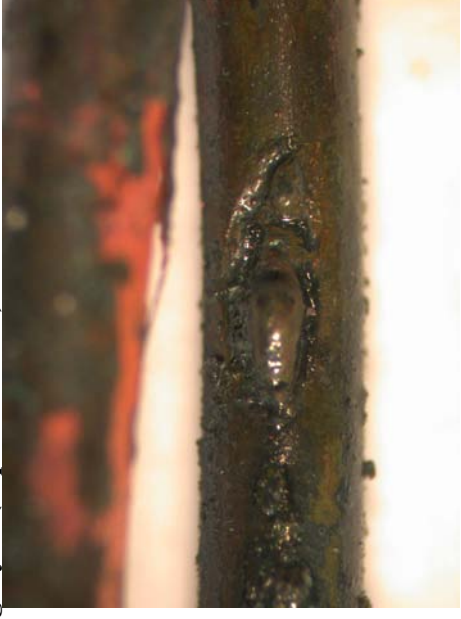
Figure 548 - Microscope image at 20 x magnification, detailing the bead within a small notch.

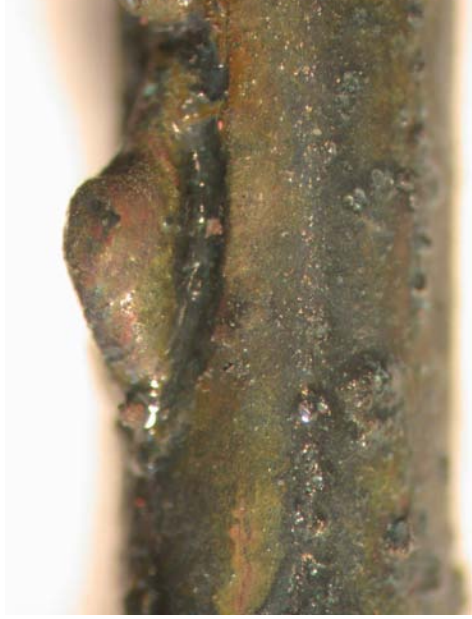
Figure 550 - 40x magnification microscope image of the bead and notch. This image details the demarcation between the localised metallic damage and the un-damaged conductor.

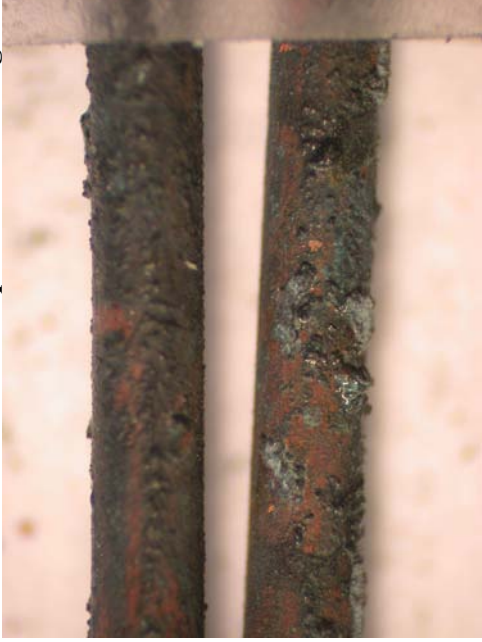
Figure 551 - Microscope image of exhibit 080 detailing the shallow metallic damage to both conductors.

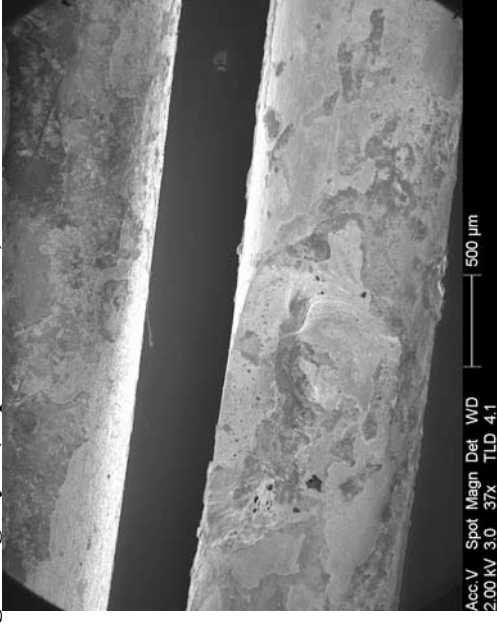
Figure 552 - SEM image highlighting the shallow notch damage of the bottom conductor in figure 551.

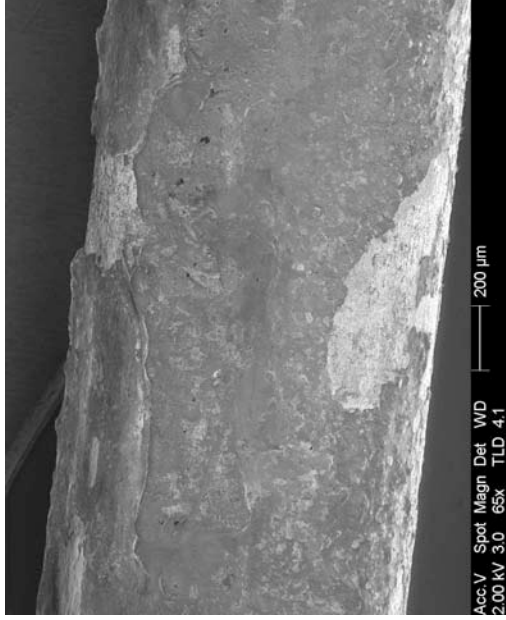
Figure 553 - SEM image of the minimal melting damage to the top conductor in figure 551.

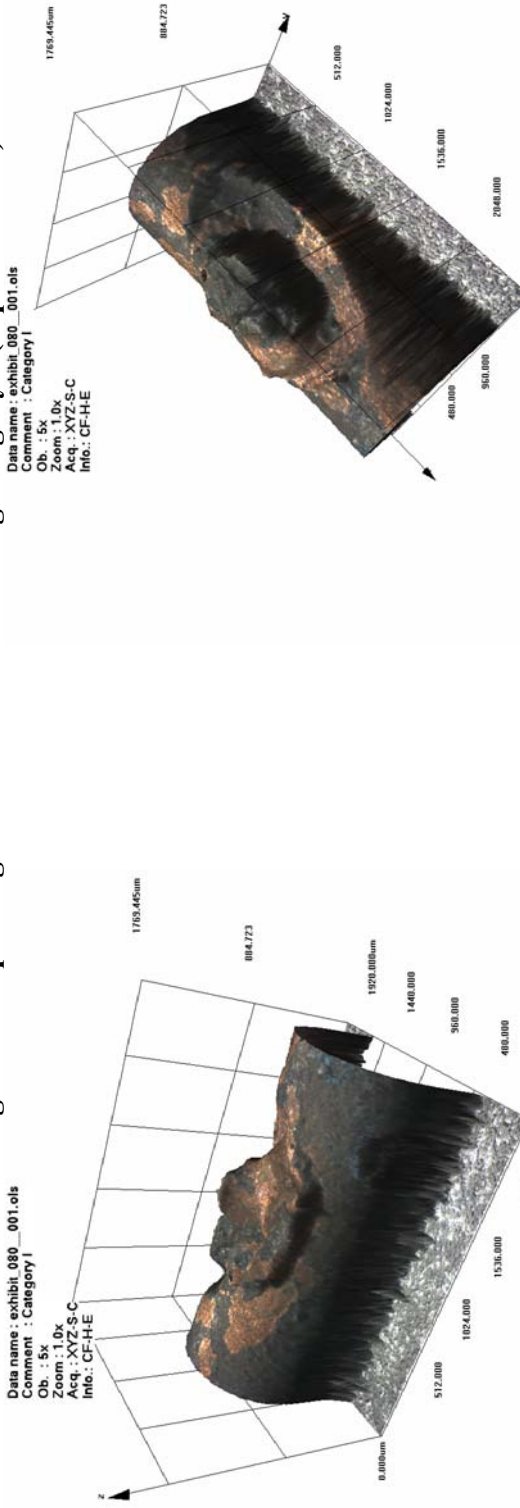
Figure 554 - LEXT image of exhibit 080, figure 552 is the comparison SEM image.
