**University of Strathclyde**  
**Department of Pure and Applied**  
**Chemistry**  
**Centre for Forensic Science**

**Developing a reliable systematic**  
**analysis for arc fault mapping**

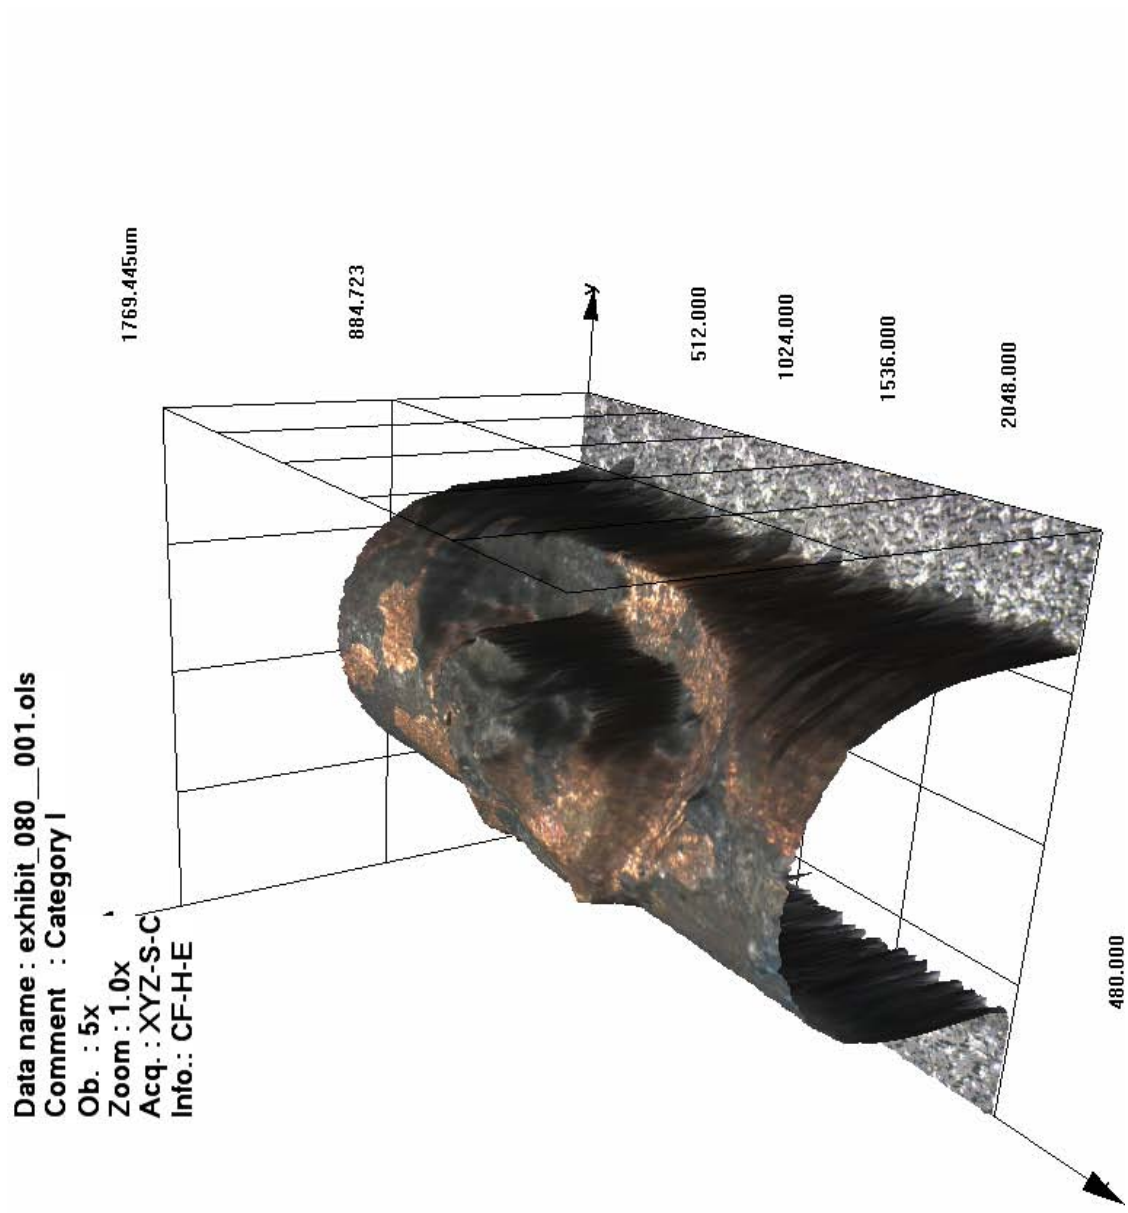
Figure 558 - Full-size LEXT image for exhibit 080 detailing the demarcation area between the localised metallic (arcing) damage to the conductor and the undamaged area.

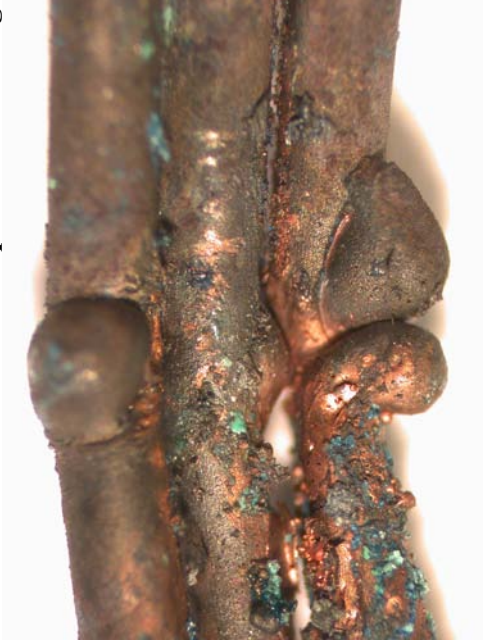
Figure 559 - Microscope image of exhibit 081 with large multiple beads to all three conductors.

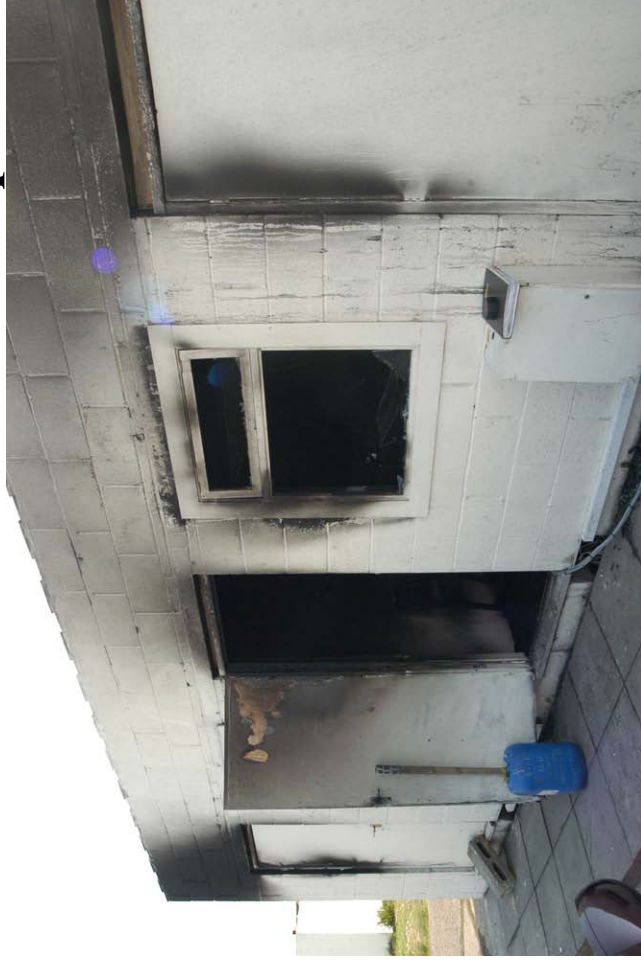
The fire in experiment 24 (scenario B) originated in a refuse bin located in the rear left corner of the compartment (as viewed from the entrance door).

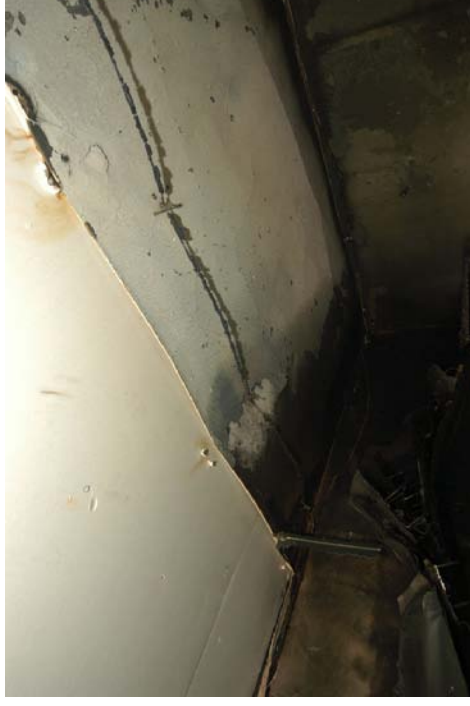
Figure 569 - View of the fire damaged wiring above the fire's area of origin.

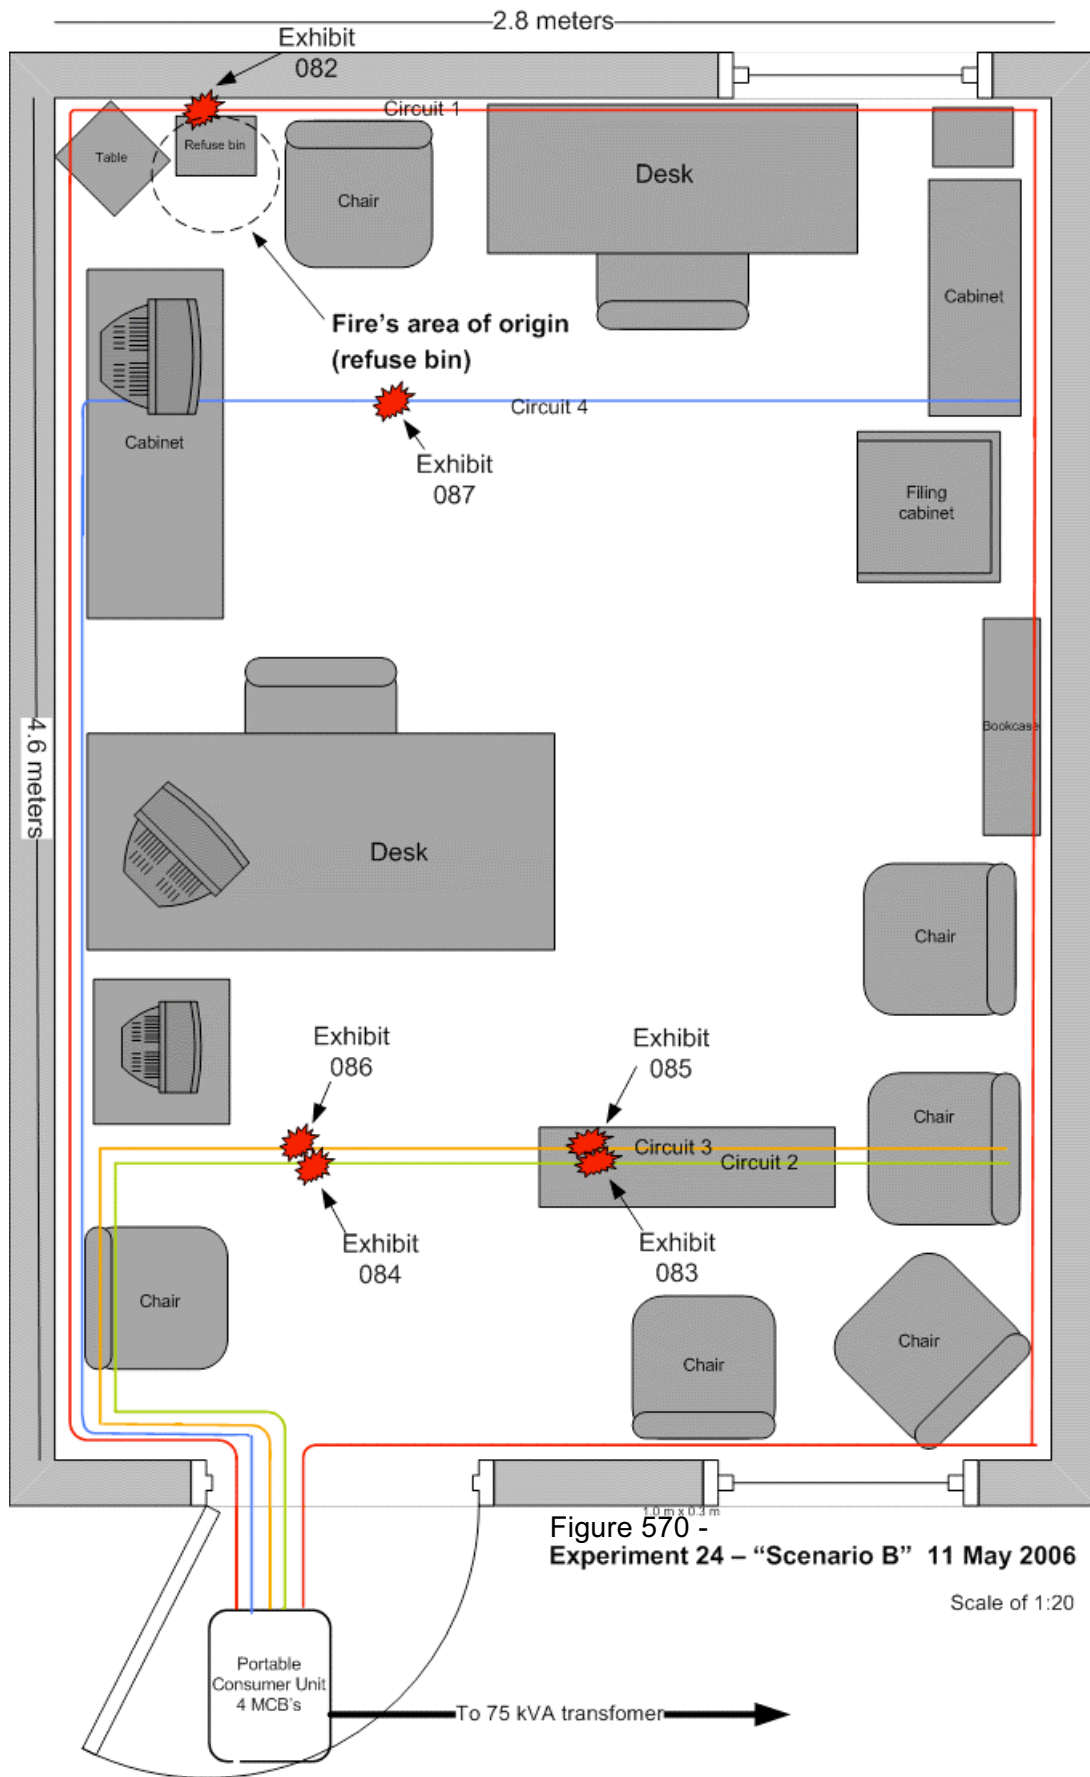
**Microscope images for exhibit 082 - arcing category B (experiment 24)**

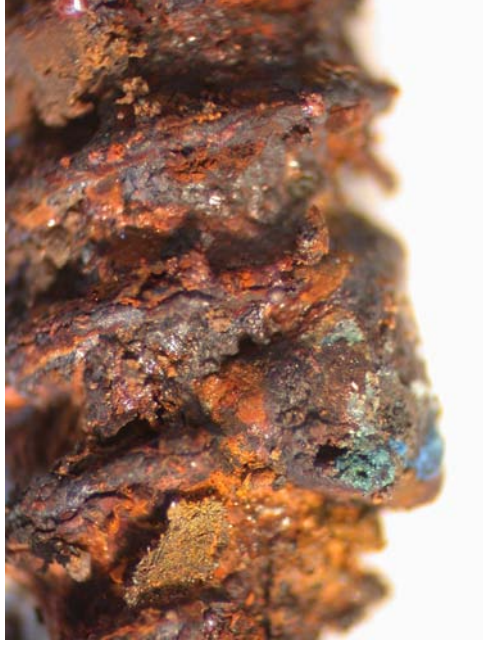
Figure 574 - A molten bead was attached to the fixing screw adjacent to the arcing damage for this exhibit.

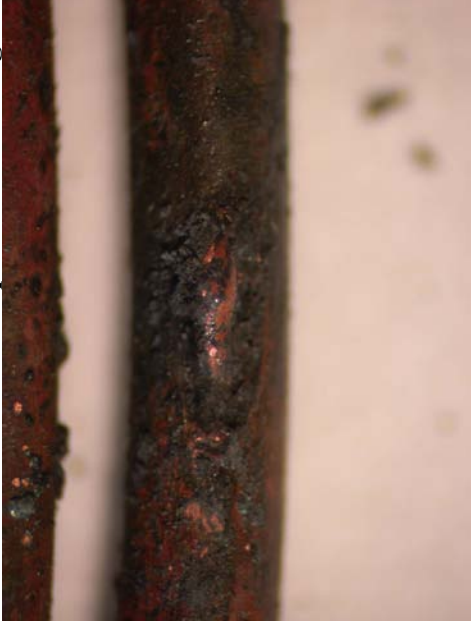
Figure 575 - Microscope image of exhibit 083. This arcing damage is one of two areas affecting this circuit. This exhibit was furthest away from the electrical source.

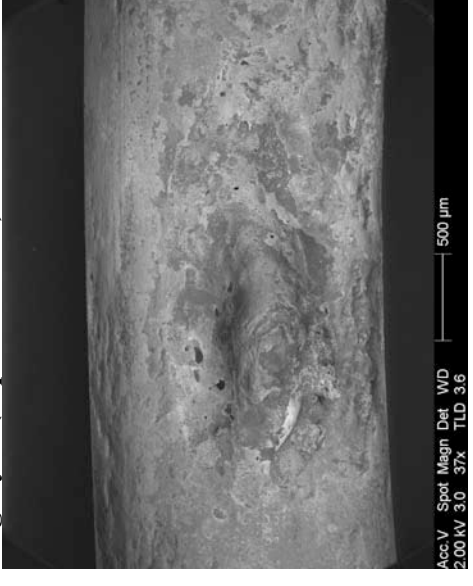
Figure 576 - SEM image of the small elongated bead located within the notch.

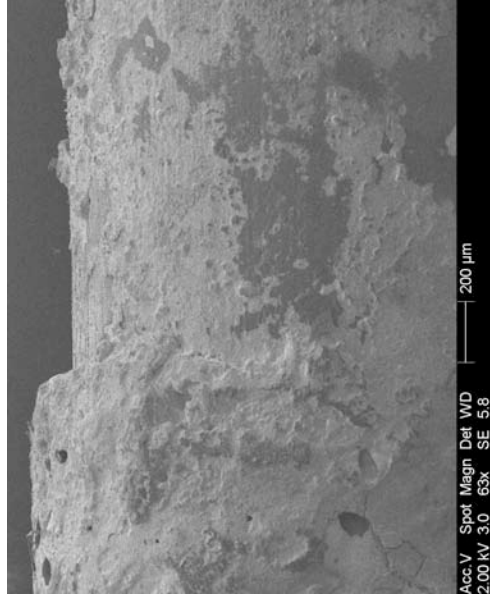
Figure 582 - SEM image at 63x magnification detailing the right edge of the arcing damage.

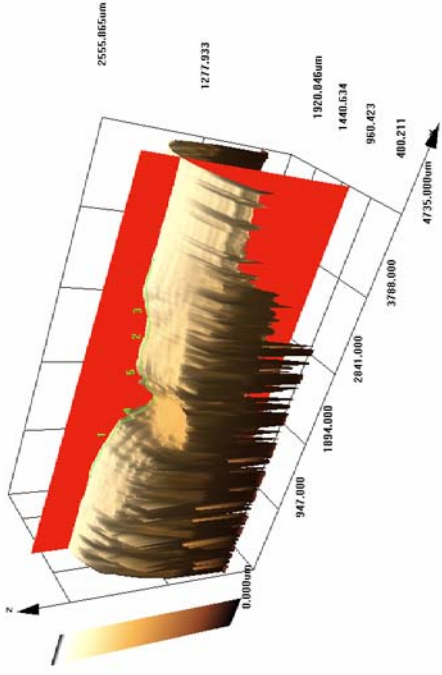
Figure 583 - LEXT image of exhibit 084 detailing the overall localised melting damage.

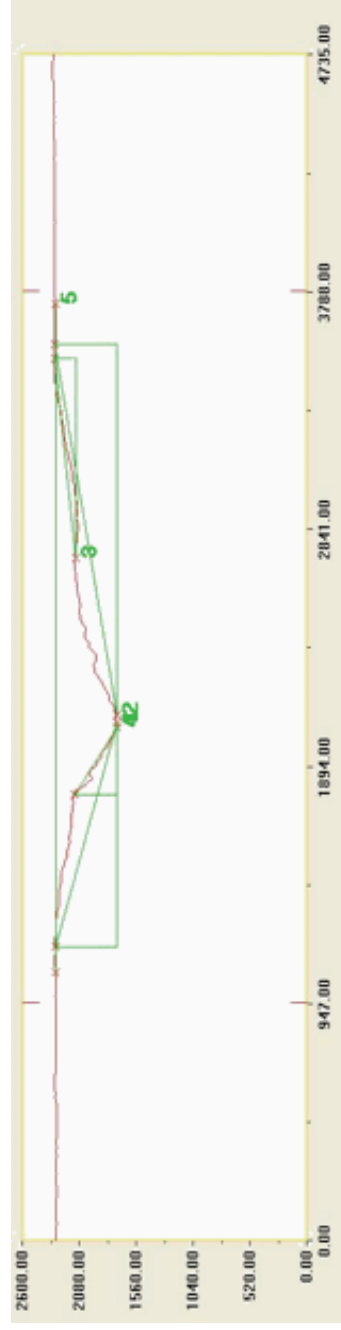
Figure 585 - Profile of the notch in the location shown by the “slice tool” in figure 584.

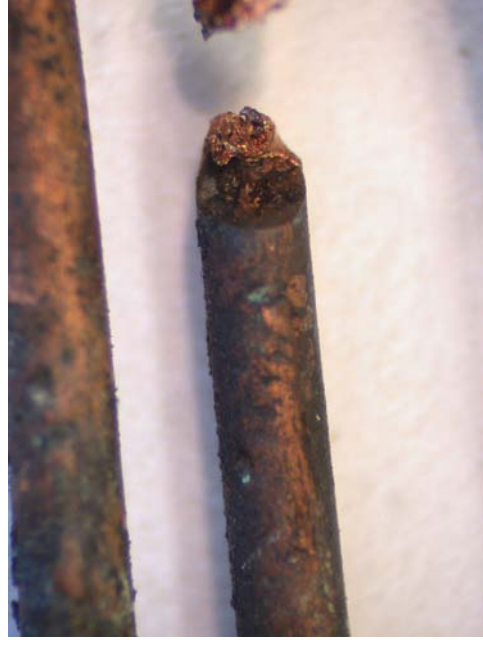
Figure 589 - Left severed end detailing the demarcation area between the arcing damage and the un-damaged conductor.

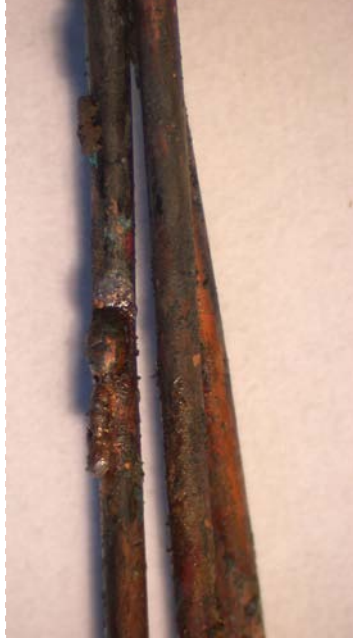
Figure 590 - Microscope image of exhibit 086 with localised melting affecting one of the three conductors.

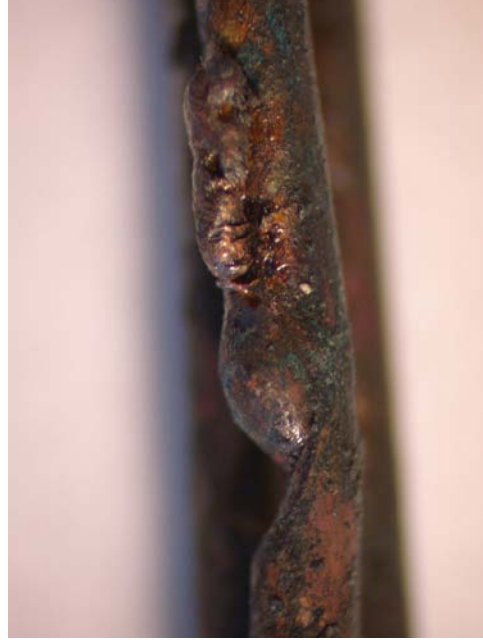
Figure 592 – The exhibit has been rotated 180 degrees detailing the opposite side of the arcing damage to figure 591.

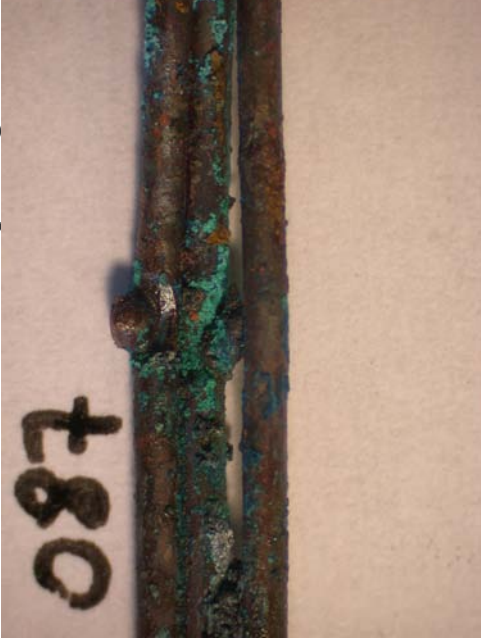
Figure 593 - Microscope image of exhibit 087. Two of the conductors are affected by this arcing damage.

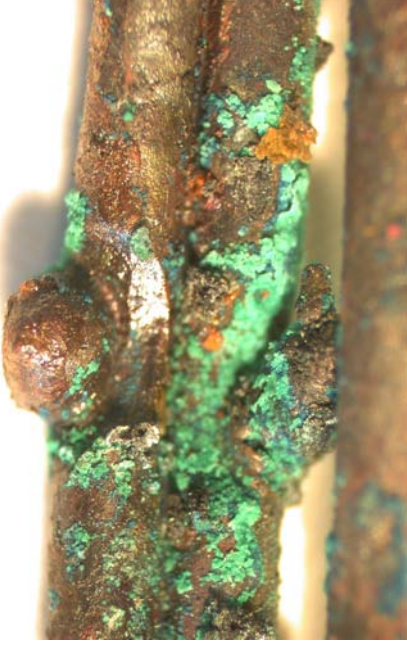
Figure 594 - Microscope image at 20x magnification of the top conductor in figure 593.

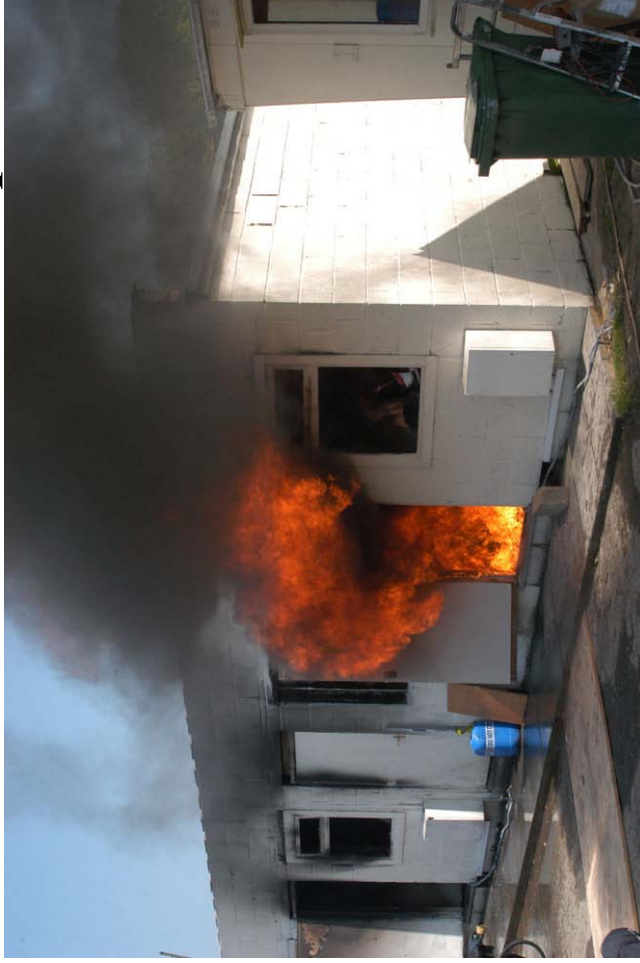
The fire in experiment 25 (scenario D) originated in three separate areas. They were at a large armchair located against the centre of the rear wall, a two-seat settee adjacent to the left wall and a two-seat settee adjacent to the front wall under the window.

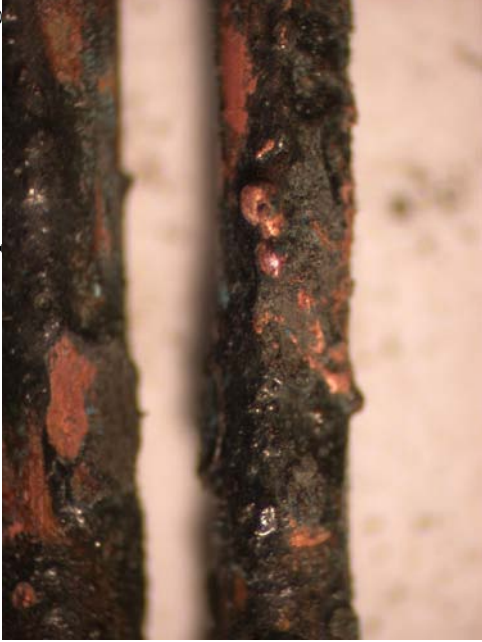
Figure 605 - Microscope image of one of the two conductors affected by the arcing damage.

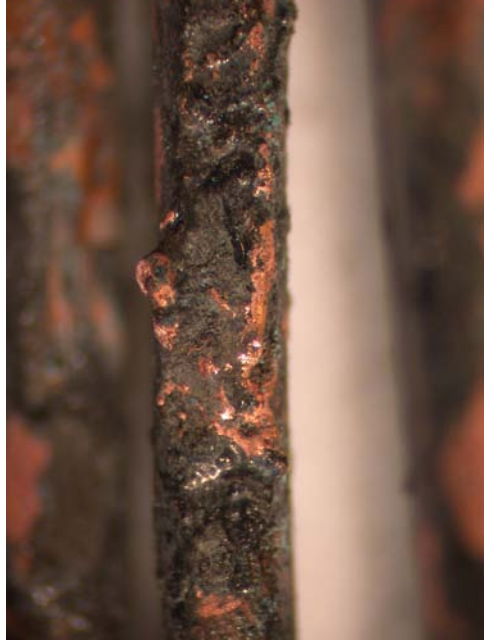
Figure 607 - Microscope image of the second conductor with arcing category A.

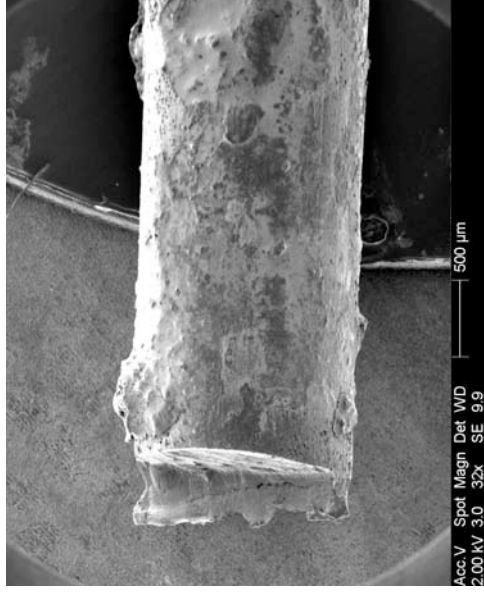
Figure 608 - The right side of this SEM image indicates the edge of the arcing damage in figure 606 and the demarcation. The left side is the cut end of the conductor.

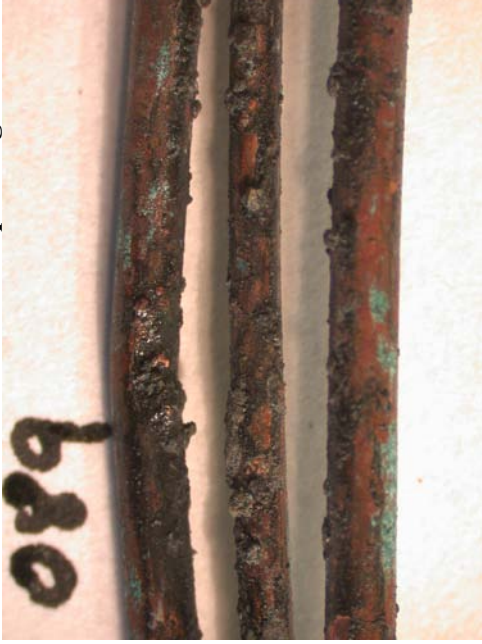
Figure 609 - Microscope image of exhibit 89 detailing all the conductors. The arcing damage is confined to the top conductor.

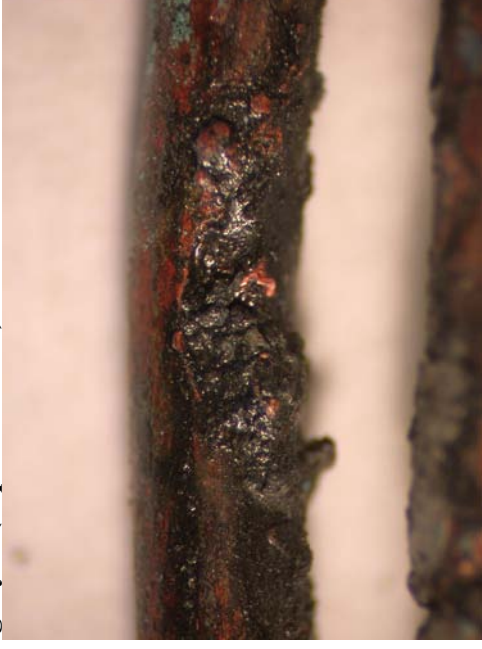
Figure 610 – A microscope image of the notch with beads attached to the edge of the notched area.

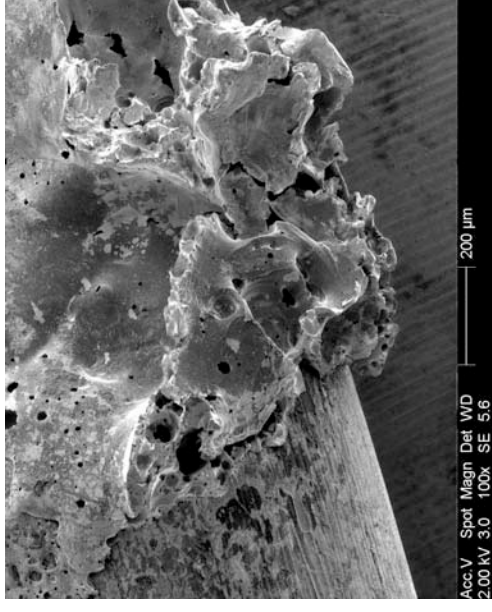
Figure 615 - SEM image at 100x magnification of the view in figure 614, detailing the demarcation area between the arcing damage and the undamaged conductor.

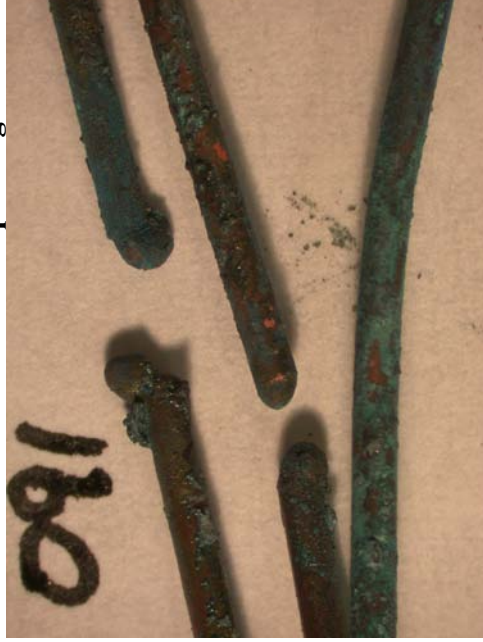
Figure 619 - Microscope image of exhibit 091. Two of the conductors are damaged and both have severed.

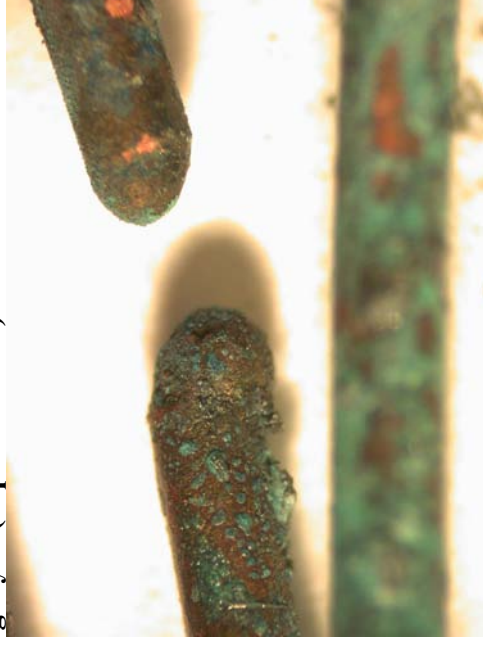
Figure 620 - The severed ends of the middle conductor detailed in figure 619.

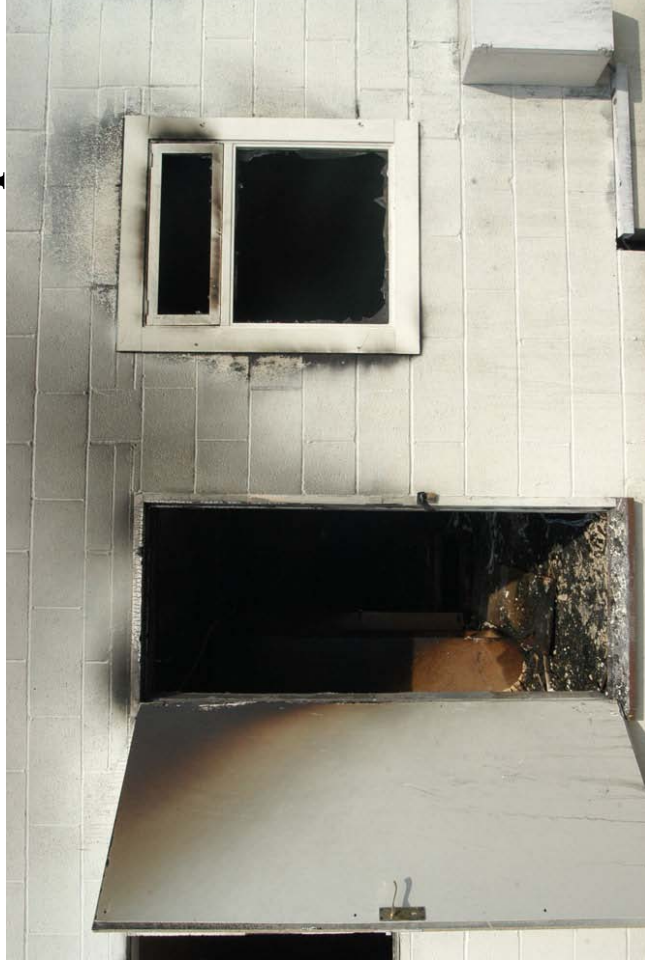
The fire in experiment 26 (scenario A) originated in three separate areas. The areas of origin for this fire were located close to each other on the edge of the beds either side of the clothes rail and at the bottom of the clothes rail. The three points of origin create a zone 1.3m wide and 0.3m deep.

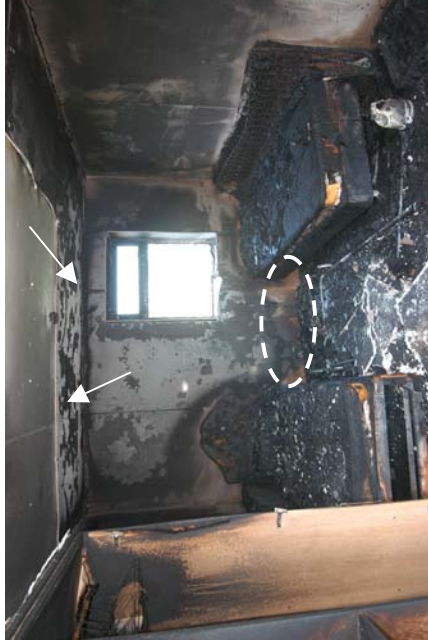
Figure 627 - Post-fire photograph, a 'U' shaped burn pattern was visible on the rear wall. Arcing damage was located above the area of origin on circuits 1 and 4 and is indicated by the white arrows.

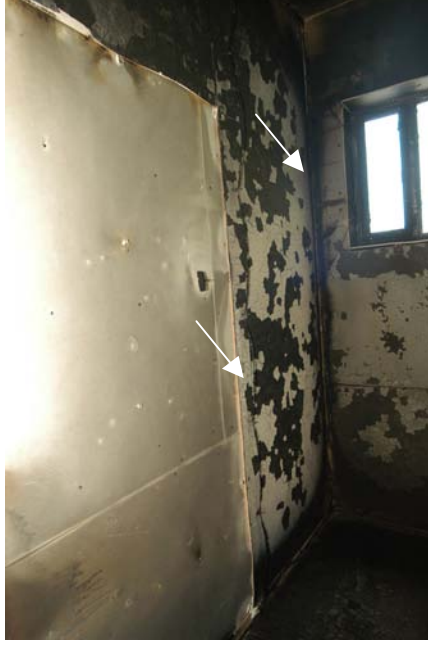
Figure 628 - Post-fire view of the ceiling above the area of origin. The left arrow was the arcing location of circuit 4 and the right arrow was the location on circuit 1.

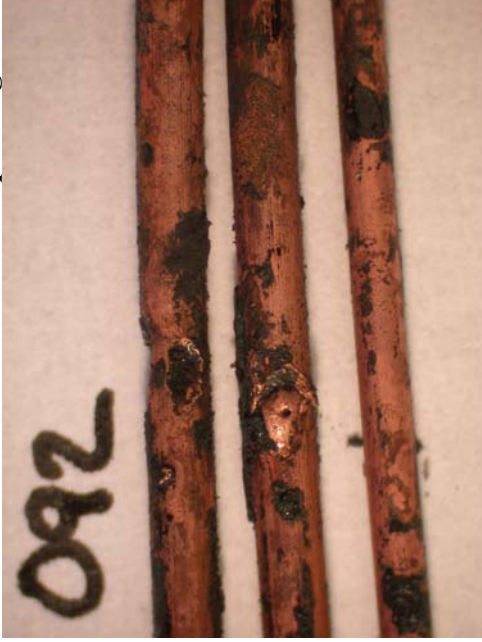
Figure 630 - Microscope image of exhibit 092. The top and middle conductors are affected by arcing damage.

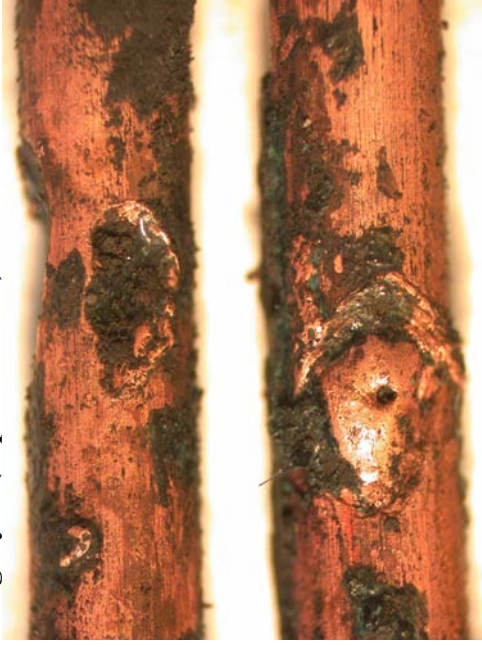
Figure 631 - View of both conductors and the notch damage on the conductors.

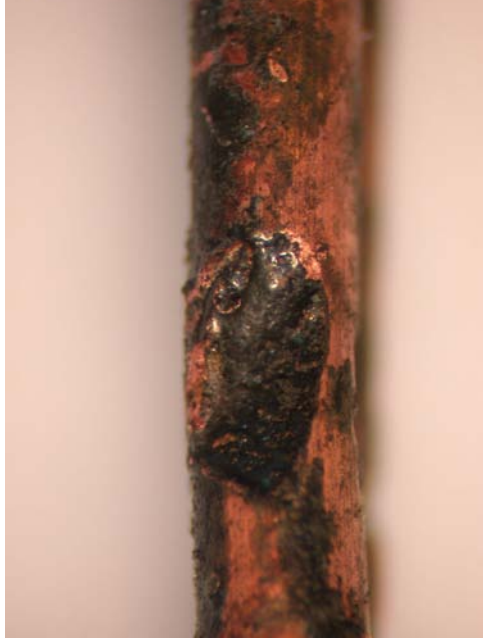
Figure 632 - View of the larger notch affecting the top conductor. The clear demarcation is indicated at the edge of the notch and the undamaged conductor.

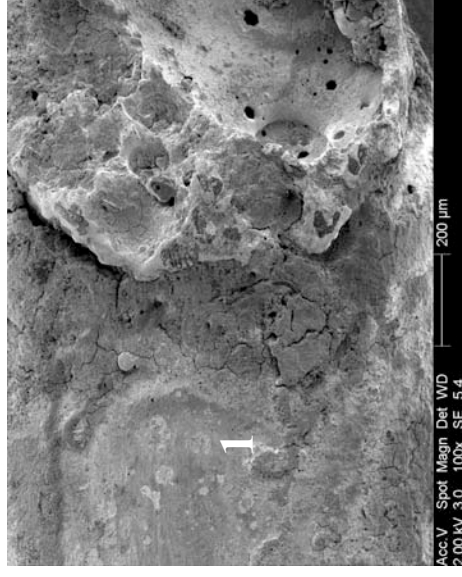
Figure 637 - SEM image of the demarcation area detailing the edge of the arcing damage in figure 635 above.

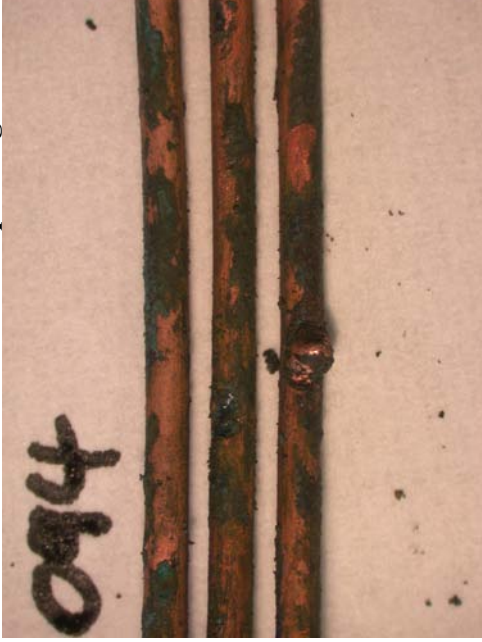
Figure 639 - Microscope image of exhibit 094. The middle and bottom conductors had localized metallic damage.

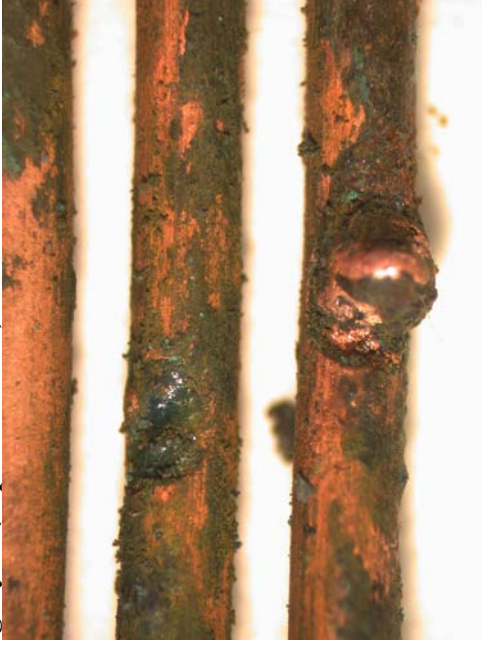
Figure 640 - 20x magnification detailing the localized melting to the middle and bottom conductors.

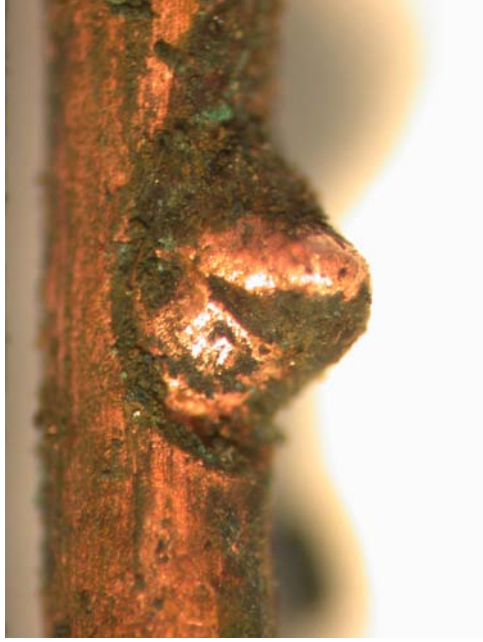
Figure 641 - 40x magnification of the notch with a bead within detailing the clear demarcation between the arcing damage and the undamaged conductor.

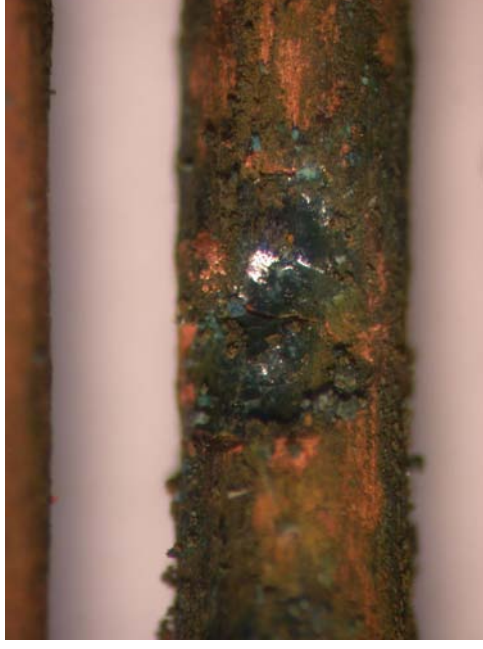
Figure 642 - 40x magnification of the notch affecting the middle conductor.

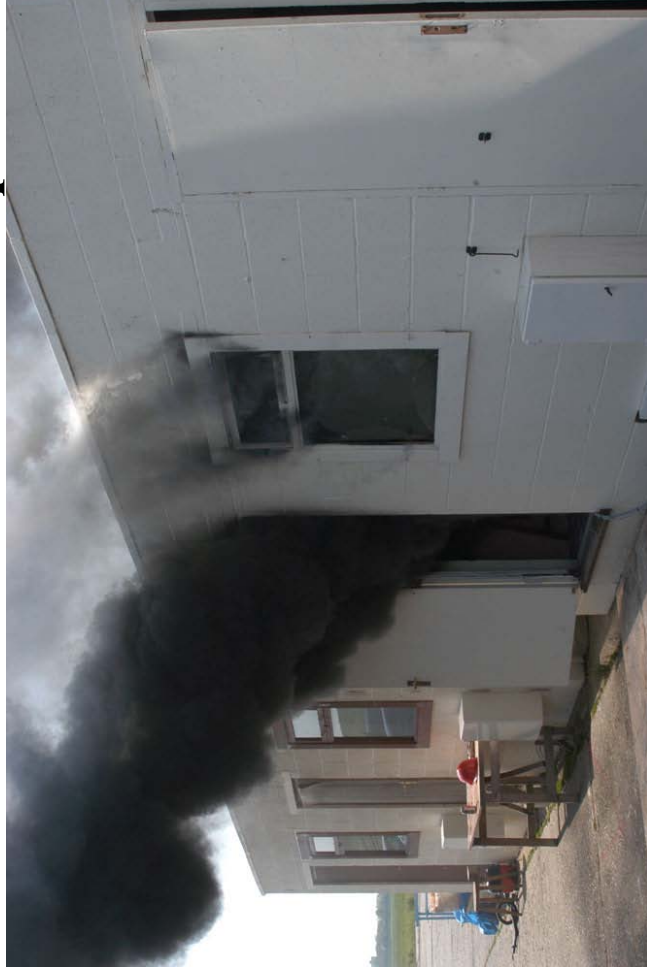
The fire in experiment 27 (scenario C) originated in a box of toys located under a Christmas tree 1380mm from the left wall and 700mm from the rear wall.

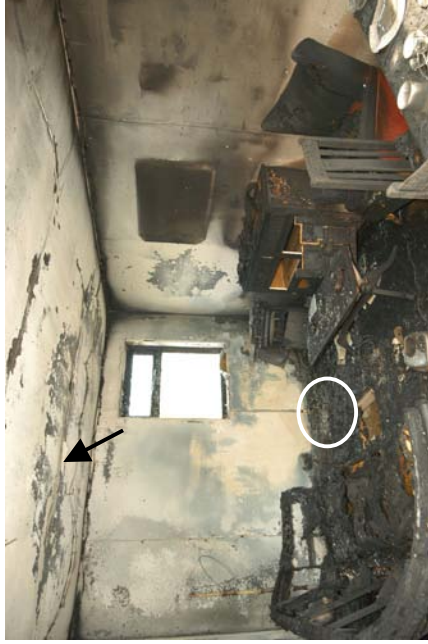
Figure 648 - Post-fire photograph detailing the fire's area of origin. The black arrow was the location of the arcing damage to circuit 4 above the fire's area of origin.

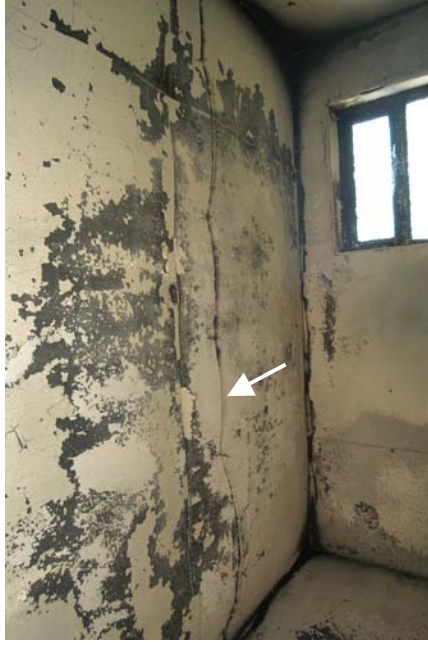
Figure 649 - Post-fire photograph of the ceiling area above the fire's area of origin. The white arrow details the arcing damage location of circuit 4 - exhibit 097.

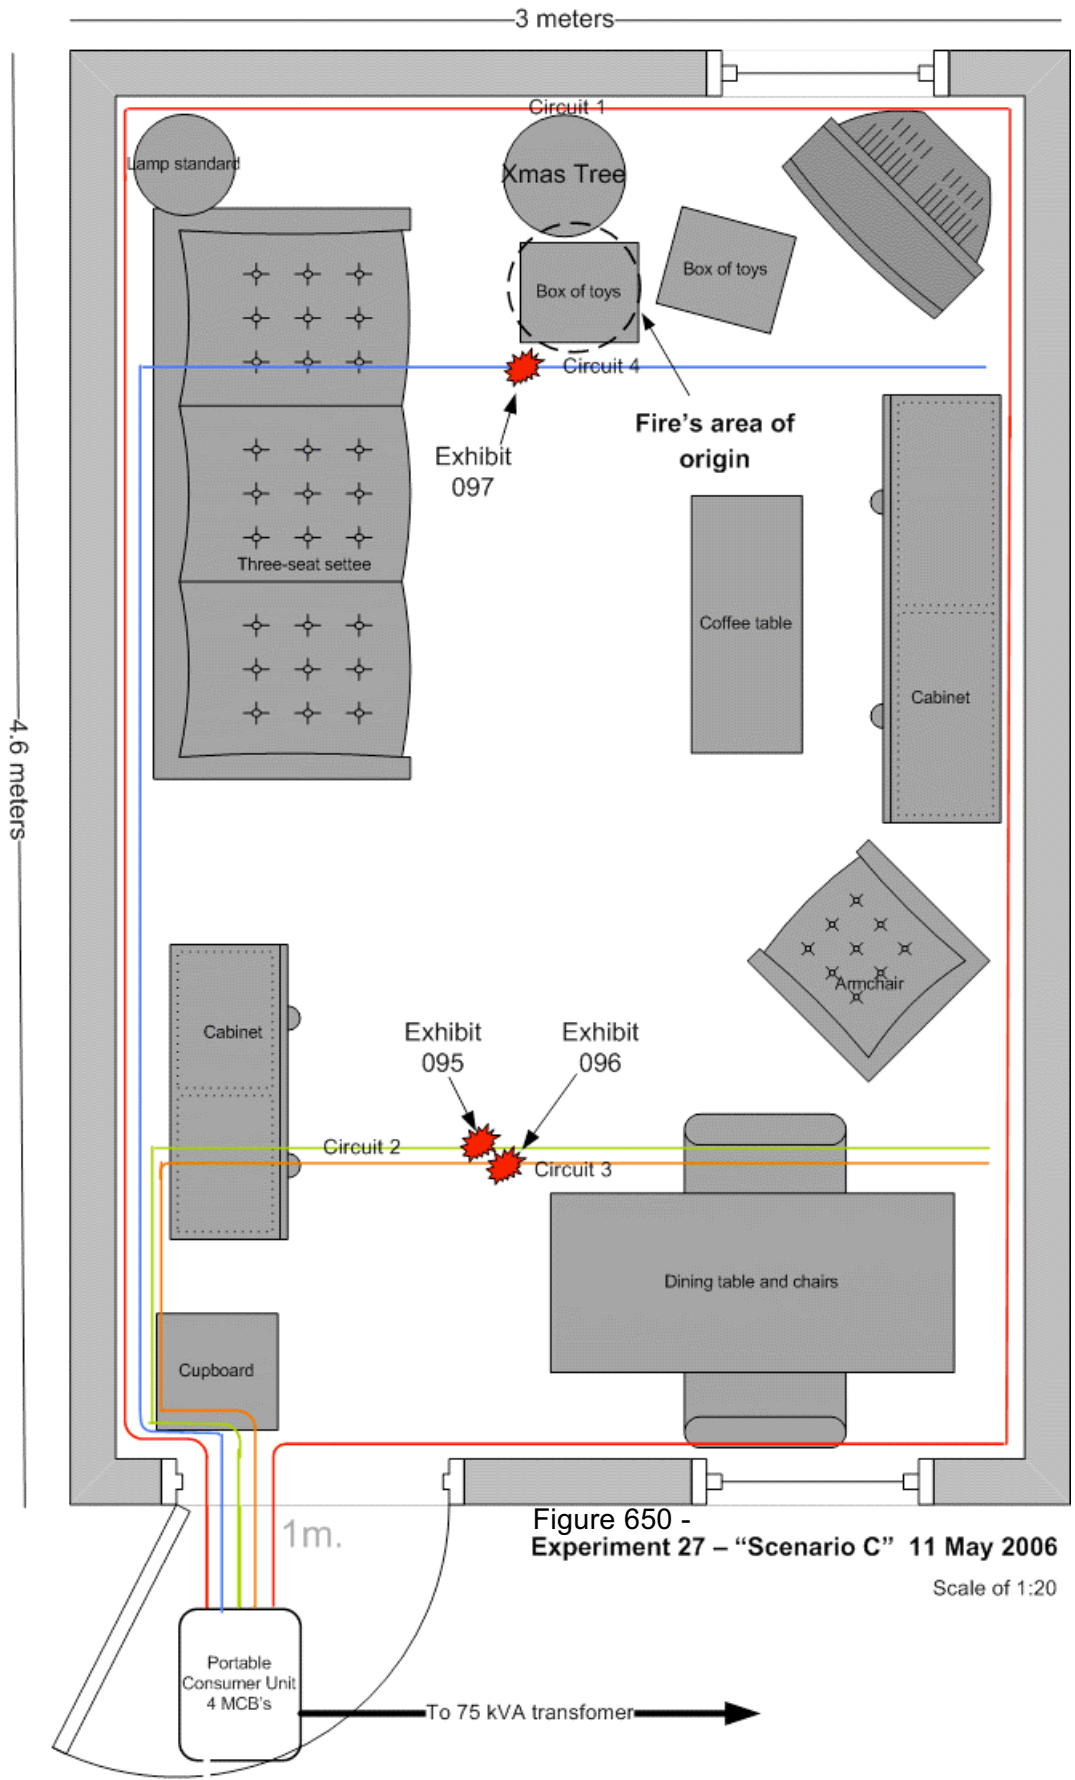
Figure 650 - Experiment 27 - "Scenario C" 11 May 2006

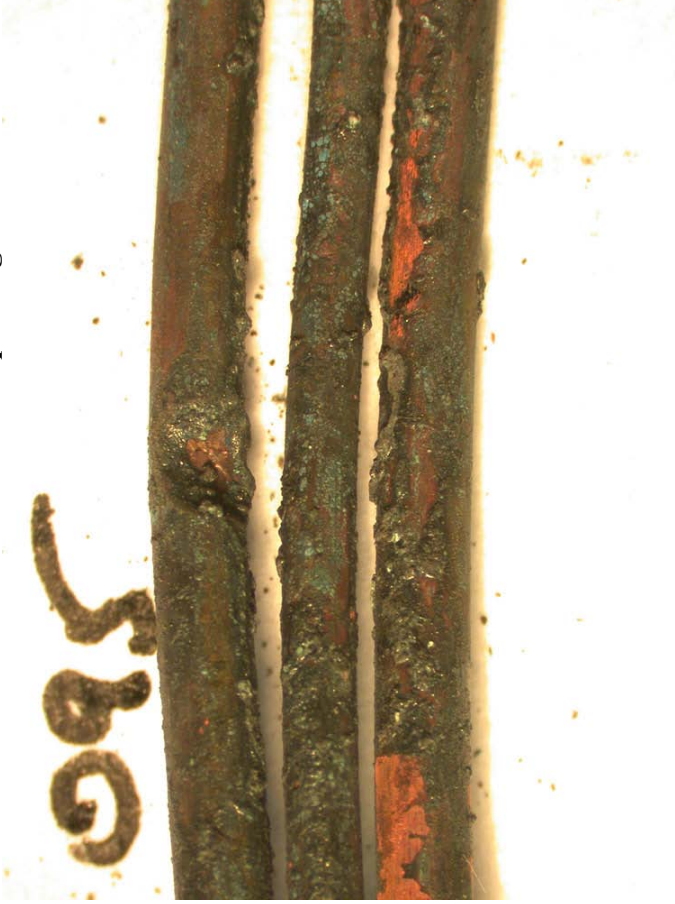
Figure 651 - Microscope image for exhibit 095 detailing the notch damage to one of the three conductors.

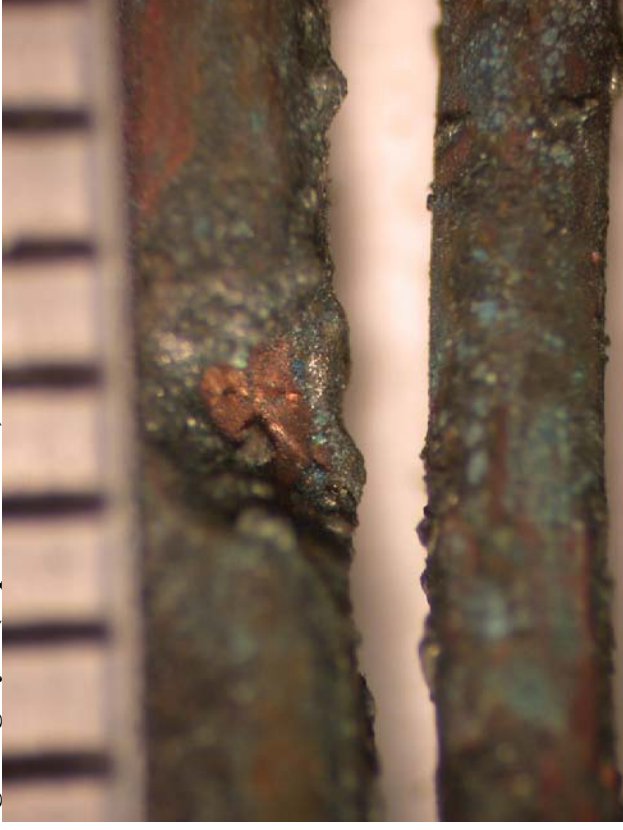
Figure 652 - 20x magnification of the notch on the top conductor detailed in figure 651. The notch is 2mm wide. A limited depth of field using the digital camera on the dedicated microscope coupler limited the area of this image that is in focus.

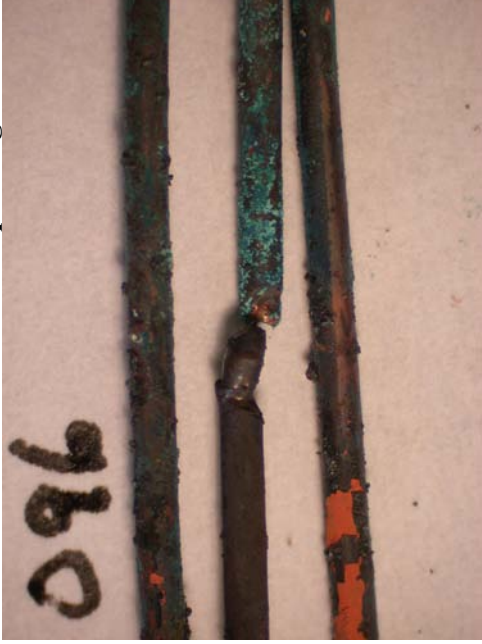
Figure 653 - Microscope image of exhibit 096. The arcing damage has affected one of the three conductors.

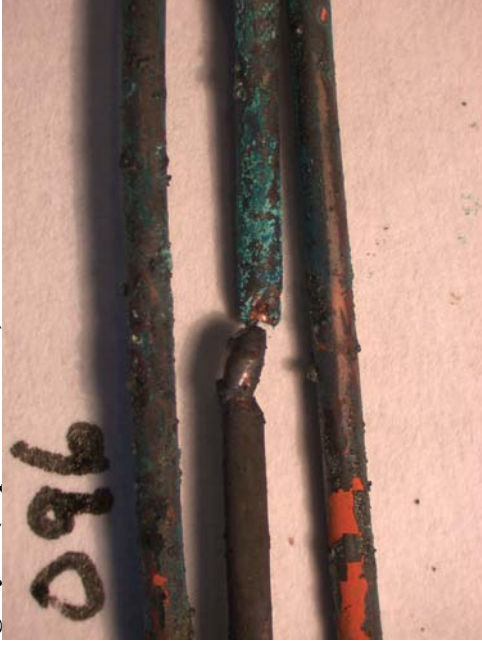
Figure 654 - The middle conductor is severed with a large bead on one end and a smaller bead on the other severed end.

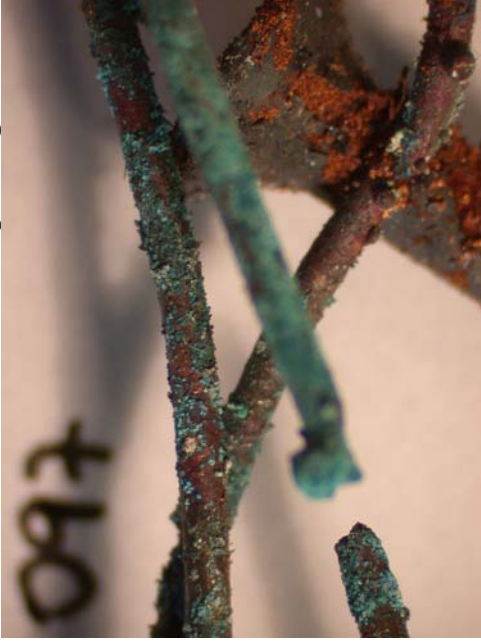
Figure 656 - Microscope image of exhibit 097. Two conductors have arcing damage. One is severed and the other is welded to a fixing screw.

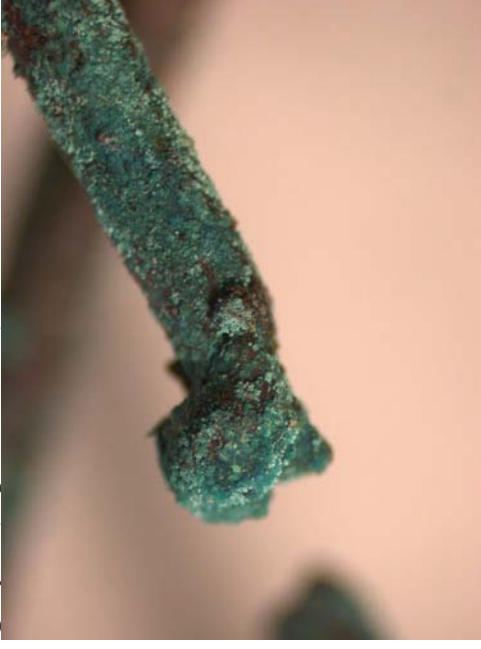
Figure 657 - 20x magnification of the right severed end. There was a lot of oxide and corrosion on the surface of this conductor.

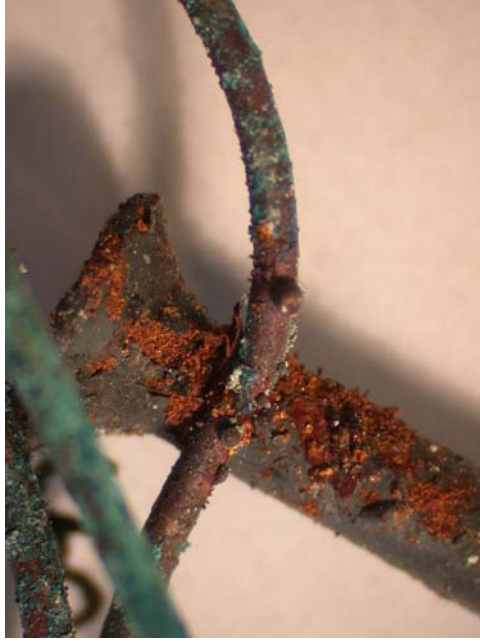
Figure 658 - 20x magnification of the conductor welded to the screw.

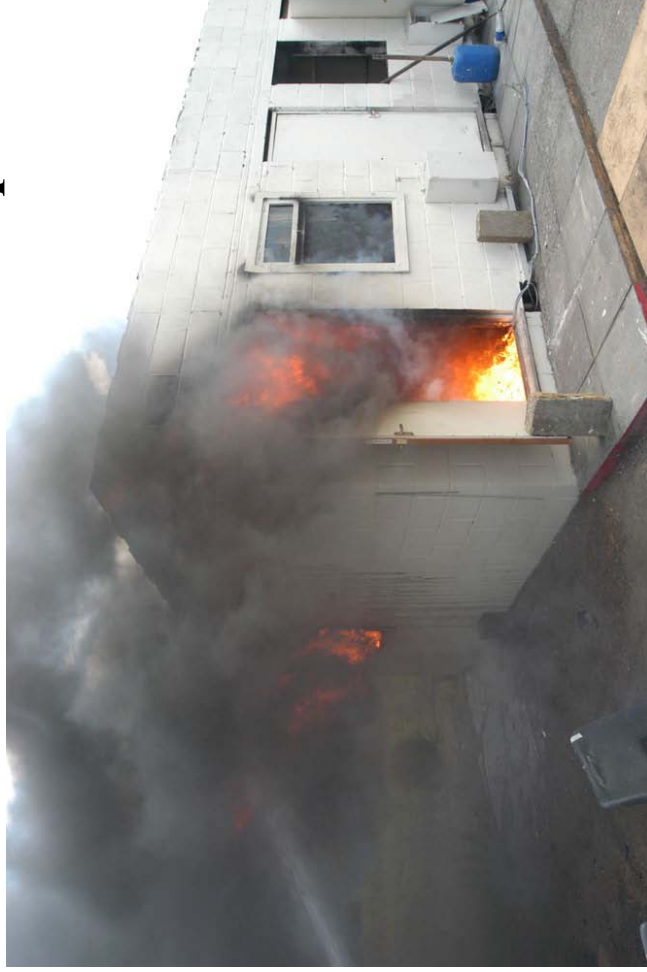
The fire in experiment 28 (scenario D) originated in three separate areas within the compartment. The first area was above an electric fire located on the rear wall. The second area of origin was on a seat of an armchair located in the rear left corner of the room (this was the fire’s main plume affecting the ceiling in the initial stages of the fire). The third area of origin was on the left armrest area of a two-seat sofa located on the left wall.

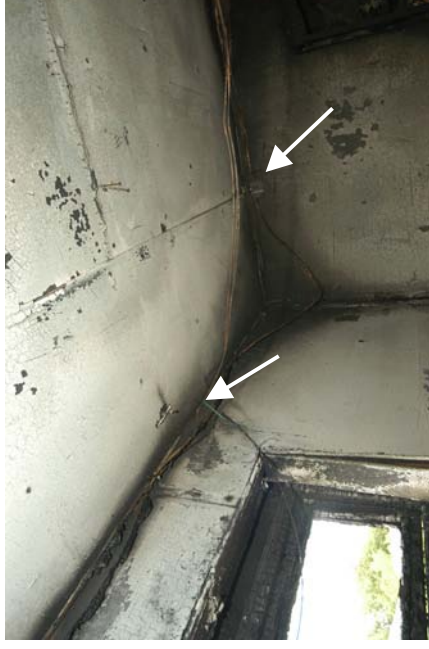
Figure 666 - Post-fire view of the ceiling above the fire's dominant plume. The left arrow details the arcing damage location of circuit 4 (exhibit 101). The right arrow details exhibit 098 (circuit 1).
