**University of Strathclyde**  
**Department of Pure and Applied**  
**Chemistry**  
**Centre for Forensic Science**

**Developing a reliable systematic**  
**analysis for arc fault mapping**

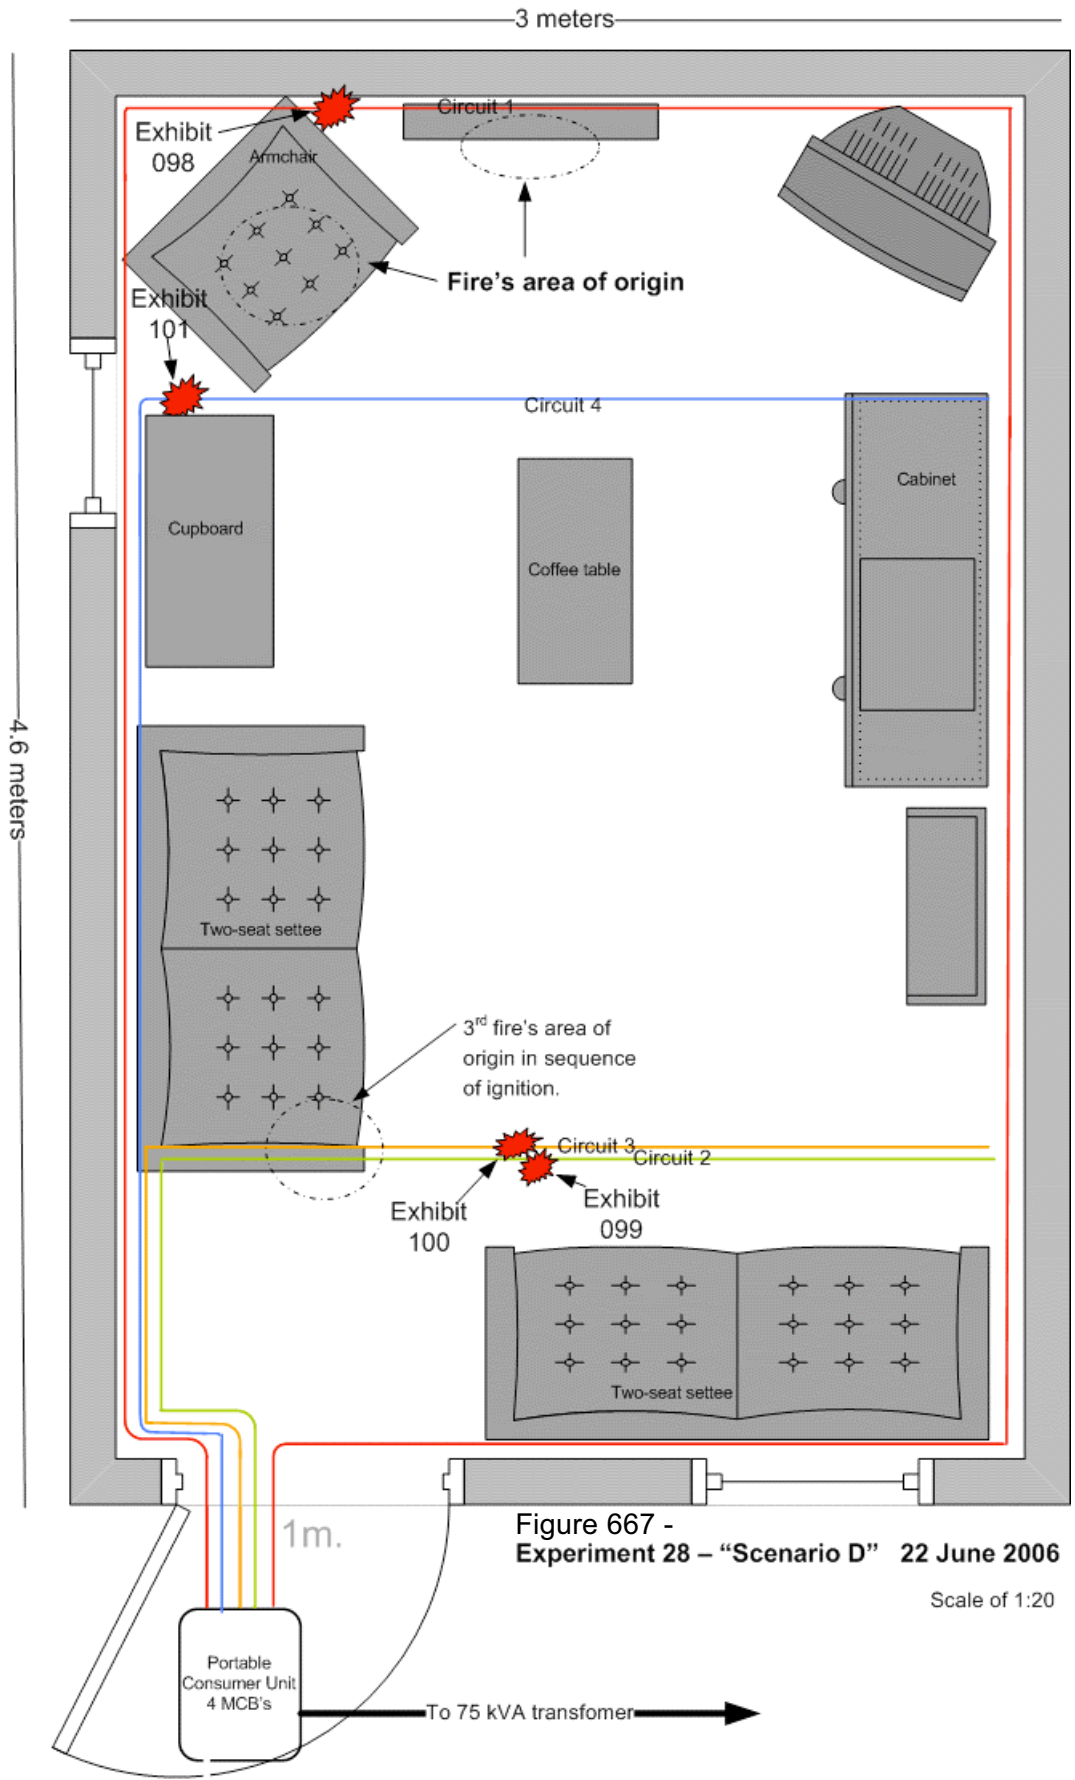
Microscope images for exhibit 098 - arcing category D (experiment 28)

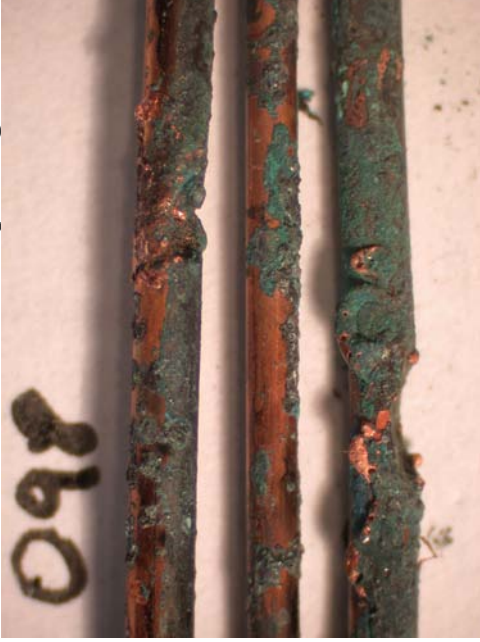
Figure 668 - Microscope image of exhibit 098. The live and neutral 2.5mm<sup>2</sup> conductors have arcing damage. Each one was a notch.

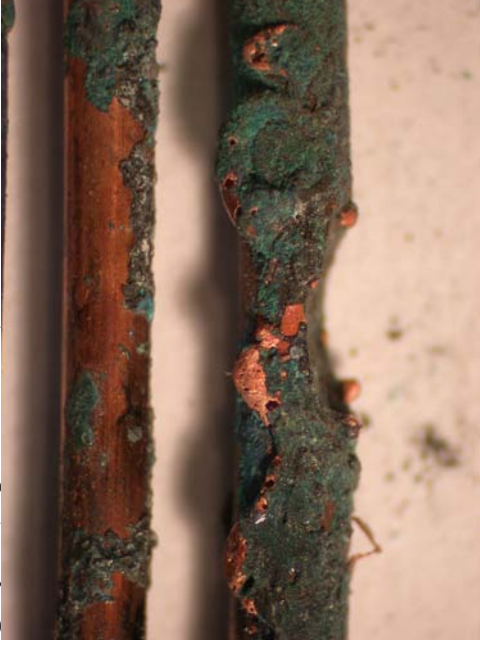
Figure 669 - 20x magnification of the lower conductor notch with adjacent beading splatter on the conductor surface.

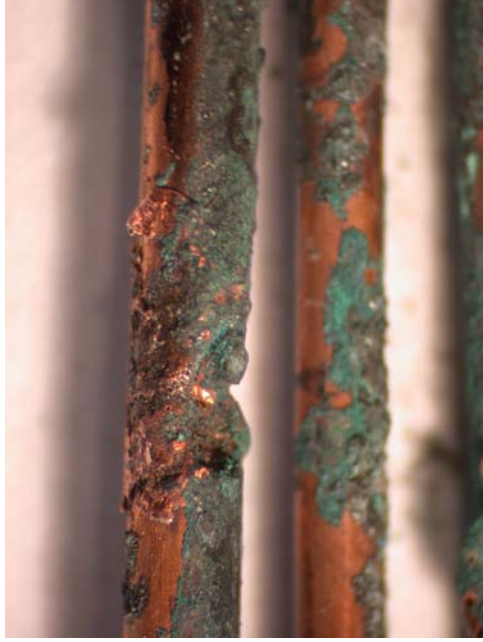
Figure 670 - 20x magnification of the top conductor detailing its notch damage.

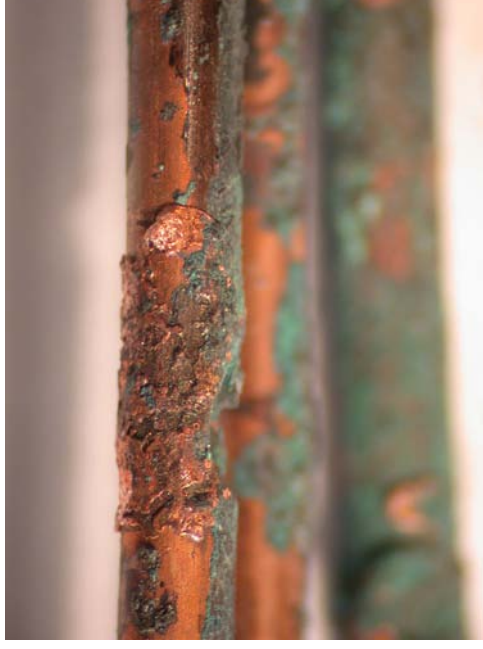
Figure 671 - A similar view to figure 670, with the conductor positioned at a different angle.

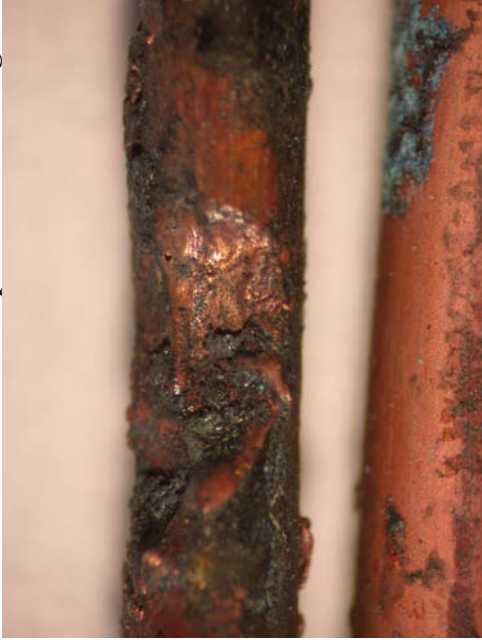
Figure 672 - Microscope image of exhibit 099. One of the three conductors had arcing damage.

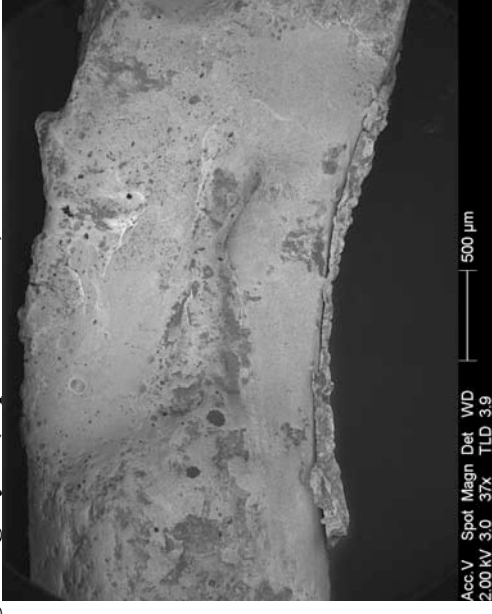
Figure 673 - SEM image of the exhibit detailing the large notch with copper splatter at the bottom of the image.

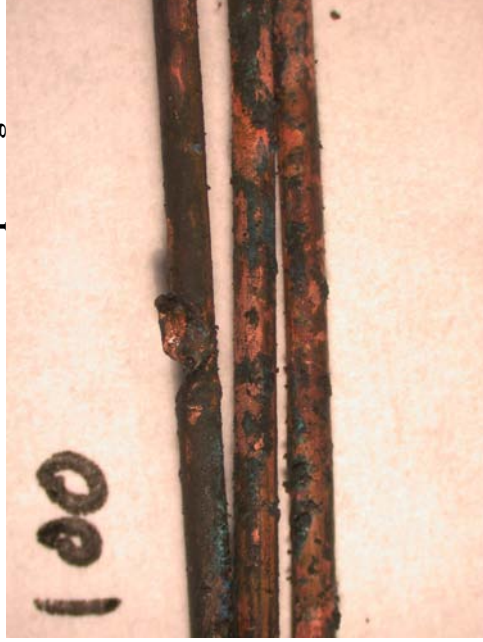
Figure 676 - Microscope image of exhibit 100. One of the three conductors had arcing damage that consisted of a deep notch with a large bead within that protruded above the conductor.

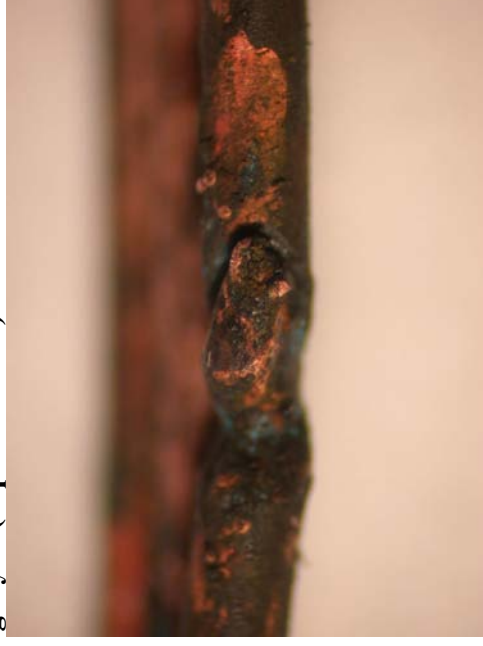
Figure 677 - 20x magnification microscope image of the bead and notch.

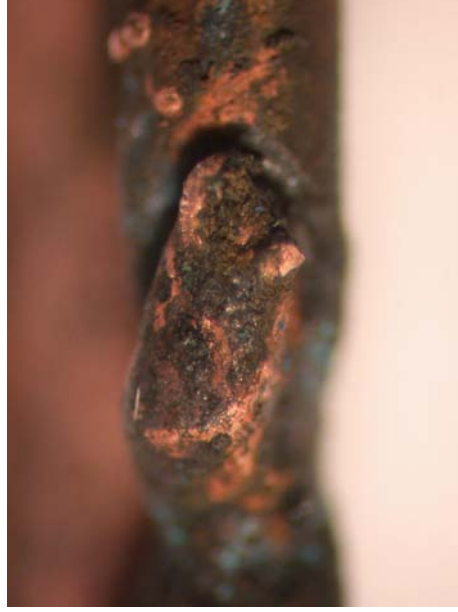
Figure 678 - 40x magnification of the bead. Several smaller beads of the adjacent conductor surface were observed and are detailed in the right of this image.

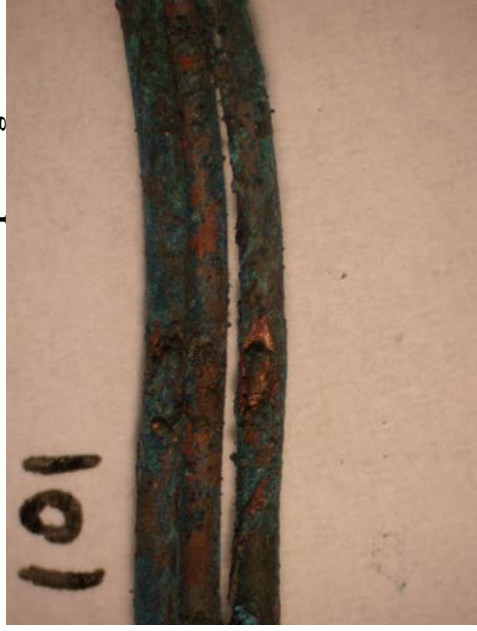
Figure 679 - Microscope image of exhibit 101. Two conductors (live and neutral) sustained arcing damage.

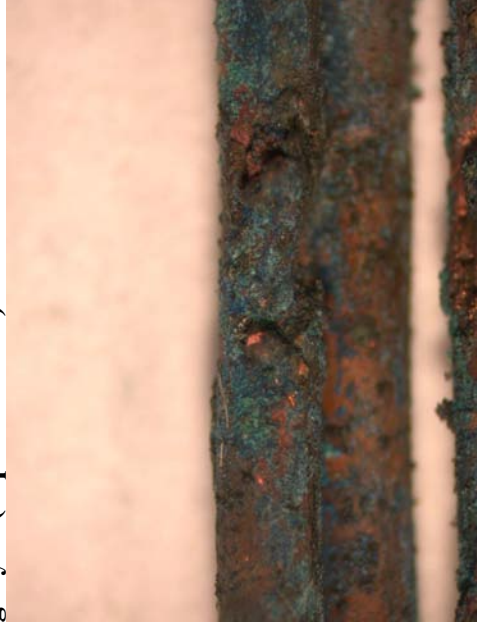
Figure 680 - 20x magnification of the top conductor detailed in figure 679 with a notch and small beads at the notch edge.

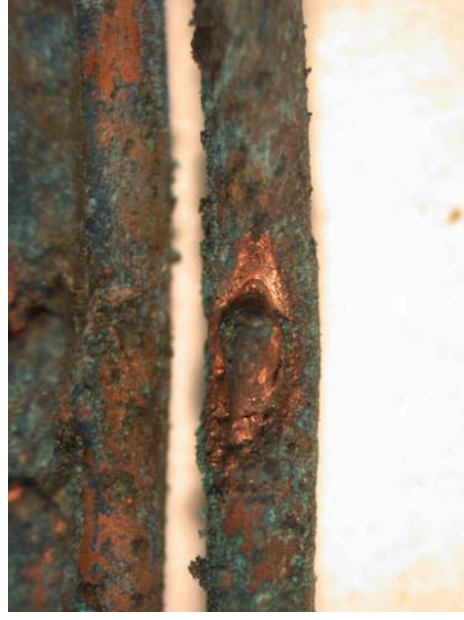
Figure 681 - 20x magnification of the bottom conductor detailed in figure 679. The conductor has a notch with a bead within it. This image details the demarcation between the arcing damage and the undamaged area.

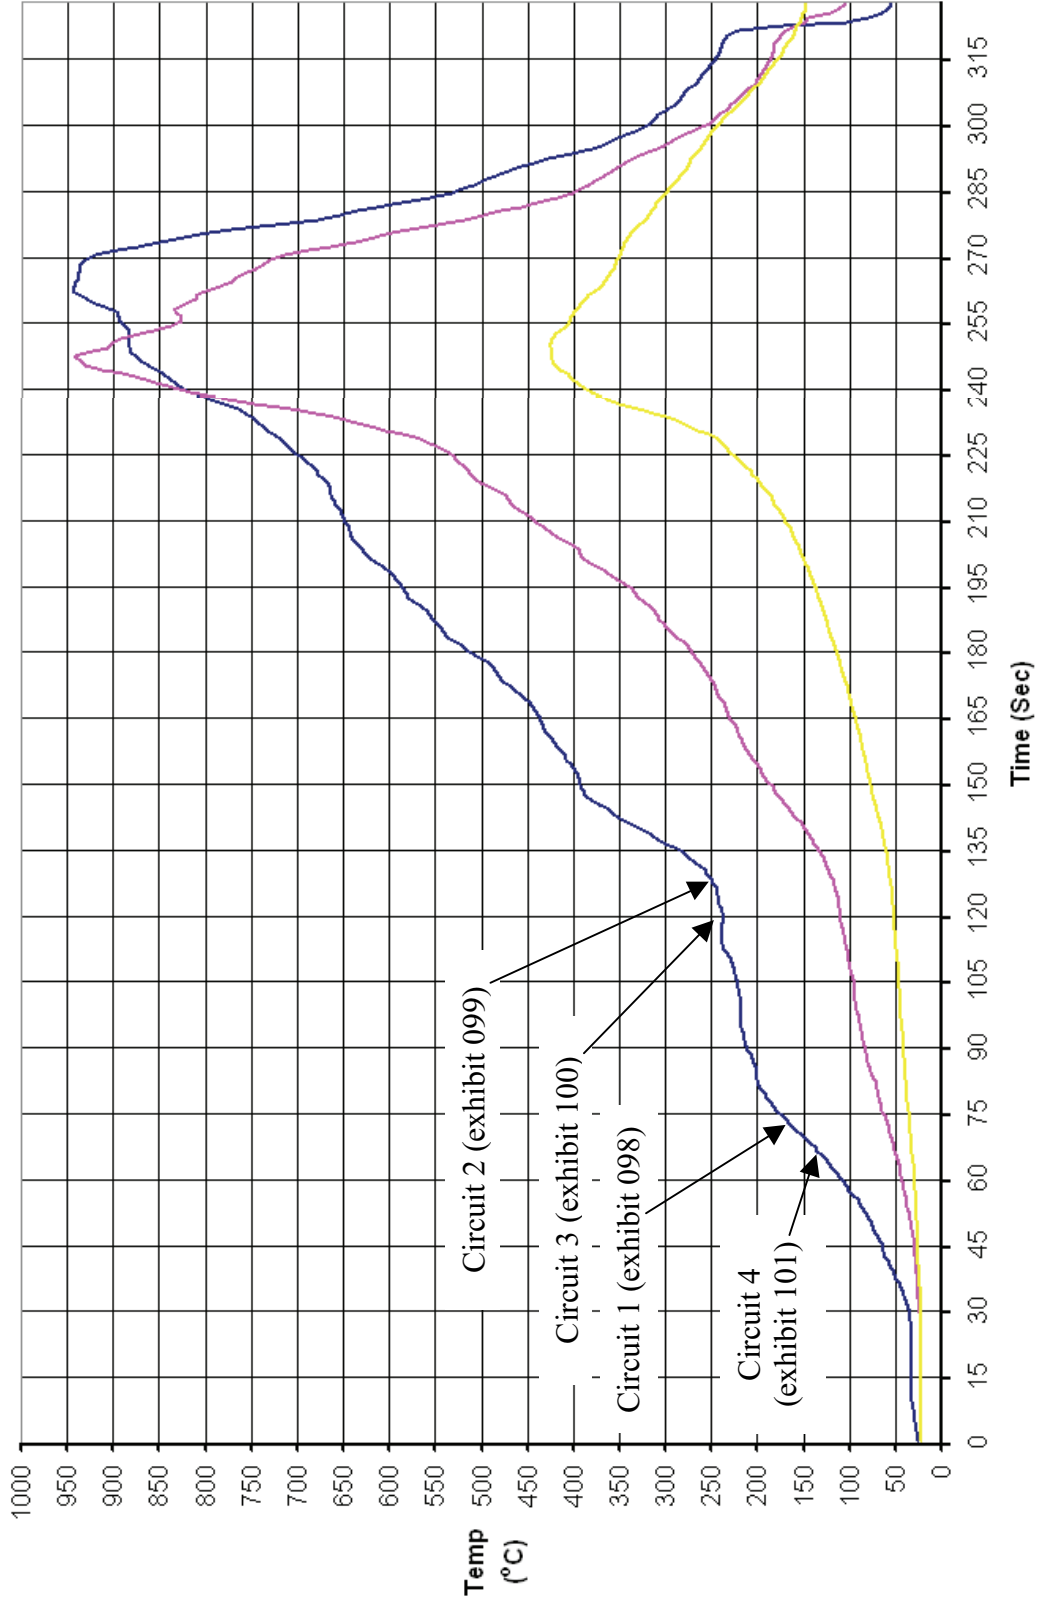
Figure 682 - Time temperature graph for experiment 28

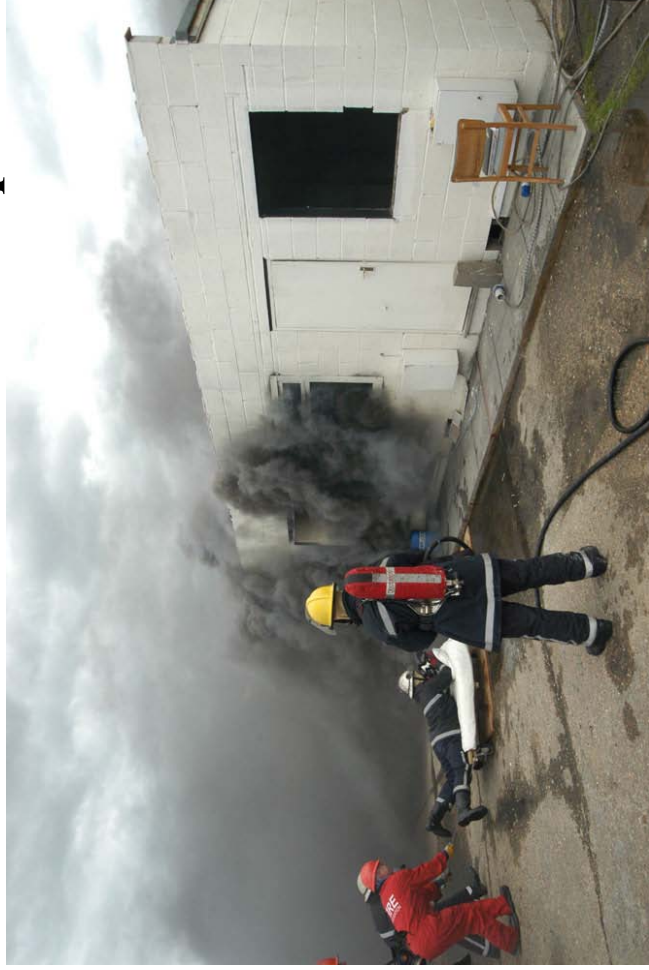
The fire in experiment 29 (scenario B) originated in a refuse bin located in the rear left corner of the compartment.

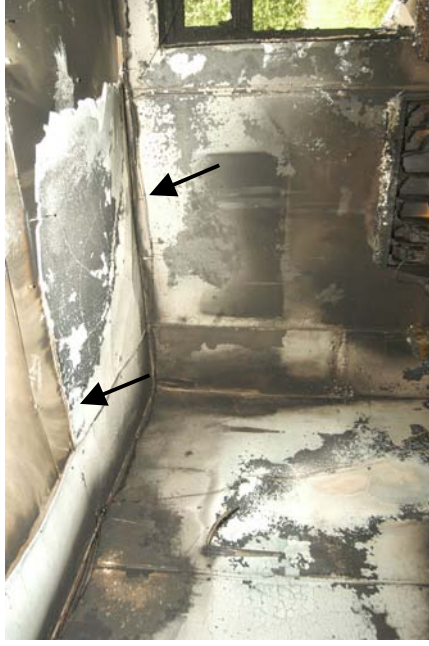
Figure 688 - Post-fire view of the fire's area of origin. The black arrows indicate the arcing damage to circuit 1 (R) and circuit 4 (L).

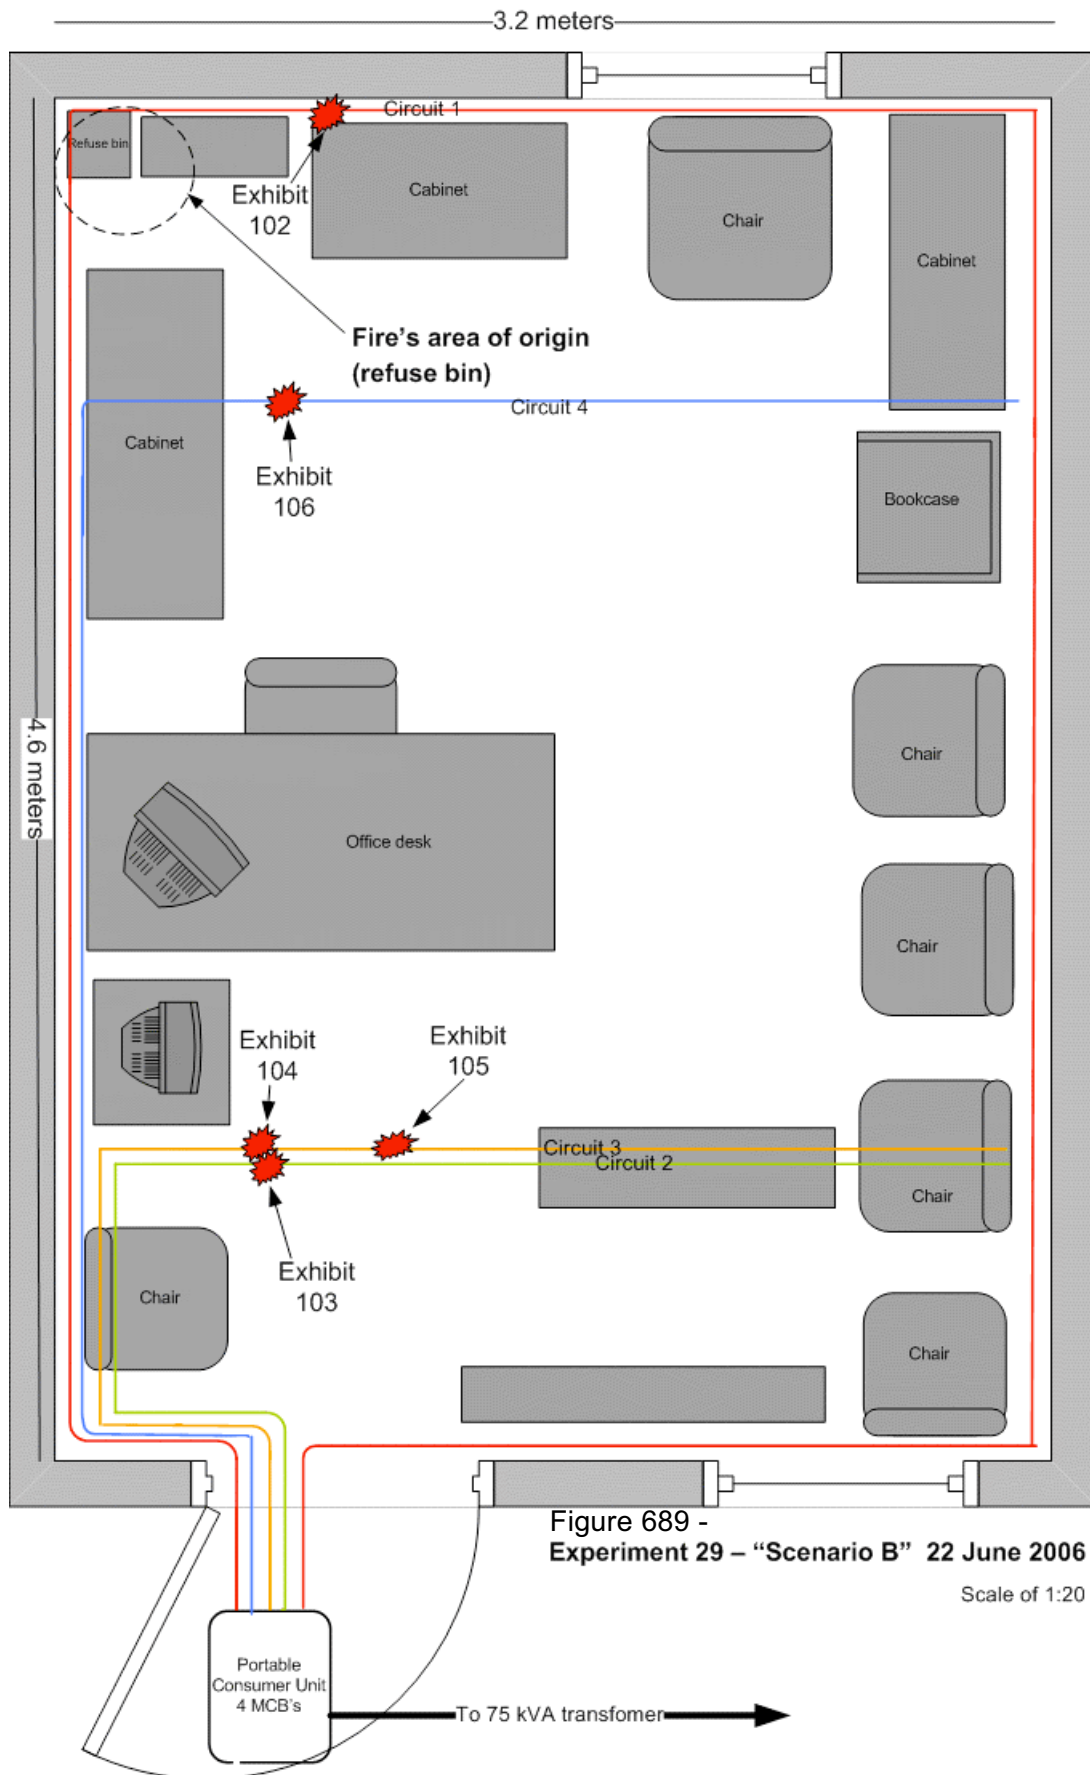
Microscope images for exhibit 102 - arcing category D (experiment 29)

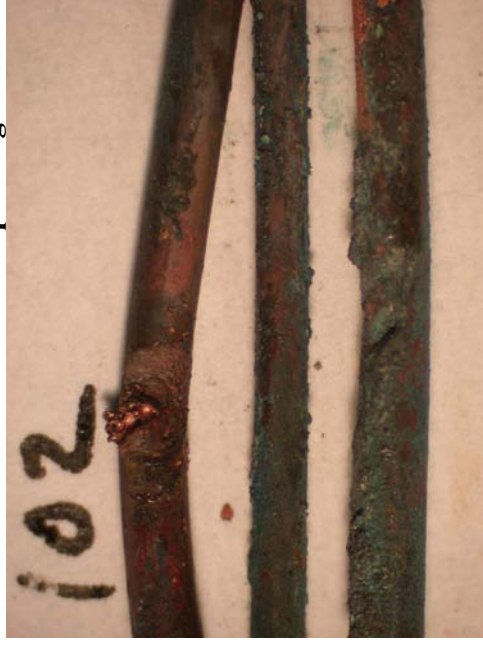
Figure 690 - Microscope image of exhibit 102. The arcing damage affected the two 2.5mm<sup>2</sup> conductors (live & neutral). A fixing screw adjacent to this metallic damage had a small notch on the thread.

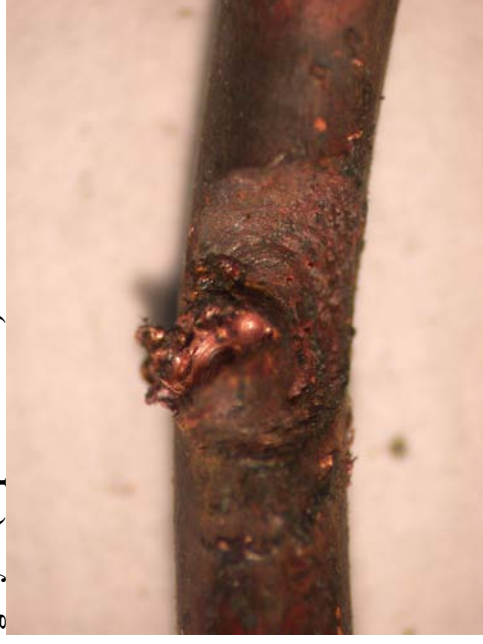
Figure 691 - 20x magnification of the top conductor. The notch has a bead with a chaotic surface.

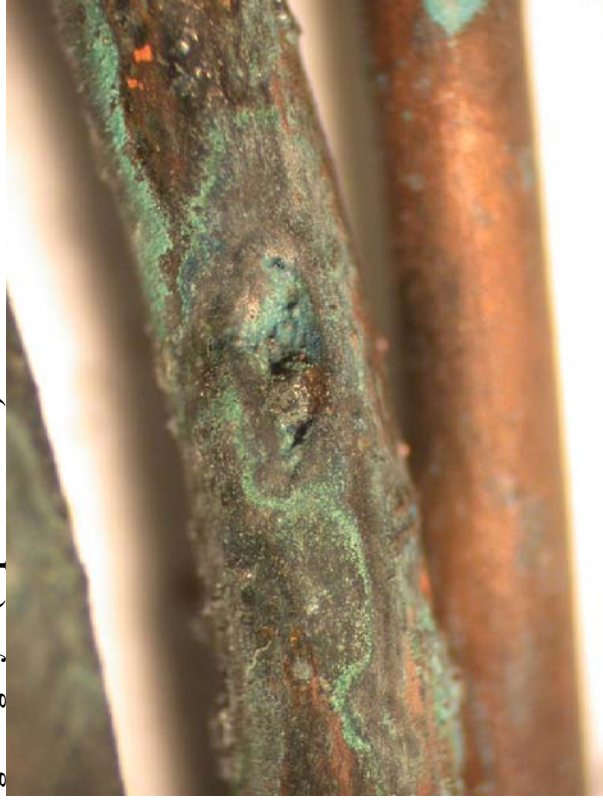
Figure 694 - A close-up of the arcing damage to this conductor, the middle conductor detailed in figure 693.

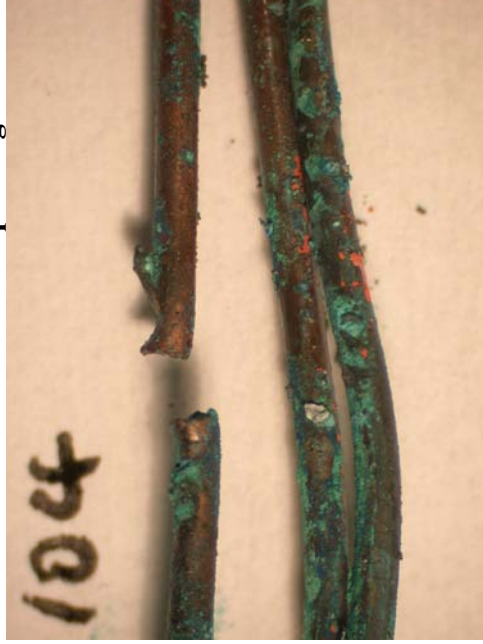
Figure 695 - Microscope image of exhibit 104. This arcing damage is closest to the electrical source

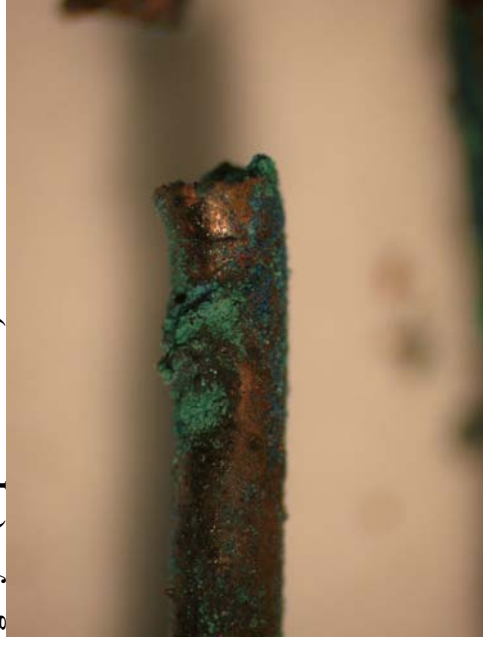
Figure 696 - The left severed conductor in figure 695. The severed edge appears to be fractured.

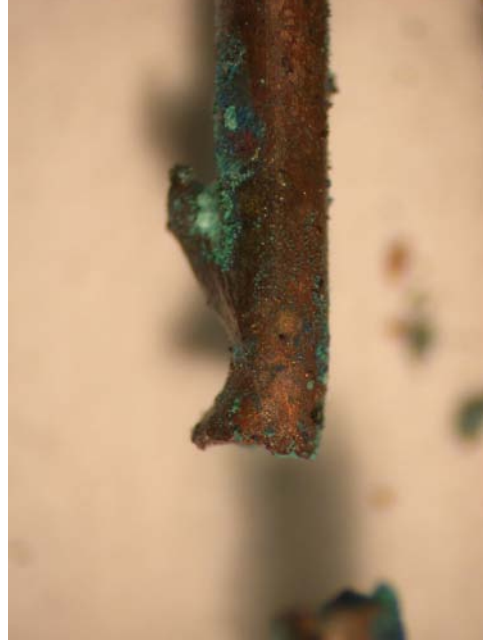
Figure 697 - The right severed conductor. The surface of the severed end appears to be a fracture at the edge of the notch.

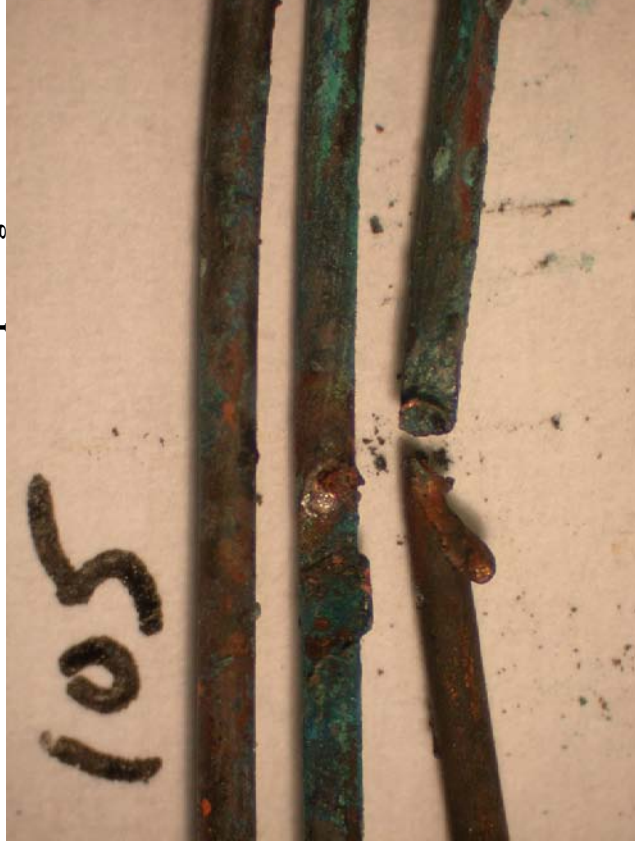
Figure 698 - Microscope image of exhibit 105. Two conductors are affected. The bottom one is severed and has a large bead protruding from the conductor surface.

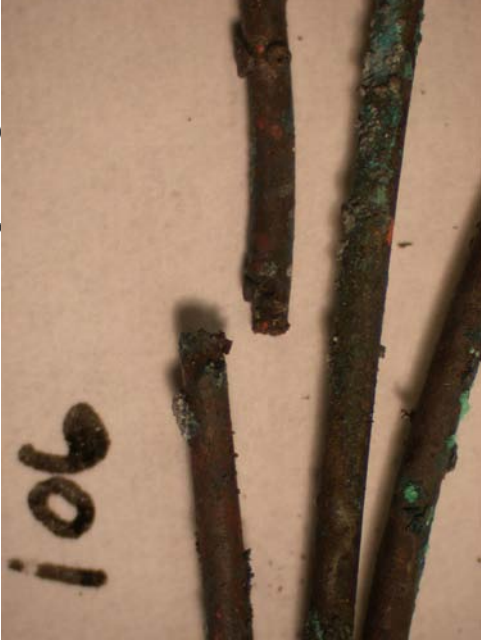
Figure 700 - Microscope image of exhibit 106. The arcing damage has only affected one conductor. It appears to be a large notch that has fractured after recovery at the scene.

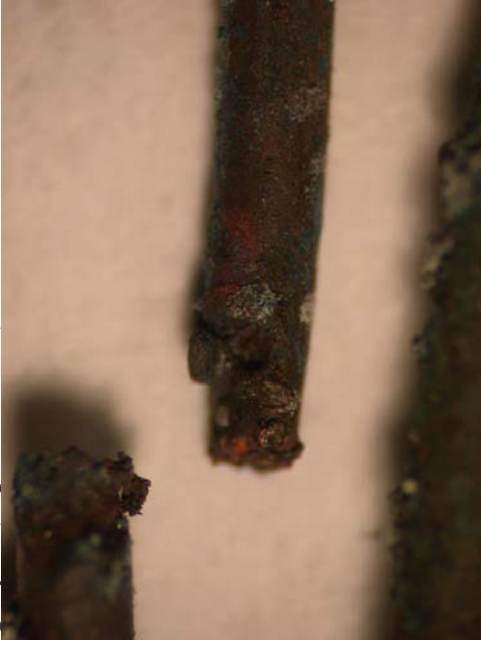
Figure 701 - 20x magnification of the right severed end.

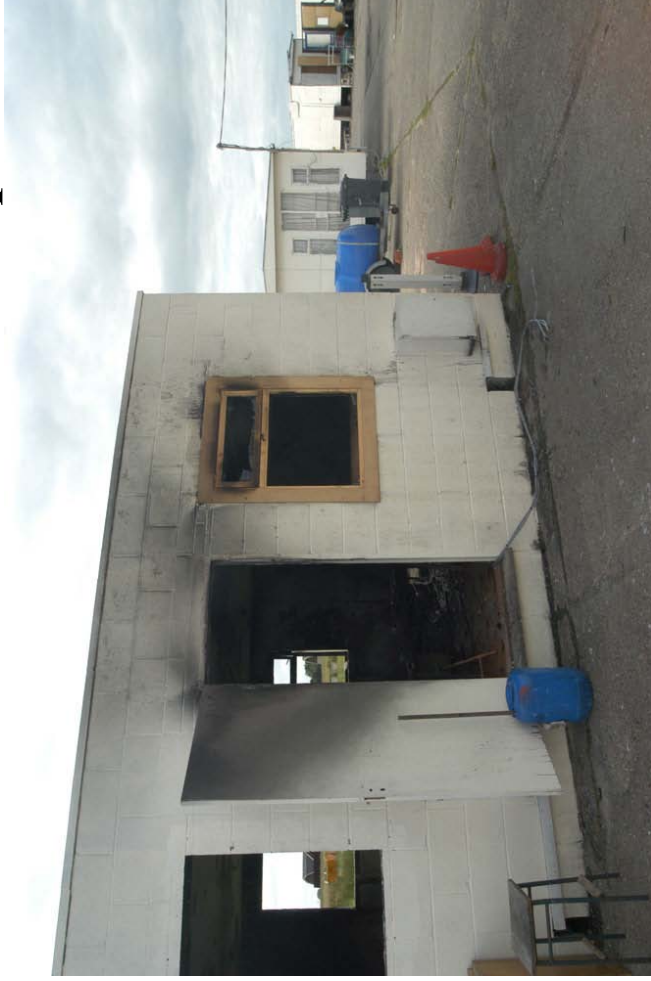
The fire in experiment 30 (scenario C) originated in a toy box located in front of a Christmas tree located adjacent to the centre of the rear wall.

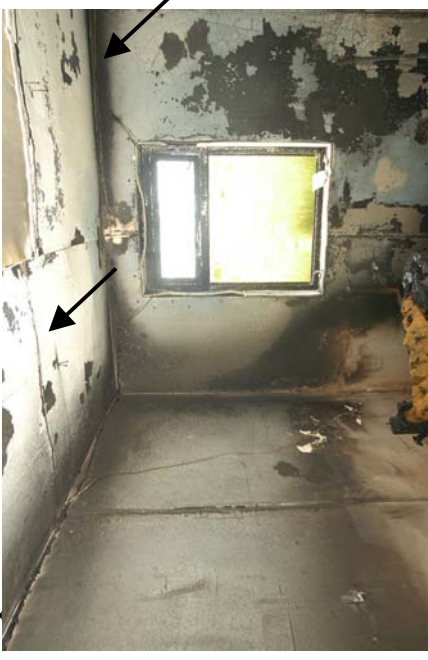
Figure 707 - Post-fire photograph of the ceiling area above the fire's area of origin. The left arrow indicates the arcing damage to circuit 4. The right arrow indicates the arcing damage location to circuit 1.

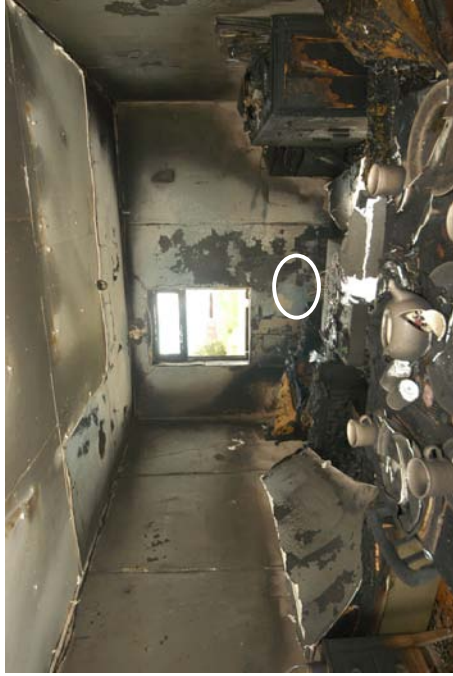
Figure 708 - Post-fire photograph of the scene. The fire's area of origin is indicated with the white circle.

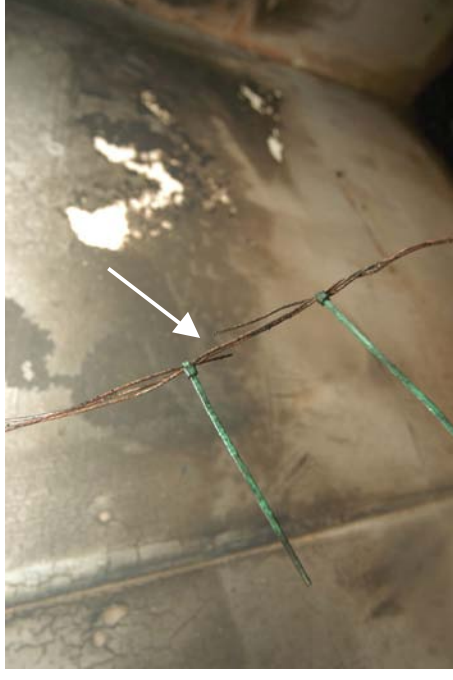
Figure 709 - A close-up photograph of the cable ties used during the electrical examination to identify the arcing damage to circuit 4.

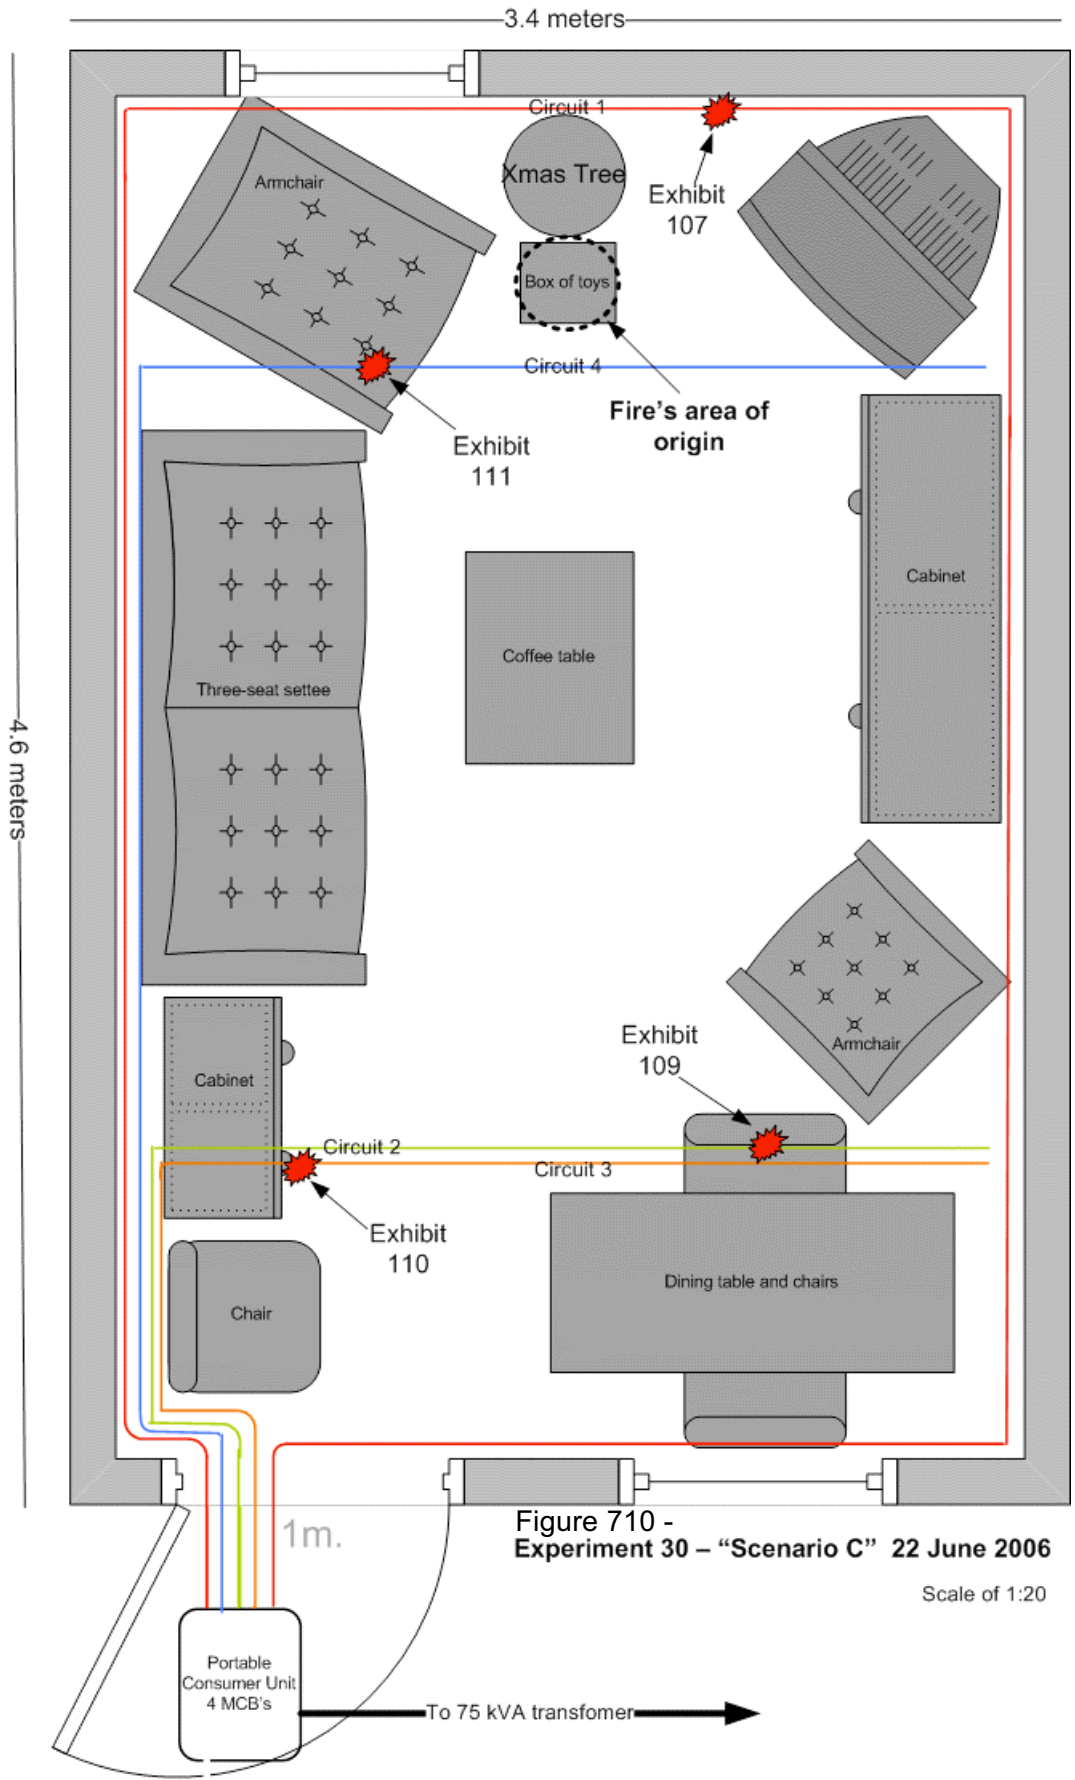
Figure 710 - Experiment 30 - "Scenario C" 22 June 2006

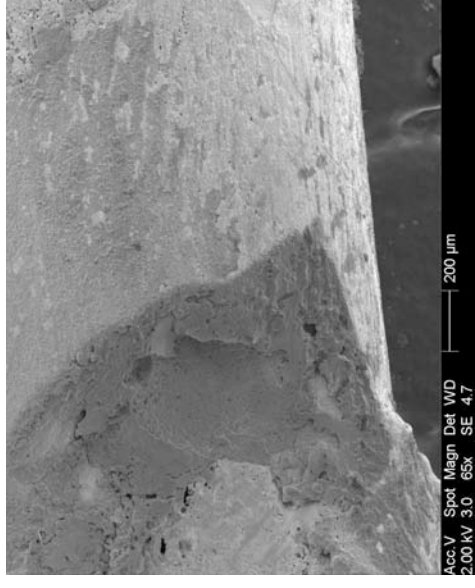
Figure 714 - SEM image at 65x magnification detailing the left of the notch in fig. 713 with a clear demarcation area between the arcing damage and the undamaged conductor surface.

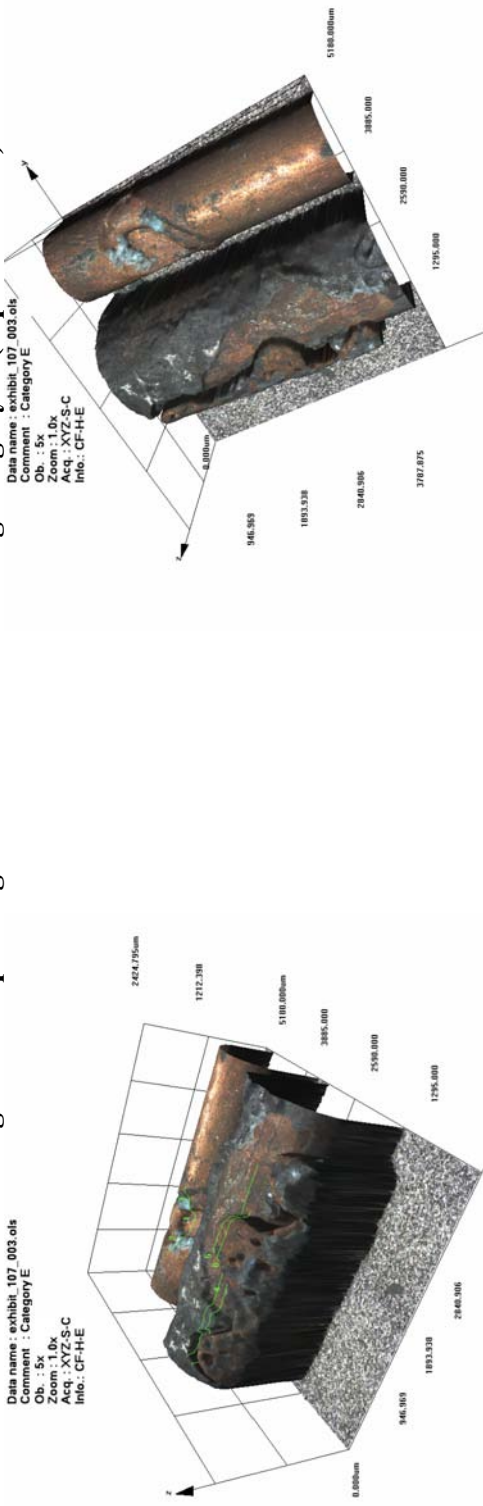
Figure 715 - LEXT image of exhibit 107.

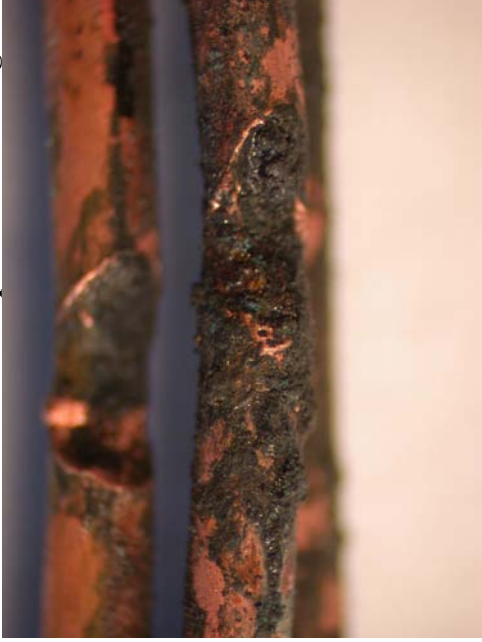
Figure 722 - Microscope image of exhibit 110. Two of the three conductors have arcing damage.

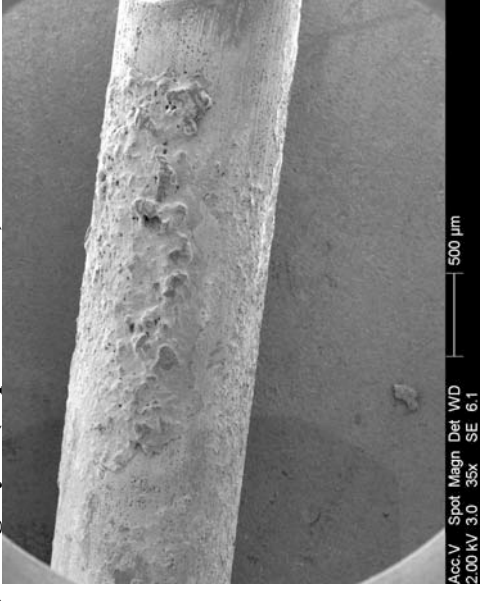
Figure 723 - SEM image of the bottom conductor detailed in figure 722.

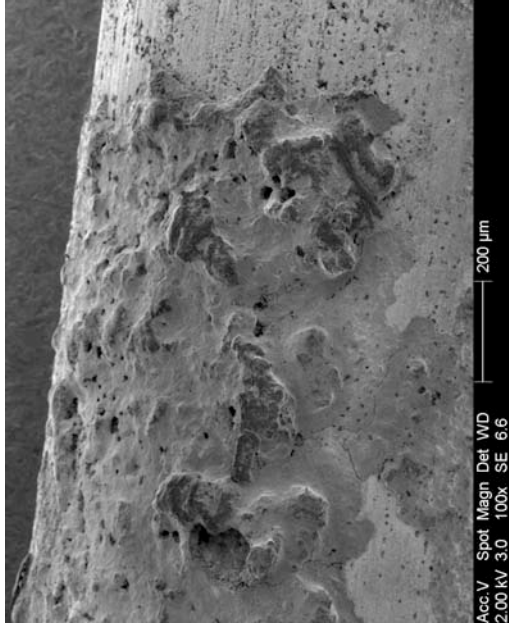
Figure 724 - SEM image of figure 723 at 100x magnification. The demarcation area at the edge of the arcing damage detailed.

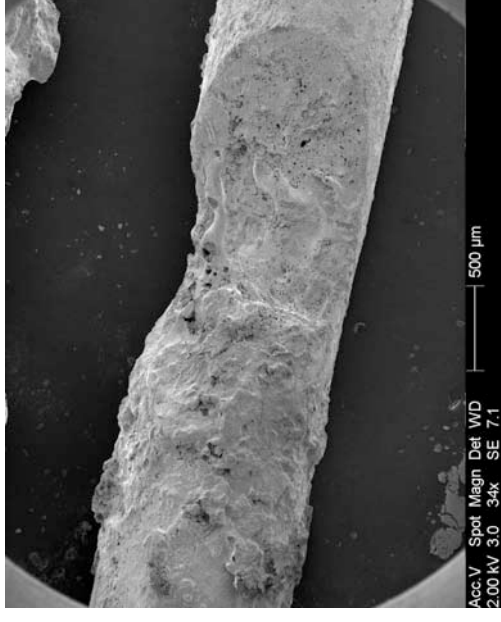
Figure 725 - SEM overview of the top conductor detailed in figure 722, with its large notch on the conductor surface.

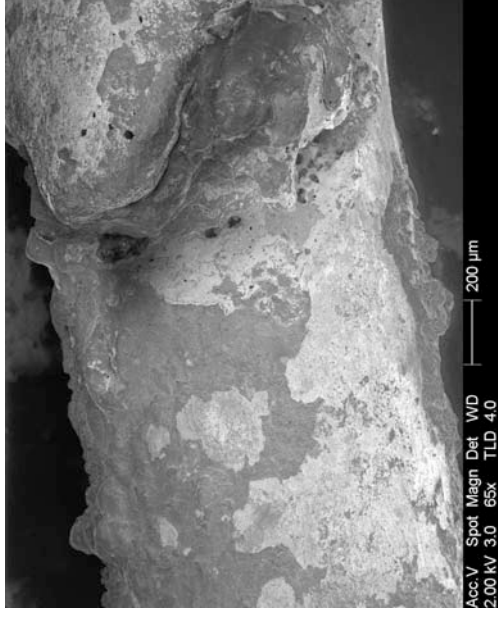
Figure 732 - SEM image of the left side of the bead detailed in figure 731, highlighting the demarcation area at the edge of the arcing damage.

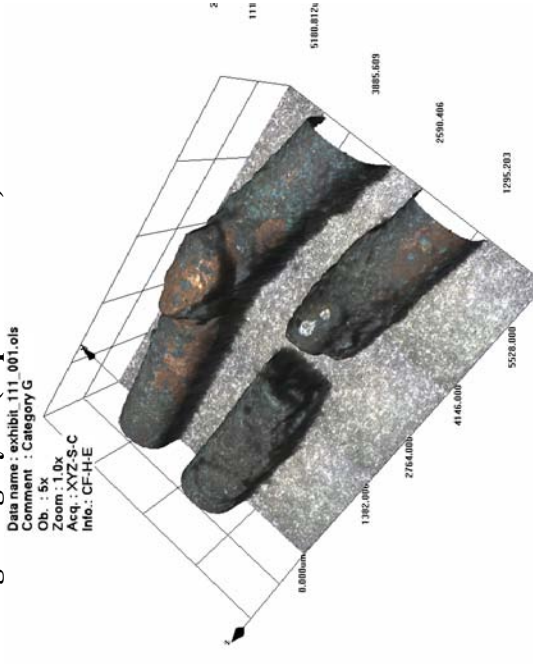
Figure 733 - LEXT image of both conductors viewed side-by-side.

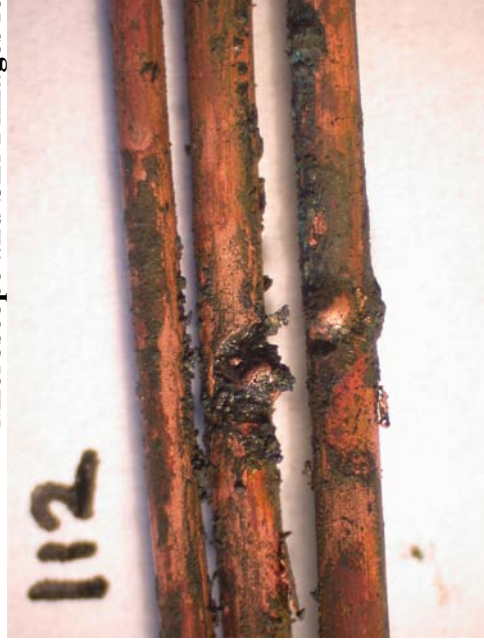
Figure 746 - Microscope image of exhibit 112. Two conductors have arcing damage consisting of a notch with a bead within each notch.

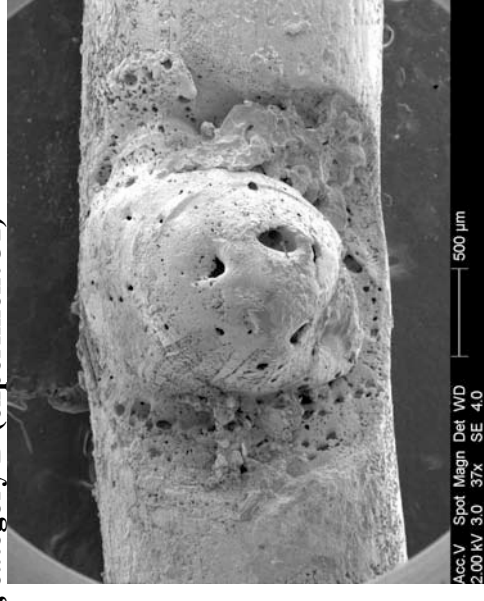
Figure 747 - SEM image of the middle conductor detailed in figure 746. The demarcation area is clear on this exhibit.

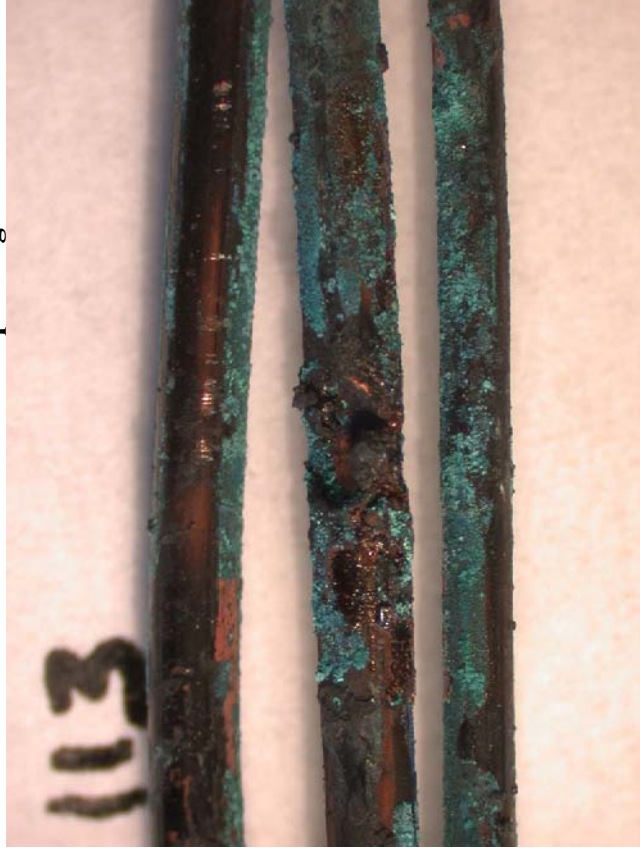
Figure 753 - Microscope image of exhibit 113. The arcing damage affected one conductor with a notch and copper splatter around the notch edge.

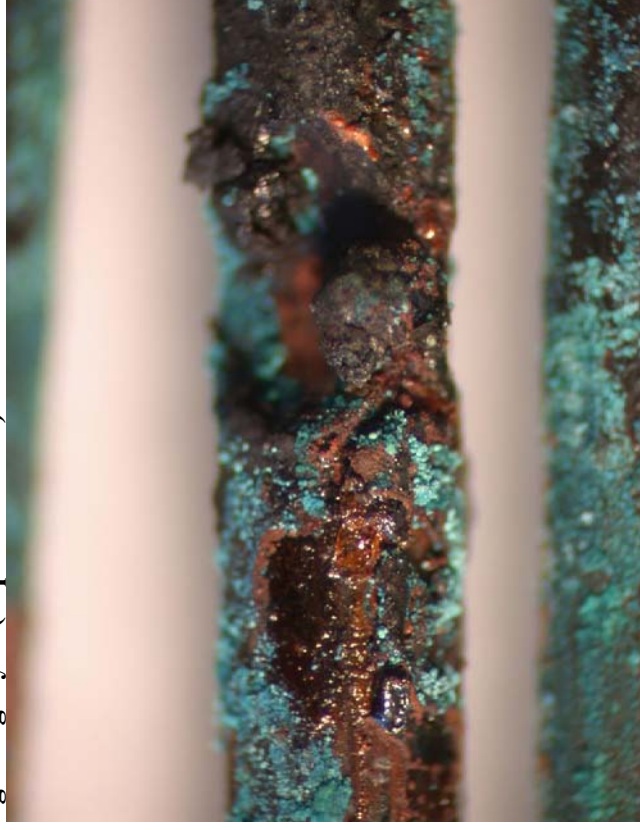
Figure 754 - 20x magnification microscope image of the notch. There was a lot of PVC debris and oxidation on the surface of this conductor.

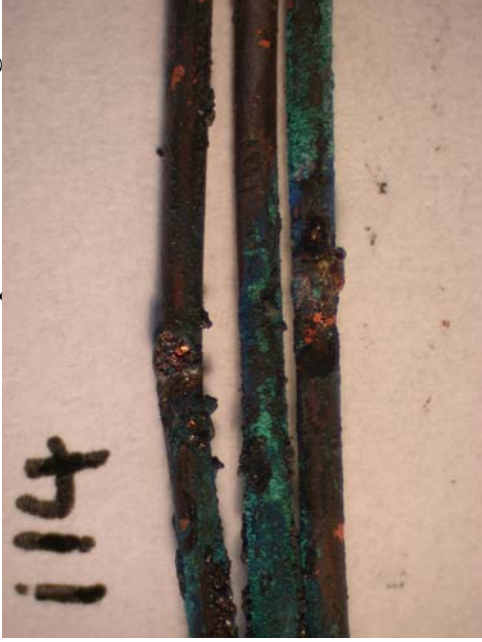
Figure 755 - Microscope image of exhibit 114. The arcing damage affected two of the three conductors. Each conductor has a notch with a bead at the edge.
