**University of Strathclyde**  
**Department of Pure and Applied**  
**Chemistry**  
**Centre for Forensic Science**

**Developing a reliable systematic**  
**analysis for arc fault mapping**

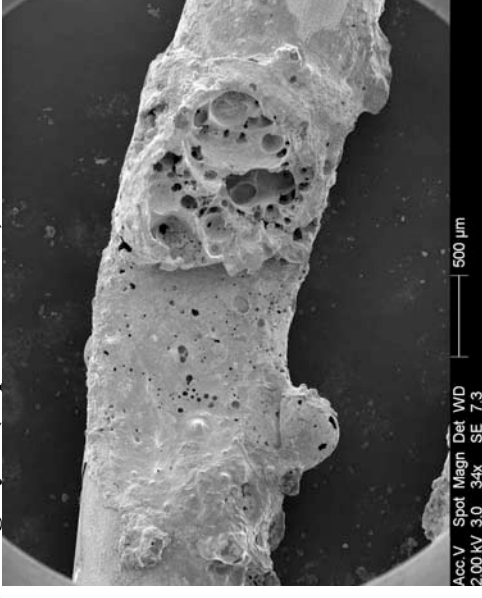
Figure 756 - SEM image of the top conductor detailed in figure 755.

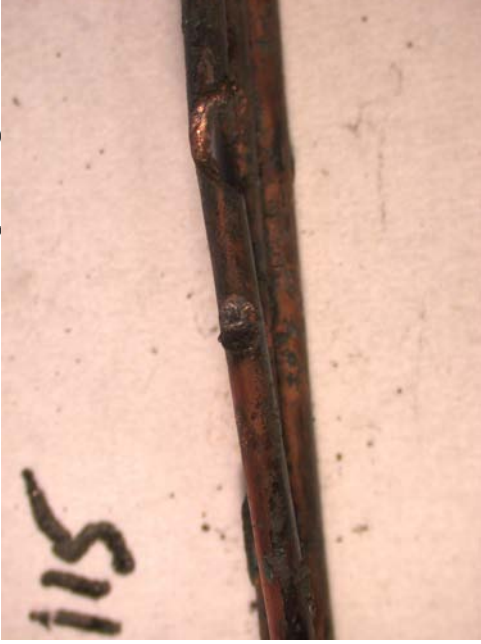
Figure 762 - Microscope image of exhibit 115. Two notches are located close to each other on the same conductor. The smaller notch arcing damage may have failed to operate the circuit breaker. The circuit breakers for circuits 2 and 3 operated simultaneously.

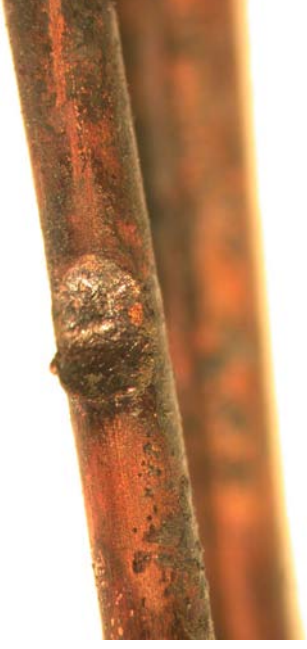
Figure 763 - 20x magnification of the smaller notch. There is a demarcation area at the edge of the notch between the arcing damage and the undamaged conductor.

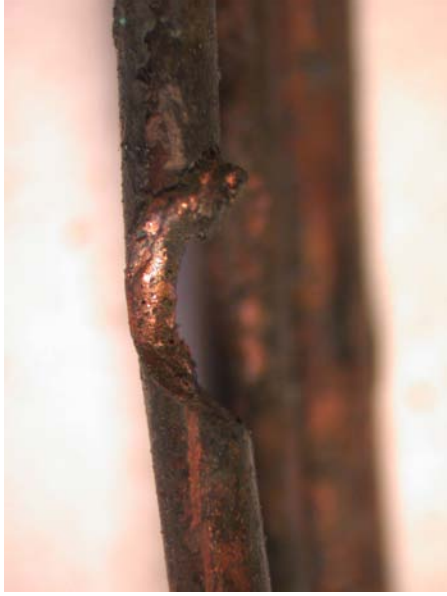
Figure 764 - 30x magnification of the larger notch and associated bead at the notch edge.

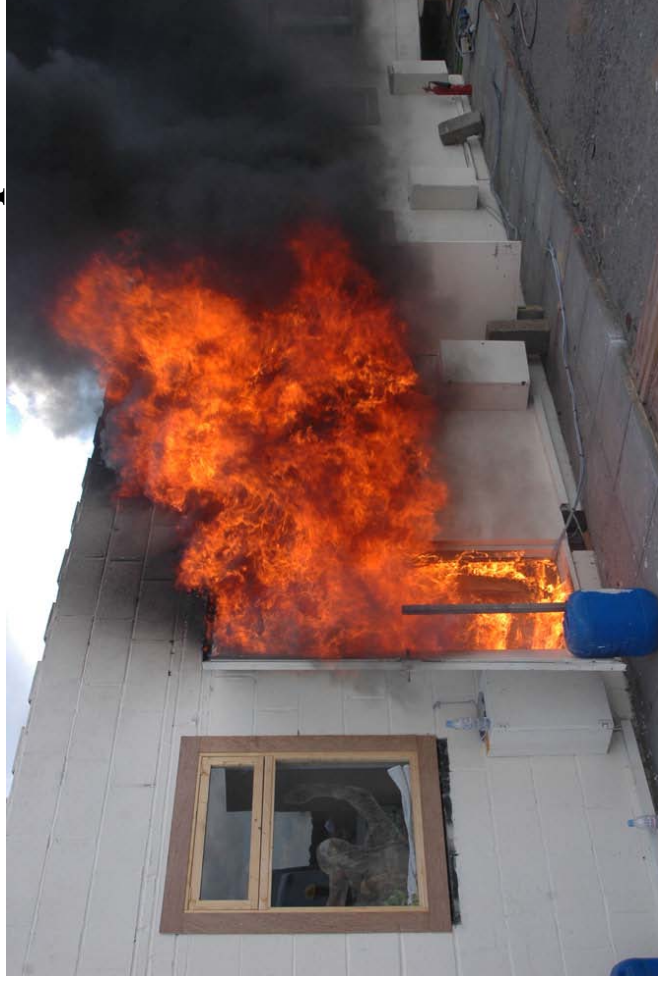
The fire in experiment 32 (scenario A) had three separate areas of origin. One was located on an armchair adjacent to the rear left corner of the compartment. The second area of origin was on a two-seat settee on the left wall. The third area of origin was on a three-seat settee located against the front wall of the compartment, this was the predominant fire plume in the early development of the fire with flames impinging on the ceiling before the other two areas. The fire developed rapidly and was at flashover conditions within 2.5 minutes.

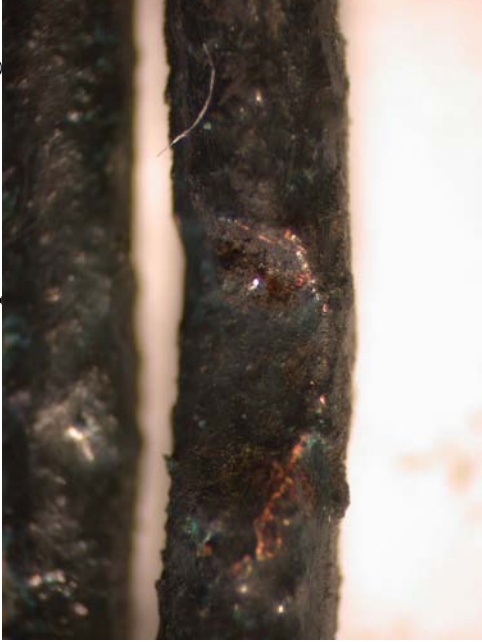
Figure 781 - Microscope image of exhibit 118. The arcing damage is confined to a large notch to one of the conductors.

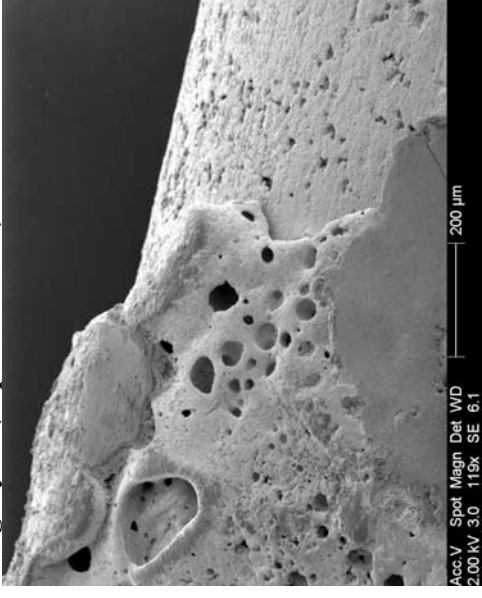
Figure 782 - An SEM image at 118x magnification of the top right edge of the notch with a clear demarcation area.

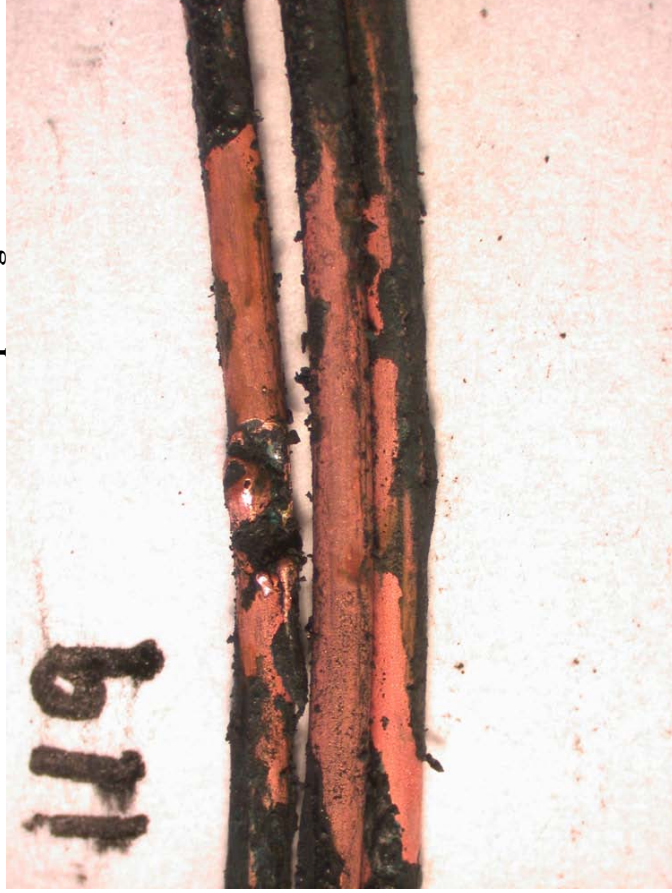
Figure 788 - Microscope image of exhibit 119. The arcing damage was restricted to one conductor with a notch and a bead within the notch. Some copper splatter was also observed on the conductor surface to the side of the notch.

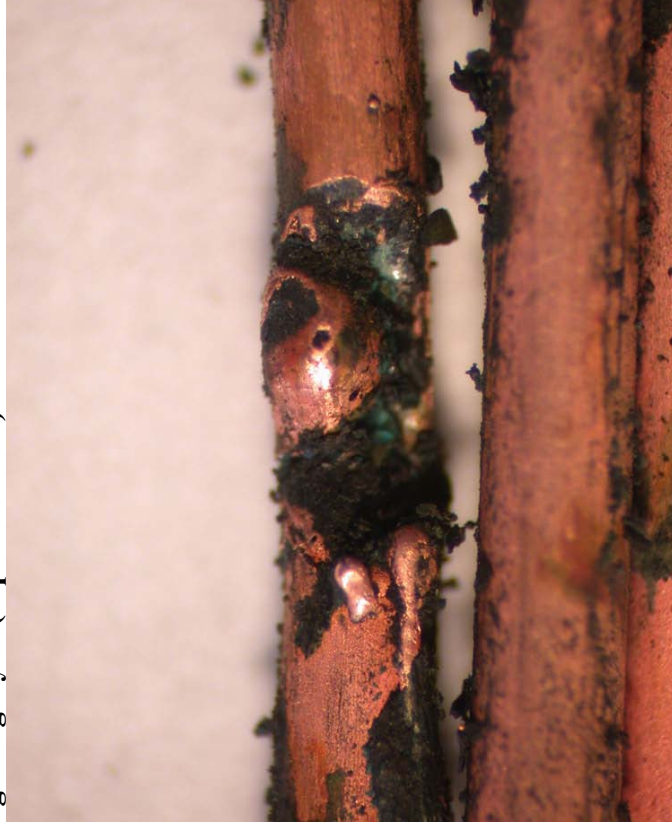
Figure 789 - 20x magnification of the arcing damage. The demarcation is clear in this image on the right and left sides of the notch.

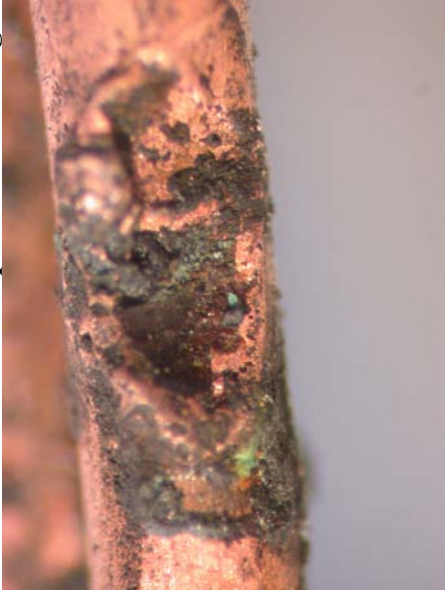
Figure 790 - Microscope image of exhibit 120. The arcing damage is limited to one conductor. The limited depth of field renders the edge of the notch out of focus.

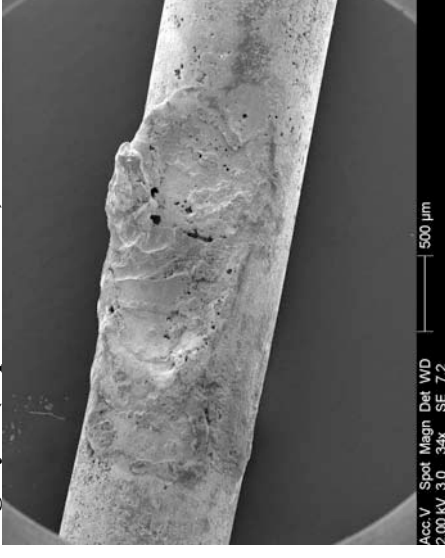
Figure 791 - SEM image of the notch. The demarcation at the edge of the notch is defined.

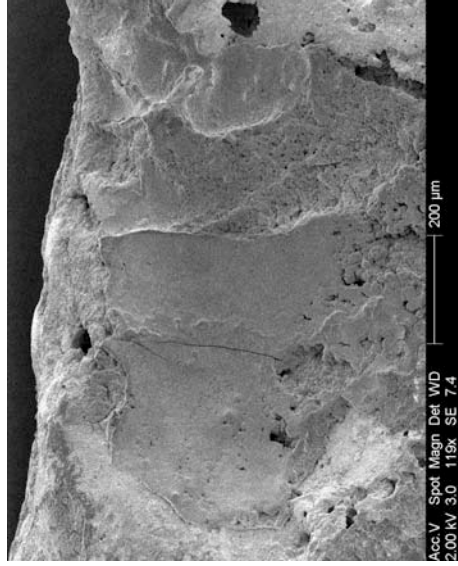
Figure 792 - SEM image of the left side of the notch. The ridge patterns in this image were observed on other exhibits and this could be an effect of alternating current during the arcing event.

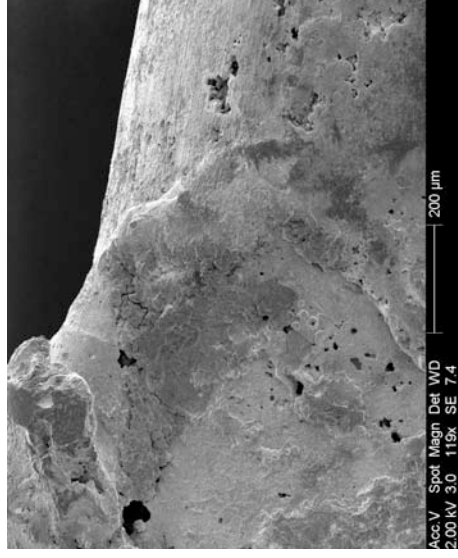
Figure 793 - SEM image of the right side of the notch. This image re-enforces the defined demarcation between the arcing damage and the undamaged conductor that is consistent with electrical localised metallic (arcing) damage to conductors.

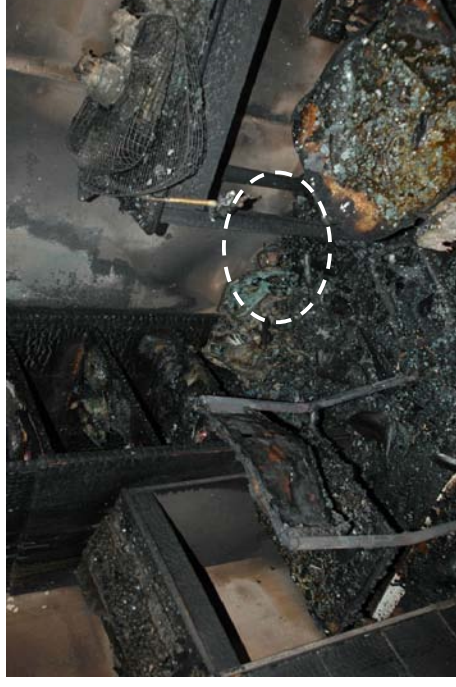
Figure 805 - Post-fire view of the area of origin for this fire. The refuse bin and the vacuum cleaner have been severely damaged in the fire.

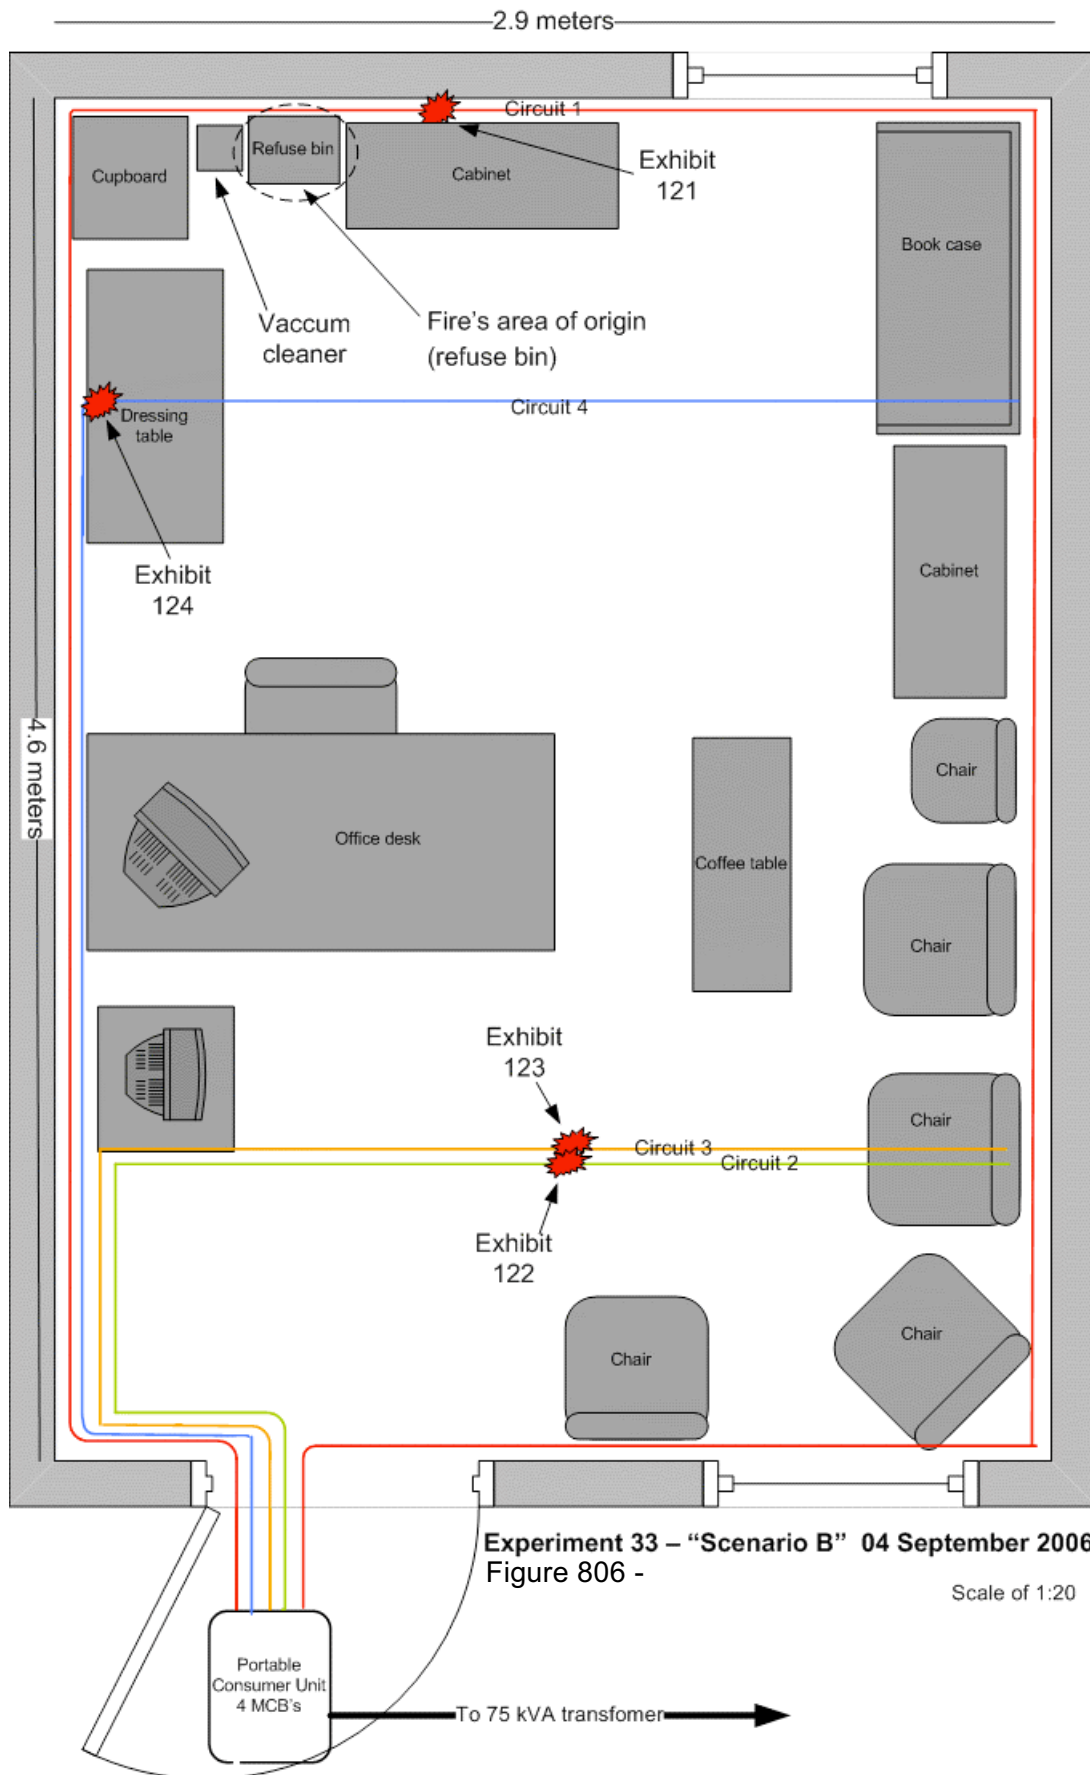
Microscope images for exhibit 121 – arcing category D (experiment 33)

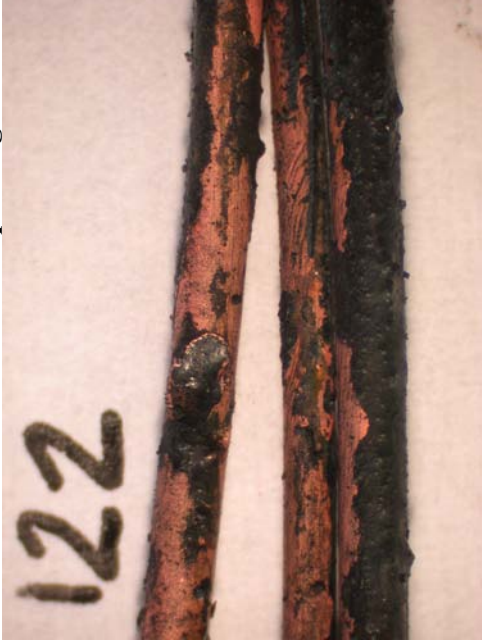
Figure 811 - One of the three conductors had arcing damage in the pattern of a notch. This circuit (number 2) appears to have faulted with circuit 3.

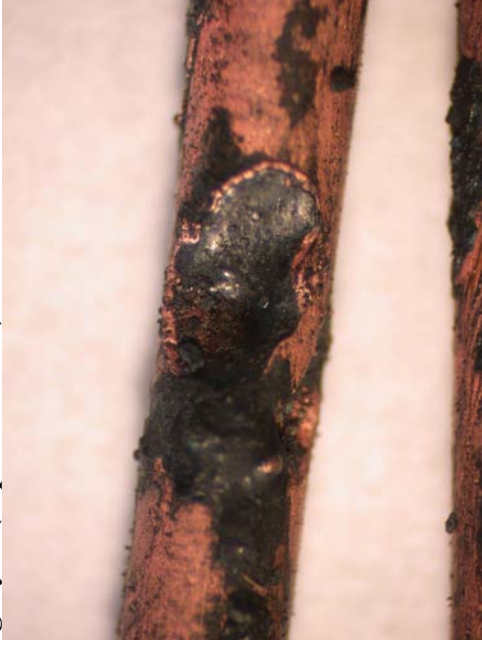
Figure 812 - 15x magnification of the notch with a small bead at the left edge of the notch.

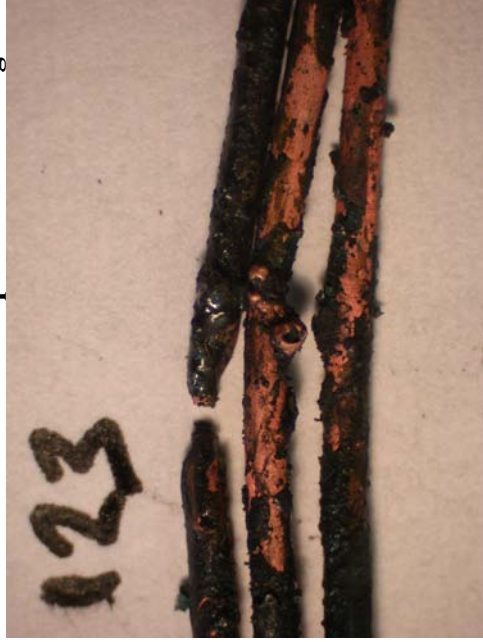
Figure 815 - Microscope image of exhibit 123. Two conductors had arcing damage. The lower conductor has a bead with a large hole.

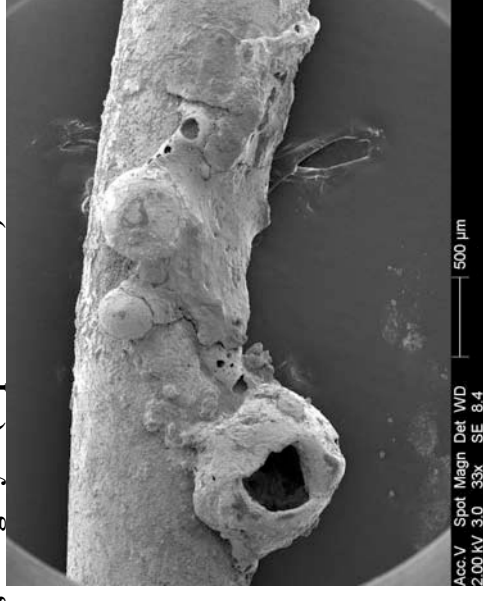
Figure 816 - SEM image of the lower conductor. The demarcation is clearly defined at the notch edge.

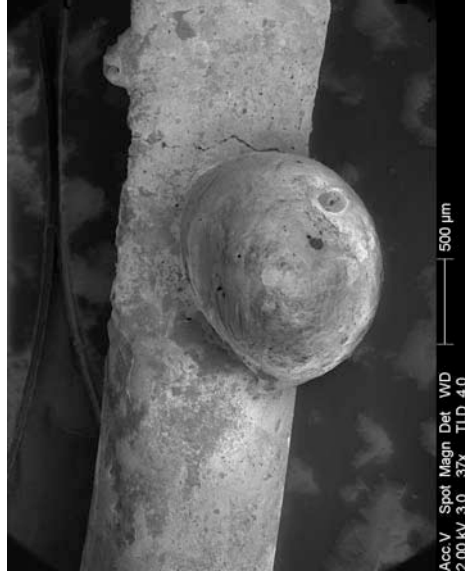
Figure 824 - SEM image of the notch with a bead on the surface. There was a crack in the conductor surface to the right of the bead.

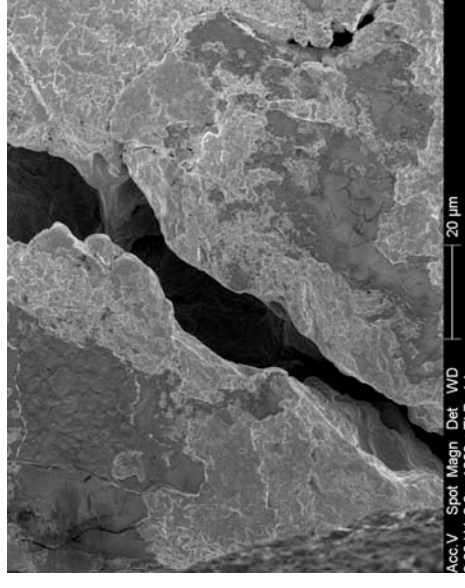
Figure 825 - SEM image at 1000x magnification documenting the crack in the conductor surface detailed in figure 824.

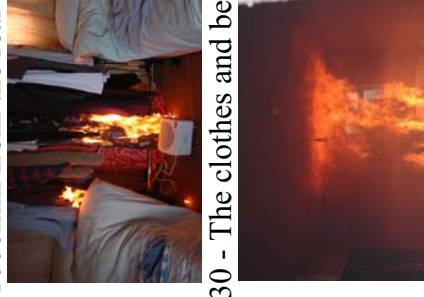
Figure 830 - The clothes and beds ignited.

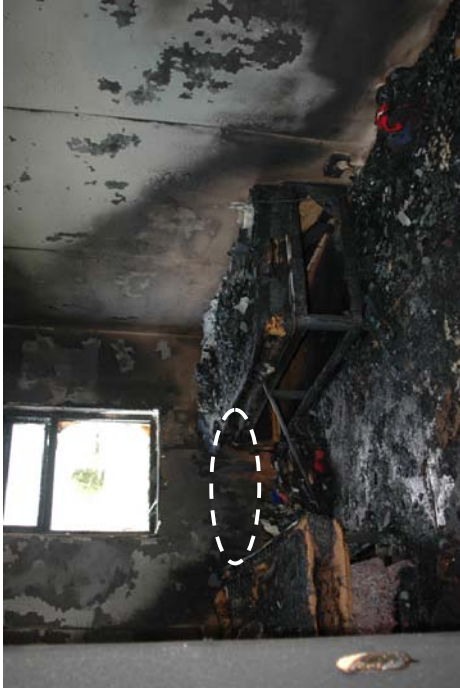
Figure 834 – Post-fire view of the experiment. There are burn patterns on the rear and right wall of the compartment.

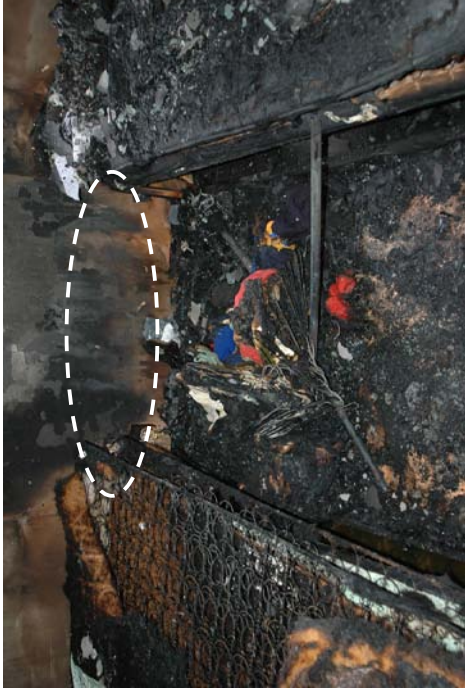
Figure 835 - Close-up view of the fire's area of origin. Arcing damage to circuits 1 and 4 was located above this area on the ceiling.

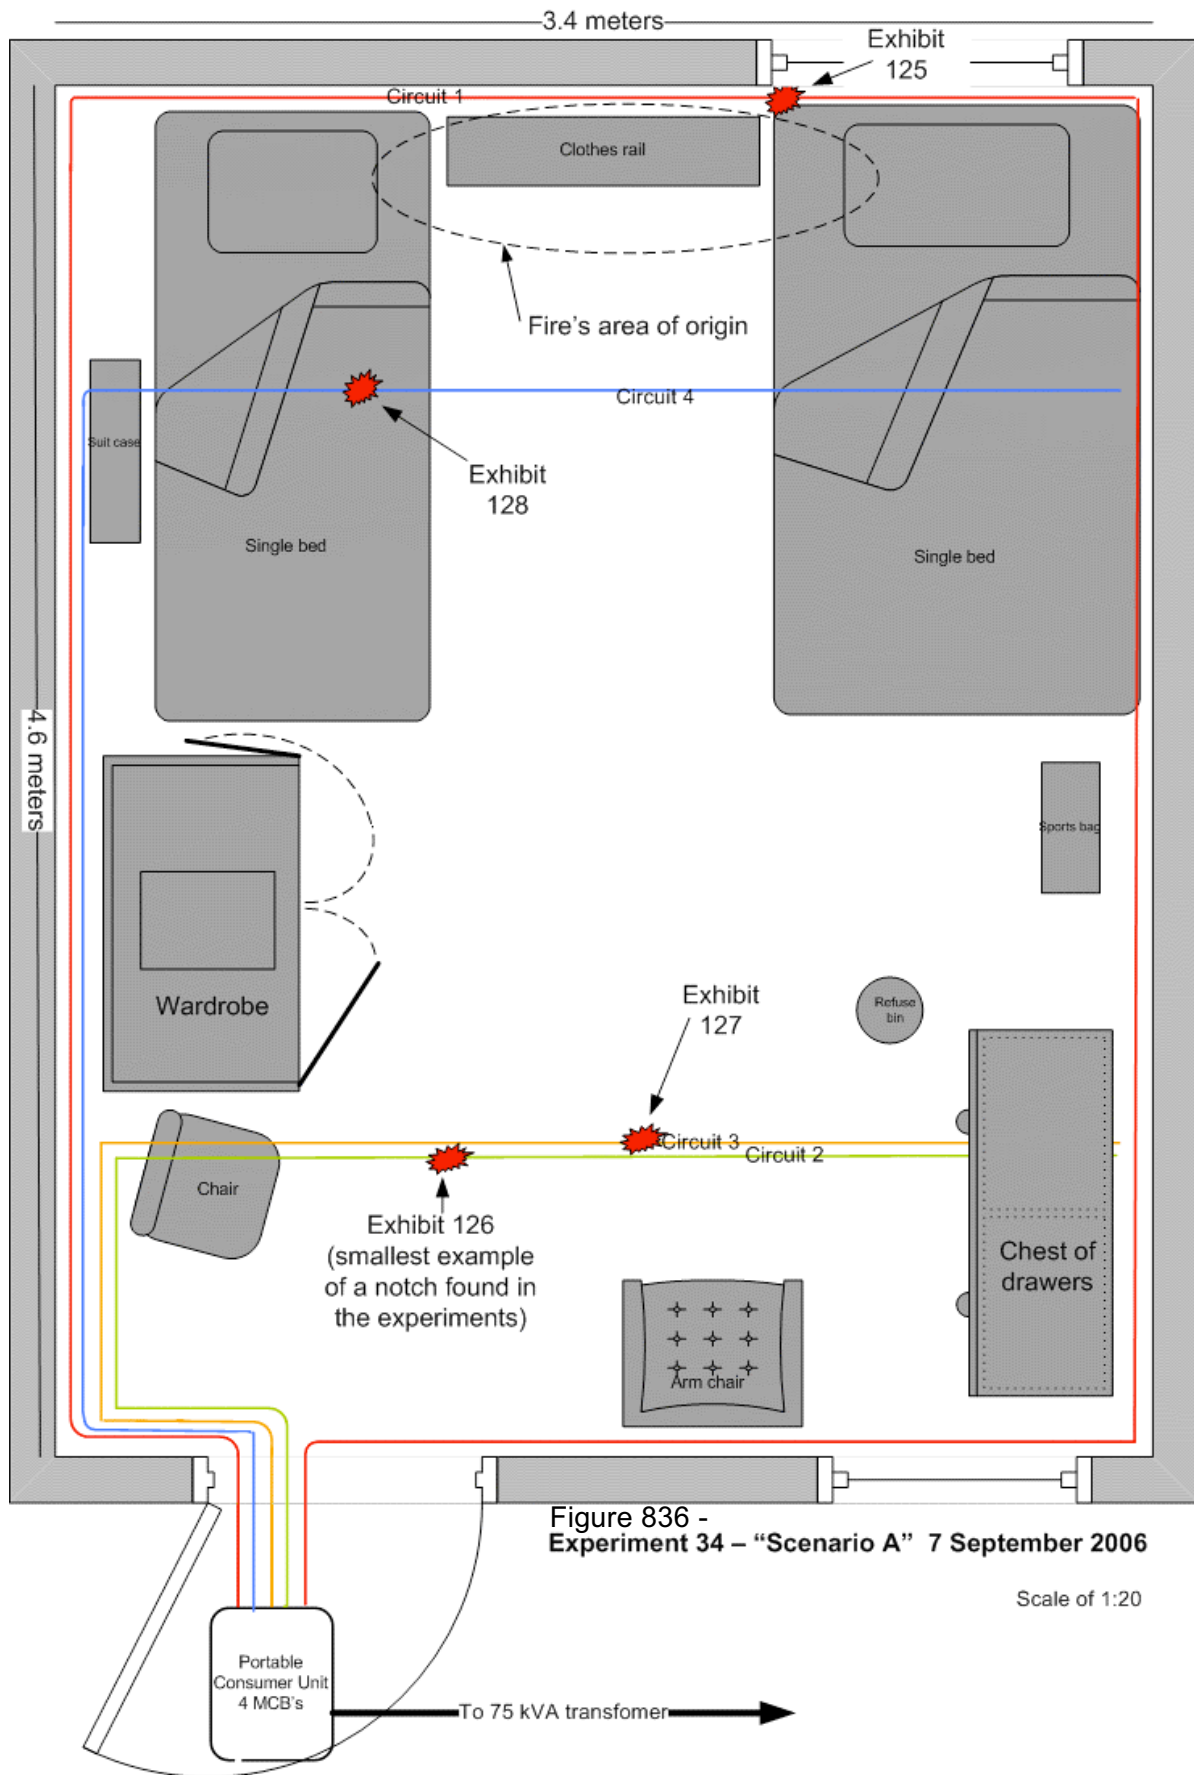
Figure 836 -  
Experiment 34 – “Scenario A” 7 September 2006

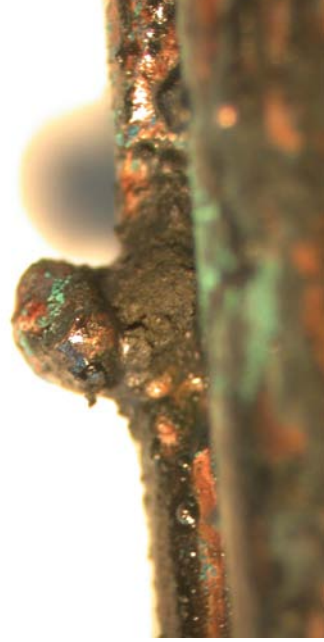
Figure 837 - Microscope image of exhibit 125. Two conductors had notch arcing damage. One had a large bead protruding from the surface and has a sub-category “I”.

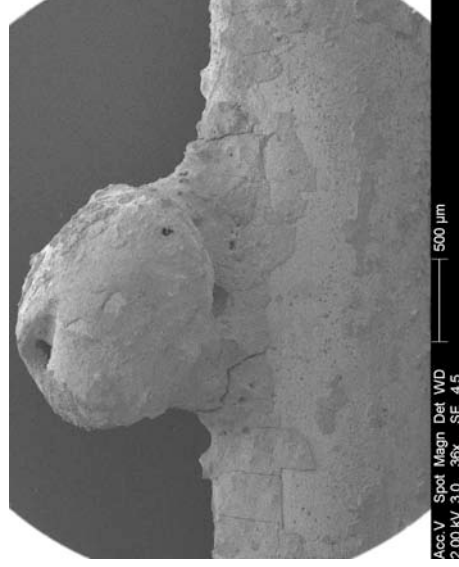
Figure 839 - SEM image of the top conductor with its tall bead. This is one of the best examples of arcing category I from the experiments.

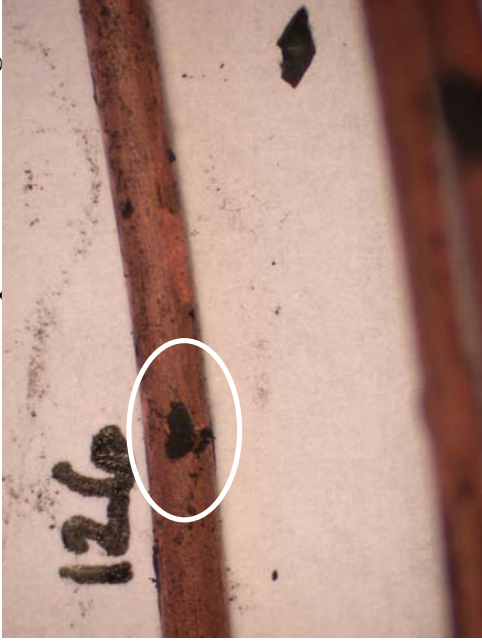
Figure 845 - Microscope image of exhibit 126. This was the smallest notch observed in the series of experiments

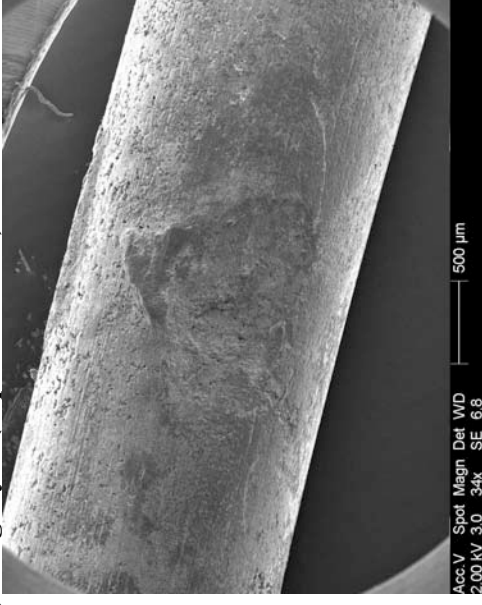
Figure 846 - SEM image of the small notch.

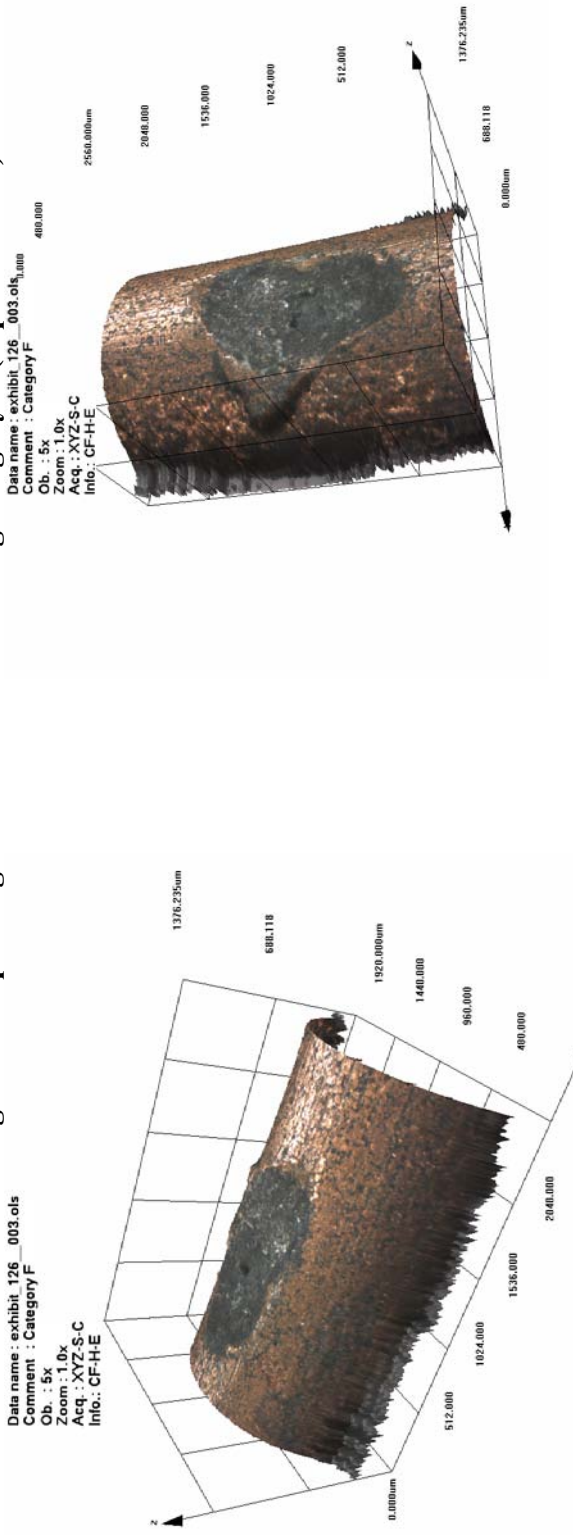
Figure 849 - LEXT image clearly detailing the shallow notch damage to this exhibit.

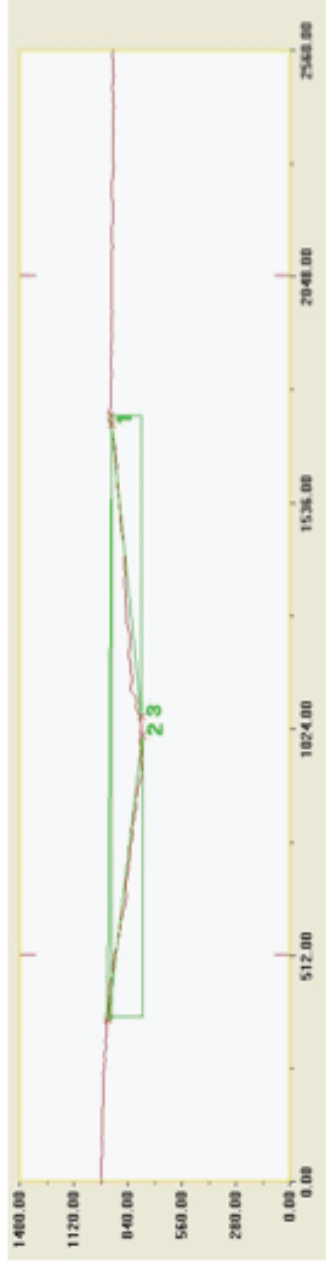
Figure 851 - Profile of the notch using the “slice tool” option in the LEXT software. Measurement details for the smallest notch located in the series of 39 experiments: notch width=1345 microns, (1.34mm), notch height=173.9 microns (0.174mm)

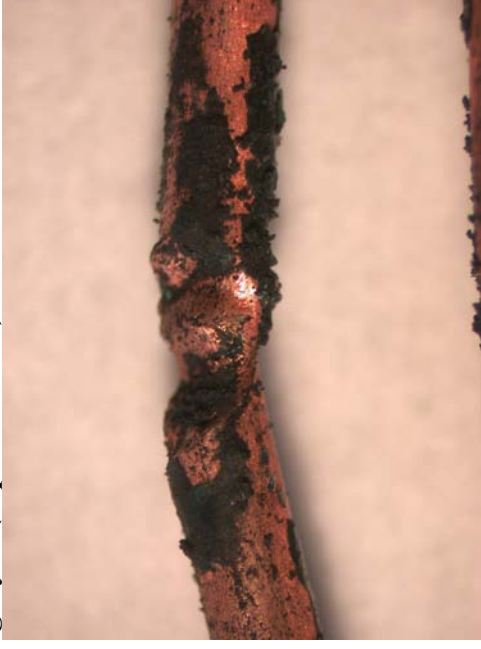
Figure 853 - 20x magnification of the exhibit. The left edge of the notch displays a clear demarcation between the arcing damage and the undamaged conductor surface.

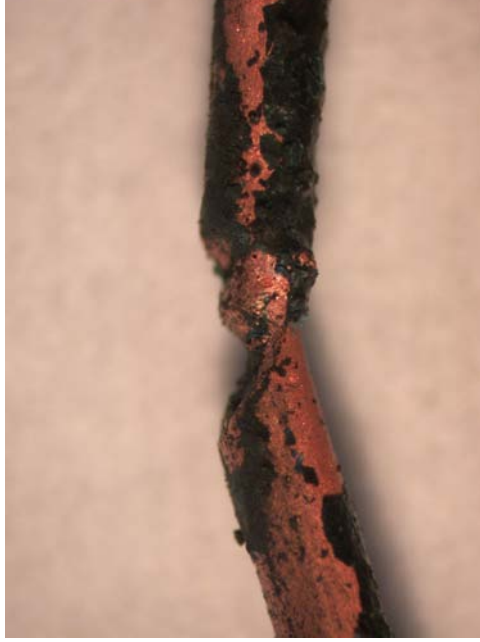
Figure 854 - A side view of the notch detailing its depth. There is a lot of PVC debris attached to the conductor surface.

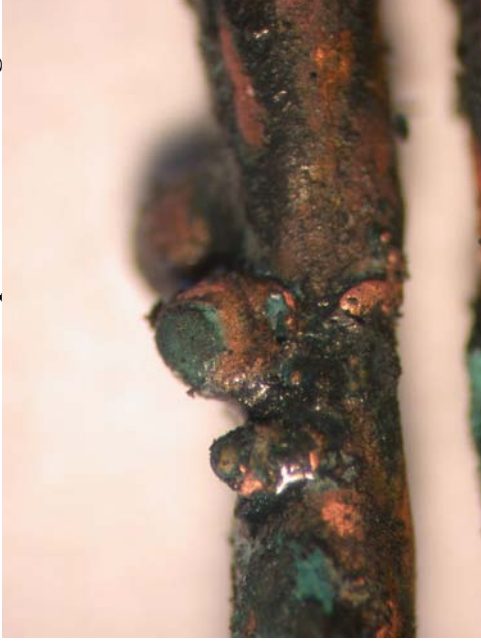
Figure 855 - Microscope image of exhibit 128. Two of the three conductors had arcing damage and one conductor produced some unusually shaped multiple beads.

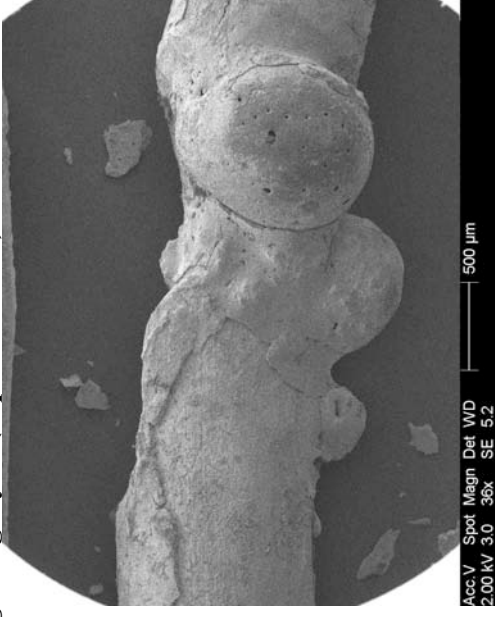
Figure 856 - SEM image of the bottom conductor. Incorrect adjustment of the SEM produced lower quality images than normal.

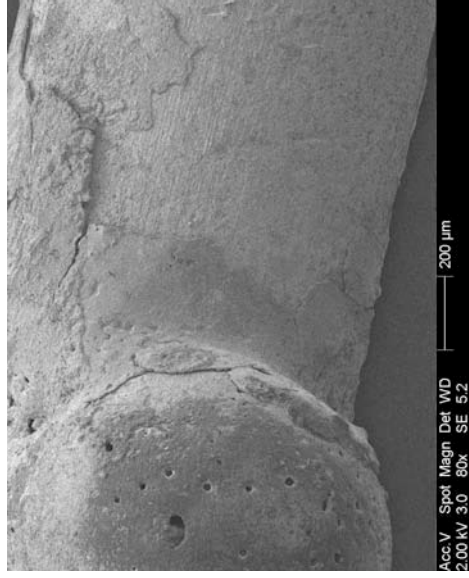
Figure 857 - SEM image at 80x magnification detailing the right side of the arcing damage and the demarcation area.

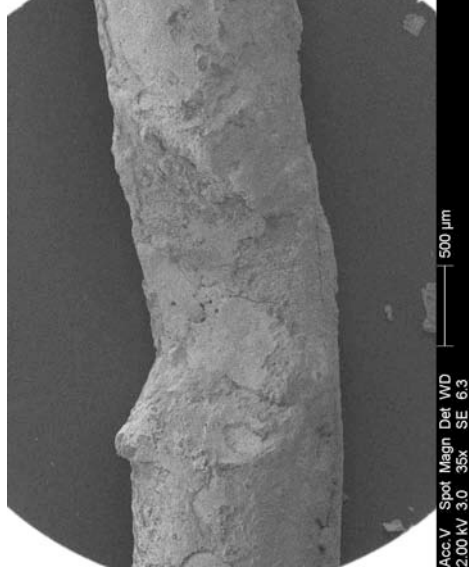
Figure 858 - SEM image of the top conductor detailing the notch damage and the demarcation area.

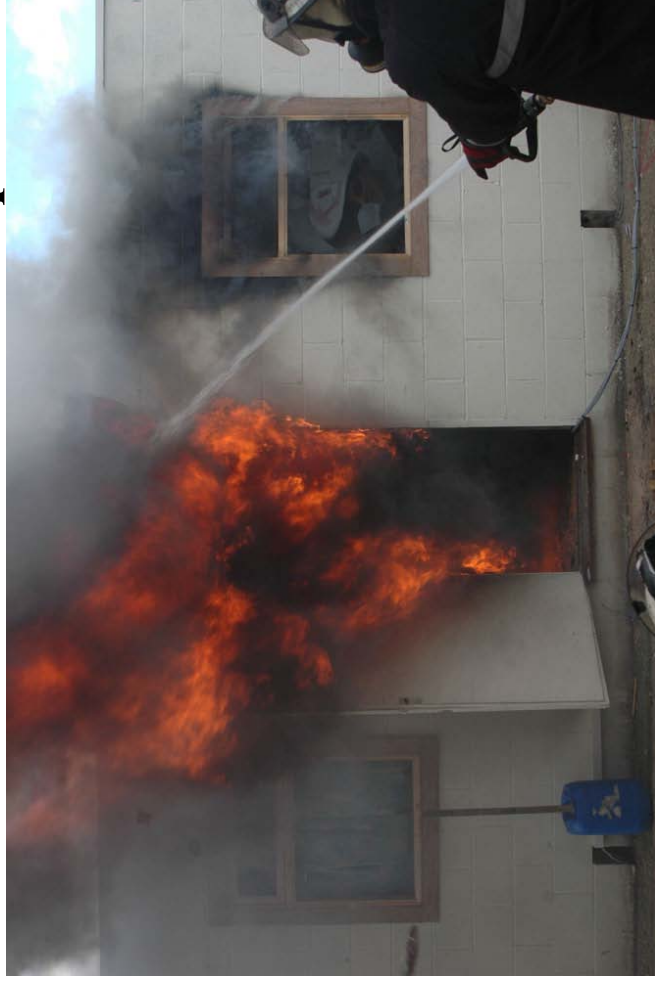
The fire in experiment 35 (scenario C) originated in a toy box located in front of a Christmas tree adjacent to the centre of the rear wall of the compartment. The fire developed steadily with a ceiling temperature of 825° C recorded at 6 minutes. The middle thermocouple recorded a temperature of 650° C and the floor thermocouple recorded 200° C at this time. The compartment did not appear to have reached flashover conditions prior to being extinguished.

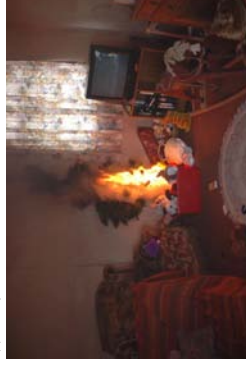
Figure 865 - The toy box ignited.

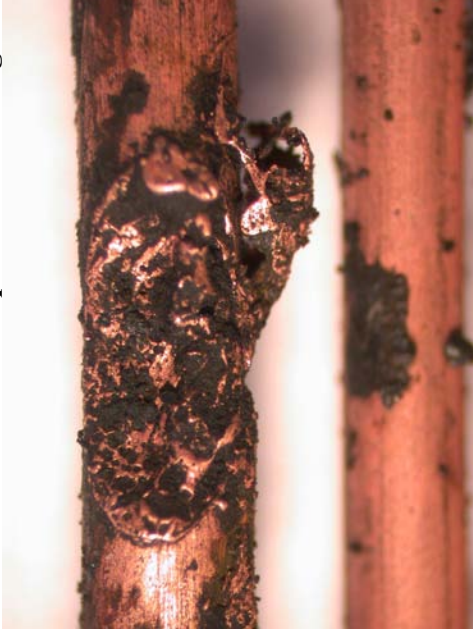
Figure 872 - Microscope image of exhibit 129. Arcing damage affected one conductor. The splatter attached to the lower area of the conductor came away during the subsequent cleaning process.

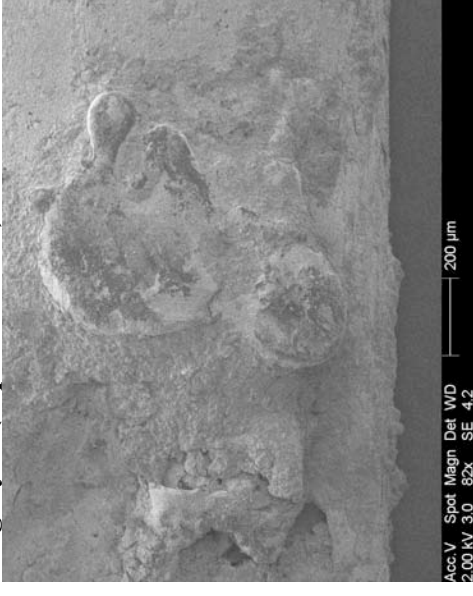
Figure 873 - SEM image at 82x magnification. This is the right side of the notch edge as detailed in figure 875.

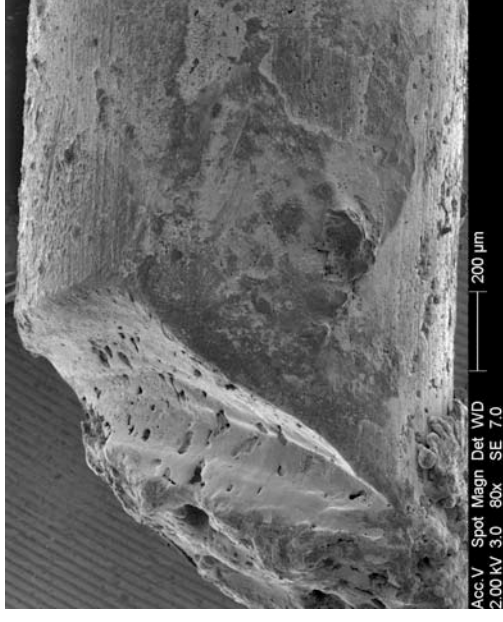
Figure 882 - SEM image at 80x magnification detailing the demarcation at the edge of the arcing damage.

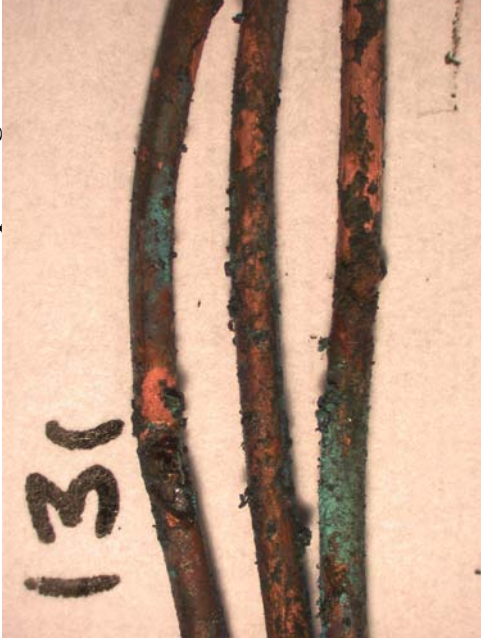
Figure 886 - Microscope image of exhibit 131. This is the second area of arcing for circuit 4 closest to the electrical source. Two conductors have localised melting damage in the shape of a notch.

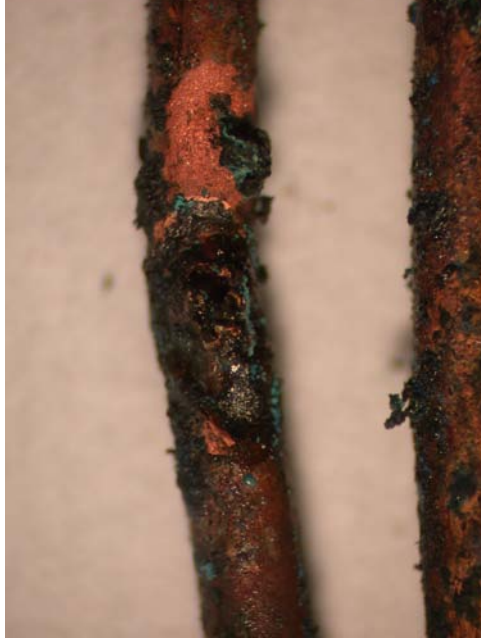
Figure 888 - 20x magnification of the top conductor detailed in figure 886. The edge of the notch and demarcation is visible.

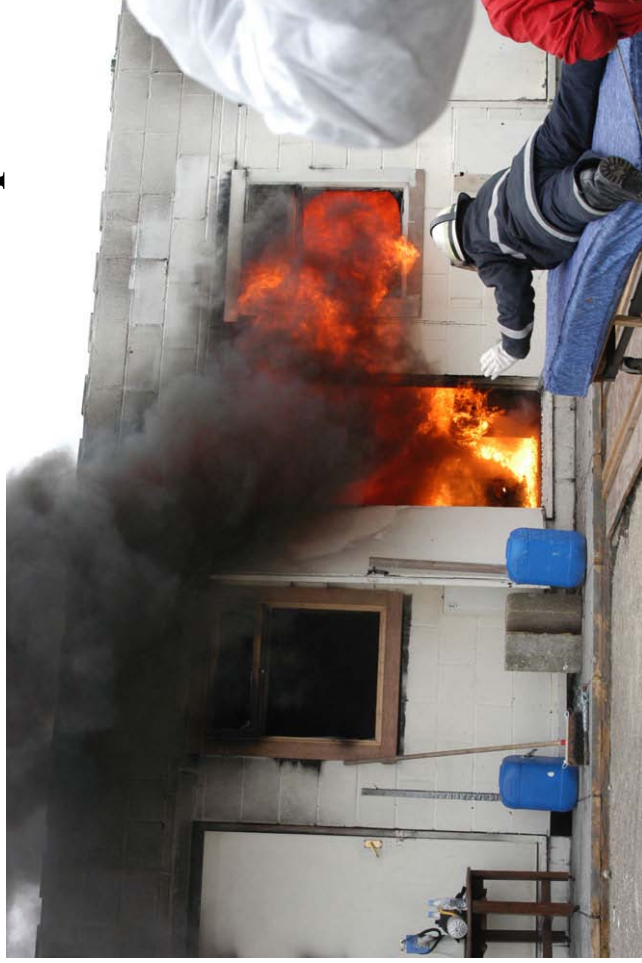
The fire in experiment 36 (scenario D) originated in five separate areas. An armchair located in the left rear corner, (this was observed as the dominant fire plume in the fire’s development). A television against the centre of the rear wall. On top of the cabinet located adjacent to the rear right corner. A three-seat settee adjacent to the left wall. A second three-seat settee adjacent to the front wall.

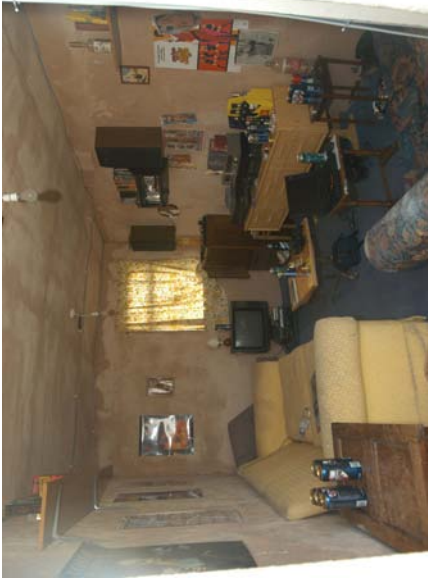
Figure 900 - Pre-fire photograph of experiment 36. This fire had 5 areas of origin that are documented on the scene diagram Figure 904. The dominant fire plume was the armchair in the rear left corner.

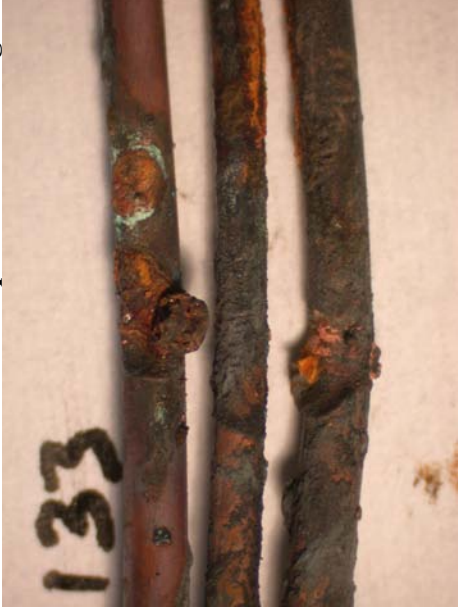
Figure 905 - Microscope image of exhibit 133. The two 2.5mm<sup>2</sup> conductors (L&N) had arcing damage. The conductors had arced across the fixing screw.

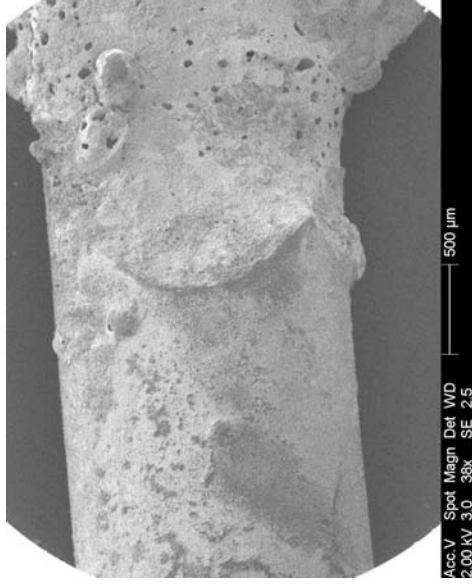
Figure 907 - SEM image of the bottom conductor detailed in figure 905. The notch is large with holes in the copper surface and clear edge demarcation.

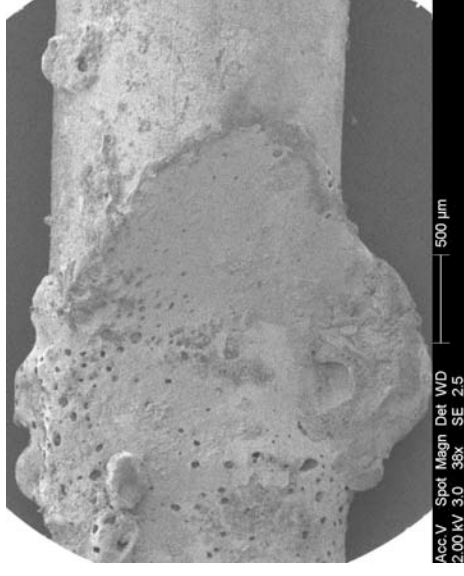
Figure 908 - SEM image displaying the majority of the notch and the right edge indicates a clear demarcation between the arcing damage and the undamaged metallic surface.

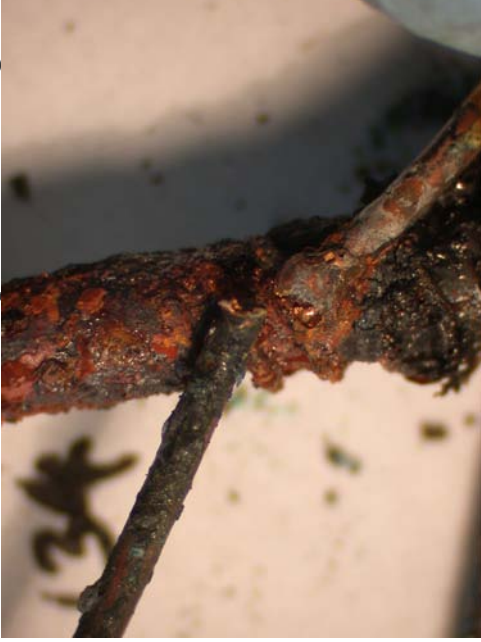
Figure 911 - Microscope image of exhibit 134. The conductor is welded to the fixing screw. The conductor has fractured at the bead.

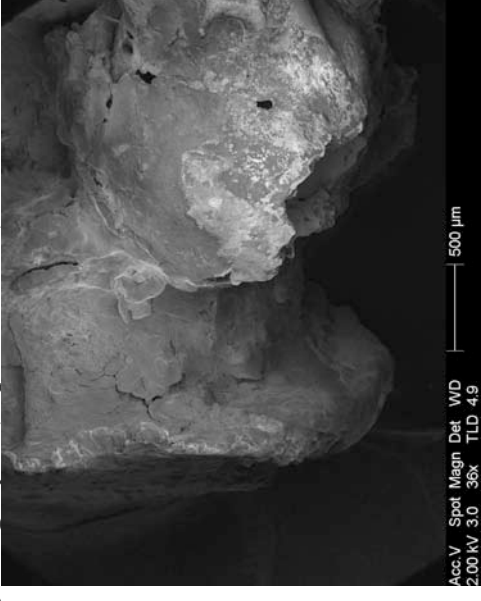
Figure 912 - SEM image of the read on the left side of the image. The edge of the screw thread is visible on the left side of the image.

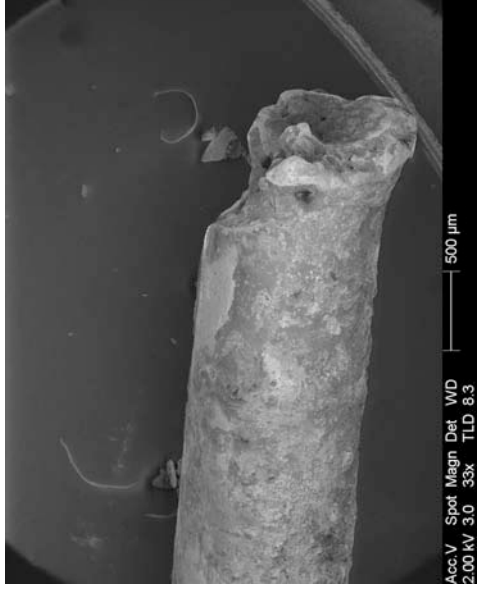
Figure 914 - SEM image of the fractured end of the conductor visible in the microscope image above.

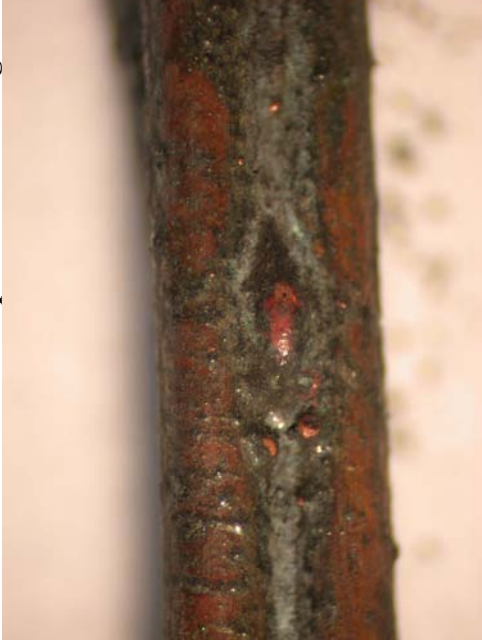
Figure 915 - Microscope image of exhibit 135. Two of the three conductors are welded together with a bead.
