**University of Strathclyde**  
**Department of Pure and Applied**  
**Chemistry**  
**Centre for Forensic Science**

**Developing a reliable systematic**  
**analysis for arc fault mapping**

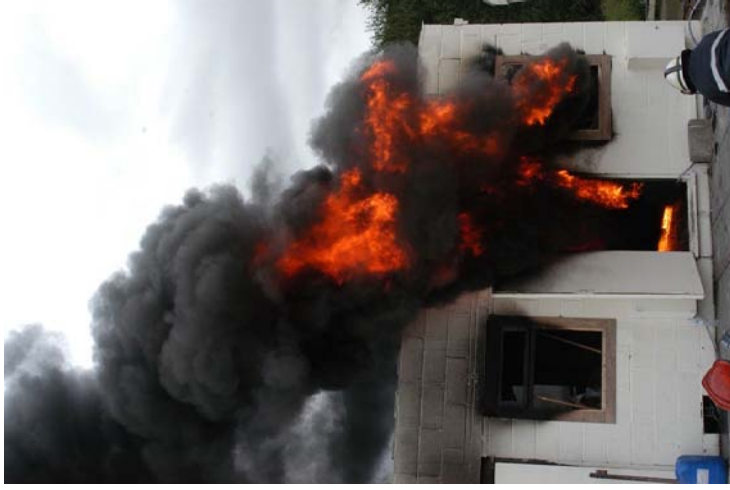
Figure 925 – “Scenario B” 28 September 2006

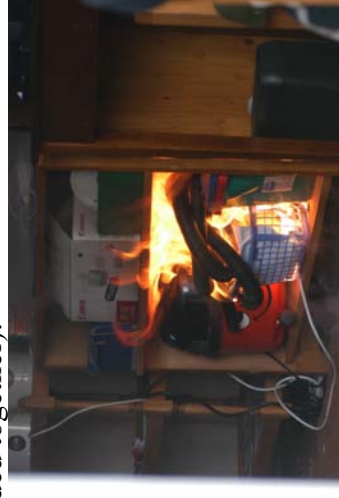
Figure 926 - Early development of the fire in the bottom of the high display unit.

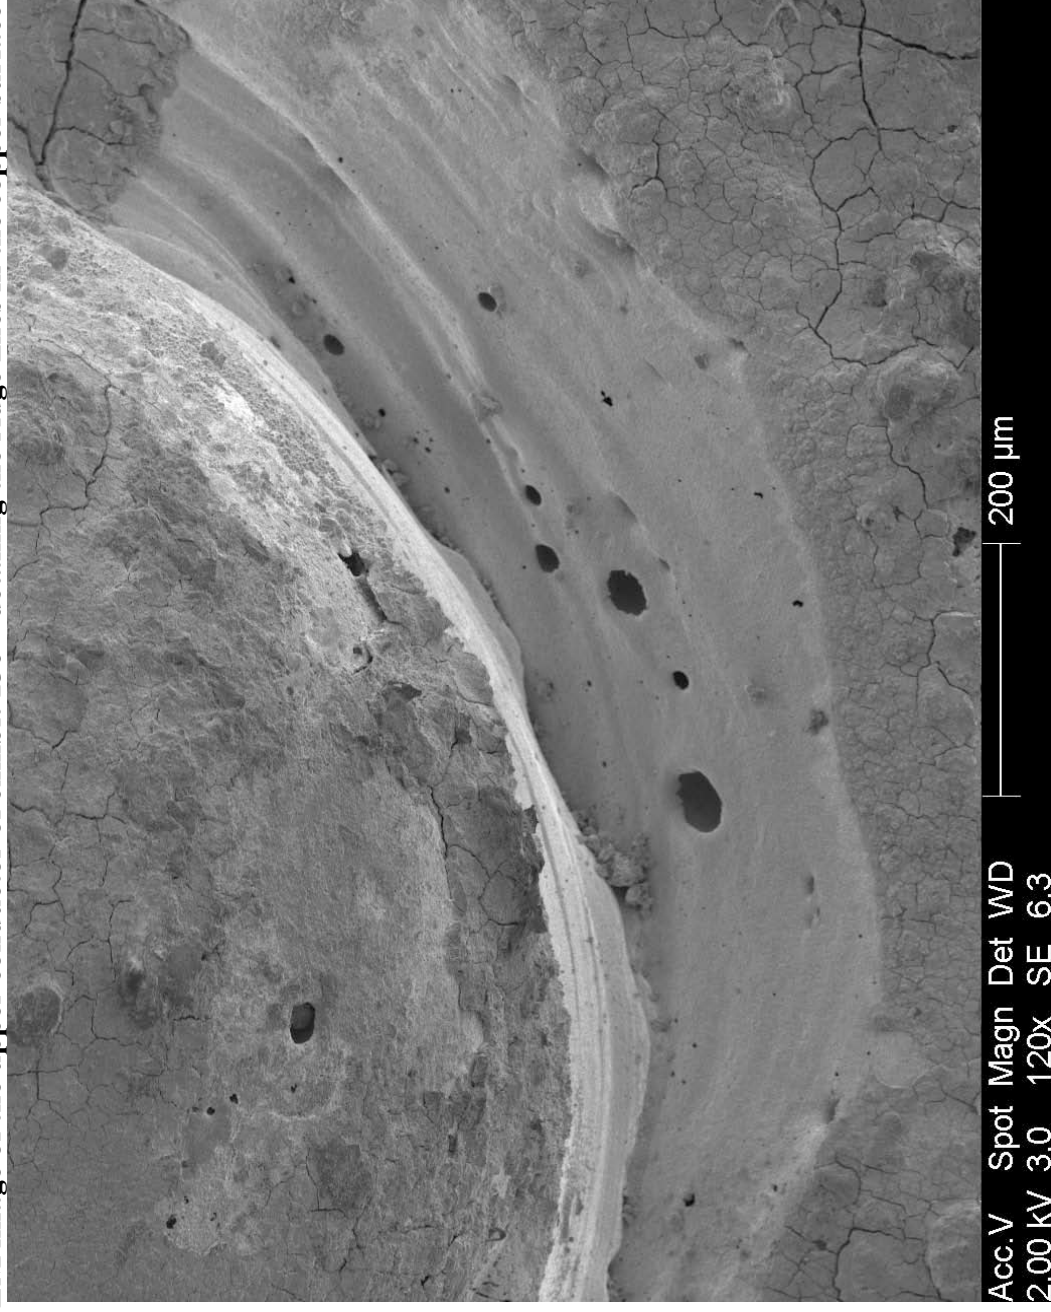
**Figure 936 – Rib lines observed in the copper surface of the notch**

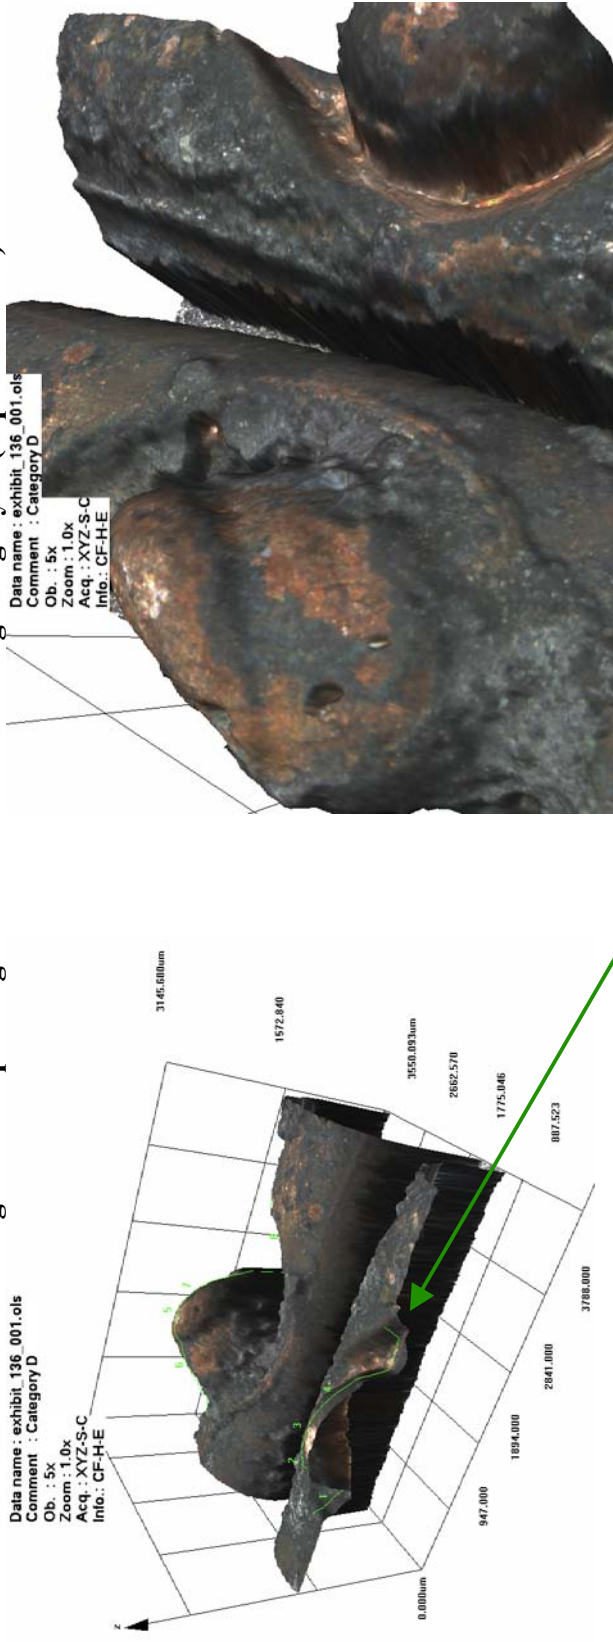
Figure 937 – LEXT image detailing exhibit 136.

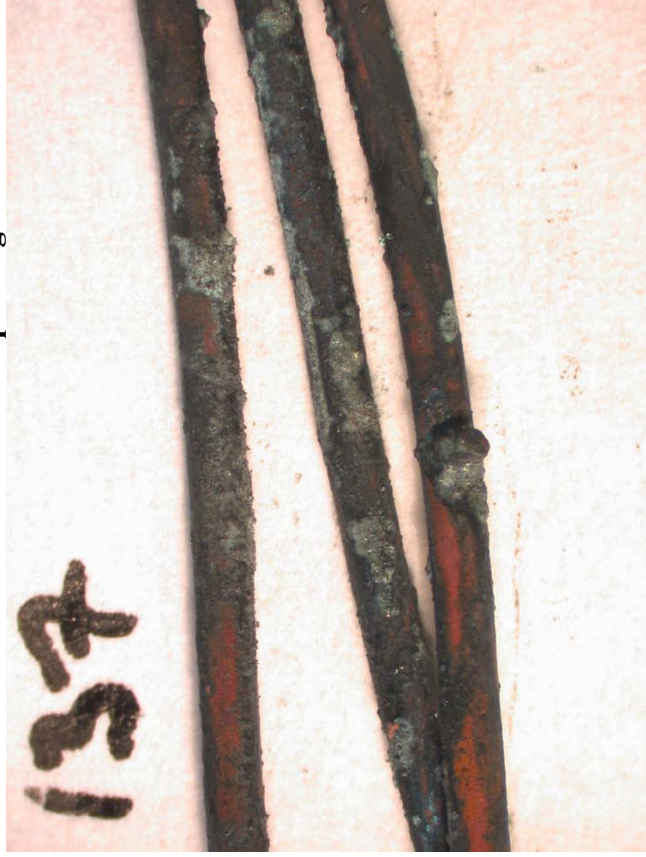
Figure 940 - Microscope image of exhibit 137. Arcing damage located on one of the three 1mm<sup>2</sup> conductors, a notch with a bead within the notch.

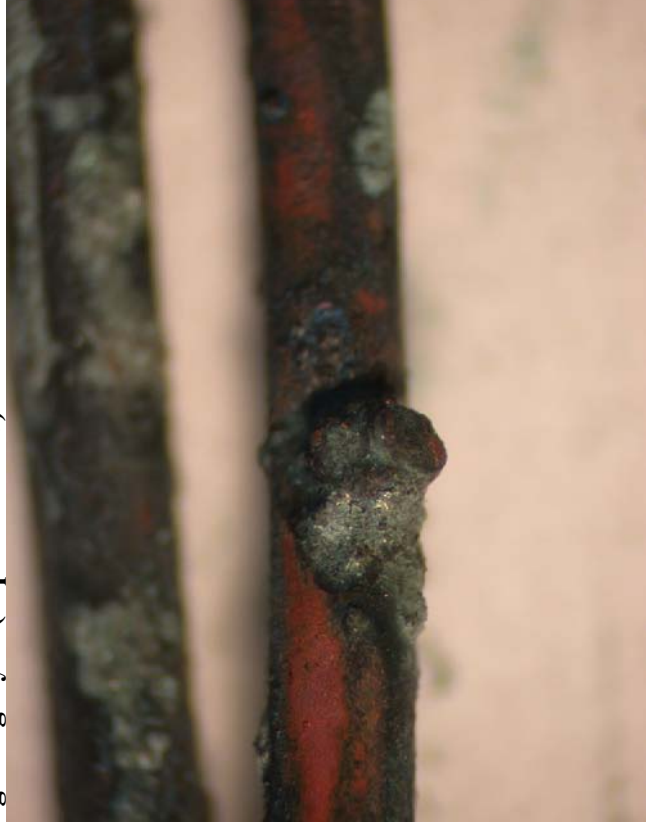
Figure 941 - 20x magnification of the notch and bead detailed in figure 940.

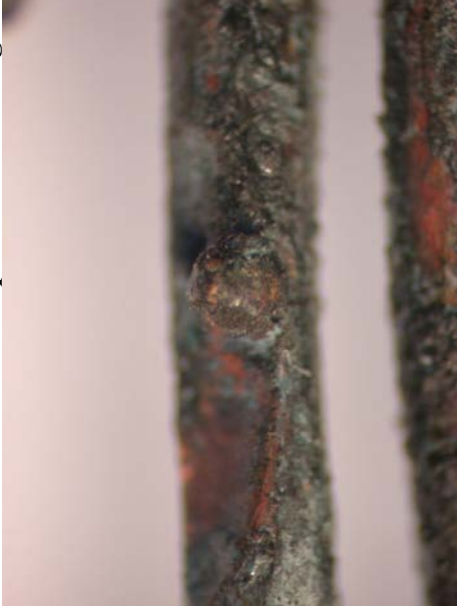
Figure 942 - Microscope image detailing one of the two conductors for exhibit 138. Both conductors had notch damage. This top conductor notch was unusually large at 4mm wide.

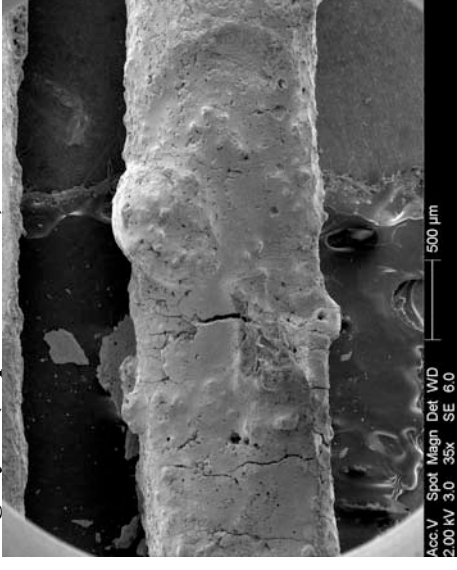
Figure 943 - SEM image of the bottom conductor. There was still a lot of PVC residue remaining following the cleaning process.

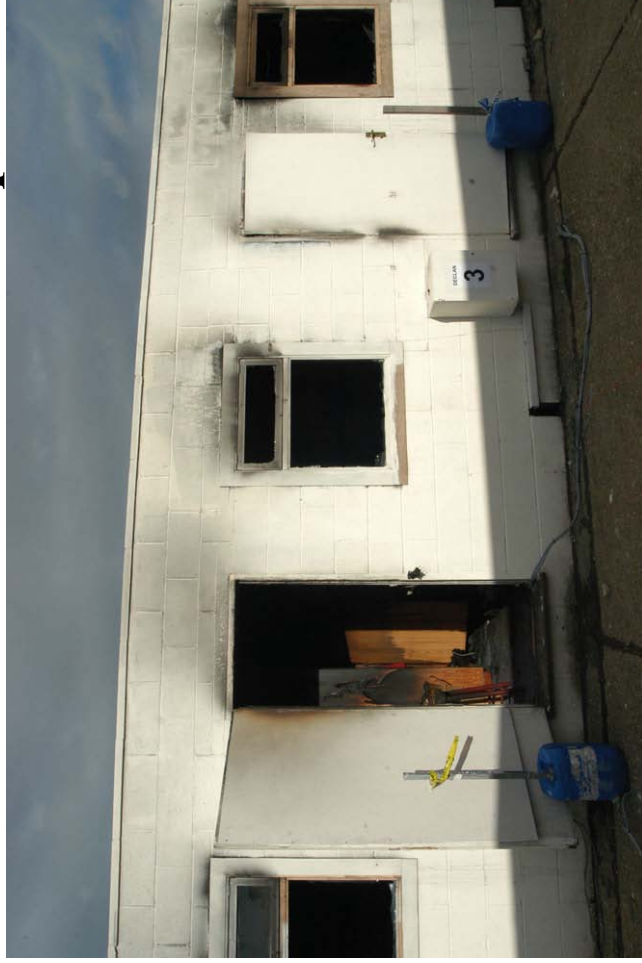
The fire in experiment 38 (scenario A) originated in a clothes rail adjacent to the centre of the rear wall and the side of two single beds located either side of the clothes rail.

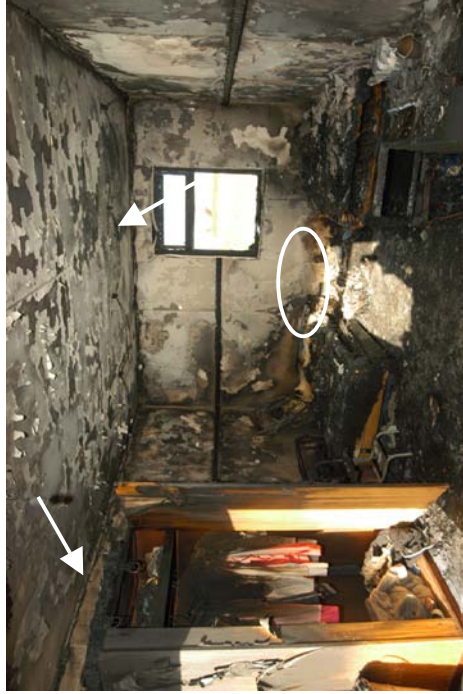
Figure 952 - Post-fire photograph of the experiment. The arrows indicate the location of the arcing damage to circuit 1 & 4 (L) and the initial arcing damage to circuit 4 (R).

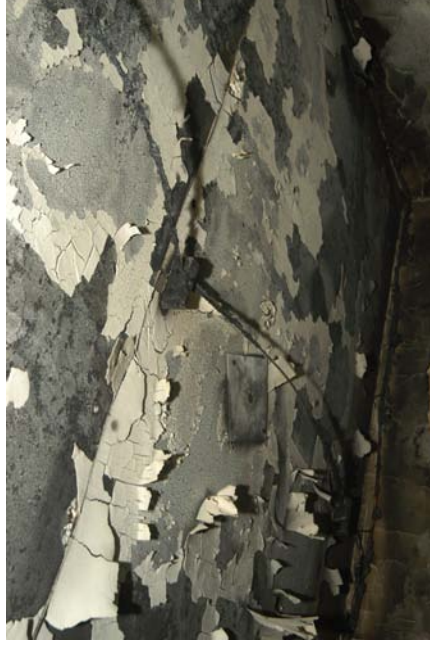
Figure 953 - Post-fire view of the ceiling detailing the fire-damaged circuit 4, suspended by the charred timber blocks. The arcing damage to circuit 4 is out of view to the right.

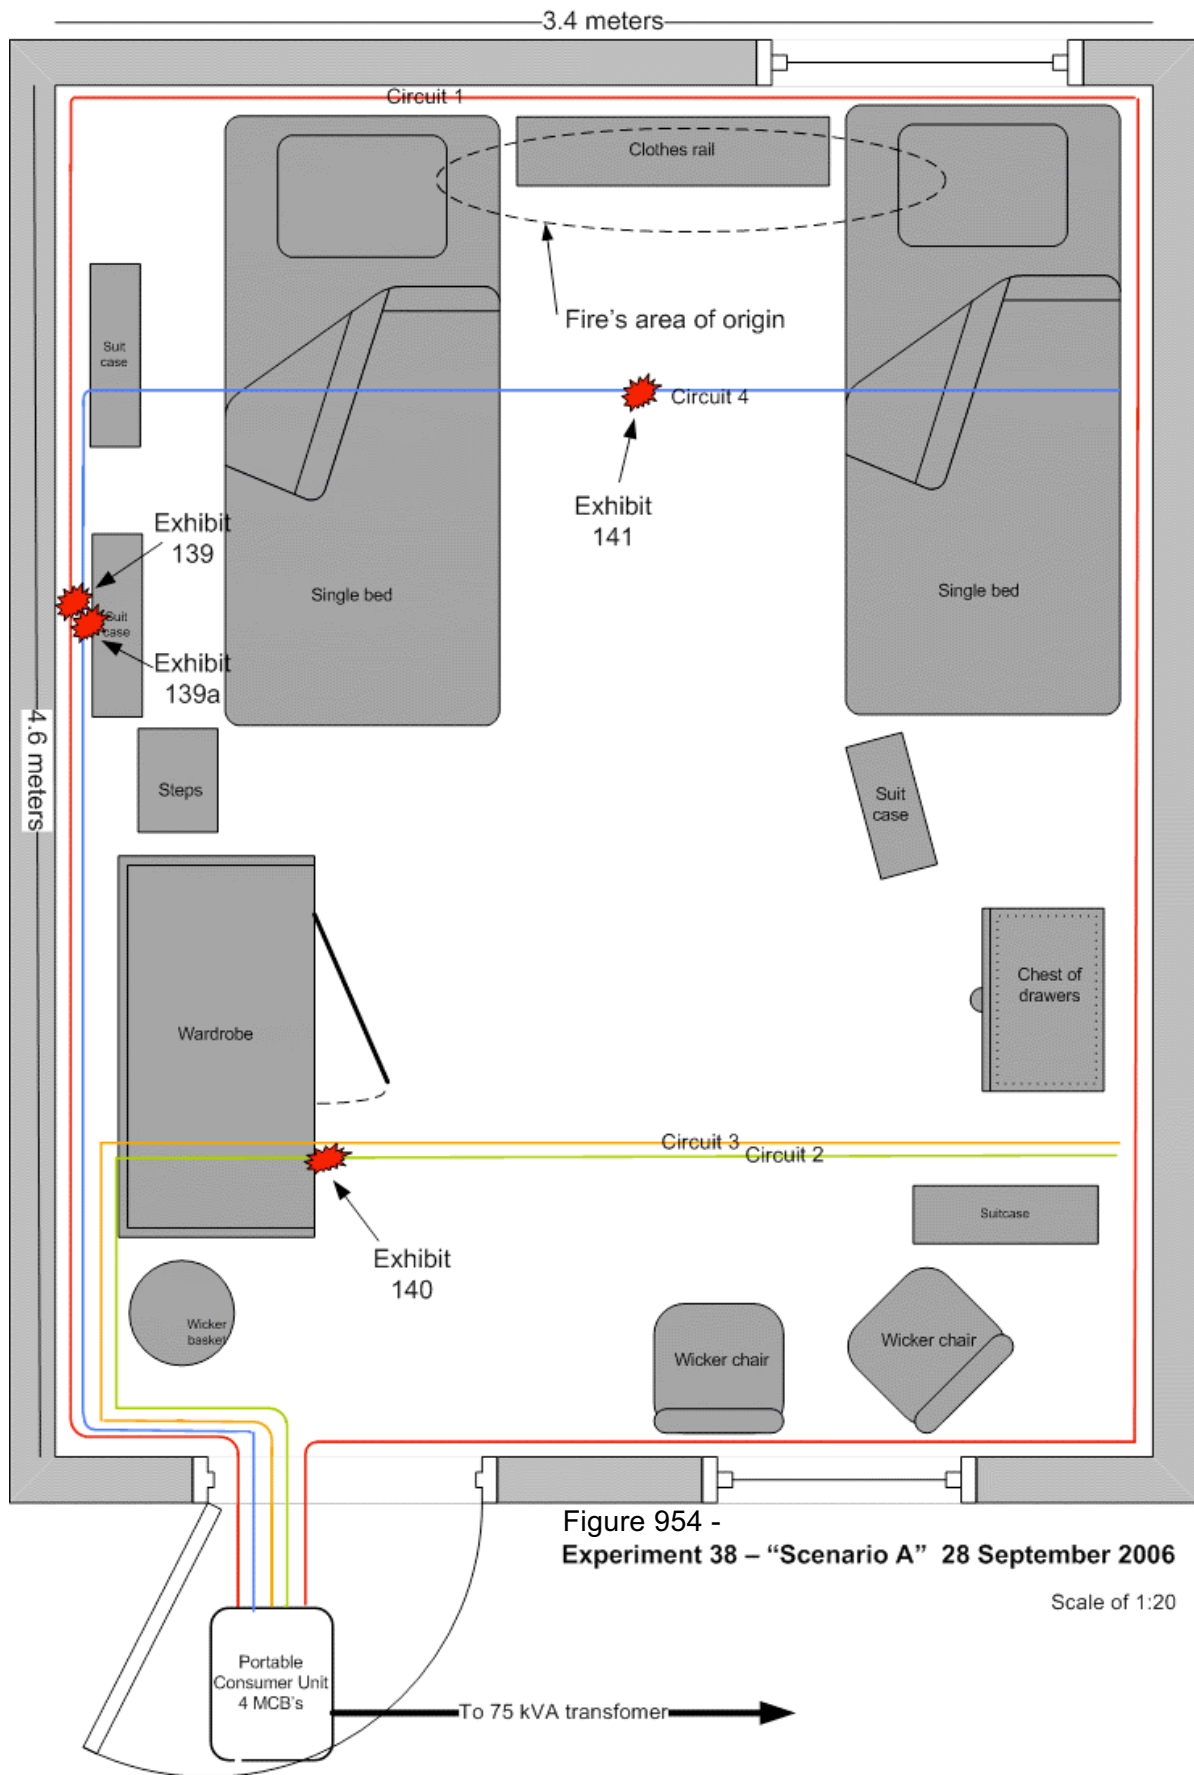
Figure 954 -  
Experiment 38 - "Scenario A" 28 September 2006

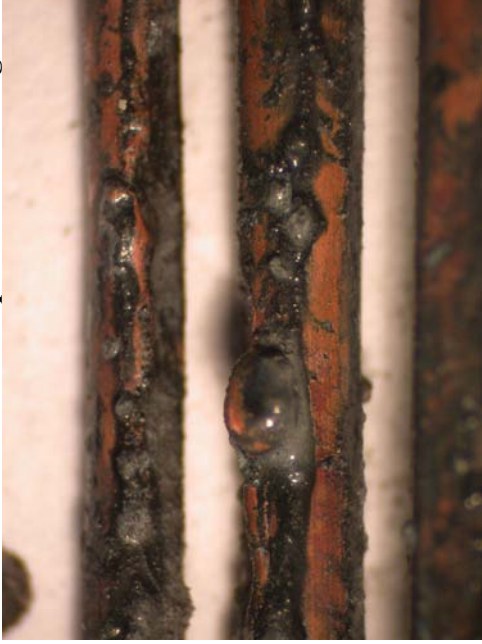
Figure 964 - Microscope image of exhibit 140. The arcing damage has affected the live and smaller earth conductor. The damage extends to 7mm in length and is a good example of arcing through char.

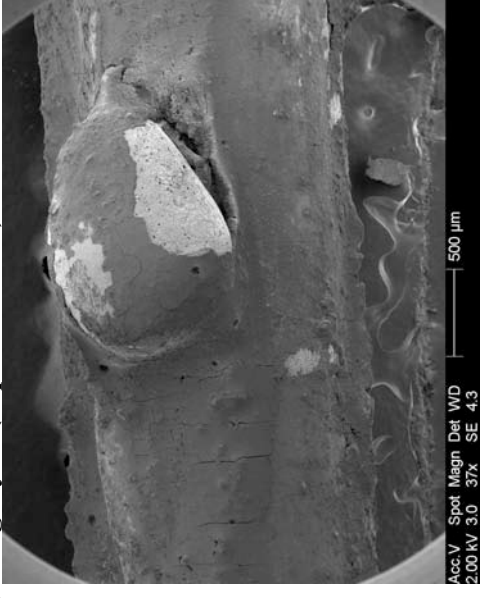
Figure 965 - SEM image detailing one of the beads on the lower conductor as detailed in figure 964.

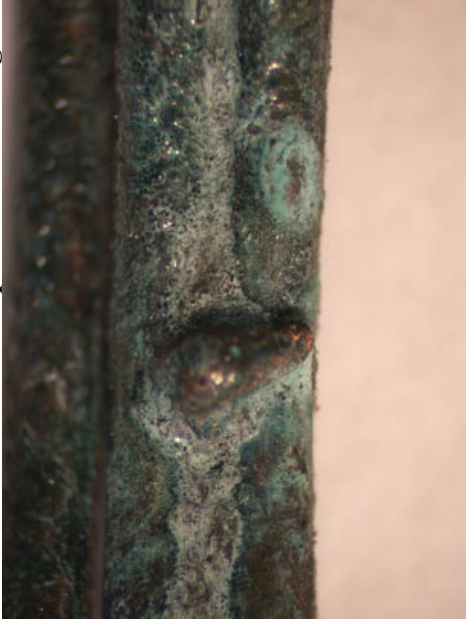
Figure 969 - Microscope image of exhibit 141. The arcing damage welded two conductors of circuit 4 together.

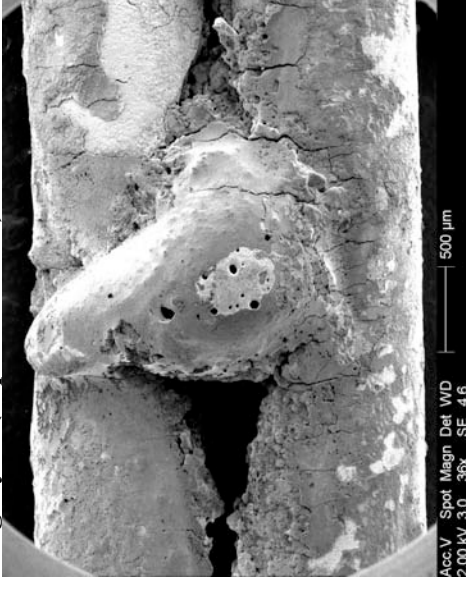
Figure 970 - SEM image of the bead forming the weld between the two conductors.

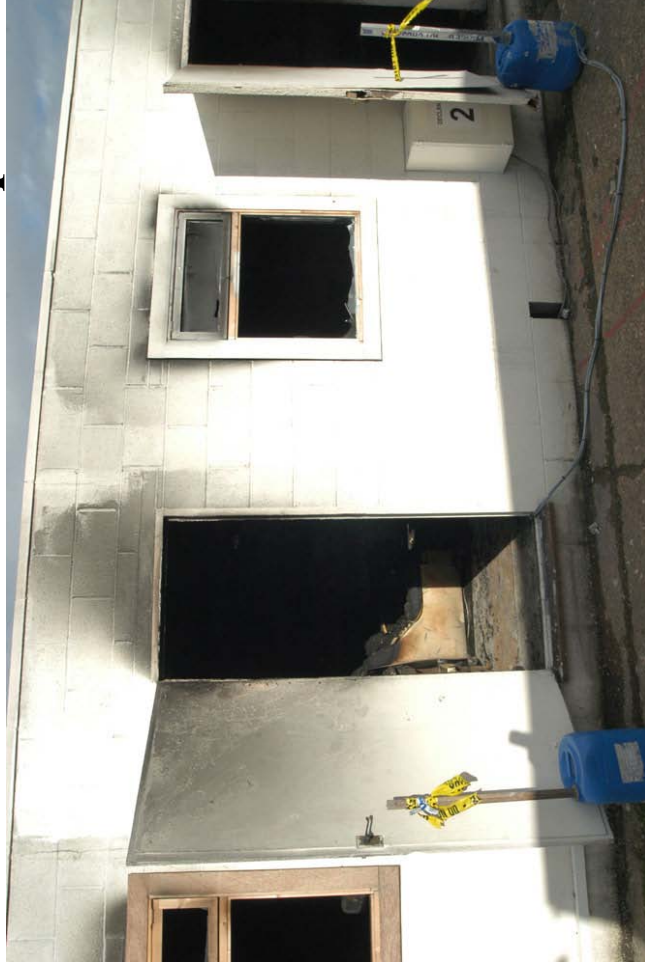
The fire in experiment 39 (scenario C) originated in a toy box located between a Christmas tree and a television. They were both adjacent to the rear wall of the compartment.

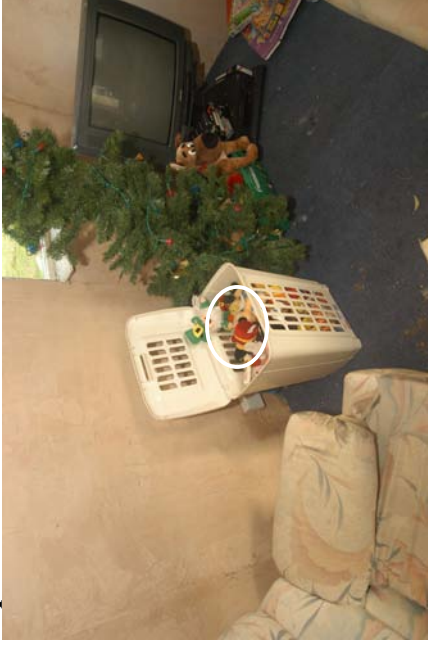
Figure 981 - A close-up view of the fire's area of origin. Arcing damage was located on circuits 1 and 4 on the ceiling above the Christmas tree and television area.

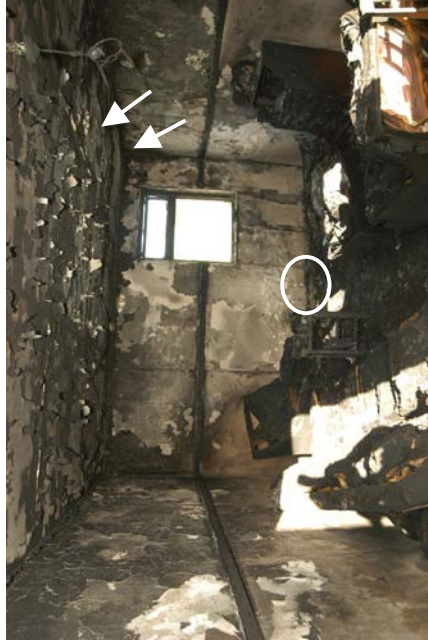
Figure 982 - Post-fire view of the fire scene with the area of origin indicated with a white circle as above. The left arrow is arcing damage to circuit 1 and the right arrow is arcing damage to circuit 4.

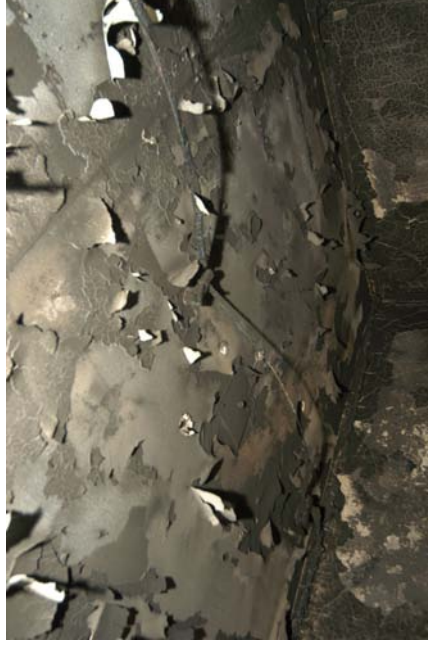
Figure 983 - Post-fire view of the ceiling above the fire's area of origin and the armchair located in the left rear corner of the compartment.

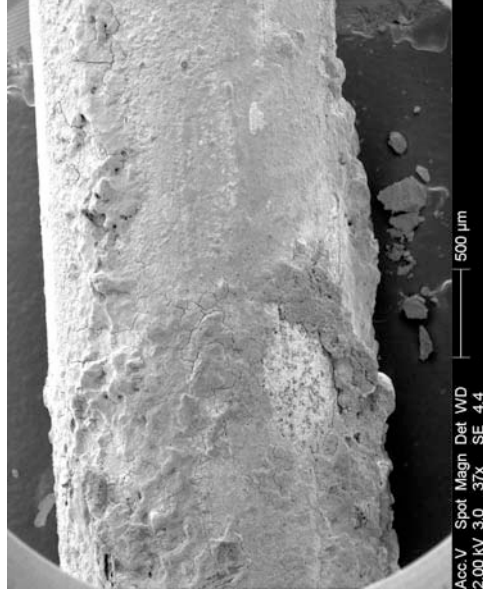
Figure 988 - SEM image of the right edge of the arcing damage to the top conductor detailed in figure 985.

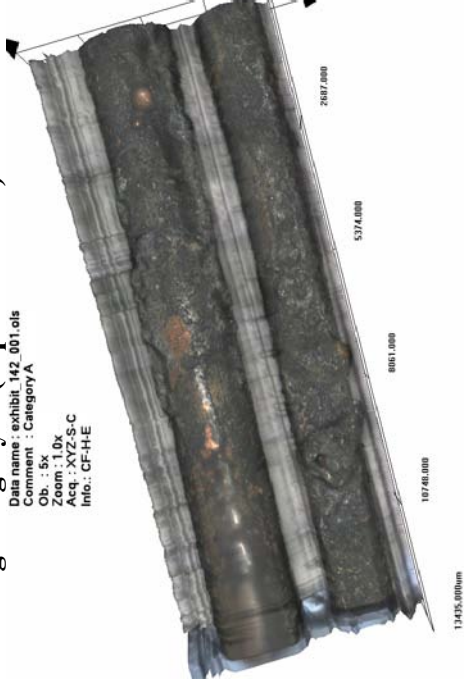
Figure 989 - LEXT image that displays the entire exhibit in detail.

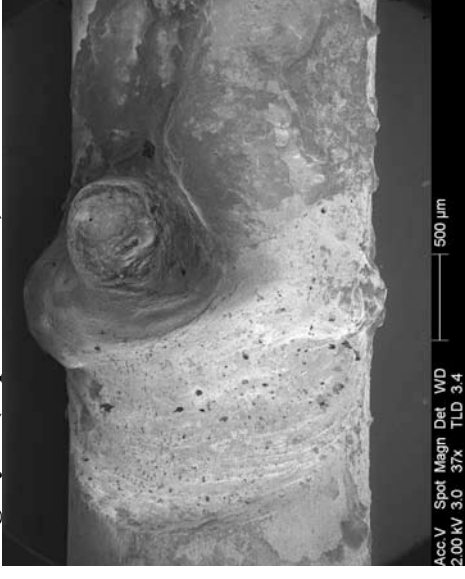
Figure 994 - SEM image of the bottom conductor displayed in figure 993. Rib lines in the notch surface were observed.

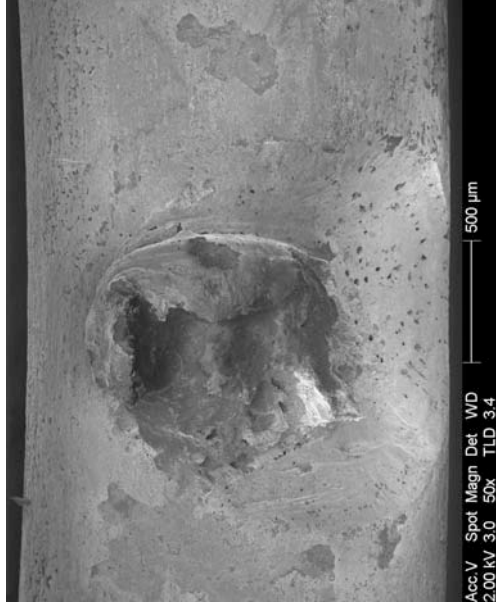
Figure 995 - SEM image of the notch and small bead for the top conductor in figure 993.

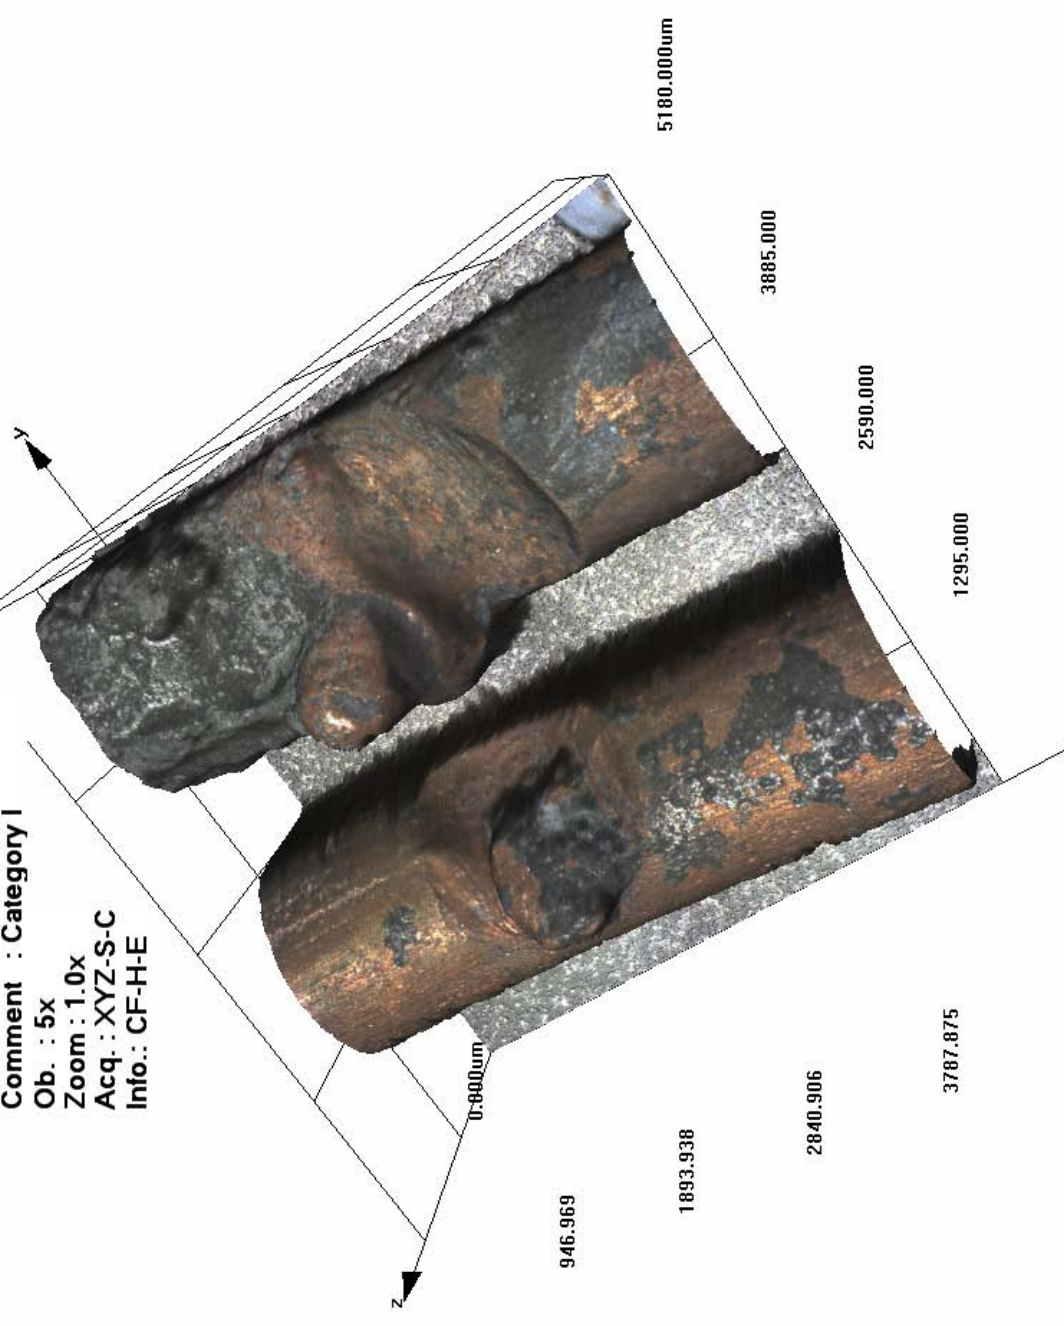
Figure 997 - LEXT image that effectively displays the arcing damage to both conductors in context and in detail.

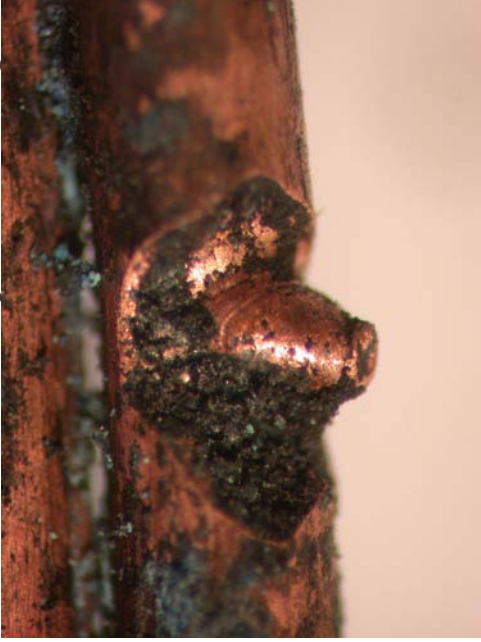
Figure 998 - Microscope image of exhibit 144. There is one conductor with arcing damage. The demarcation edge is very clear.

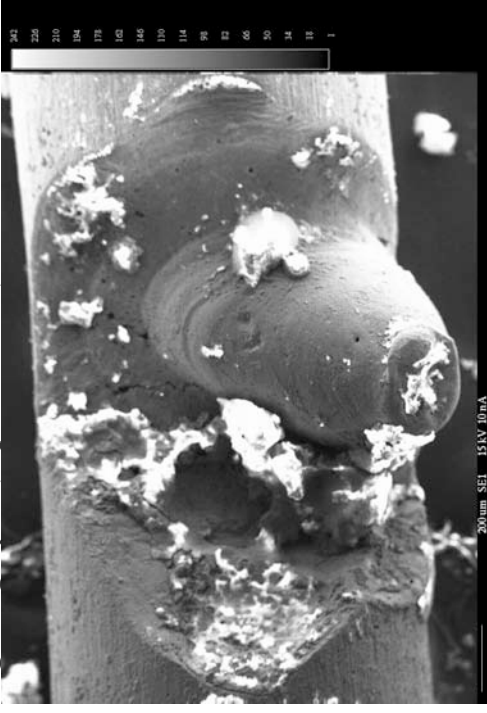
Figure 999 - Cameca SEM image of this exhibit.

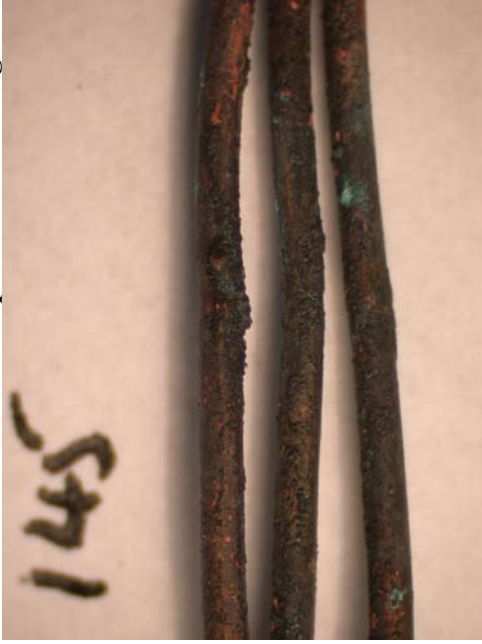
Figure 1005 - Microscope image of exhibit 145. The arcing damage affected two conductors with shallow notches.

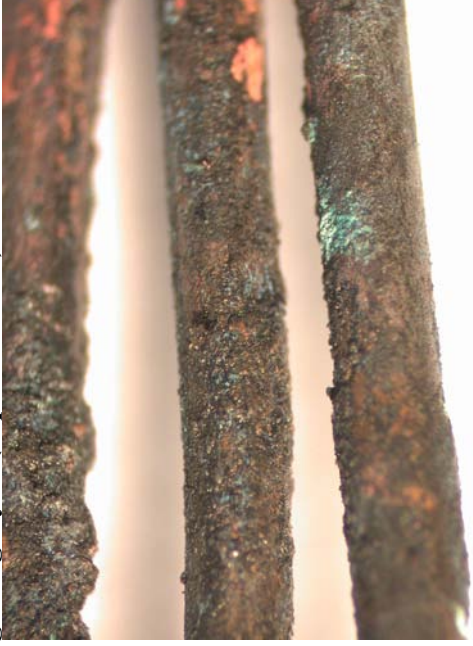
Figure 1006 - 20x magnification of the surface damage, a lot of PVC debris was attached to the conductor surface.

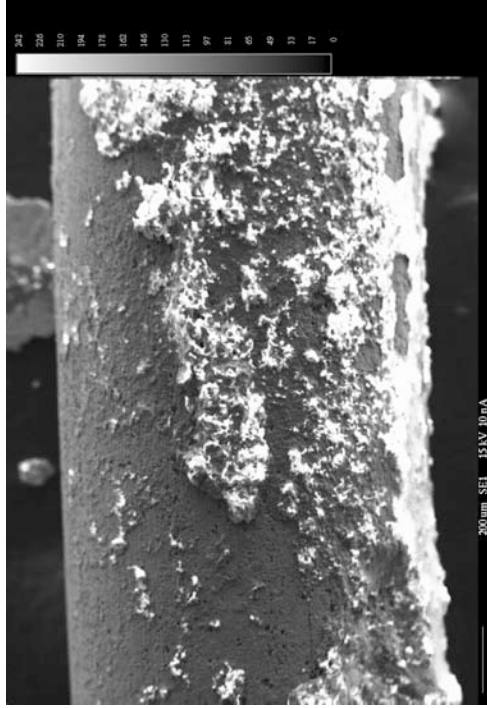
Figure 1007 - SEM image with the bottom of the conductor detailing the notch outline.

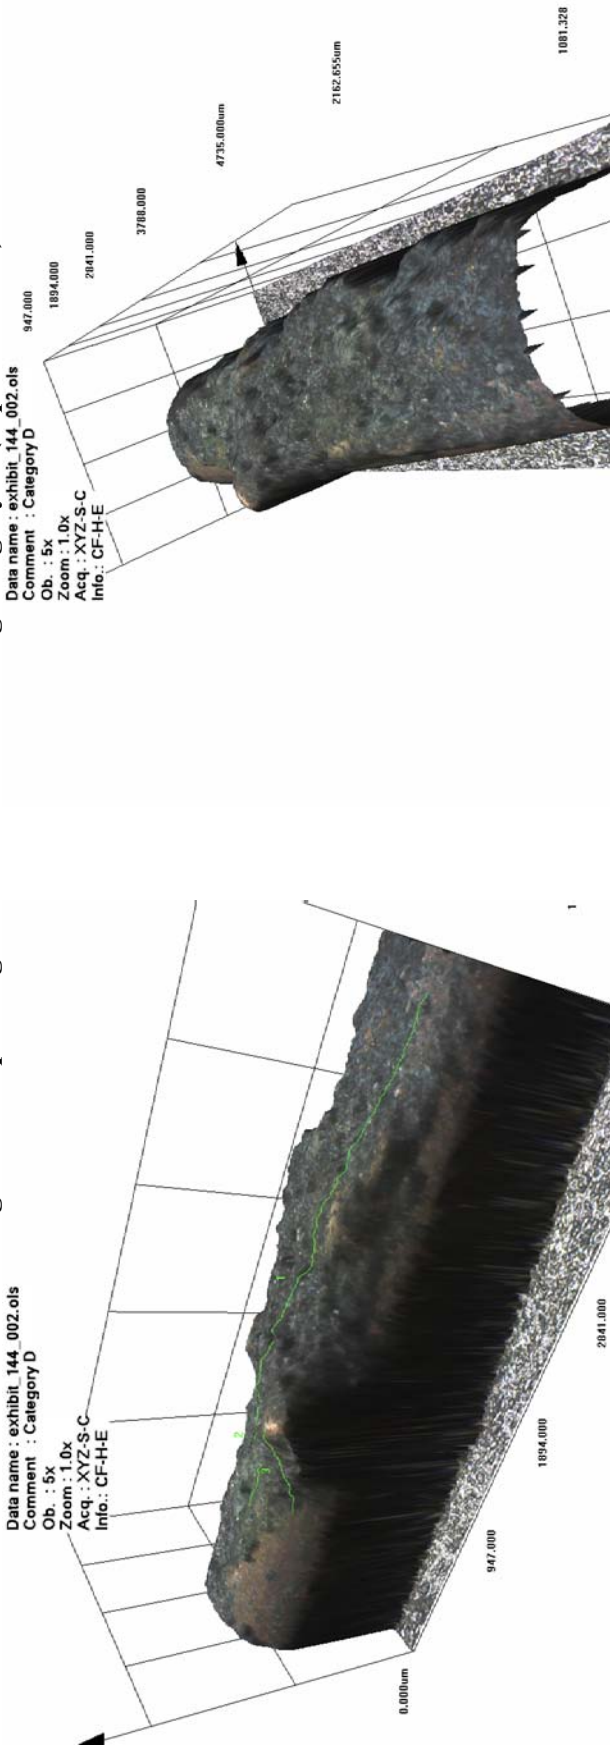
Figure 1009 - LEXT image that enables an overall perspective of the arcing damage to this conductor.

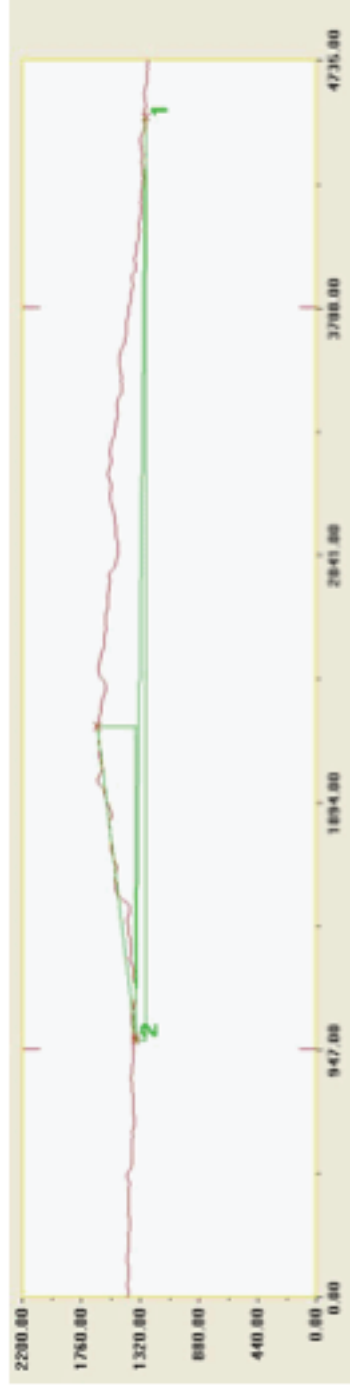
Figure 1011 - Profile of the conductor surface. Length of arcing damage = 3531 microns (3.53mm), height = 271 microns (0.27mm)

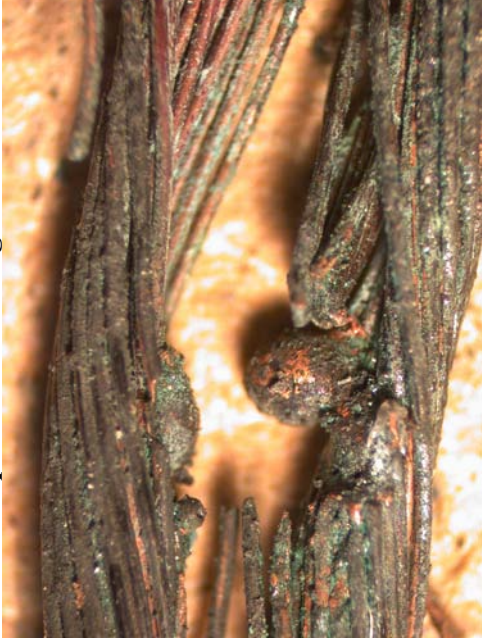
Figure 1012 - Microscope image of the arcing damage sustained to a fan heater appliance flexible cable during experiment 39.

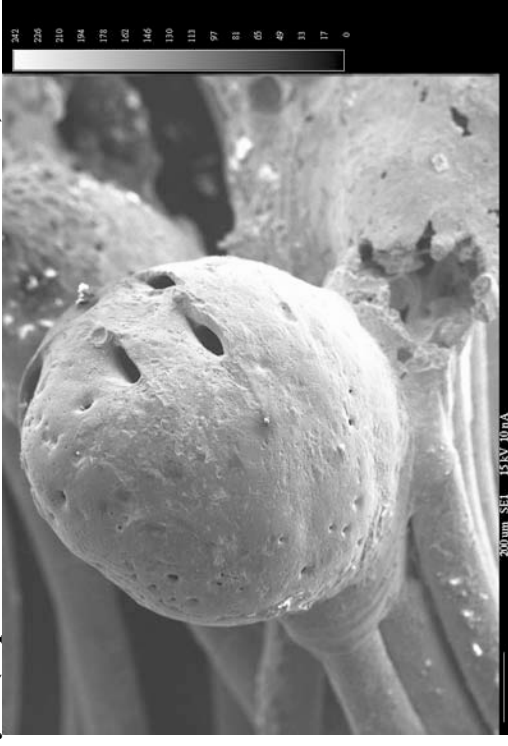
Figure 1013 - SEM image of the bead and adjacent notch with three holes in the bead surface.
