**Building skills for conserving
seventeenth- and eighteenth-century
Scottish built heritage:
the initial assessment of timber roof structures**

Anna Serafini

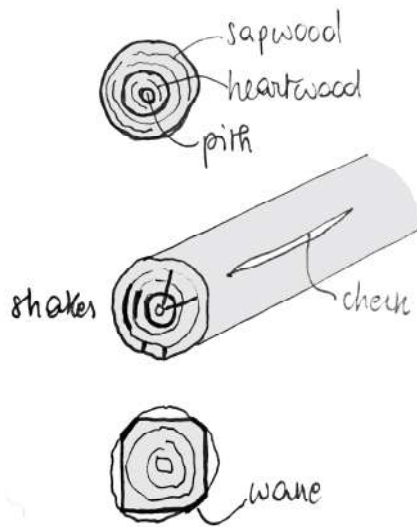
Figure 5: Main parts and defects of a timber log

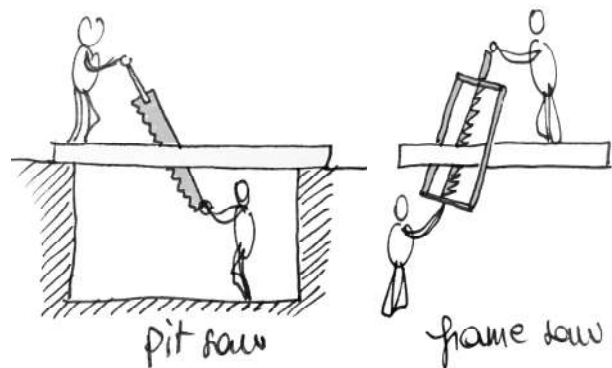
Figure 6: Types of hand saws used for wood

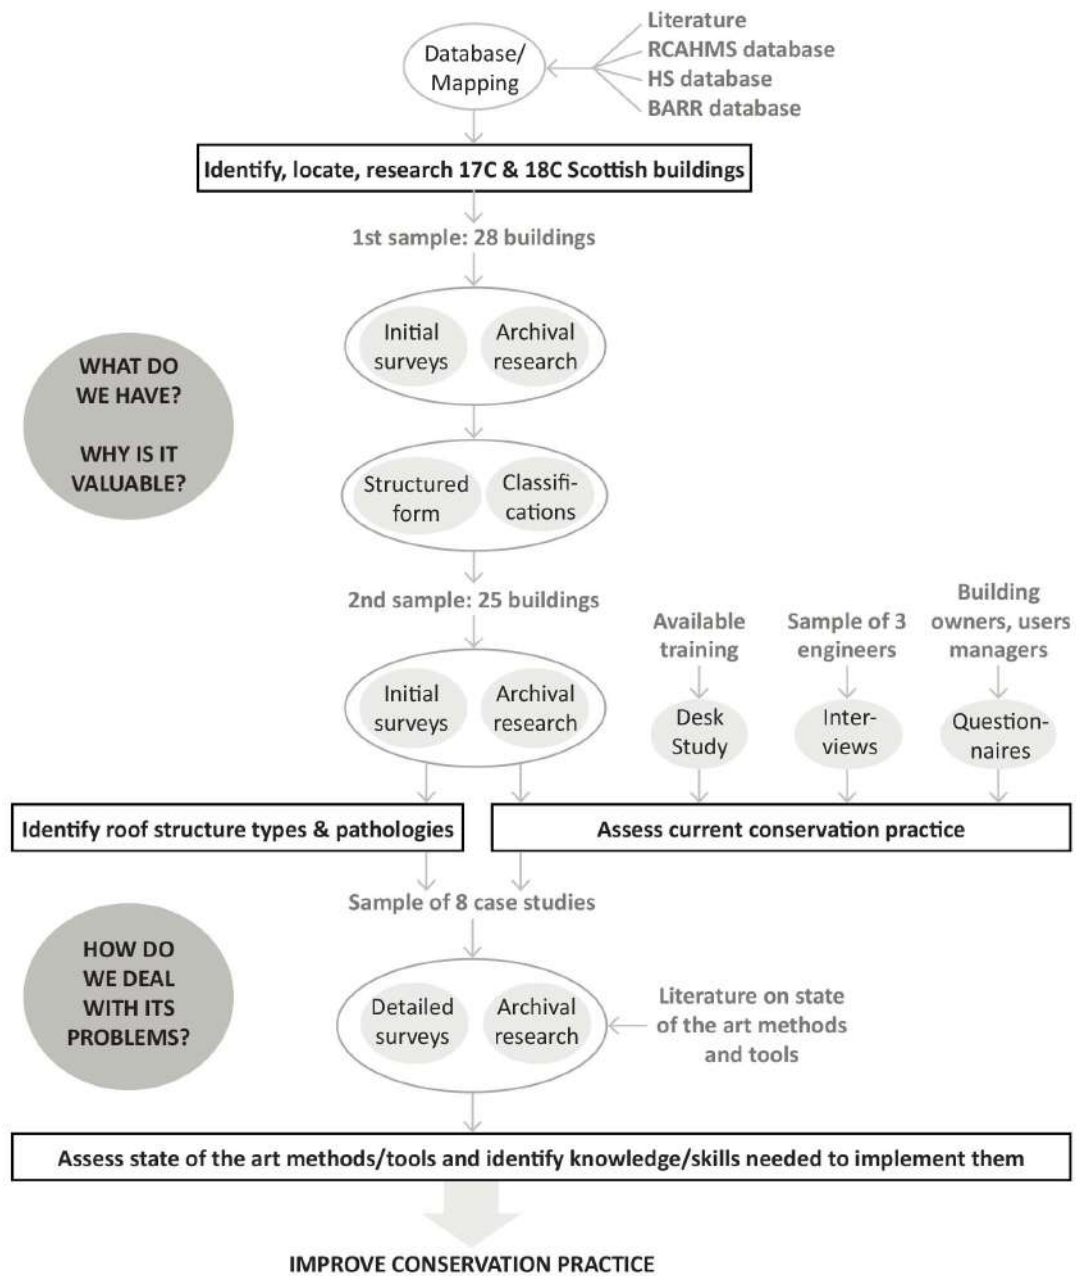
Figure 11: The research methodology employed in this thesis

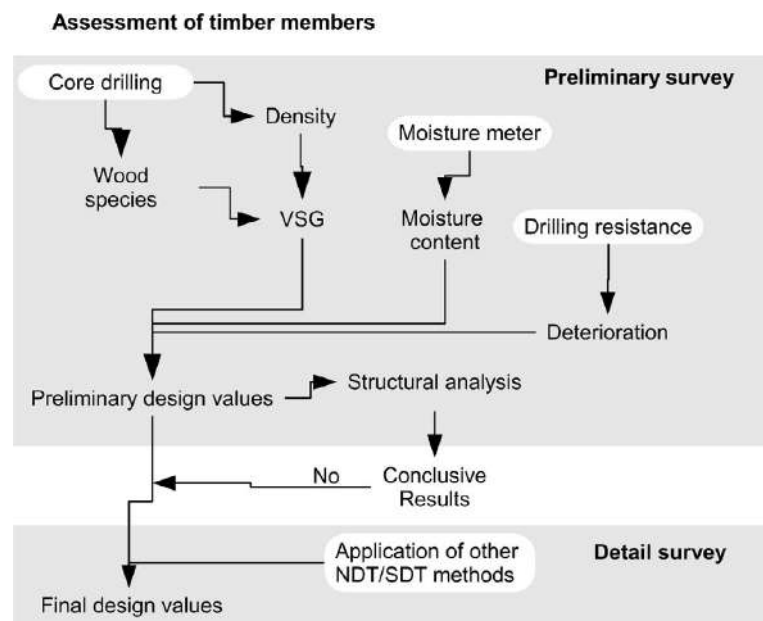
Figure 12: Methodology for the assessment of existing timber structures (Feio and Machado, 2015)

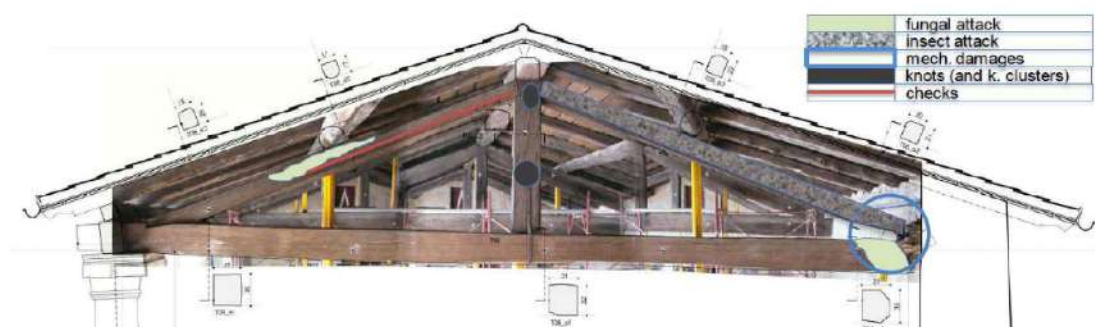
Figure 13: Example of graphics reporting results of visual inspection of a timber truss (Massari et al., 2010)

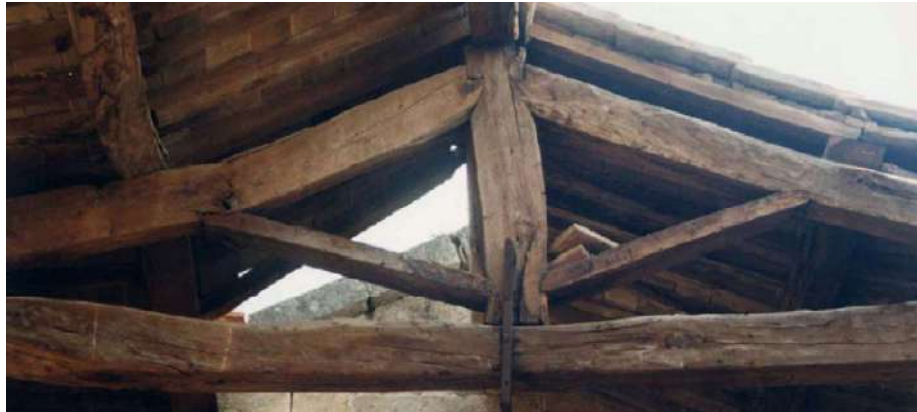
Figure 14: Failure of a rafter caused by the instability of the strut and favoured by a knot in the rafter and the notch for the joint; the efficient connection of the rafter to the post is the cause of the bending of the post (Tampone, 2007)

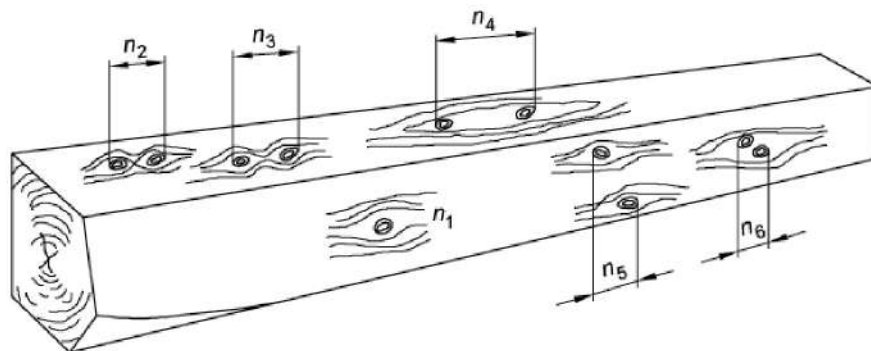
Figure 15: Knots classification according to UNI 11035 (2003): $n_1/n_3/n_5$ = single knots, $n_2/n_4/n_6$ = groups of knots

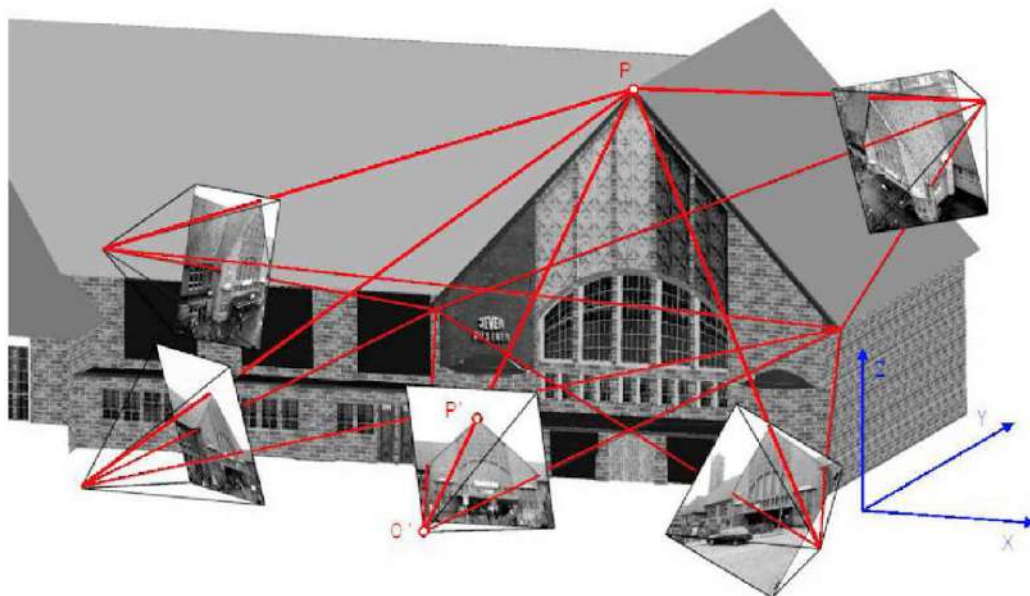
Figure 16: principle of photogrammetric measurement (Luhmann et al., 2014).

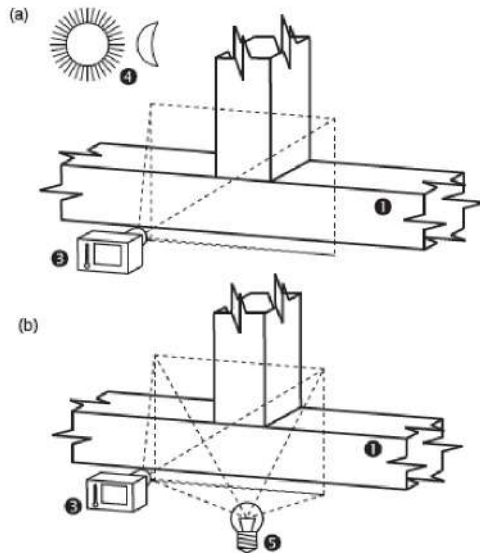
Figure 19: Principle setup for active (a) and passive (b) thermography (Riggio et al., 2015b).

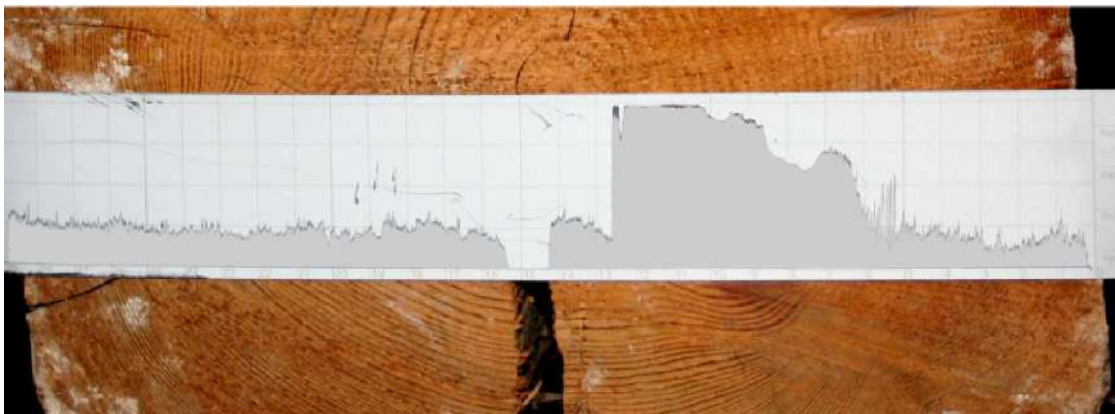
Figure 22: Example of graph resulting from the Resistance micro-drilling test (Nowak et al., 2016)

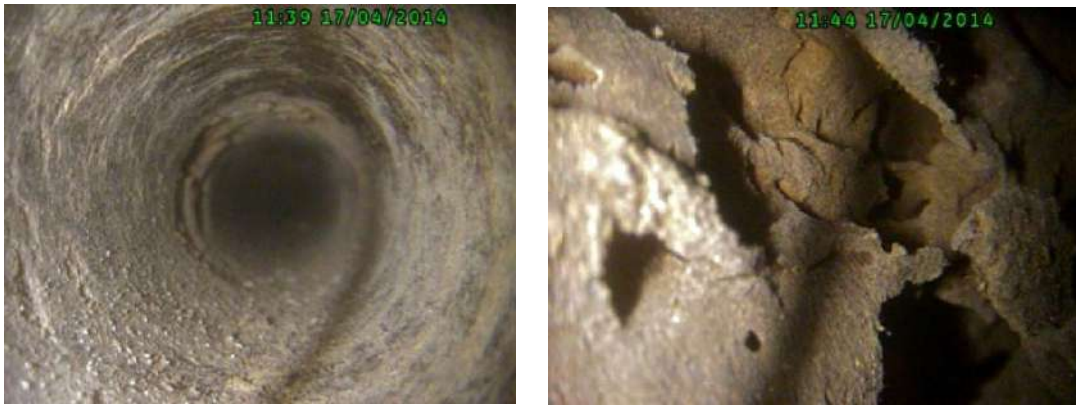
Figure 23: Example of pictures taken with an endoscope inside a borehole in a timber strut (Kloiber et al., 2015a)

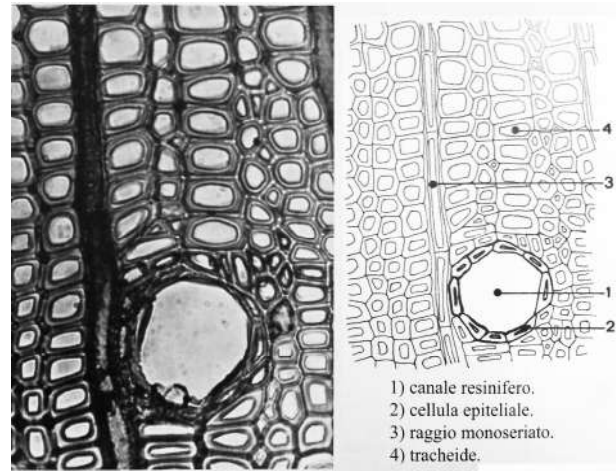
Figure 25: Example of identification of microscopic features in the transversal section of a sample of Douglas fir (*pseudotsuga douglasii*) (Nardi Berti et al., 2006); 1=resin canal, 2=epithelial cell, 3=uniseriate ray, 4=tracheid

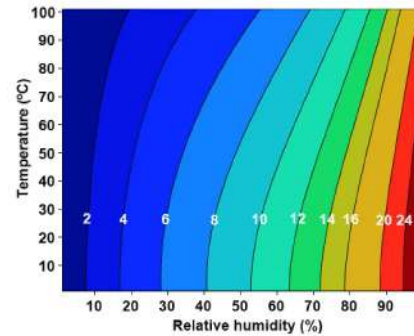
Figure 27: Equilibrium moisture content based on the air temperature and relative humidity (Ross, 2010)

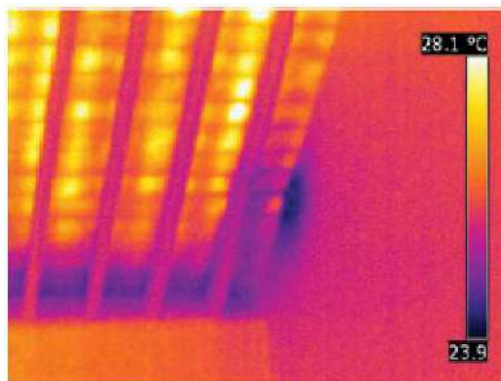
Figure 28: damp areas identified in thermographic imaging (Rodríguez Liñán et al., 2015)

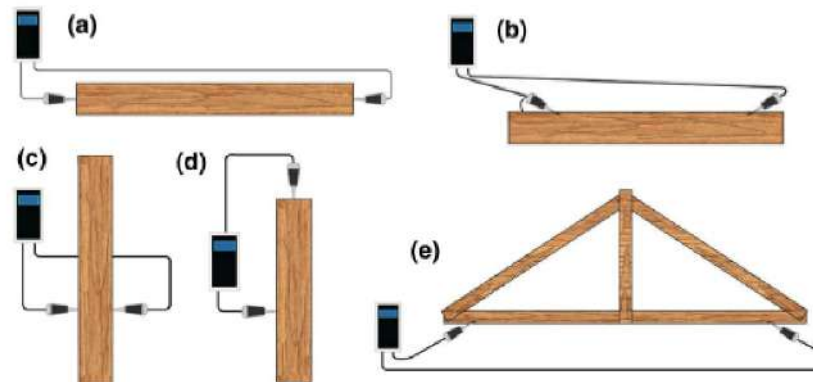
Figure 30: time-of-flight measurements in structural timber using different wave propagation modes: direct longitudinal (a), indirect longitudinal (b and e), transverse (c), semi-direct (d) (Dackermann et al., 2014)

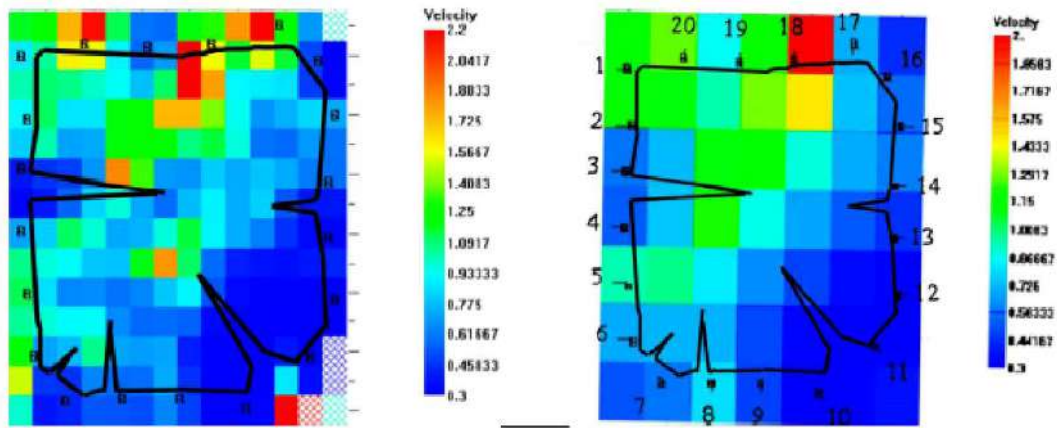
Figure 32: velocity model (14x14 pixels) of a timber section, corrected for material anisotropy, obtained from 5 iterations of straight type and 6 iterations of curved type; signal velocity legend from 300 to 2200 m/s (left) - velocity model (7x7 pixels) of the same timber section after 5 straight iterations and 5 curved iterations; signal velocity legend from 300 to 2000 m/s (Colla, 2015)

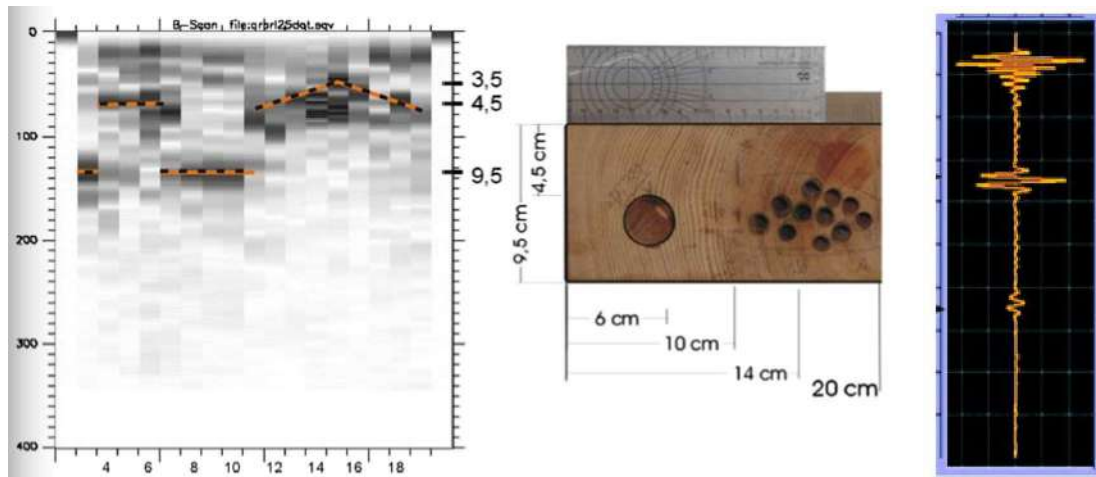
Figure 33: Example of elements investigated with the ultrasonic echo technique: in the centre a section of the investigated element (Dackermann et al., 2014), on the left an A-scan (Dackermann et al., 2014) and on the right a B-scan (RILEM, 2010)

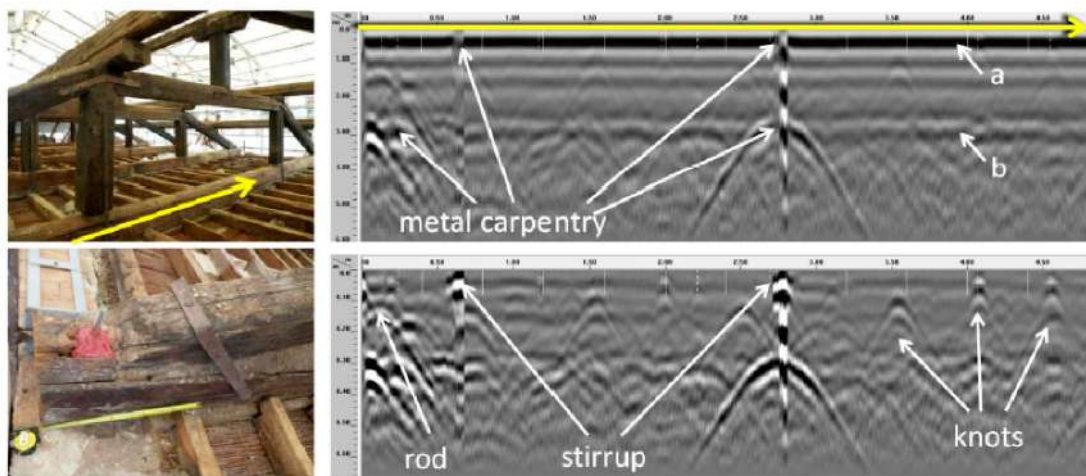
Figure 34: GPR test carried out on a timber tie-beam in reflection mode: survey line on the lateral face of the tie-beam (top left in yellow), detail of the metal elements near the beam head (bottom left), raw and post-processed radargrams (right, top and bottom) (Colla and Gabrielli, 2015)

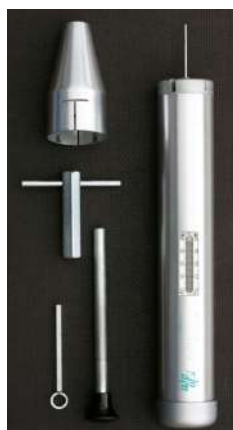
Figure 35: Pilodyn device: the penetration depth of the striker can be read directly on the scale attached on its side (Tannert et al., 2014)

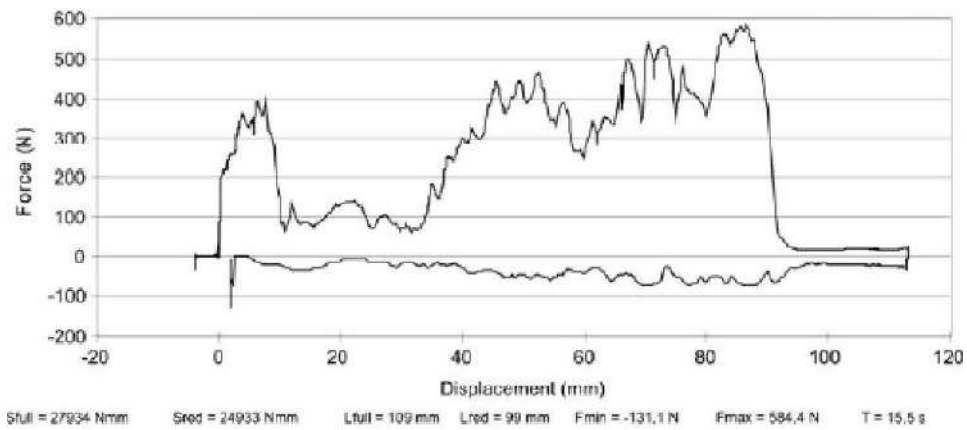
Figure 37: The output graph of the pin pushing test: the x axis is the depth to which the pin was pushed, the y axis is the force needed for pushing (Kloiber et al., 2015b)

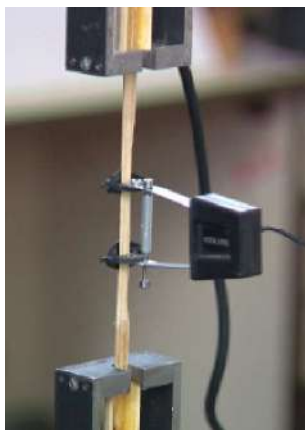
Figure 38: Tensile test of a triangular bar (Kloiber et al., 2015b)

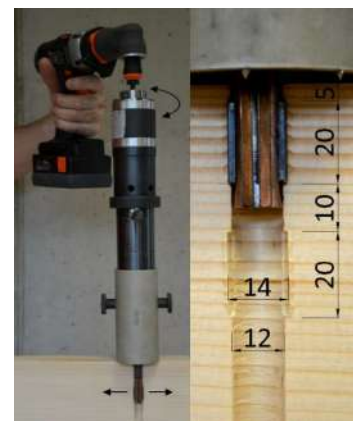
Figure 40: The loading jack device (Kloiber et al., 2015c)

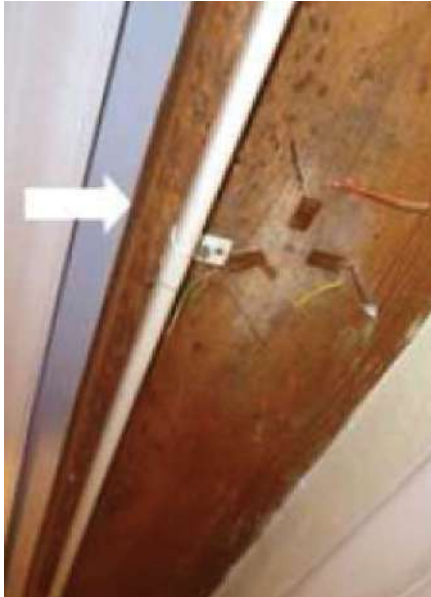
Figure 41: A rosette of three gauges placed around the drilled hole to measure bending stresses (Crespo de Antonio et al., 2016)

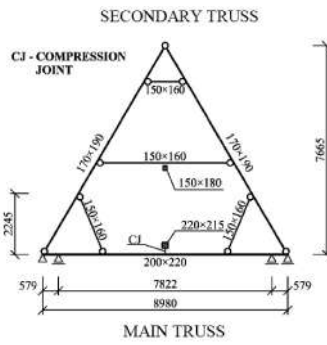
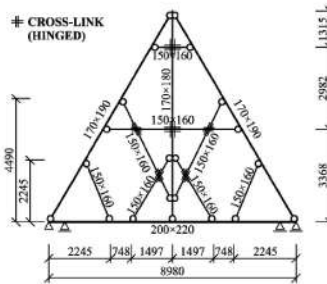
Figure 44: Non-linear joints modeled by Gocal et al. (2015)

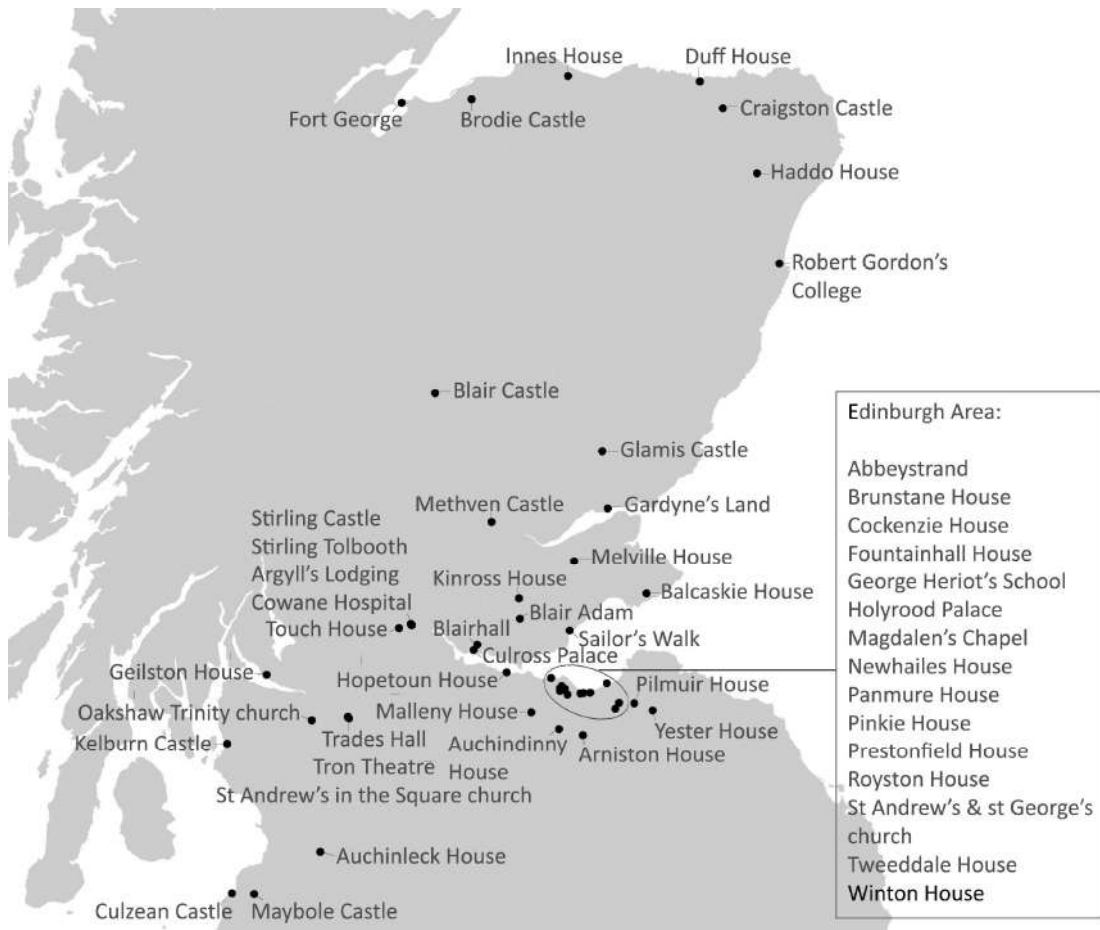
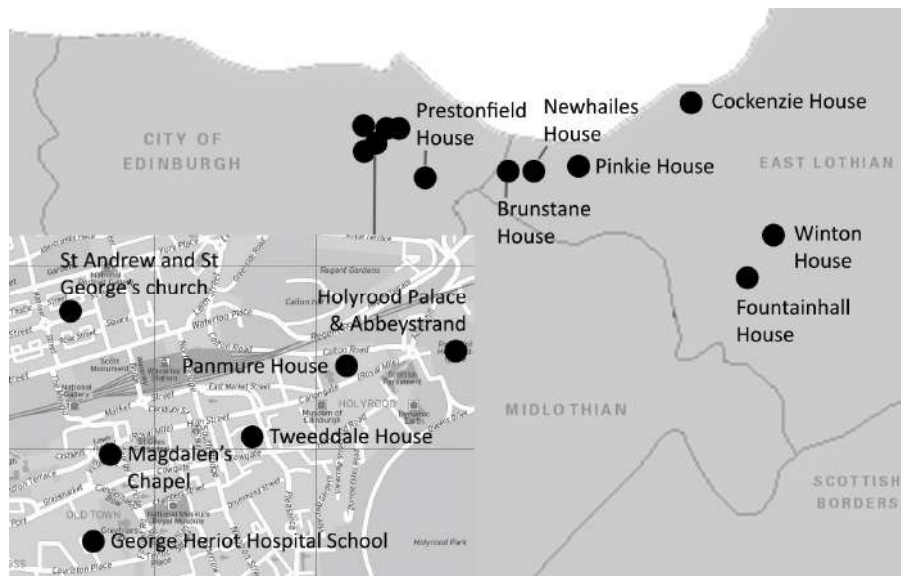
Figure 46: Names and locations of the 53 reference buildings surveyed - adapted from Serafini and Gonzalez Longo (2016) - with a zoom on the Edinburgh area

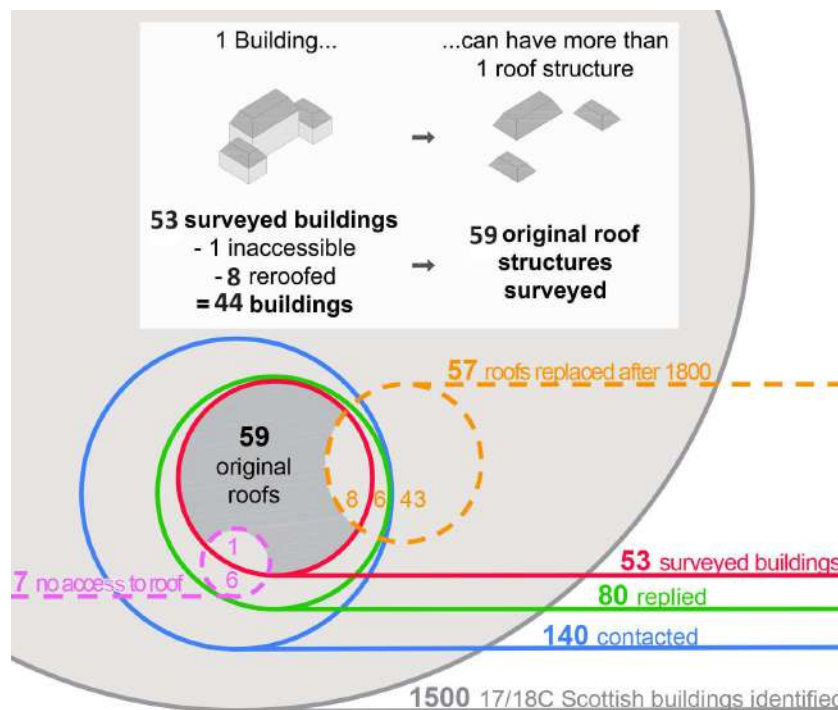
Figure 47: The selection process of the reference buildings surveyed and the results of the surveys in terms of number of original roof structures found - adapted from Serafini and Gonzalez Longo (2016)

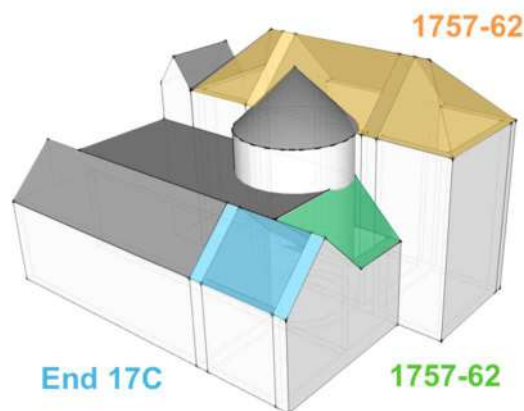
Figure 48: A model of Touch House seen from North-West showing the three roof structures surveyed

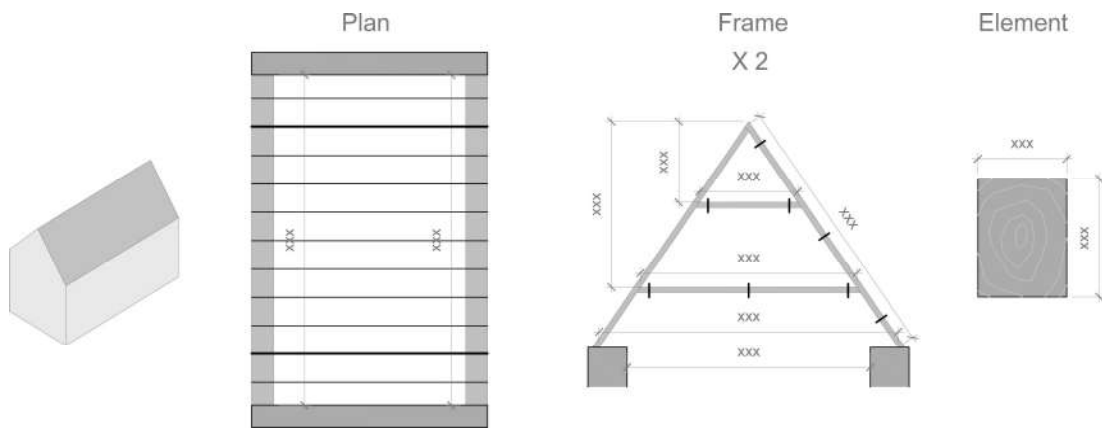
Figure 49: Diagram of measurements taken during the preliminary surveys in a typical common rafter roof

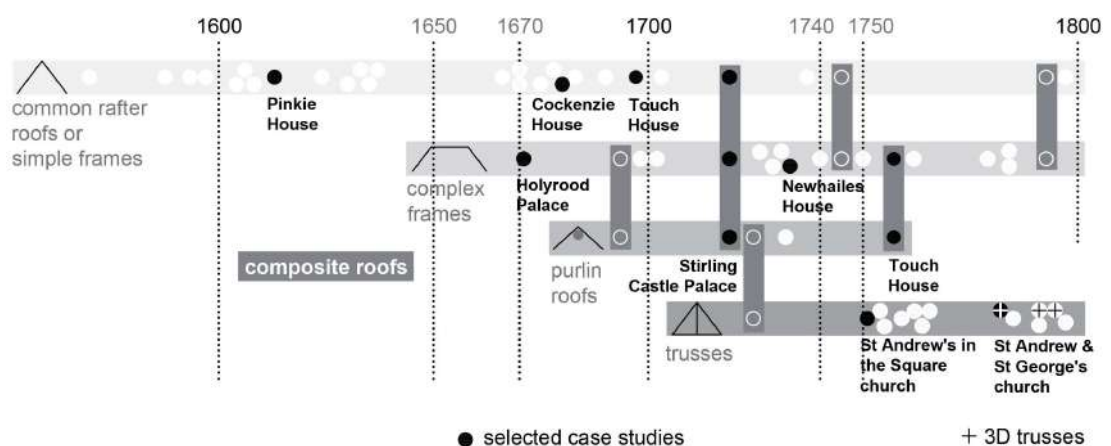
Figure 52: Timeline showing the chronological distribution of the selected case studies amongst the 59 roof structures surveyed

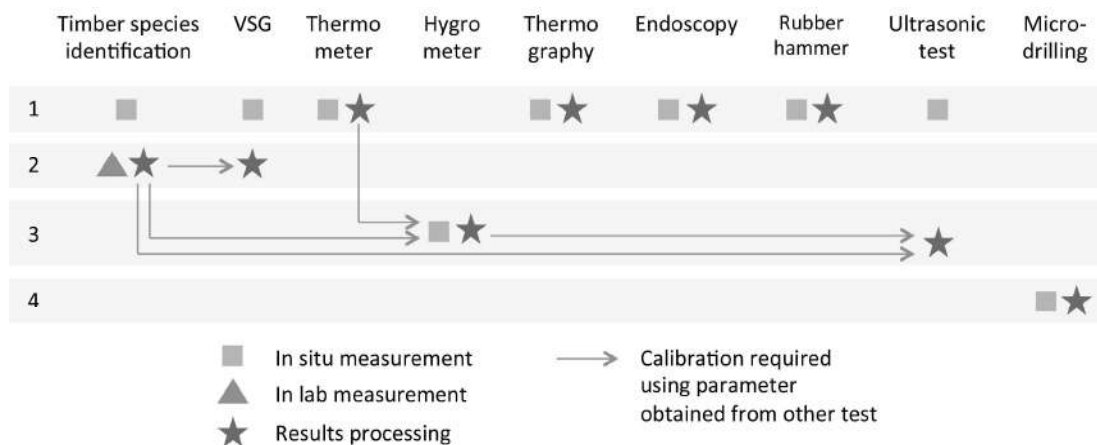
Figure 53: Assessment phases resulting from the need to calibrate some tests with parameters obtained from other tests

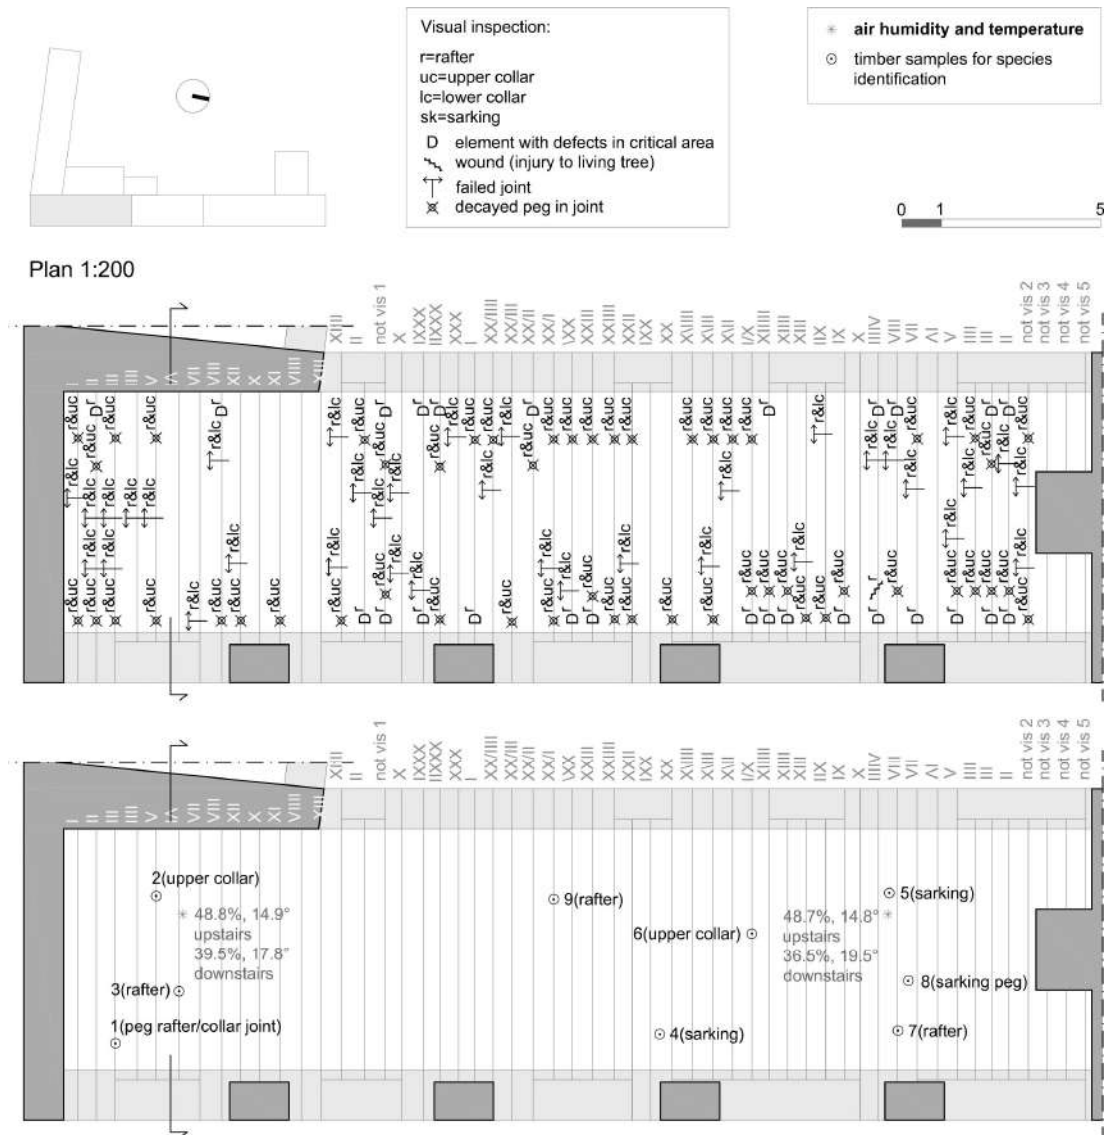
Figure 55: the plan of the roof of Pinkie Houses' long hall with the results of the detailed visual inspection and of the air temperature and relative humidity measurements, and the location of the sampling for the timber species identification

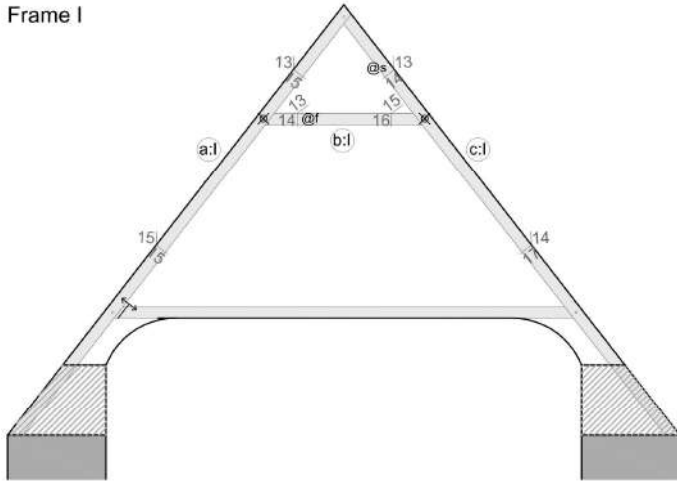
Visual inspection and VSG:

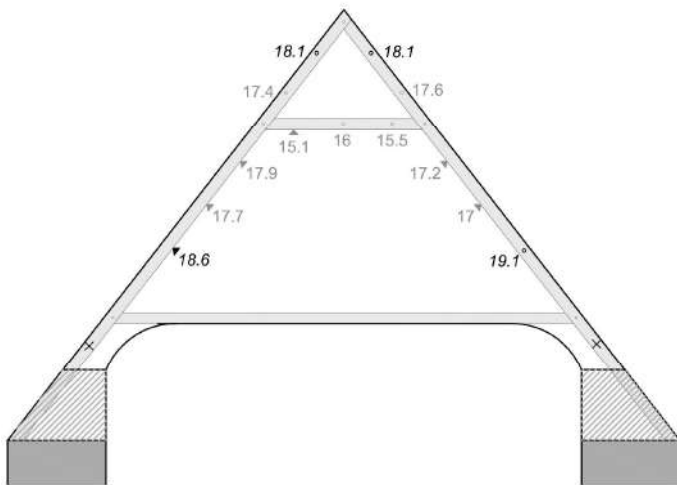
Moisture content readings:

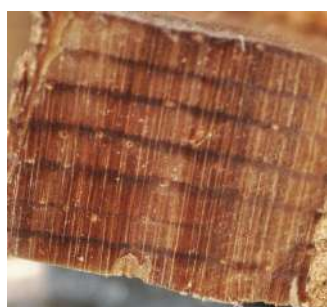
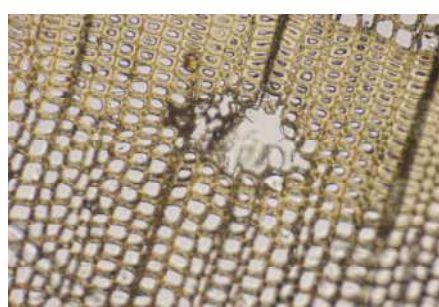
Figure 57: Hand lenses used for the macroscopic identification of the timber species (left) and a sample of *pinus sylvestris* taken from Cockenzie House (right)

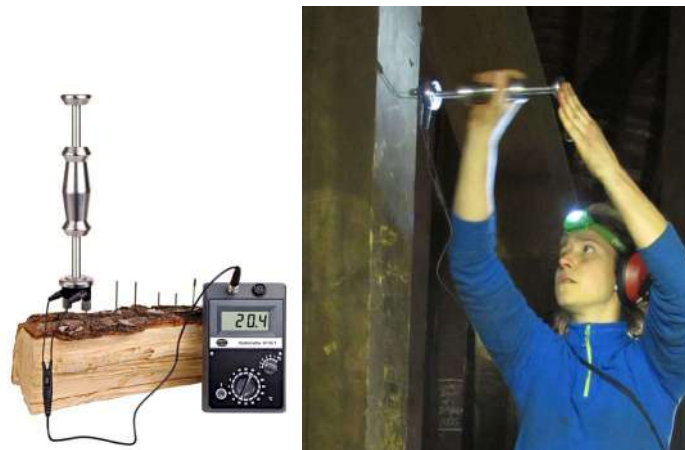
Figure 59: The hygrometer GANN Hydromette RTU 600 used during the surveys (left) and a picture of the author while taking measurements with it (right)

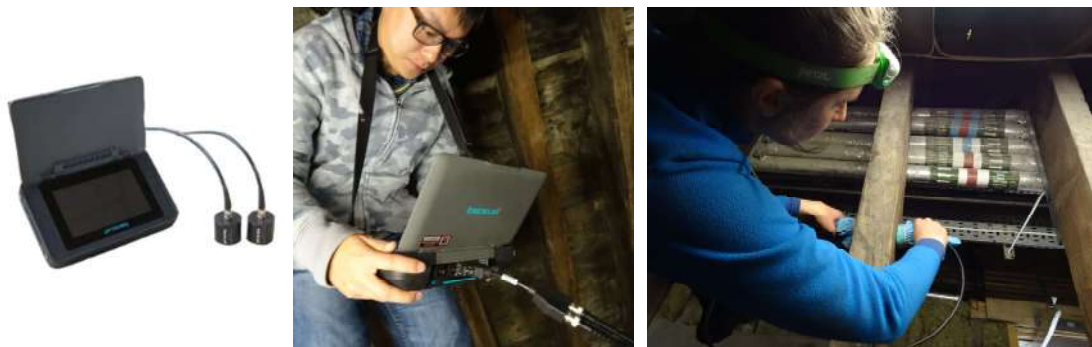
Figure 61: The ultrasonic device Proceq Pundit PL-200 used during the surveys (left), PhD student Bowen Qiu using it during the surveys in Stirling Castle Palace (centre) while the author applies the transducers to the timber (right)

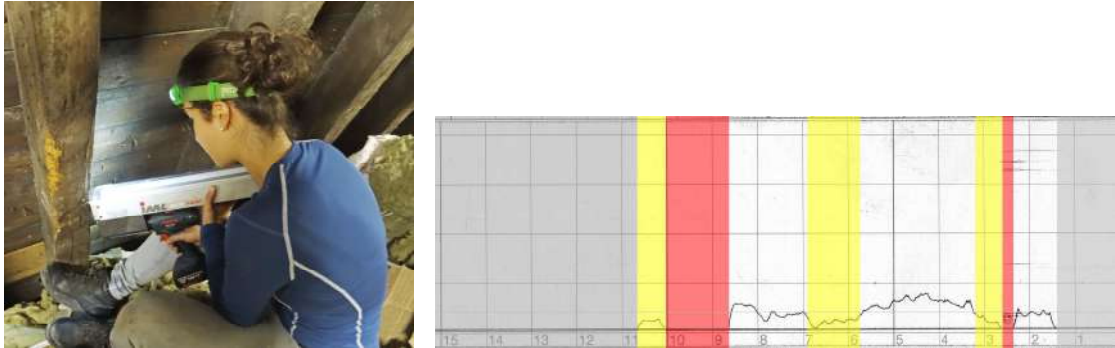
Figure 63: The micro-drilling device IML RESI-F400 used during the surveys (left) and an example of micro-drill graph from Holyrood Palace - North range, frame 43, North strut, point b (right)

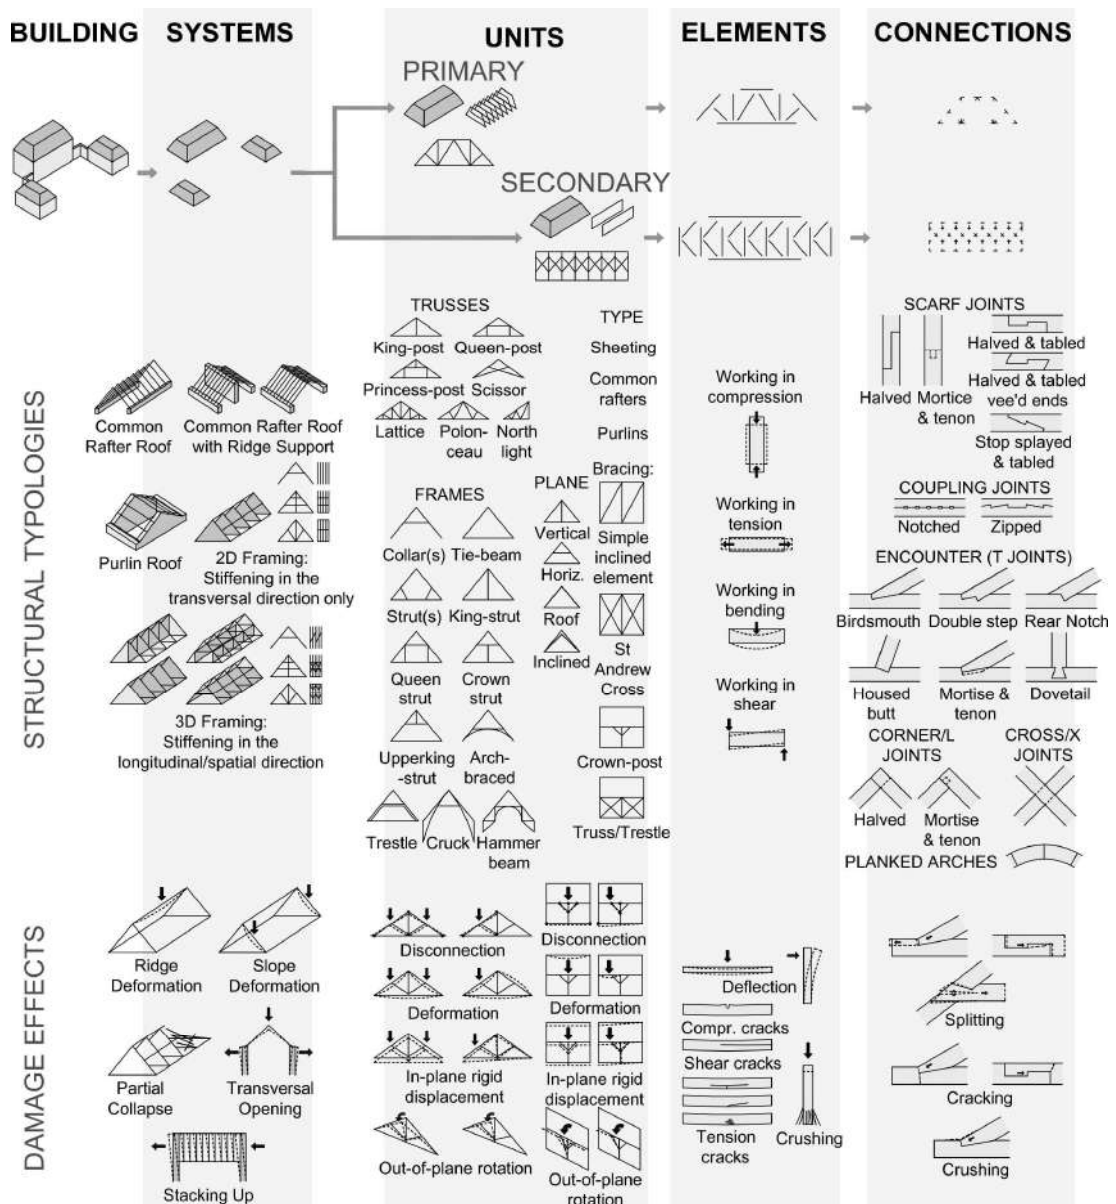
Figure 64: The tree like organization of the structured form, with a classification of structural typologies and damage effects identified for each level: building, system, unit, element, connection (Serafini et al., 2016)

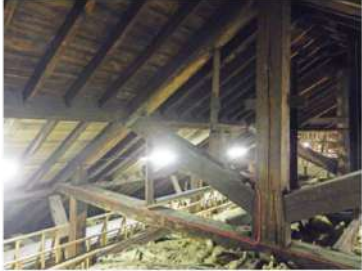
Roof structure [link I:\Arch\A](#)

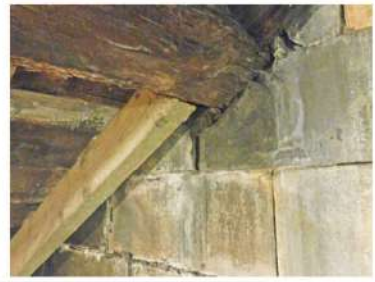
Material degradation [link I:\Arch\A](#)

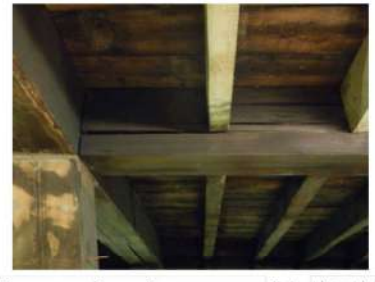
Damage: purlin cracking [link I:\Arch\A](#)

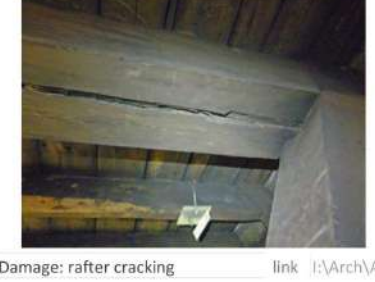
Damage: rafter cracking [link I:\Arch\A](#)

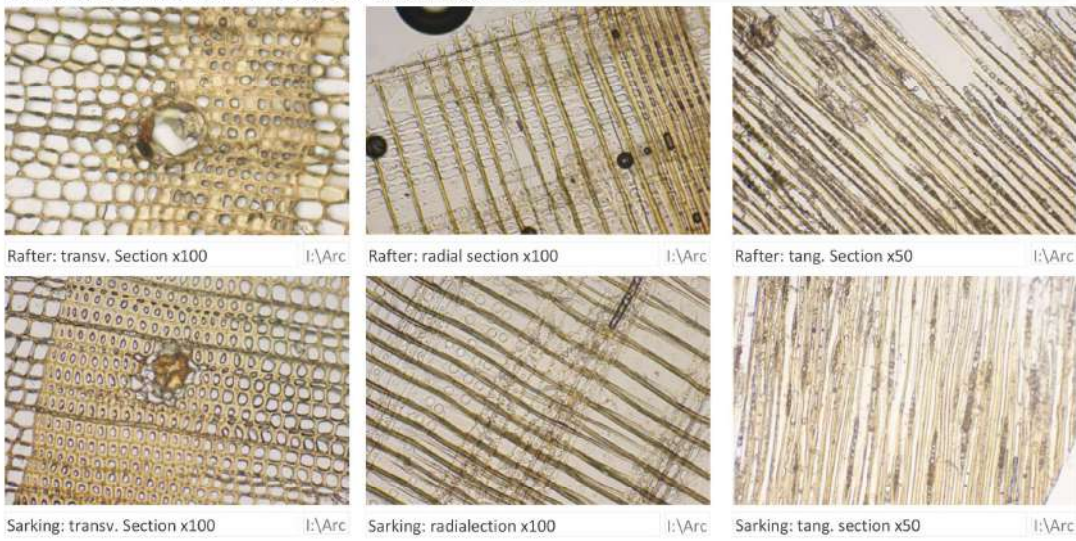
Air Temperature and Relative Humidity measurements See drawing SCP-SW-2

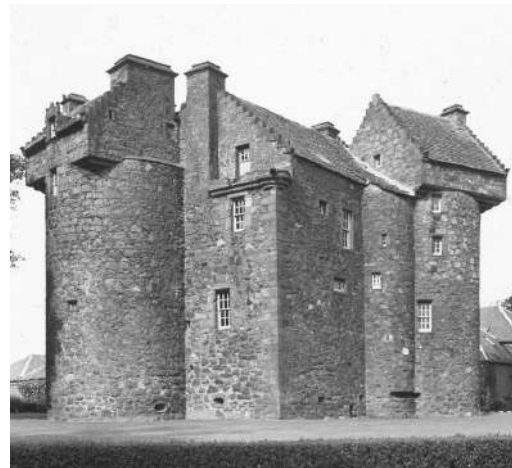
Figure 73: Claypotts Castle (1569-88): view from West (RCAHMS SC1324316, 1971) and plan (RCAHMS SC1202662, Undated)

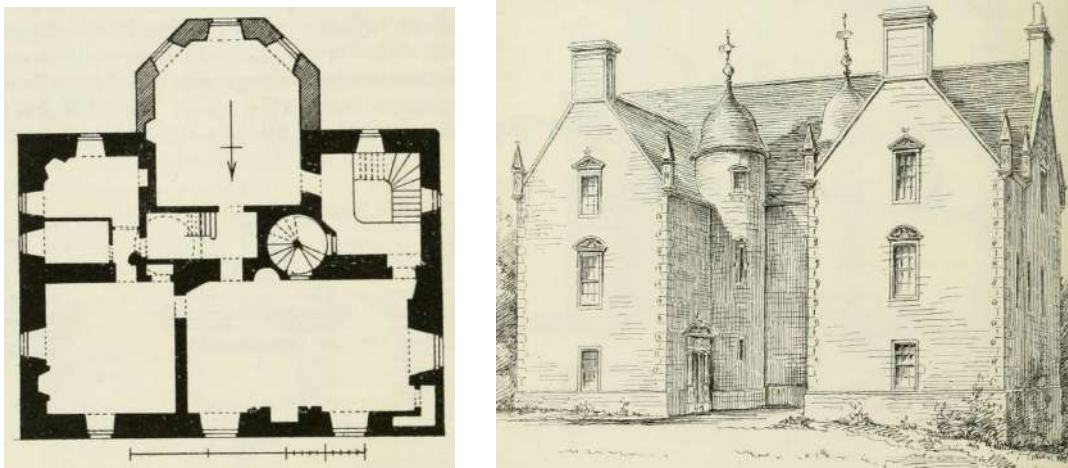
Figure 74: Baberton House (1622-3): plan and view of the South-East facade before the eighteenth-century additions (Macgibbon and Ross, 1887-92)

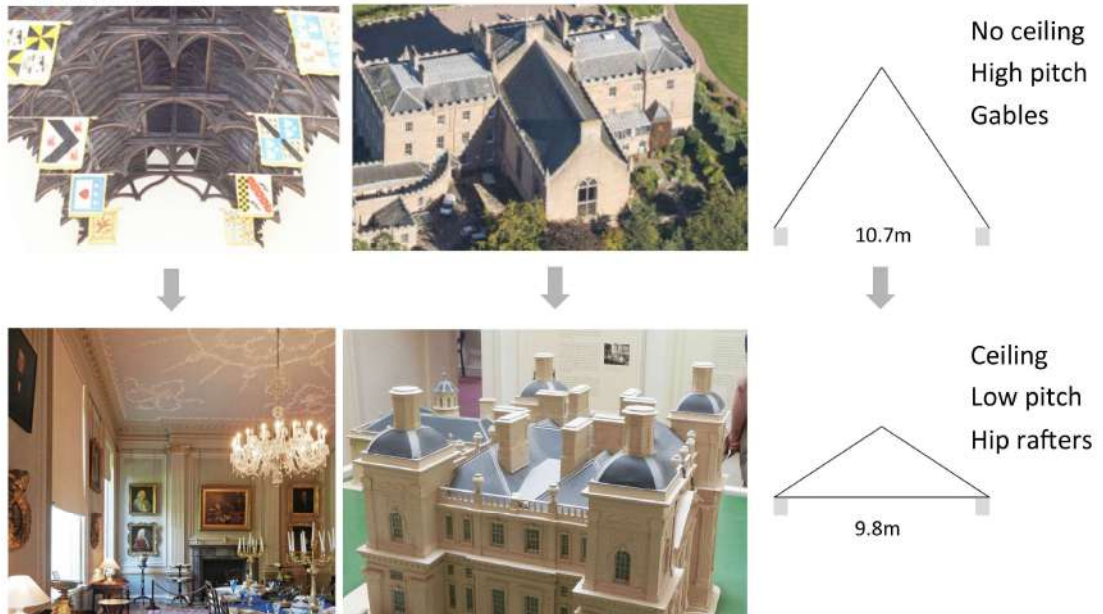
Darnaway Castle 1387

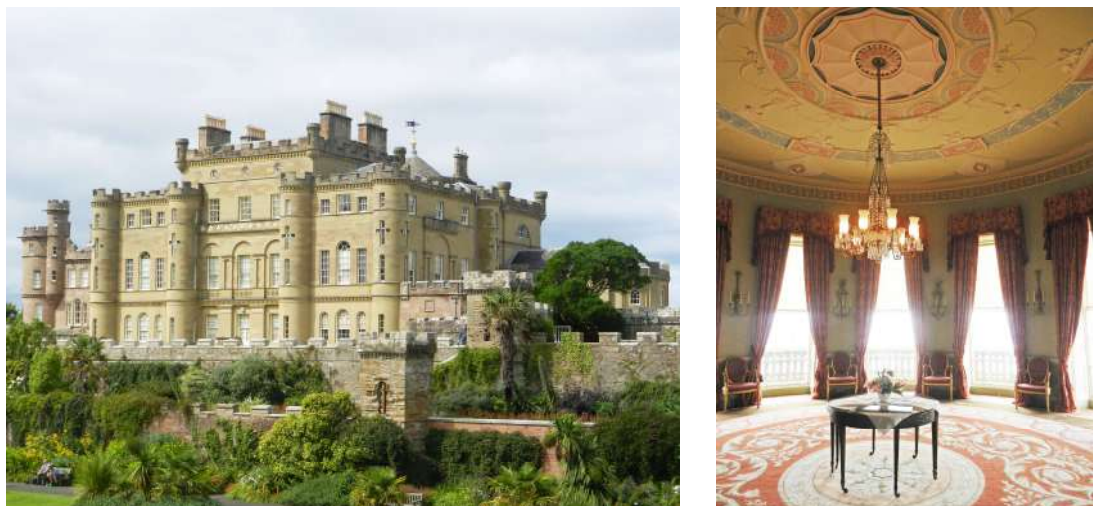
Figure 80: Culzean Castle (1776-92): view from North-East (left) and interior of the Drum tower (right)

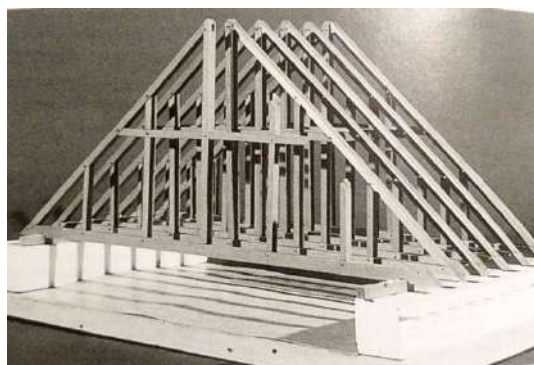
Figure 99: Roof with tension-absorbing posts in Saint-Pierre-de-Montmartre church in Paris (1164-74) (Corvol-Dessert et al., 2009)

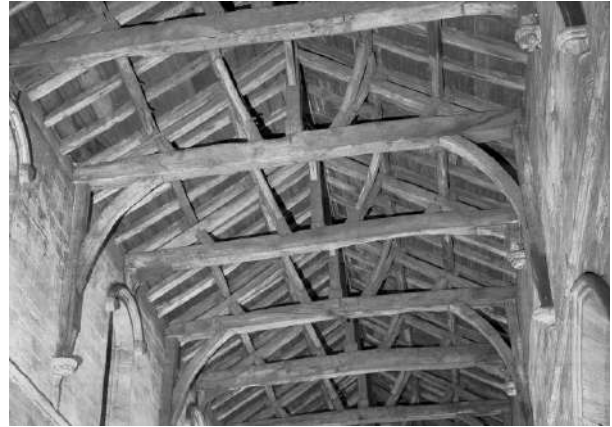
Figure 110: The roof of the central nave of Holy Rude church in Stirling (1455) (RCAHMS SC 738897, 1959)

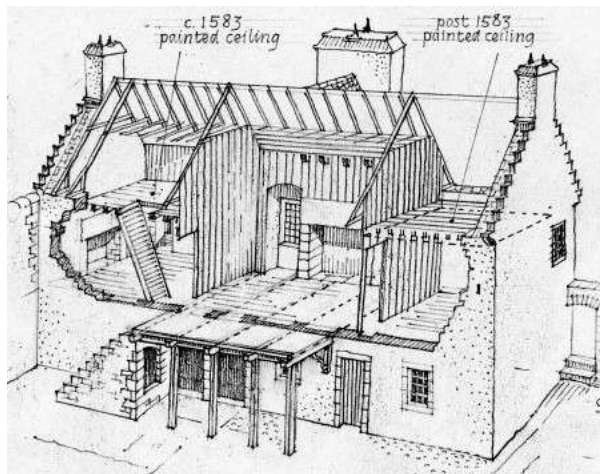
Figure 118: The roof of Dysart Bay Horse Inn (1583) (RCAHMS SC 989070, 1969) in Hanke (2006)

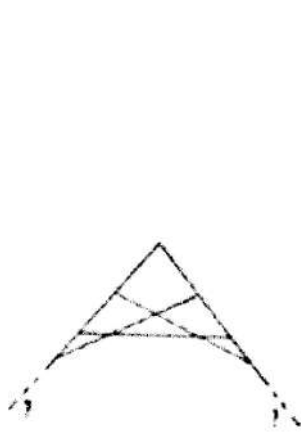
Figure 125: The scissor-braced roof of Moray House (1623) (Hanke, 2006)

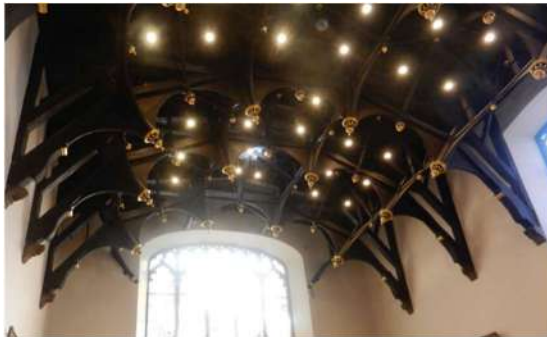
Figure 128: The roof of Parliament Hall in Edinburgh (1631-40)
