**Building skills for conserving
seventeenth- and eighteenth-century
Scottish built heritage:
the initial assessment of timber roof structures**

Anna Serafini

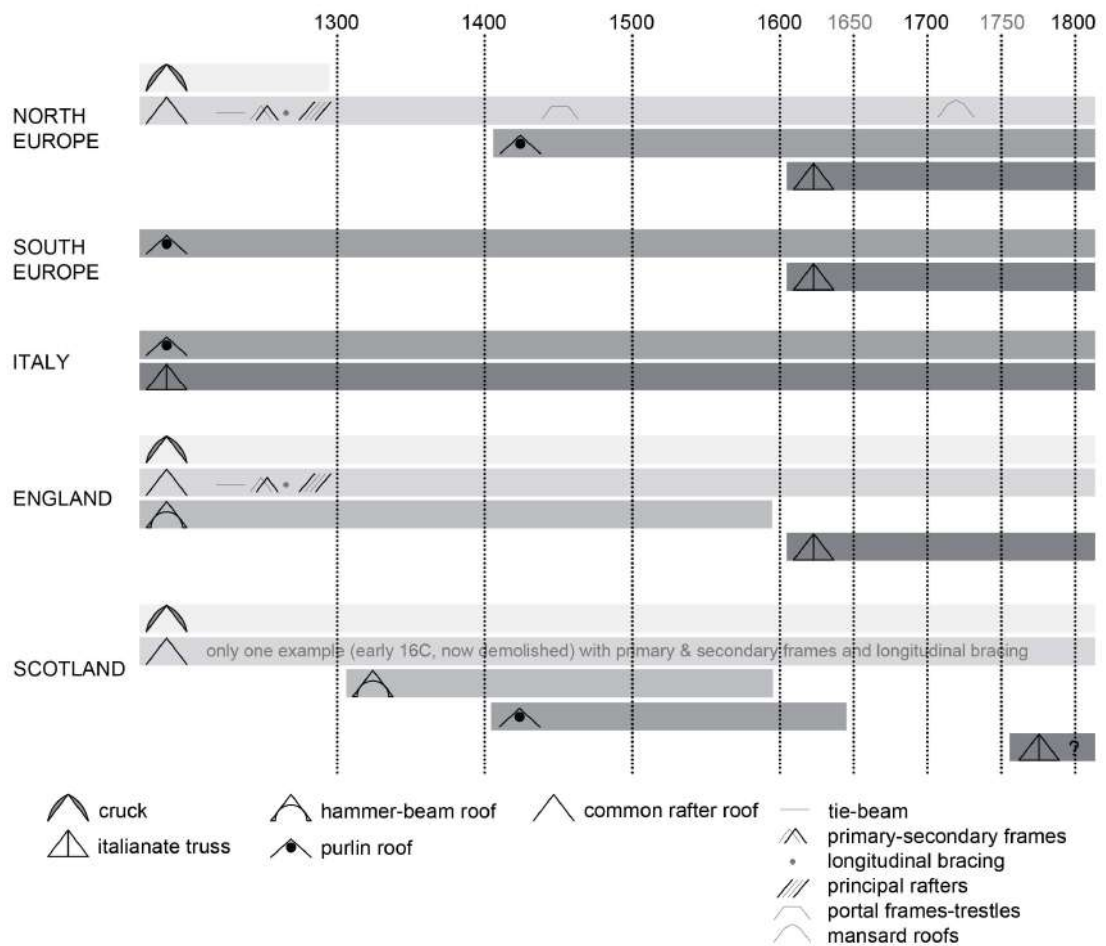
Figure 135: Timeline of different roof structures types used in continental Europe and England, compared to what is reported in literature about Scottish roofs

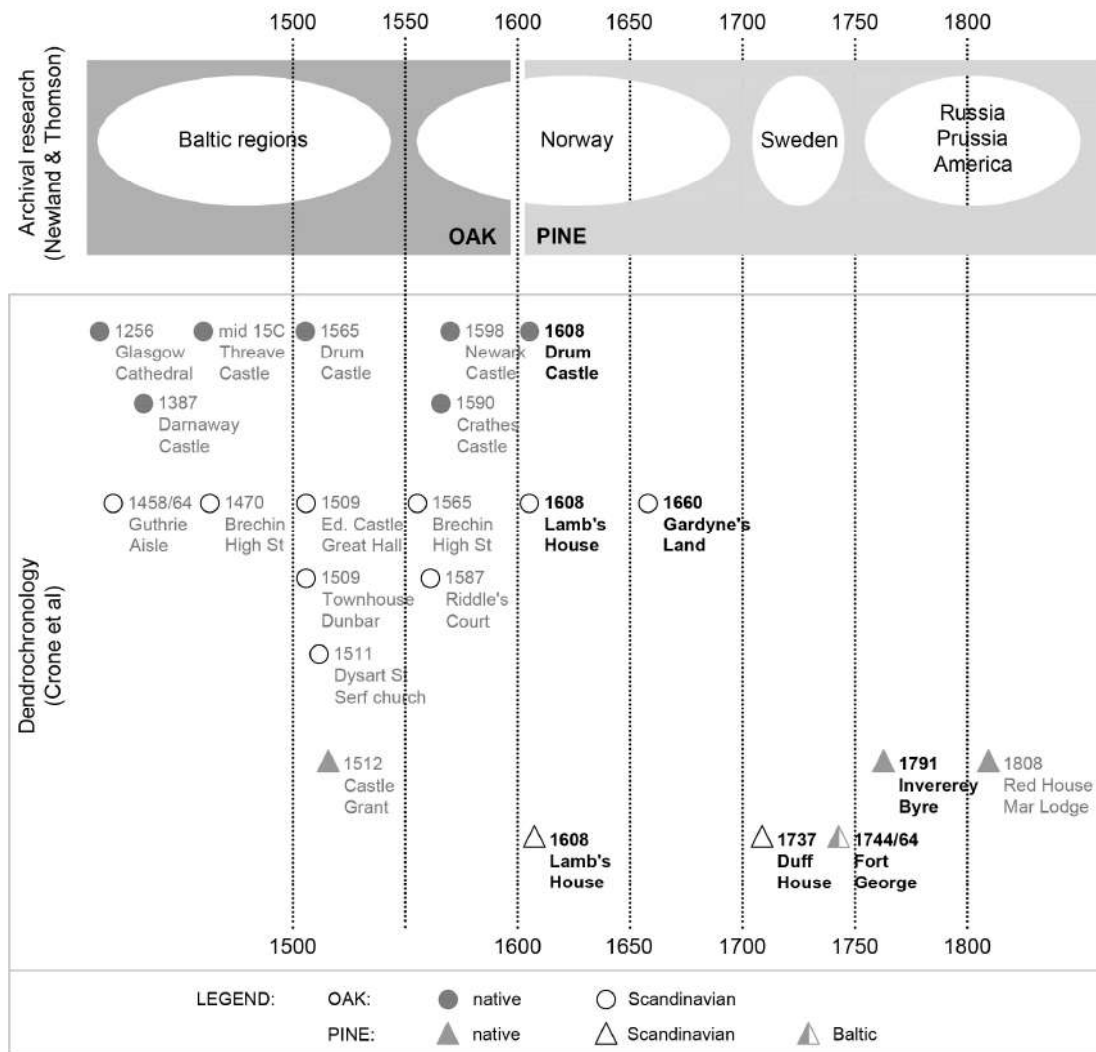
Figure 136: The species and provenance of timbers used in Scottish roofs according to archival research carried out by Newland (2007, 2010, 2011, 2012a, 2012b, 2012c) and Thomson (1991) and dendrochronological analysis carried out by Crone (2001, 2008b, 2008a, 2011) and others (Crone and Fawcett, 1998, Crone and Gallagher, 2008, Crone et al., 2004, Crone and Mills, 2007, Crone and Mills, 2008, Crone and Mills, 2011, Crone and Mills, 2012, Crone and Sproat, 2011, Mills and Crone, 2012)

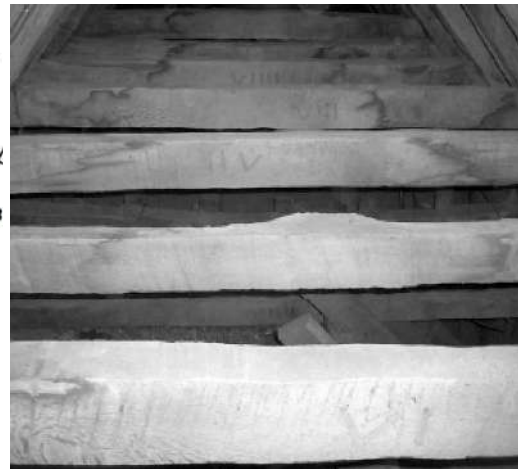
Figure 138: Hand-sawn oak collars in the roof of the Mansion House at Drum Castle (1598-1621) (Crone and Mills, 2011)

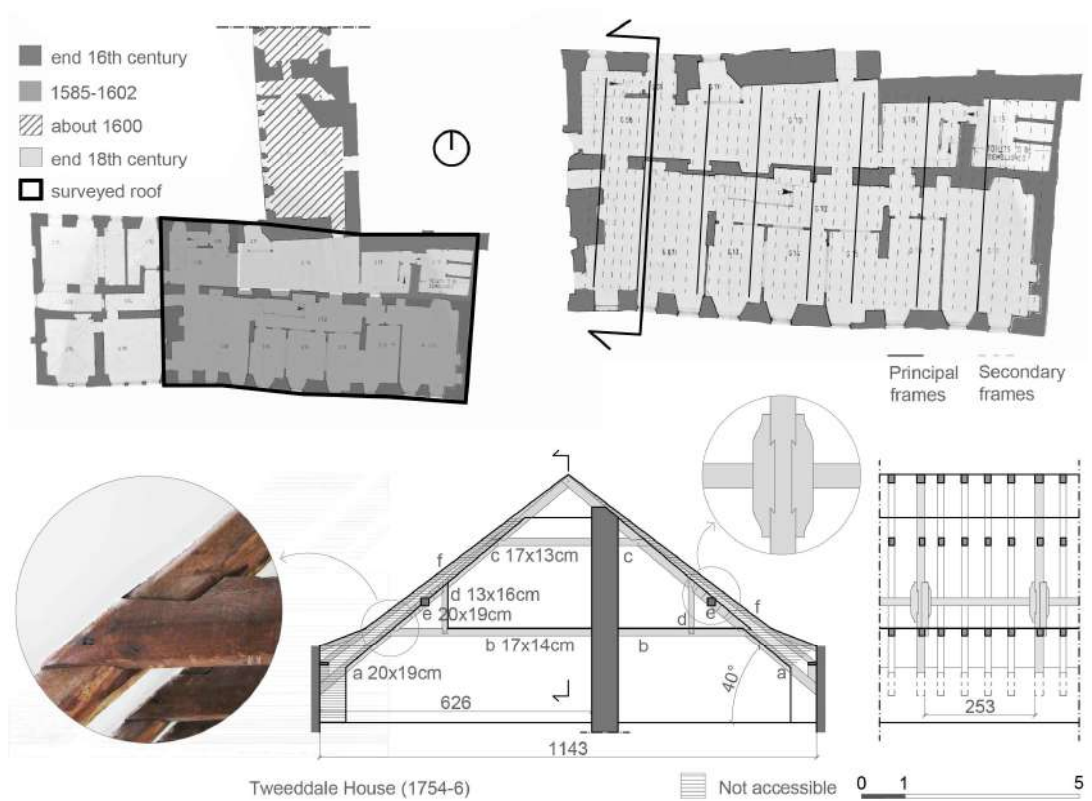
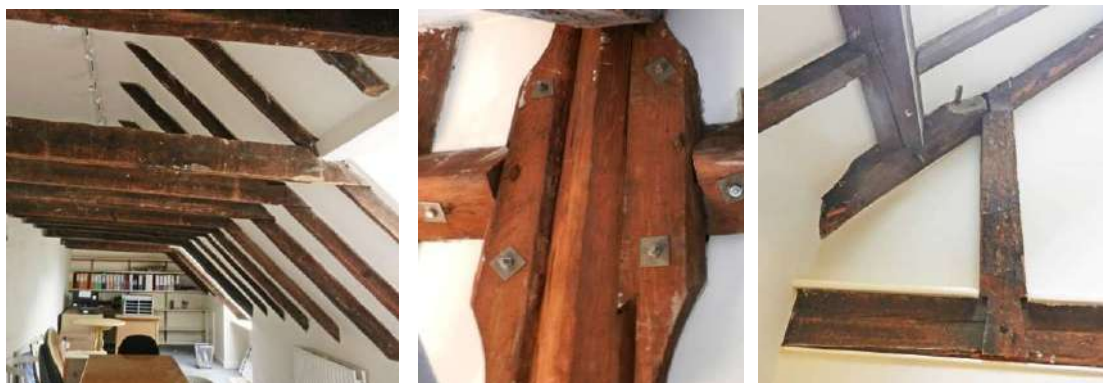
Figure 151: The roof of Tweeddale house (1750-6): reference plans and sections (top), general view from inside (bottom left), cleats reinforcing the rafters' section where the purlins abut (bottom centre), vertical struts supporting the collars (bottom right)

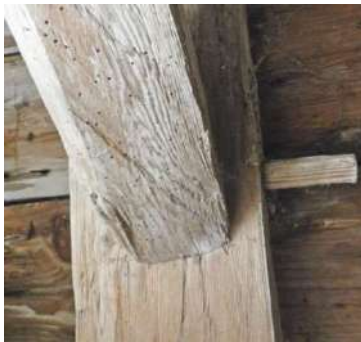
*a) Craigston Castle (1604-7):
mortice and tenon joint secured by
timber peg (rafter & collar)*

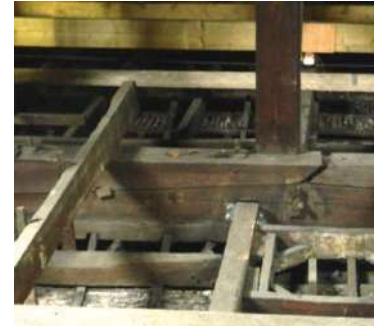
q) Oakshaw Trinity Church (1754-6): scarf joint secured by timber key and metal bolts (tie-beam)

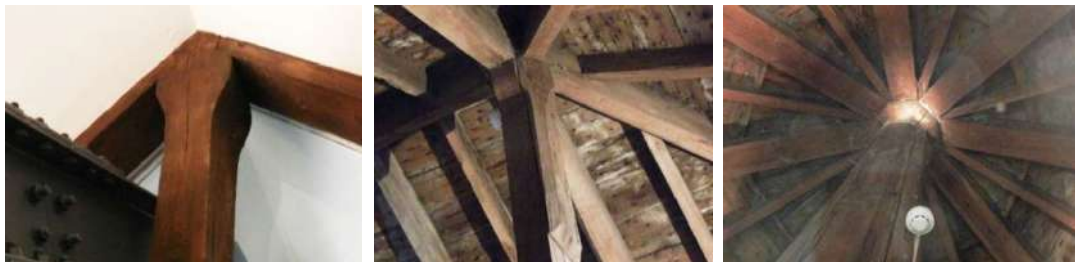
Figure 163: Bulb shaped joggles: Aunchinleck House (1755) (left), Stirling Tolbooth (1785) (centre), Culzean Castle (end eighteenth century) (right) (Serafini and Gonzalez Longo, 2015a)

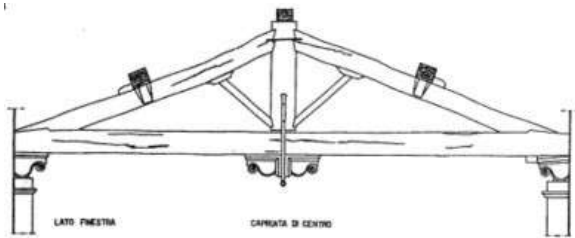
Figure 164: The roof of the church of Sant'Agata di Mugello in Scarperia (Tampone 2001)

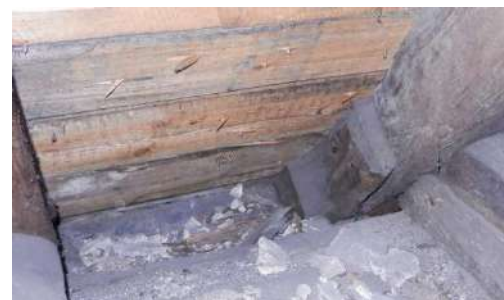
Figure 169: Cleats used to reinforce the connection between rafters and purlins in the common rafter roof of Touch House (end seventeenth century, but the purlins might be a later addition)

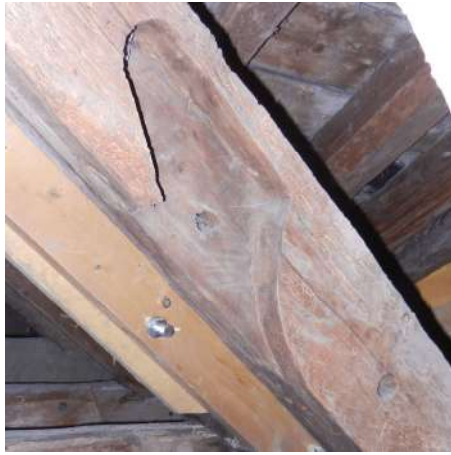
Figure 170: Redundant lapped/halved joints found in Blair Castle (1745)

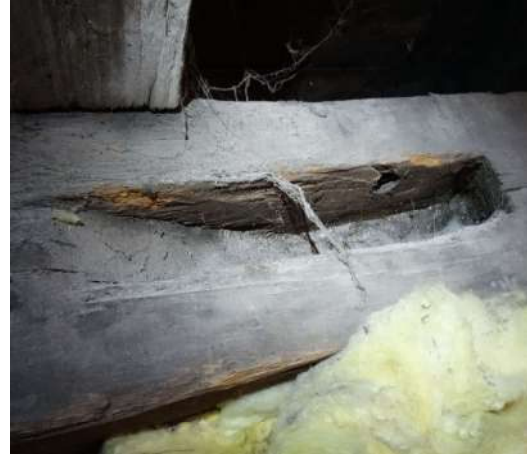
Figure 171: Redundant chase mortice and tenon joints found in the North-West corner of Stirling Castle Palace (1719)

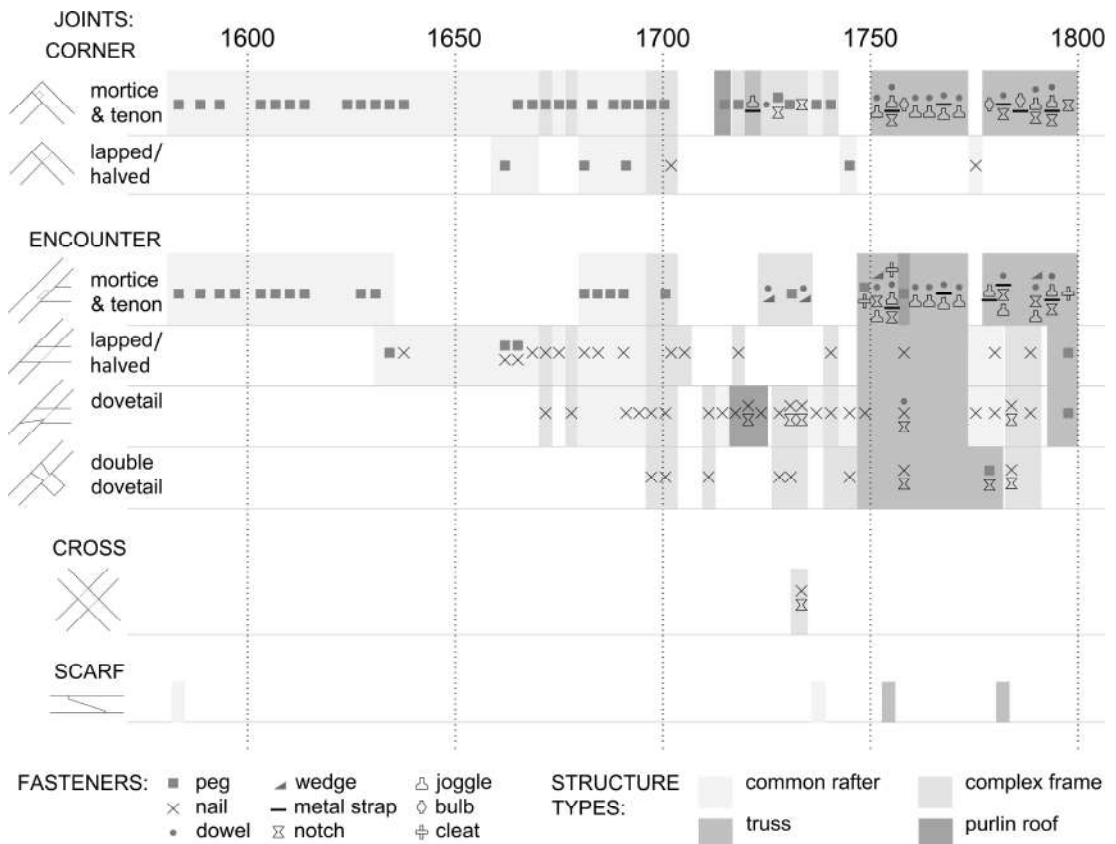
Figure 172: Timeline of types of joints and fasteners found in the surveyed Scottish roofs

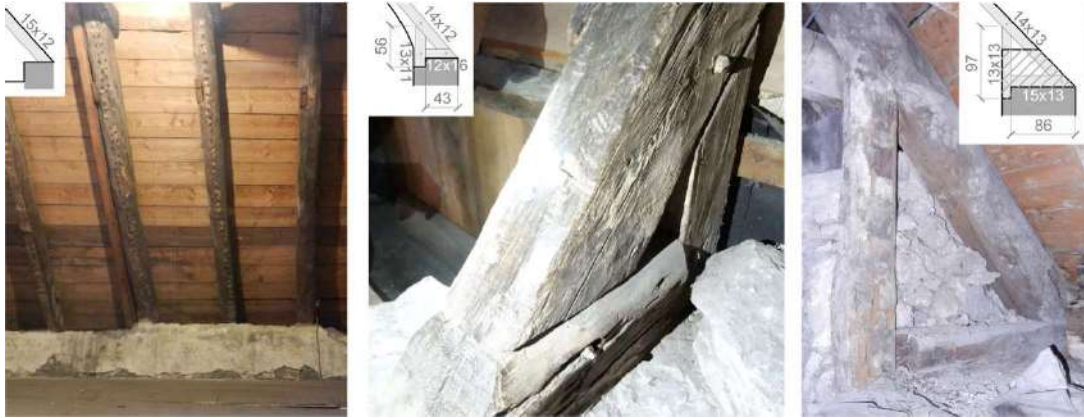
Figure 173: Connection with the lateral walls: simple contact between the rafter ends and the wall-head in Sailor's Walk (1670s) (left), rafter feet in Culross Palace (1597-1610) (centre) and Methven Castle (1678) (right)

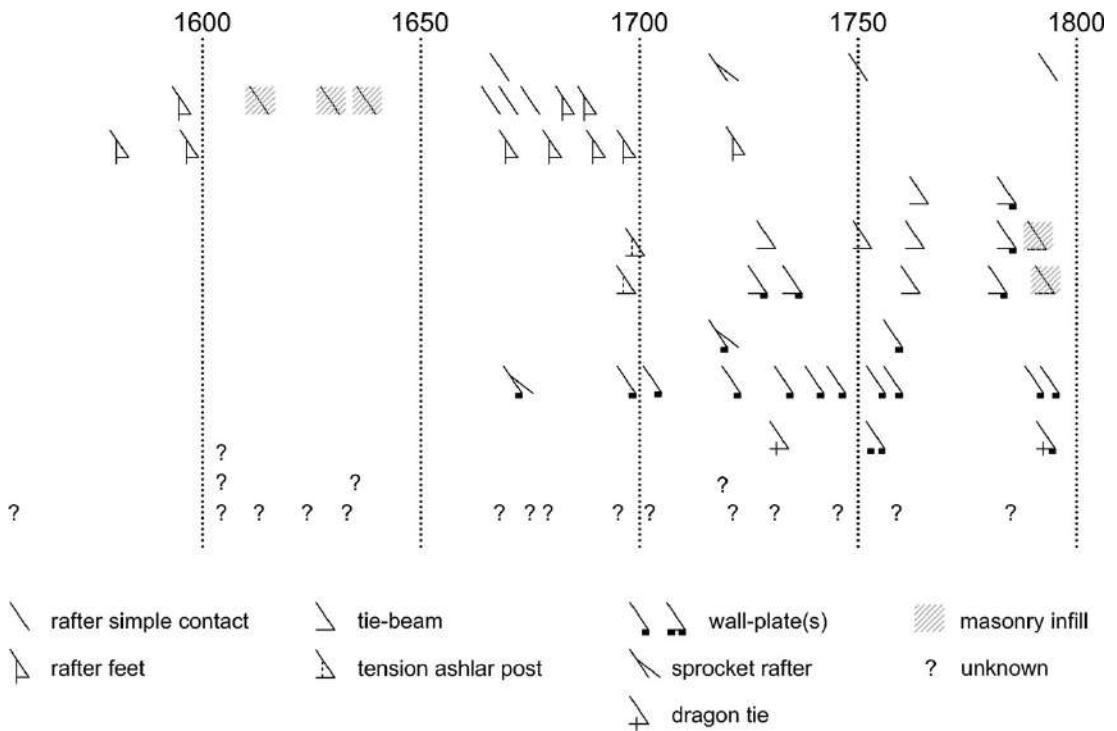
Figure 174: Timeline of different types of connections with the lateral walls found in the surveyed roofs

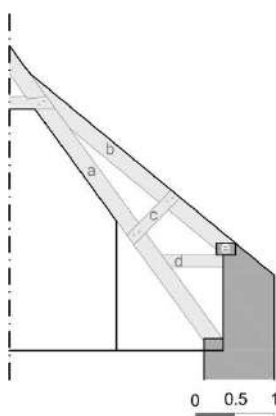
Figure 175: Connection with the wall in Holyrood Palace (1671-8): this is the first Scottish roof to employ wall-plates as well as sprocket rafters and a raised wall-head to protect the rafter ends and create a 'bell-cast' profile

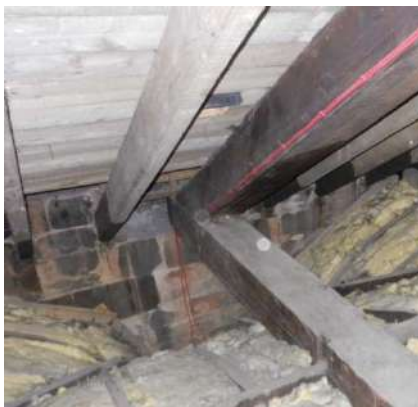
Figure 177: Connection with the wall in St Andrew's in the Square church (1751-3): the tie-beam simply sits on the ashlar masonry

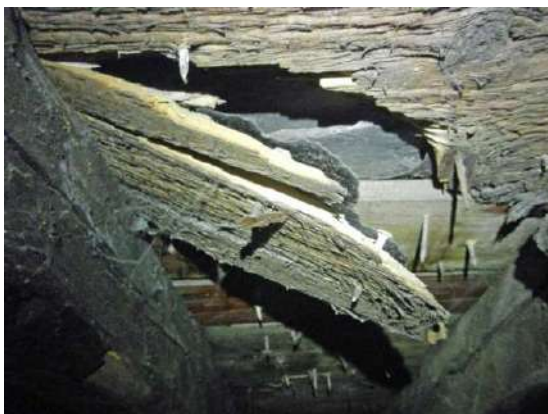
Figure 180: A broken sarking deal in Cockenzie House (1680-3) reveals the tar layer on top of the deals and the slates above

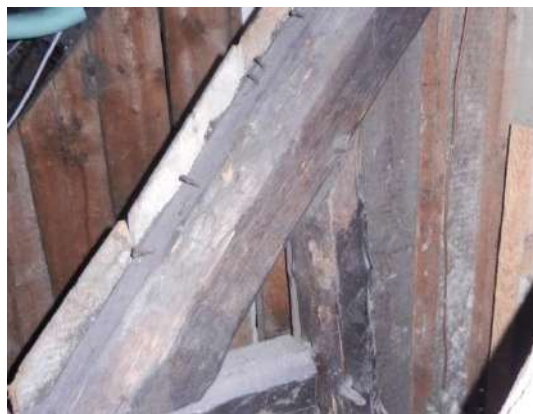
Figure 181: Nails on rafter feet of Cockenzie House (1680-3) left after the removal of the sarking boards

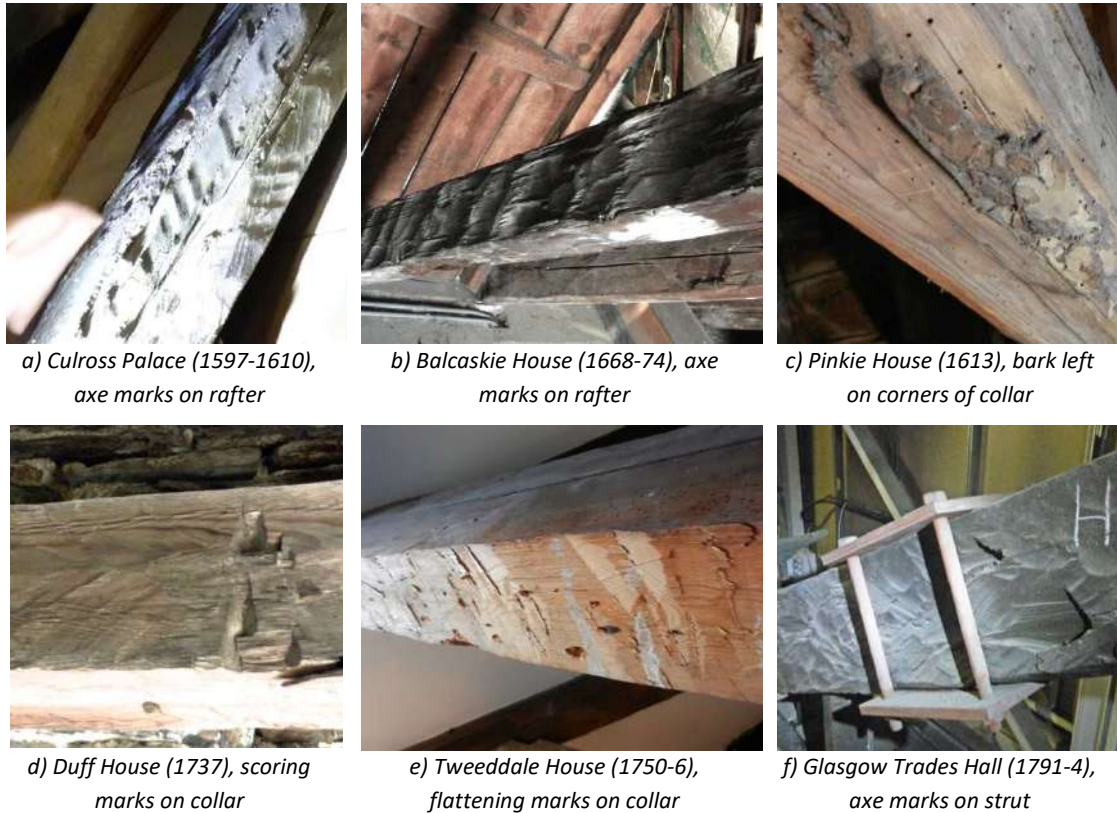
Figure 190: Tool marks on hewn timber found in the surveyed roofs

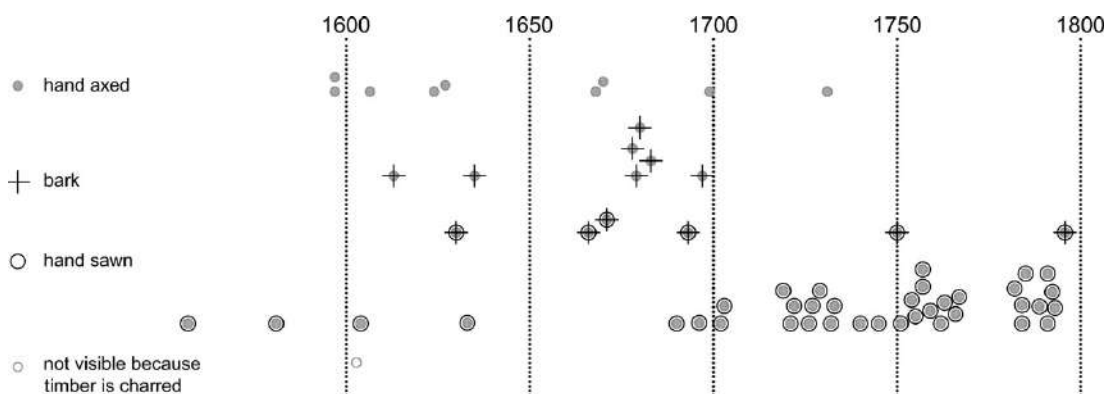
Figure 191: Timeline of the timber dressing found in the surveyed roofs

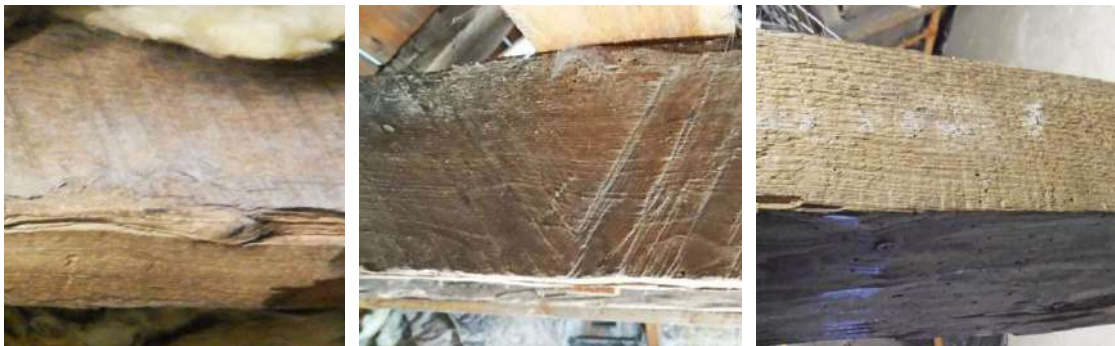
Figure 192: Saw marks on collars in King's Old Buildings at Stirling Castle (1557) (left), collars in Kelburn Castle (1581) (centre), struts in Newhailes House (1733-51) (right)

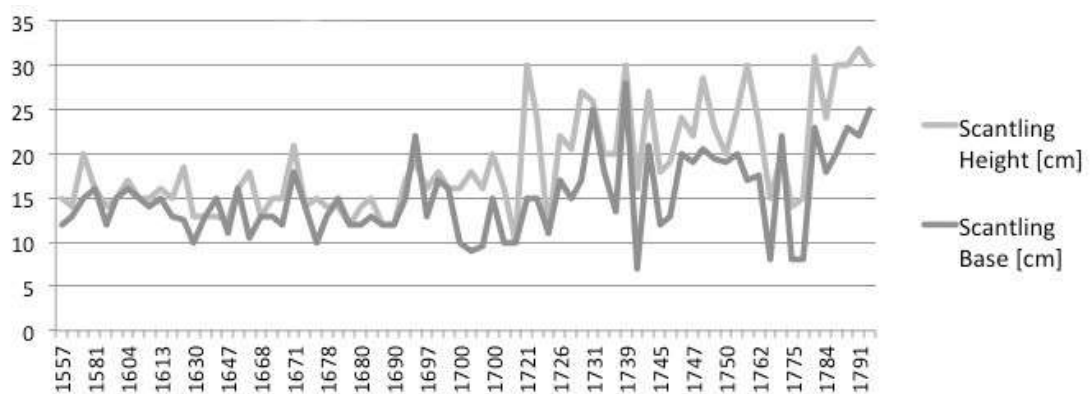
Figure 193: Timeline of the height and base of primary structural timber elements (rafters and purlins) in the surveyed roofs

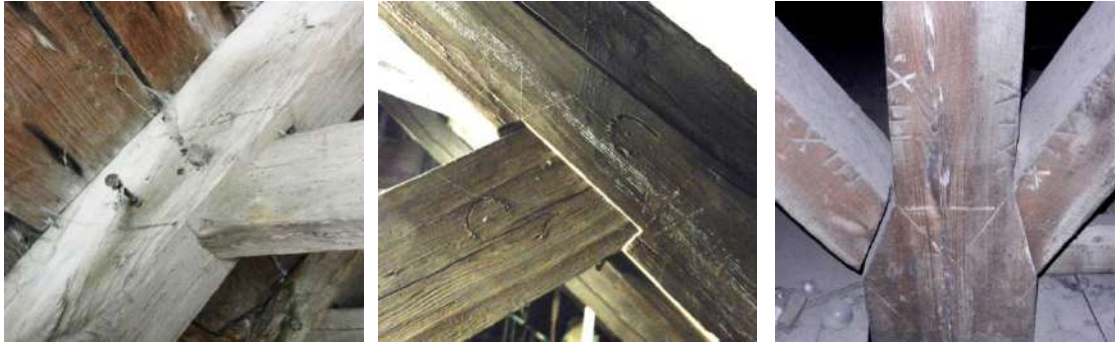
Figure 194: Marks of geometric tracing in Craigston Castle (1604-7) (left), Oakshaw Trinity church (1754-6) (centre), Glasgow Trades Hall (1791-4) (right)

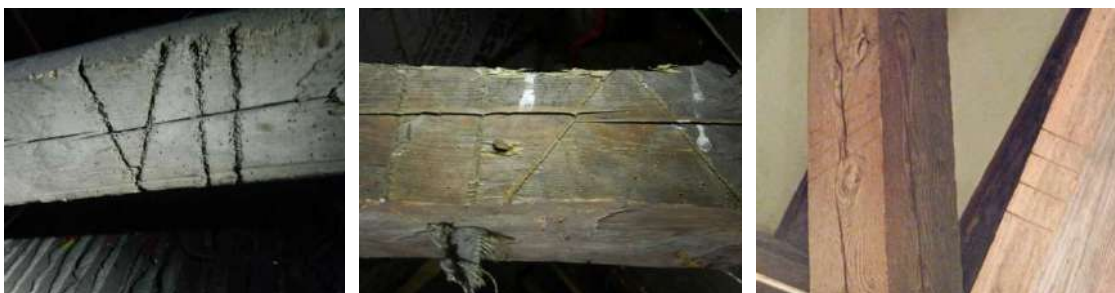
Figure 195: Big sawn roman numerals in Malleny House (1635) (left), Balcaskie House (1668-74) (centre), Brodie Castle Stables (end eighteenth century) (right)

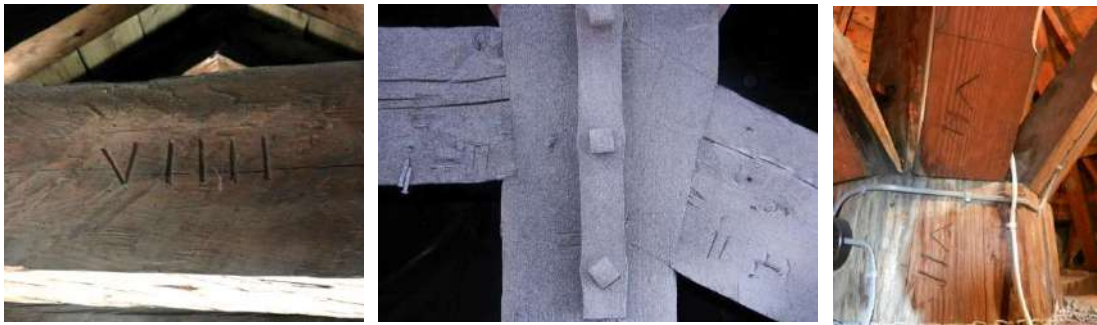
Figure 196: Small chiselled roman numerals in Duff House (1737) (left), Trades Hall (1791-4) (centre), Culzean Castle (after 1791) (right)

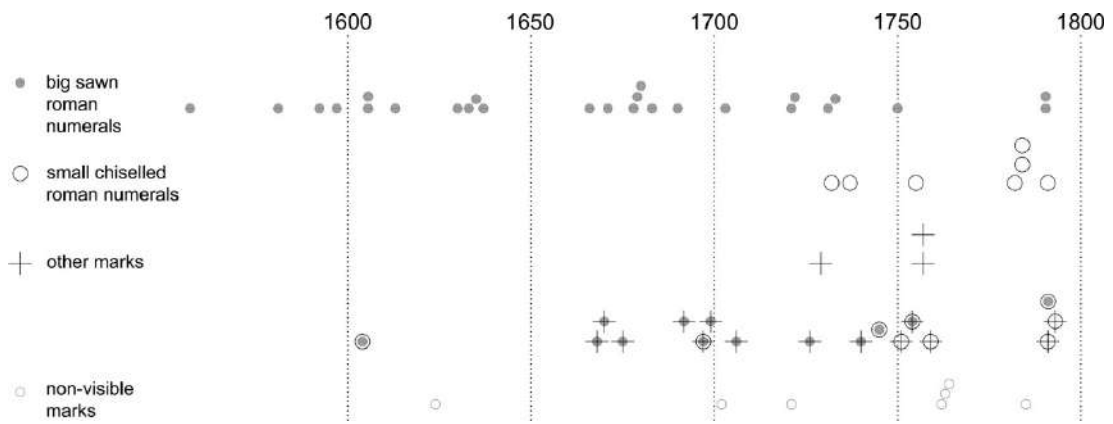
Figure 198: Timeline of types of carpentry marks used in the surveyed roofs

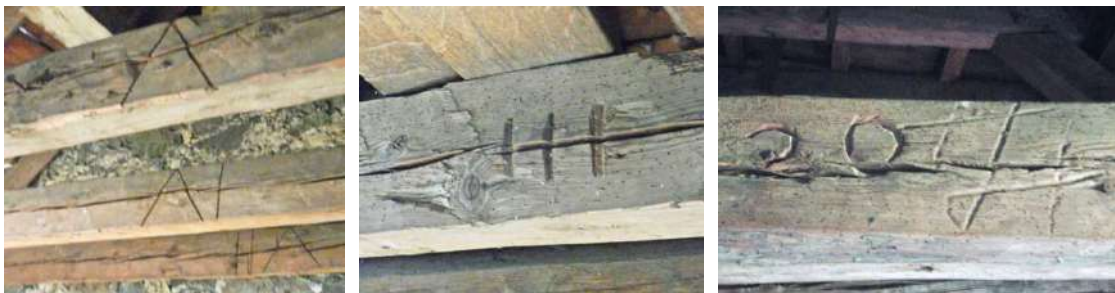
Figure 199: Carpentry marks in Melville House (1697-1703)

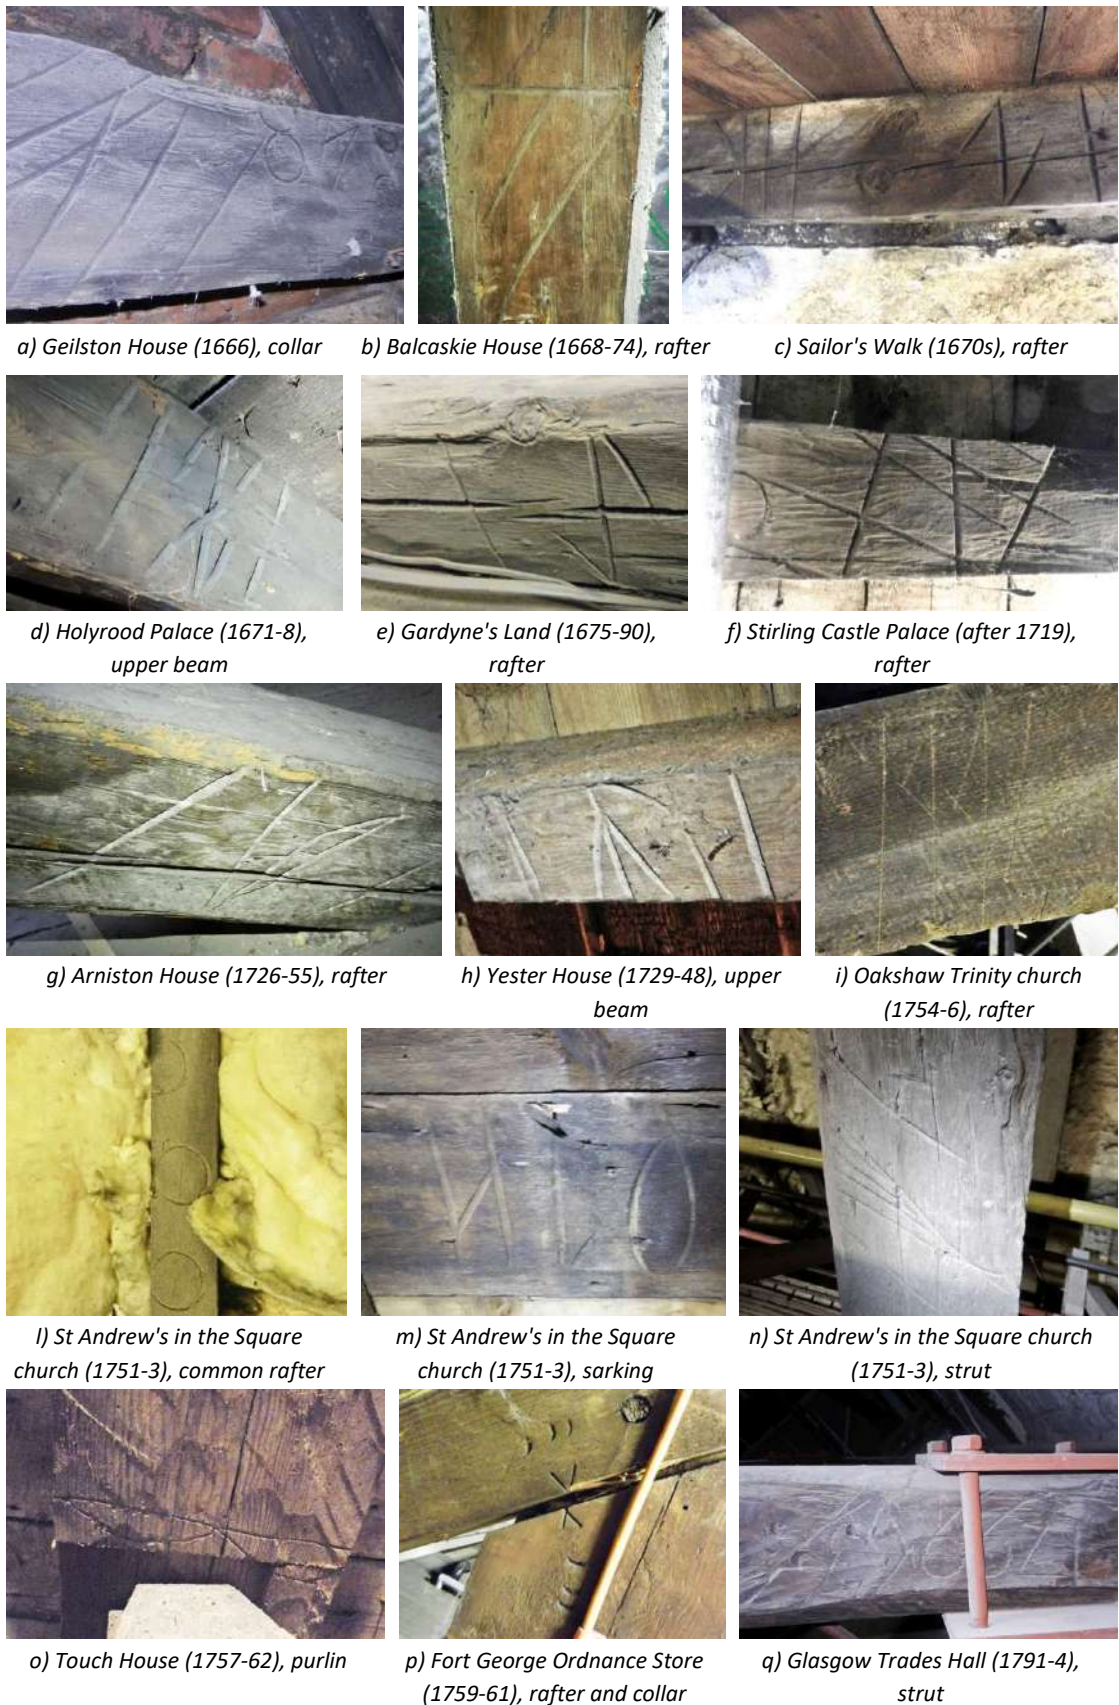
Figure 200: A representative sample of different types of carpentry marks found in the surveyed roofs

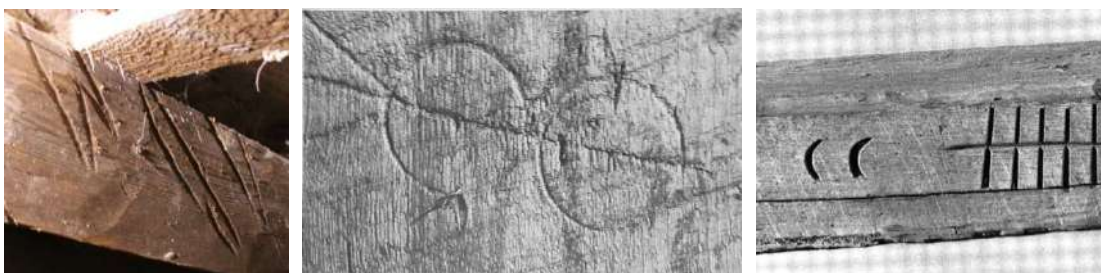
Figure 201: Carpentry marks in Falsterbo church in Sweden (picture by Karl Magnus Melin) (left), in Saint Pierre Cathedral in Beauvais (after 1573) (Corvol-Dessert et al., 2009) (centre), in Bovenkarspel Herv. church in Netherlands (1540) (Janse, 1989) (right)

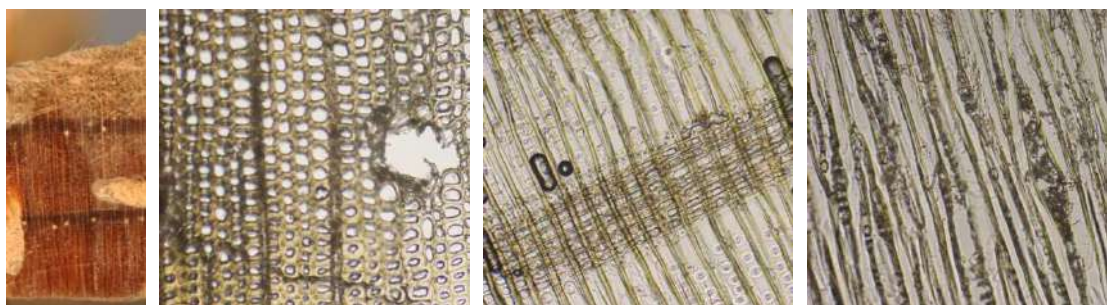
Figure 202: Sample of Scots pine extracted from a sarking board of the roof in Cockenzie House (1680-3): transversal section macro (left); transversal section X100 (centre left); radial Section X100 (centre right); tangential section X100 (right)

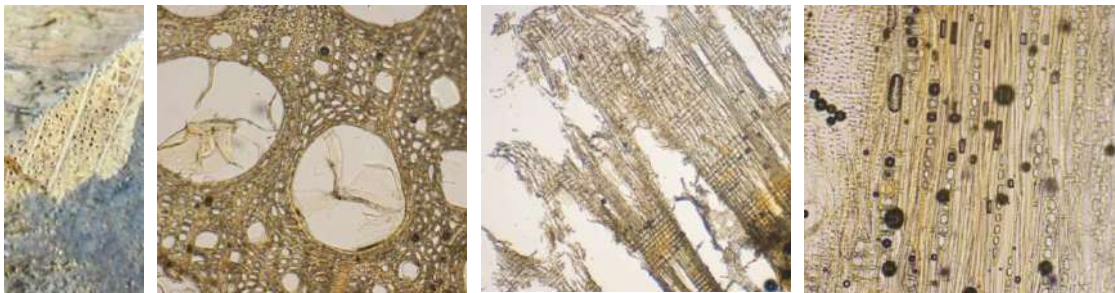
Figure 203: Sample of oak extracted from a peg securing the joint between a rafter and an upper beam in the roof of the North range of Holyrood Palace (1671-9): transversal section macro (left); transversal section X50 (centre left); radial Section X50 (centre right); tangential section X100 (right)

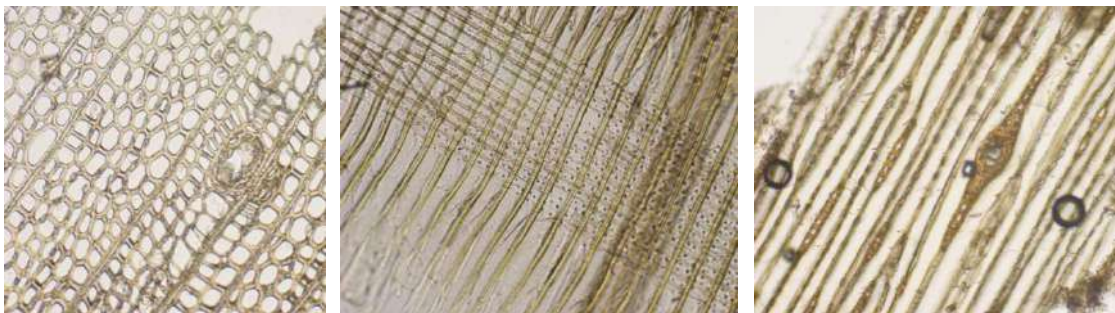
Figure 204: Sample of spruce extracted from a post of the roof in Newhailes House (1733-51): transversal section X100 (left); radial Section X100 (centre); tangential section X100 (right)

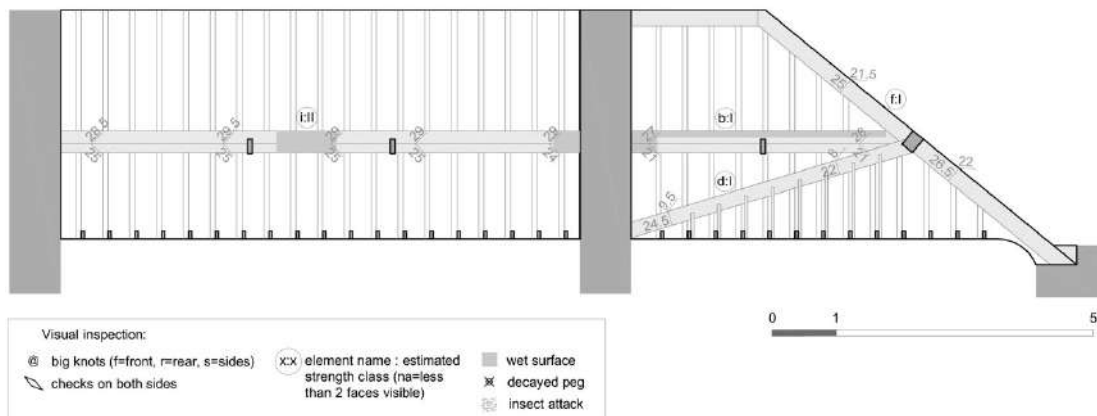
Figure 207: Part of the VSG results of the roofs of Holyrood Palace (top) and Touch House (bottom)

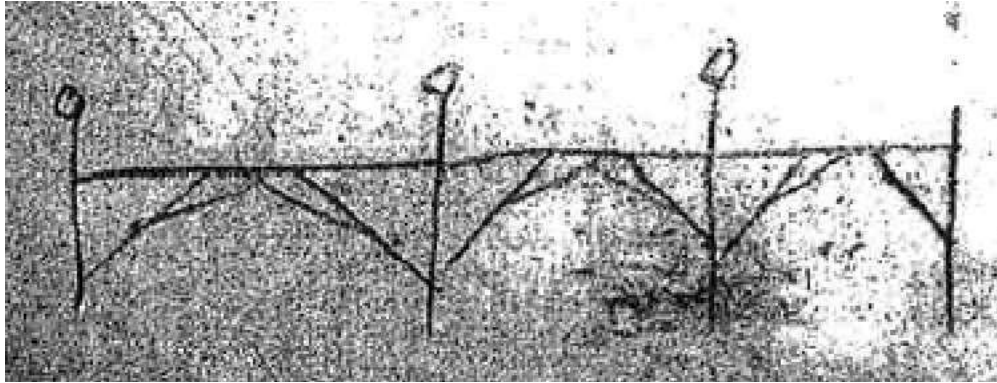
Figure 210: A sketch of Brechin's roof structure included in the assessment of James Baine's work drafted by Thomas Bachop in 1694 (Newland, 2010)

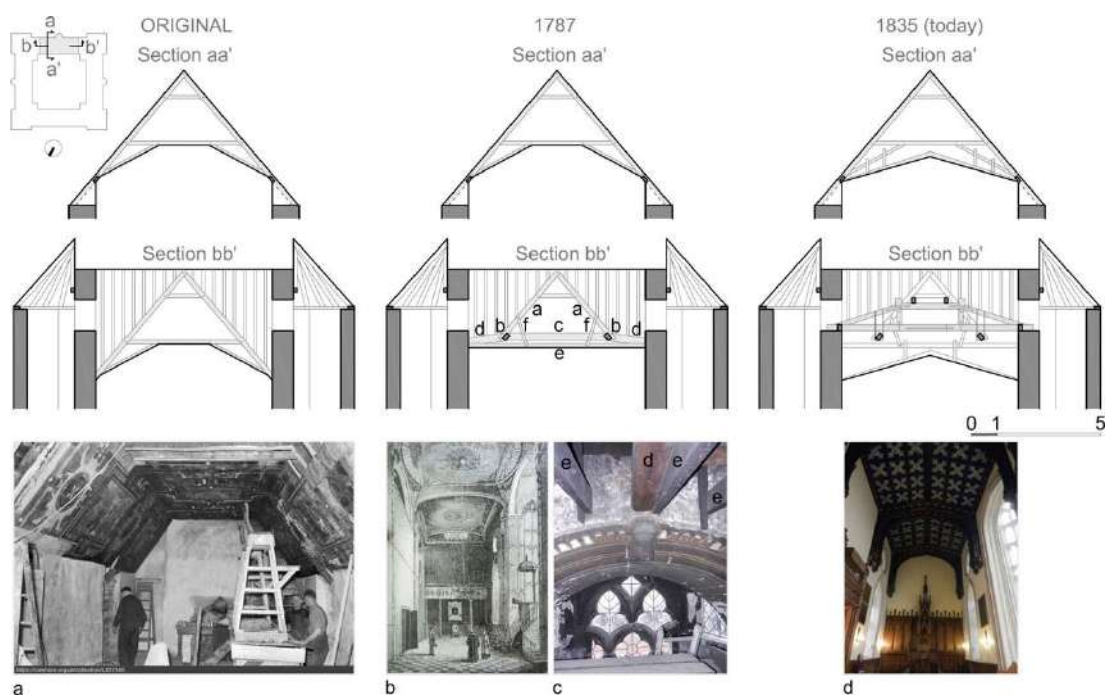
Figure 213: Alterations in time to the roof structure and ceiling of George Heriot's Chapel: a) hypothesis of the original ceiling, that might have been similar to the 1626 one in Provost Skene's House (RCAHMS SC 1327346, 1952); b) an undated drawing probably showing what the 1787 ceiling looked like (Lockhart, 2003); c) remains of the eighteenth century plaster decorations visible in the roof space; d) a view of the ceiling today, as renewed in 1835 (Serafini and Gonzalez Longo, 2015b)

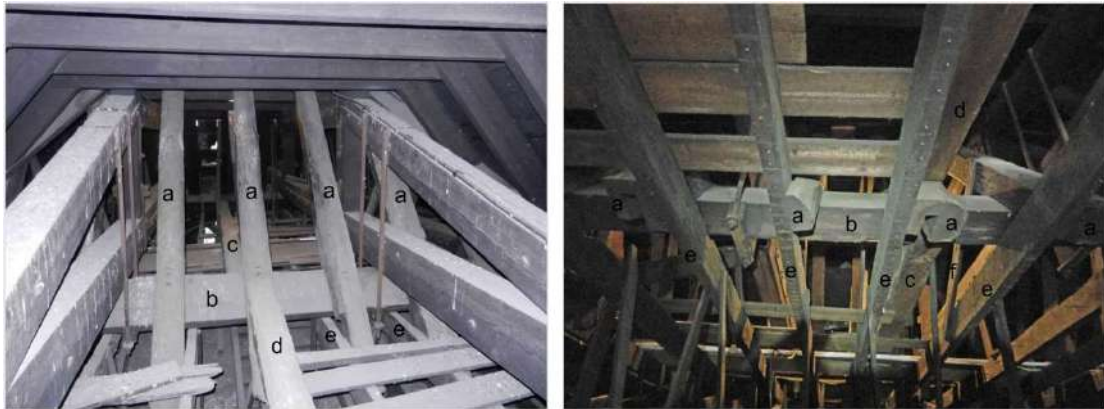
Figure 214: Alterations in time to the roof structure and ceiling of George Heriot's Chapel; the letters correspond to those in Figure 214 (Serafini and Gonzalez Longo, 2015b)

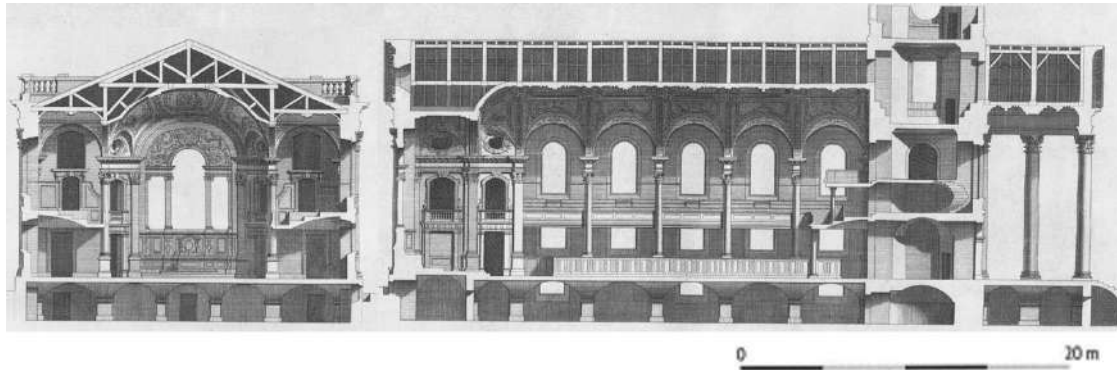
Figure 215: The roof of St Martin's in the fields church as drawn by James Gibbs (1728)

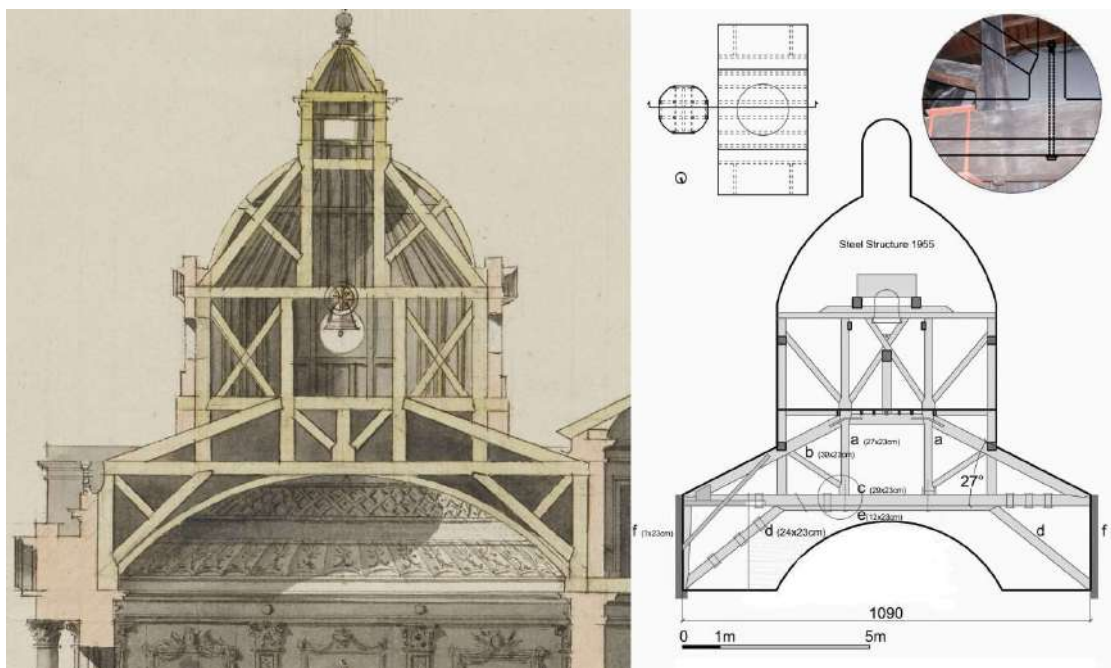
Figure 221: The roof of Glasgow Trades Hall, as designed by Robert Adam on the left (SM Adam 48/25, 1791), and as built on the right; the graphic scale relates to both drawings (Serafini and Gonzalez Longo, 2015a)

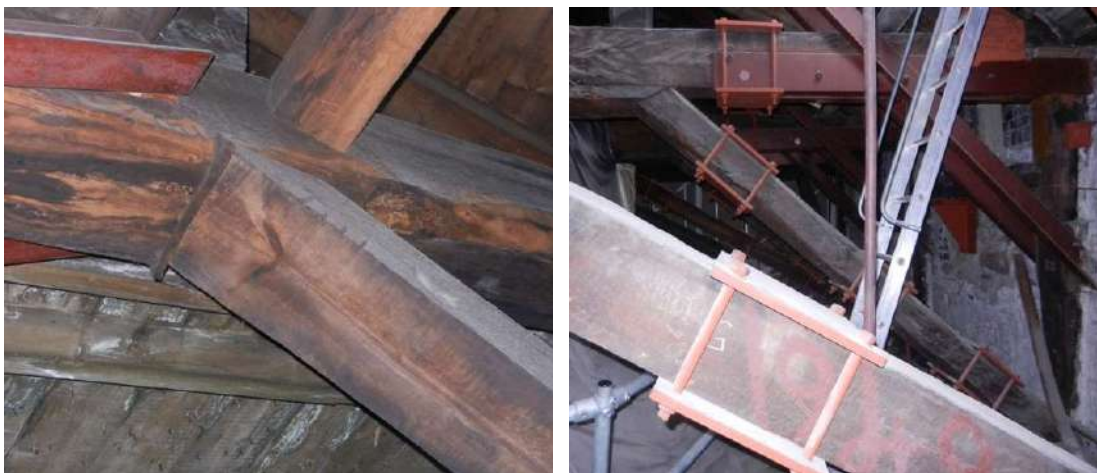
Figure 222: Repair works to the roof structure of Glasgow Trades Hall (1791-4): a timber wedge inserted between a slanted brace and a horizontal beam (left); steel rods, plates and brackets added in 1990s (right)

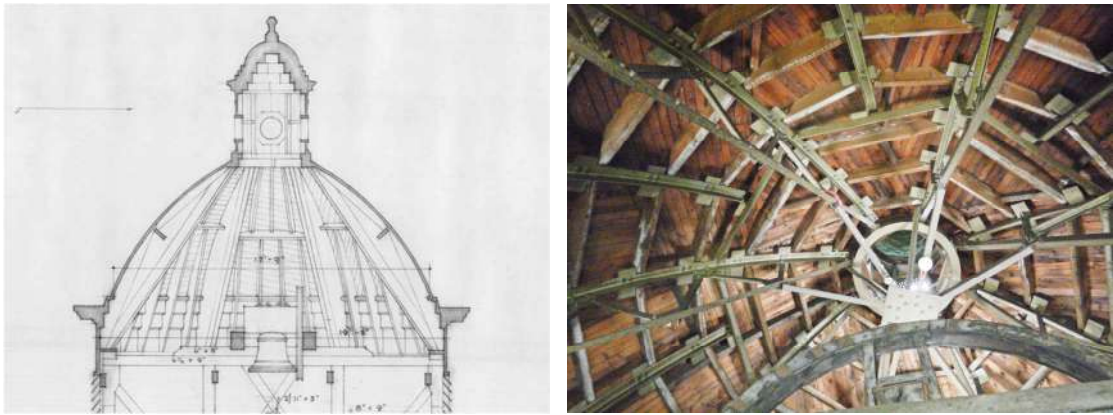
Figure 223: The original timber structure of the dome of Glasgow Trades Hall (1791-4) surveyed by W. Underwood in 1950s (ML Shanks 152/T6, 1955) (left) before the replacement in steel (right)

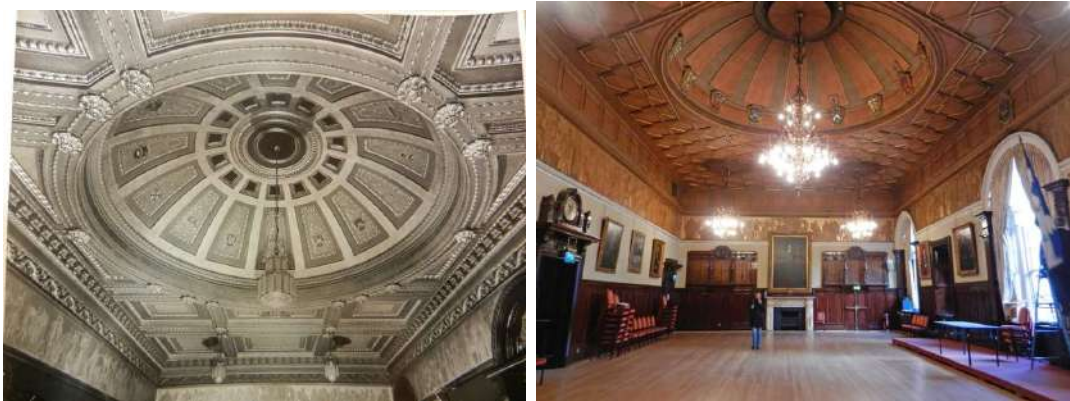
Figure 224: The ceiling of Glasgow Trades Hall (1791-4): an undated picture probably showing the original ceiling (ML T-TH 1/34/3, Undated) (left) and the present ceiling, installed by W. Underwood in 1950s (right)

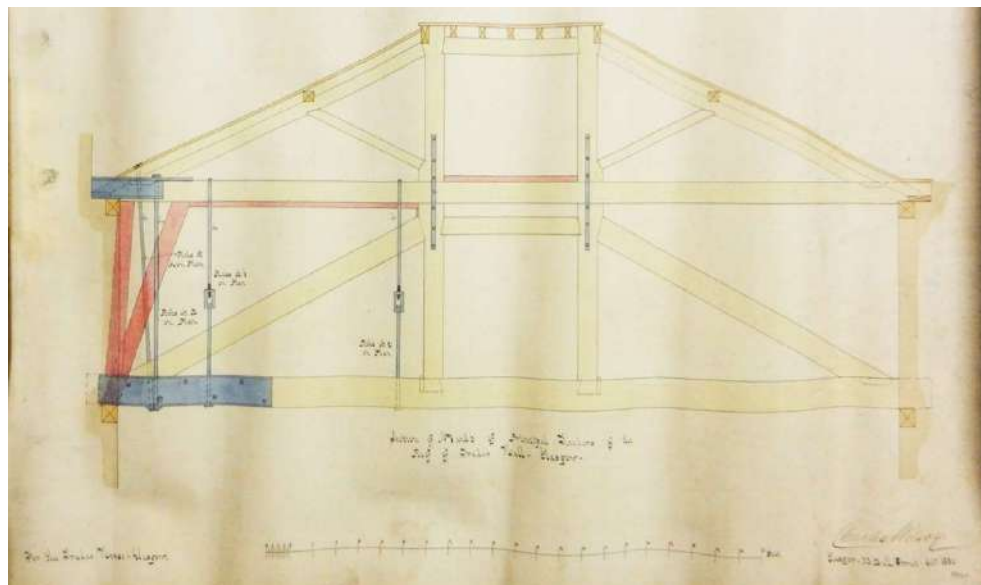
Figure 225: Strengthening of the roof of Glasgow Trades Hall (1791-4): drawing by Charles Wilson architect dated 1856 showing in yellow the original structure, in red new timber elements added by C. Wilson, in blue metal work added by C. Wilson (TDH 1/899, 1856)

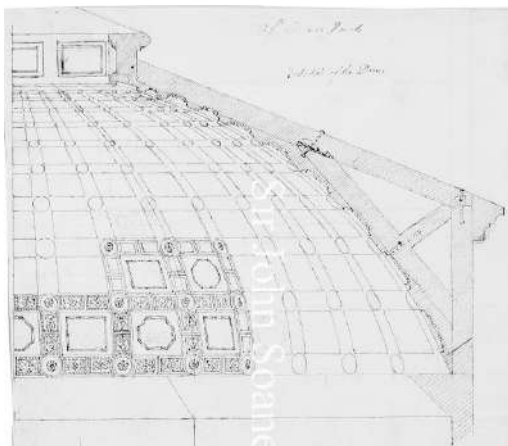
Figure 226: Design for the dome of Edinburgh Assembly Rooms and Musical Society by James Adam (SM Adam 7/225, 1755)

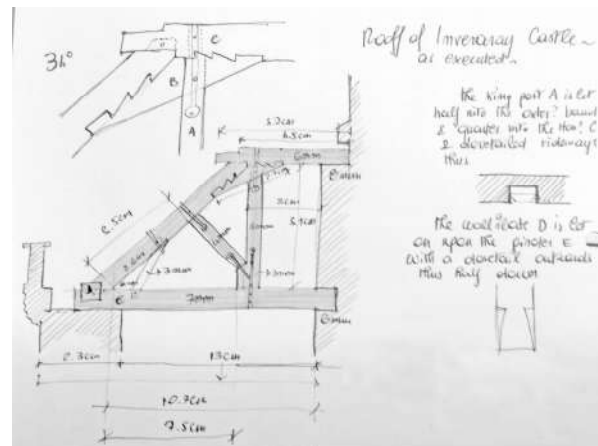
Figure 227: Design for the roof of Inveraray Castle (copy of drawing found in John Adam's diary held at Blair Adam House)
