**Building skills for conserving
seventeenth- and eighteenth-century
Scottish built heritage:
the initial assessment of timber roof structures**

Anna Serafini

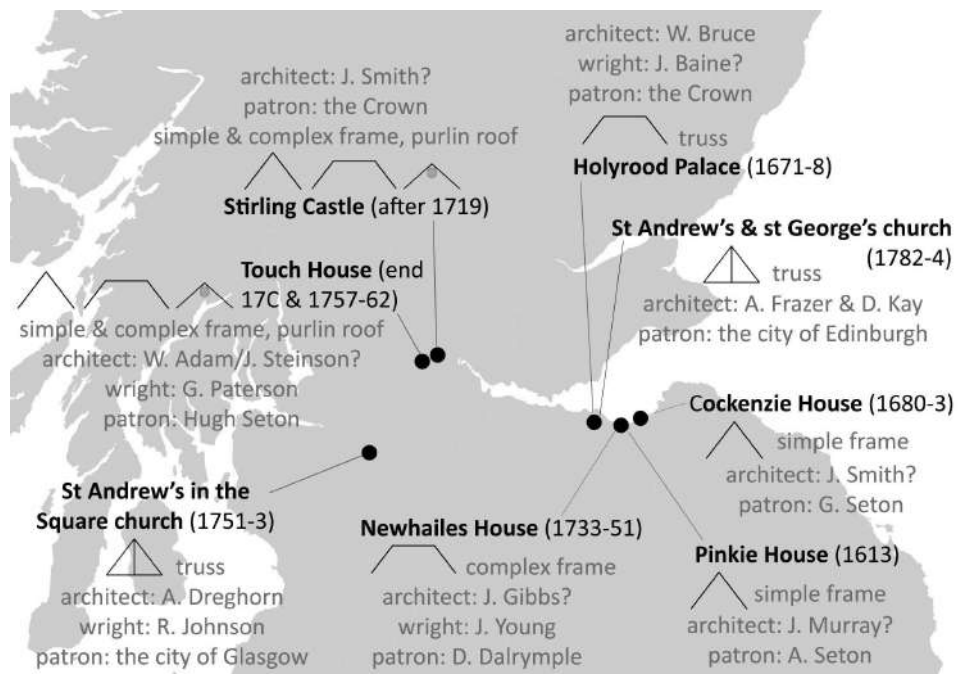
Figure 228: The location, date, structural typology, architect, wright and patron of the roofs of the 8 case studies investigated

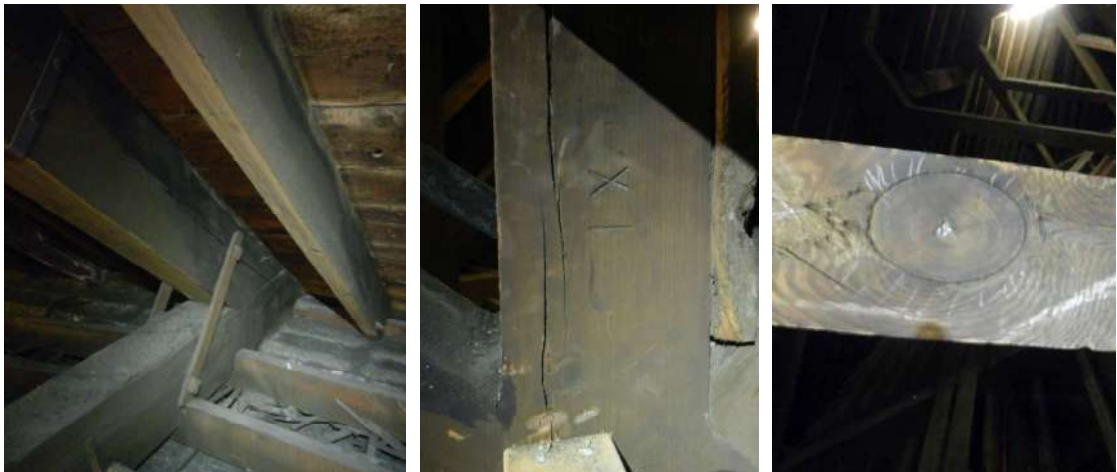
Figure 231: The roof of St Andrew and St George's church: the connection with the wall (left), carpentry marks on a post (centre) and a big knot in a strut (right)

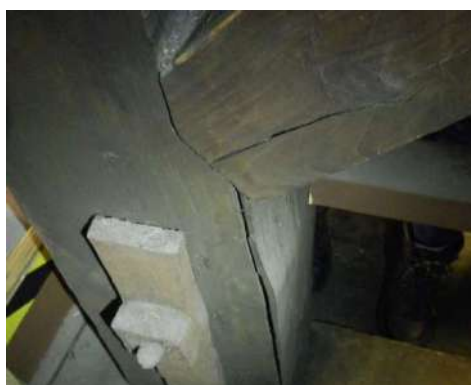
Figure 232: The roof of St Andrew and St George's church: compression cracks in a strut and in the joggle of a post

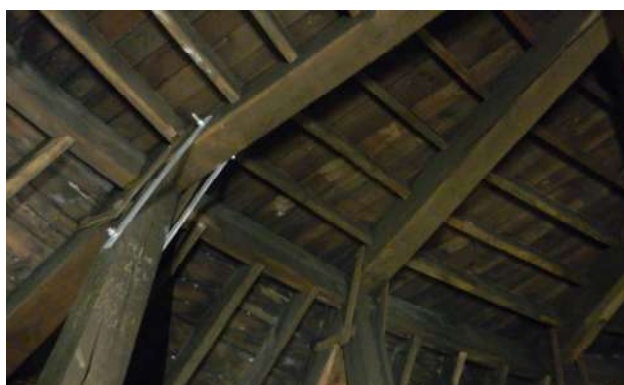
Figure 233: The roof of St Andrew and St George's church: strengthening of a joint between post and upper beam

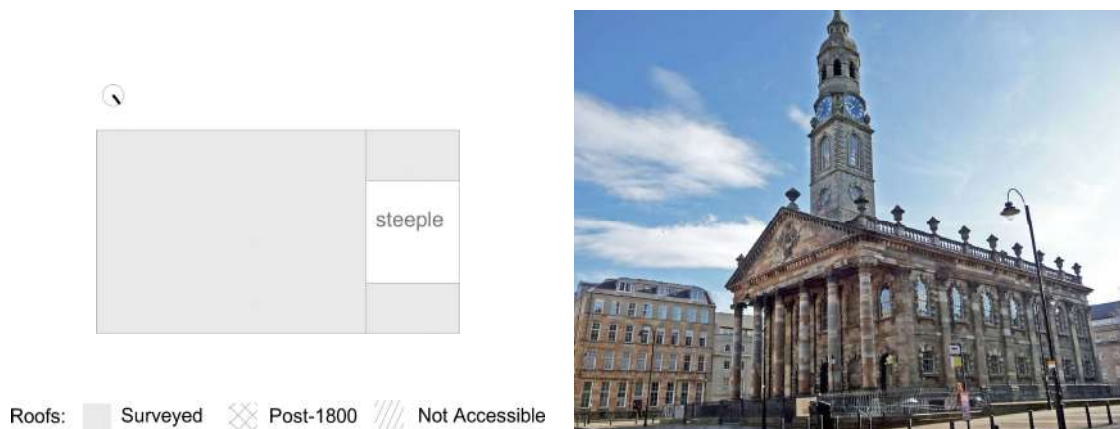
Figure 234: St Andrew's in the square church (1739-57): plan (left) and view from West (right)

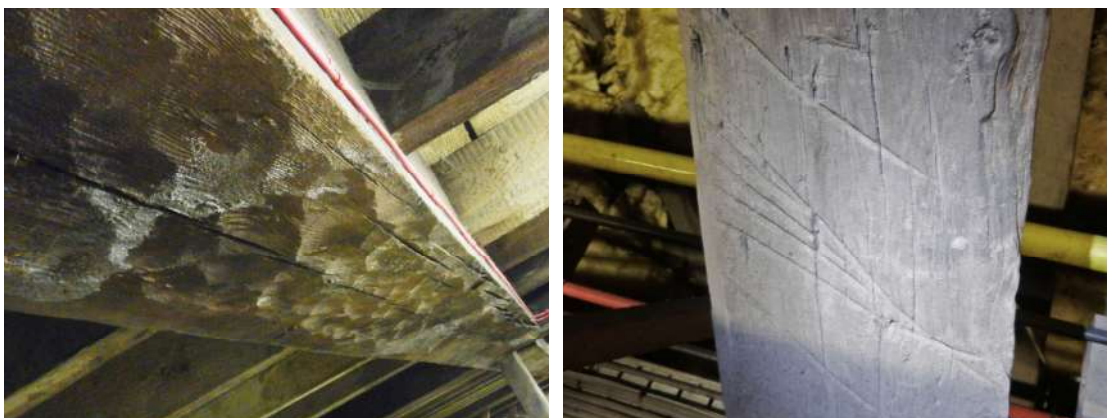
Figure 236: The roof of St Andrew's in the Square church: the dressing of a butt-purlin (left) and unusual carpentry marks on a strut (right)

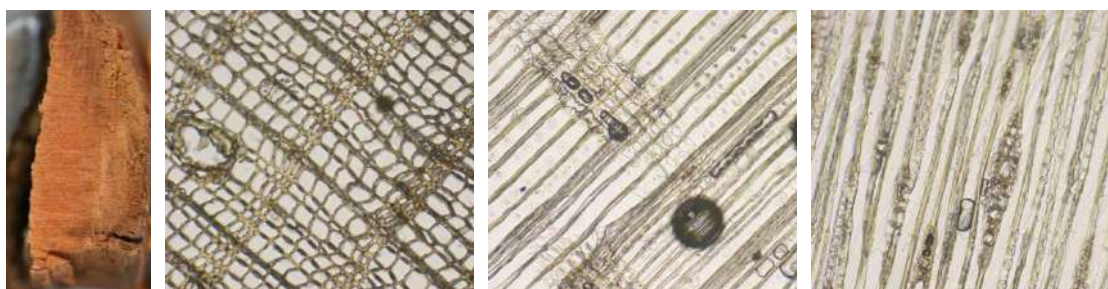
Figure 237: Sample of Scots pine extracted from a strut of the roof of St Andrew's in the Square Church: transversal section macro (left); transversal section X100 (centre left); radial section X100 (centre right); tangential section X100 (right)

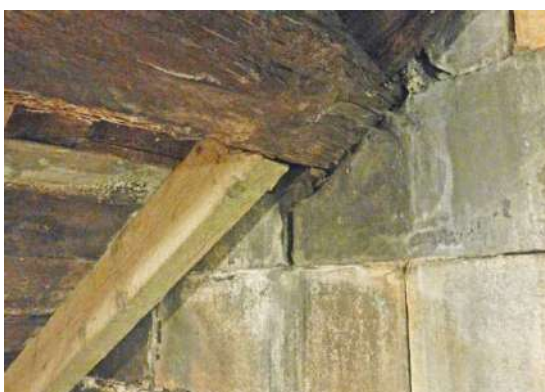
Figure 238: Fungi attack in the North-West gable of the roof of St Andrew's in the square church, affecting the butt-purlin, the common rafter and the sarking

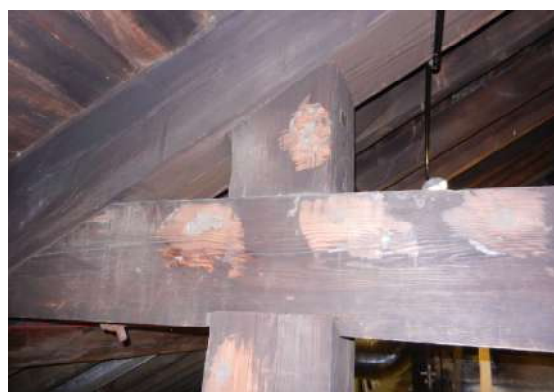
Figure 239: Resin injections used in 1980s to treat insect attack in the roof of St Andrew's in the square church

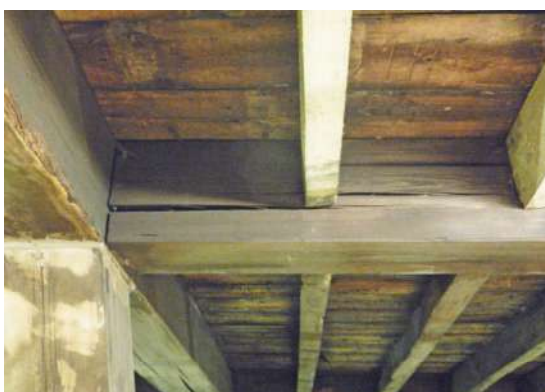
Figure 240: Cracks in a butt-purlin of the roof of St Andrew's in the square church

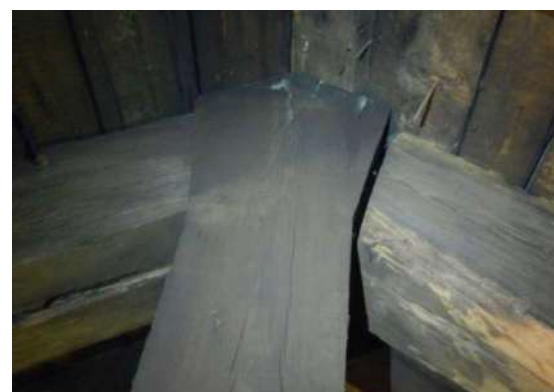
Figure 241: A rotation of the principal rafter causing the opening of the joint with the central post in the roof of St Andrew's in the square church

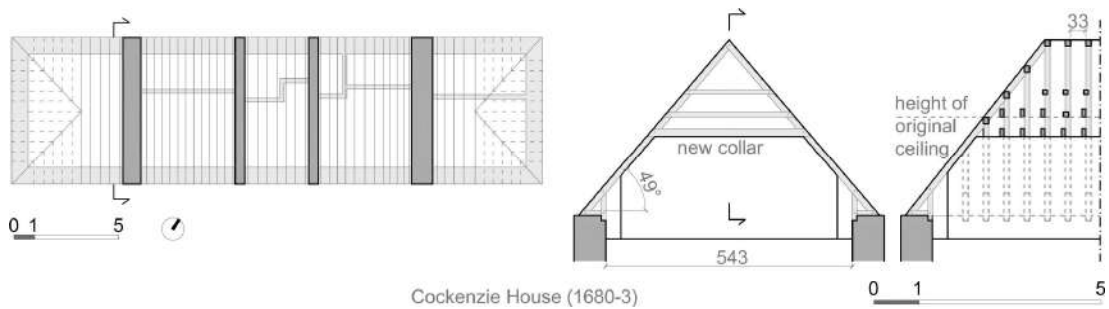
Figure 245: The roof of the central block of Cockenzie House (1680-3)

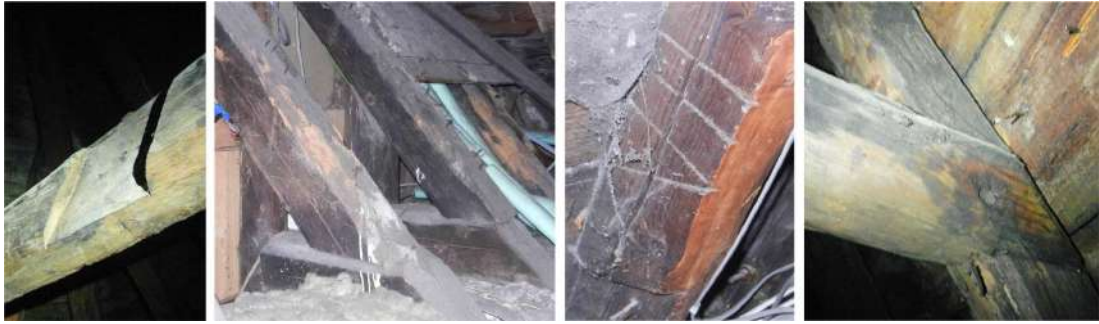
Figure 246: The roof of Cockenzie House: redundant joint on a collar (left), rafter feet (centre left), big sawn roman numerals on a rafter (centre right), lap joint between collar and rafter secured by metal nail (right)

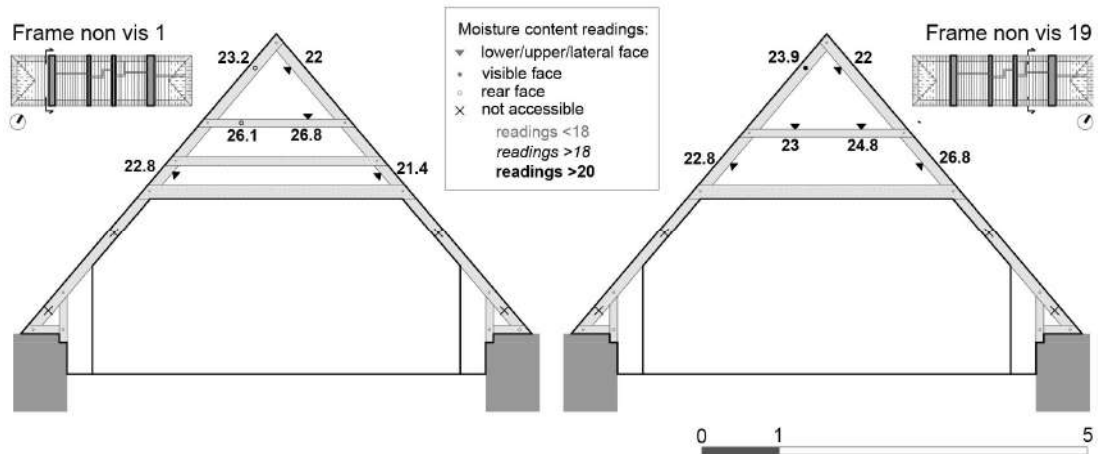
Figure 247: Moisture content readings in two frames of Cockenzie House

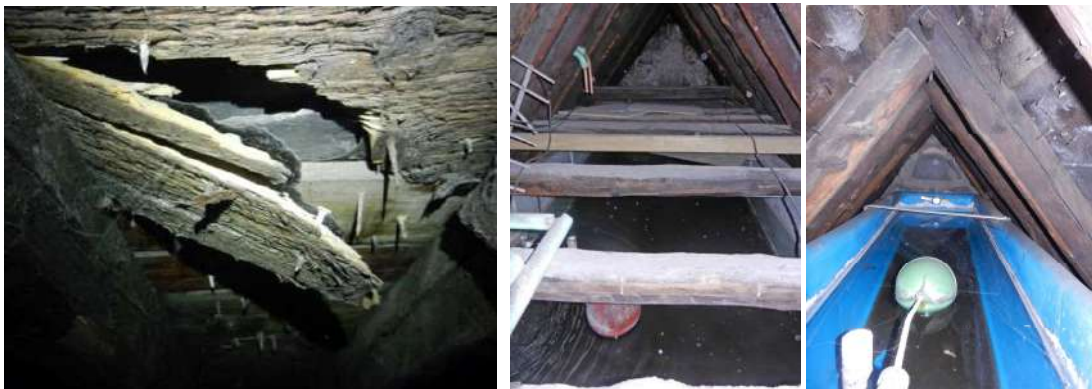
Figure 248: Broken sarking in the roof of Cockenzie House

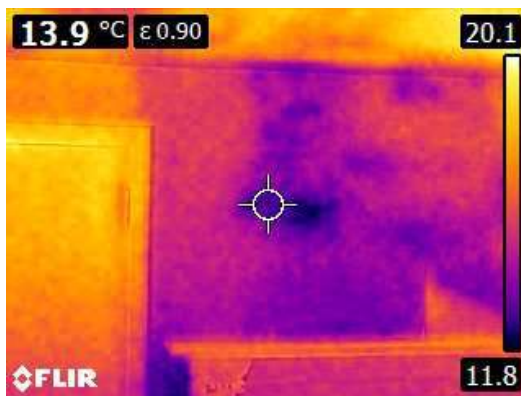
Figure 250: Thermal image showing humidity stains on the inner West gable of the attic of Cockenzie House

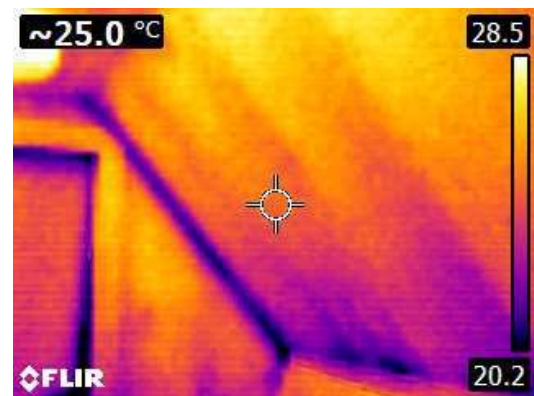
Figure 251: Thermal image showing lower temperatures in proximity of the flashings in the attic of Cockenzie House

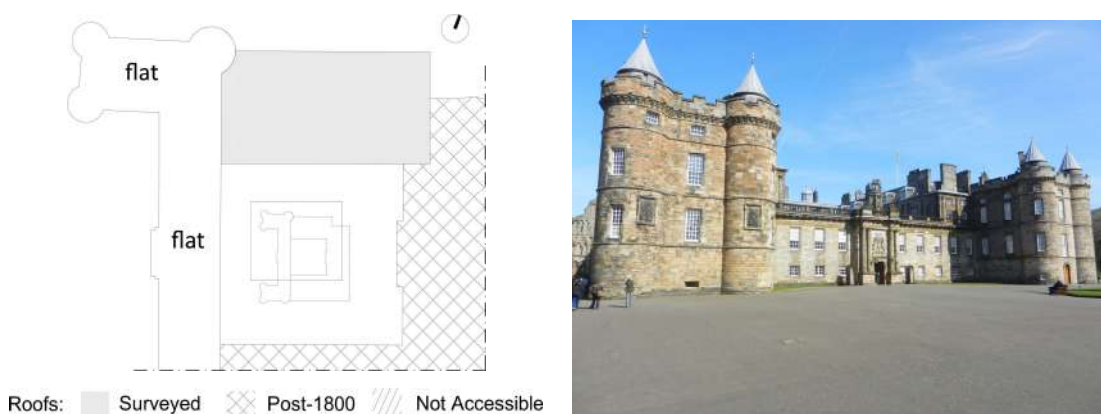
Figure 254: Holyrood Palace (mainly sixteenth century and 1671-9): plan (left) and view from West (right)

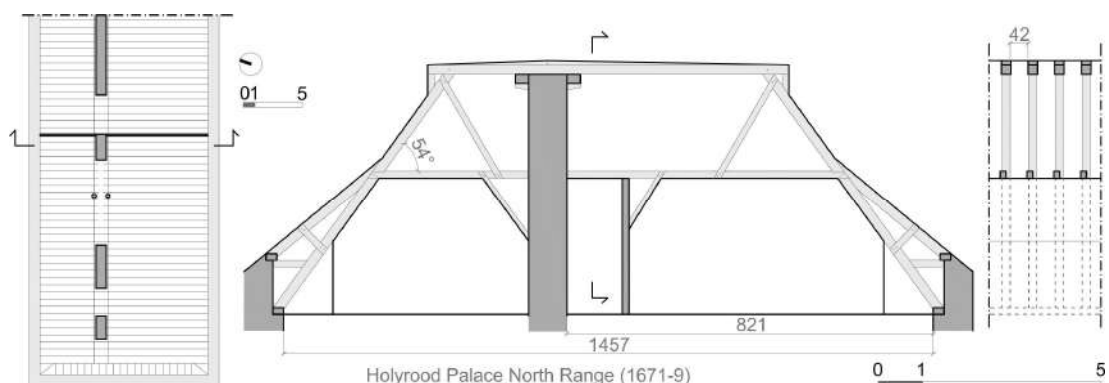
Figure 255: The roof of the North range of Holyrood Palace (1671-9)

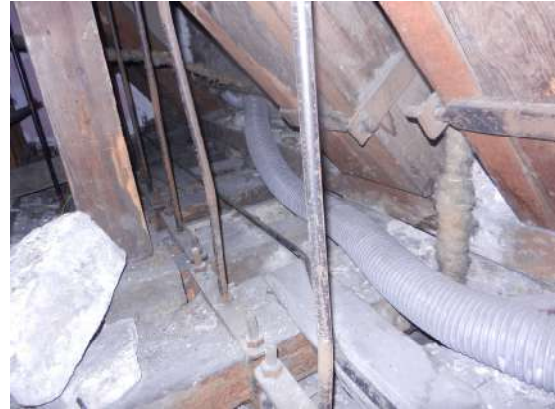
Figure 257: Strengthening of the rafter ends and floor beams on the South side of the North range of Holyrood Palace

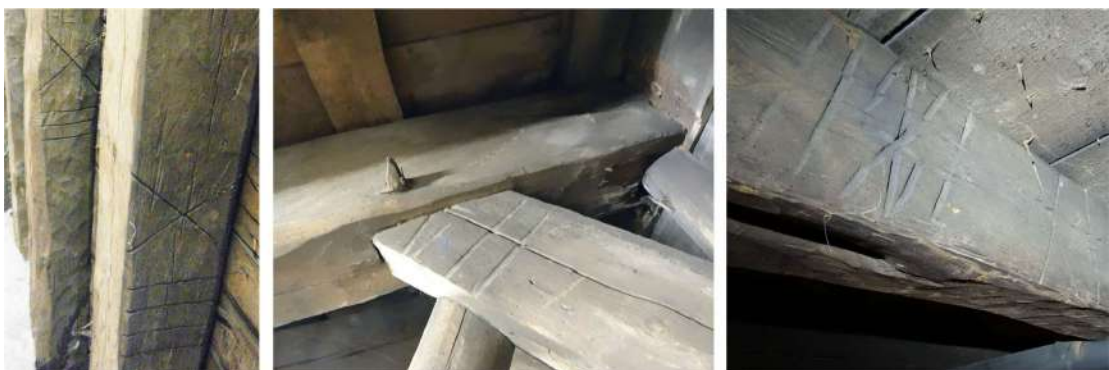
Figure 258: The roof of the North range of Holyrood Palace: the dressing and carpentry marks on two rafters (left), the joint between rafter and upper beam (centre), unusual carpentry marks on a rafter (right)

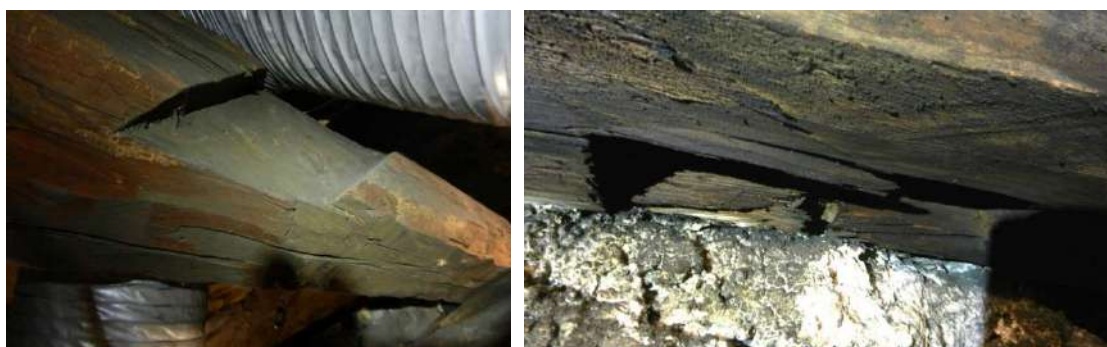
Figure 259: Redundant joints in purlin on West side of the roof of the North range of Holyrood Palace

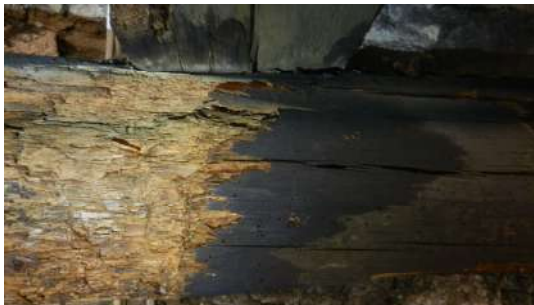
Figure 260: Old insect attack treated with insecticides on a purlin of the roof of the North range of Holyrood Palace

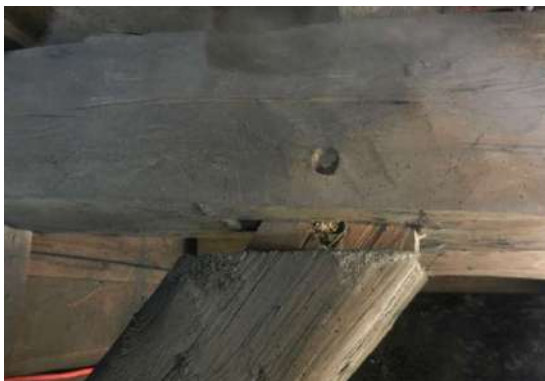
Figure 262: A degraded peg causing the disconnection and slip of a joint between rafter and upper beam of the roof of the North range of Holyrood Palace

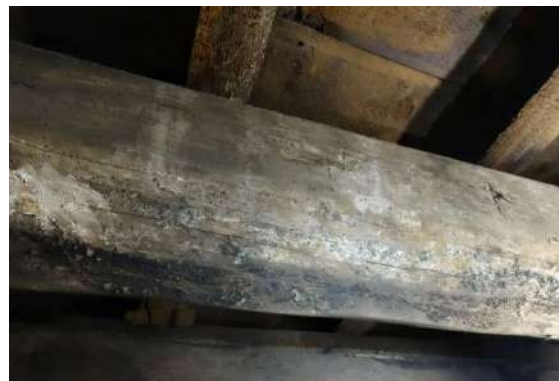
Figure 263: Fungi attack - status and type not identified - on a beam of the roof of the North range of Holyrood Palace

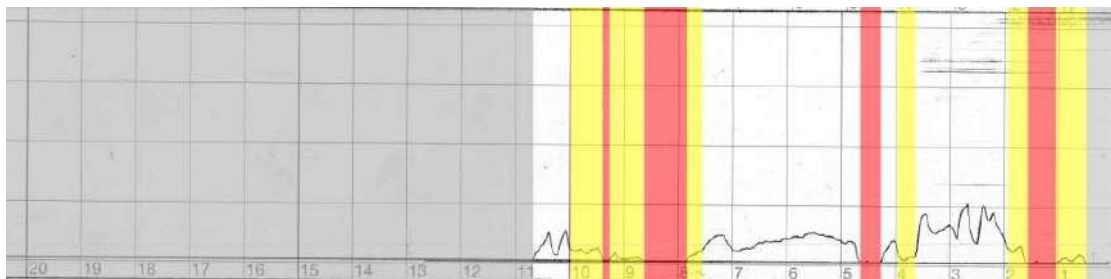
Figure 264: Micro-drill graph of point a in the North strut of frame 42 of the roof of the North range of Holyrood Palace identifying external and internal section loss

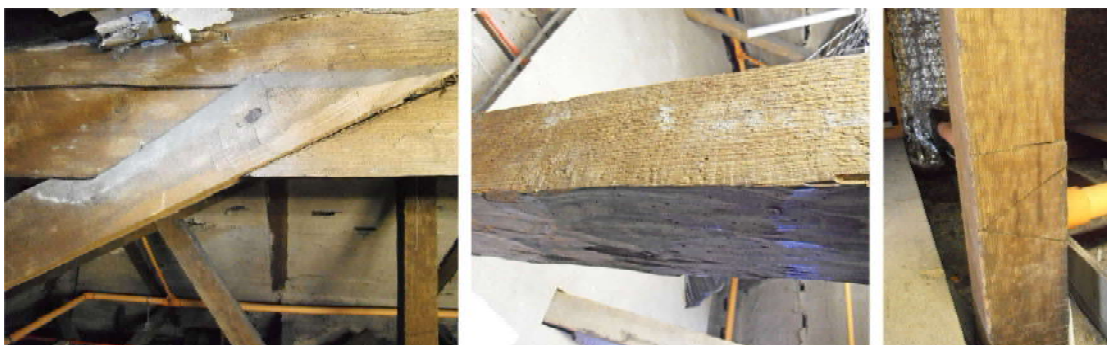
Figure 268: The roof of the North-West wing of Newhailes House: a dovetail lap joint between struts and upper beam (left), the dressing of a strut (centre), carpentry mark on a post (right)

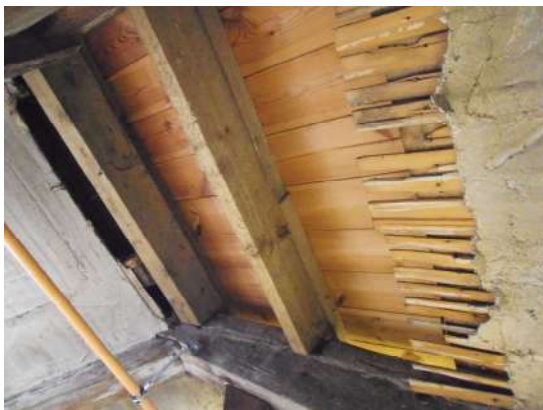
Figure 269: Recently replaced purlins and sarking boards in the roof of the North-West wing of Newhailes House

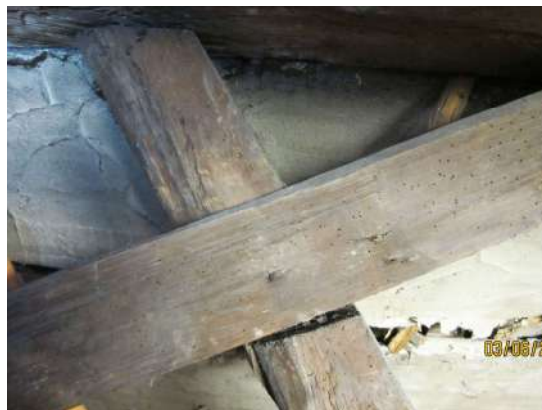
Figure 270: Cross joint between struts with an opening of 1cm in the roof of the North-West wing of Newhailes House

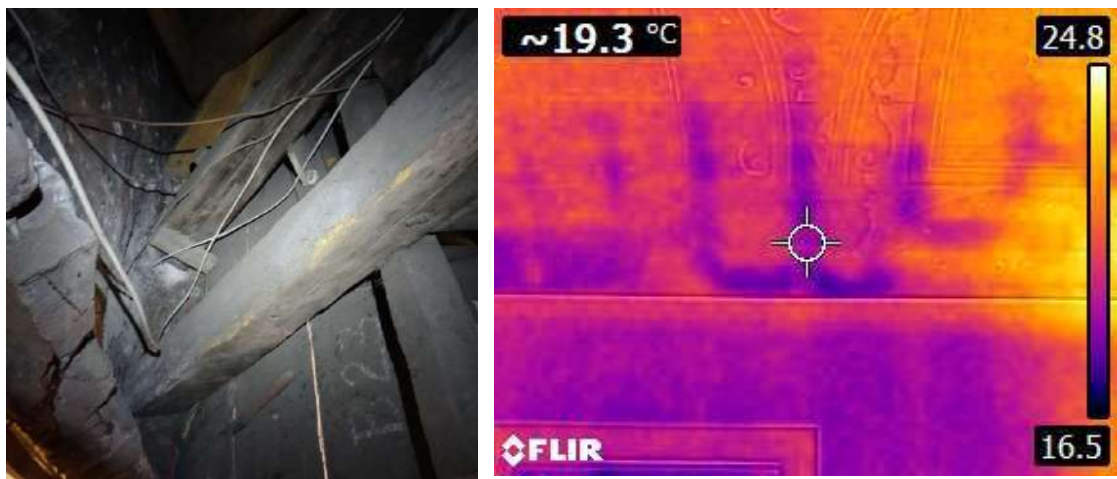
Figure 273: The roof of the long gallery at Pinkie House: the connection with the wall on the West side, with the rafters simply sitting on the wall-head (left), a thermographic image of the wall-head and ceiling on the East side, taken from the gallery below (right)

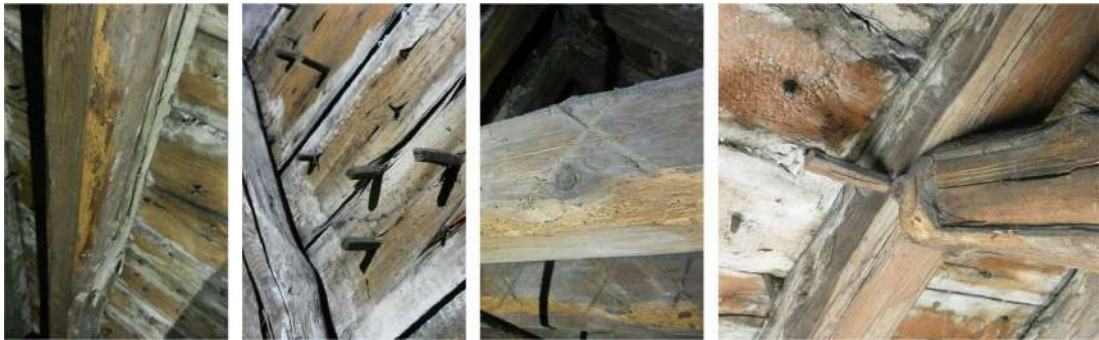
Figure 274: The roof of the long gallery at Pinkie House: the dressing of the rafters (left), the oak pegs securing the slates to the sarking (centre left), carpentry marks on collars (centre right), mortice and tenon joint between rafter and collar secured with a timber peg (right)

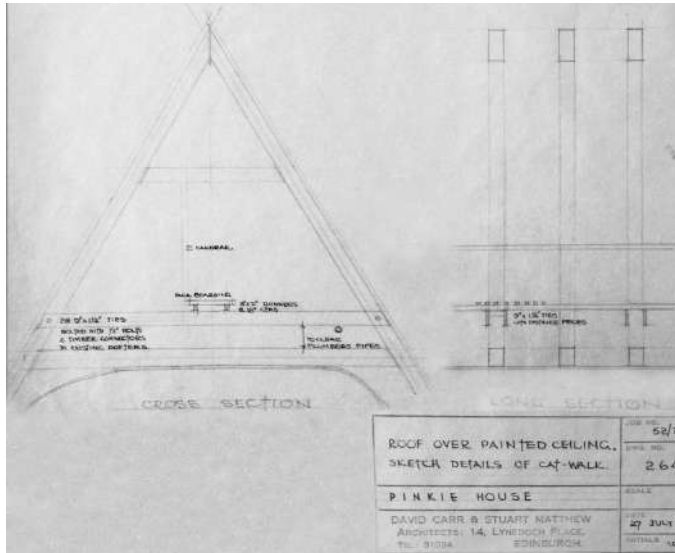
Figure 275: Drawing showing the strengthening intervention carried out in 1950s in the roof of the long gallery at Pinkie House (RCAHMS LOR/M/17/5, 1953)

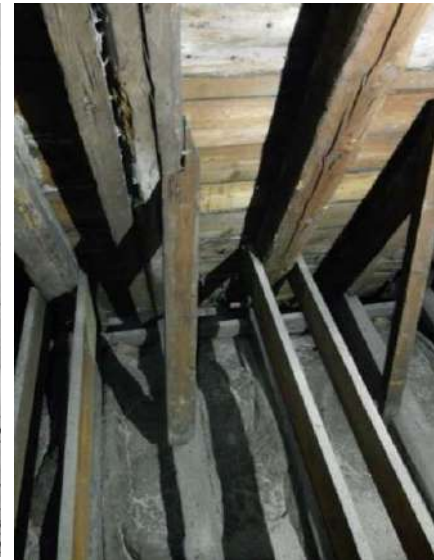
Figure 276: Struts probably added in eighteenth century and double collars added in 1950s in the roof of the long gallery at Pinkie House

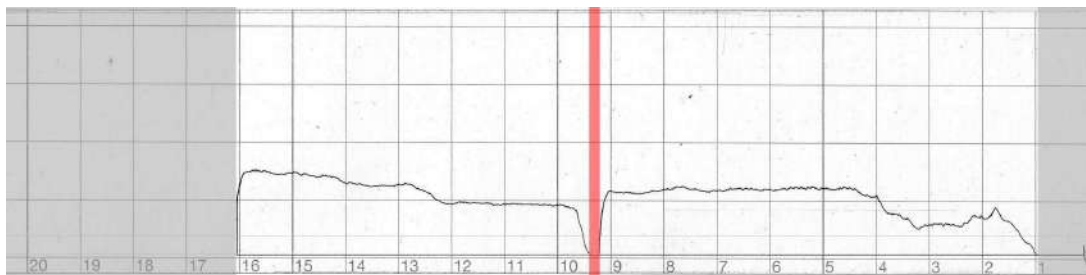
Figure 277: Micro-drill graph of measurement point 10 on frame I of the long gallery roof at Pinkie House

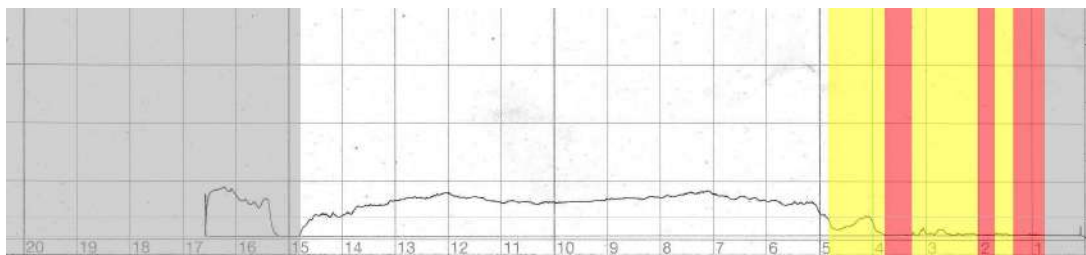
Figure 278: Micro-drill graph of measurement point 1 on frame XVII of the long gallery roof at Pinkie House

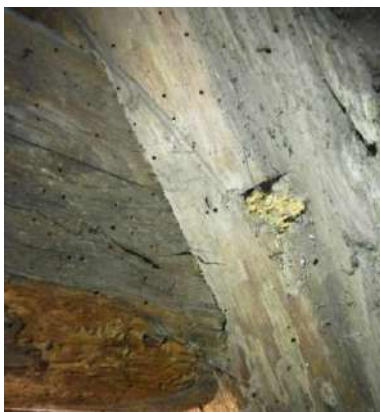
Figure 279: A degraded peg in a mortice and tenon joint between rafter and upper collar in the roof of the long gallery at Pinkie House

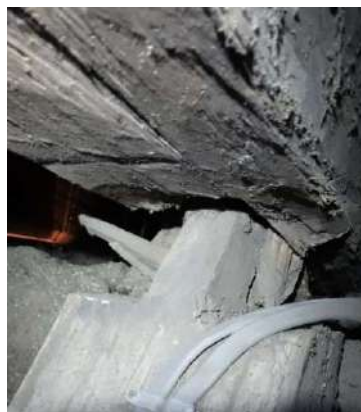
Figure 280: A failed joint between rafter and lower collar with an opening of 8cm in the roof of the long gallery at Pinkie House; the peg is broken

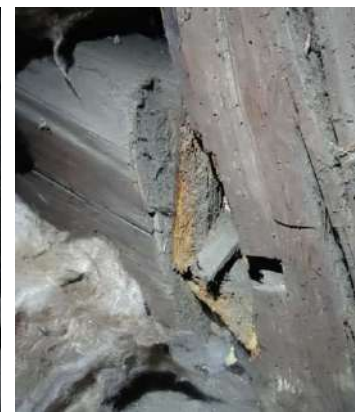
Figure 281: A failed joint between rafter and lower collar with an opening of 4cm in the roof of the long gallery at Pinkie House; the rafter is broken

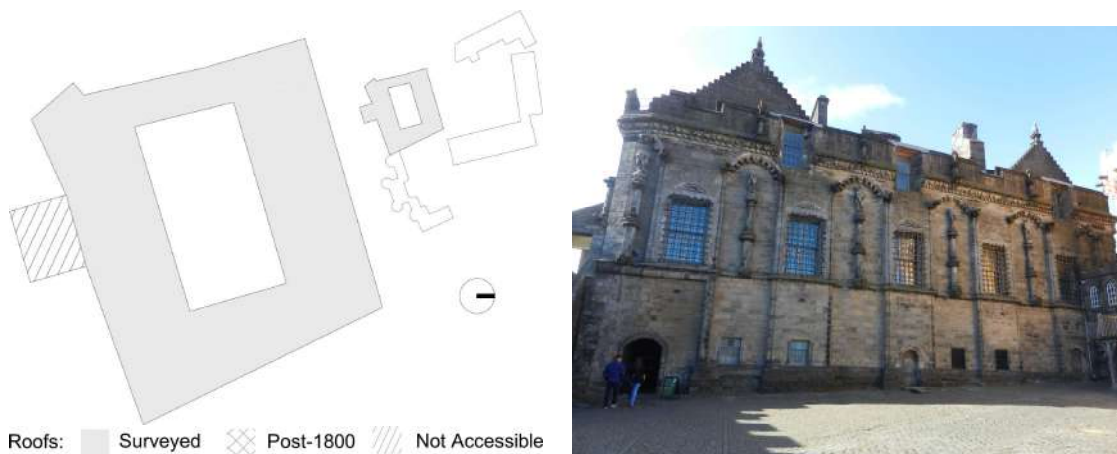
Figure 283: Stirling Castle Palace (1530-55): plan (left) and view from West (right)

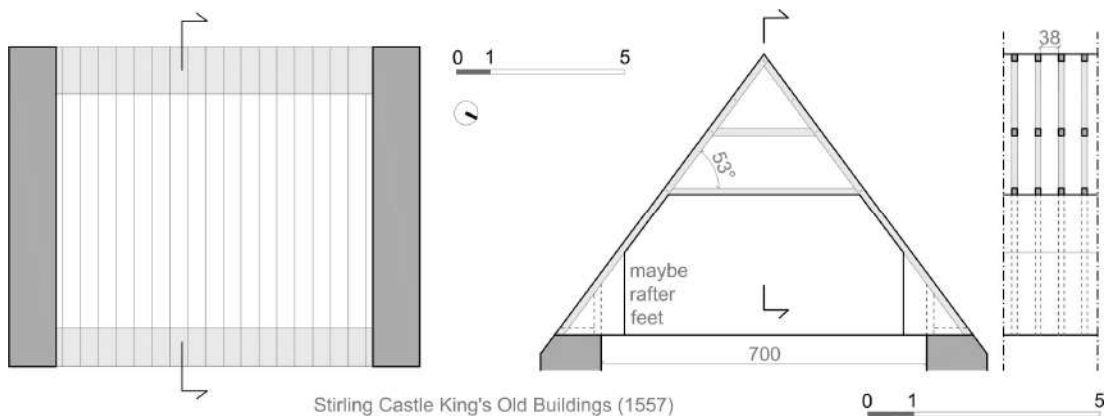
Figure 284: The roof of the King's Old Buildings (1557) at Stirling Castle

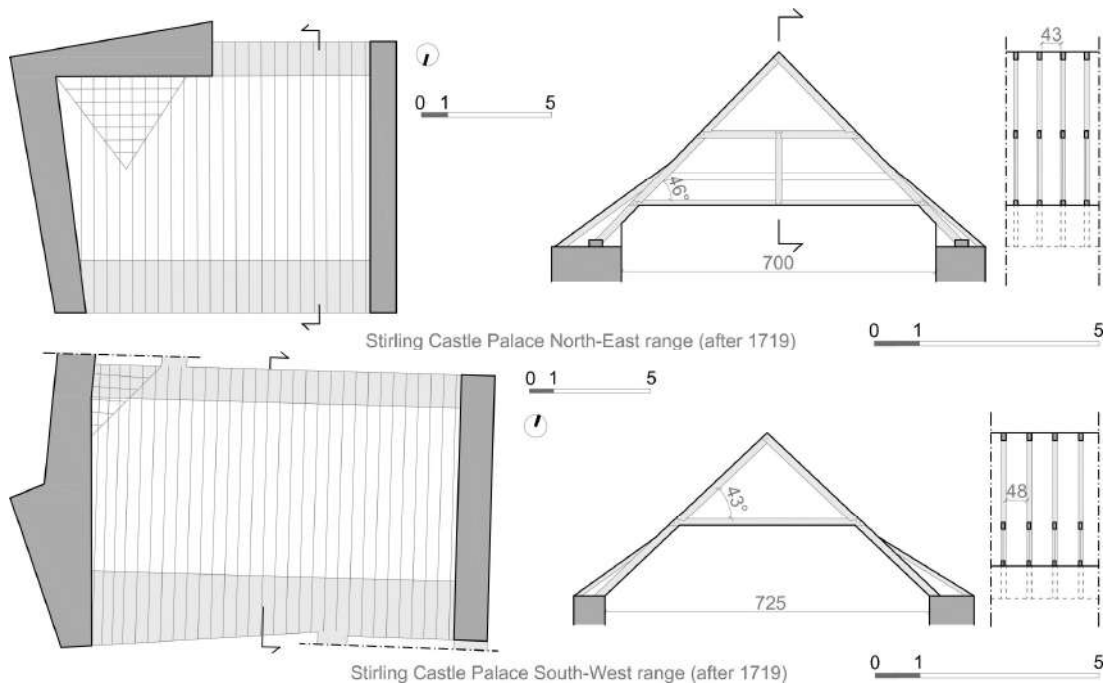
Figure 286: The roofs in the North-East (above) and South-West (below) ranges of Stirling Castle Palace (after 1719)

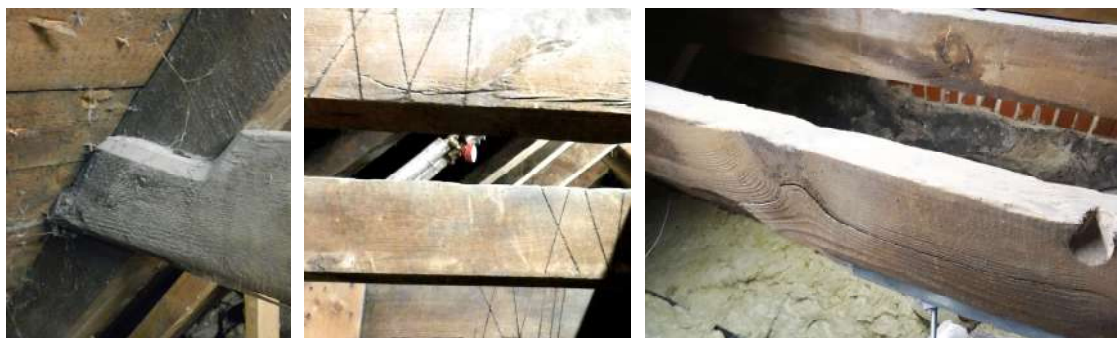
Figure 287: The roofs of Stirling Castle Palace: dovetail lapped joint securing a collar to a rafter in the South-West range (left), carpentry marks on collars in the North-West range (centre), wavy grain and knots in a collar in the North-East range (right)

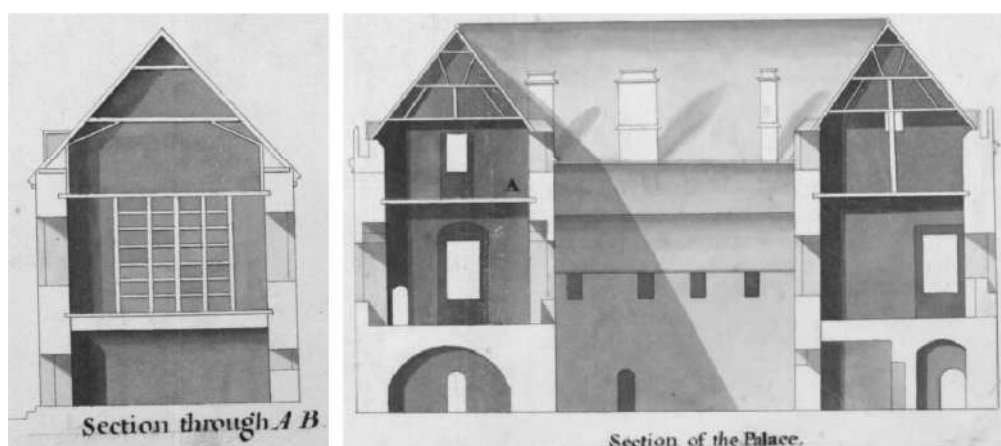
Figure 288: The roofs of Stirling Castle surveyed by Thomas Moore in 1719: the King's Old Building (NLS MS1646 Z.02/18b, 1719) and the Palace (NLS MS1646 Z.02/18b, 1719)

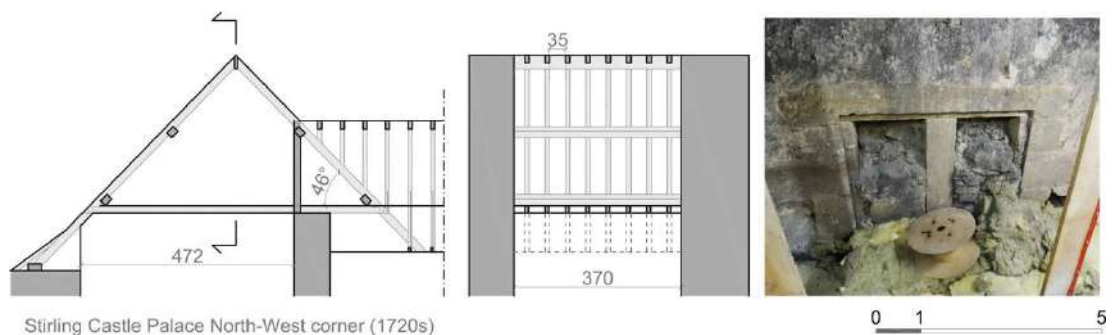
Stirling Castle Palace North-West corner (1720s)
 Figure 289: The roof of the North-West corner of Stirling Castle Palace (after 1719) with a picture of the blocked mullion window in the East gable

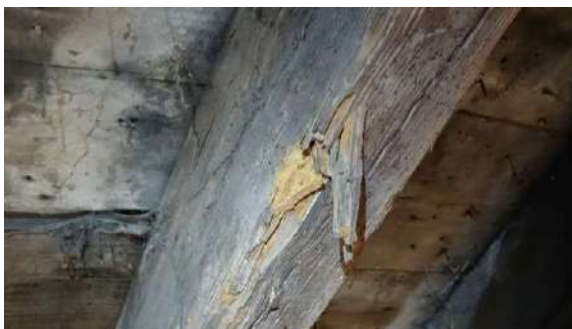
Figure 290: Insect attack on a rafter in the North-East range of Stirling Castle Palace

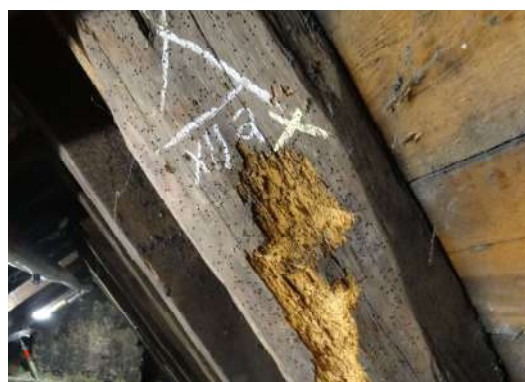
Figure 293: Old insect attack on rafter in the South-East range of Stirling Castle Palace

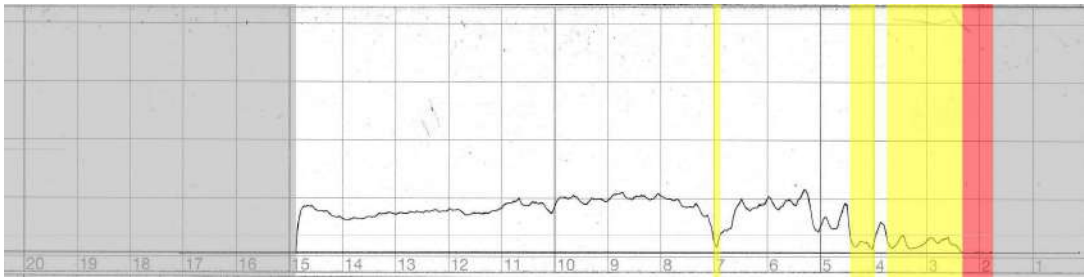
Figure 294: Micro-drill graph of point 'a' in the South rafter of frame 3 in the North-East range of Stirling Castle Palace identifying extensive external section loss and limited internal section loss

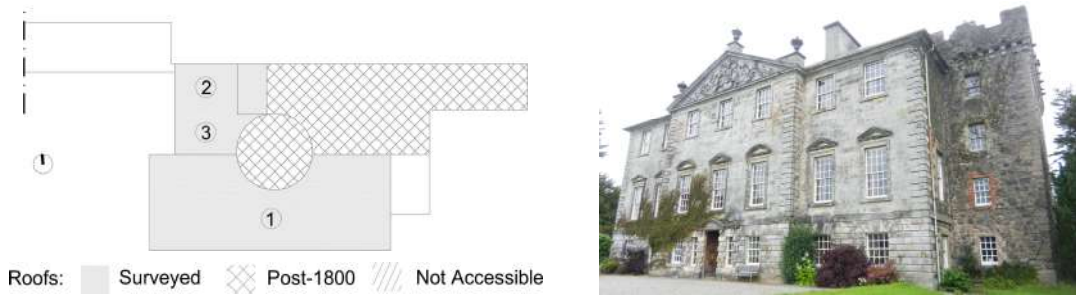
Figure 296: Touch House (sixteenth century and 1757-62): plan (left) and view from South-East (right)

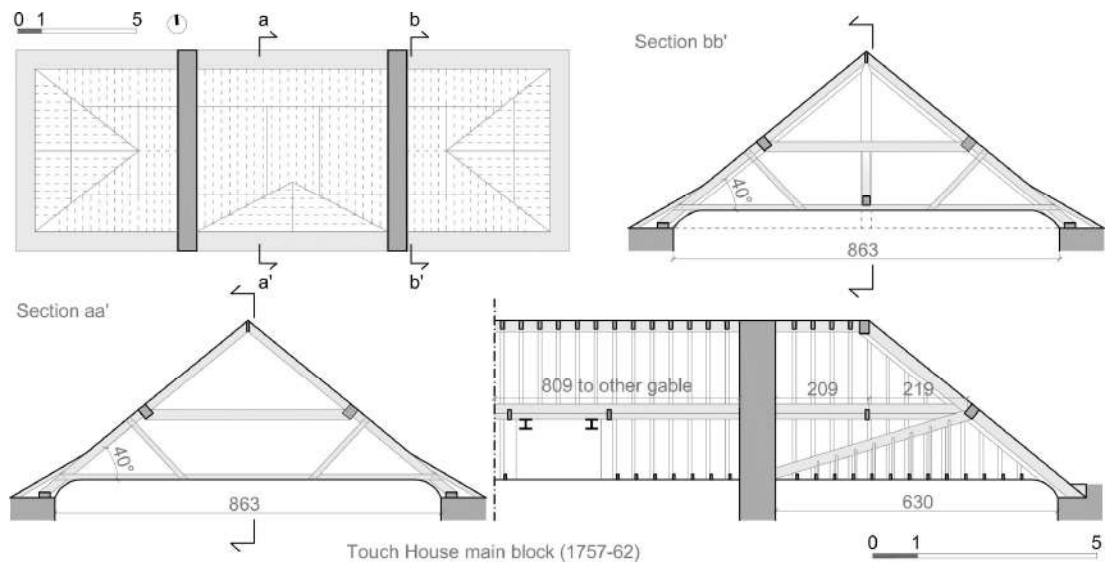
Figure 297: The roof of the central block of Touch House (1757-62)

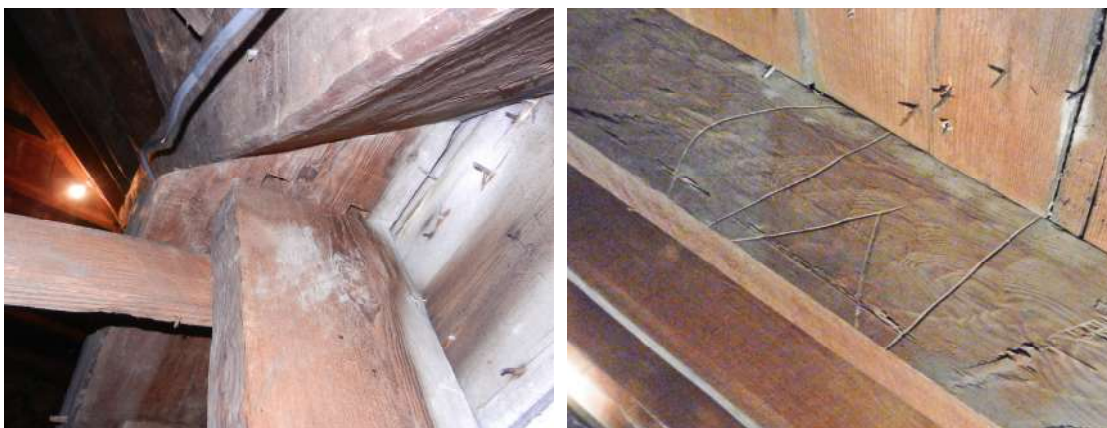
Figure 298: The roof of the central block of Touch House: double mortice and tenon joint securing a common rafter to a purlin (left) and unusual carpentry mark found on a common rafter (right)

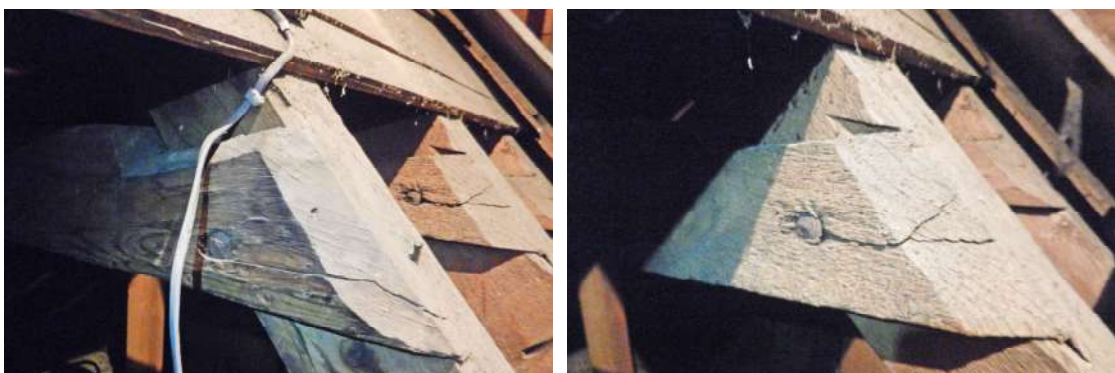
Figure 300: two collars with a different dressing in the roof of the North-West range of Touch House

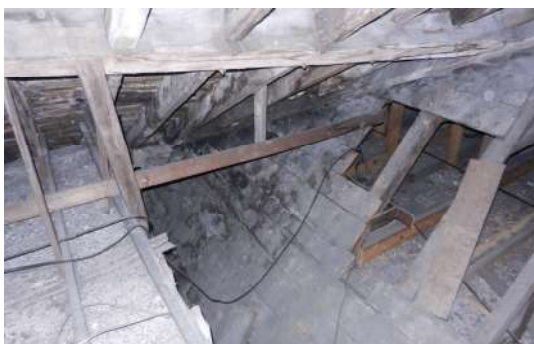
Figure 303: Remains of sarking on the North side of the roof of the North-West range of Touch House

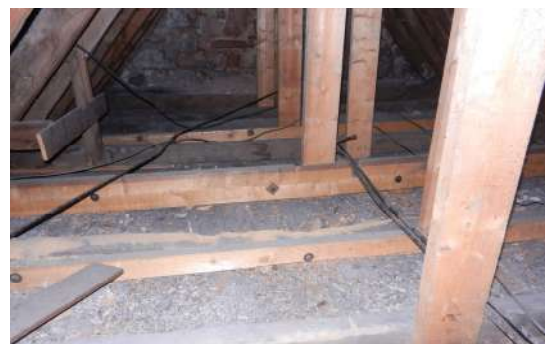
Figure 304: Additional collars and struts reinforcing the roof of the North-West range of Touch House

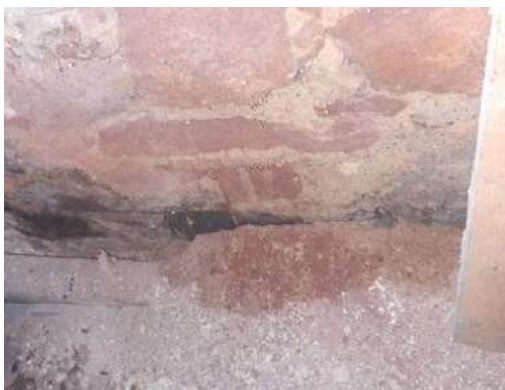
Figure 305: The dampness disintegrating the East gable in the roof of the North range of Touch House

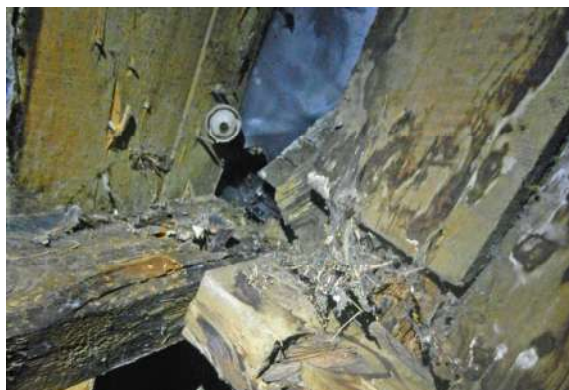
Figure 306: Broken sarking in the roof of the North-West range of Touch House

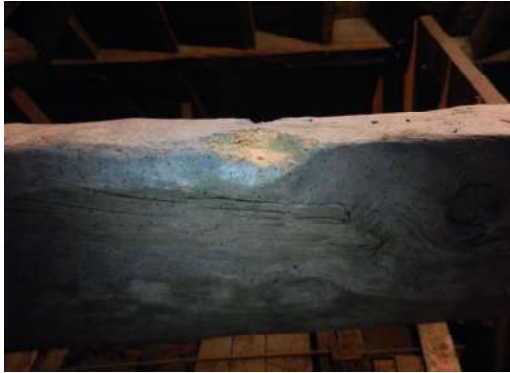
Figure 307: Insect attack on the West side strut of the roof of the central block of Touch House

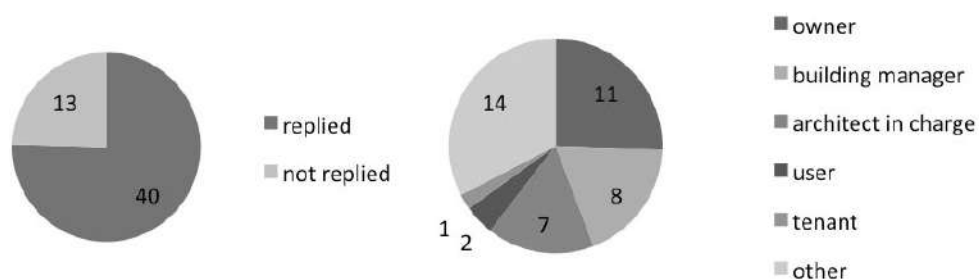
Figure 309: Respondents to the online questionnaire: number (left) and types (right)

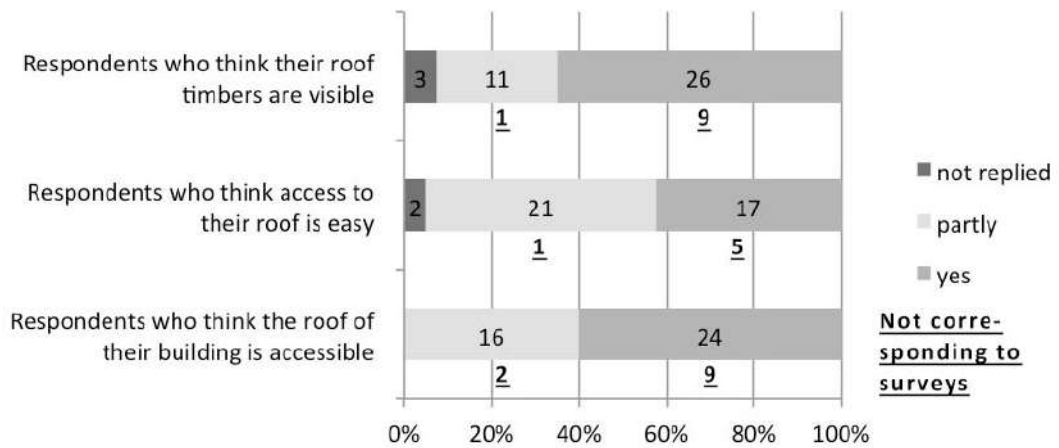
Figure 310: Accessibility and visibility of the surveyed roofs according to the respondents of the online questionnaire and compared to what we have found during our surveys

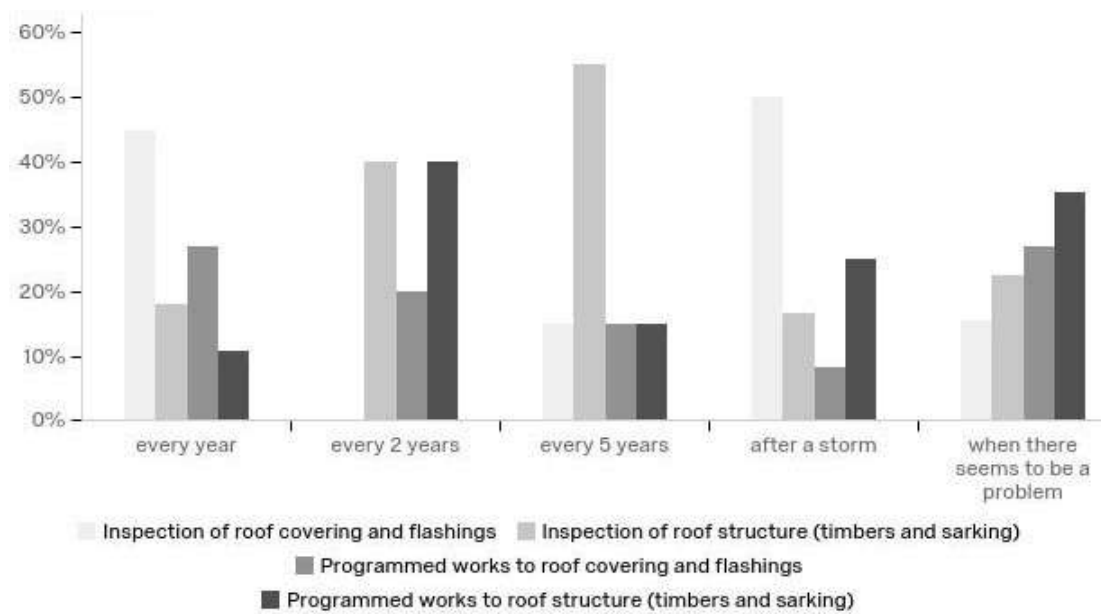
Figure 311: Frequency of inspections and programmed works to the roof structure, covering and flashings according to the respondents of the online questionnaire; 35/40 respondents replied

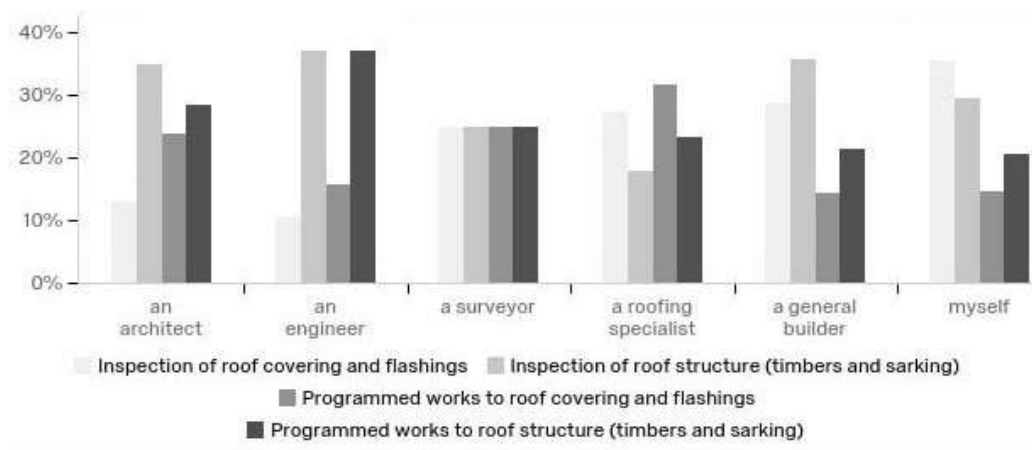
Figure 312: Professionals called to carry out inspections and programmed works to the roof structure, covering and flashings according to the respondents of the online questionnaire; 33/40 respondents replied

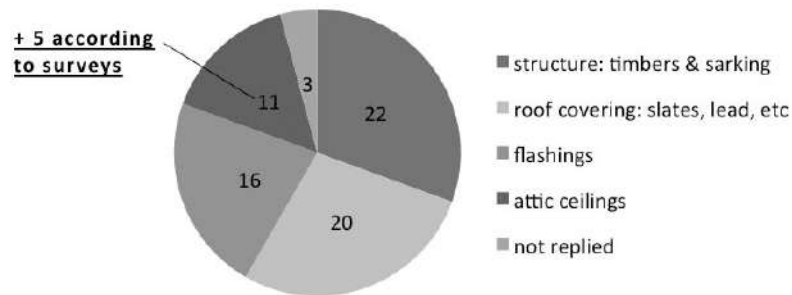
Figure 313: Current problems to the roof structure, covering, flashings and attic ceilings according to the respondents of the online questionnaire and compared to what we have found during our surveys
