**Building skills for conserving
seventeenth- and eighteenth-century
Scottish built heritage:
the initial assessment of timber roof structures**

Anna Serafini

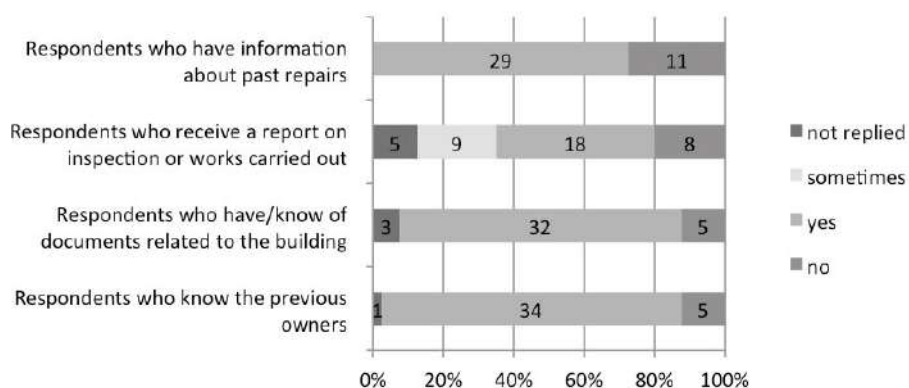
Figure 314: Building documentation according to the respondents to the online questionnaires: information on past repairs, inspection reports, historic documents, name of previous owners

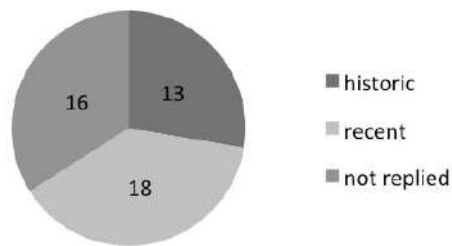
Figure 315: Types of documents related to the building that respondents to the online questionnaire know of

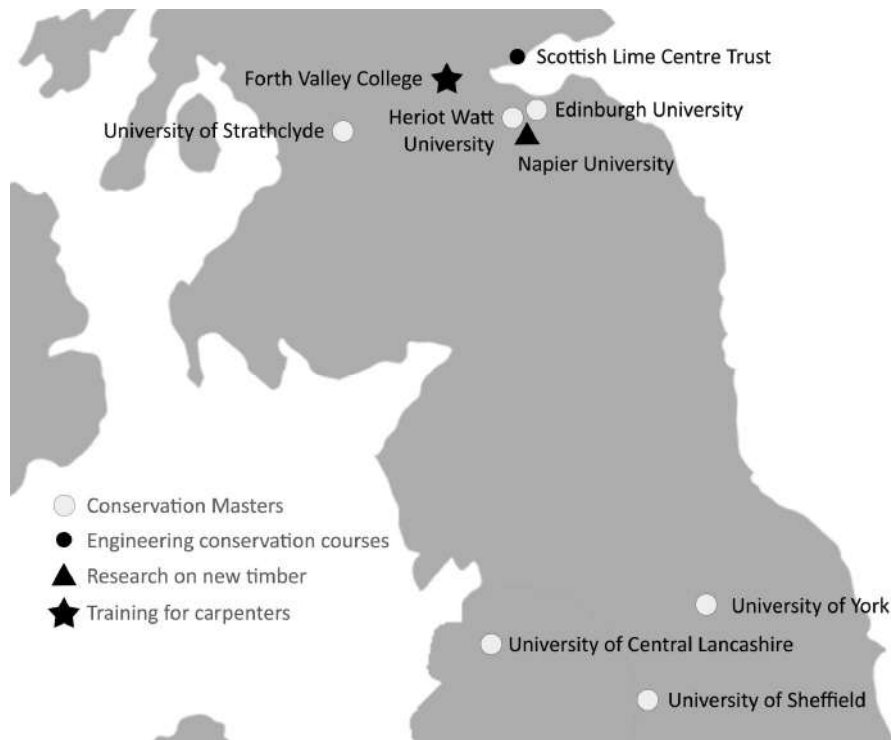
Figure 316: Available academic and training courses offered to conservation professionals dealing with historic timber structures in Scotland and North England

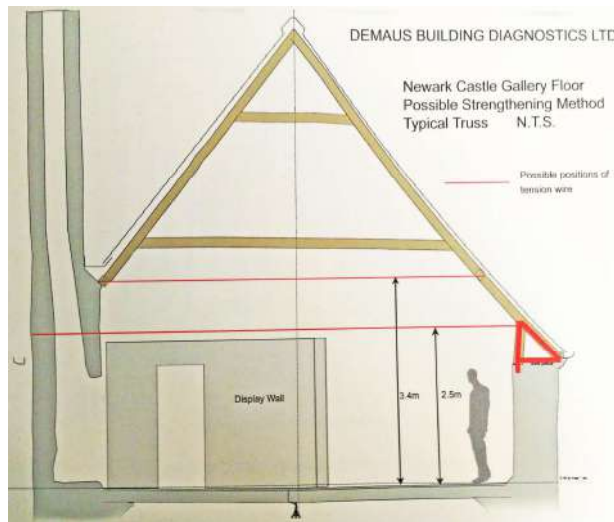
Figure 317: Proposed repairs to the roof of Newark (in red): steel brackets reinforcing the rafter feet and steel wires connecting them transversally (Demaus Building Diagnostics Ltd, 2007)

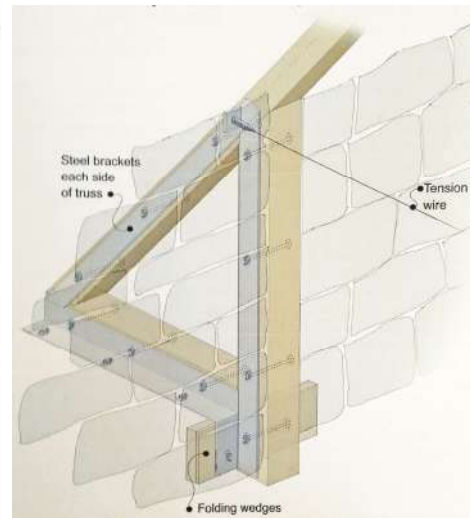
Figure 318: Detail of the steel brackets proposed as reinforcement for the rafter feet of the roof of Newark Castle (Demaus Building Diagnostics Ltd, 2007)

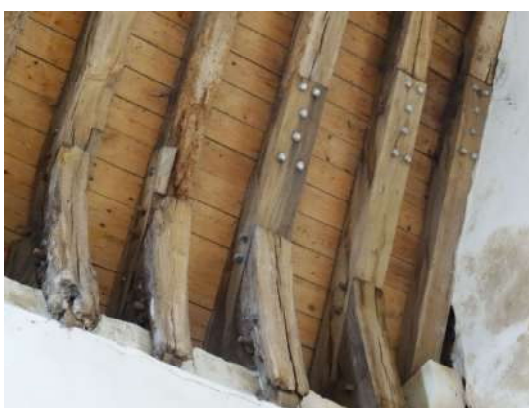
Figure 319: Repairs carried out in the roof of Alloa tower: some rafter ends, sole pieces and ashlar posts partly replaced with new timber and connected to the original timber with scarf joints and steel bolts

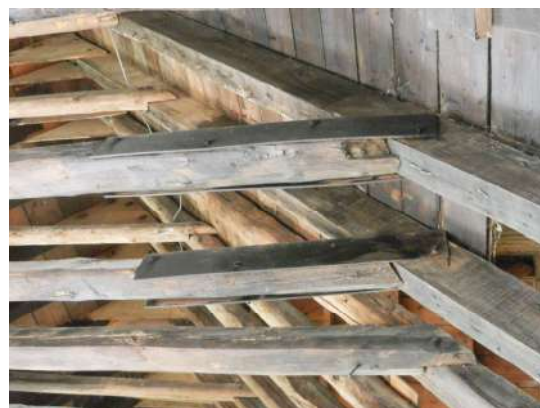
Figure 320: Repairs carried out in the roof of Methven Castle: many original rafters substituted with reused nineteenth century timbers, but many original collars retained and steel plates used to reinforce the lap joints between them

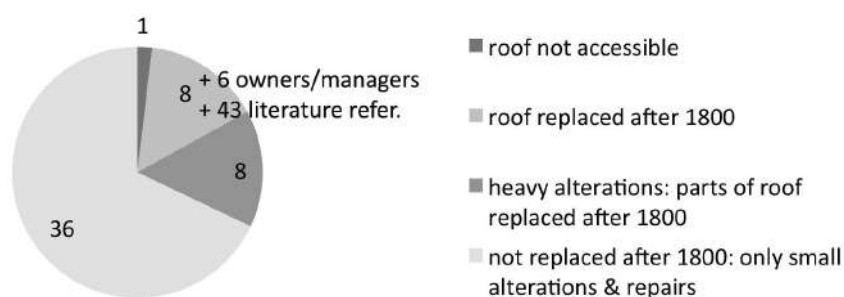
Figure 321: Replacements and alterations to surveyed roofs

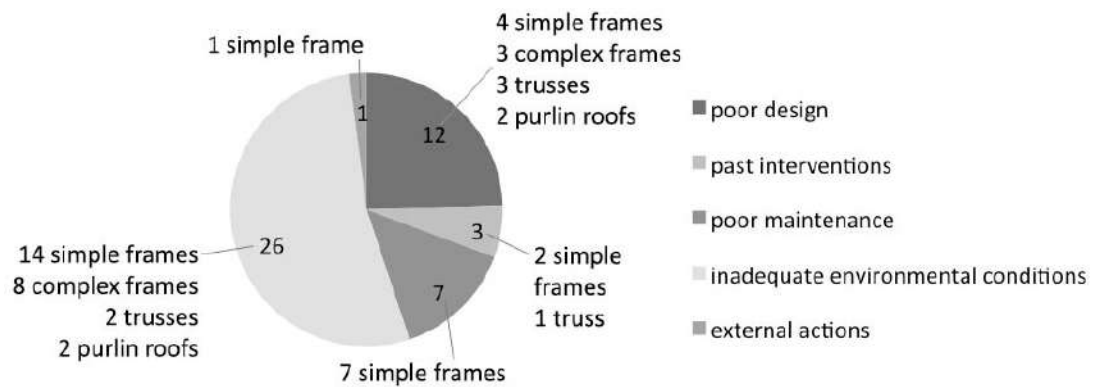
Figure 322: Estimated causes of the pathologies identified in the surveyed roofs

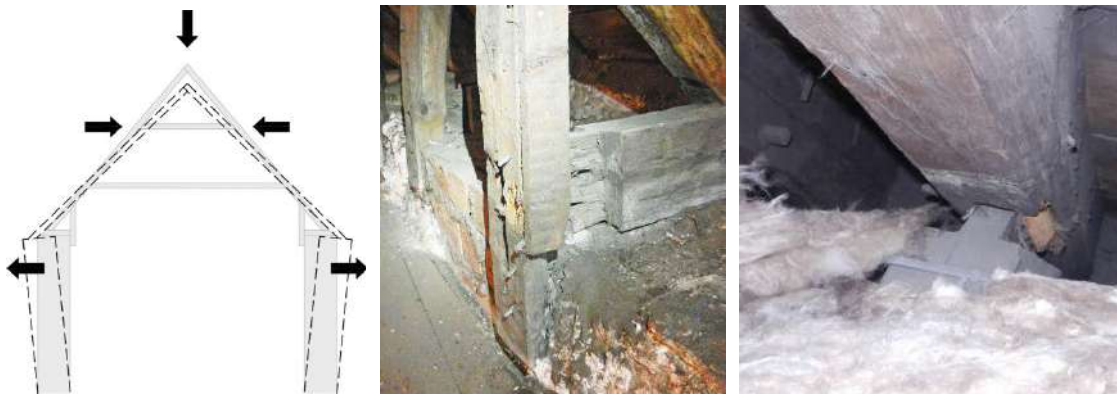
Figure 323: Mechanical damage in common rafter roofs: schematic of the transversal opening of roofs (left), joint disconnection in a rafter foot of Sailor's Walk (1670s) (centre), an open joint between lower collar and rafter in the roof of the long gallery at Pinkie House (1613) (right)

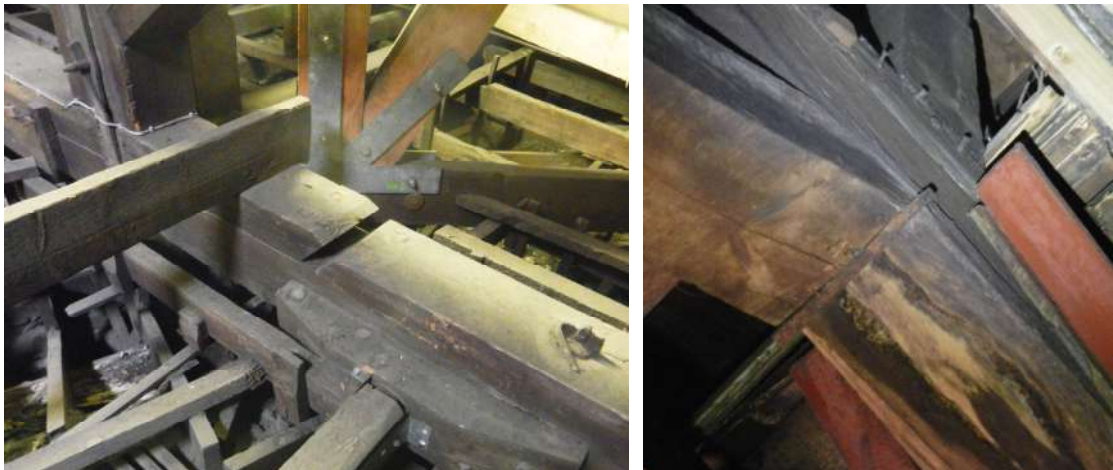
Figure 324: The transversal opening of eighteenth century roofs without a tie-beam: open scarf joint in a tie-beam of the roof of Oakshaw Trinity church (1754-6) (left), wooden peg inserted in an open joint between a slanted strut and a horizontal beam in the roof of Glasgow Trades Hall (1791-4) (right)

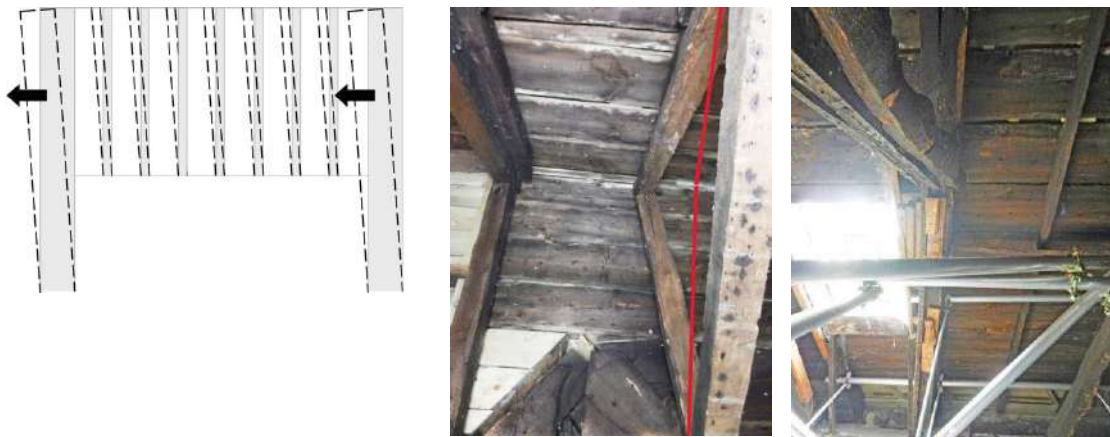
Figure 325: Mechanical damage in common rafter roofs: schematic of the stacking up of frames (left) and pictures of the roof of Geilston House (1666) (centre and right); the black line in the central picture represents the position that the frame should have if there was no out of plumb

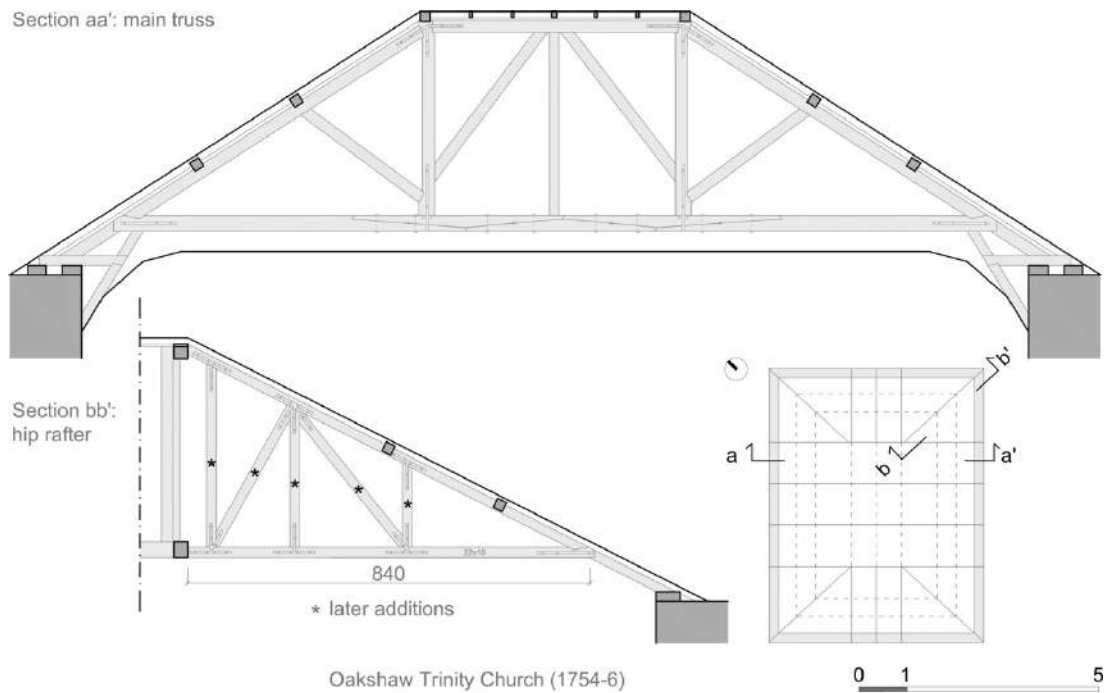
Figure 326: The roof of Oakshaw Trinity Church (1754-6)

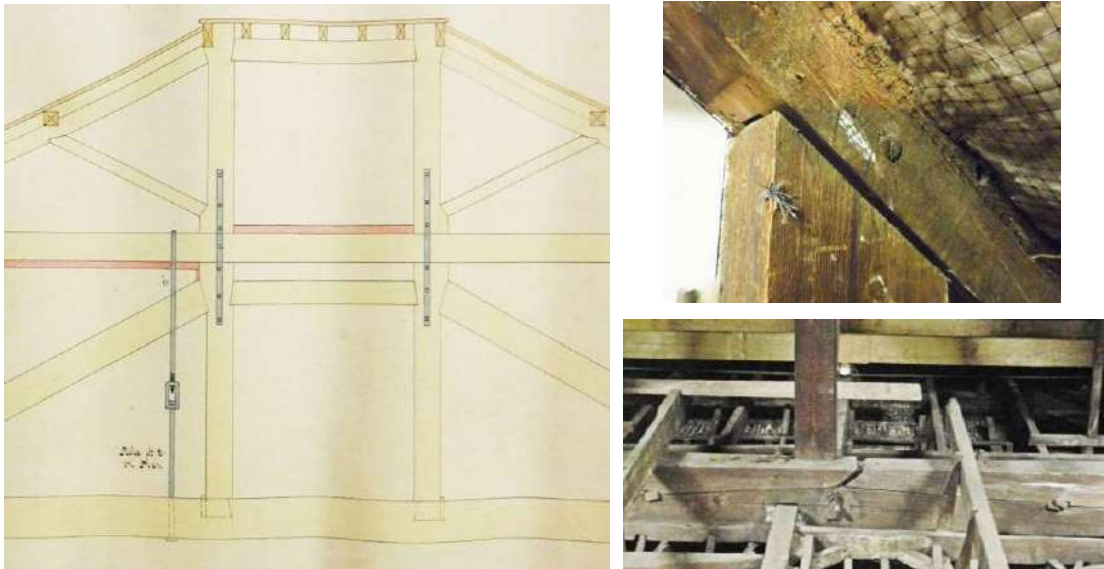
Figure 328: Mechanical damage in trussed roofs: drawing showing in red and blue the timber and steel added to the roof of the Trades Hall in Glasgow (TDH 1/899, 1856) (left), joint disconnection in the roof of Fort George Ordnance Store (1759-61) (top right) and in the roof of Oakshaw Trinity Church (1754-6) (bottom right)

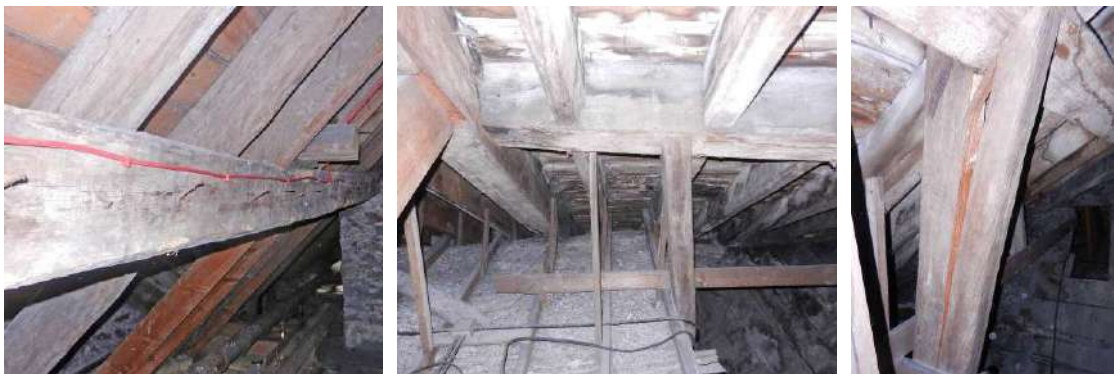
Figure 329: Mechanical damage in purlin roofs and complex frames: deflected purlin in Melville House (1697-1701) (left), deflected purlin in Touch House (1757-62) (centre), crack in strut supporting the purlin in Touch House (1757-62) (right) (Serafini and Gonzalez Longo, 2016)

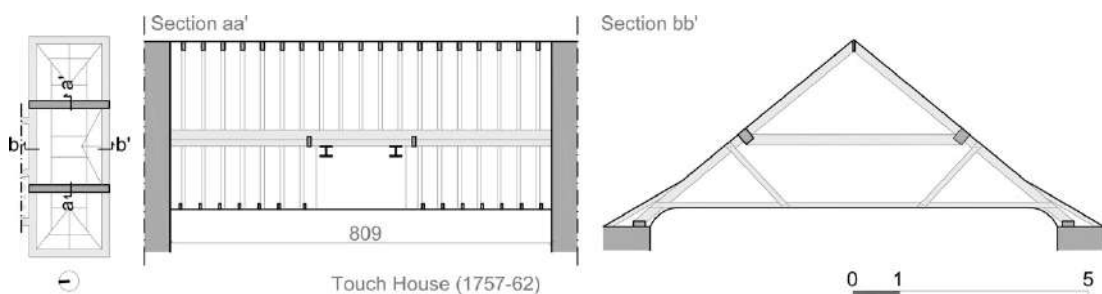
Figure 330: The central part of the roof of the main block of Touch House (1757-62)

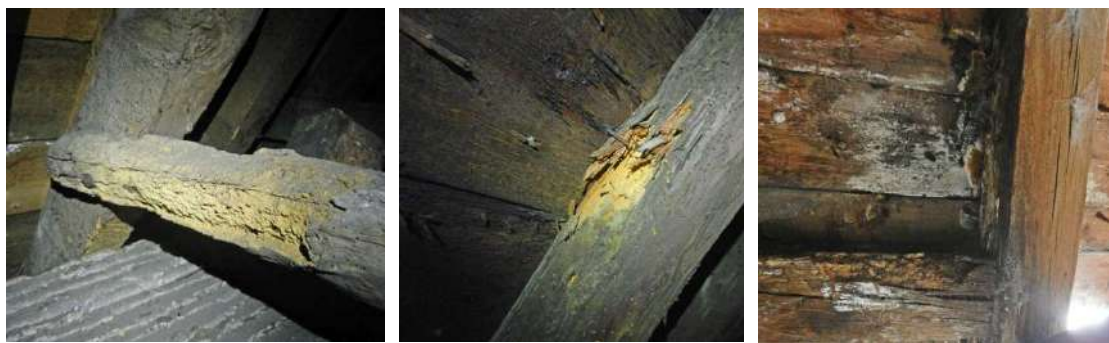
Figure 331: Material degradation in common rafter roofs: old insect attack in Mallyen House (1635) (left), active insect attack in Cockenzie House (1680s) (centre), fungi attack in Kelburn Castle (1581) (right)

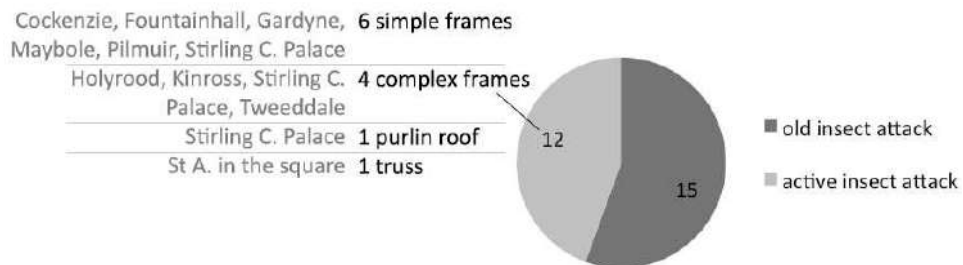
Figure 332: Estimated status of the insect attack affecting the surveyed roofs

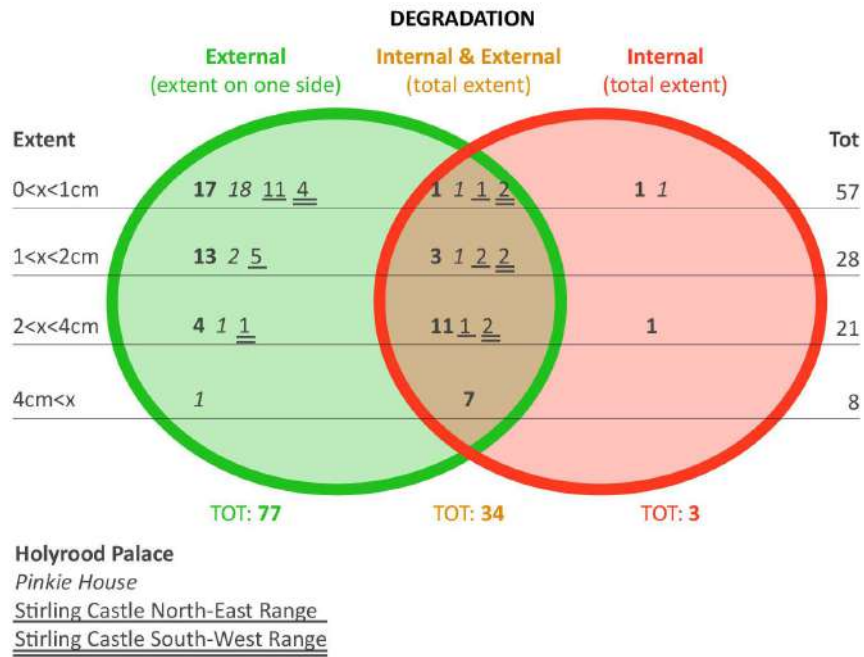
Figure 333: Number of micro-drills carried out in the roofs of Stirling Castle Palace, Holyrood Palace and Pinkie House, organized according to the position and extent of the degradation detected

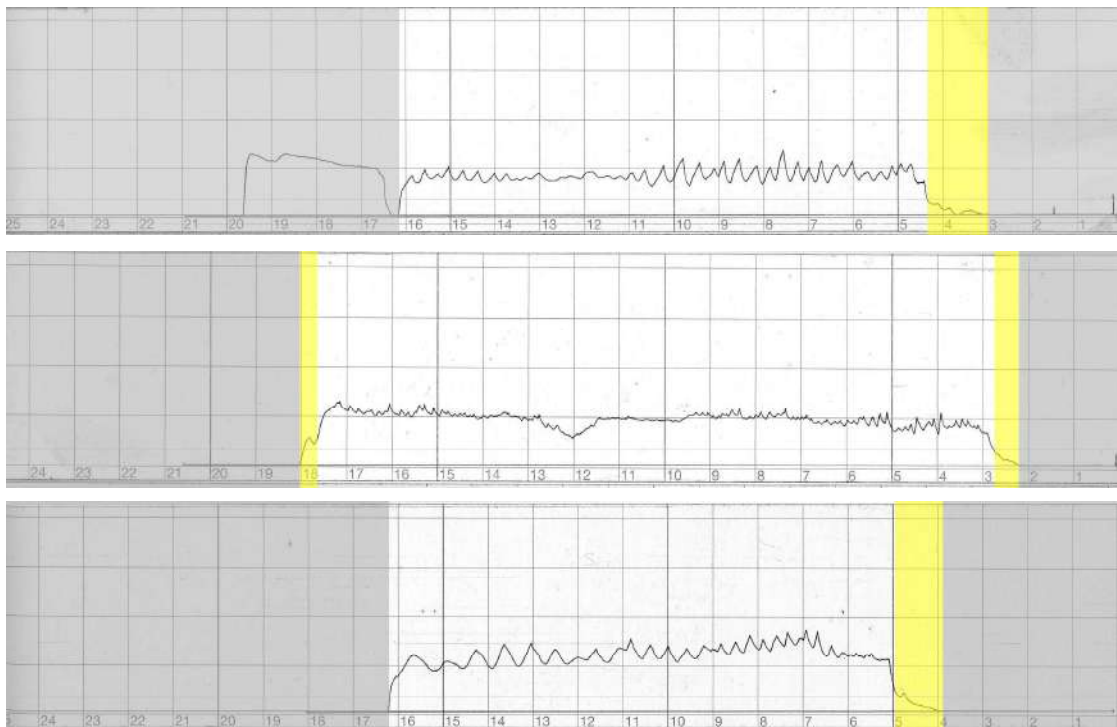
Figure 334: Examples of micro-drill graphs that show external degradation limited to the sapwood, up to 2cm deep. From the top:

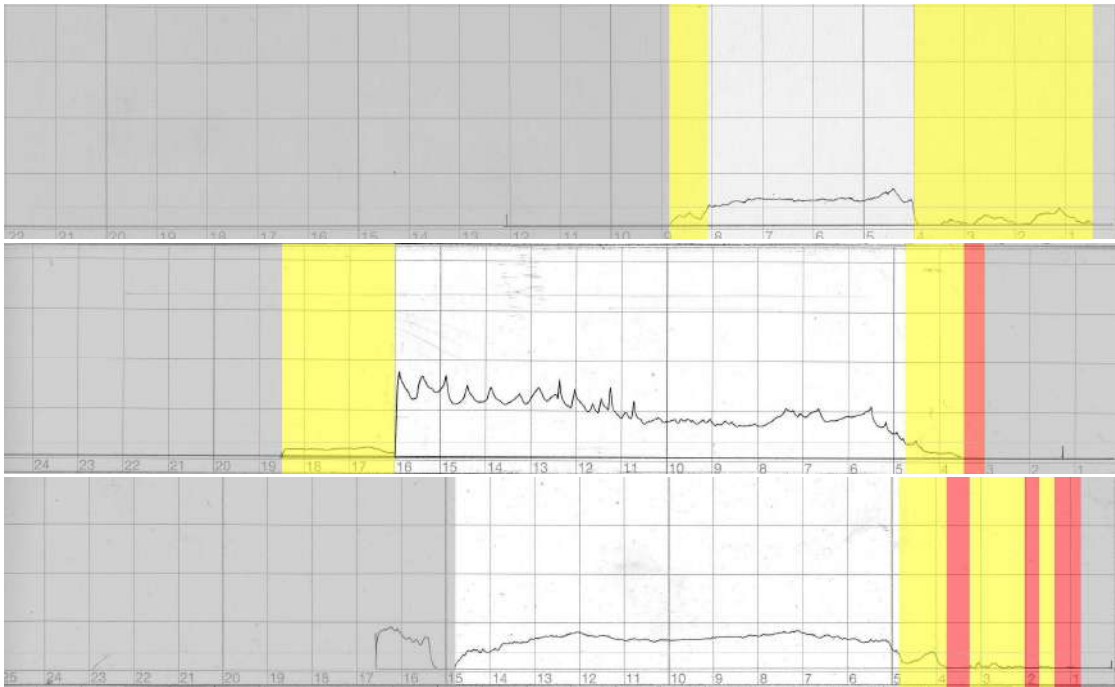
Figure 335: Examples of micro-drill graphs showing extensive external degradation (more than 2cm deep).

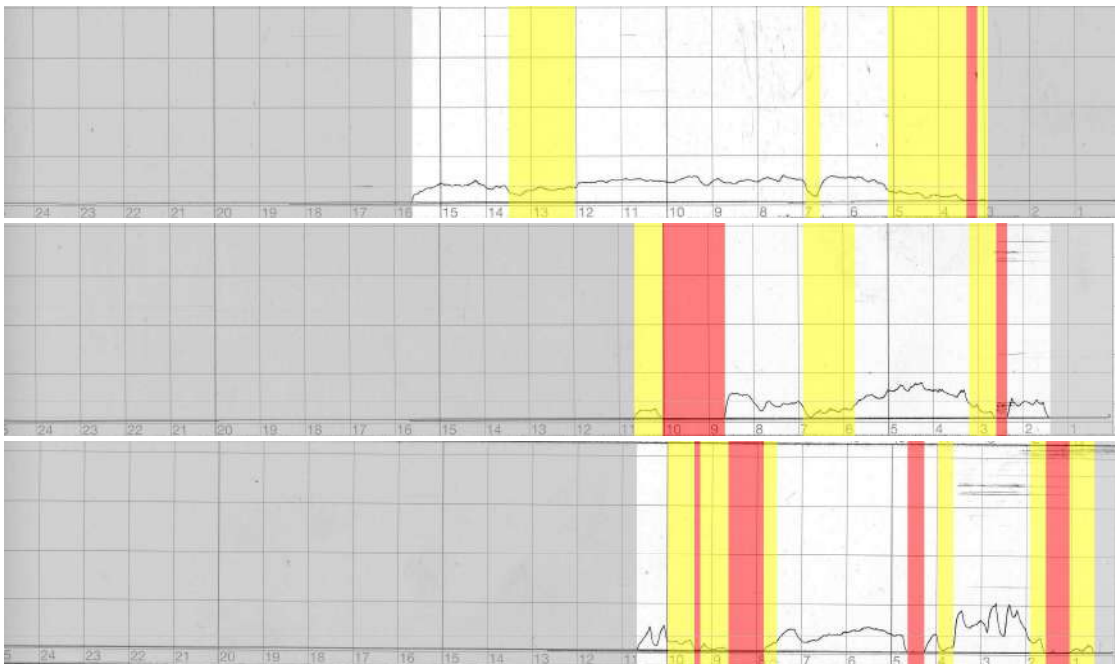
Figure 336: Examples of micro-drill graphs showing internal degradation. From the top:

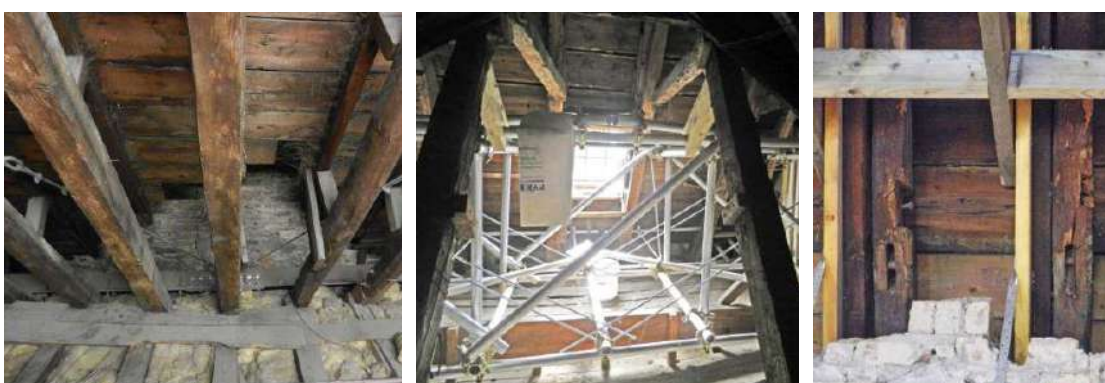
Figure 337: Past interventions: steel beam and ties counteracting the collars' deflection in Gardyne's Land (1675) (left), steel truss supporting the roof of Geilston House (1666) (centre), eighteenth century and twenty-first century timbers strengthening the original seventeenth-century timbers in Panmure House (1680s) (right)

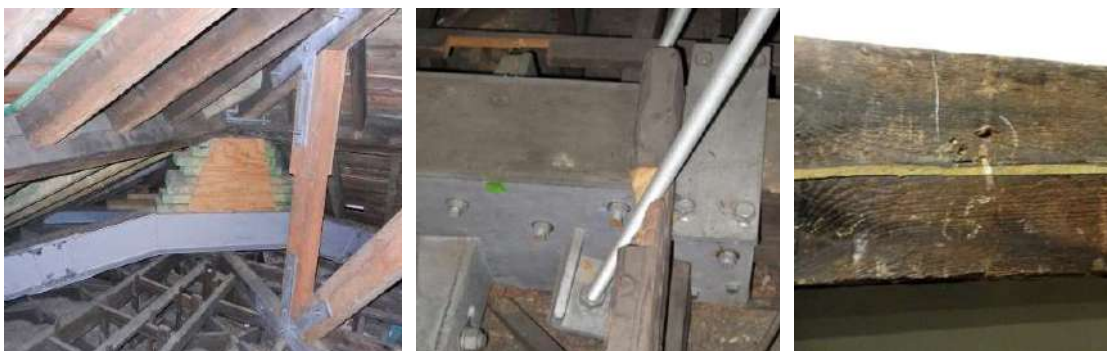
Figure 338: Past interventions: timber and steel elements counteracting the hip rafters' deflection in Oakshaw Trinity church (1754-6) (left), a secondary beamcut to make place for the steel reinforcements in Oakshaw Trinity Church (1754-6) (centre), filled checks in the roof of the Ordnance Store at Fort George (1759-61) (right)

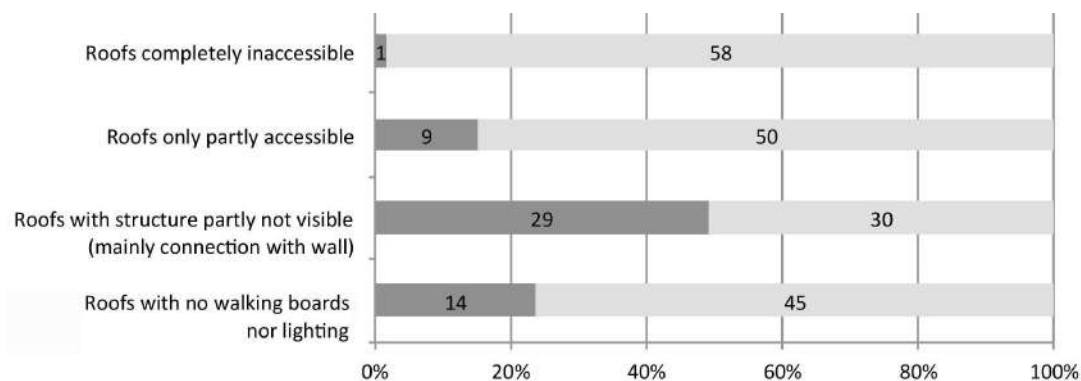
Figure 339: Accessibility and visibility issues found in the surveyed roofs

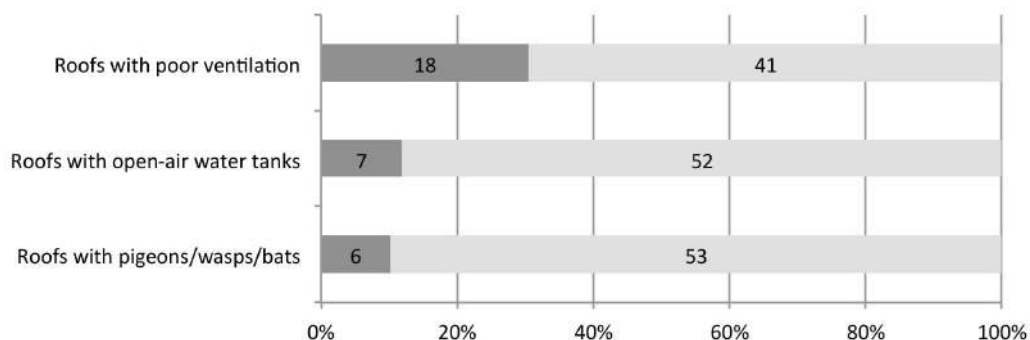
Figure 340: Surveyed roofs affected by inadequate environmental conditions

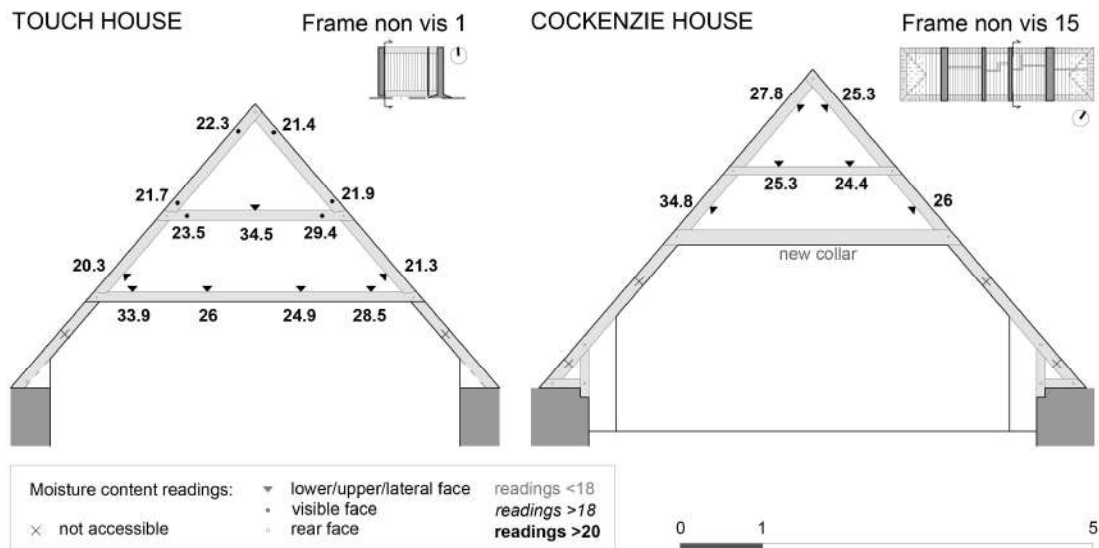
Figure 341: Moisture content readings in one frame in the roof of the North range of Touch House (left) and in one frame in the roof of Cockenzie House (right)

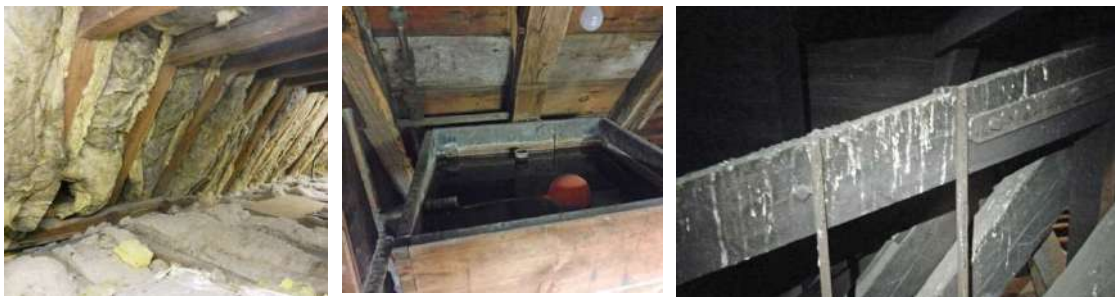
Figure 342: Unfavourable conditions in simple frames: over-insulation in the roof of King's Old Buildings in Stirling Castle (1557) (left), uncovered water tank in Kelburn Castle (1581) (centre), pigeons' droppings in George Heriot School (1630s) (right)

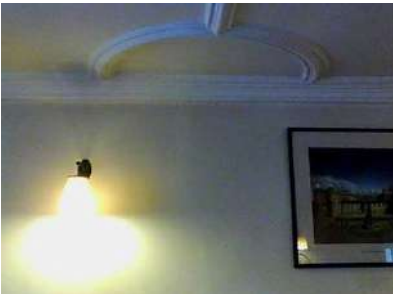
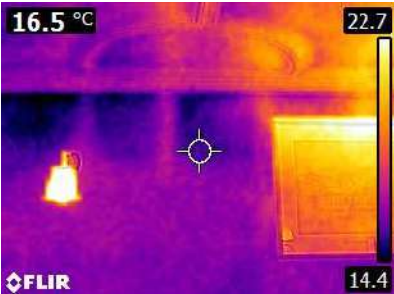
<i>A) higher temperatures identify the position of the timber roof structure hidden behind the wall and the ceiling: the presence of an ashlar post, typical of the Scottish rafter foot, is highlighted</i>	
	roof 10° 65%

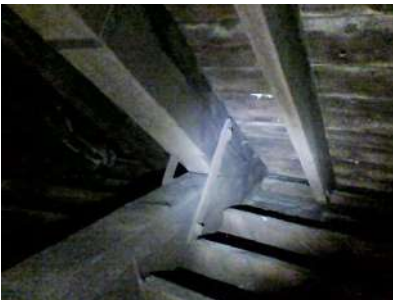
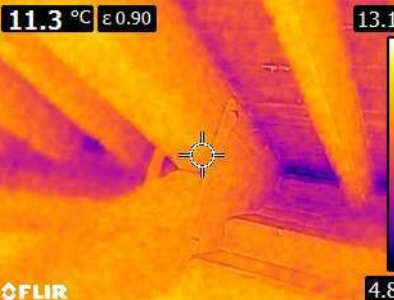
<i>C) lower temperatures at the eaves identify deficiencies in the flashings allowing air to come in from outside (wood MC=14.1%)</i>

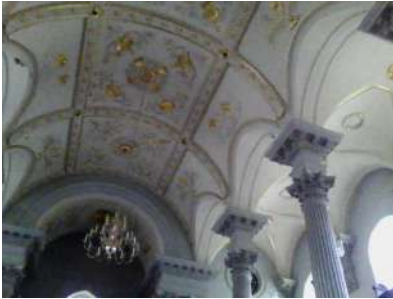
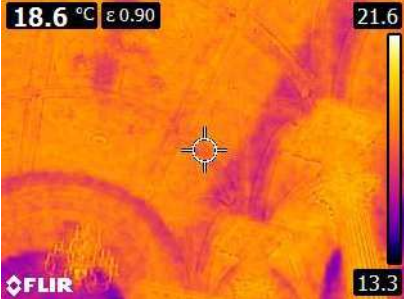
<p><i>D) lower temperatures at the top of the columns and in the central part of the vaults identify missing insulation sheets above the plaster ceiling; the masonry parts in the bottom left corner are also identified by lower temperatures</i></p>
<p>16/02/2016</p>	<p>roof</p>	<p>13.3° 56.2%</p>

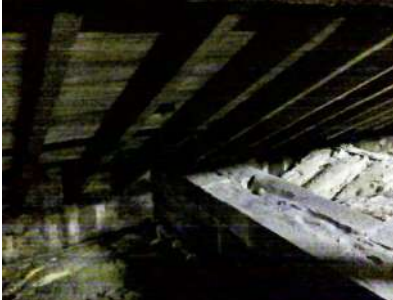
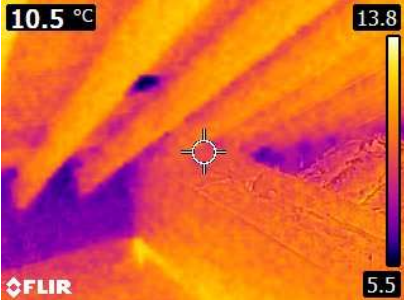
<p><i>E) lower temperatures identify the masonry and a gap in the sarking boards between the rafters allowing air to come in from outside (wood MC=16%)</i></p>
<p>Cockenzie House</p> <p>22/01/2016</p>	<p>attic</p>	<p>9.7° (14° after heatin g) 77.3%</p>

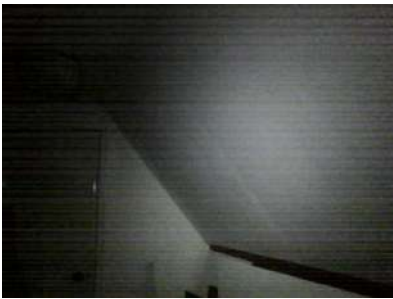
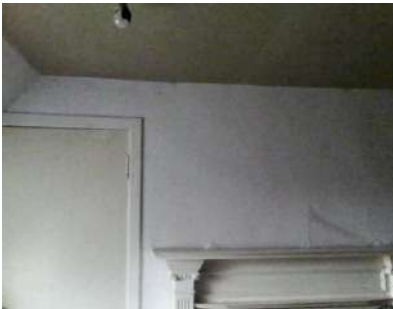
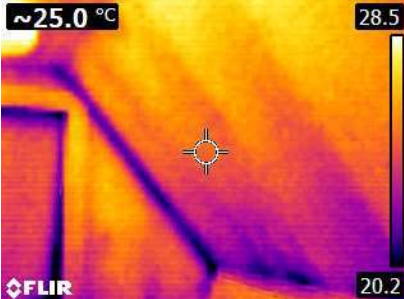
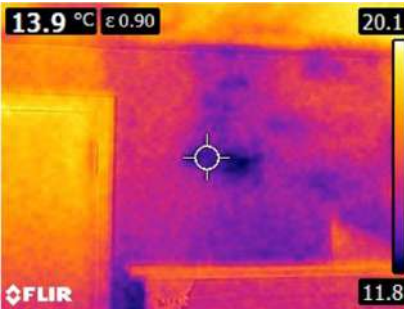
<p><i>F) lower temperatures at the junction between the roof structure and the gable wall identify deficiencies in the flashings</i></p> <p><i>G) lower temperatures on an intermediate gable wall identify damp masonry</i></p>

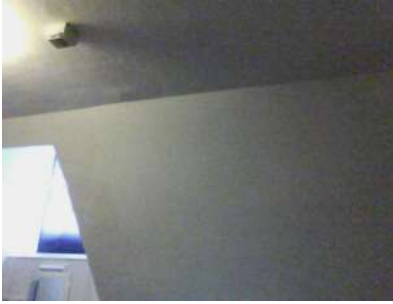
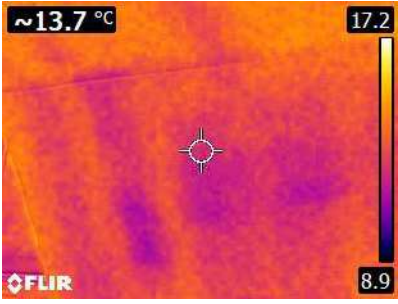
<p>H) higher temperatures identify the position of the timber roof structure hidden behind the plaster panelling</p>
	roof	12/02/2016 11° 55%

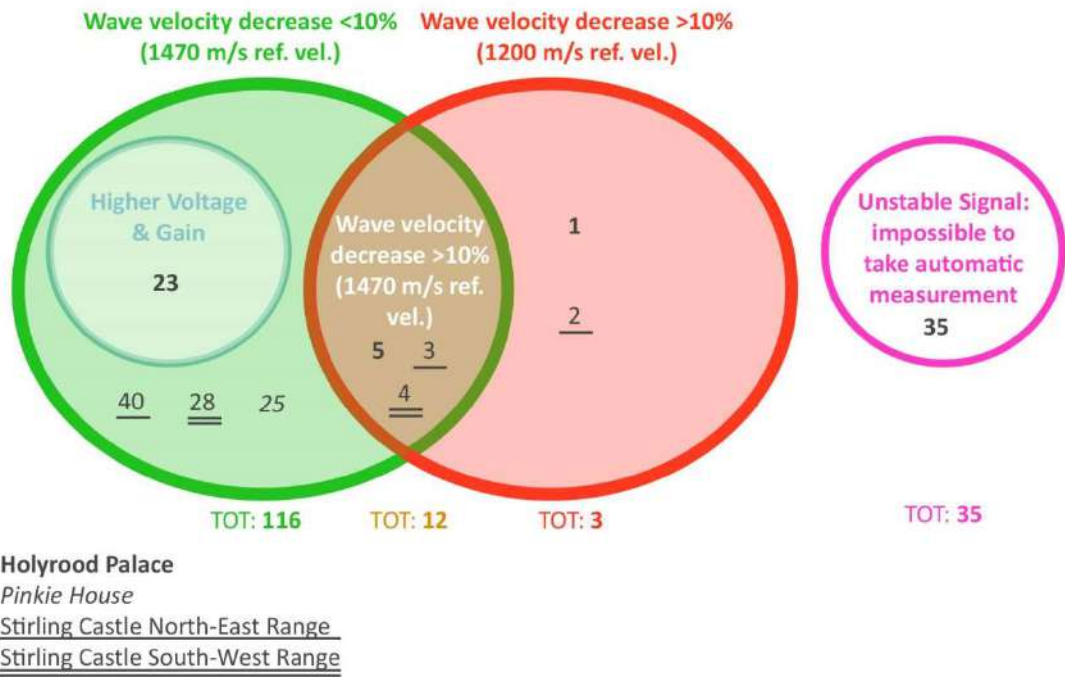
Figure 343: Results of the ultrasonic measurements taken in the roofs of Stirling Castle Palace, Holyrood Palace and Pinkie House

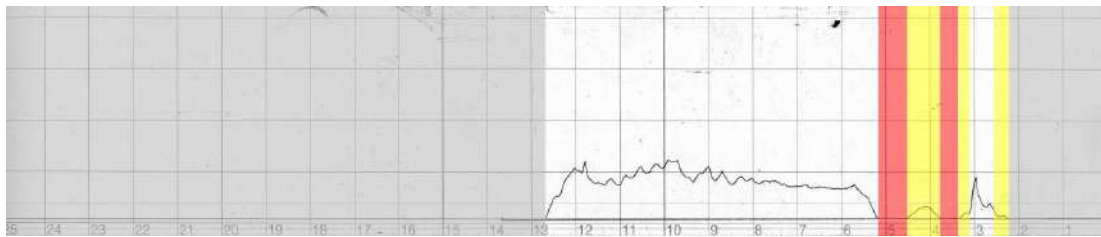
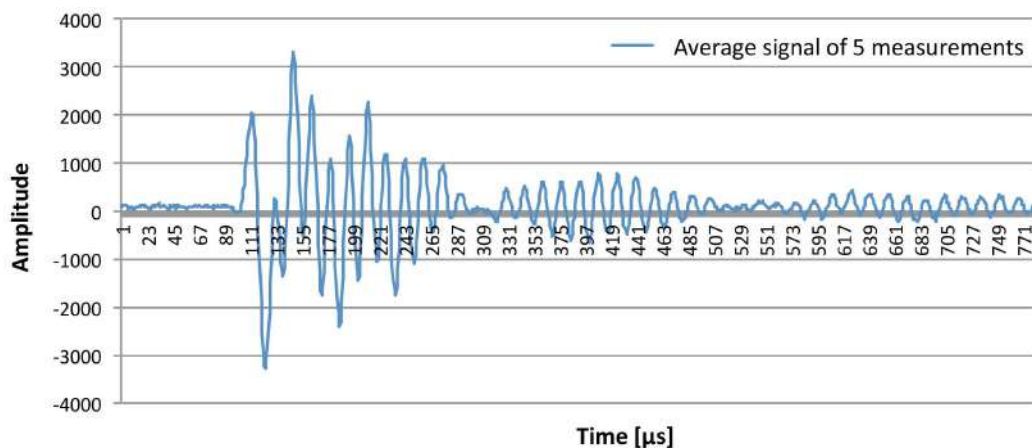
The resulting average time of flight is 101,6 μ s with a standard deviation of 0,89 μ s

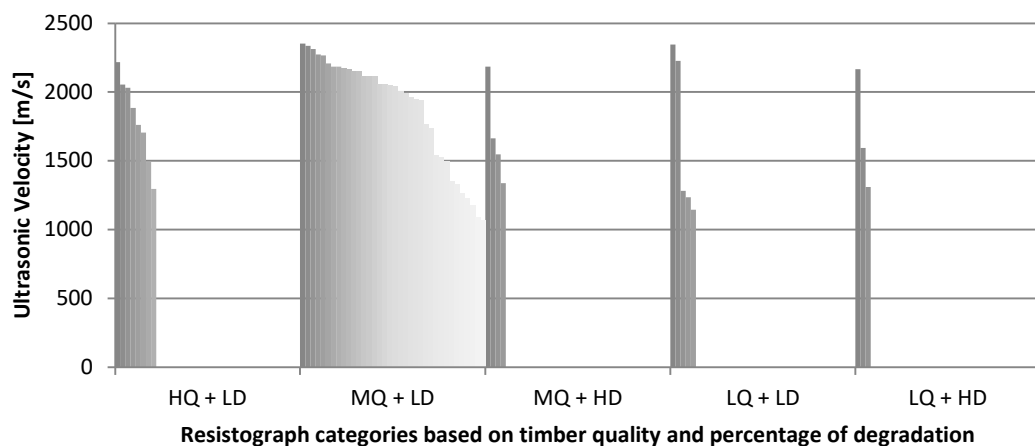
Figure 344: Ultrasonic wave velocities grouped according to the categories of the corresponding micro-drills: HQ = High Quality, MQ = Medium Quality, LQ = Low Quality, LD = Low Degradation, HD = High Degradation

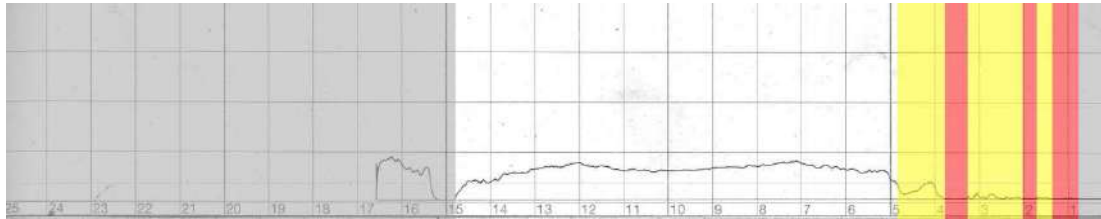
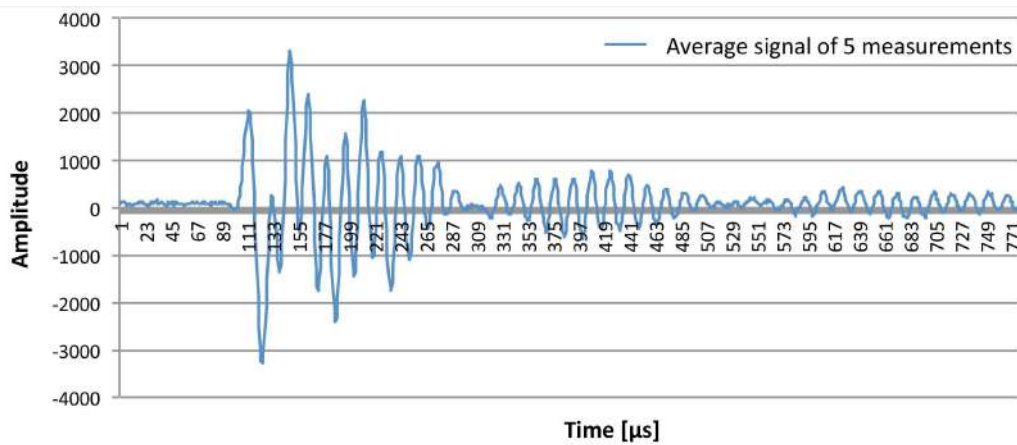
The resulting average time of flight is 84,2 μ s with a standard deviation of 0,84 μ s

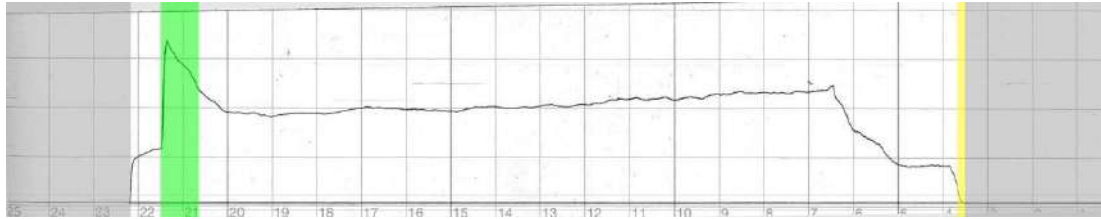
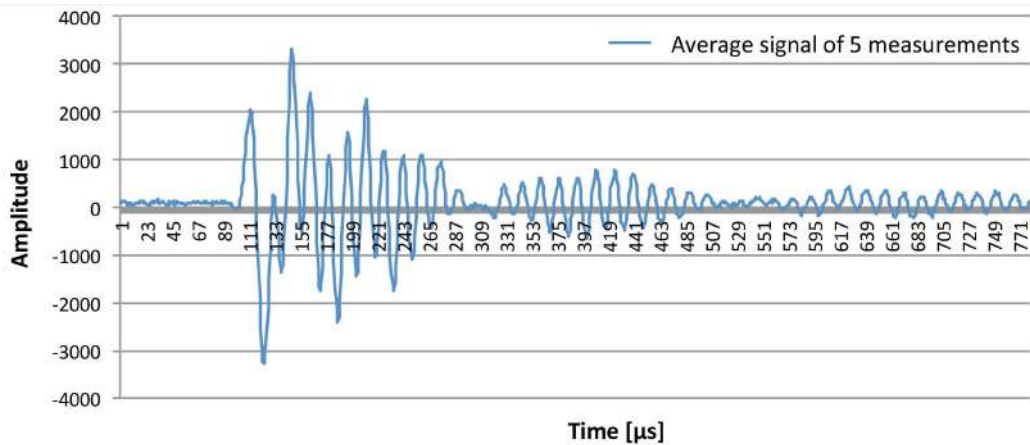
The resulting average time of flight is 78,8 μ s with a standard deviation of 0,45 μ s

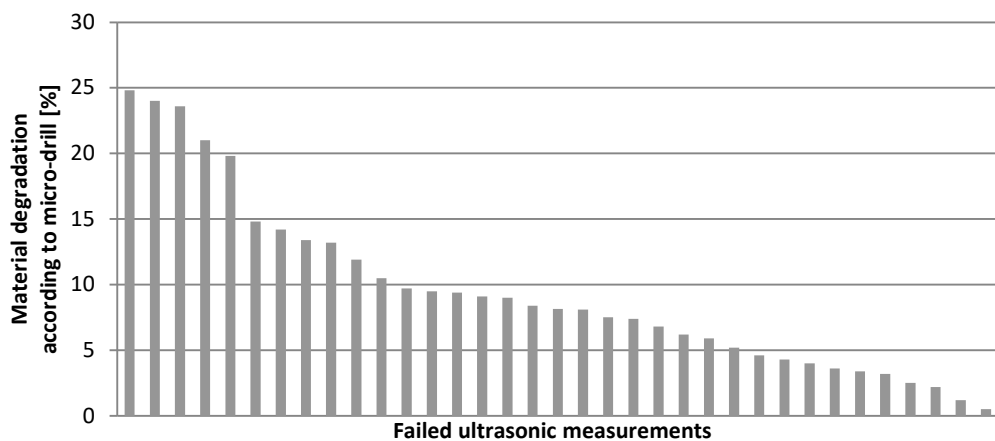
Figure 345: Extent of material degradation estimated for the micro-drill graphs in the measurement points where the unstable signal has not allowed recording the ultrasonic wave velocity

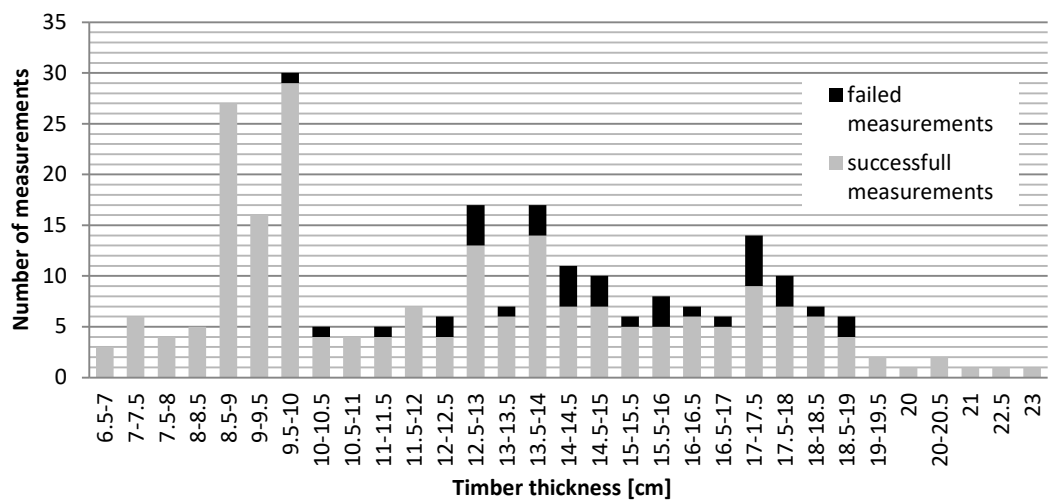
Figure 346: Graph showing the failed ultrasonic measurements, that could not be recorded due to the unstable signal (highlighted in black) distributed according to the thickness of the timber elements tested

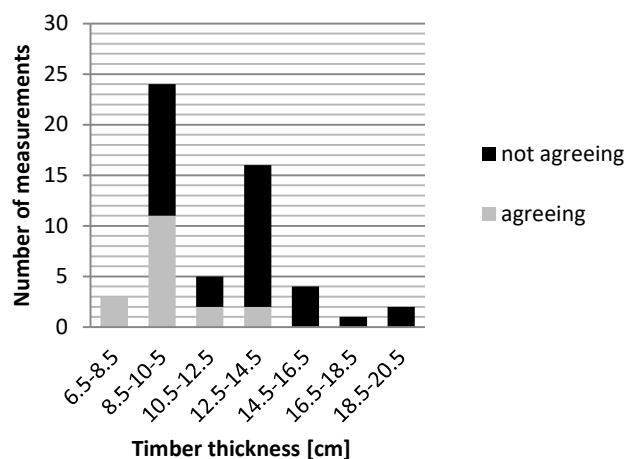
Figure 347: Graph showing the correspondance between the ultrasonic results and the micro-drill results distributed according to the thickness of the timber elements tested
