**University of Strathclyde**  
**Bioengineering Department**

**The design of a prosthetic foot unit for use in  
developing countries**

**This thesis is presented in fulfilment of the  
requirements for the degree of Doctor of Engineering  
in Medical Devices.**

The majority of prosthetic feet used in low-income countries suffer from a limited lifespan and limited durability. The aim of this project is to design a prosthetic foot suited to use in low-income countries that incorporates both durability and a high level of function.

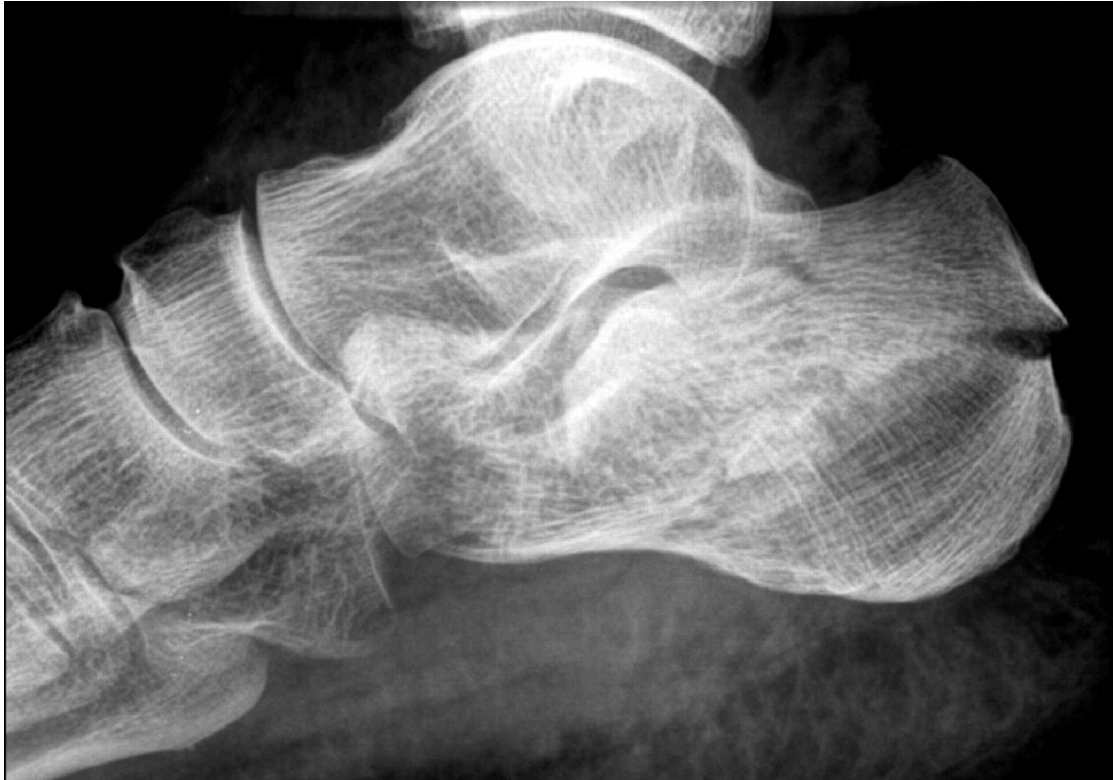
Figure 3 - An x-ray image of the rear of the foot. The trabeculae are visible as thin white lines. It should be noted that the trabeculae of different bones continue to follow the principal stress lines across the gaps between the segments (University Hospitals of Geneva, 2012)

of the trabeculae are consistent across bones although separated by the gaps between the bones. This displays the way in which the elements act together in order to form a suitable structural base for the rest of the body. This may be observed in Figure 3, an x-ray image of the rear of a foot.

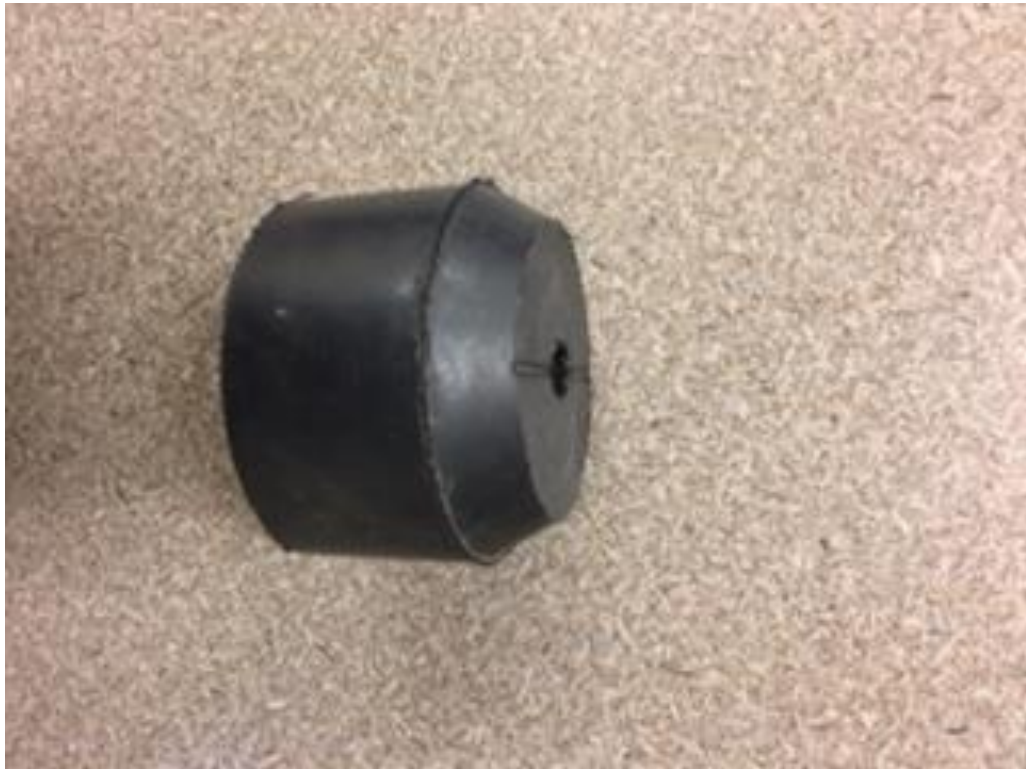
Figure 5 - The all-terrain foot, displaying the simple and rugged design (Mathews, 2017)

The peg leg was the traditional replacement for a lost leg and is still used in more or less its original form in some areas of the world. Some updates have been made as in the case of Muller (Muller, 1957), where a cosmesis was added to improve the look of the peg leg without contributing to its function. Alternatively, Mathews et al. (Mathews, Burgess, & Boone, 1993), reported on the 'all-terrain foot' which was designed in response to the difficulties found by many users of foot shaped prostheses. The foot shaped prostheses were apparently prone to become caught or tangled on undergrowth and were difficult to use in wet or muddy conditions where they could get stuck. The all-terrain foot is a peg leg with a large, circular rubber pad at the end. The rubber is shaped as a tapered cylinder with a convexly curved bottom surface. A hole in the base allows for a bolt to be used in attaching the foot to the leg, which the authors acknowledge, may fill with mud or snow unless otherwise plugged. The smaller footprint and simpler shape would prevent catching on undergrowth and the durability would make it suitable for use in wet and muddy conditions (see Figure 5).

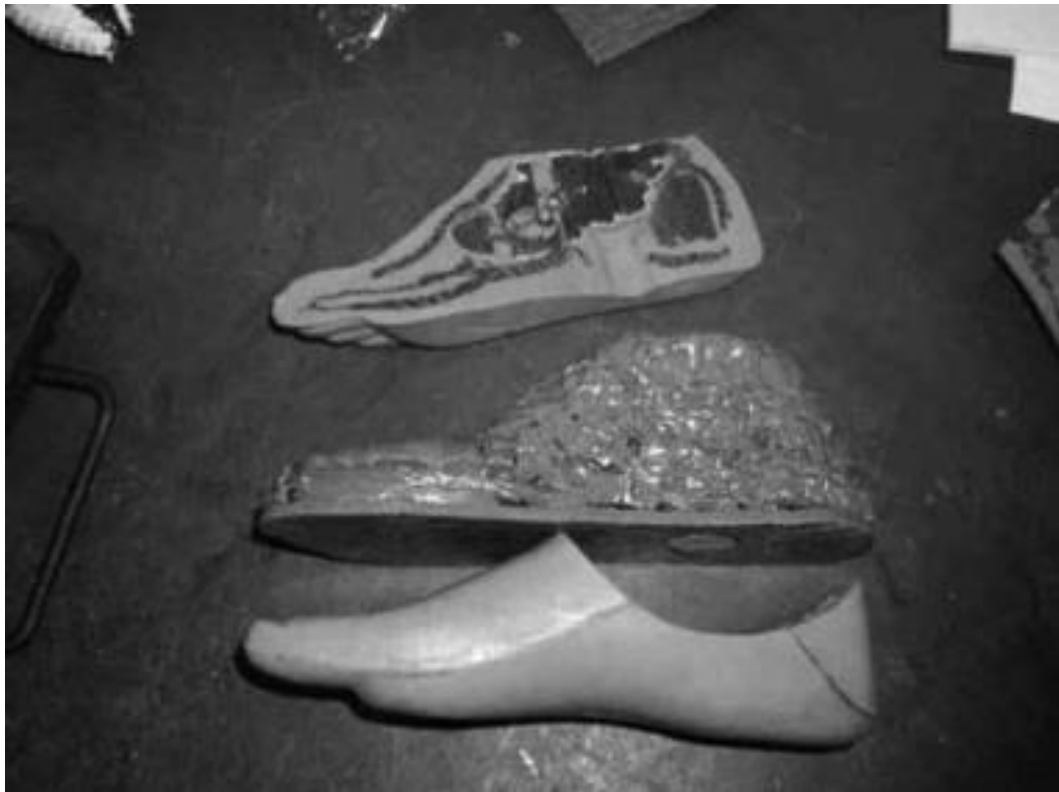
Figure 11 – A cross section of the VI-Solid foot showing the internal makeup (Jensen, Nilsen, Zeffer, et al., 2006)

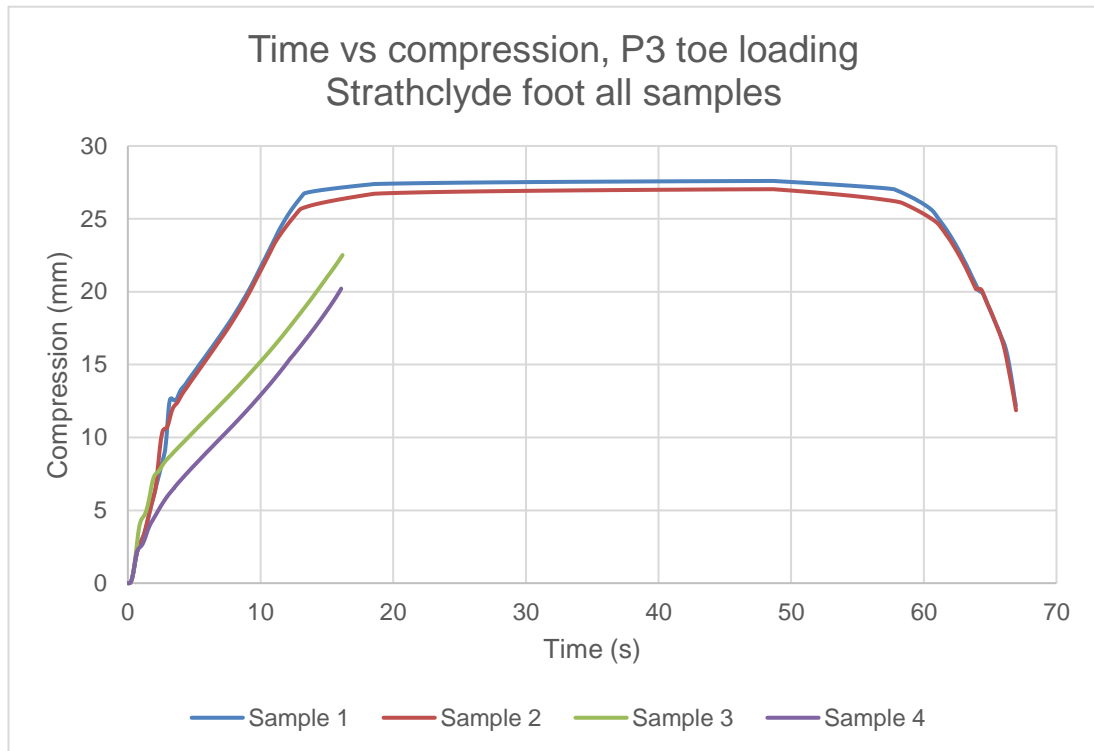
Figure 34 – A graph showing time vs. compression of all samples of the Strathclyde foot under P3 toe loading conditions

Figure 34 shows all samples of the Strathclyde foot having undergone P3 static load testing per ISO 10328. Samples 1 and 2 successfully completed testing but samples 3 and 4 failed at approximately 16.1s in each case. The change in gradient seen in samples 1 and 2 corresponded with the contact of the lower toe section to the upper toe section while in samples 3 and 4 the earlier change in gradient corresponded to the contact of the lower toe section to the glass fibre rods. In both cases the stiffness was increased however, once samples 3 and 4 reached approximately 16.1s both rods fractured, as did one section of the upper toe in sample 4 while samples 1 and 2 were able to continue the test to completion.

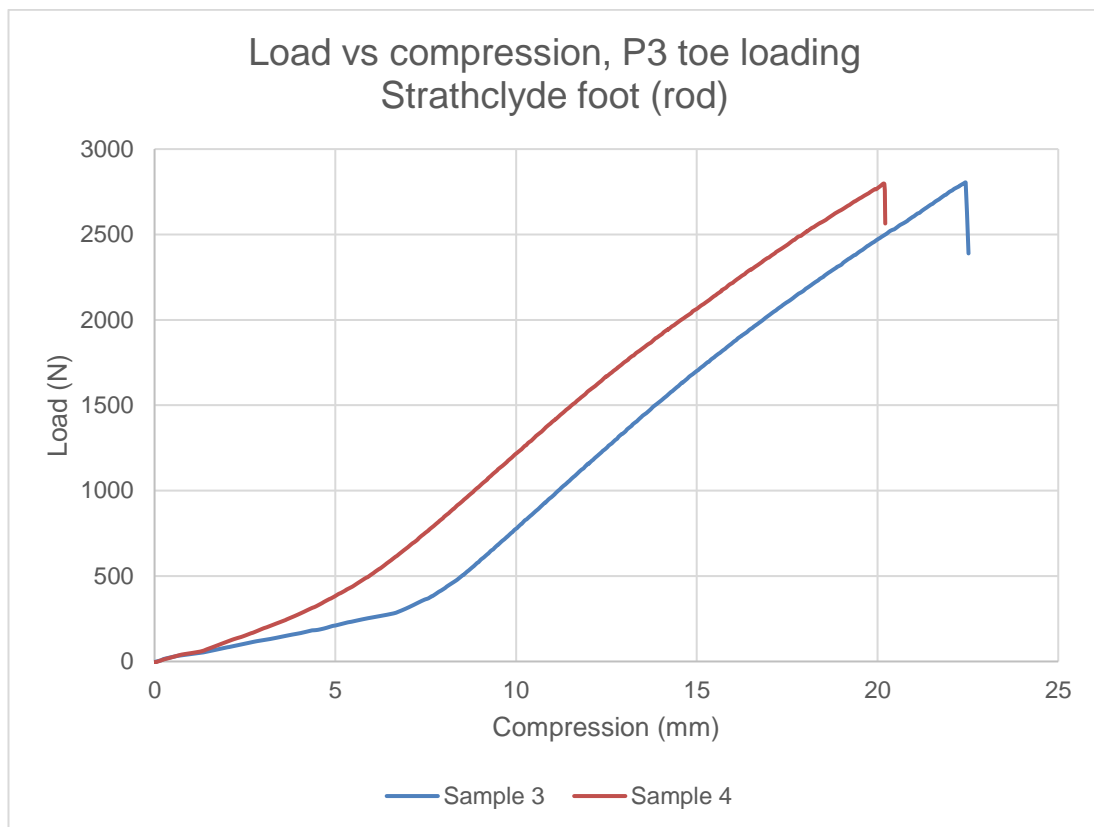
Figure 35 – A graph showing load vs. compression of samples 3 and 4 of the Strathclyde foot under P3 toe loading conditions prior to fracture

Figure 35 shows the loading of samples 3 and 4 until the rods fractured and the test was concluded. For the first millimetre of compression the samples showed a similar response however, sample 4 then became stiffer, sooner than sample 3 (at approximately 7mm). This change in stiffness corresponded to contact being made between the deformed lower toe sections and the glass fibre rods. The difference in deformation before contact was likely due to the production method as holes were manually drilled into the keel to accommodate the rods which introduced variation in manufacture. Within a single keel this can lead to rods contacting at different times which may explain why the change in stiffness observed in sample 3 (rods contacting separately) is less rapid than that of sample 4 (rods contacting together).

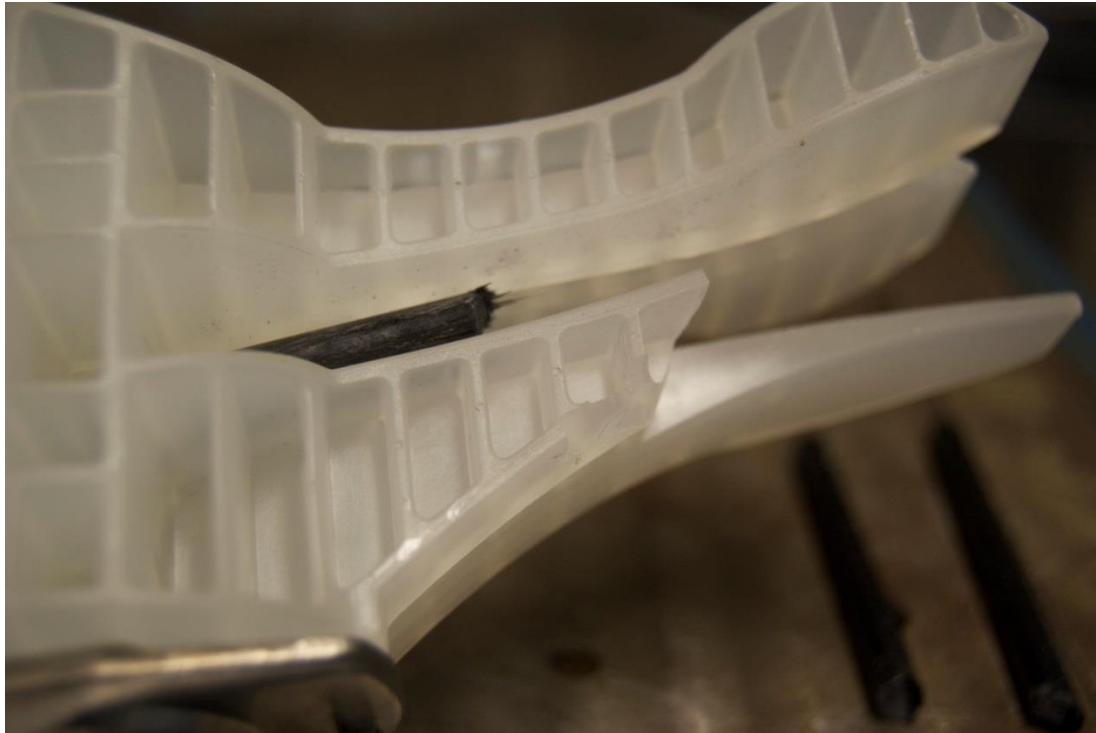
Figure 37 – An image of sample 3 showing the broken toe section and rods following P3 testing

The rods in both samples broke in similar positions (see Figure 36 and Figure 37), being closer to the insertion contact point than the toe section contact. The failure itself showed more fibres extending from the underside of the rod which suggests a failure in tension on this part. Once a crack was formed it would rapidly propagate across the rod leading to failure.

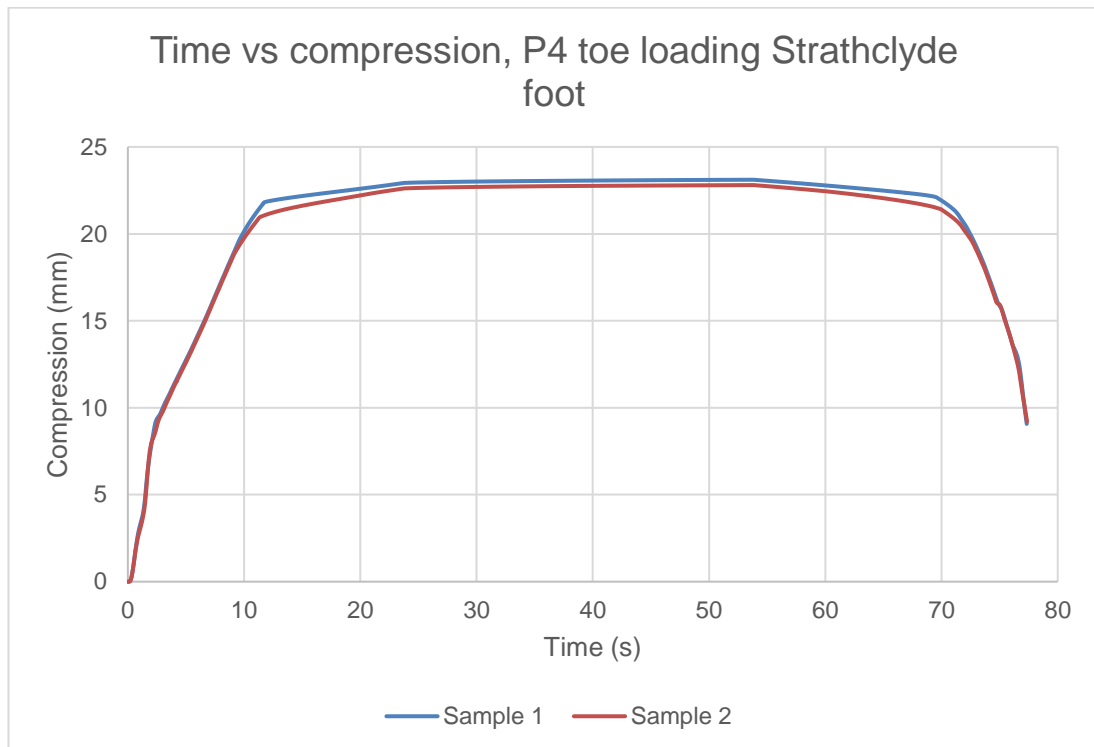
Figure 44 – A graph showing time vs. compression of samples 1 and 2 of the Strathclyde foot under P4 toe loading conditions

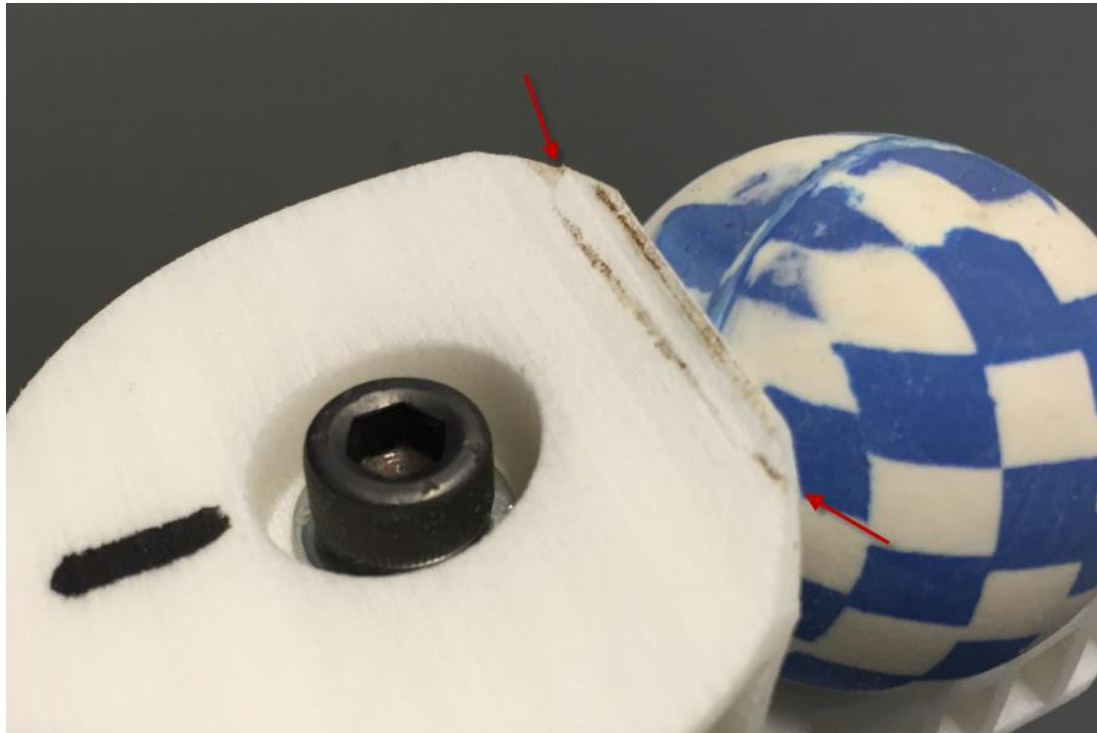
Figure 86 – An image showing the fracture in sample 1 from P3 heel testing. Arrows indicate the edges of the dark line highlighting the break

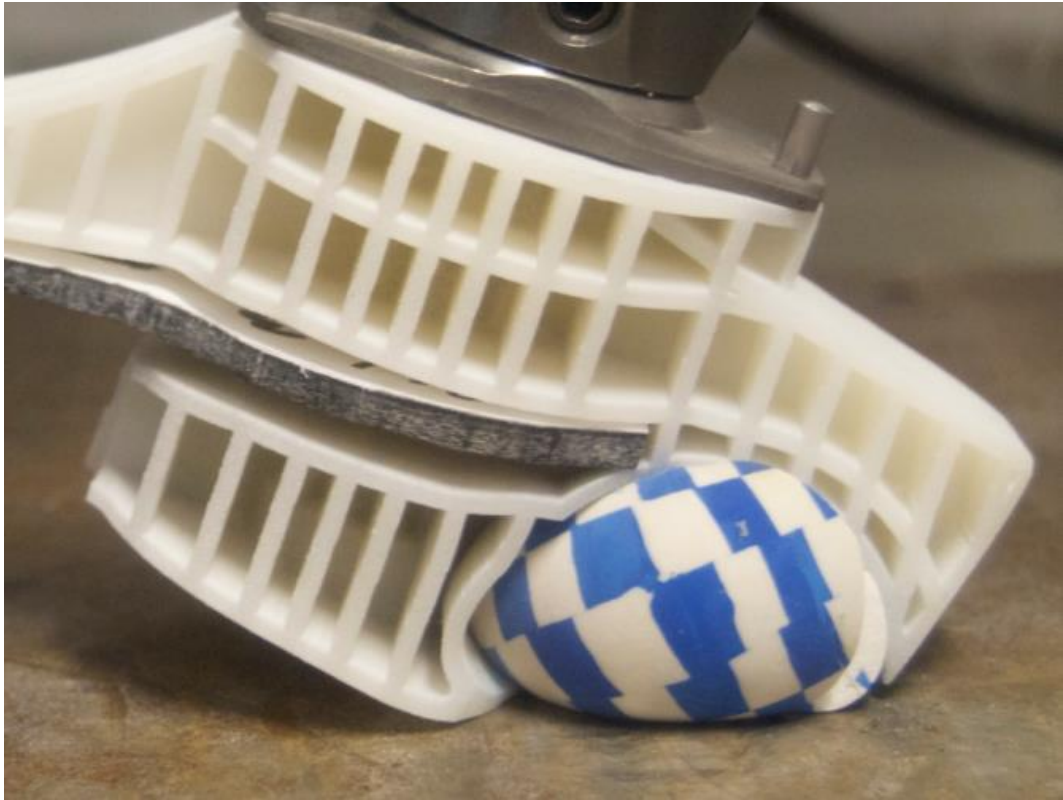
Figure 93 – Sample 3 showing the split ball under maximum P4 ultimate static load

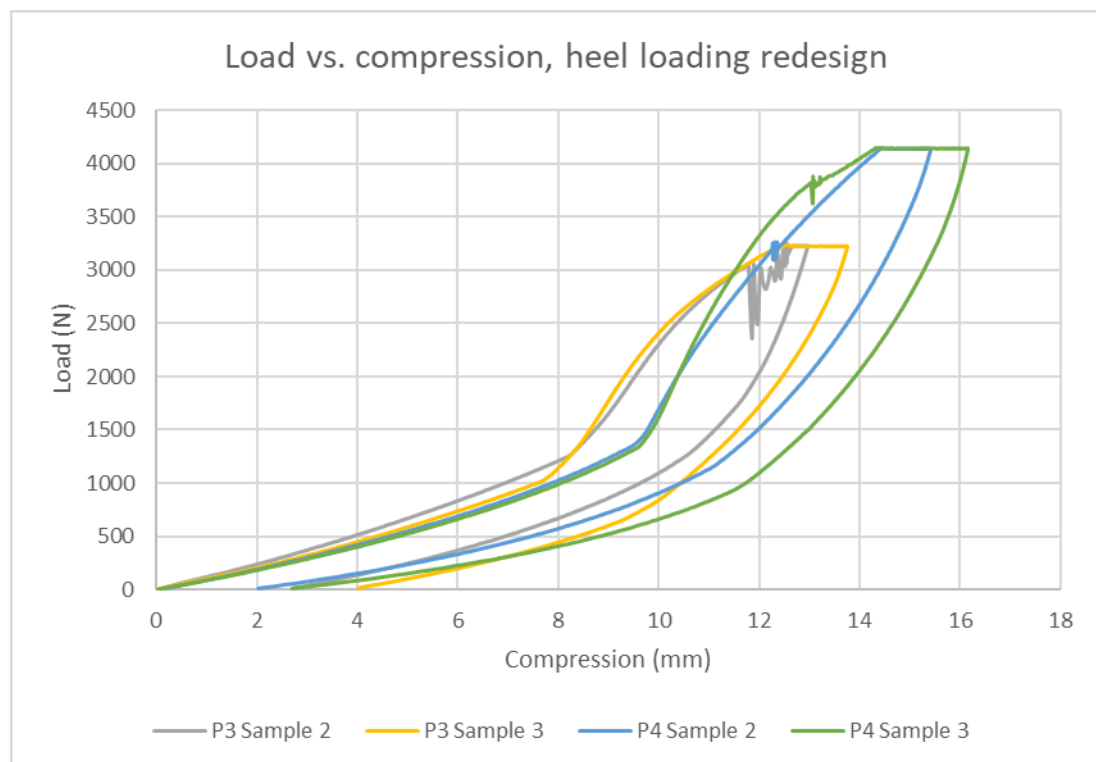
Figure 96 – Load vs. compression results for Strathclyde redesign at P3 and P4 levels

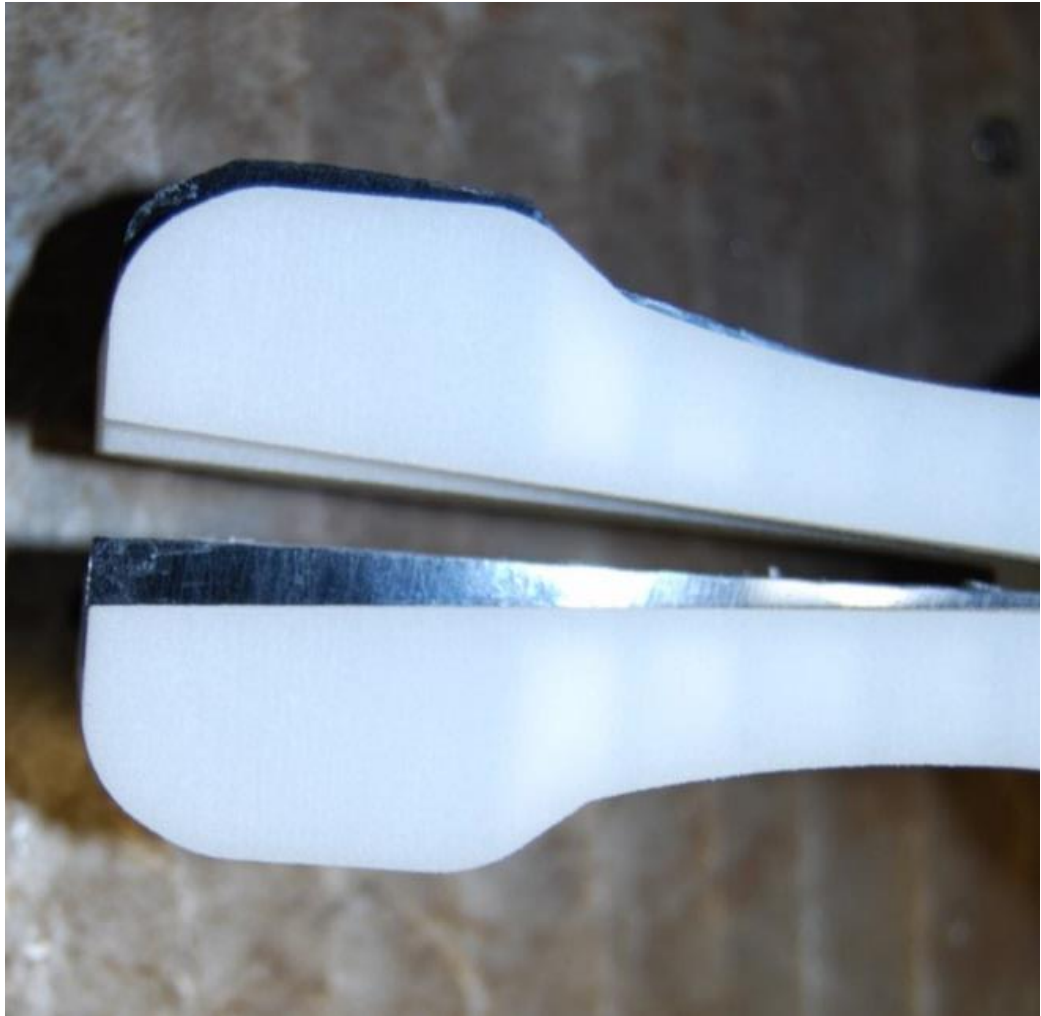
Figure 111 – The blade slipped to the right side during the P3 toe loading test
