Additively Manufactured Polymers and Polymer Composites for Minerals Processing Technology

A thesis in fulfilment of the requirements for the degree of Doctor of Philosophy

Department of Mechanical and Aerospace Engineering

University of Strathclyde

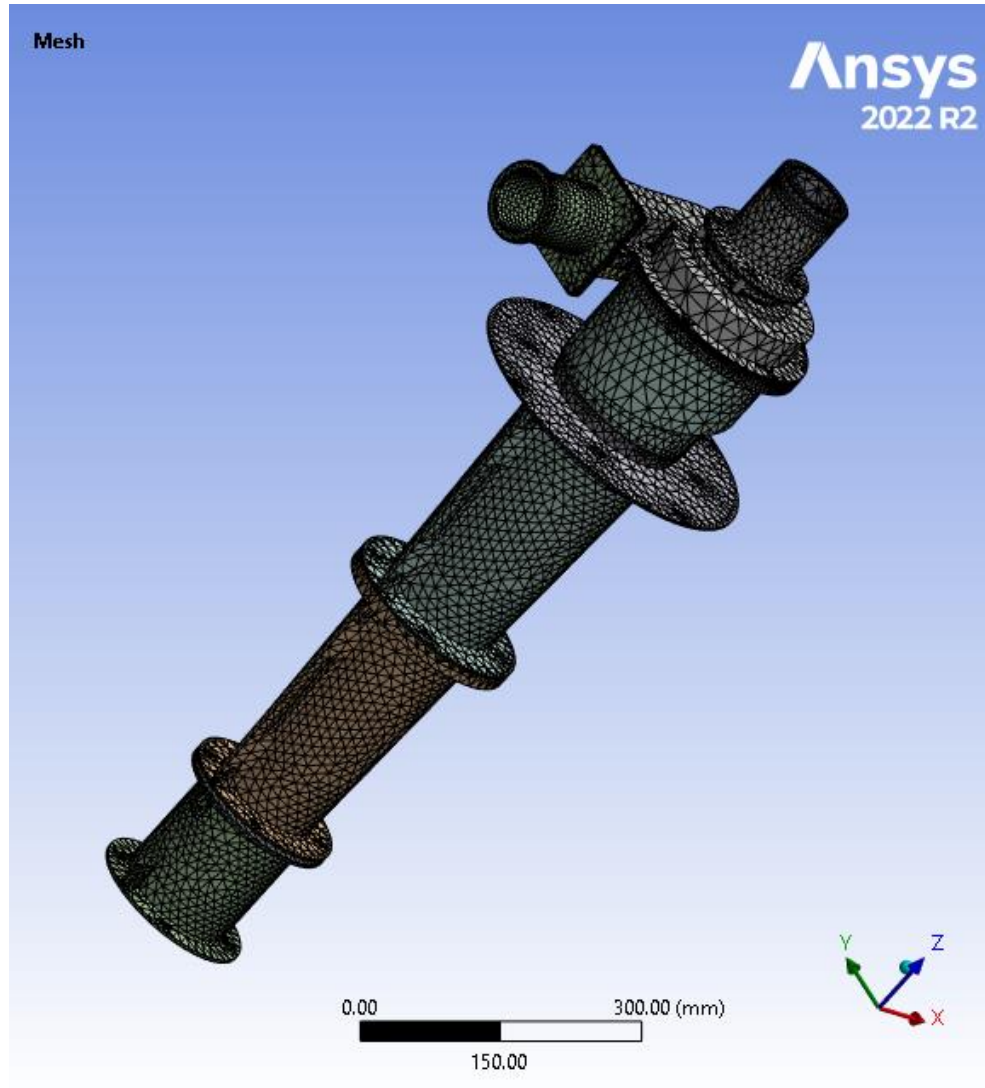
Figure 22. Mesh of 150 CVD in 'ANSYS Static Structural'.

In order to verify the geometry and begin meshing, the geometry for the casing and the rubber liner were inputted into ANSYS. A default mesh with a resolution of 5,99261 elements and 24796 nodes was used and is shown in Figure 22.

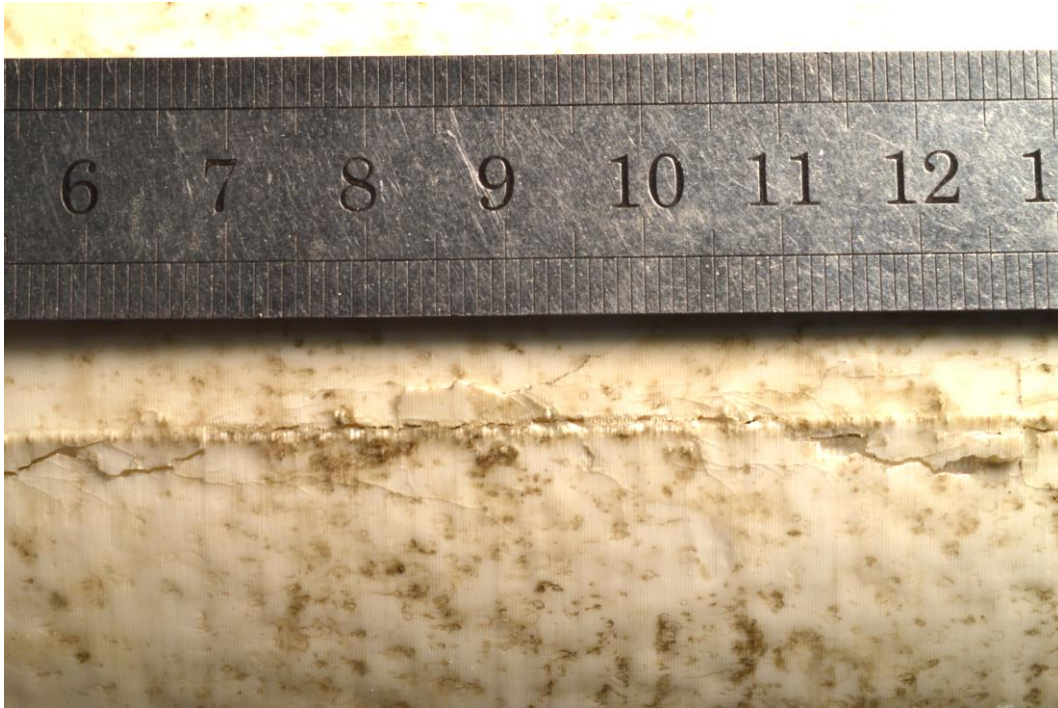
Figure 75. Image of brittle failure on the outside of the ABS cylinder.

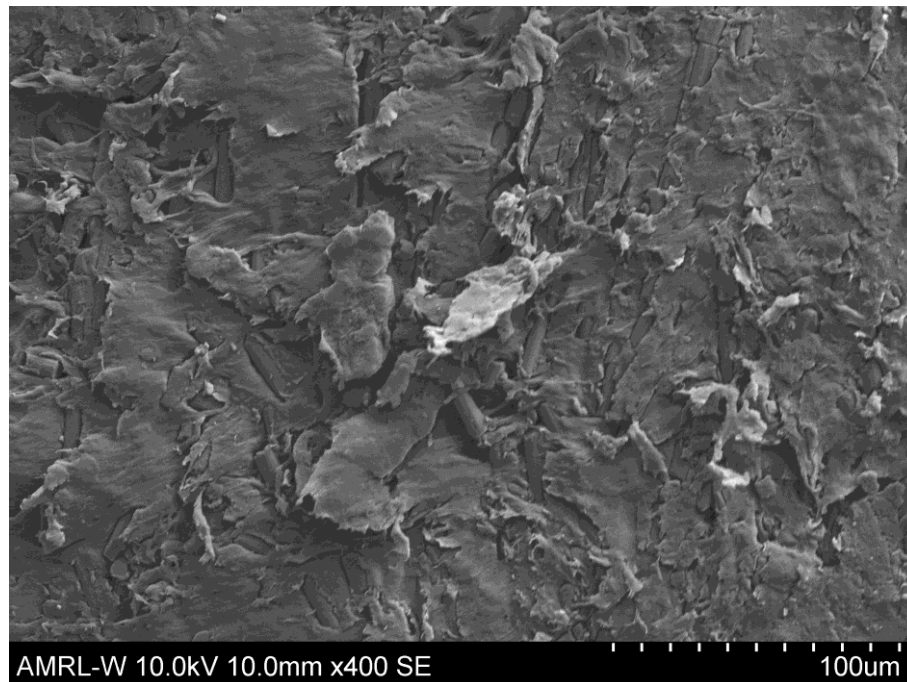
Figure 151. Edge of wear scar for Nylon 12CF 45,90 impingement angle with epoxy sealed surface. x400 magnification.

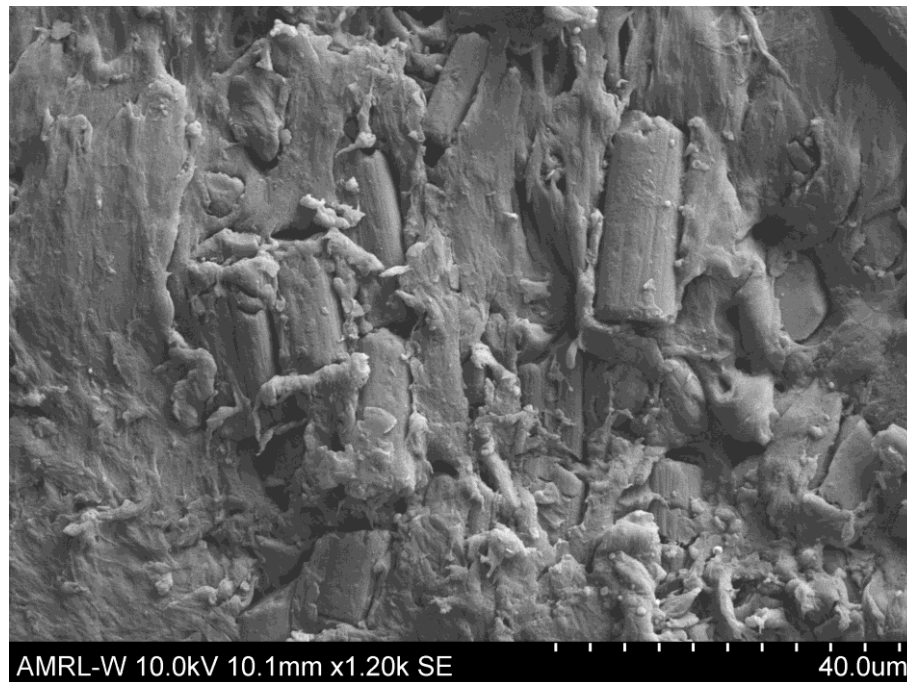
Figure 153. Exposed fibres at the edge of the wear scar Nylon 12CF 45,0 impingement angle. X1.20k magnification.

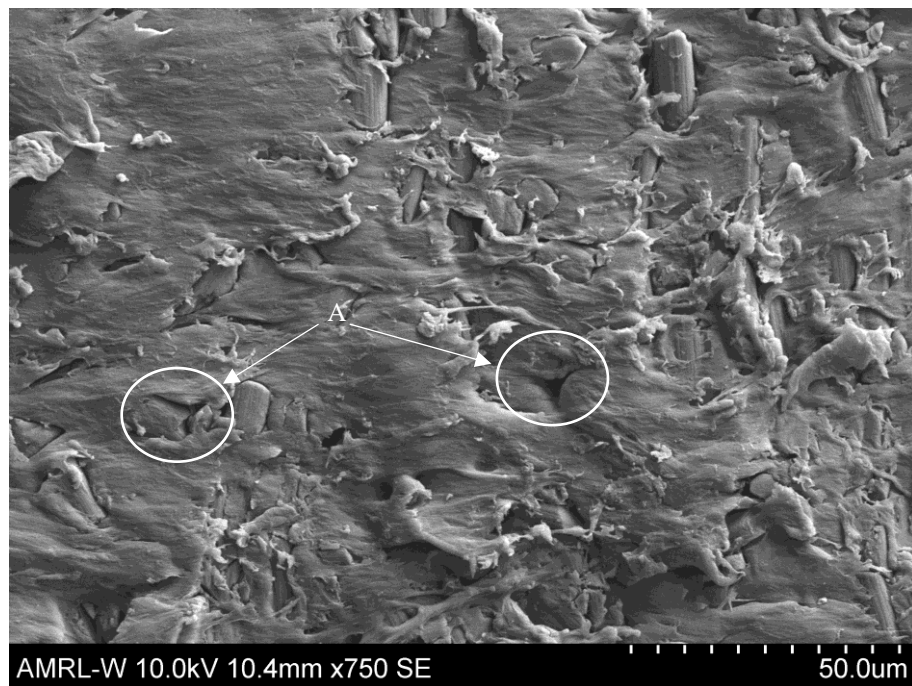
Figure 154. Details of wear scar Nylon 12CF 45,0 impingement angle with epoxy sealed surface, x750 magnification.

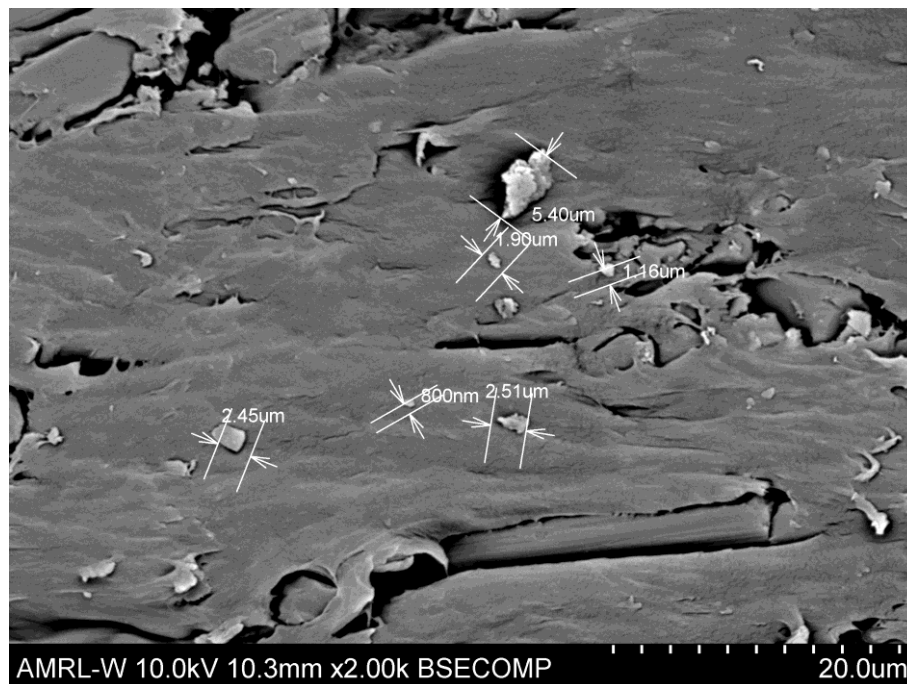
Figure 158. Sand found embedded in Nylon 12CF 45,0 impingement angle specimen with epoxy sealed surface, x2.00k magnification.
