The role of materials engineering to mitigate corrosive wear in oil field pumping applications

A Thesis submitted for the degree of Doctor of
Philosophy (Ph.D.)

Frazer Craig Brownlie

University of Strathclyde

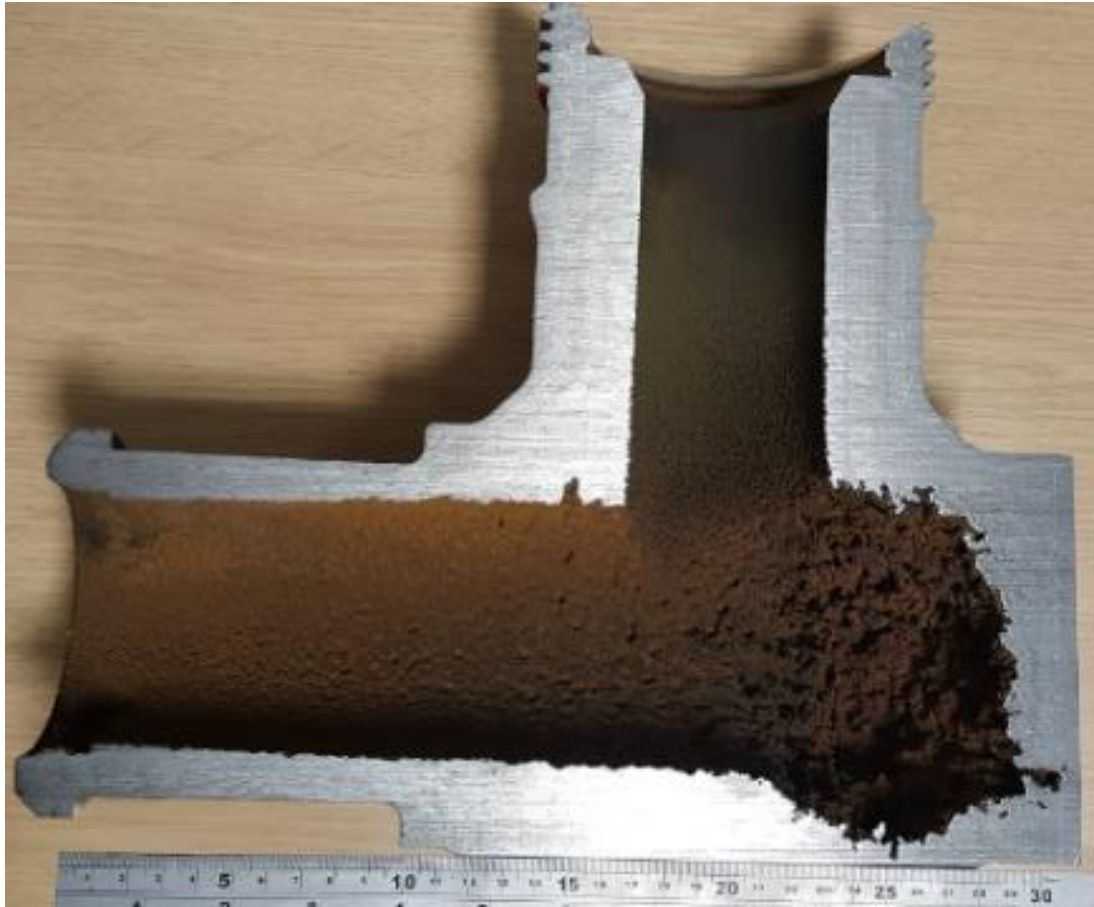
Figure 1.2: 90° elbow which has suffered severely from erosion-corrosion damage (courtesy of WSPM)

Figure 1.2 demonstrates the extreme corrosive wear which is commonly seen in engineering components, such as elbows in pipework, in the hydraulic fracturing industry. The 90° elbow shows severe corrosion damage throughout the inner bore, with large, deep pits occurring at the vicinity of the corner where the high pressure and turbulent fluid has caused extreme erosion-corrosion damage. The positive displacement pump casing (also referred to as the fluid end), also suffers significantly from erosion-corrosion damage.

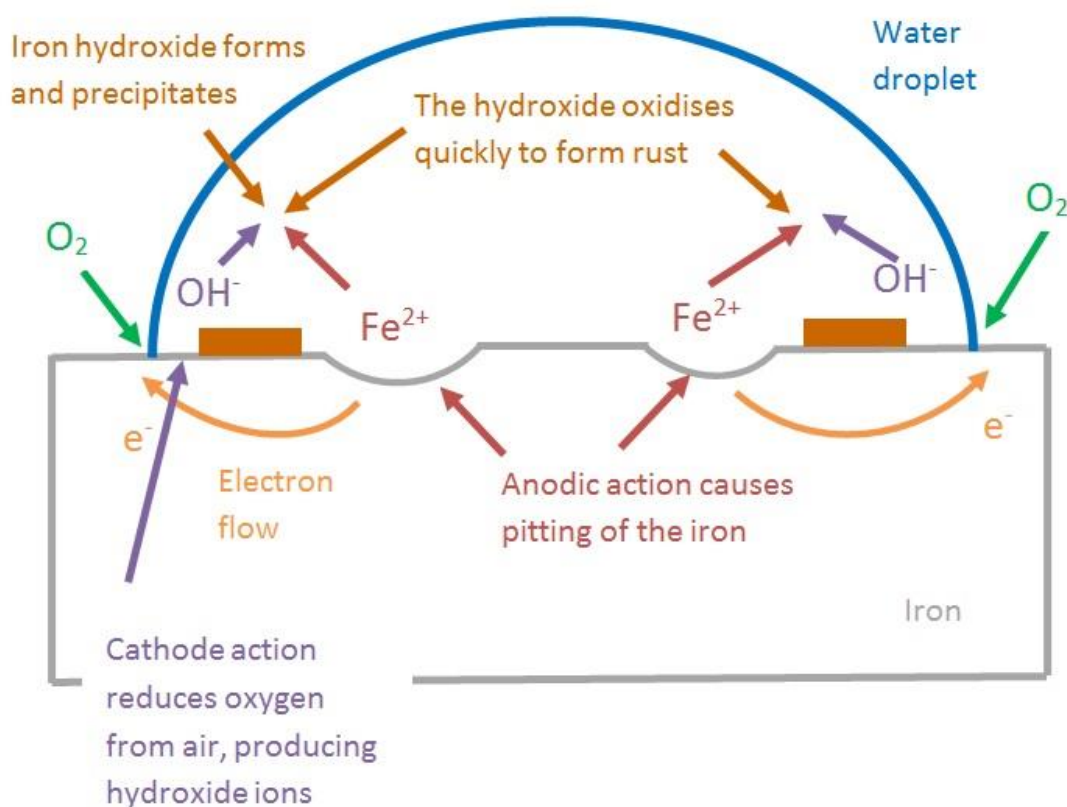
Figure 2.5: Schematic diagram of iron corroding at the surface in an aqueous environment

Figure 2.5 illustrates the process which occurs when iron corrodes in an aqueous environment. The anodic oxidation and oxygen reduction reactions (Eq. 2.3 & 2.7) occur simultaneously to produce hydroxyl and iron ions which precipitate and form corrosion product on the surface. Pits are formed on the surface as a result of dissolution of iron ions from the surface of the material.

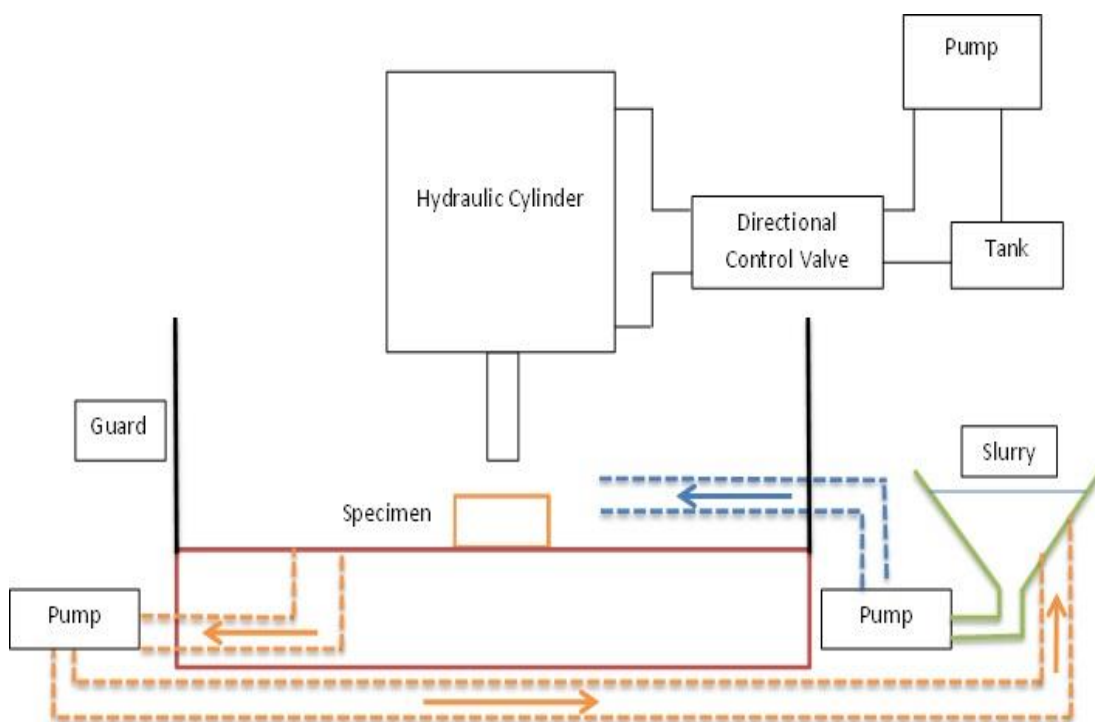
Figure 3.12: Schematic of repetitive impact test rig

As there are also sand particles which are crushed between the valve and seat during the operation of the valve closing, it was also important to incorporate this aspect into the rig. Therefore, a constant supply of hydraulic fracturing sand was fed between the impactor and specimen to replicate the crushing of sand. The proppant was mixed with a cellulose gel which was capable of holding the sand in suspension. The suspended sand was supplied to the sample through a Verderflex peristaltic pump. The sand concentration of the rig was 54g/l. The specimen holder contained a guard with an inlet and outlet for the slurry. The repetitive impact test set up is shown in Figure 3.12.

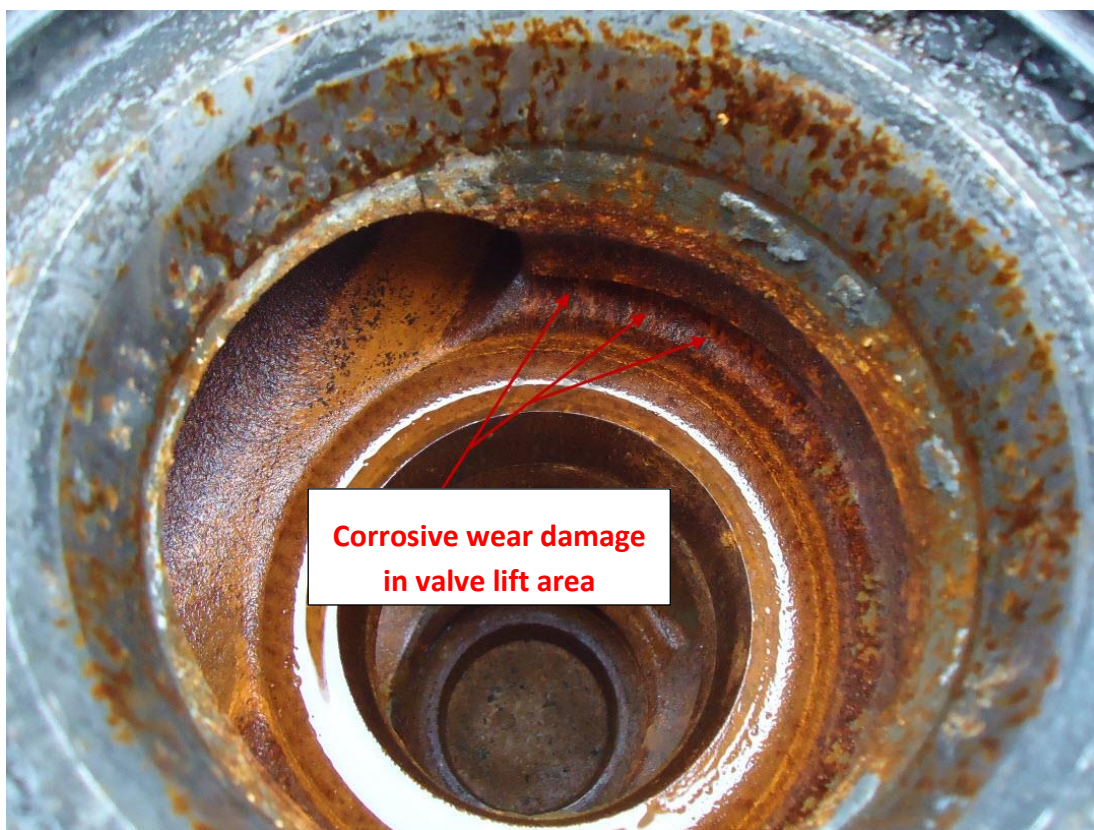
Figure 4.1: Corrosive wear damaged observed in valve lift area in fluid end (courtesy of Weir SPM)

The durability of fluid ends (which are the positive displacement pump casings) is essential to the life of the hydraulic fracturing positive displacement pumps. The fluid ends can experience a broad range of operating conditions (different pumping pressures, proppant loading, etc.) as well as various hydraulic fracturing fluid chemical compositions. These extreme operating conditions can cause severe corrosive wear (as demonstrated in Figures 4.1 and 4.2) to the wetted areas of the fluid end. A high strength low alloy steel (UNS G43400) is currently widely used as the fluid end material in hydraulic fracturing fluid ends. To increase the life expectancy of the fluid ends, it is clear that a reduction in the corrosive wear damage would be extremely beneficial.

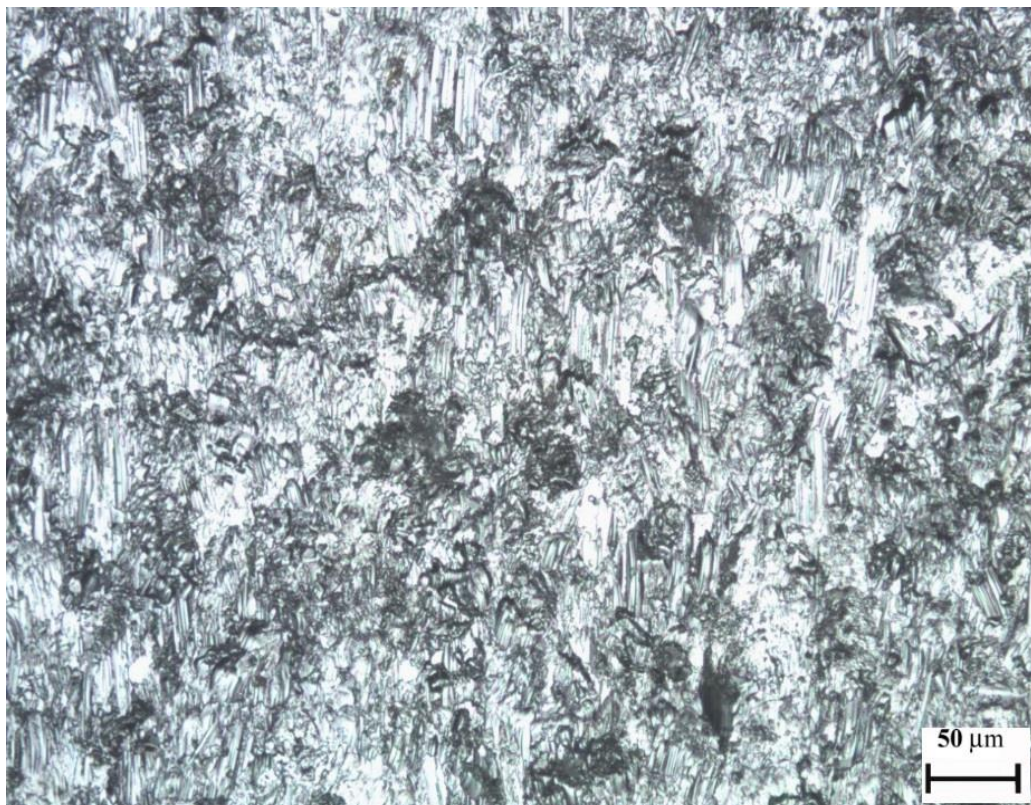
Figure 4.25: *Sliding abrasion damage in the OA of the UNS S15500 in 3.5%NaCl solid-liquid conditions*

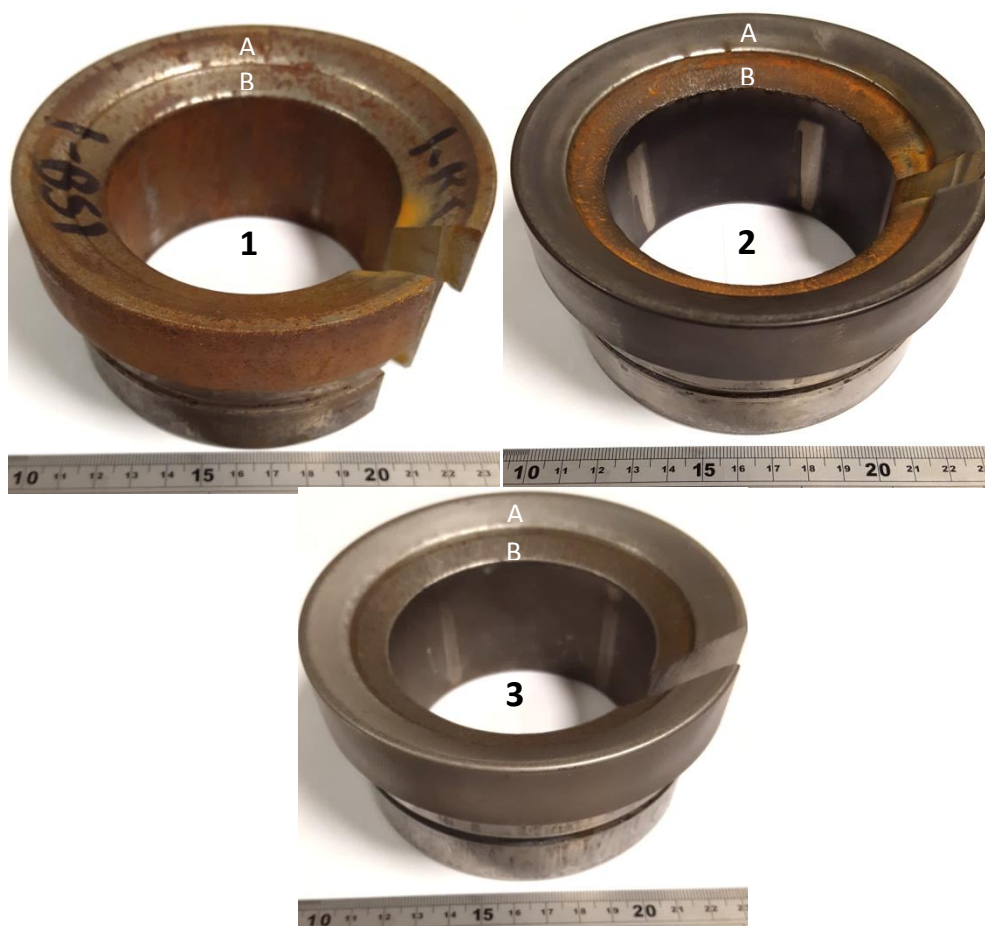
Figure 5.4: Field Trial valve seats: carburised UNS G86200 (1), nitrided 905M39 steel (2), UNS S42000 (3). Showing metal-urethane region (denoted A) and metal-metal region (denoted B)

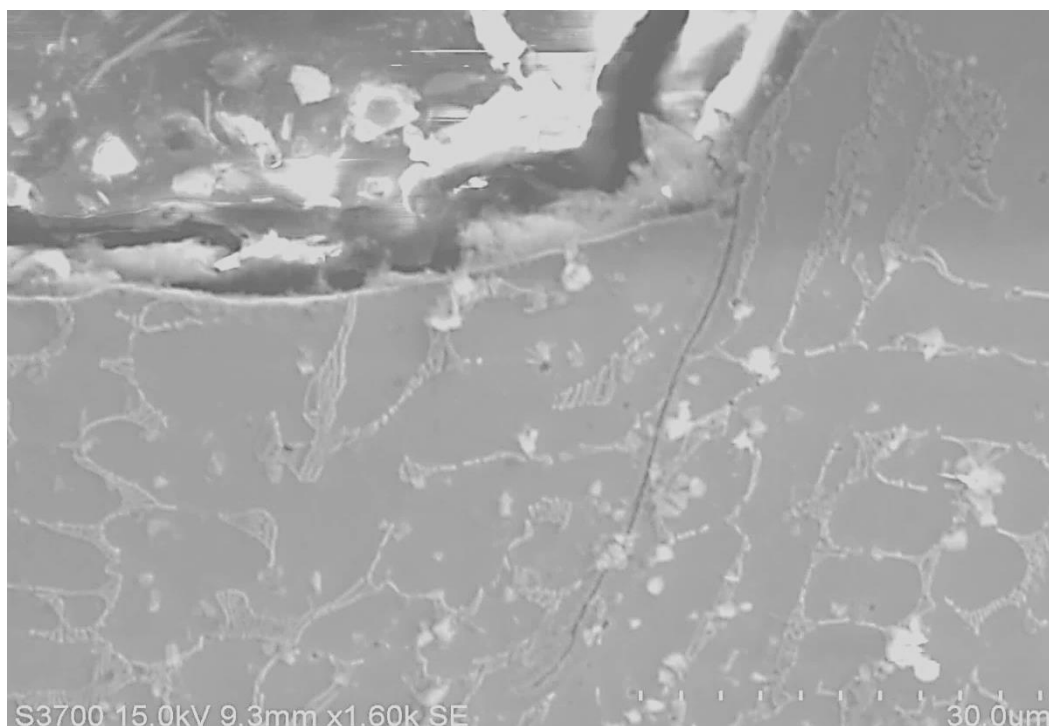
Figure 6.20: Cross section of repetitive impact wear scar of Stellite 6 double layer weld cladding demonstrating subsurface crack at edge of wear scar

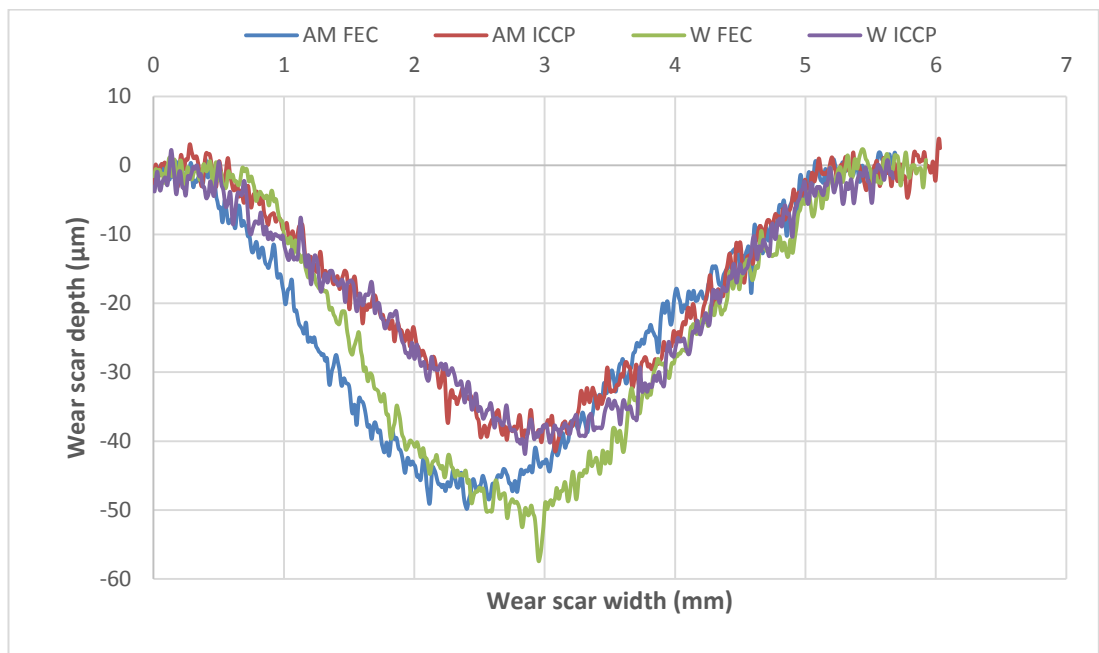
Figure C-16: Wear scar profiles for UNS N07718 W and AM in FEC and ICCP conditions
