UNIVERSITY OF STRATHCLYDE  
DEPARTMENT OF CIVIL ENGINEERING

**Influence of desiccation fissuring on the  
stability of flood embankments**

A thesis presented  
in fulfilment of the requirements  
for the degree of Doctor of Philosophy

2009

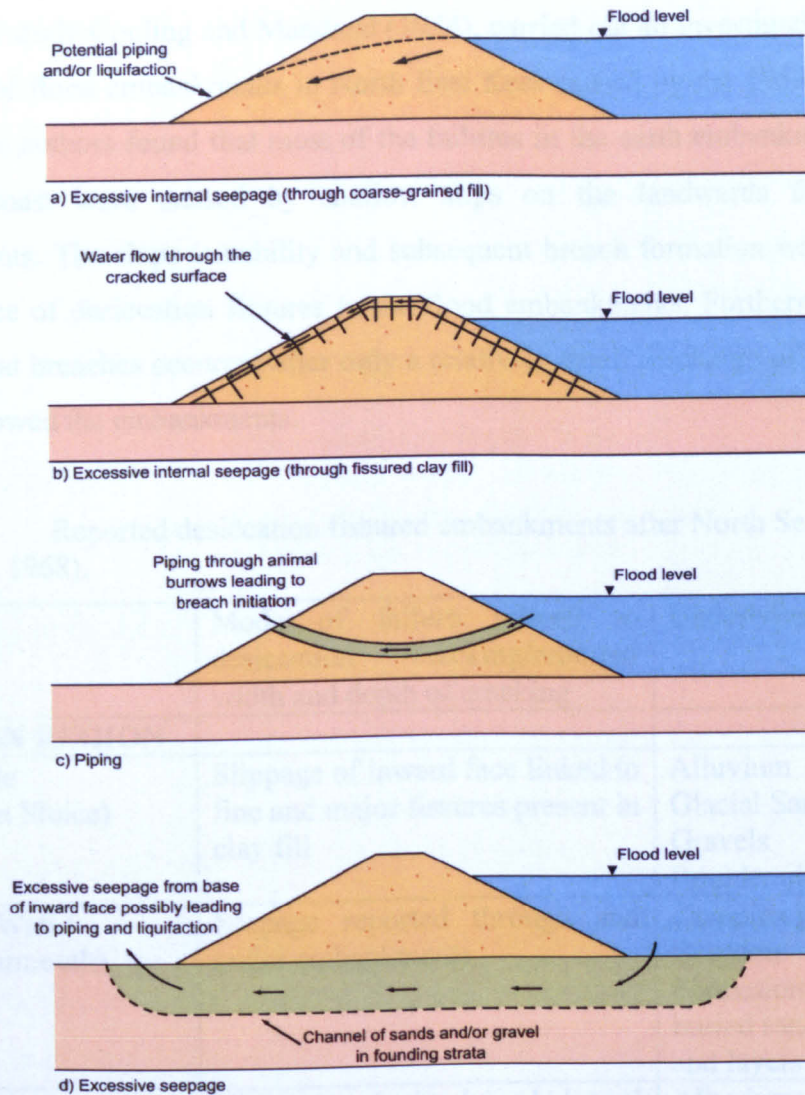
Figure 1.3 Seepage and piping through or under a flood embankment (modified from HR-Wallingford, 2004).

Lastly, one of the causes of embankment failure is seepage of flood water through or under an embankment. In the worst case, this can lead to collapse and breach formation of the structure. This may be accompanied by overtopping, which of course increases the seepage flow. However, especially in its early stages, the volume of water lost from internal seepage is often relatively small and the problem is sometimes ignored. If left untreated, finer particles of soil will be washed out of the embankment or the embankment's foundation by the flow. Thus, the problem is one of progressive deterioration; as the soil becomes more permeable, the flow rates increase and as a result, more particles of soil are eroded. Seepage will also increase the likelihood of slip failure as a result of changes to the piezometric regime within the embankment, causing a softening of the fill materials or increasing the uplift pressures beneath an embankment toe. This is well illustrated in Figure 1.3. The first image of Figure 1.3 shows a steady state seepage through a uniform flood embankment of coarse grained fill. In the second image, it is possible to visualise the localised seepage through the desiccated clay fill. In the third image, it is shown seepage through animal burrow holes leading to erosion. Finally the last image shows seepage beneath the embankment itself through channels, lenses or strata of highly permeable soil that can lead to erosion and / or piping.

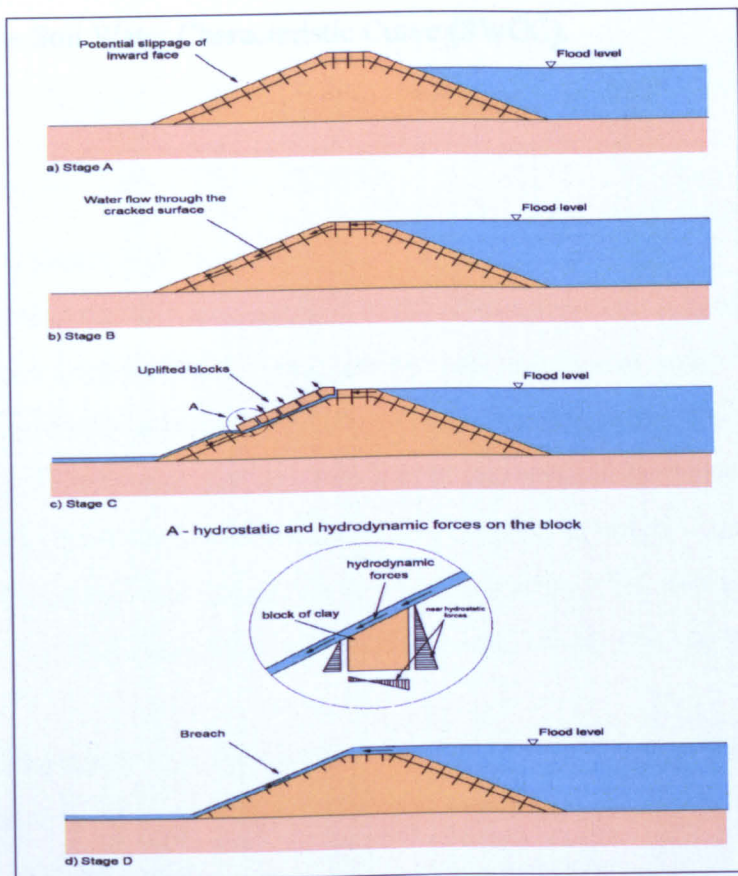
Figure 1.5 Proposed failure mechanism with breach formation of uplifted clay blocks (Dyer et al., 2009).

developed for uplift to take place. This kind of failure can take place only in the case, when the water is confined inside the cracking network with no outlet.

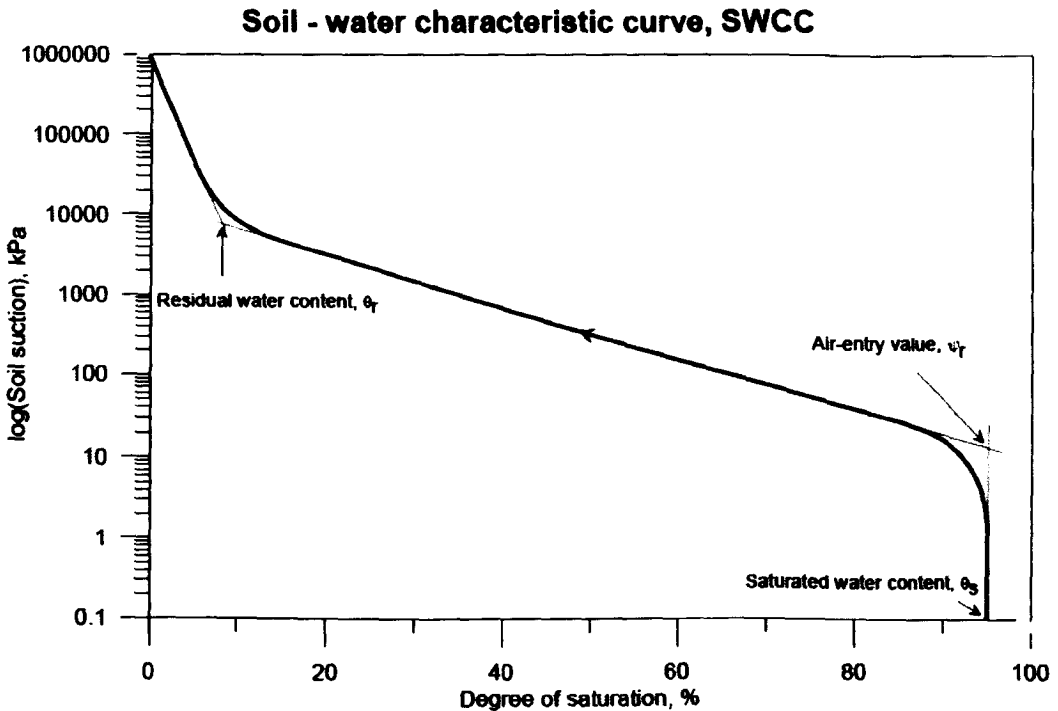
Figure 2.7 A typical Soil Water Characteristic Curve (after Leong and Rahardjo, 1997).

A typical SWCC using degree of saturation versus matric suction is presented below.

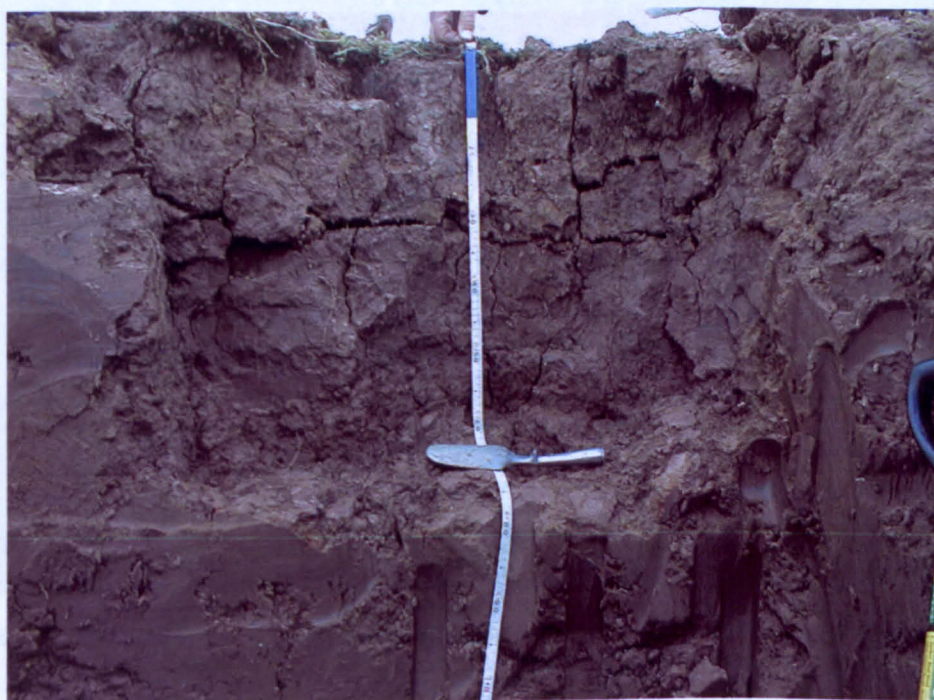
Figure 3.3 Desiccation fissures observed in trial trench at Thorngumbald flood embankment at an approximate depth of 600 mm below crest level (after Dyer et al. 2009).

Four trial trenches were excavated into the crest and landward slope of the flood embankment using a hydraulic back-actor with the final portion excavated by hand to minimise disturbance and expose the fissures. Disturbed and undisturbed soil samples were taken from the trenches for laboratory analysis. In addition, undisturbed samples were taken using a  $U_{100}$  sampling tube pushed into the side and base of the trench and then excavated. Visual inspection of the trenches revealed extensive fissuring of desiccated clay fill to a depth of approximately 600 mm below the crest height of the embankment in each excavation. A photograph of one side of the trench is shown in Figure 3.3.

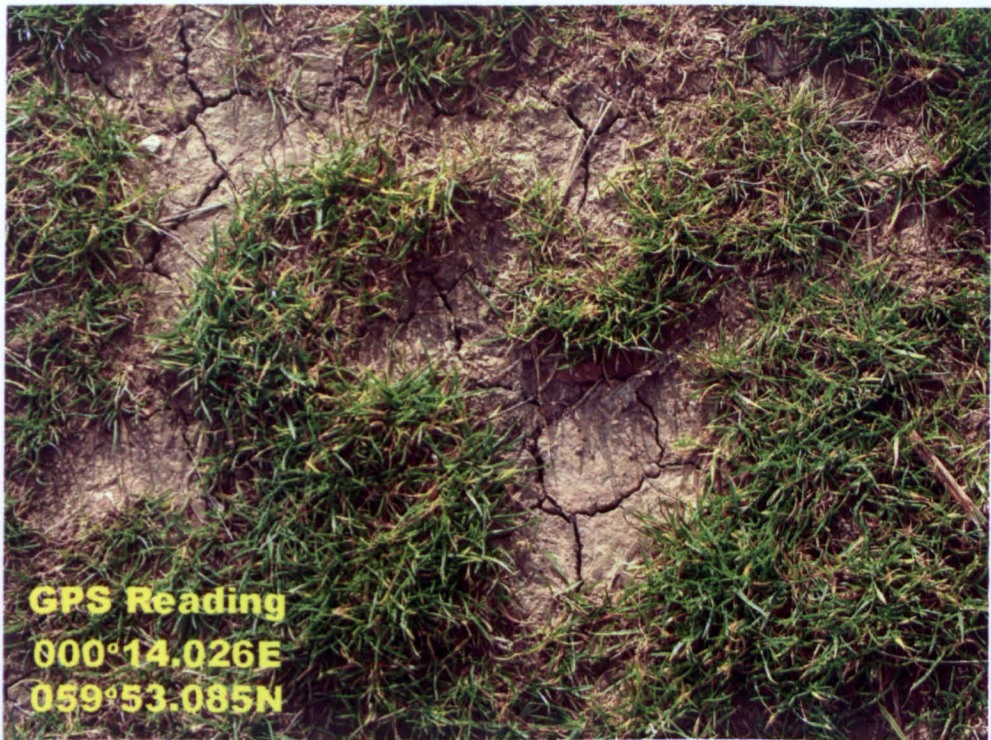
Figure 3.9 Pattern of desiccation cracks observed on the crest of the new embankment (2006).

The field survey of the new embankment in 2006 identified desiccation fissures along the crest of the embankment as shown in Figure 3.9 and Figure 3.11. The image in Figure 3.9 shows a polygonal pattern of fissures that are characteristic of desiccation cracking. Figure 3.10 shows the sketch of measured dimensions for one particular polygonal pattern. In comparison the image in Figure 3.11 shows a pronounced longitudinal crack that is more characteristic of differential movement. The widths of the polygonal desiccation fissures varied from 5 mm to 25 mm and were generally found where the embankment lacked a healthy grass cover, for the reasons explained earlier in Chapter 1.

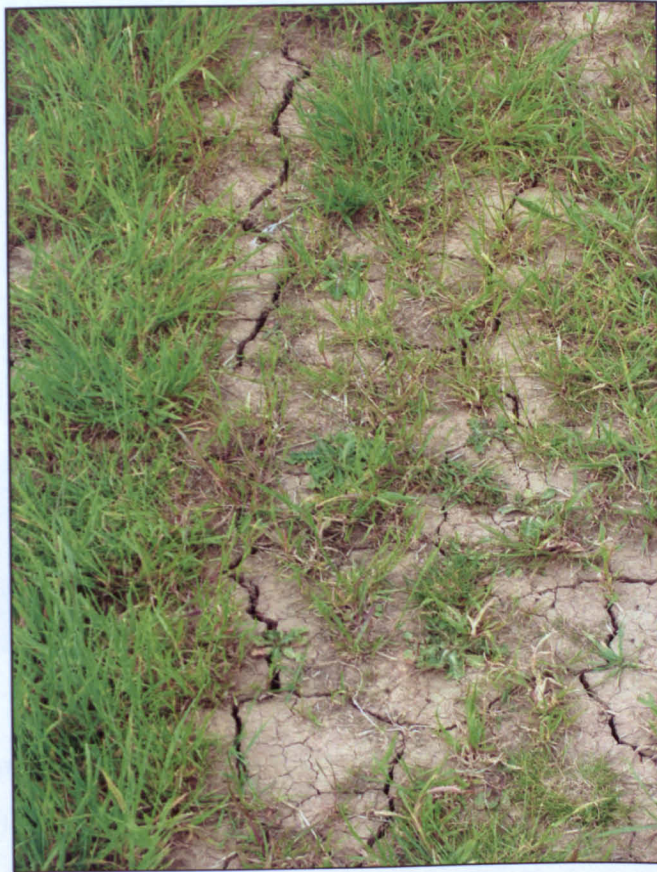
Figure 3.11 Pattern of desiccation and differential fissures observed along crest of new embankment (2006).

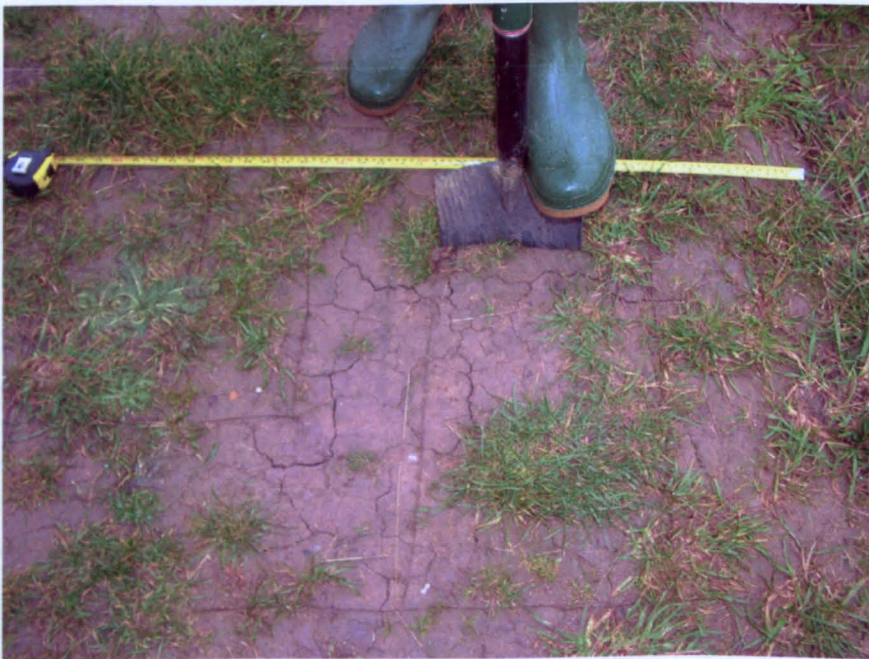
Figure 3.13 Photograph of surface desiccation fissuring on crest of new embankment prior to hand excavation (2006).

These fissures appeared to be more pronounced where grass cover was bare or absent (see Figure 3.13).

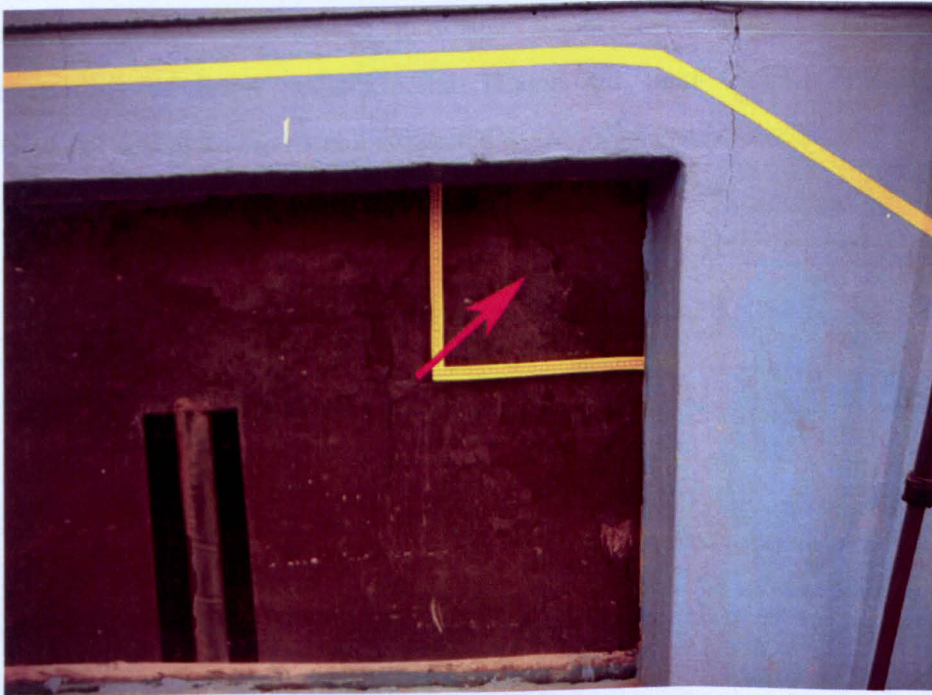
Figure 7.38 Crack parallel to the slope.

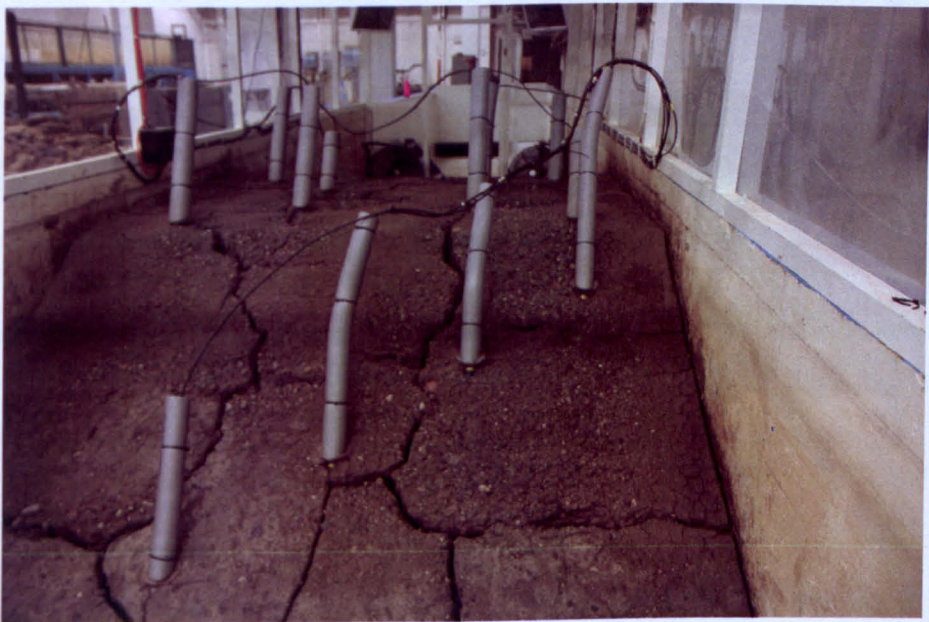
Figure 8.2 Gap between embankment model and concrete flume.

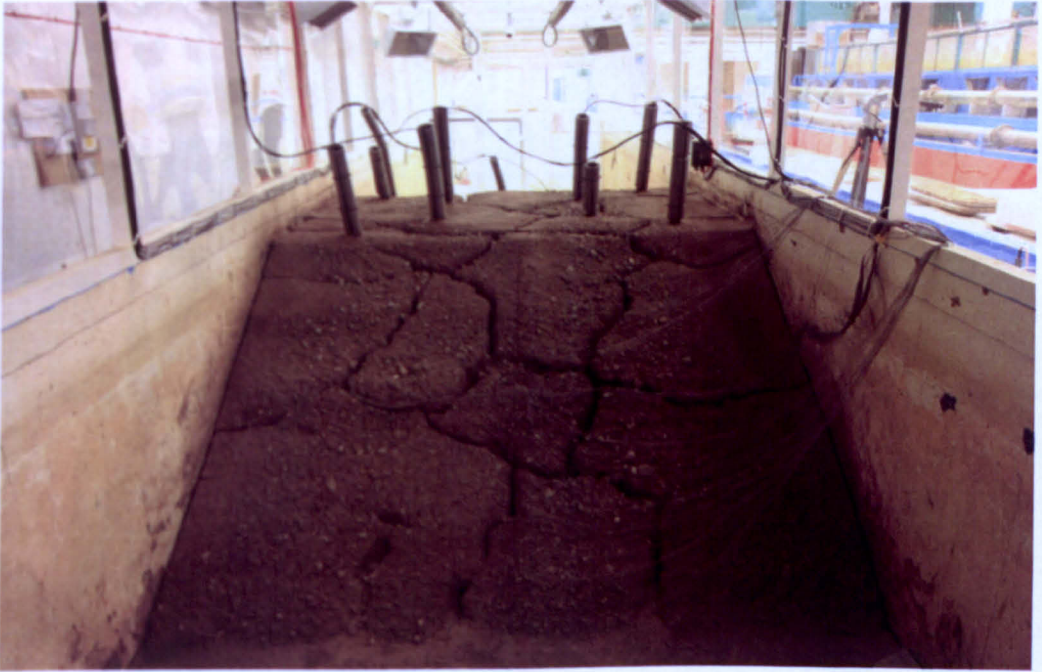
Figure 8.3 Embankment model with the experimental set up.

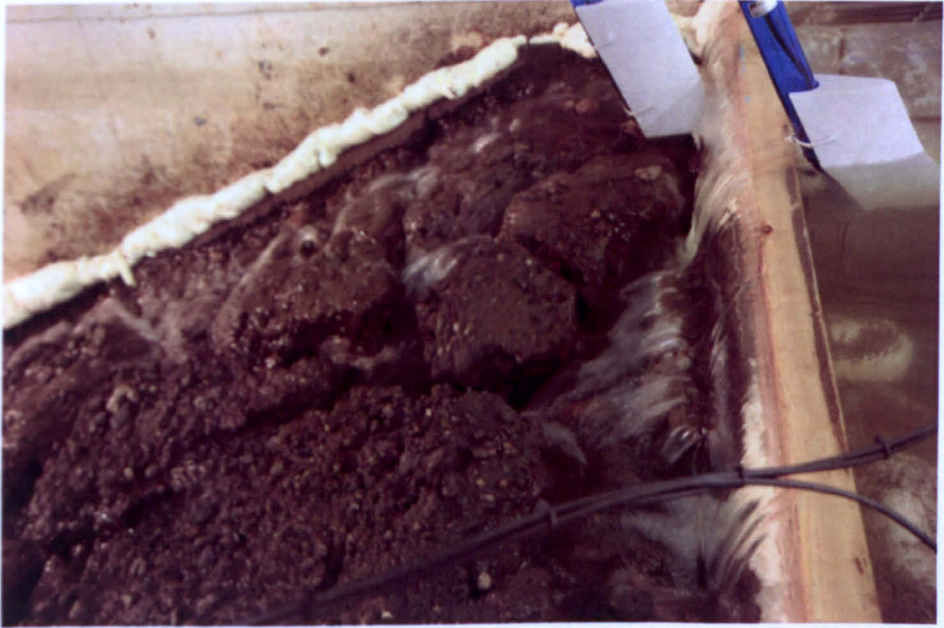
Figure 8.22 Collapsing clay block.

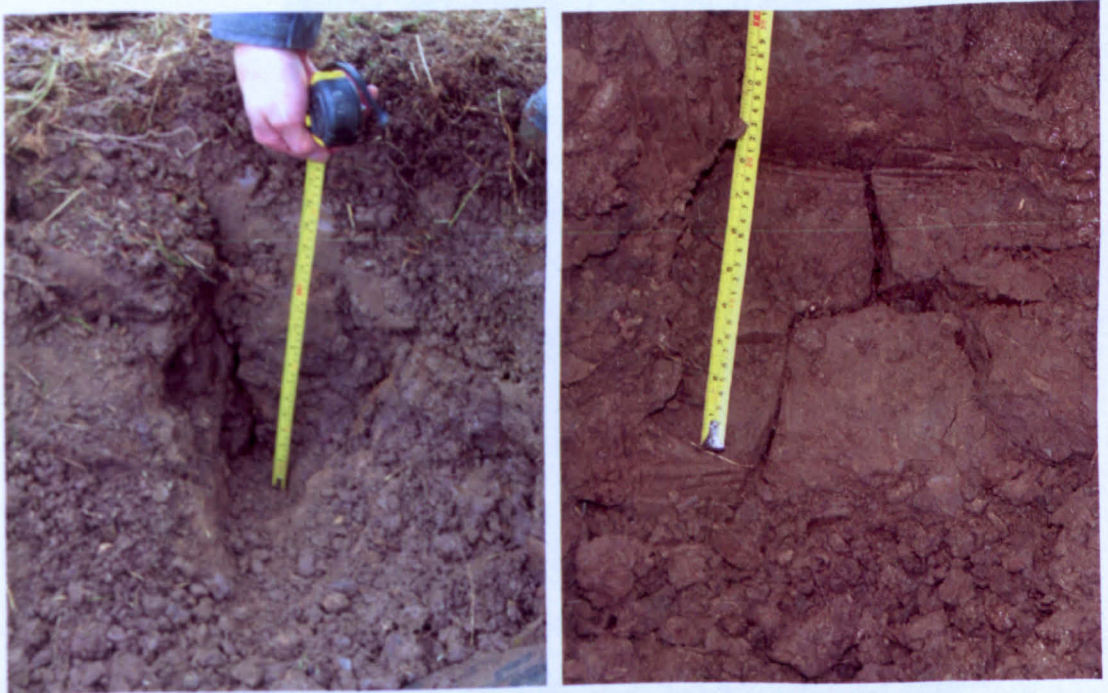
Figure 14.11 Left picture - vertical crack (depth-300mm), right picture - crack network (depth-400mm).
