An Experimental Approach into the Degradation of Wind Turbine Blade Coating Systems due to Rain and Weathering

PhD Thesis

Wind & Marine Energy Systems CDT,
Department of Electronic & Electrical Engineering,
University of Strathclyde, Glasgow

February 2023

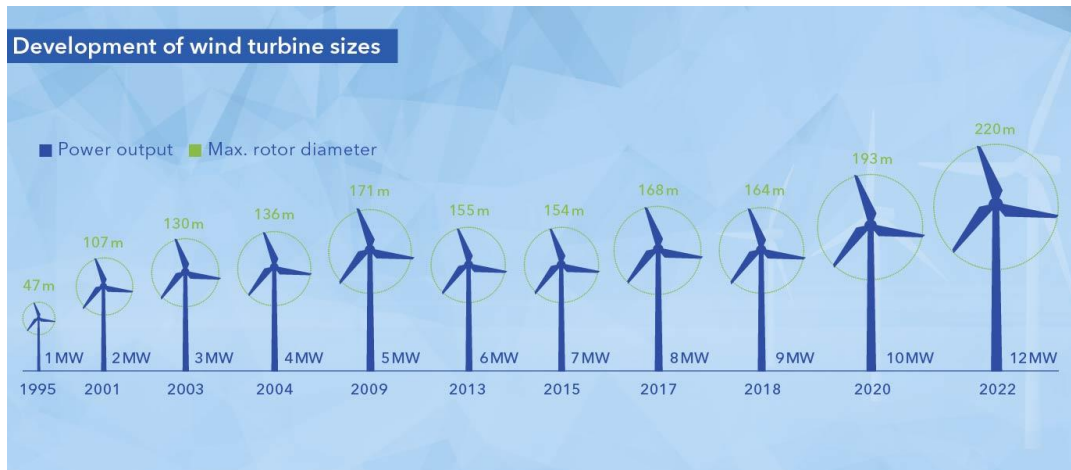
Figure 2.1: Growth in Wind Turbine Swept Area and Power Output. [8]

If the goal is to utilise the maximum available wind potential energy, the main approach is to enlarge the area of wind that the turbine can access, which is achieved by increasing the length of the blades. Figure 2.1 shows the trend in wind turbine design to increase the rotor swept area to allow for greater power capture, which will, in turn, enable the turbine to produce an increased power output, from the A term in Equation 2.1.

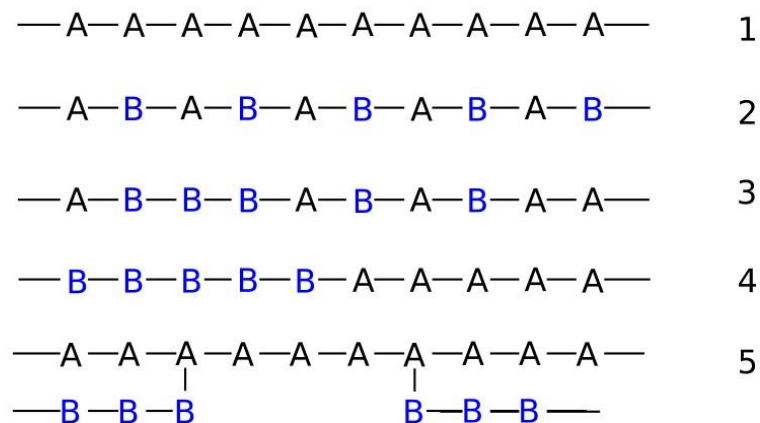
Figure 2.13: Common Polymer Architectures, Where A and B Are Two Distinct Monomers. 1 - Homopolymer, 2 - Alternating Copolymer, 3 - Statistical Copolymer, 4 - Block Copolymer, 5 - Graft Copolymer. [35]

Polymer architecture affects how polymer chains interact. The architecture depends on the arrangement of monomers within the polymer chain. Polymer architecture can be controlled through varying the polymerisation method. Some typical architectures are shown in Figure 2.13. The structure of homopolymers and alternating copolymers allow for multiple polymer chains to interact and bond together in a tight, dense, ordered structure, meaning they can crystallise [34]. Some other polymer architectures can partially crystallise such as block polymers and graft polymers. The amount of crystallisation will have an effect on the material properties, an increase in crystallinity, the percentage of crystallisation, will yield a denser material which would tend to become more brittle, but this is dependent on molecular weight. The Young's modulus of the material will increase linearly, along with the degree of crystallinity [34].

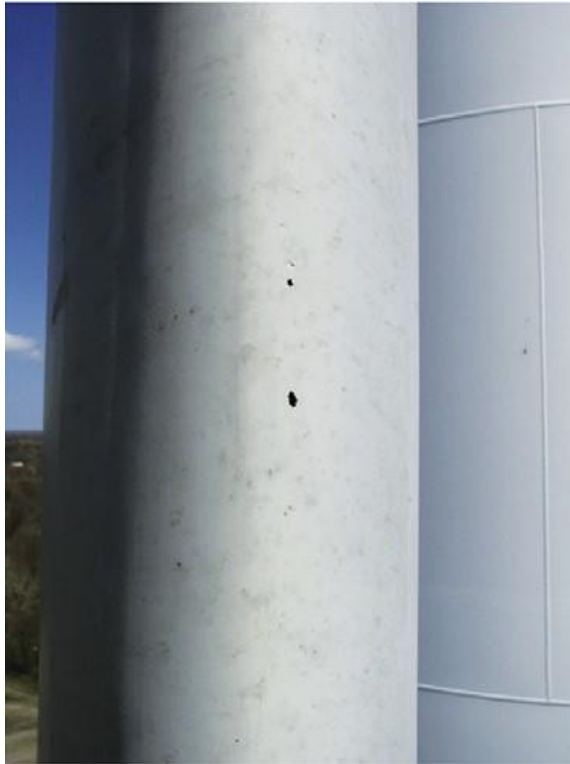
Figure 2.23: Small Pits Form [47]

Erosion is a gradual process which develops over time. Over this period of time, several stages of the erosion process are identifiable. Figure 2.23, Figure 2.25 & Figure 2.24 show photographs of wind turbine blades which have suffered from erosion damage. Figure 2.23 displays the initiation of the erosion damage where small pits develop along the leading edge of the blade. These small pits then deepen and coalesce to form larger eroded patches as shown in Figure 2.24. The larger patches further erode until the protective coating has been completely removed from the blade's leading edge, the erosion damage then starts to attack the blade structural material as shown in Figure 2.25.

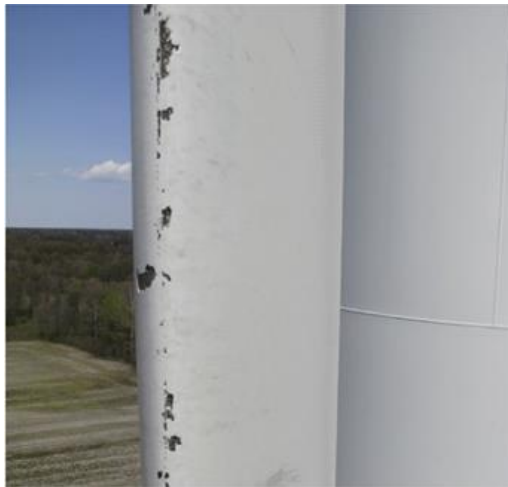
Figure 2.24: Pits Join and Deepen [47]

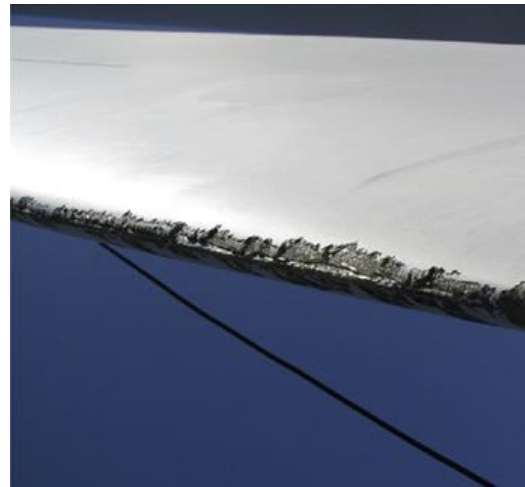
Figure 2.25: Exposure of the Blade Structure Material. [47]

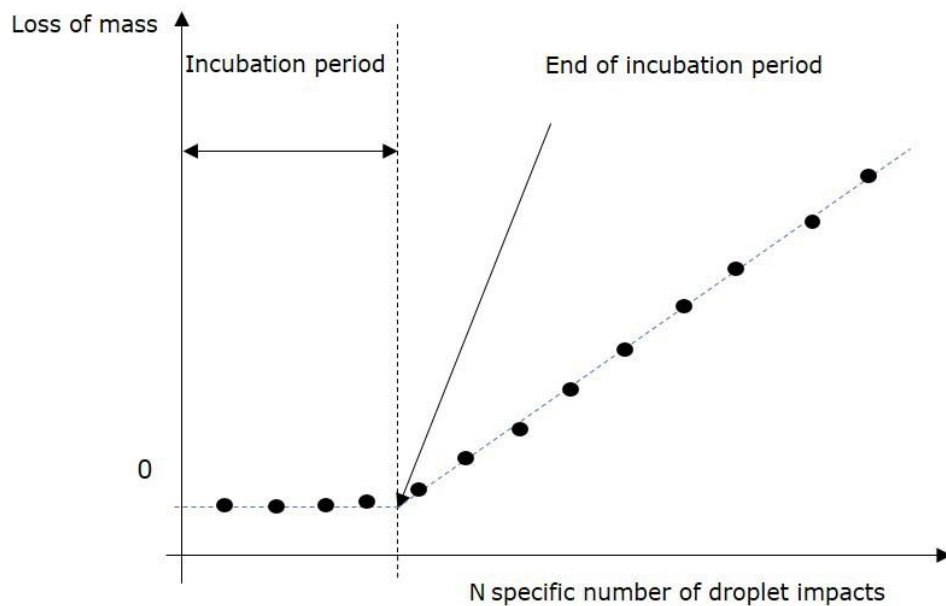
Figure 2.29: Erosion Test, Showing the Incubation Period. [50]

begin to crack and fatigue the surface [49]. Figure 2.29 illustrates the incubation period on a plot of mass loss versus the number of impacting water droplets.

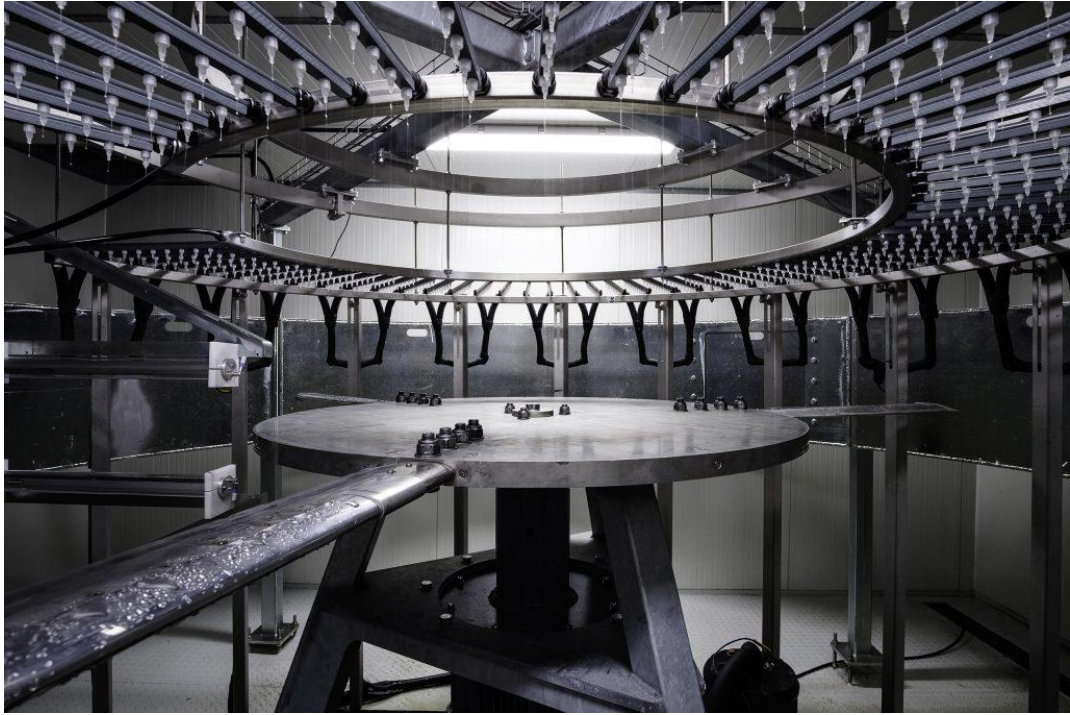
Figure 2.34: Photograph of R&D A/S Whirling Arm Type Rain Erosion Rig. [55]

Below the grid of droplet creating needles sits the rotating arms which the test samples are mounted to. The rotating arms and the grid of needles are shown in Figure 2.34. During testing, the rotating arms spin and strike the water droplets created by the needles, simulating leading edge strikes of a turbine blade. The rotating arms are controlled via a central motor, much like a helicopter blade, where the rotational speed of the arms is set. Additionally, the droplet flow rate from the needles can be adjusted via the water pressure and the water droplet size can be altered by changing the needle size.

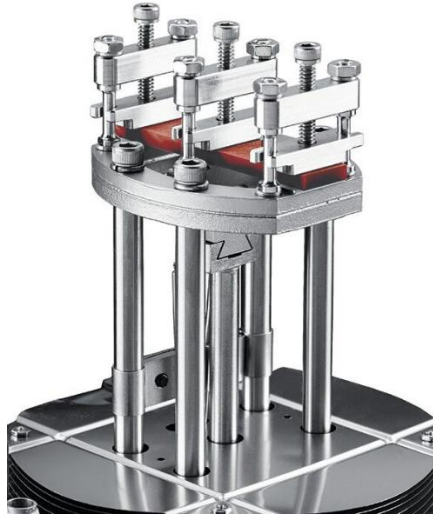
Figure 3.1: DMA Dual-Cantilever Clamp Type [68]

Within this work, a dual-cantilever clamp with a multi-frequency test mode was used. Initially, a 3-point bend clamp was used as this clamp type requires no clamping on the specimen, however, during testing specimens fell out of the clamp at the higher frequencies. Therefore, the dual-cantilever clamp was selected to secure the specimens in place. The dual-cantilever clamp held the specimen in place by a static clamp at either end, as shown in Figure 3.1, with the central clamp moving according to the test mode selected.

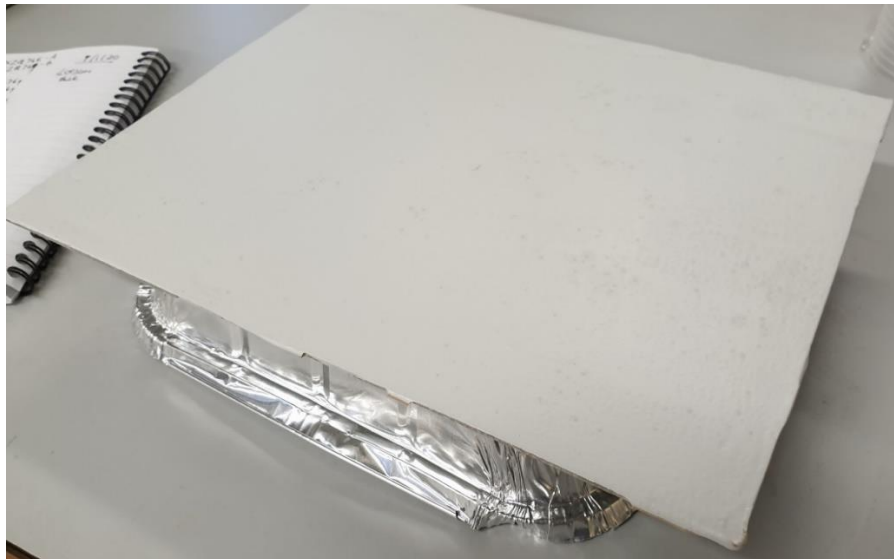
Figure 3.12: Coated Substrate

Once the substrate had been sanded and cleaned, the filler layer of the supplied coating system was applied to the substrate using a putty spreader tool, according to the manufacturers guidelines. A thickness of 2mm was achieved, using a wet film thickness gauge to check. The filler layer was left to cure overnight at ambient conditions. The following morning, the filler layer was sanded, using P240 paper, to even out the surface and remove a thin layer of the filler. After sanding, the filler layer was lightly cleaned with ethanol to remove any surface debris. Next, the topcoat layer was prepared and mixed according to the manufacturers guidelines. The topcoat was applied by a fine napped roller to a thickness of 150 μ m, checked by a wet film thickness gauge. The topcoat was allowed to cure, at ambient conditions, for 18 hours overnight. The following day, the LEP was prepared and mixed according to the manufacturers guidelines. The LEP was then applied by a fine napped roller to a thickness of 400 μ m, checked by a wet film thickness gauge. No sanding of the topcoat layer was required as the LEP was applied within the allowed overcoating interval. Once the LEP was applied, the coating system was complete. The coated substrate was then left to cure at ambient conditions for one week, see Figure 3.12.

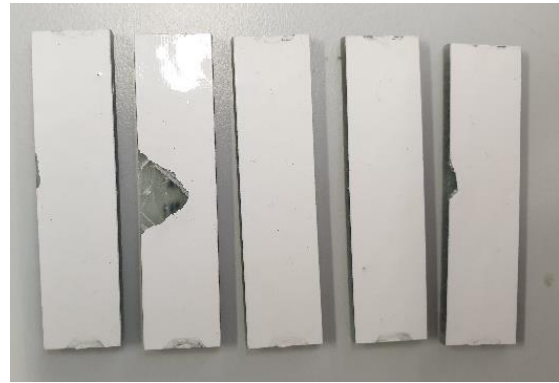
Figure 4.5: Photo, Stage 2, RET, Coating B

Looking at the coating B specimens, the first area to note is that some of the specimens are failing prematurely. For example, in Figure 4.5 the incubation stage is shown where there should be no visible surface damage, however, the second specimen in from the left is showing a large area of substrate exposure where the coating system has been removed. This is also observable, though on a smaller scale, in the first and last specimens shown in Figure 4.5. Again, this same behaviour of premature failure can be seen in Stage 3 erosion in Figure 4.6.

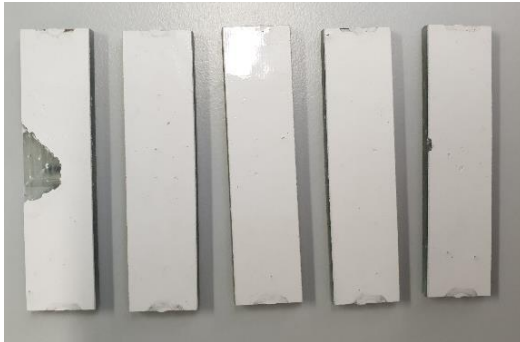
Figure 4.6: Photo, Stage 3, RET, Coating B

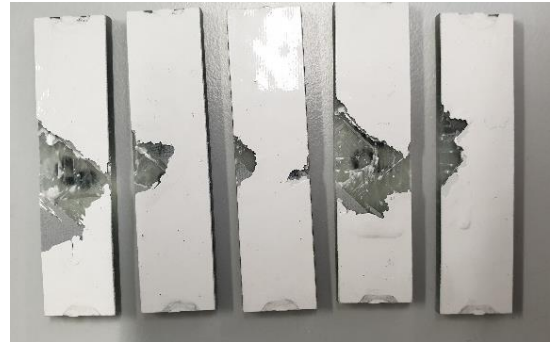
Figure 4.7: Photo, Stage 4, RET, Coating B

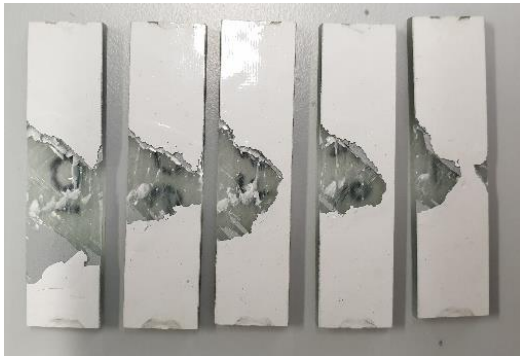
Figure 4.8: Photo, Stage 5, RET, Coating B

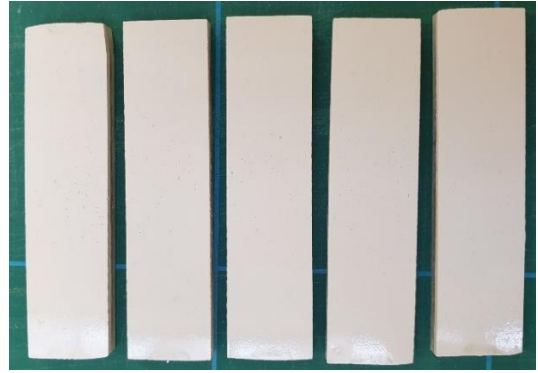
Figure 4.10: Photo, Stage 2, RET, Coating C1

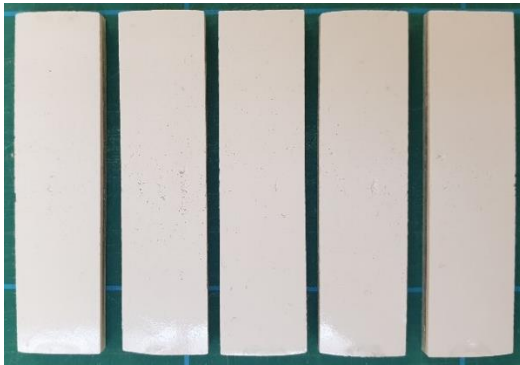
Figure 4.11: Photo, Stage 3, RET, Coating C1

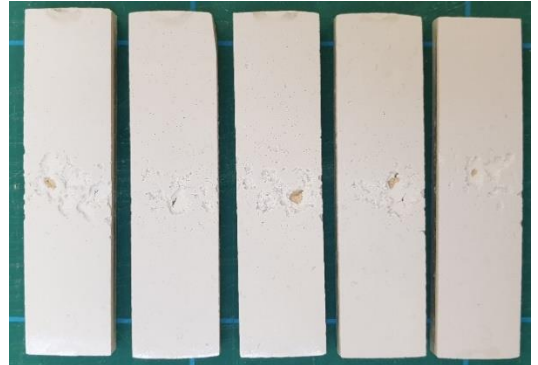
Figure 4.12: Photo, Stage 4, RET, Coating C1

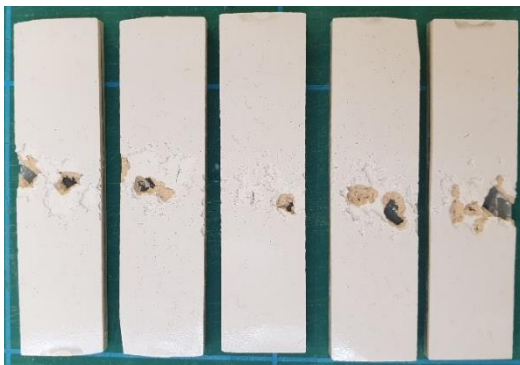
Figure 4.13: Photo, Stage 5, RET, Coating C1

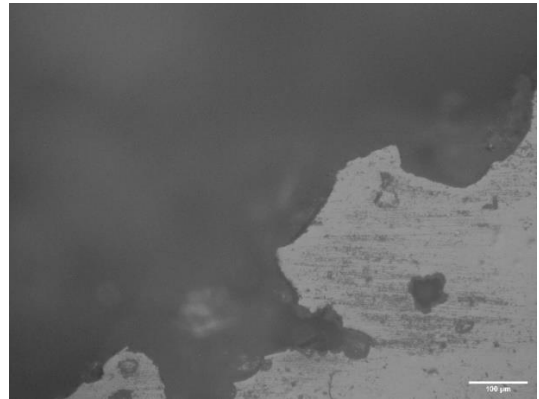
Figure 4.22: Microscopy, Stage 4, RET, Coating C1

respectively. Stage 1 shows that the surface is not entirely smooth and uniform, as would be expected from looking at Figure 4.9. There are small pinholes and defects in the surface microstructure. Similar to coating B, this is due to the mixing and application of the coating system where air pockets have been trapped and rise to the surface during curing. Moving to Stage 2, Figure 4.10 shows that the pinholes have begun to grow and deepen, however, this damage is still not visible to the naked eye. Stage 3 is where the surface microstructure begins to heavily degrade. Figure 4.21 shows areas of coating removal, in the form of craters, at significant depth and size. In Stage 3, the smaller pinholes present at Stage 2 have collated and merged into much larger holes. Looking at Stage 4, large areas of coating have now been removed. This is also now easily detectable to the naked eye, Figure 4.12. Under the microscope, Figure 4.22 shows a cliff edge like erosion pattern where, once the LEP has been eroded, the remaining layers of the coating system fail and are removed quite quickly. Stage 5, Figure 4.23, shows that the coating system has failed entirely and there is no coating remaining on the specimen at the droplet impact area and the composite substrate is exposed.

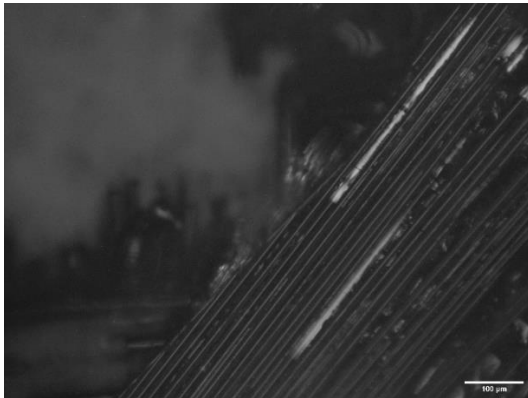
Figure 4.23: Microscopy, Stage 5, RET, Coating C1

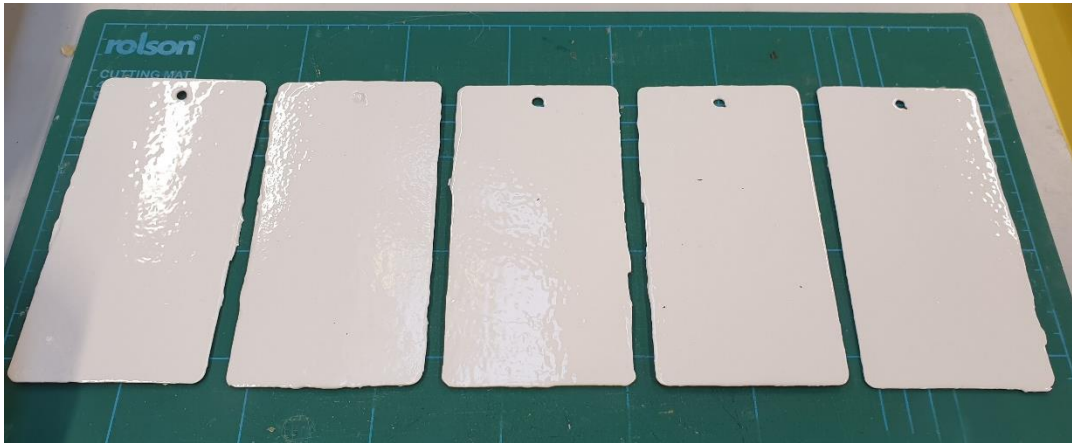
Firstly, specimens were prepared as described in Specimen Manufacture and Preparation, Chapter 3, Section 3.2, however, the dimensions of the specimens differed due to the dimension requirements of the accelerated testing equipment. Dimensions of all specimens tested in this work were 76mm by 152mm (3 by 6 inches). Coated specimens which were ready for testing can be seen in Figure 5.1.

Figure 5.1: Weathering Specimen Size

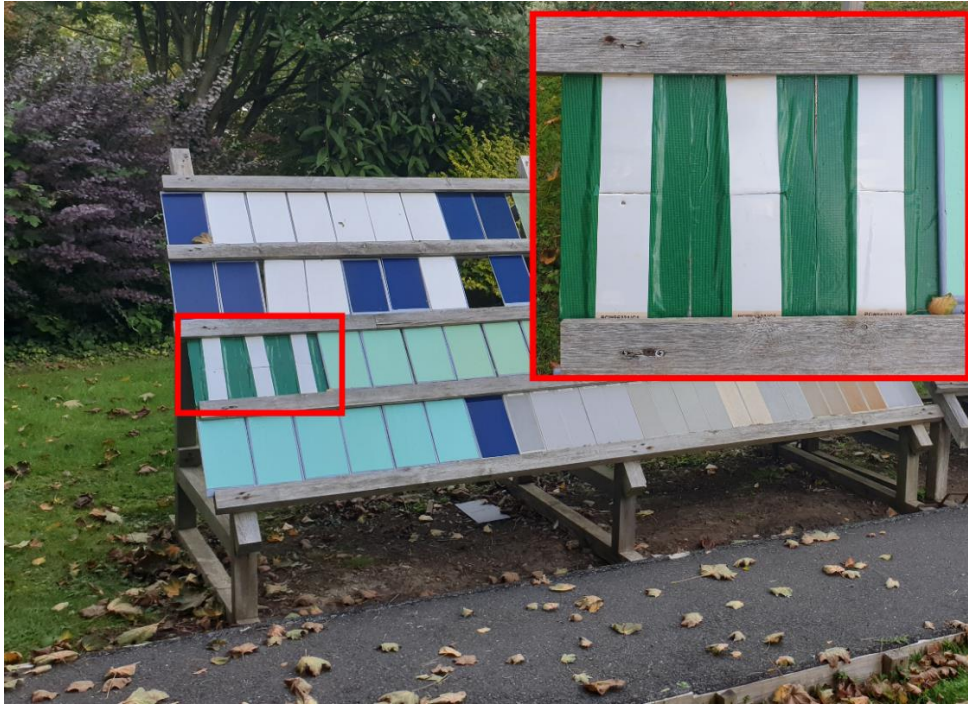
Figure 5.4: Natural Outdoors, Coating C, Gateshead. Red box highlights sample location.

Coating B, shown in Figure 5.3 was tested onsite at OREC, Blyth and coating C1 & C2, shown in Figure 5.4 was tested onsite at the coating manufacturer in Gateshead.

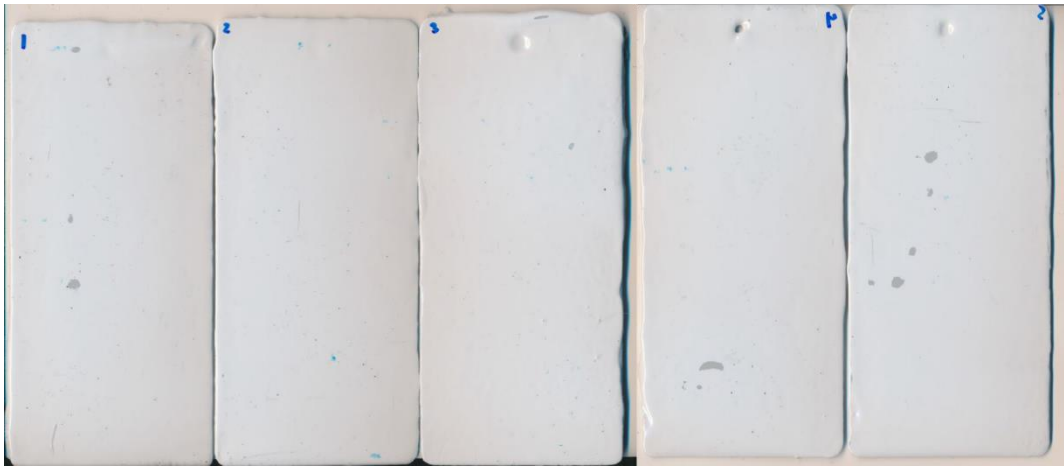
Figure 5.6: Photograph, Coating B, UVa, End of Test (3000hrs)

The comparison of photographs of coating B specimens taken before and after the UVa weathering cycle, Figure 5.5 and Figure 5.6 respectively, show that the accelerated UVa cycle causes a physical surface change in the coating system. After the period of UVa weathering, the surface begins to bruise where darker patches of surface coating develop.

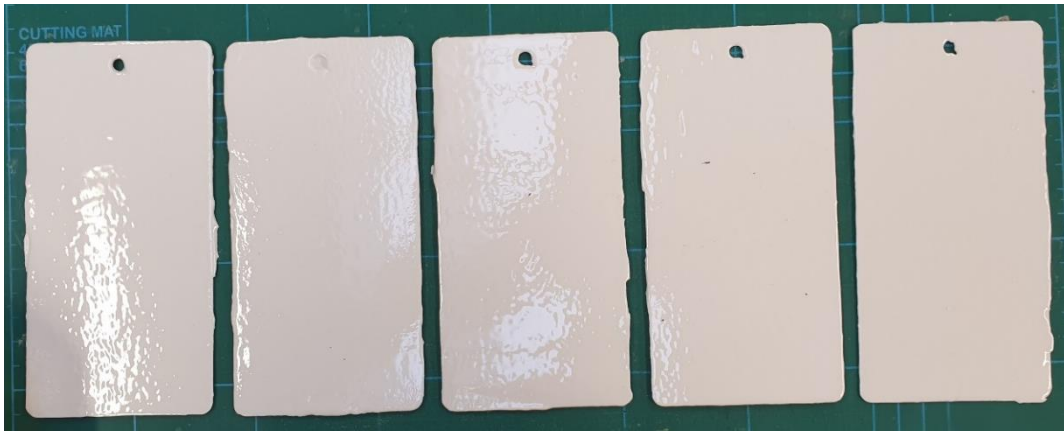
Figure 5.7: Photograph, Coating B, Natural Outdoors, Start of Test (0hrs)

Looking at the naturally weathered specimens, Figure 5.7 and Figure 5.8, there is not much change between the start of test specimens and the end of test specimens. Some surface staining is present along the top of the specimens, just below the hole, in a linear pattern. This is due to the mounting fixture of the test rack which holds the specimens in place. The mounting fixture would secure the samples along this line. Therefore, it can be reasonably assumed that the observed staining is due to dirt and grime collection along the mounting fixture.

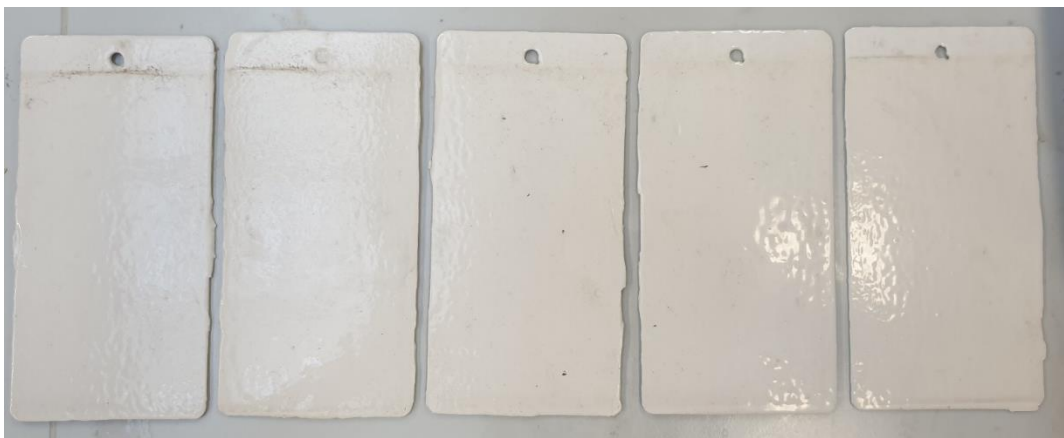
Figure 5.8: Photograph, Coating B, Natural Outdoors, End of Test (4750hrs)

Some other darker marks are present on a few of the specimens at the end of the test. Upon close inspection, these marks look like scuffs on the specimen.

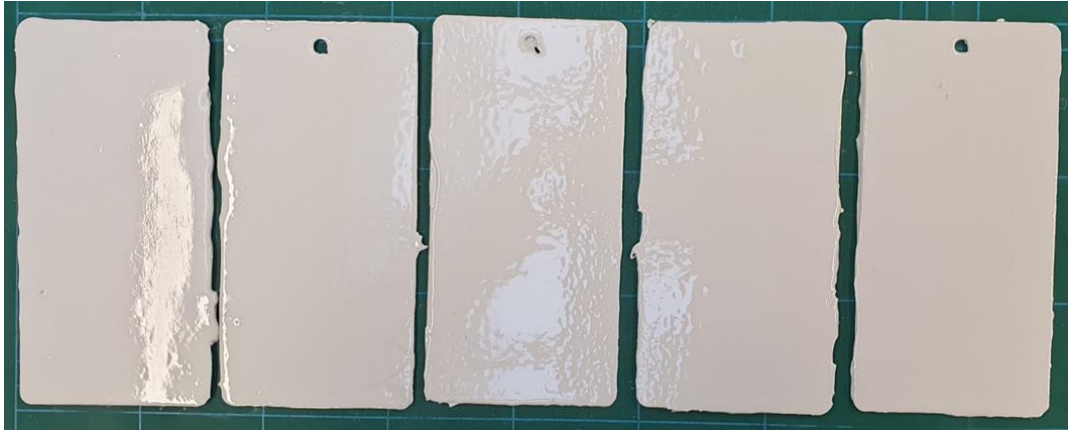
Figure 5.9: Photograph, Coating B, NSM, Start of Test (0hrs)

Next, the comparison of photographs for the North Sea Method of coating B. The start of test photographs are shown in Figure 5.9 and the end of test are shown in Figure 5.10. The specimens remain largely unchanged in their appearance, this is likely due to the shorter duration of the test at 1500 hours, versus the standard UVa cycle as well as the NSM cycle using lower irradiance and temperature values. Upon close inspection there are small dark marks which appear after on the specimen surface after the test, again, similar to the previous weathering tests.

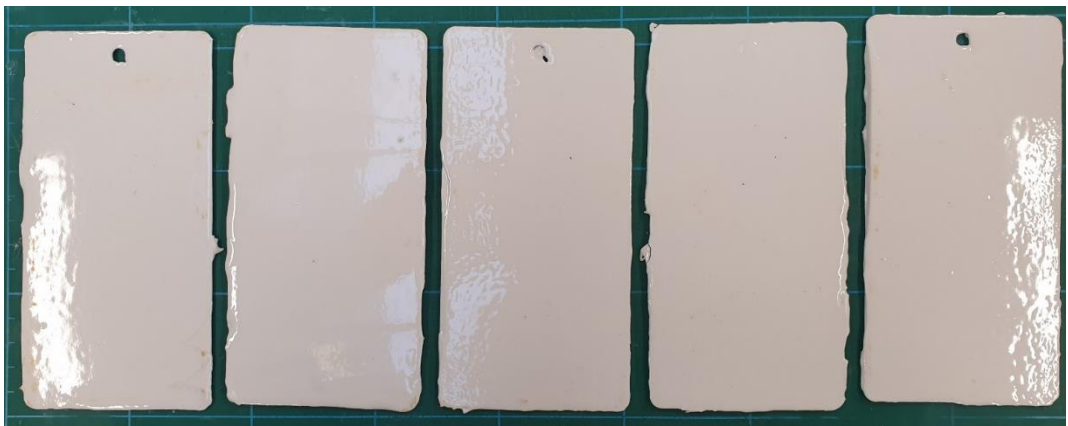
Figure 5.10: Photograph, Coating B, NSM, End of Test (1500hrs)

The dark marks which appear on the specimen surface of coating B after each weathering test are likely a resultant factor of exposure to UV radiation and/or humidity.

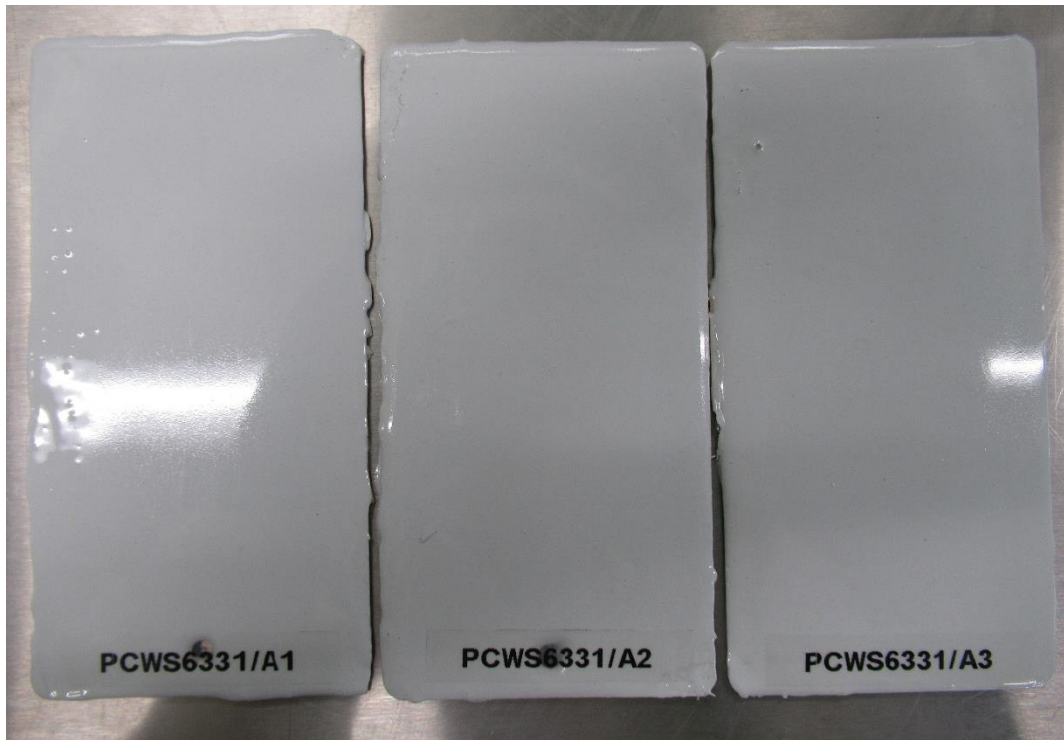
Figure 5.11: Photograph, Coating C1, UVa, Start of Test (0hrs)

Figure 5.11 and Figure 5.12 show coating C1 under UVa weathering at the beginning and end of the test. Overall, there is no drastic change in the surface appearance of the specimens. Some small dark marks have appeared throughout the test.

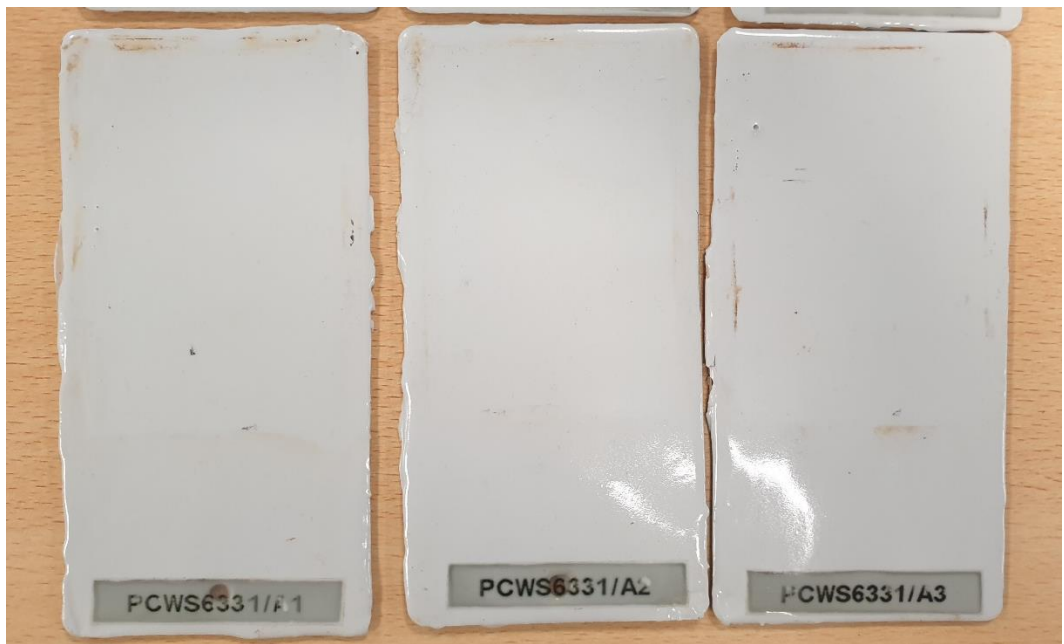
Figure 5.12: Photograph, Coating C1, UVa, End of Test (7500hrs)

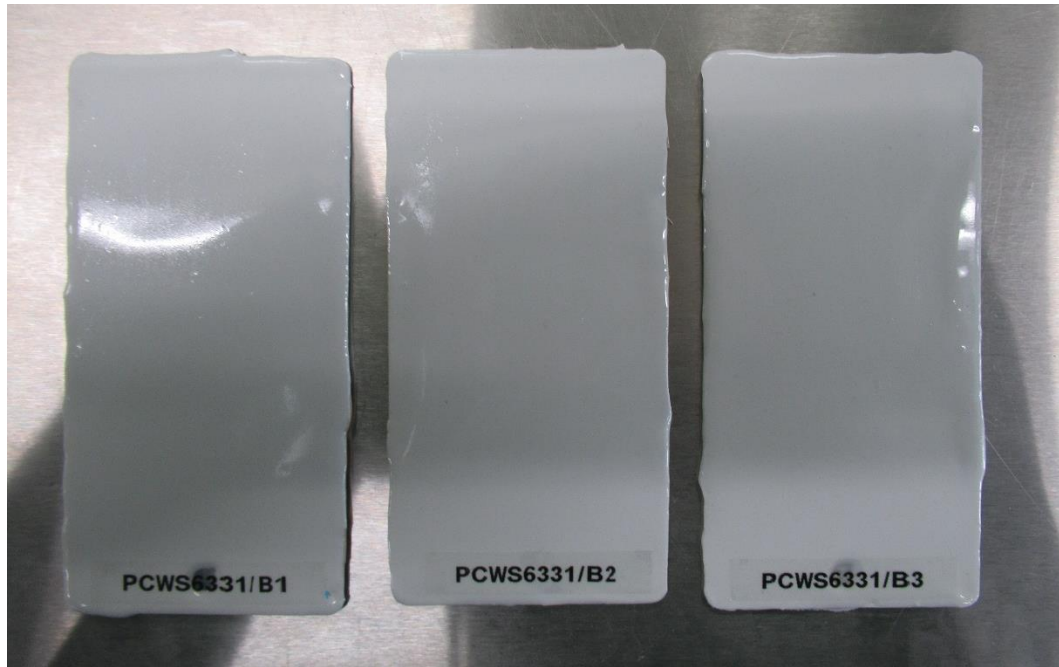
Figure 5.13: Photograph, Coating C1, Xenon-Arc, Start of Test (0hrs)

Looking at the Xenon-Arc test of coating C1, Figure 5.13 and Figure 5.14 Figure 5.15, it is clear that at the end of the test, there is a noticeable change in the surface appearance. Firstly, the surface is no longer shiny and glossy, it appears more matt. Also, a large crack had developed on one of the specimens on the left hand edge half way up.

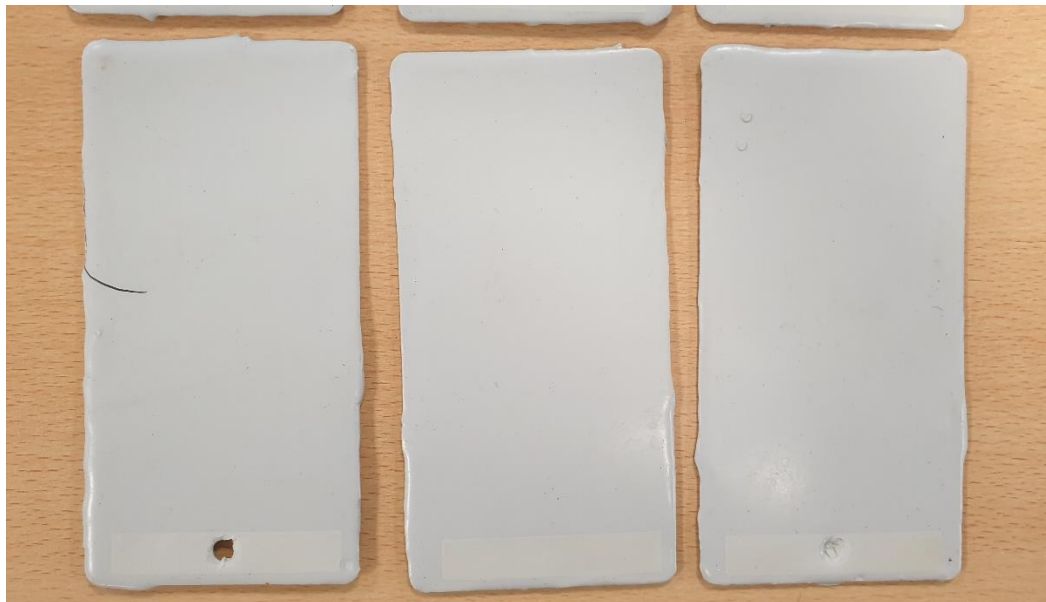
Figure 5.14: Photograph, Coating C1, Xenon-Arc, End of Test (6000hrs)

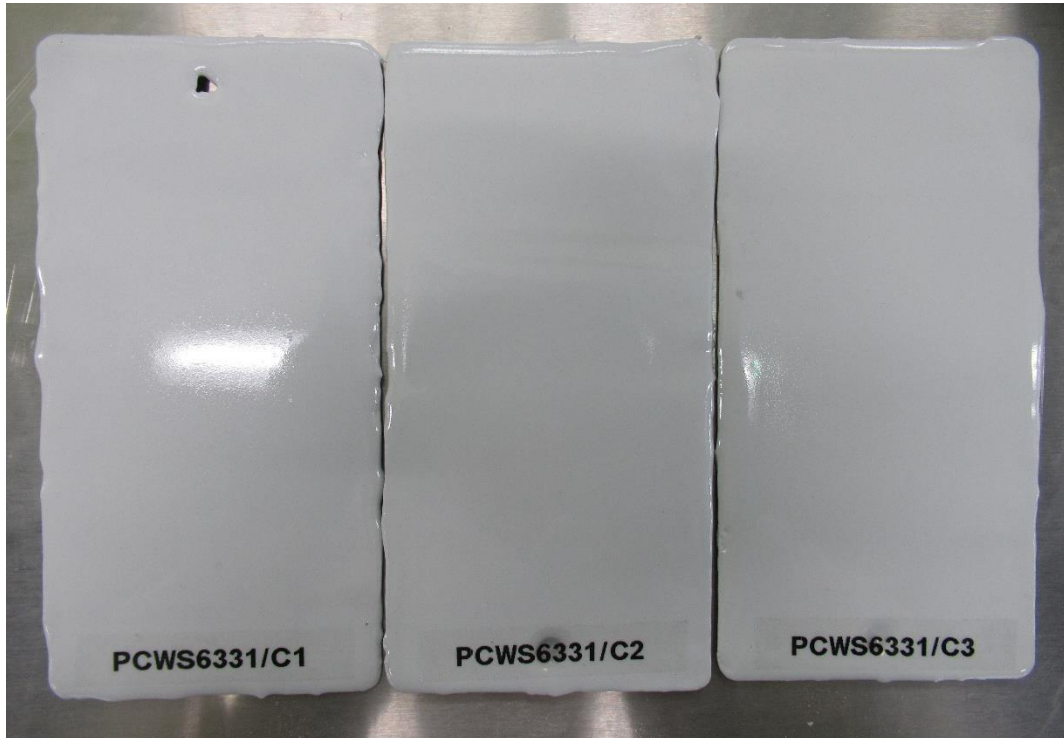
Figure 5.15: Photograph, Coating C1, Natural Outdoors, Start of Test (0hrs)

Next, the naturally weathered samples, Figure 5.15 and Figure 5.16, show a distinct surface appearance change after weathering. The lines which are present on the sides of each specimen are due to the tape used to hold the specimens to the test rack, the middle area of the sample should be considered for analysis. Surface staining is apparent as well as surface debris. Both are likely due to the test location, near a wooded area. Leaves and branches are known to fall from the surrounding trees onto the specimens.

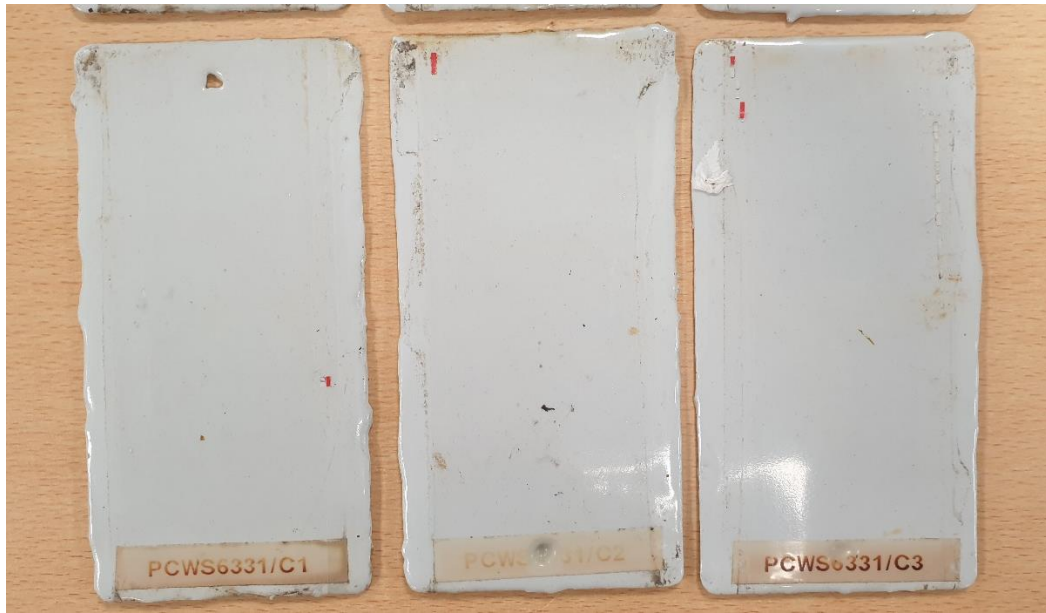
Figure 5.16: Photograph, Coating C1, Natural Outdoors, End of Test (13650hrs)

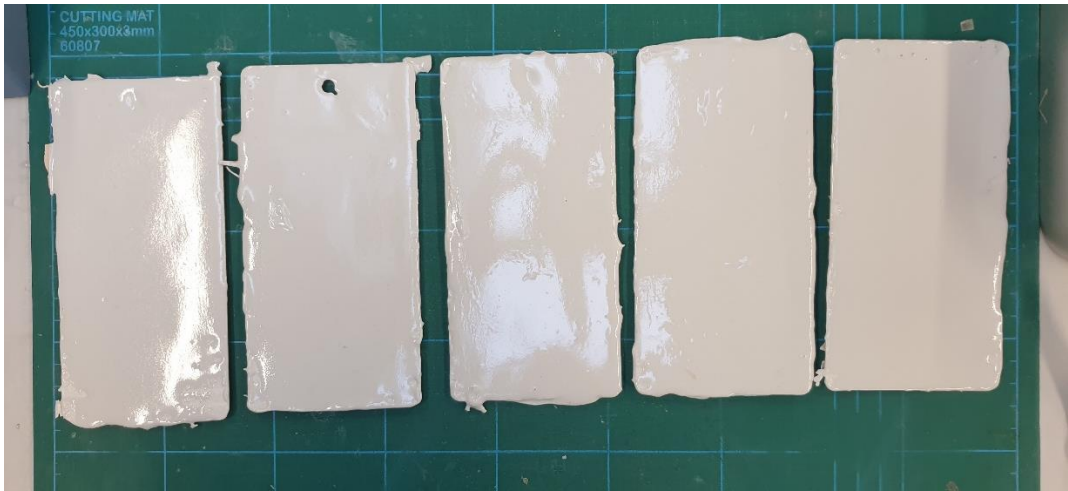
Figure 5.17: Photograph, Coating C1, NSM, Start of Test (0hrs)

Then, looking at the North Sea Method test specimens for coating C1 shown in Figure 5.17 and Figure 5.18, there is very little visually observable difference between the start and end of test. However, there are a few small bruise marks which appear on some of the test specimens, but no significant observable change. This is primarily due to the reduced test duration of 1500 hours as well as the reduced irradiance intensity of the test.

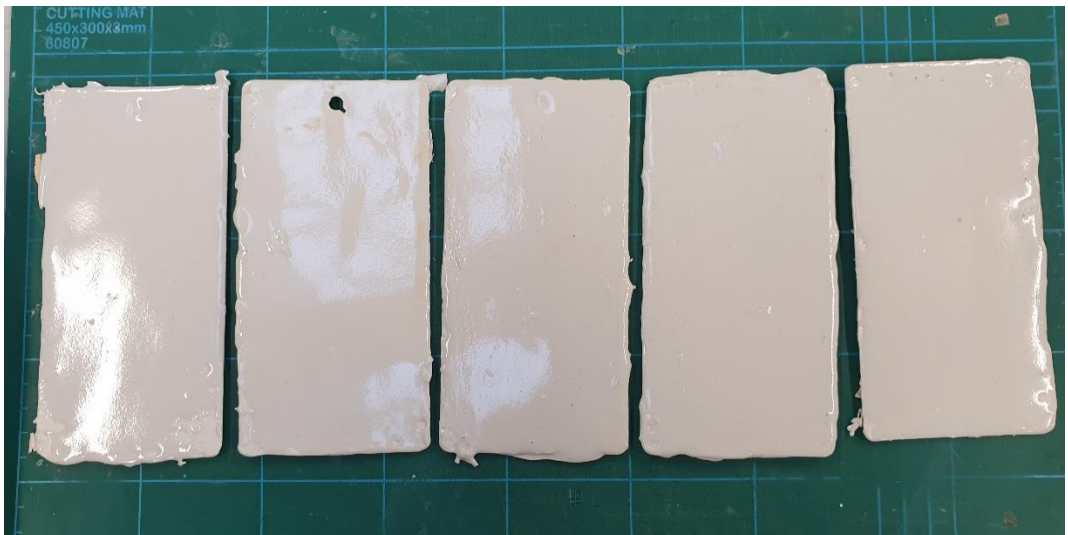
Figure 5.18: Photograph, Coating C1, NSM, End of Test (1500hrs)

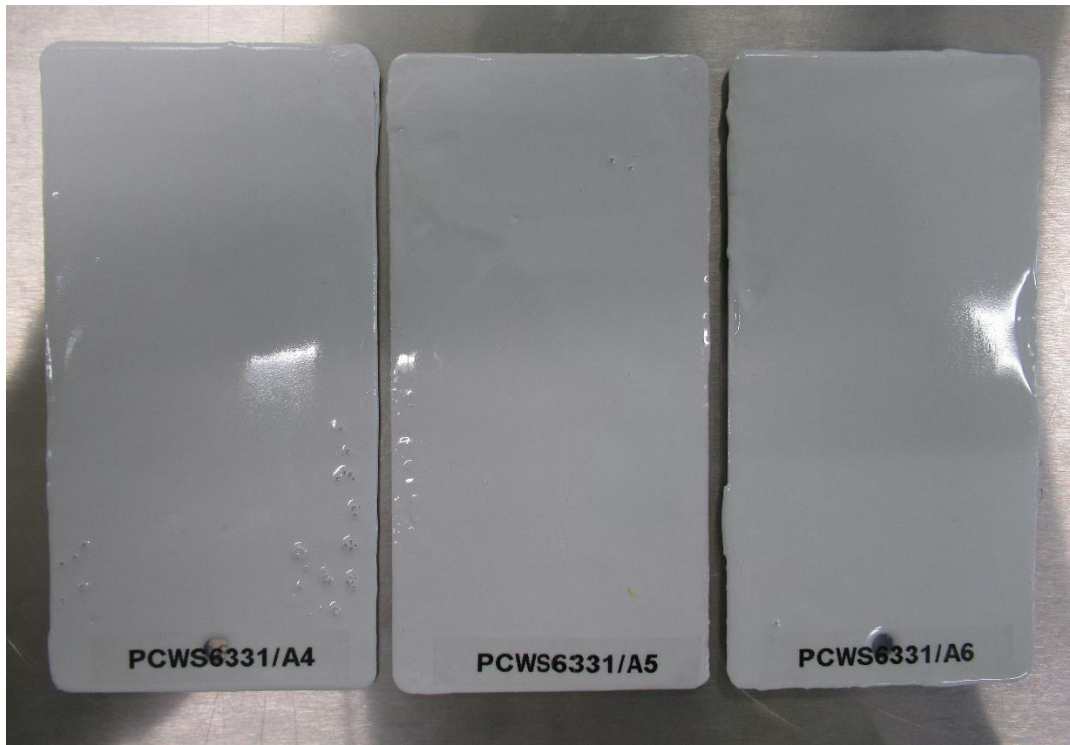
Figure 5.19: Photograph, Coating C2, UVa, Start of Test (0hrs)

Looking at the UVa weathering of coating C2, Figure 5.19 and Figure 5.20 show the beginning and end of test. The most noticeable change is that of the formation of a crack at the top of one of the specimens as a result of the accelerated weathering. Aside from the crack, there is no obvious visual difference in the start and end of the test.

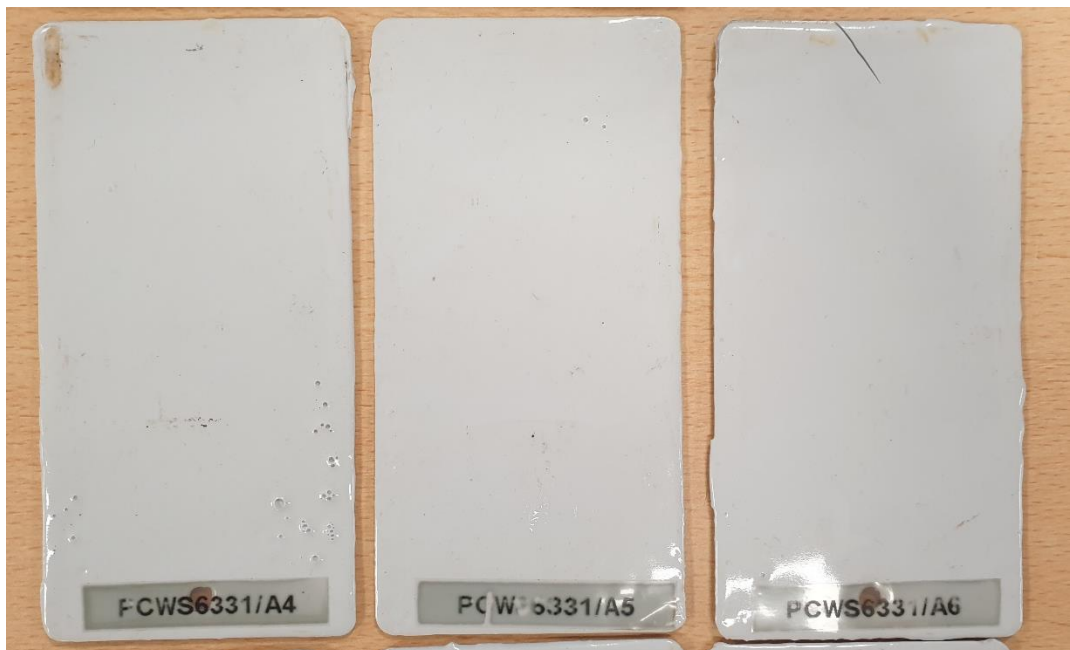
Figure 5.20: Photograph, Coating C2, UVa, End of Test (7500hrs)

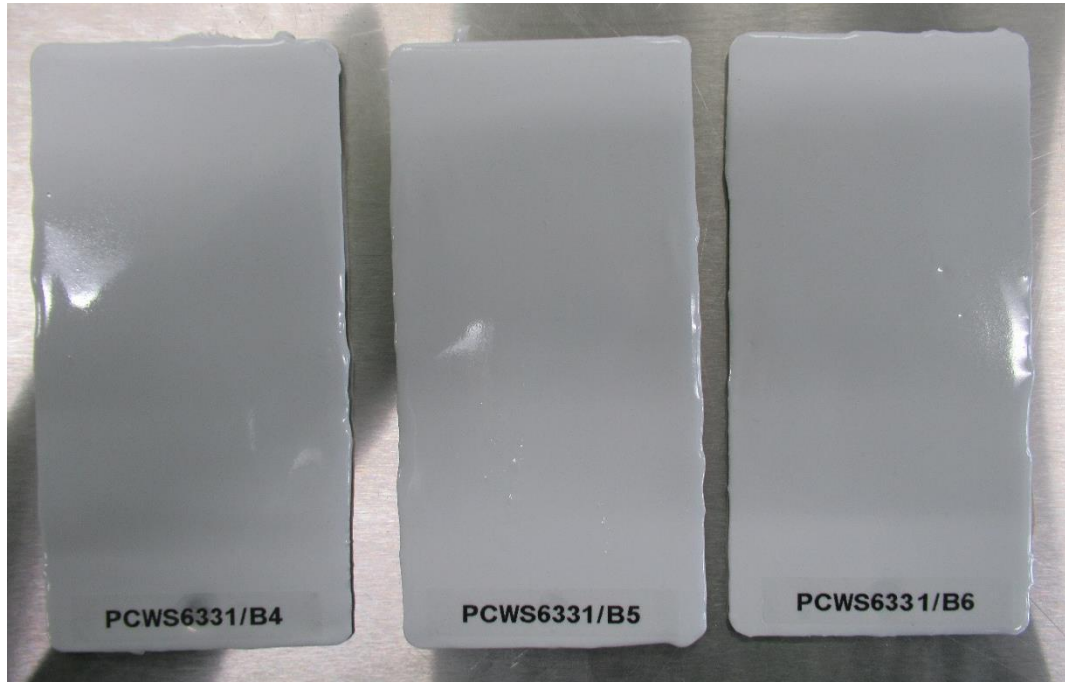
Figure 5.21: Photograph, Coating C2, Xenon-Arc, Start of Test (0hrs)

Next, the Xenon-Arc weathering of coating C2 shown in Figure 5.21 and Figure 5.22. The surface of the specimens after the weathering test appears to be more matt and less glossy. Additionally, there is a small crack developing at the top of one of the samples.

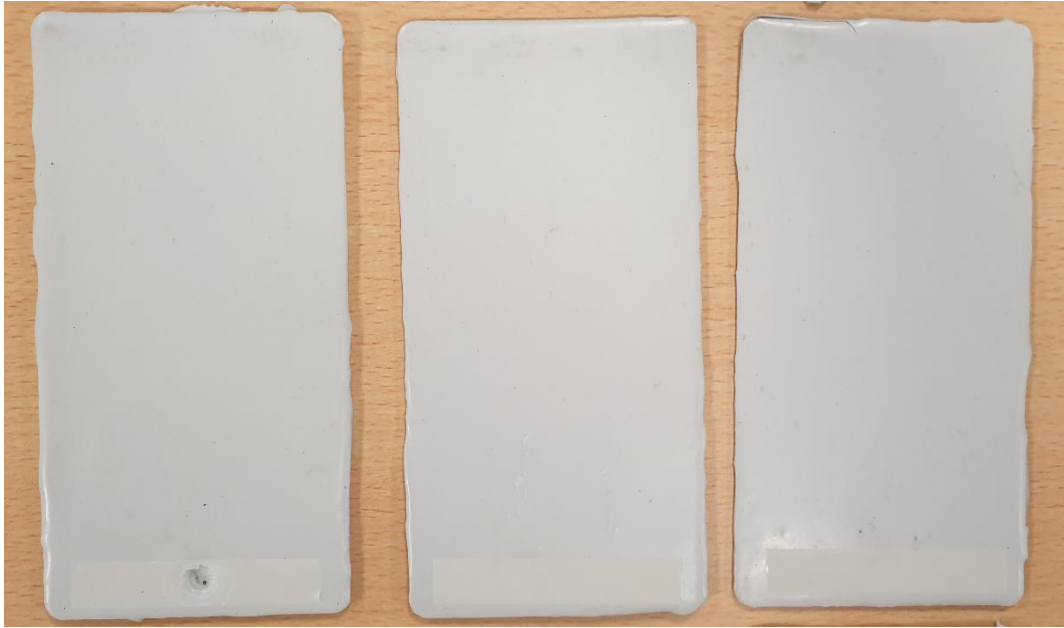
Figure 5.22: Photograph, Coating C2, Xenon-Arc, End of Test (6000hrs)

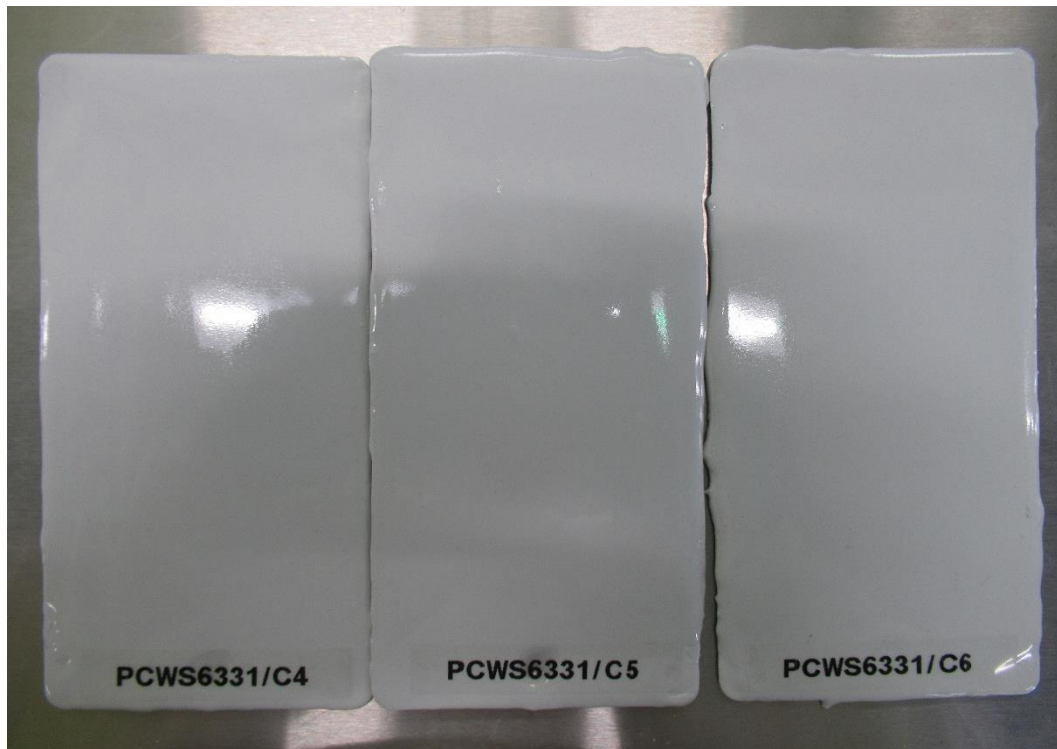
Figure 5.23: Photograph, Coating C2, Natural Outdoors, Start of Test (0hrs)

Now looking at the Natural Weathering of coating C2, shown in Figure 5.23 and Figure 5.24. Lines are present at the sides of the specimens, as well as
