An Experimental Approach into the Degradation of Wind Turbine Blade Coating Systems due to Rain and Weathering

PhD Thesis

Wind & Marine Energy Systems CDT,
Department of Electronic & Electrical Engineering,
University of Strathclyde, Glasgow

February 2023

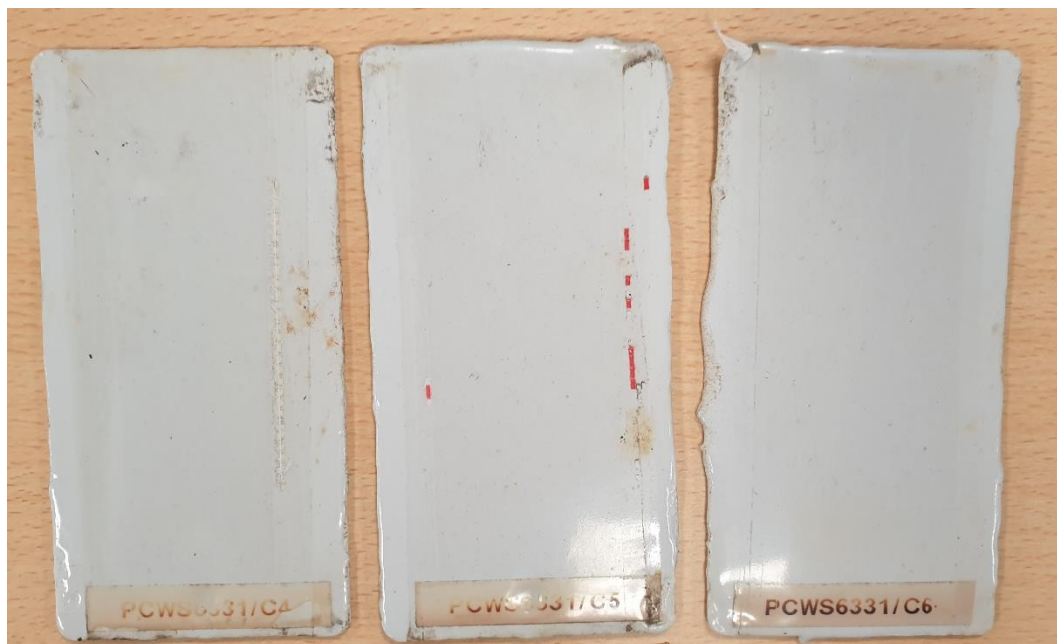
Figure 5.24: Photograph, Coating C2, Natural Outdoors, End of Test (13650hrs)

Now looking at the Natural Weathering of coating C2, shown in Figure 5.23 and Figure 5.24. Lines are present at the sides of the specimens, as well as

some residue tape, as a result of the tape used to fix the specimens to the test outdoor rack. Therefore, the middle area of the specimens should be used for analysis. Light surface staining as well as some surface debris is present on the specimens. This is a result of the test location near a wooded area where leaves and branches can fall on the specimens.

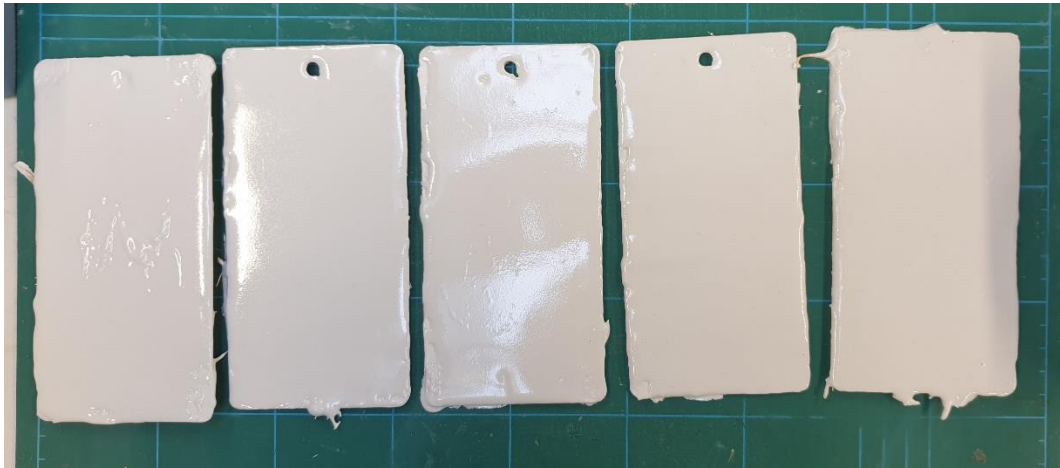
Figure 5.25: Photograph, Coating C2, NSM, Start of Test (0hrs)

Then, looking at the North Sea Method test specimens for coating C2 Figure 5.25 and Figure 5.26, again, there is very little, if any, visually observable difference between the start and end of test. This is primarily due to the reduced test duration of 1500 hours as well as the reduced irradiance intensity of the test.

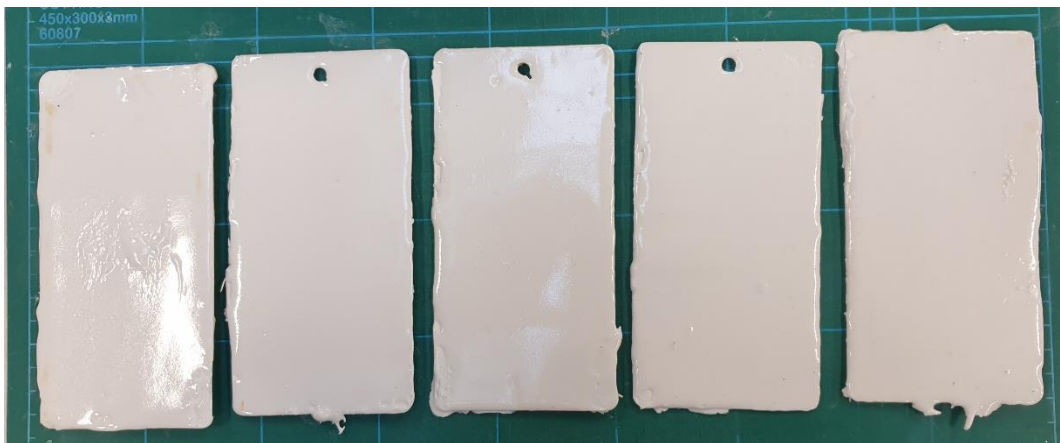
Figure 5.26: Photograph, Coating C2, NSM, End of Test (1500hrs)

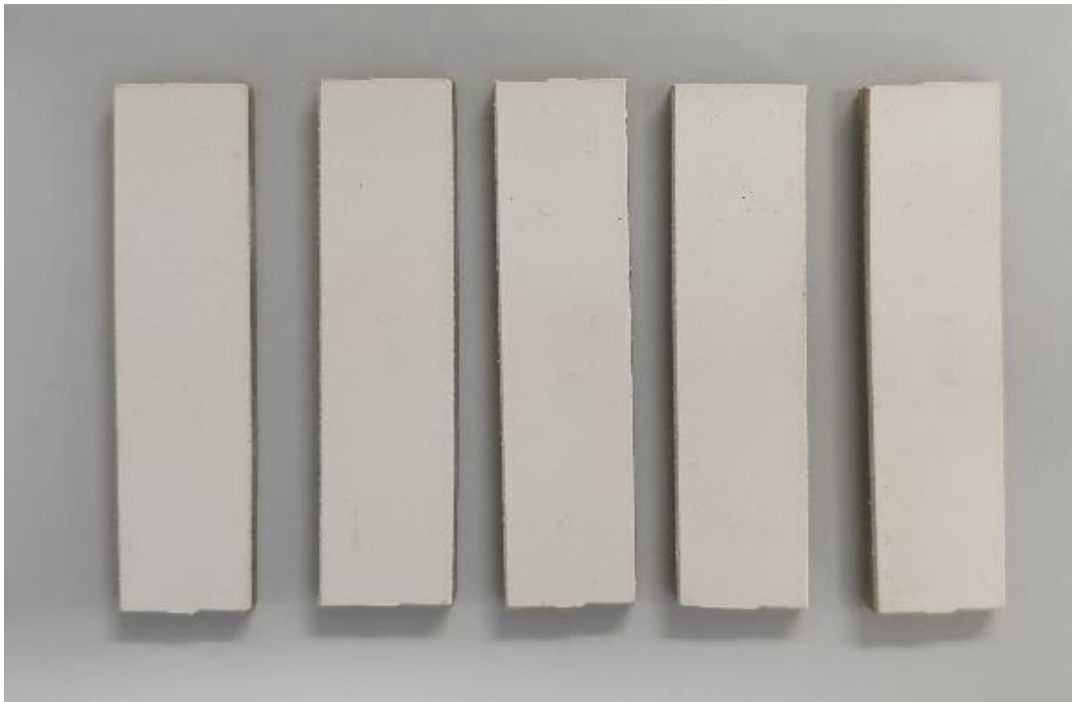
Figure 6.2: Photograph, Stage 1, Coating B

Figure 6.2 shows the combined test specimens for coating B at Stage 1, a new sample with no exposure to RET or weathering. The specimen surface is

smooth and uniform to the naked eye, with no major defects. However, at the end of the combined test at Stage 7, shown in Figure 6.3, the specimen surface has visibly changed. Pinholes are present on each specimen along with small patches displaying a corrosion like surface staining.

Figure 6.6 displays the RET only specimens for coating B at the start of the test. These specimens are in the same condition as in Figure 6.2. After 60 minutes of RET, as shown in Figure 6.7, the surface of the specimens has changed. The surface has begun to show pinholes as a result of the RET exposure.

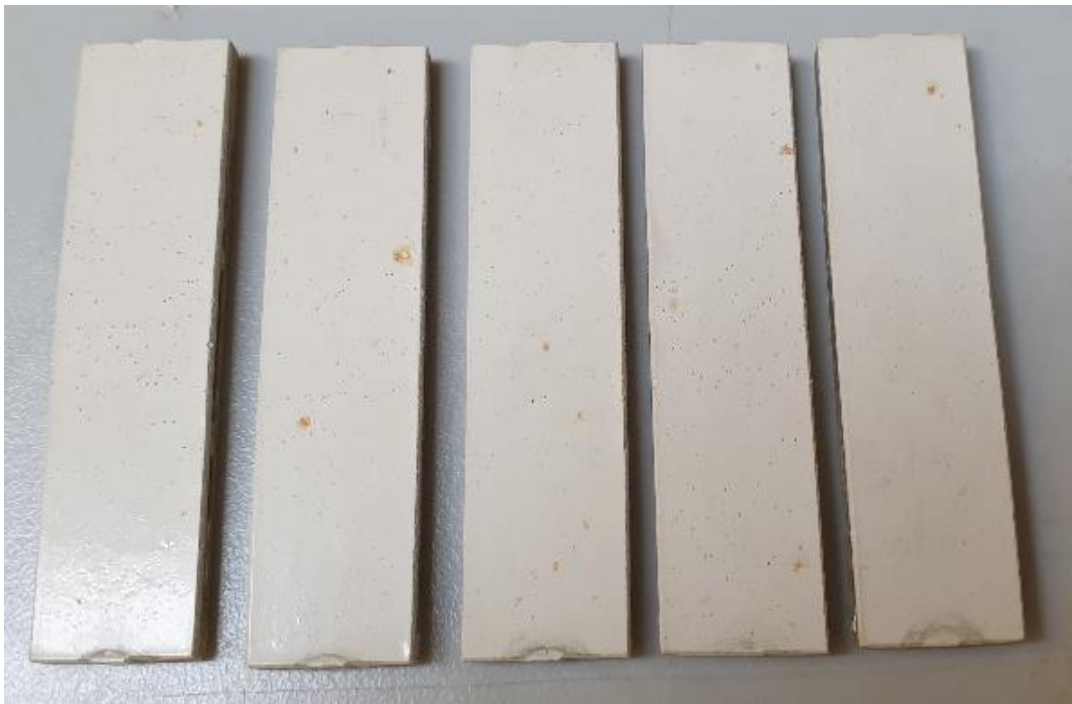
Figure 6.3: Photograph, Stage 7, Coating B

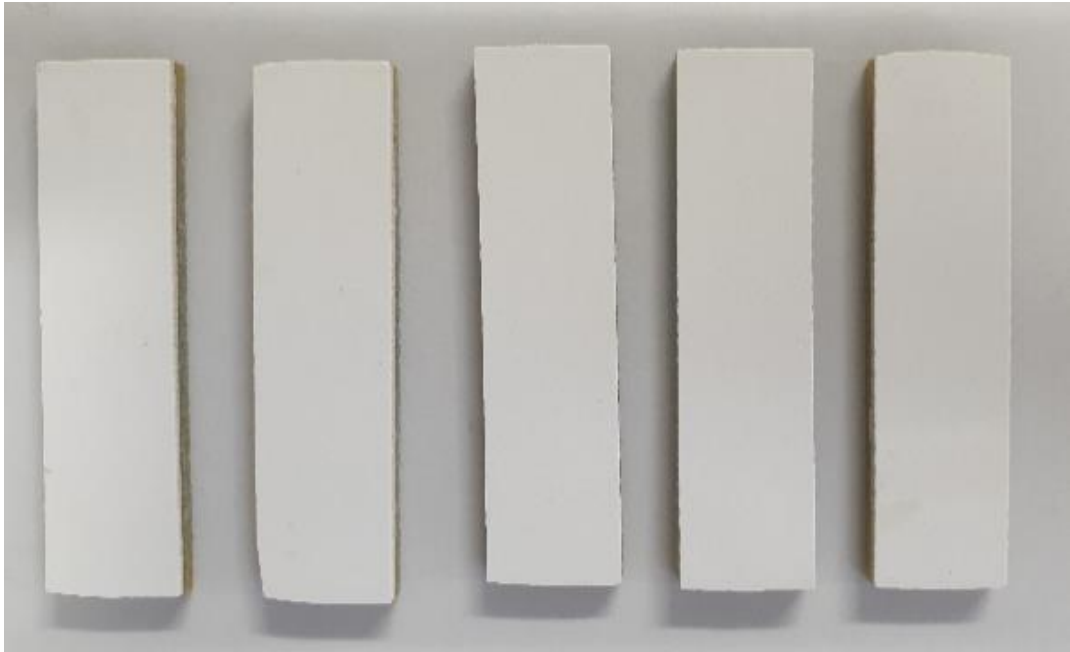
Figure 6.4: Photograph, Stage 1, Coating C1

Next, looking at Figure 6.4 which displays the coating C1 specimens at Stage 1. Again, the specimen surface looks smooth and uniform, with no major defects, as is expected of a new specimen. Then, at the end of the combined test at Stage 7, the specimens show signs of erosion which appear as pinholes on the surface with some areas of progressed erosion where larger holes have begun to develop.

Then, looking at Figure 6.8 which shows the start of test for the RET only specimens for coating C1. The same as Stage 1 of the combined test, as in Figure 6.4. Then, Figure 6.9 presents the RET only specimens after 60 minutes on test. The specimen surface has changed in that there are large sections where the top layer of LEP has been removed and other sections which show surface pinhole damage.

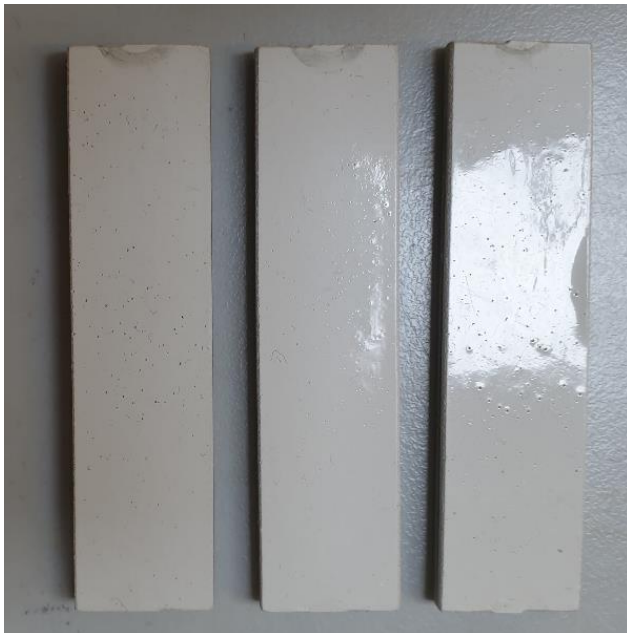
Figure 6.7: Photographs, RET only, 60 mins, Coating B

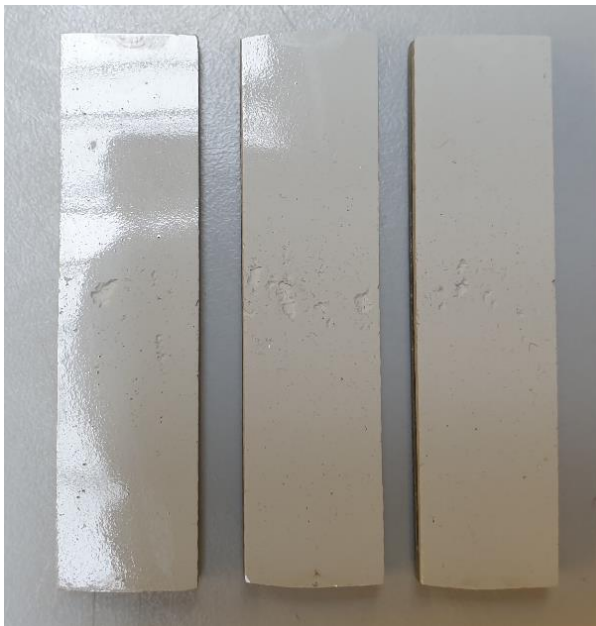
Figure 6.9: Photograph, RET only, 60 mins, Coating C1

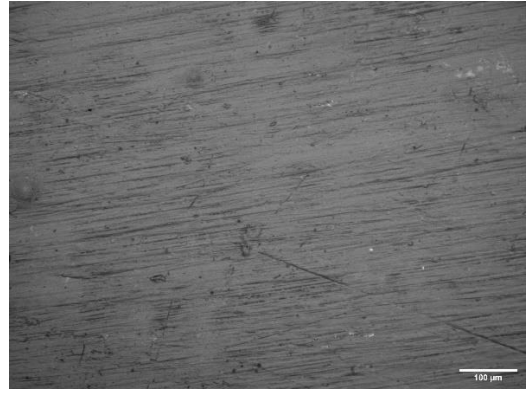
Figure 6.22: Microscopy, Stage 2, Coating C1

For coating C, the microscopy images for the combined test are presented in Figure 6.21 through Figure 6.27. Stage 1 shows a mostly smooth surface with some small pinholes/bubbles. However, after the first weathering period at Stage 2, lines are easily observable on the specimen surface. Moving to the next RET period at Stage 3, the lines have disappeared and the amount of pinholing has increased, with some larger holes beginning to emerge. Then, at Stage 4 the lines reappear after the second weathering period. Stage 5 brings the second RET period and a drastic change in surface texture with the removal of the lines which were present after weathering and an increase in the number and size of surface holes. The final weathering period at Stage 6 produces the lines on the surface of the specimens. The last RET period at Stage 7 causes large amounts of LEP loss with deepening surface pits and holes.

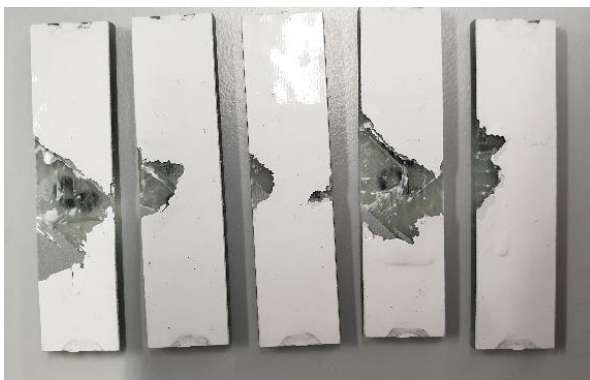
Figure 7.1: Coating B, RET, 60mins (1)

Figure 7.1 and Figure 7.2 both have been exposed to 60 minutes of RET. However, Figure 7.1 has experienced 60 mins of RET in one continuous test

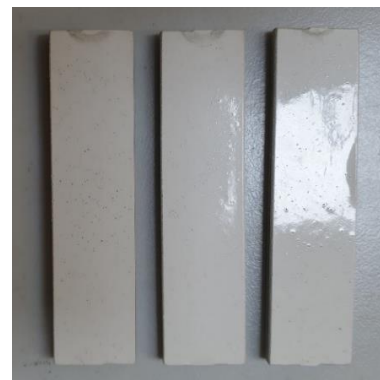
Figure 7.2: Coating B, RET, 60mins (2)

and Figure 7.2 has experienced three periods of 20 minutes each separated by a period of six weeks. There is a clear visual difference in specimens after each test, the continuous 60-minute test has caused massive damage to the coating with large areas of coating removal. The three 20-minute RET exposures show very little signs of erosion, with only small surface pinholes observable. This difference in survival time highlights the importance and effect of stoppage intervals and specimen recovery time during RET. However, the difference is more likely due to batch-to-batch variation in specimen manufacture. The batch variation explanation is more likely as the failure mechanism changes between both tests, the initial test shows an edge type delamination failure and the second test shown a surface erosion type failure.

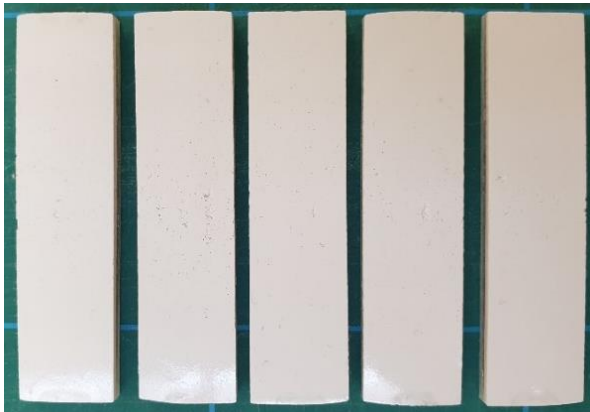
Figure 7.3: Coating C1, RET, 48mins (1)

Figure 7.3 shows coating C1 after 48 minutes of continuous RET and Figure 7.4 shows coating C1 after three periods of 20 minute RET, totalling 60 minutes RET, each separated by a rest period of six weeks. Figure 7.3 presents slightly less surface damage than Figure 7.4, it also has 12 minutes less RET time in total. However, it was expected that both test specimens, with continuous and long rest periods, would show similar amounts of erosion at 60 minutes of RET. This highlights the differences in coating systems and their individuality to testing. Coating B displayed a clear reaction to RET stoppage intervals, whereas coating C1 does not show significant variation.

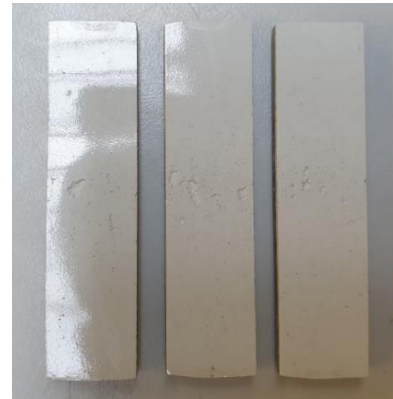
Figure 7.4: Coating C1, RET, 60mins (2)

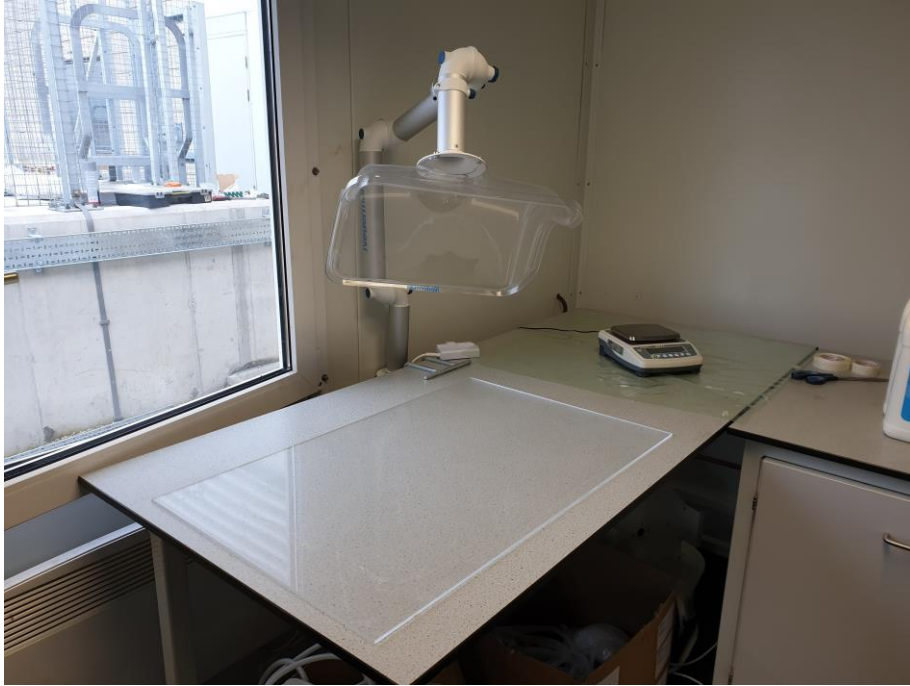
Figure 0.1: Flat Mould for Composite Forming

The first stage of the composite manufacture was to clean and prepare the mould, as shown in Appendix A Figure 0.1, for resin infusion. The mould used was an 850mm by 535mm Perspex sheet. Firstly, the mould was cleaned using Zyvox Breez Granudan Surface Cleaner. After cleaning, the mould was sealed using Zyvox Breez Sealer BN201. The mould sealing process involves several applications of the sealing agent, four applications were used with a 15-minute waiting time between each application. The final application of the sealing agent required a cure time of 4 hours at 50°C. The last stage of the mould preparation is to apply a release agent. The release agent used was Zyvox Breez Granudan Watershield. The release agent was applied in two coats with a 15-minute wait time in between coats and a set time of 30 minutes after the

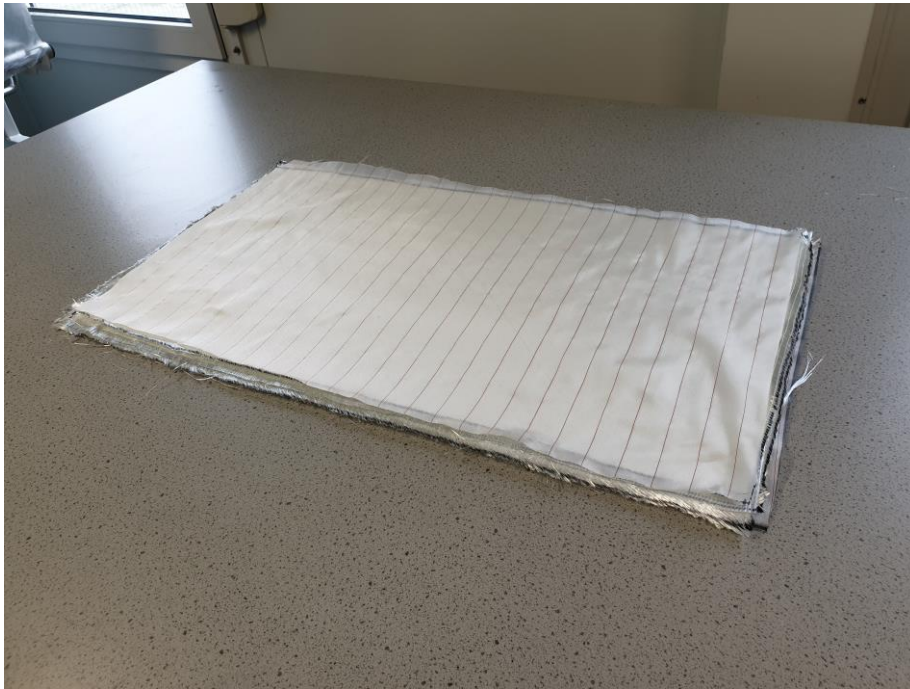
Figure 0.3: Glass Fibre Sheets Cut to Size

The next stage of the panel manufacturing process was to cut the glass fibre mats from the storing rolls, shown in Figure 0.2, down to the size required for the panel. Figure 0.3 and Figure 0.4 show the fibre mats cut down to the required size and how the mats are layered. The dimensions of the cut glass fibre mats were 550mm by 300mm and the layup of the composite starting from the bottom, on the mould, was as follows: PP/+45/-45/0/+45/-45/+45/-45/0/+45/-45/PP/RF/DM, where PP is peel-ply, RF is release film and DM is distribution mesh.

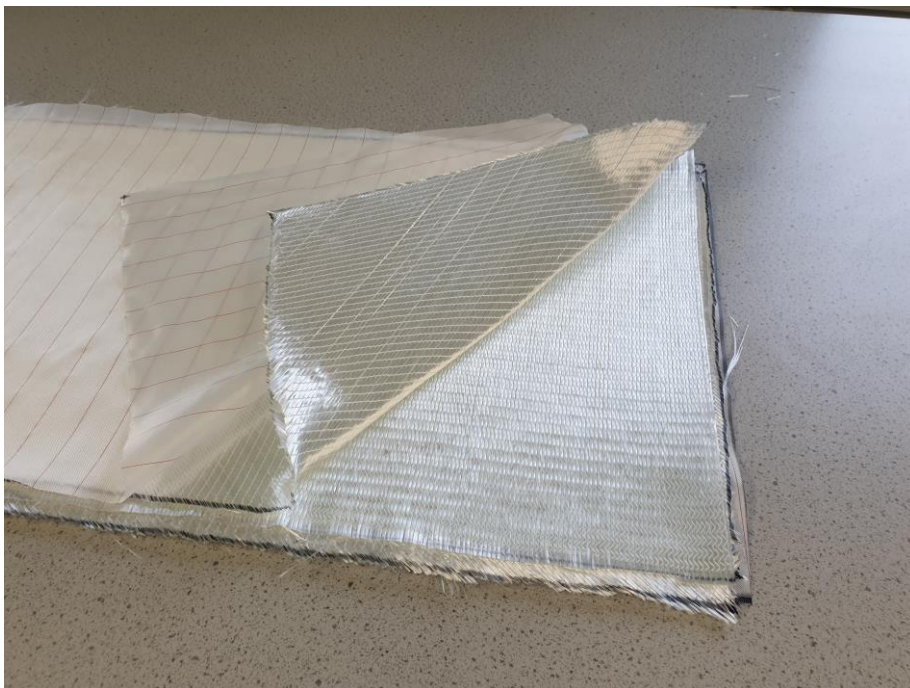
Figure 0.4: Glass Fibre Sheets – Layup

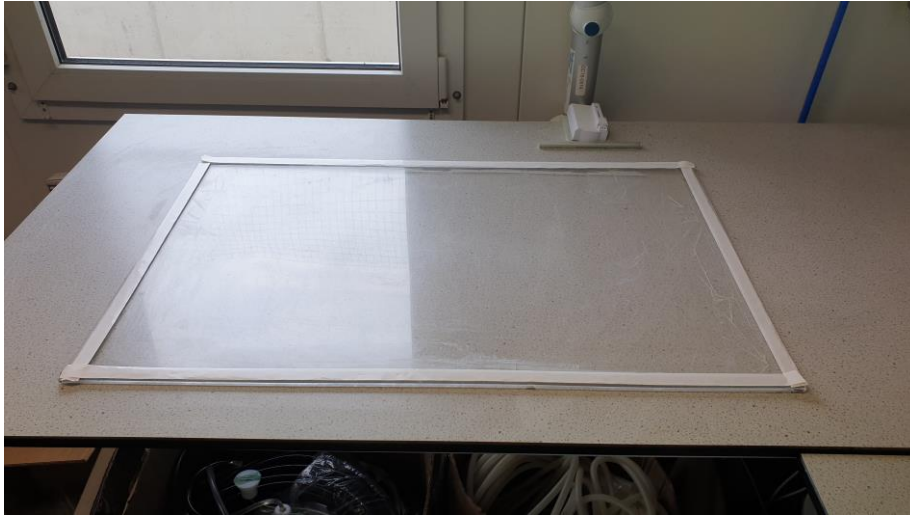
Figure 0.5: Mould with Tacky Tape Applied

Once all the glass fibre mats, peel-ply, release film and distribution mesh had been cut to size, they were laid onto the mould ensuring that the correct layup was followed. The next stage of the process was to 'bag' the layup - to seal the layup in a bag to allow for a vacuum to be drawn within the bag. The first step of 'bagging' is to seal the edges of the mould with tacky tape, as shown in Figure 0.5. In addition, pleats were added along the outer edge of the tacky tape - this is to allow for room for the bag to compress and form a solid seal against the glass fibre layup during the vacuum drawing process. The resin injection site and extraction site were located at opposite corners of the layup, with a distribution aid between each site. The resin injection and extraction sites as well as the distribution aid can be seen in Figure 0.6. The bag was then placed over the layup and mould and then sealed along the tacky tape to allow a vacuum to be drawn between the mould and the bag, as shown in Figure 0.7.

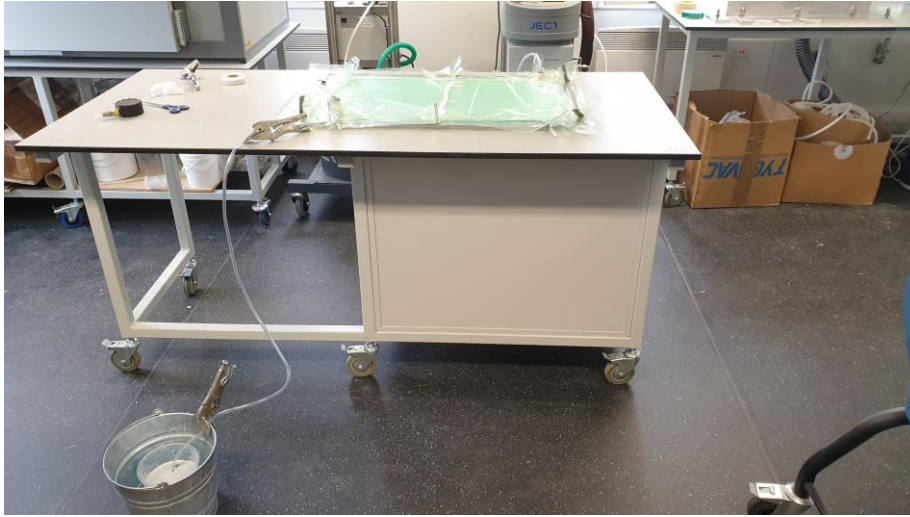
Figure 0.7: Resin Infusion Setup

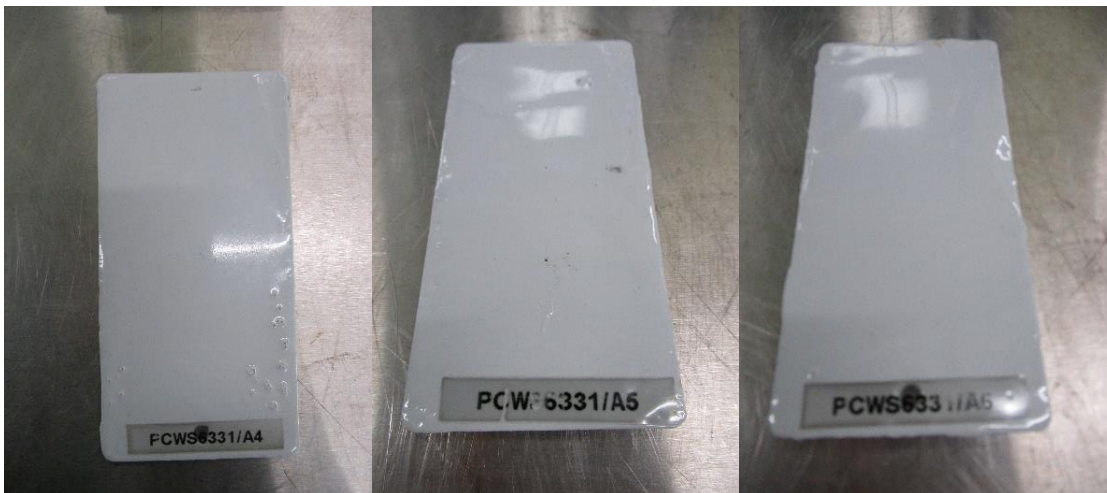
Figure 0.14: Coating C2, Aluminium Substrate, UVa, 3000hrs

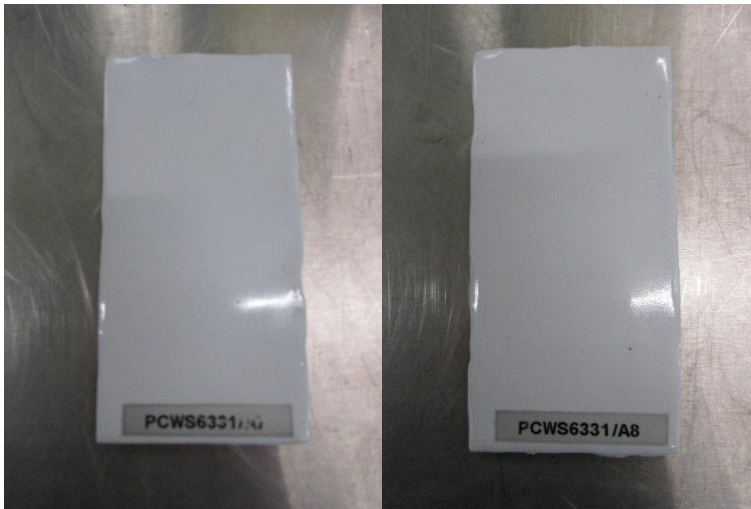
Figure 0.15: Coating C1, Composite Substrate, UVa, 3000hrs

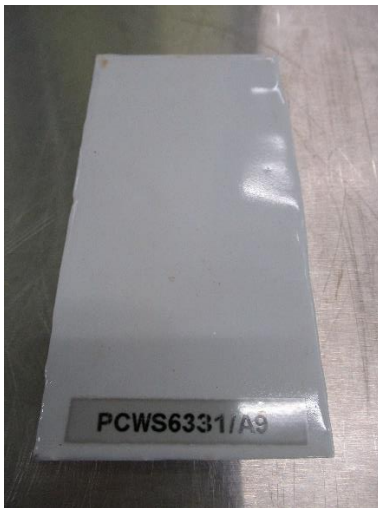
Figure 0.16: Coating C2, Composite Substrate, UVa, 3000hrs

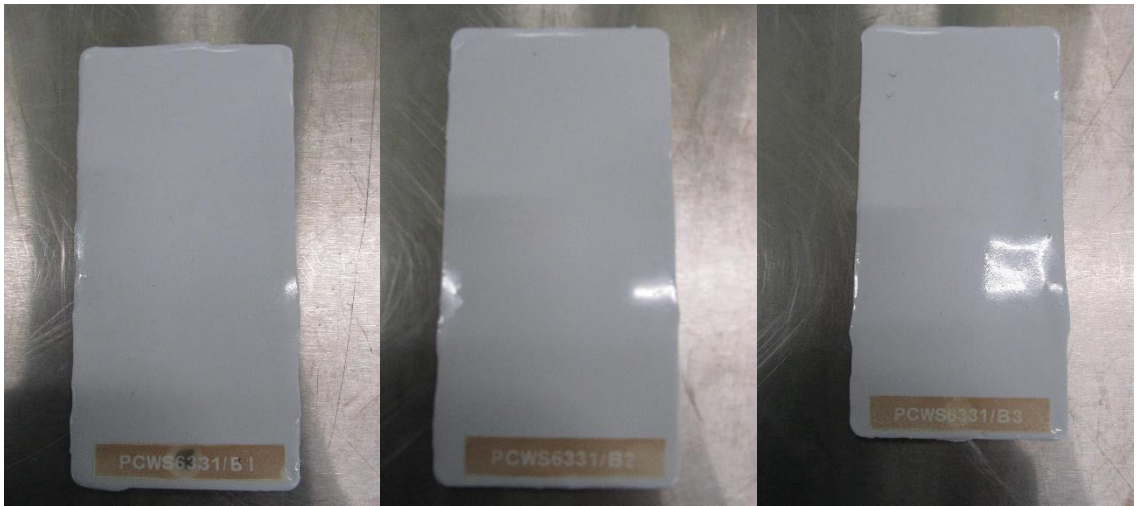
Figure 0.17: Coating C1, Aluminium Substrate, Xenon-Arc, 3500hrs

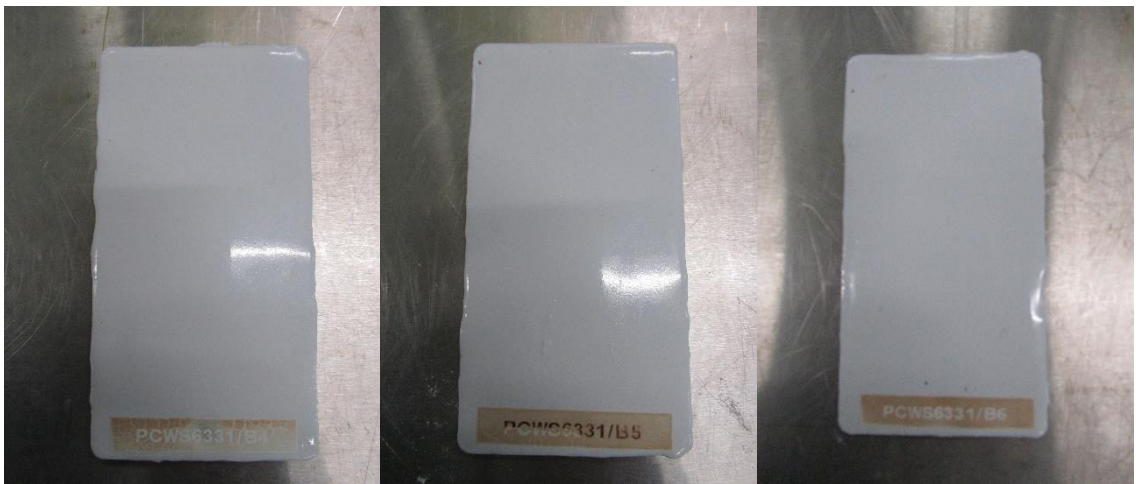
Figure 0.18: Coating C2, Aluminium Substrate, Xenon-Arc, 3500hrs

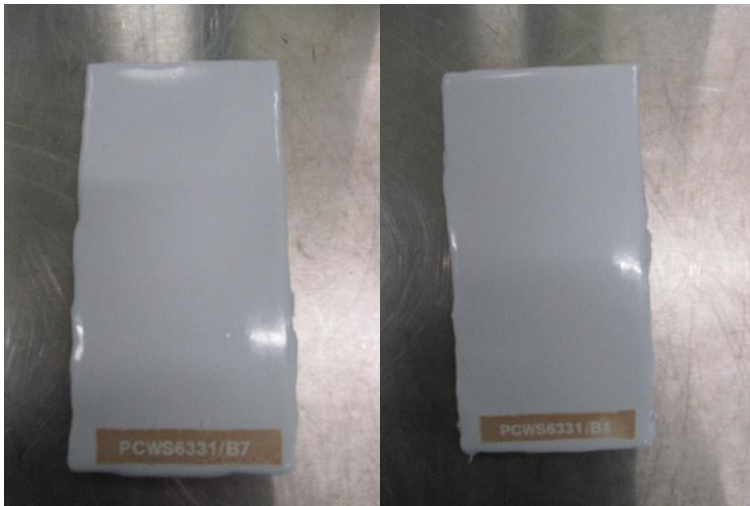
Figure 0.19: Coating C1, Composite Substrate, Xenon-Arc, 3500hrs

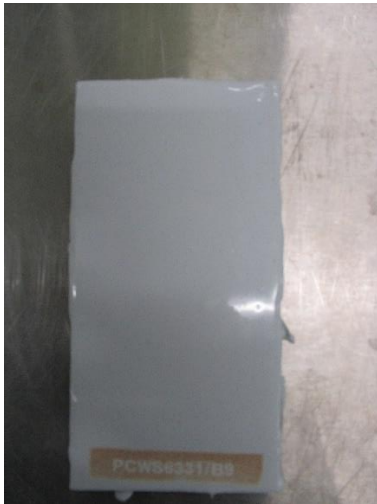
Figure 0.20: Coating C2, Composite Substrate, Xenon-Arc, 3500hrs

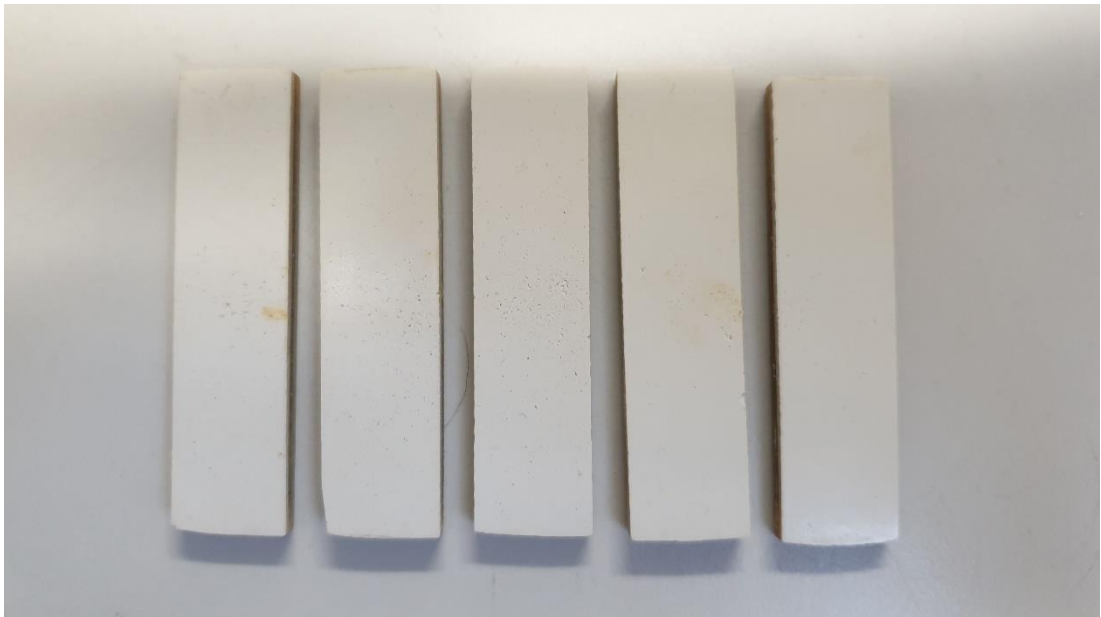
Figure 0.54: Coating C1, Stage 6
