University of Strathclyde  
Department of Architecture

**Designing a Visible City for Visually Impaired Users:  
Breaking the Barriers of Disabling Architecture**

A thesis presented in fulfilment of the requirements for the degree  
of Doctor of Philosophy

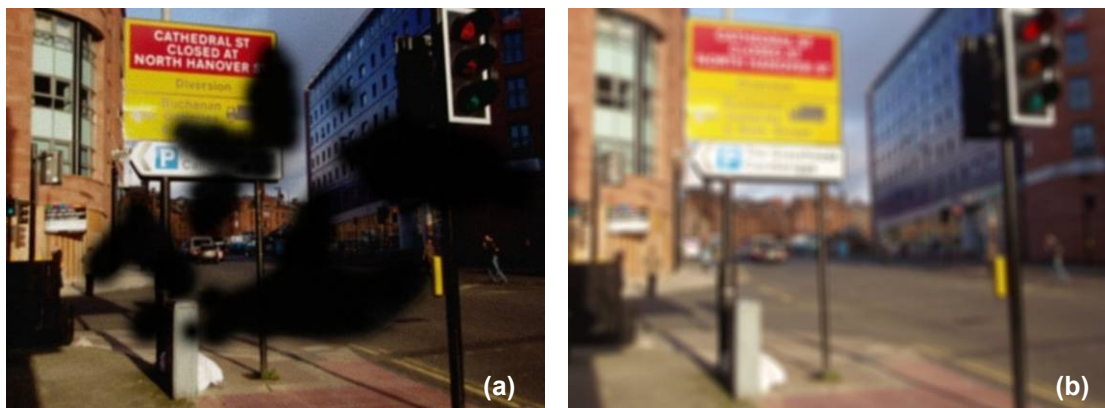
Figure 3.5: Streetscape as viewed by a person with (a) diabetic retinopathy and (b) cataracts

Although not a condition affecting the cones and rods, cataracts are also responsible for mixed vision loss. A cataract is the clouding of the crystalline lens of the eye resulting in dim or blurred vision, (Figure 3.5b) and may occur in one or both eyes. Other effects include problems with glare or the presence of a halo when in brightly lit environments; it is also possible for colour perception to change. The older generation are particularly susceptible to cataracts (senile cataracts) however this is not exclusively the

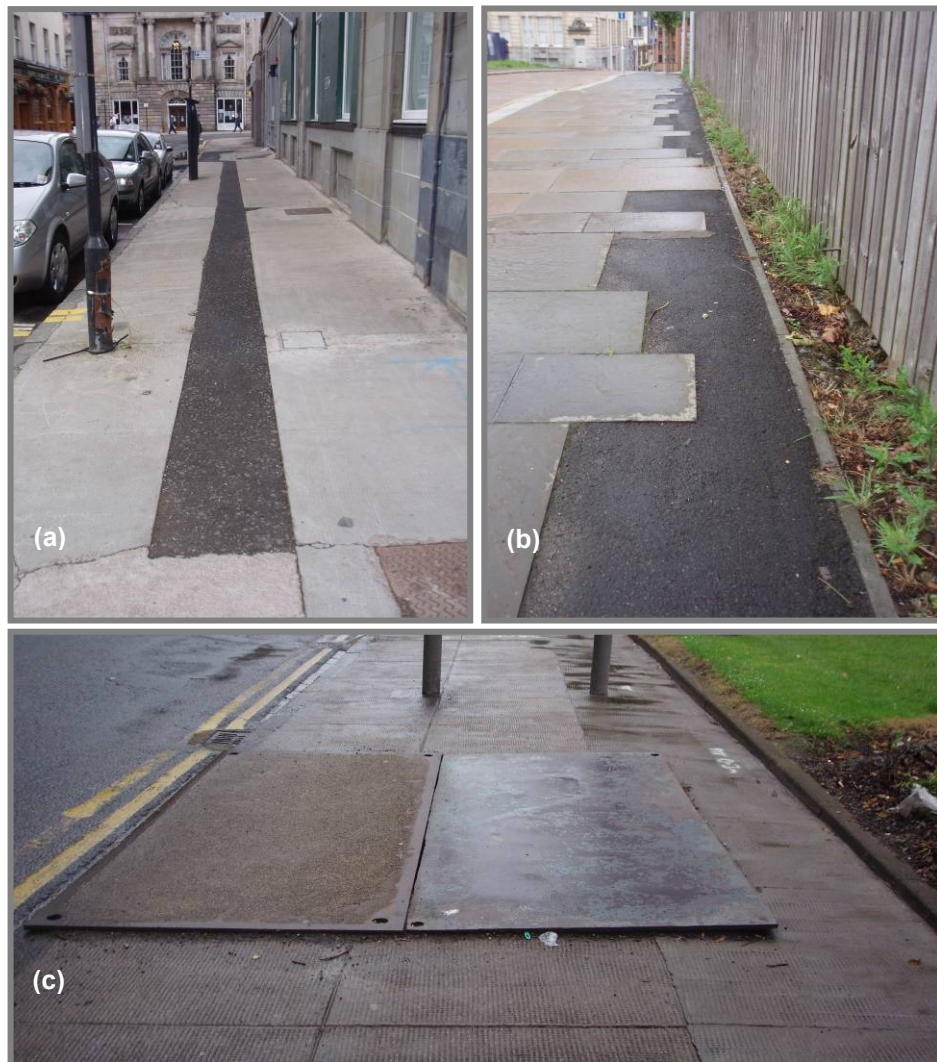
Figure 6.5: Poor pavement reinstatement (a) Garth St, (b) Shuttle St, (c) Cathedral St

The appearance and general condition of the pavement can also alter significantly as a result from the intervention of utility companies and the presence of construction works. The frequency of this type of physical feature was recorded extensively throughout the study area with only a limited number of streets being exempt from any modifications to the surface material. Figure 6.5 presents three examples of cases where the pavement surface has been affected in this way. Figure 6.5(a) illustrates a typical example of how a pavement surface can alter in appearance after a utility company has excavated the original paving in order to install services and Figure 6.5(b) provides an example of a situation where new paving meets old at the edge of a construction site. In both examples, the variation in colour, material and texture of the ground surface can be extremely confusing to a visually impaired pedestrian. This type of change in material may be perceived as a deep hole in the ground or a change in the surface level or function of the paving and may be responsible for influencing the walking speed and choice of path taken along the pavement. Figure 6.5(c) illustrates an example where the pavement has been excavated in order to maintain or upgrade utility services located underground. In this circumstance the original area has not been recovered in a similar material but has instead been covered by two metal sheets that are not positioned at the same level as the original paving, creating an unexpected level change and potential trip hazard. The material is also not in a contrasting colour to the existing paving and would not be easily distinguishable to pedestrians affected by a visual impairment.

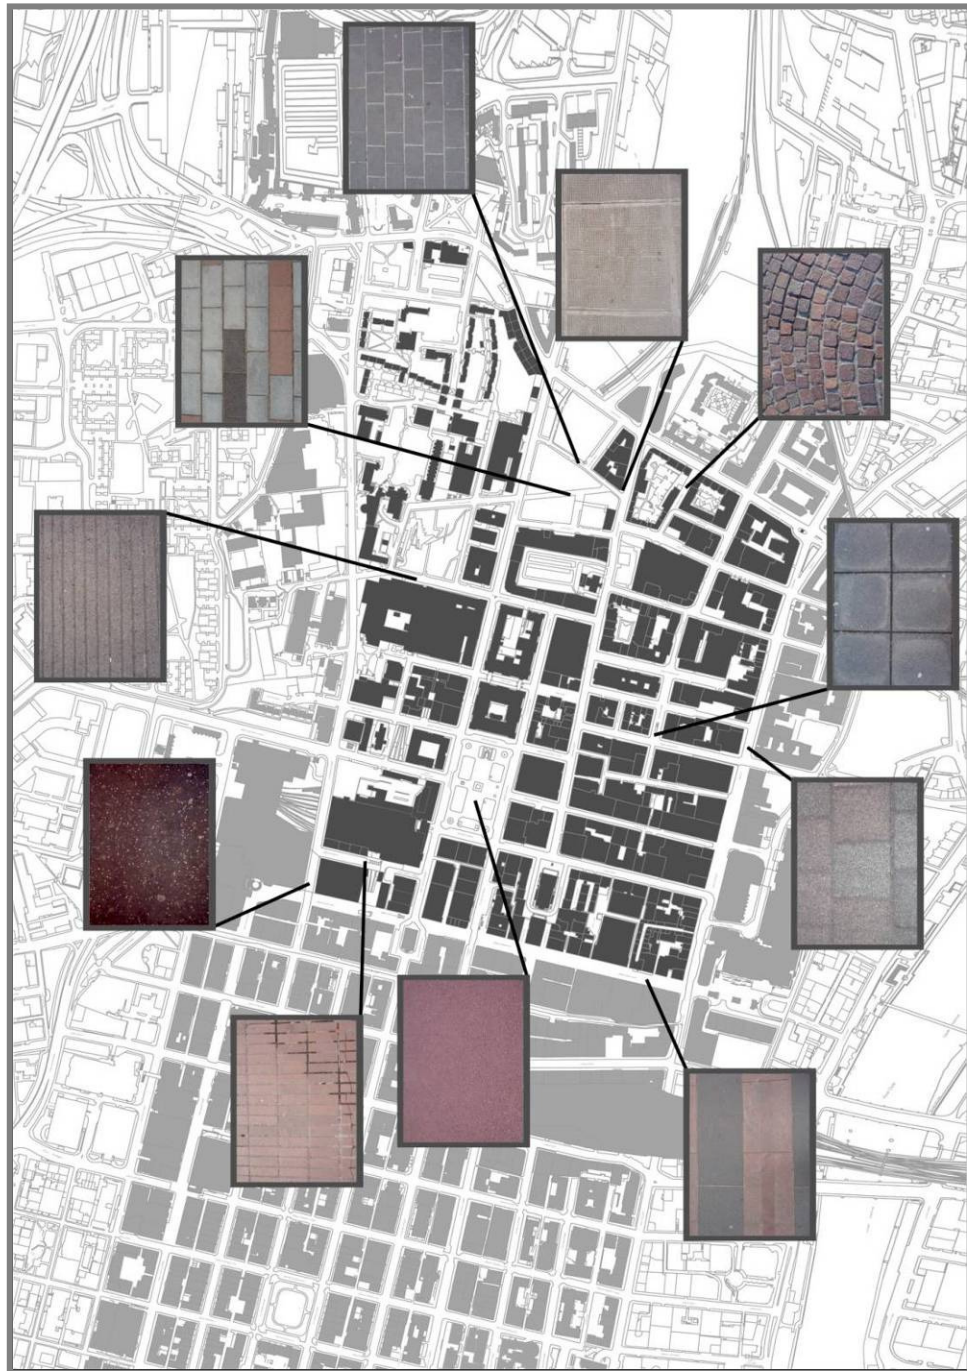
Figure 6.6: Types of paving present in Study Area

The type of paving material present within the built environment can vary considerably in terms of size, shape, texture, colour, pattern and reflectance and can therefore significantly affect the ease with which a person with a visual impairment is able to walk along a pavement. The type of paving received an average rating score of 3.01 within the survey, indicating that this feature may cause potential problems to visually impaired pedestrians. A surface material consisting of many different parts such as cobbles may be dangerous and create a trip hazard especially if the surface is uneven. (BSI, 2009, p. 18; Dept. for Transport, 2005a, p. 16; SBSA, 2009, p. 13). This type of paving can also reduce the effectiveness of a long cane as it may become caught in the gaps between the cobbles (Dept. for Transport, 2005a, p. 16). A patterned surface or a pavement with several different paving types may create a disorientating and confusing environment for a visually impaired pedestrian, leading to a difficulty in distinguishing objects on the footpath or even creating the illusion of an object or change in level. Bright *et al.* (1999) found strong evidence to suggest that plain uniform non-patterned floor designs are preferable and beneficial for individuals with a visual impairment as opposed to busy non-uniform patterns which in many cases can have a detrimental effect to an individual's navigational behaviour and therefore should be avoided. In the case of Bright *et al.* (1999), the research focused on internal floor patterns, however the same logic can be applied to paving design in external environments with the additional problem of daylight and weather, and the potential effects this may have on the appearance of the ground surface.

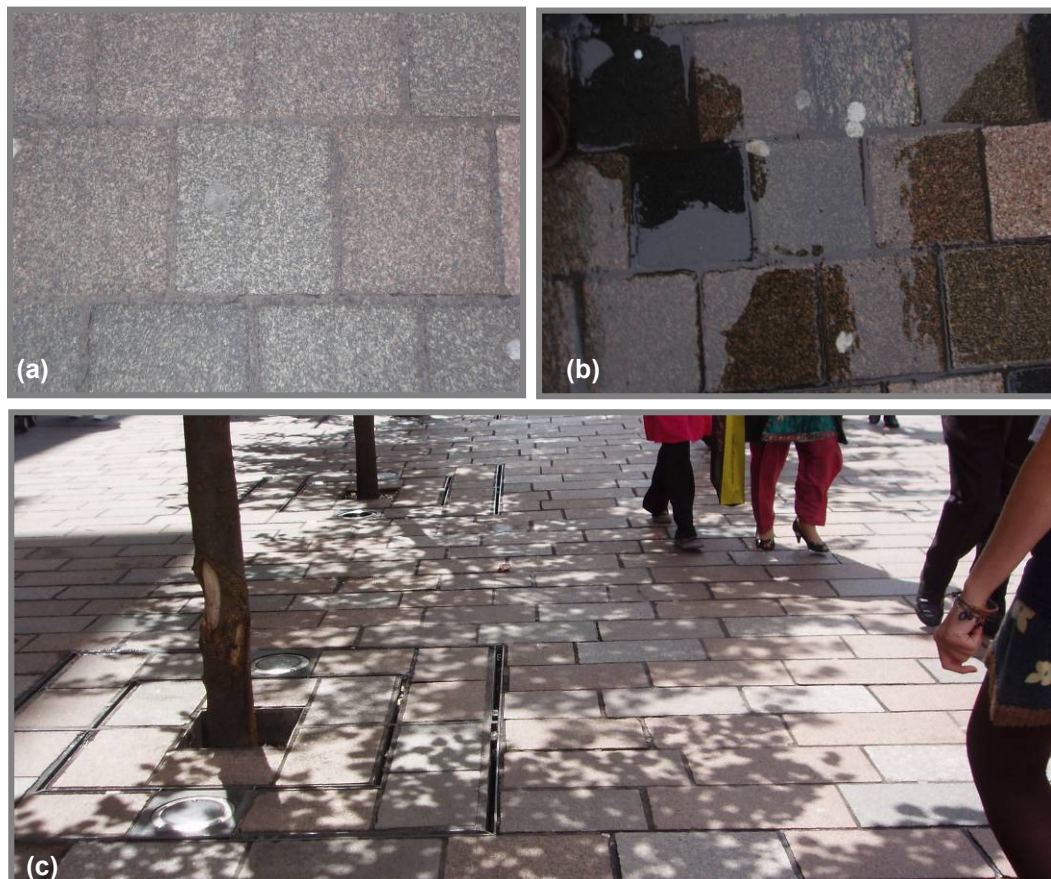
**Figure 6.7: Pavement appearance under different weather conditions (a) Argyle St – dry, (b) Argyle St – wet and (c) Buchanan St – sunshine & shadow**

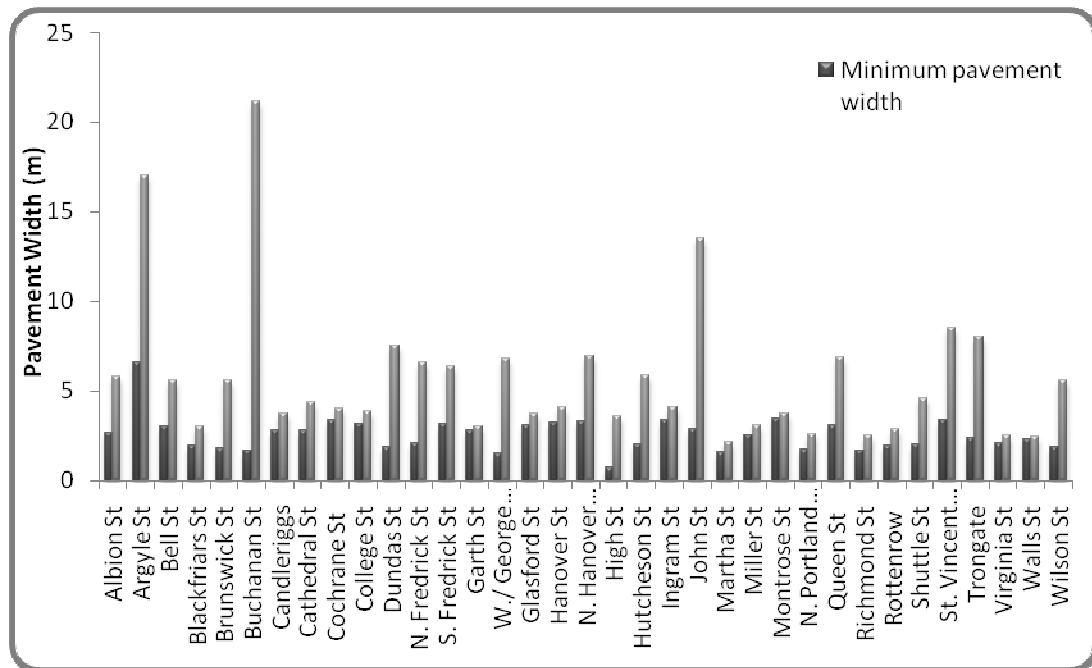
Figure 6.8: minimum and maximum pavement widths in study area

The width of each pavement within the study area was measured using a digital measuring tape at five locations along each pavement in order to calculate an overall average for the entire street. As with paving type, the width of a pavement can vary significantly throughout a small area, either along the same street or between neighbouring streets; this can influence the ease with which a visually impaired person is able to navigate safely and independently. An average unobstructed pavement width of 4.31 metres was recorded in the study area, ranging from a minimum unobstructed pavement width of 1.57 metres recorded on Martha Street to a maximum unobstructed pavement width of 21.17 metres recorded on Buchanan Street (see Figure 6.1 for street locations). The full list of minimum and maximum street widths recorded within the study area is presented below in Figure 6.8. Individual measurements taken for each street can be viewed in more detail in Appendix B.

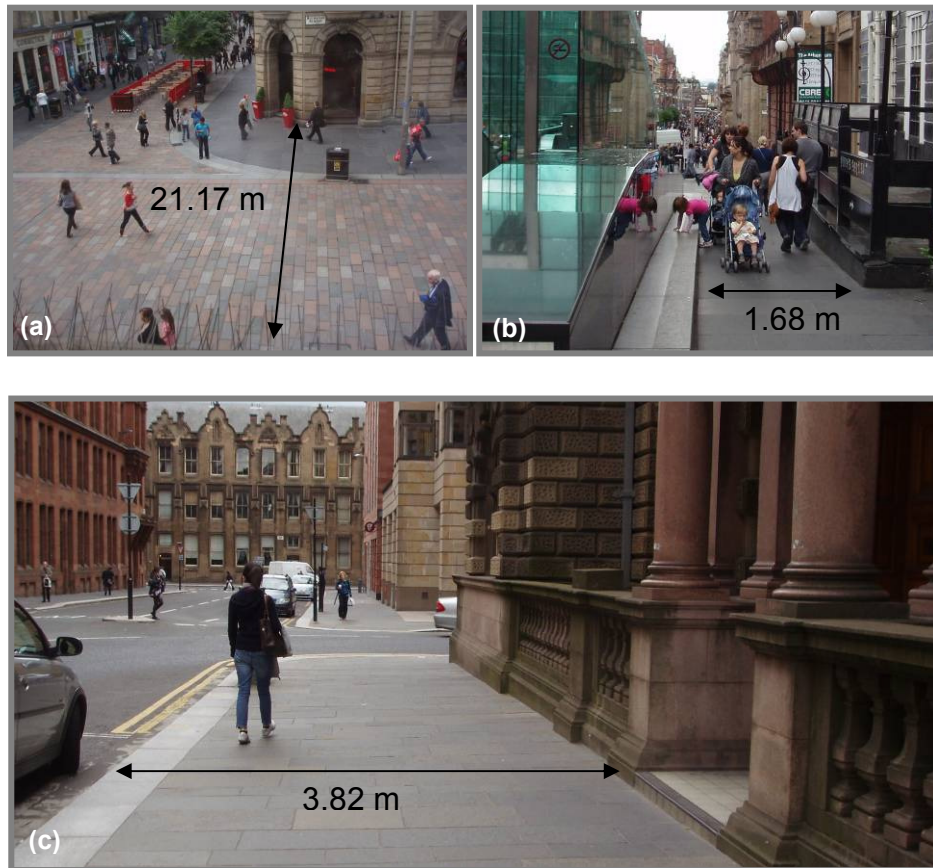
**Figure 6.9: Variation in pavement width within Study Area (a) Buchanan St – wide section, (b) Buchanan St – narrow section and (c) Montrose St**

Figure 6.9 illustrates three examples of varying pavement widths at two principle streets within the city centre. The first two examples originate from Buchanan Street, one of Glasgow's principle pedestrian shopping streets, and illustrate the dramatic way in which the width of a pavement can reduce in size at specific points along a street, from 21.17 metres (Figure 6.9a) to 1.68 metres (Figure 6.9b). A very wide pavement or pedestrian street can often create a disorientating environment for a visually impaired pedestrian, especially if they have a reduced visual field and are unable to use peripheral cues such as the wall of a building, contrasting kerb edge or parked vehicle to orientate and assist in the navigation process. Similarly, a very narrow pavement can cause difficulties to visually impaired pedestrians (BSI, 2009, p. 16). Such an environment can evoke stress and anxiety due to pedestrian congestion and close proximity to the kerb edge and moving vehicles. A high frequency of pedestrian traffic and presence of street furniture may also lead to the narrowing of a pavement at specific sections, resulting in increased anxiety and stress levels as well as the more frequent occurrence of accidents and injuries through collisions with street furniture hidden by other pedestrians.

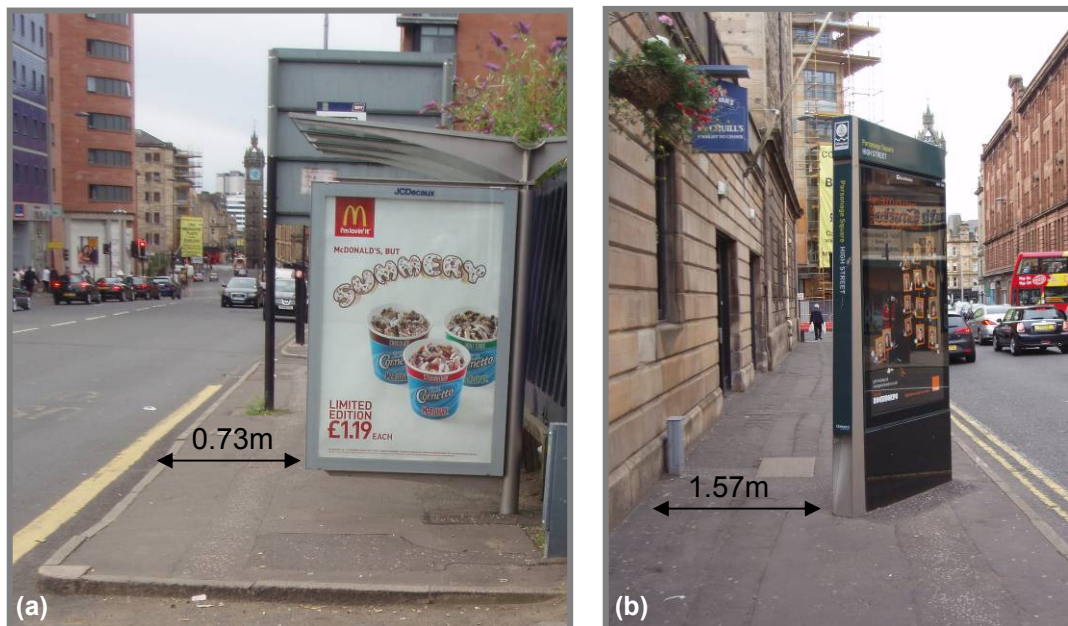
**Figure 6.10: Reduction in pavement width due to (a) Bus shelter on High St and (b) Sign on High St**

metres stretching for maximum distance of 2 metres (BSI, 2009, p. 16). However within the study area, pavements were found to be less than the recommended values at several locations due to the presence of street furniture. Figures 6.10 (a) and (b) illustrate the narrowing effect that (a) a bus shelter and (b) an advertisement sign can have on the width of a pavement. In the case of Figure (a) the presence of a bus stop narrows the pavement to 0.73 metres. This is substantially less than the recommended values outlined in Inclusive Mobility which suggest a minimum of 3 metres clear pavement width at bus stops (Dept. for Transport, 2005a, p. 11). Furthermore this measurement falls below the absolute minimum widths of 1 metre and 1.2 metres as recommended by Inclusive Mobility and British Standards respectively.

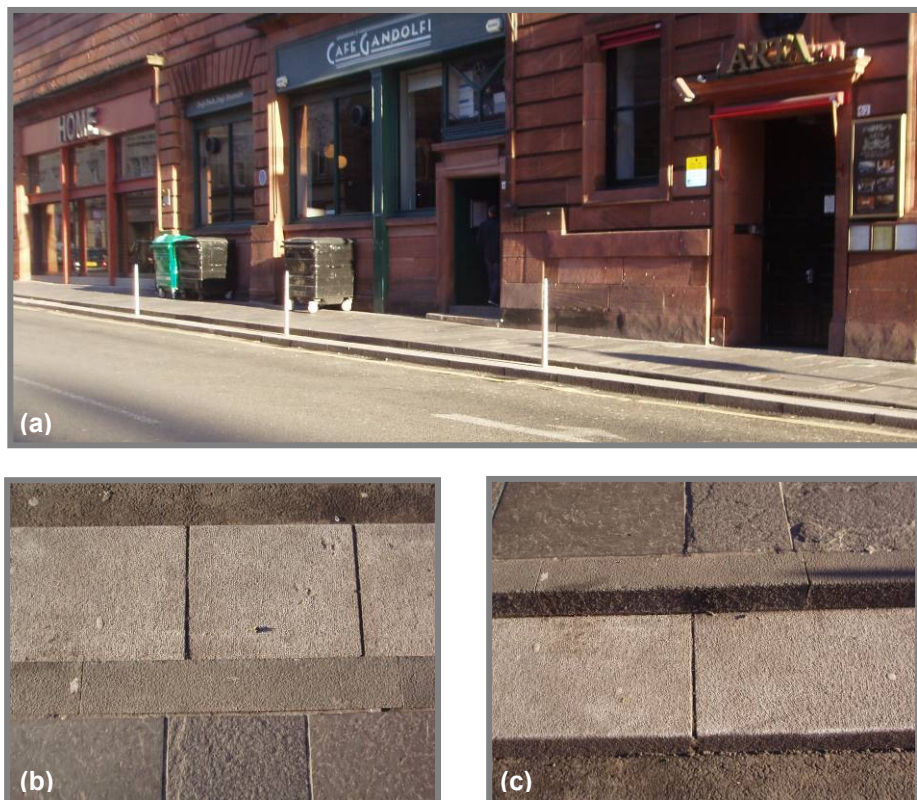
**Figure 6.13: Double kerb along Albion St (a) Double kerb, (b) kerb as viewed from road and (c) kerb as viewed from pavement**

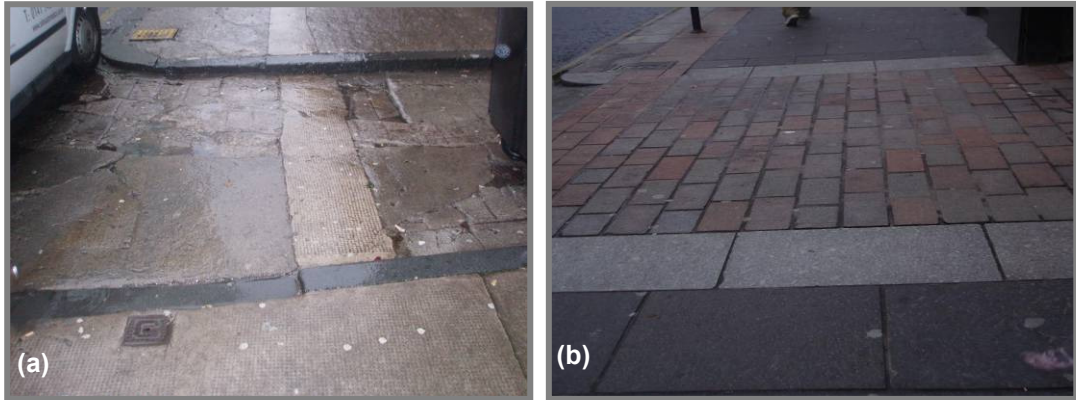
**Figure 6.14: Treatment of level changes at vehicular access entrances (a) North Fredrick St, (b) Ingram St**

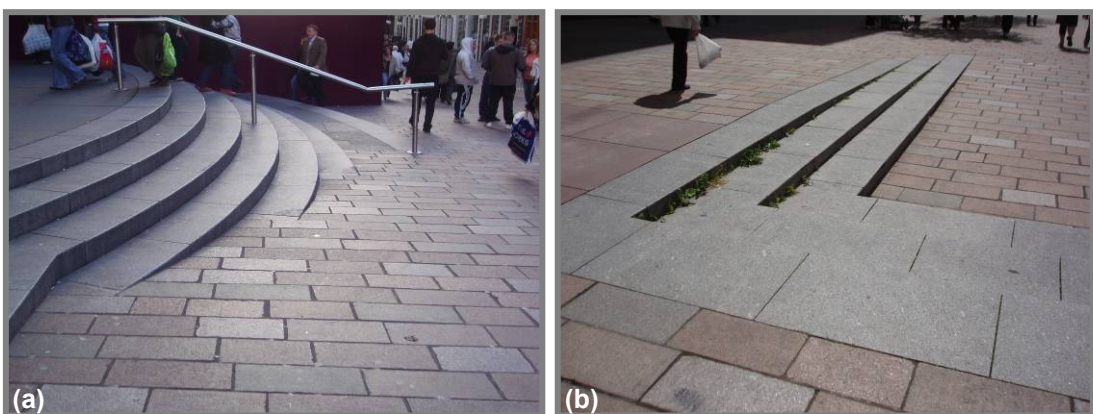
**Figure 6.16: Tapered steps on Buchanan St**

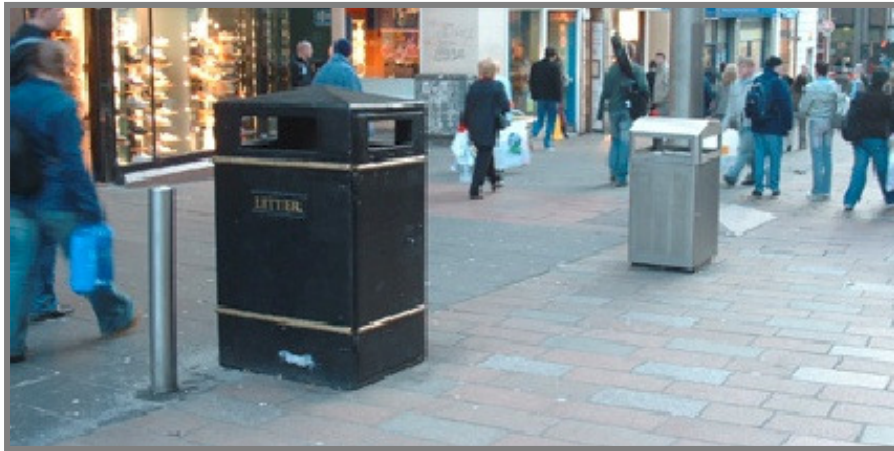
Figure 6.20: Different types of bins located along Buchanan St

Litter bins were identified by the survey participants as the second most hazardous item of street furniture present within the built environment. As with bollards and decorative cubes, the same logic is also applicable to the many litter bins located in the study area. Figure 6.20 illustrates an example of where old meets new. The older style black litter bins provide a much greater colour contrast than the newer stainless steel bins. The gold banding at the top of the black litter bin also assists a visually impaired pedestrian as to the location of the gap in which items of litter are to be placed. There was found to be a high frequency of irregular zoning of litter bins within the study area. In certain locations the bins were placed in the centre of the pavement, while on other streets they were zoned towards the kerb edge or opposite at the building line of the pavement. This leads to a high level of uncertainty with regards to the location of a litter bin as well as to the areas of the pavement which are free from obstacles.

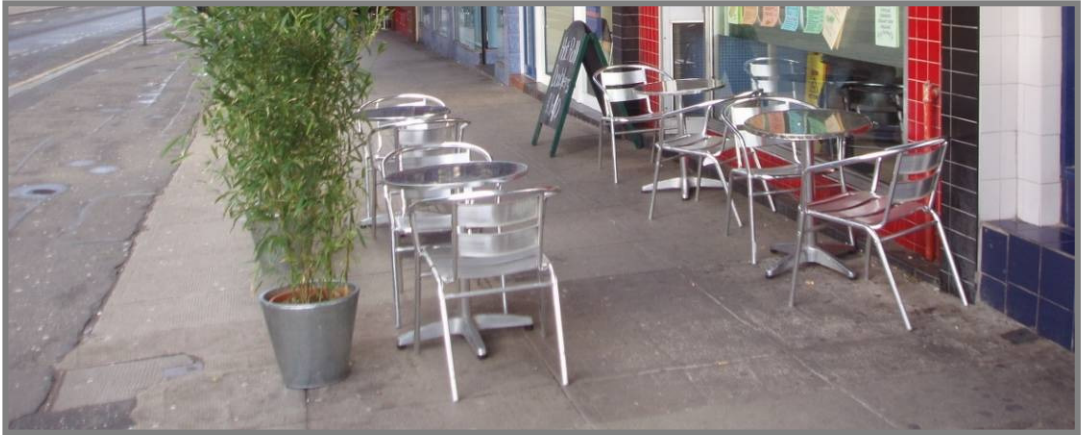
**Figure 6.21: Outside dining area on George St**

The choice of colour and material of outside dining areas can further contribute to the disabling nature of the built environment. The majority of the tables and chairs within the study area were found to be silver / stainless steel, which can be very difficult to detect for the visually impaired pedestrian. The presence of a protective barrier can increase the visibility of an outside dining area and help to contain tables and chairs within a specified boundary; however this practice was not found to be universal. Figure 6.21 illustrates a particularly hazardous example of an outside dining area, where the poorly contrasting low visibility tables and chairs have been placed on the pavement without the provision of a protective barrier. Finally it is also necessary to consider the effect that outside dining may have on the pedestrian flow of a pavement. The presence of tables and chairs can significantly reduce the available walking area leading to pedestrian congestion and an uncomfortable walking environment where people are forced to the kerb edge or even onto the road in an attempt to navigate around the obstacle.

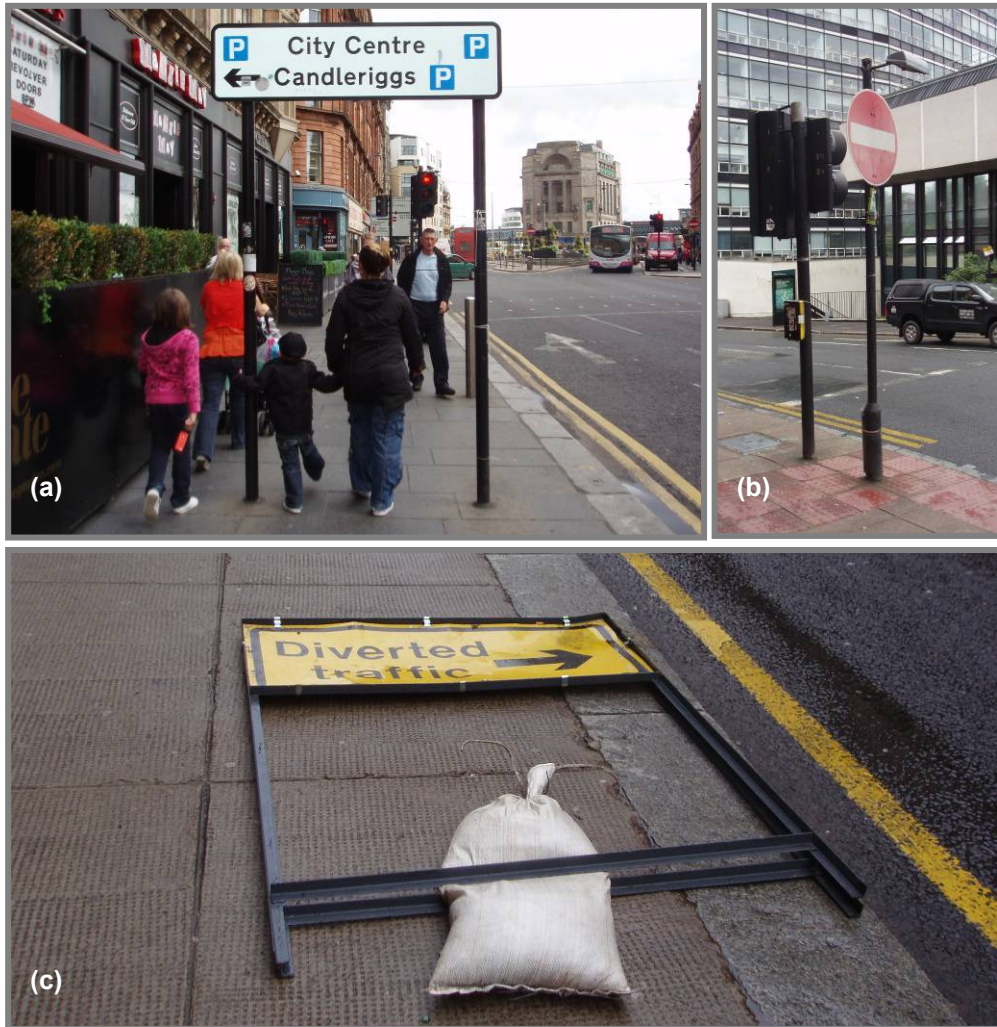
**Figure 6.22: Road signs: Double post road sign (a) on Trongate, (b) No entry sign located within tactile paving on Fredrick St and (c) Diversion road sign on George St**

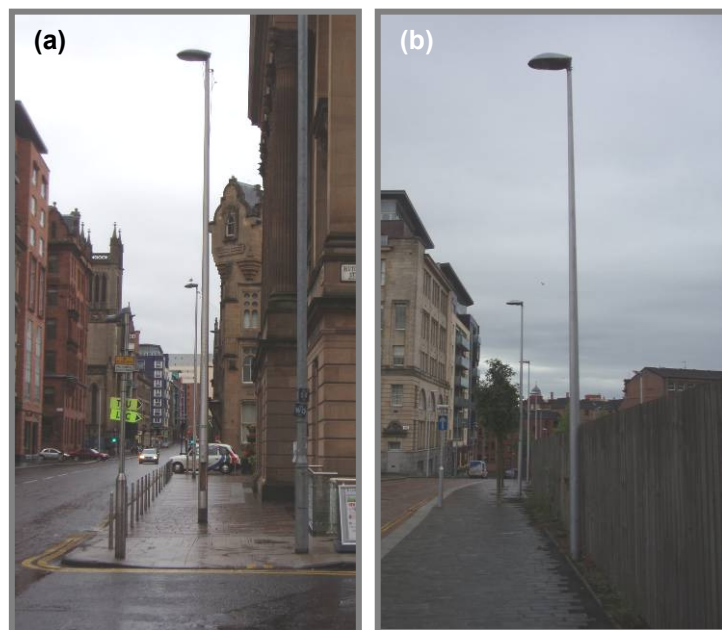
**Figure 6.23: (a) Inappropriately zoned lamppost located on centre of pavement on Ingram St and (b) Consistently well zoned lighted columns on Shuttle St**

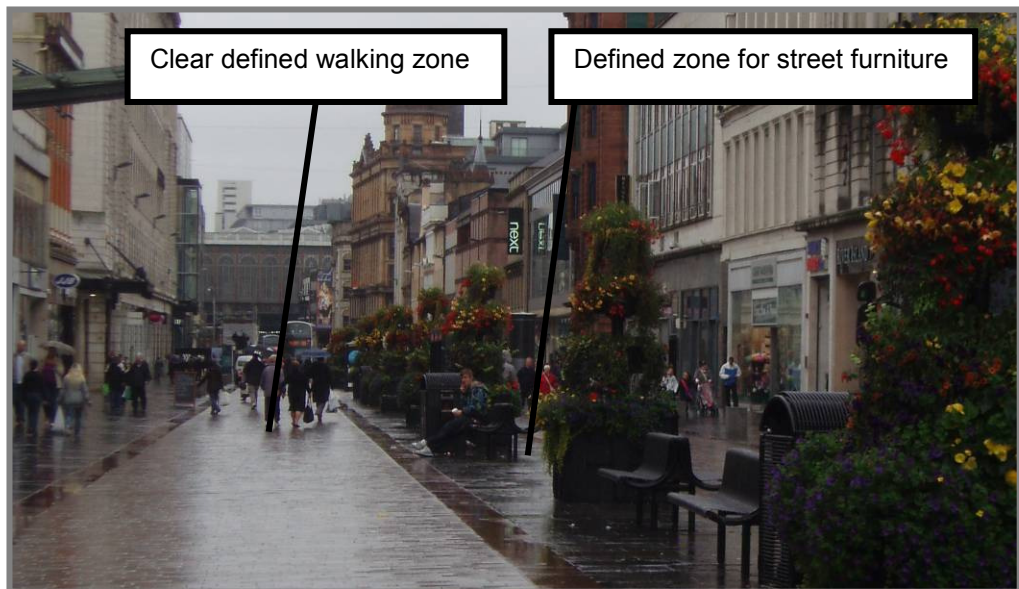
Figure 6.26: Clear zones on Argyle St (a) photography (b) schematic diagram illustrating zoning of street furniture

The street furniture on Argyle Street (Figure 6.26) has been zoned in a way that creates a clear and unobstructed path for pedestrians. The pedestrian precinct has been designed to create five distinct strips, with each strip differing in colour, material and pattern. This type of design can be particularly comforting and reassuring to a visually impaired pedestrian who is able to walk safely along a particular strip in the knowledge that they are not about to collide with an item of street furniture.

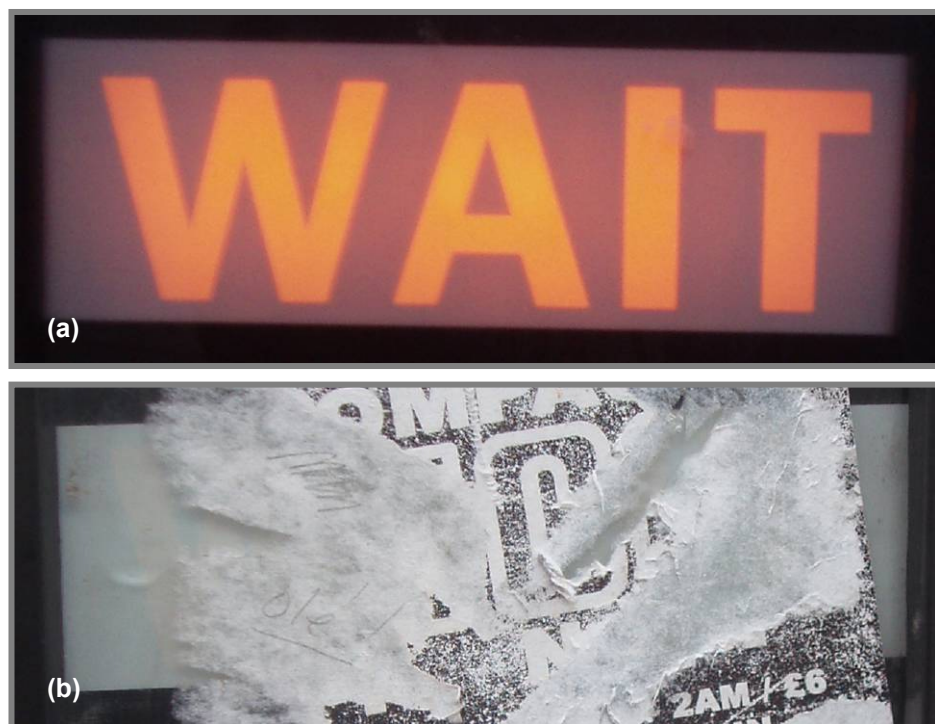
Figure 6.32: Wait light (a) on a dark night and (b) covered over with a sticker

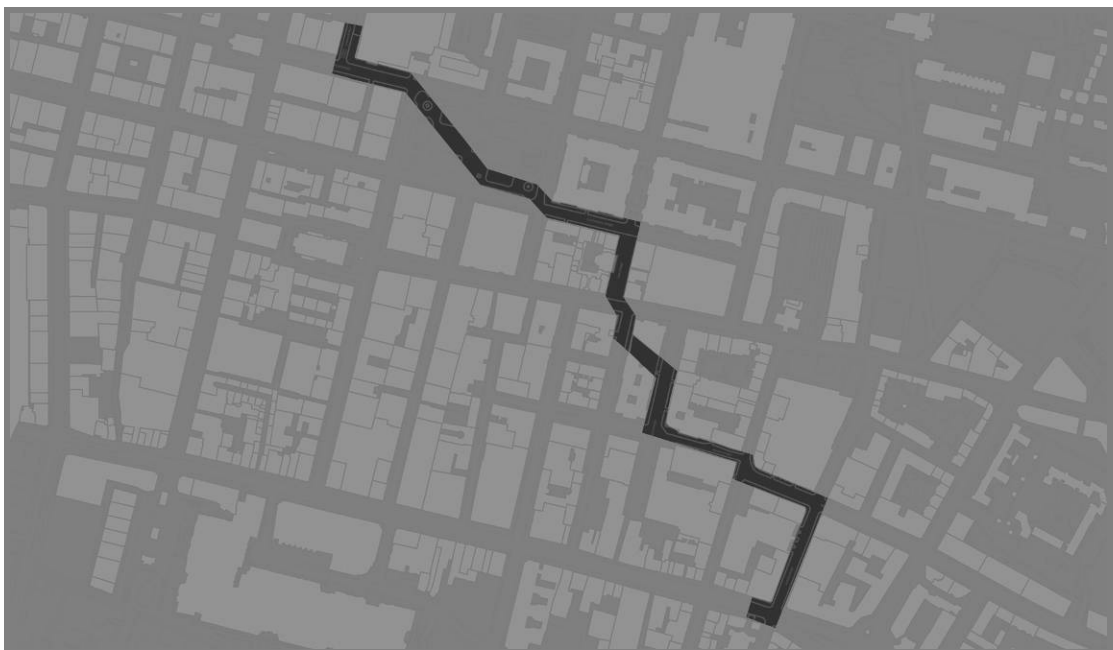
Figure 7.6: Example of a strategy adopted by a fully sighted participant

The fully sighted participants all adopted a similar strategy during the navigational experiment. In particular, none of the fully sighted participants planned their route prior to commencing the journey. Instead the strategy was based on a spontaneous decision-making process whereby decisions were made and executed in rapid progression. The routes chosen by the fully sighted were more diagonal in nature and were angled in the compass direction of the end location of the experiment. All five fully sighted participants chose to walk diagonally across George Square and thereafter weave through the streetscape of the Merchant City. It was noted that unlike the visually impaired participants, the fully sighted did not restrict their path across roads to designated controlled pedestrian crossing points. Instead they were able to use their vision to judge a time at which it was safe to cross. Furthermore, the fully sighted control group did not encounter any problems with the street design or layout while navigating through the city as they were able to use their vision to avoid potential obstacles and hazards and alter their course accordingly. Figure 7.6 provides an example of a typical route strategy adopted by the sighted participants.

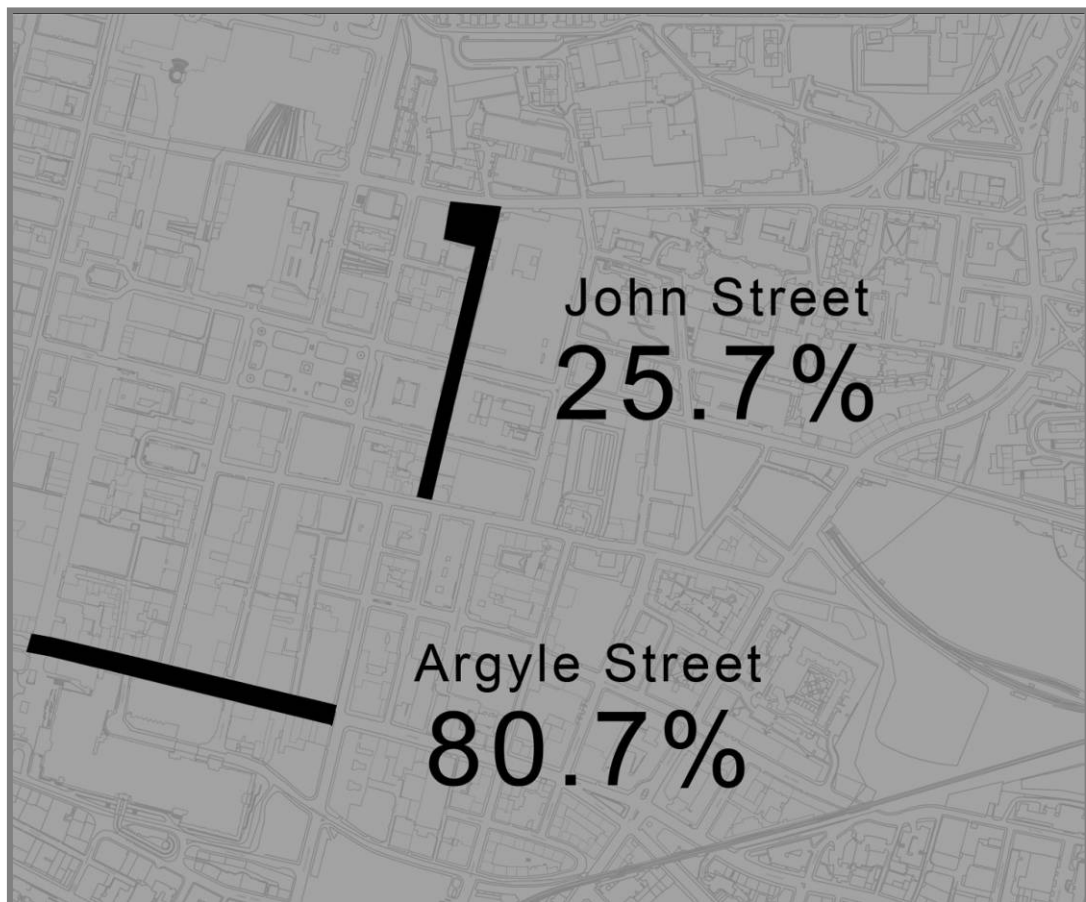
Figure 8.2: Map indicating most accessible street and most hazardous street

Figure 8.2 details the streets with the lowest and highest percentage ratings. The most hazardous street within the study area was John Street with an overall rating score of 25.7%, while Argyle Street received the highest rating with a score of 80.7%. In order to understand the reasons why these two streets differ so much in terms of accessibility, they will be examined in detail in sections 8.3.1 (most hazardous street) and 8.3.2 (most accessible street) through the use of tables and annotated street maps.
