Department of Mechanical and Aerospace Engineering
University of Strathclyde

Enhancing the Methodology for Rain Erosion Testing

PhD Thesis

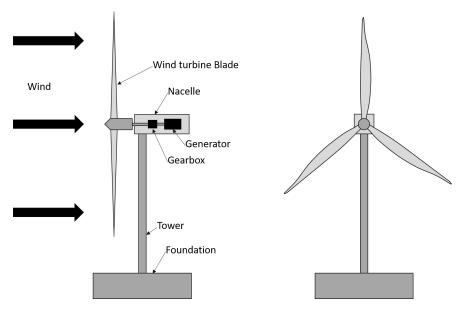
Figure 2.1: A Horizontal Axis Wind Turbine (HAWT) schematic.

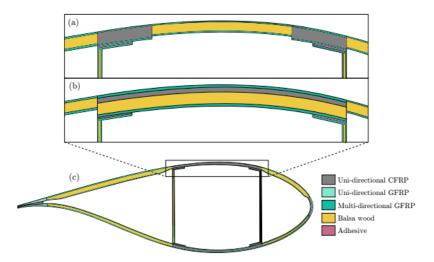
Figure 2.3: Various spar cap topologies explored by Rosemeier and M Batge [2]. (a) Split Spar Cap (SSC) concept, (b) Continuous Spar Cap (CSC) concept, and (c) baseline.

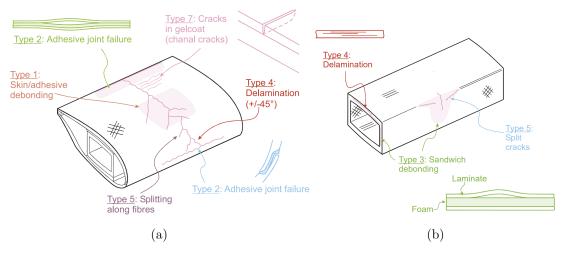
Figure 2.4: 2.4a shows damage types 1,2,4,5 and 7, 2.4a show damage types 3, 4 and 5. Damage type 6 is not shown, but is a subclass of damage type 1 (reprinted from [3]).

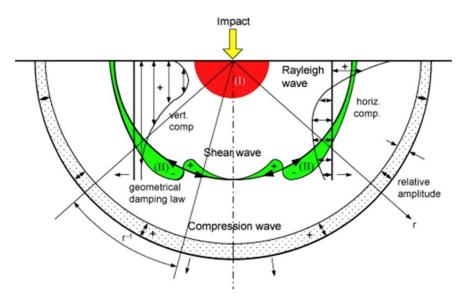
Figure 2.9: Acoustic waves generated inside the material during an impact from a droplet (taken from [7]).

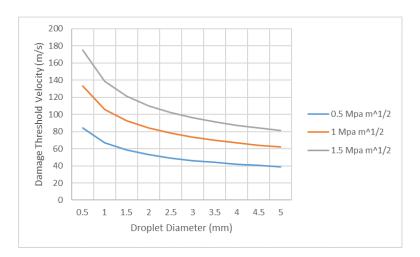
Figure 3.2: Damage Threshold Velocity (V_{DT} Vs. droplet diameter using equation 3.7 from Ref. [9] for epoxy coatings with different fracture toughness values. Figure adapted from [10]. C_R , = 942m/s, ρ_w , = 1000 kg/m^3 , C_w , = 1490 m/s.

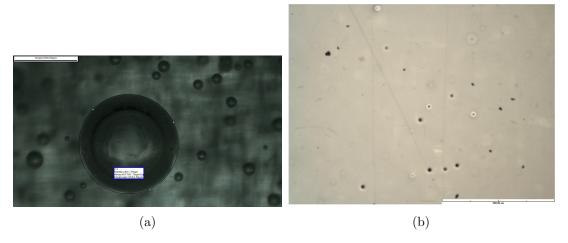
Figure 4.3: Figures 4.3a and 4.3b show images taken using optical microscopes at the university and NPL. Figure 4.3a shows one of the larger subsurface voids observed inside the coating, with a radius of approx 0.4mm.

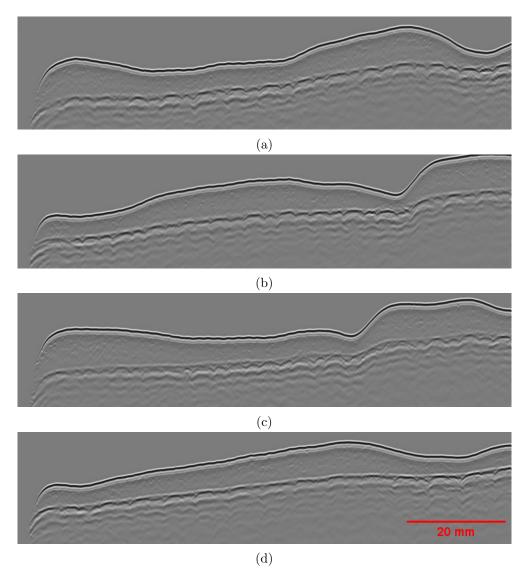
Figure 4.6: The underlying composite panel surface, visible through the coating using US.

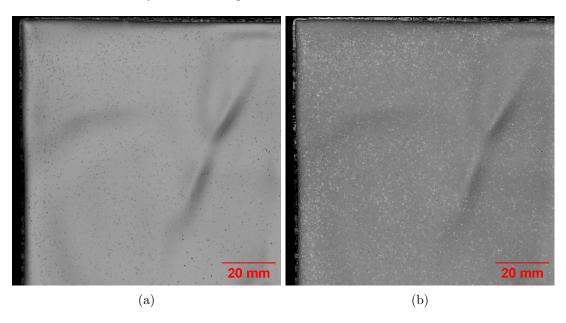
Figure 4.7: Defects on the surface of the coating 4.7a and inside the coating 4.7b, visible through the coating using US

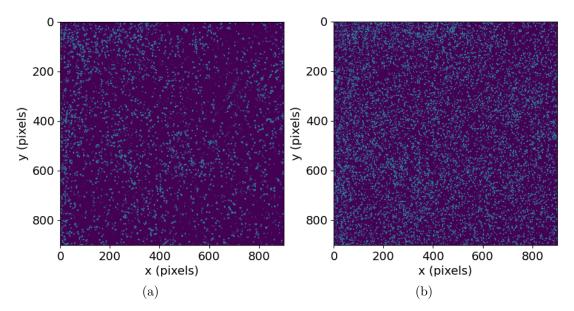
Figure 4.8: Canny edge detection of the voids on the surface 4.8a and inside the coating 4.8b, respectively.

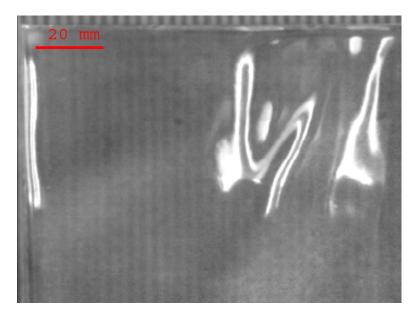
Figure 4.12: Surface Undulations of the composite sample (2nd time derivative), visible using thermography.

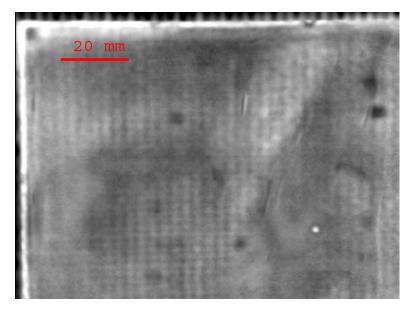
Figure 4.13: Sub-surface defects of the composite panel, visible using thermography.

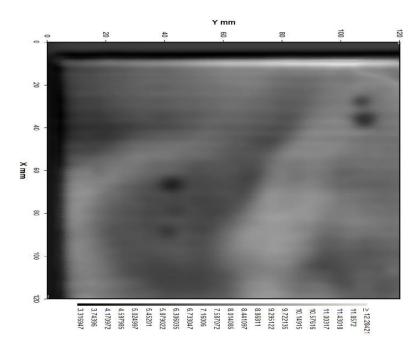
Figure 4.14: Sub-surface defects of the composite panel, visible using microwave.

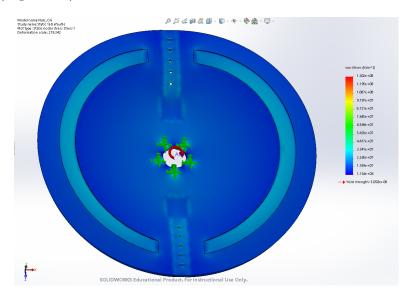
Figure 6.5: Solid plate configuration simulation results, showing stresses during max speed operation.

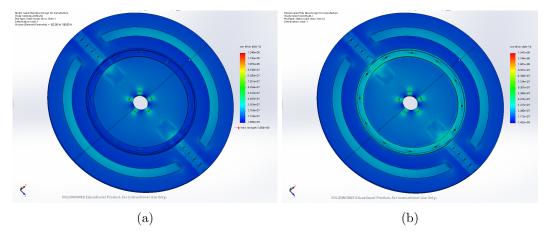
Figure 6.6: Bonded clamping plate configuration simulation results, showing stresses during max speed operation. 6.6a showing the scenario where the material is Aluminium and 6.6b showing the scenario where the material is stainless steel.

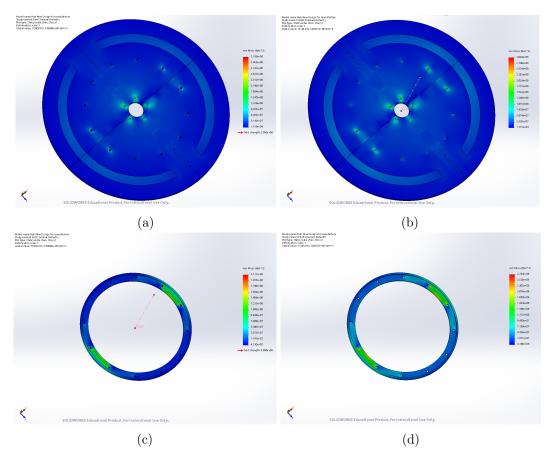
Figure 6.7: No penetration clamping plate configuration simulation results, showing stresses during max speed operation. Figures 6.7a and 6.7c showing the scenario where the material is aluminium. Figures 6.7b and 6.7d showing the scenario where the material is Stainless steel Figures 6.7a and 6.7b and Figures 6.7c and 6.7d show just the plate and just the clamp respectively.

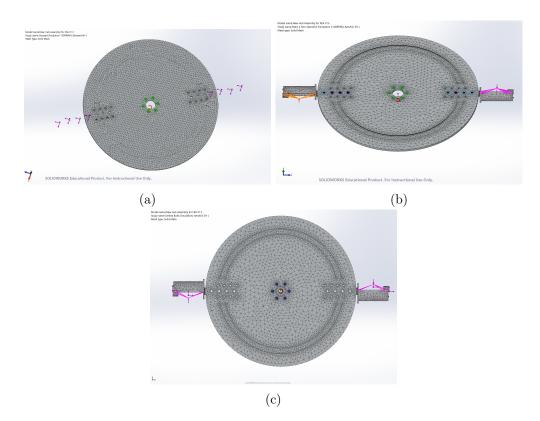
Figure 6.9: Figures 6.9a, 6.9b and 6.9c show the meshes and simulation setups for the Hub disc, the Hub disc with sample holders connected using pins and the Main bearing bolted connection simulations, respectively. For the Main bearing bolted connection simulation, the hub flange is attached to disc using bolted connection with no penetration contact between the two. Bonded connection was applied between the disc and sample holders.

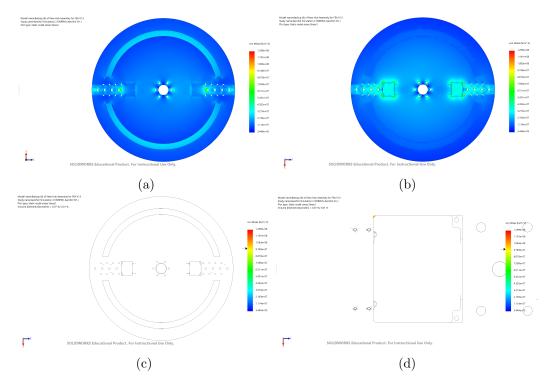
Figure 6.10: Figures 6.10a and 6.10b show stress maps of the top and bottom of the disc using the aerofoil sample holder whilst rotating at 2100 rpm, respectively. Figures 6.10c and 6.10d show the peak stresses (> 100 MPa, fatigue safety factor < 1.5) identified on the radii of the electronics box slots whilst rotating at 2100 rpm.

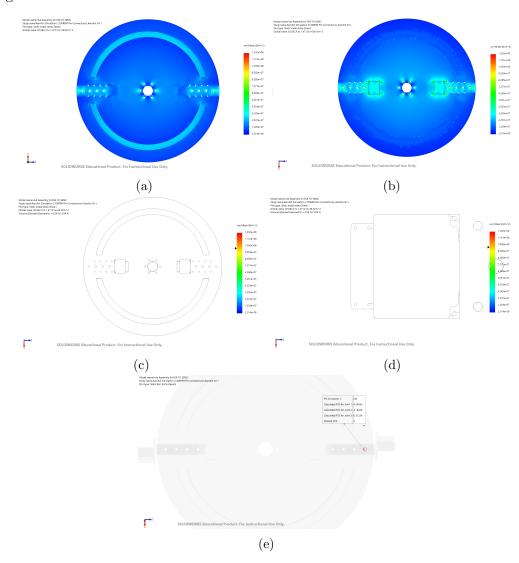
Figure 6.11: Figures 6.11a and 6.11b show stress maps of the top and bottom of the disc using the aerofoil sample holder whilst rotating at 2100 rpm, respectively. Components are connected using pin connectors. Figures 6.11c and 6.11d show peak stress hotspots on the disc (> 100MPa). The simulation results mostly show the same stress distribution as in figure 6.10. As seen in figure 6.11e Pin connector safety factors with the lowest value was found to be the connection on the section of pin in contact with the sample holders, at 3.2.

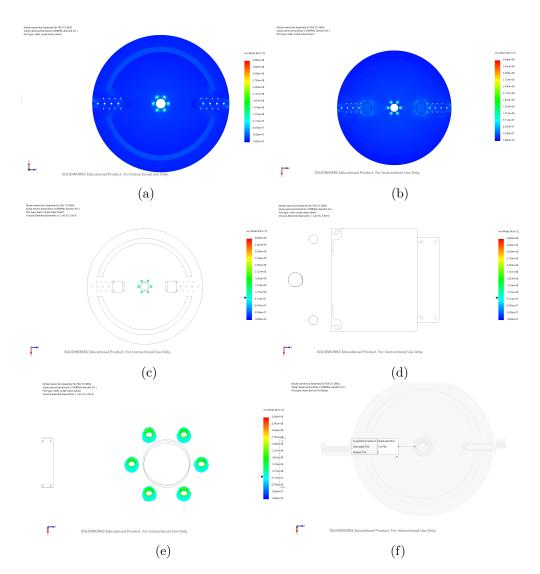
Figure 6.12: Figures 6.11a and 6.11b show stress maps of the top and bottom of the plate component with the hub connection bolted whilst rotating at 2100 rpm, respectively. Components are connected using pin connectors. Figures 6.11c and 6.11d show peak stress hotspots on the disc (> 100MPa). The simulation results mostly show the same stress distribution as in figure 6.10. As seen in figure 6.11e Pin connector safety factors with the lowest value was found to be on the pin section in contact with the sample holders, at 3.2.

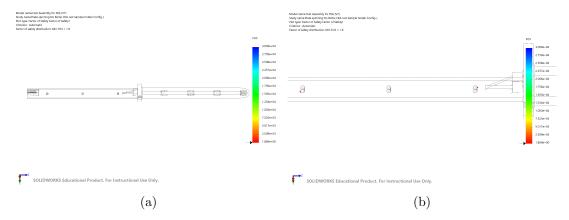
Figure 6.14: Figures 6.14a and 6.14b show the minimum safety factors found in the V9 sample holder simulation.

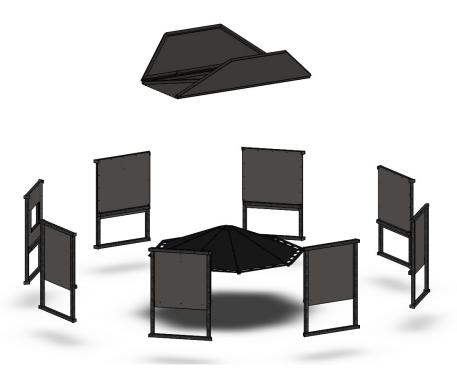
Figure 6.15: Displayed here is the Full Enclosure, including the coned drainage system and lid, however in this diagram the door was omitted.

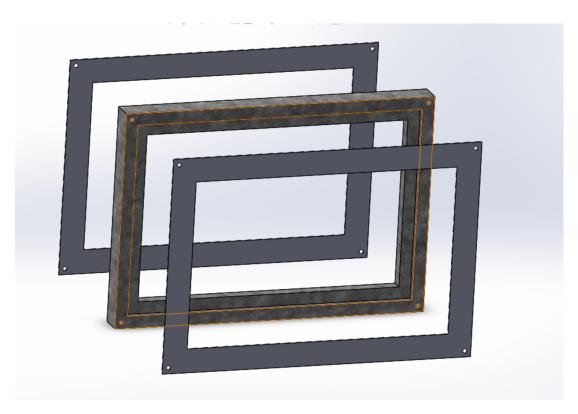
Figure 6.16: Displayed here is the door and viewing window, which comprises of 2 sections of 12mm thick polycarbonate, separated by 1" 316 stainless steel box section and sandwiched together using 3mm thick 316 stainless steel shell panels.

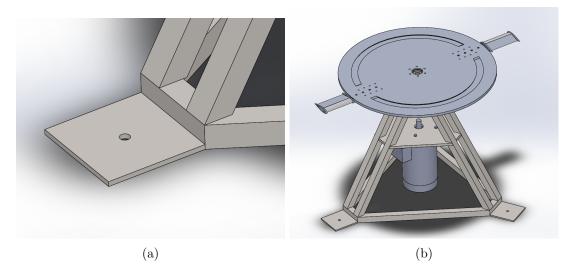
Figure 6.18: Figures 6.18a and 6.18b show The motor stand, hub and motor setup and bolted ground fixation (M20), respectively.

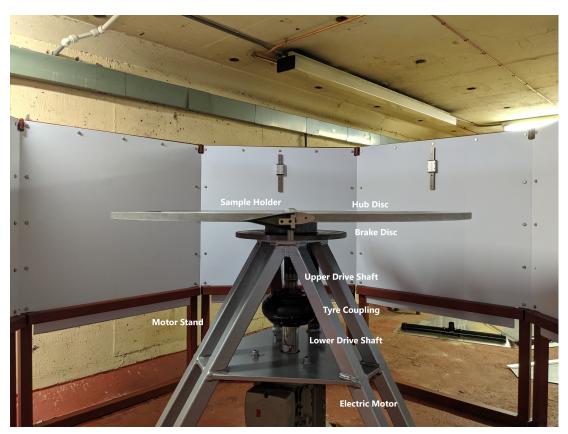
Figure 6.21: Displayed here are the Motor Stand, the Hub Disc, the Aerofoil Sample Holders, the Brake Disc, the Upper Drive Shaft, the Tyre Coupling, the Lower Drive Shaft and the Electric Motor, correctly assembled and configured.

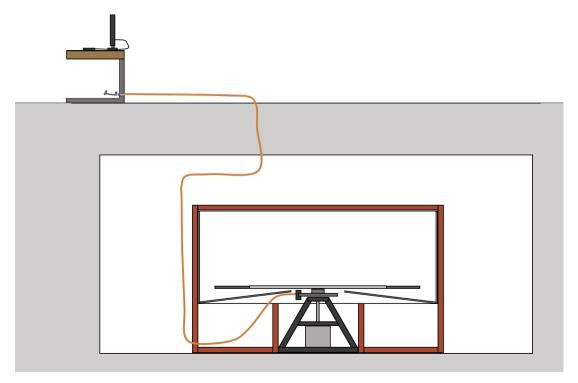
Figure 6.22: Full diagram of the brake system. The brake pedal is located at the control station, mounted onto the control station desk and is connected to the brake caliper, via copper tubing, and disc, mounted directly onto the test rig.

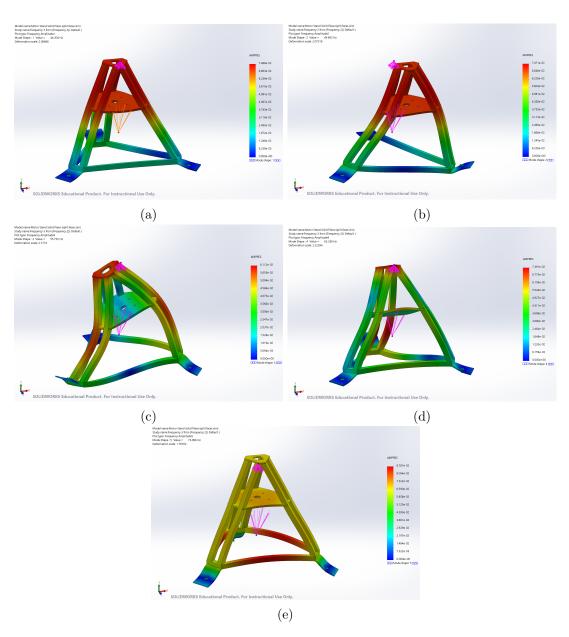
Figure 6.25: Modal shapes 1, 2, 3, 4 and 5 for motor stand, respectively

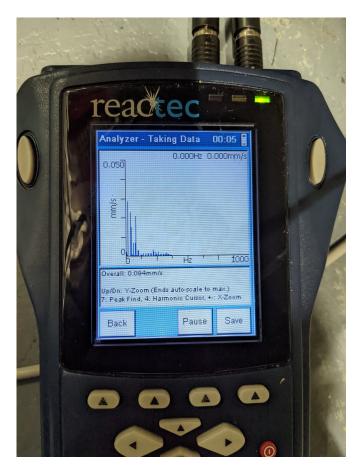
Figure 6.26: Reactec RT-440 being used to measure vibrational velocity during operation at 300rpm, in order to balance the rig.

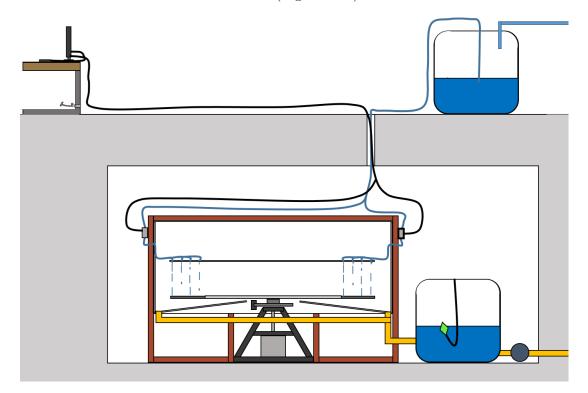
Figure 6.28: Diagram showing the full water system.

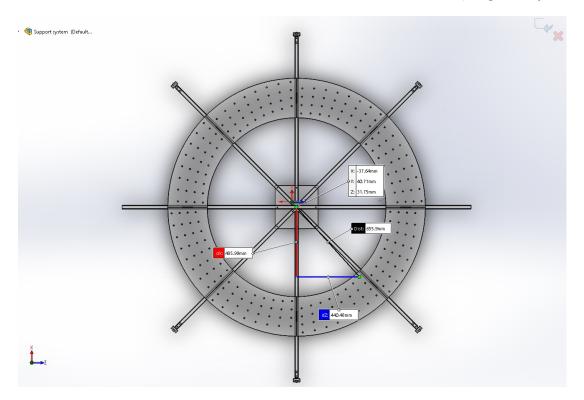
Figure 6.29: CAD drawing of the rain system from above, showing the helical needle configuration on each octant of the system as well as the U-channel frame.

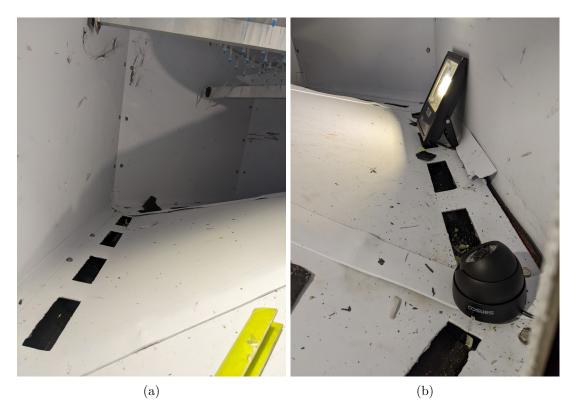
Figure 6.37: Figures 6.37a and 6.37a show some of the initial debris upon first inspection following the failure.

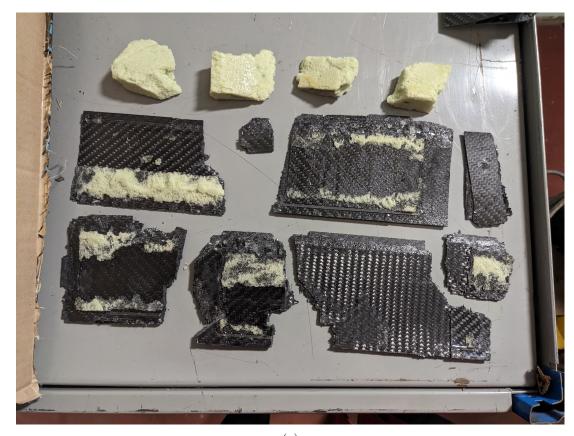
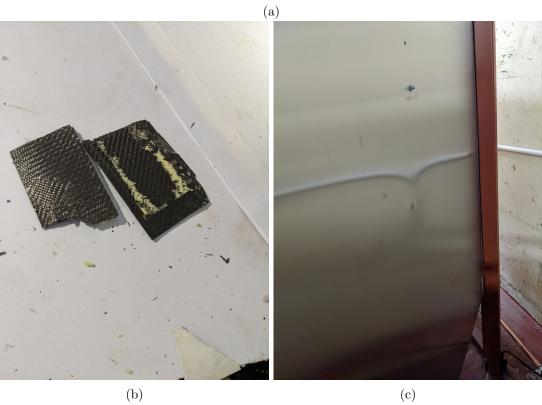
Figure 6.38: Figures 6.38a and 6.38b show $0\frac{1}{4}$ he residual debris from T2. Figure 6.38c shows the impact damage observed on the enclosure walls.

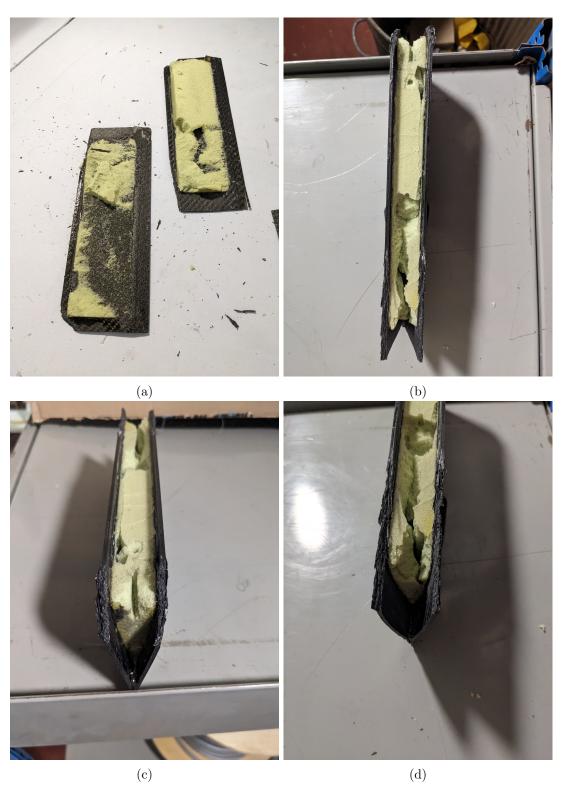
Figure 6.39: Figures 6.39a 6.39b, 6.39c and 6.39d show T1. Figures Figure 6.39b shows T1 reassembled emphasising how this tail section is nearly intact, excluding the fact that the two halves have debonded.

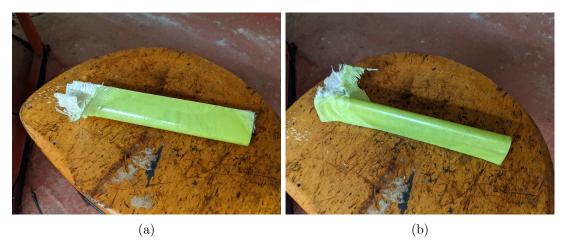
Figure 6.40: Figures 6.40a and 6.40b show the impact damage to S1.

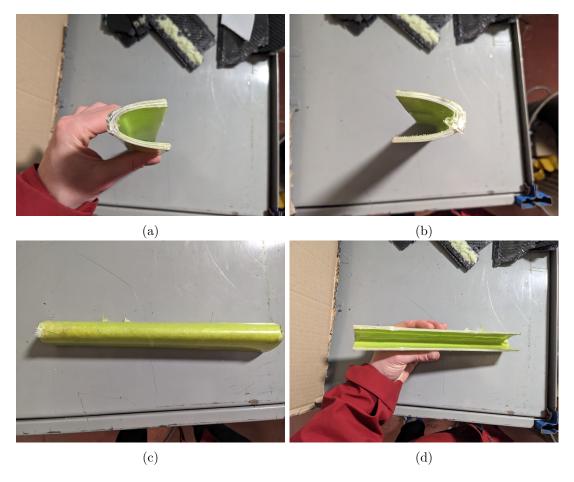
Figure 6.41: Figures 6.41a 6.41b show the ends of S2, with small impact marks visible. Figures 6.41c and 6.41d show the front of the sample, with deformation to the shape visible.

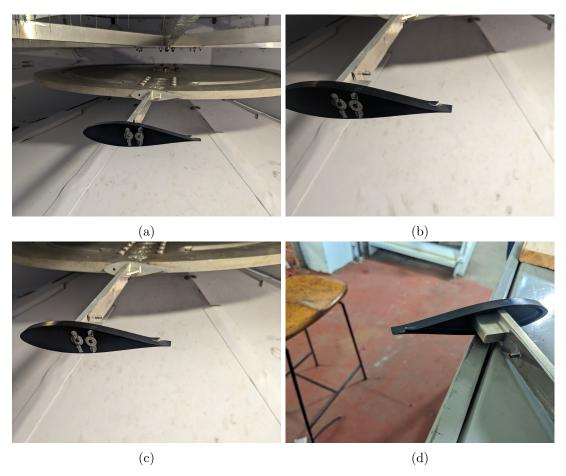
Figure 6.43: Figures 6.43a, 6.43b,6.43c and 6.43d show crack on both end pieces.

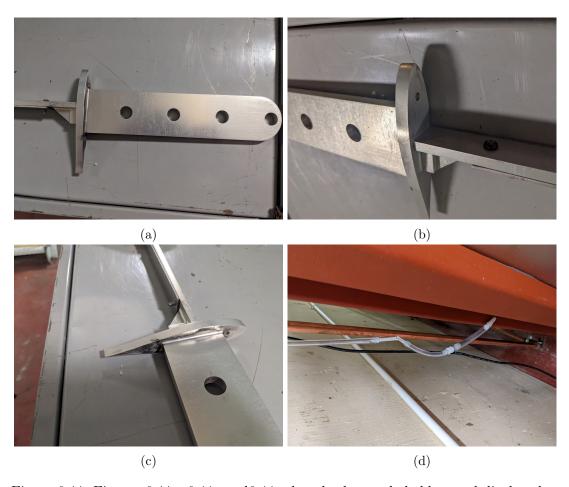
Figure 6.44: Figures 6.44a, 6.44a and 6.44c show both sample holders and display the dust observed on the sample holders posts failure. Figure 6.44d shows some of the damage observed on the rain system.

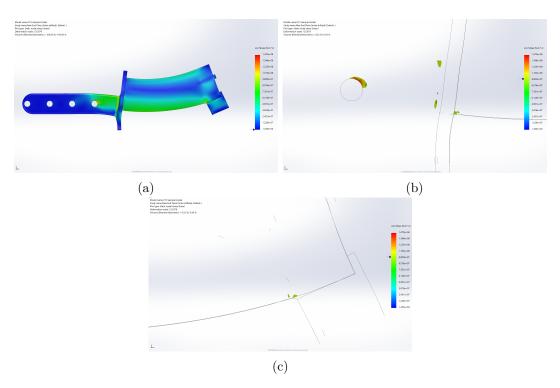
Figure 6.47: Figure 6.47a shows a stress map of the top of the aerofoil sample holder whilst rotating at 2100 rpm. Figures 6.47b and 6.47c show peak stress hotspots on the sample holder (> 100 MPa).

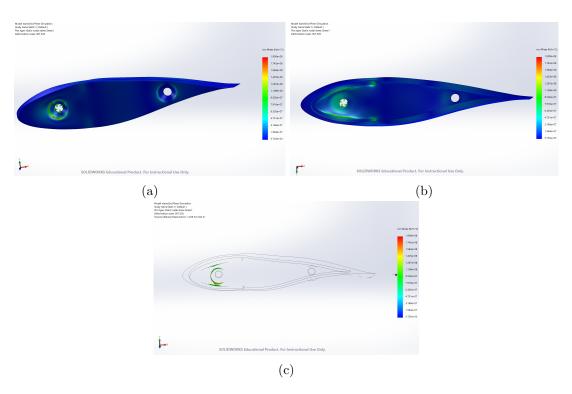
Figure 6.48: Figures 6.48a and 6.48b stress maps of both the outside and inside of the component whilst rotating at 2100 rpm, respectively. Figure 6.48c shows the peak stress hotspots on the sample holder end piece (> 100MPa).

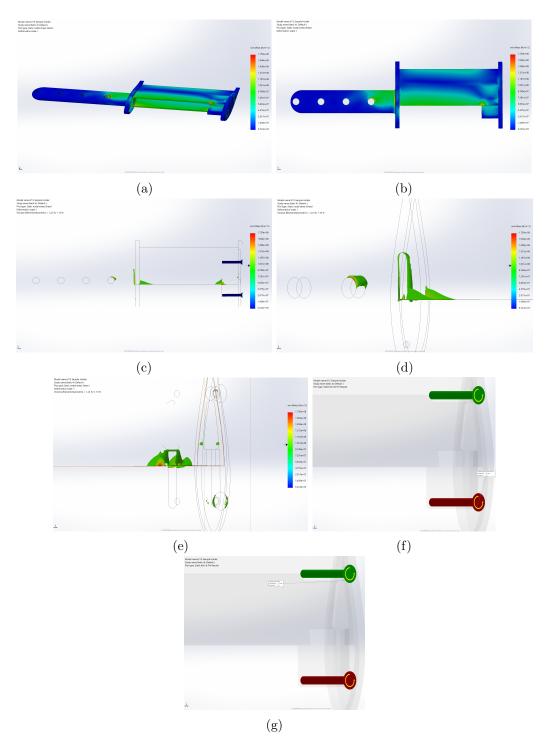
Figure 6.49: Figures 6.49a and 6.49b show stress maps of for the full simulation of the sample holder, end piece, sample and bolts. Figures 6.49c, 6.49d and 6.49e show peak hot spots ($> 100 \mathrm{MPa}$) on the main sample holder and end piece. Figures 6.49f and 6.49g show the bolt safety factors present during operation.

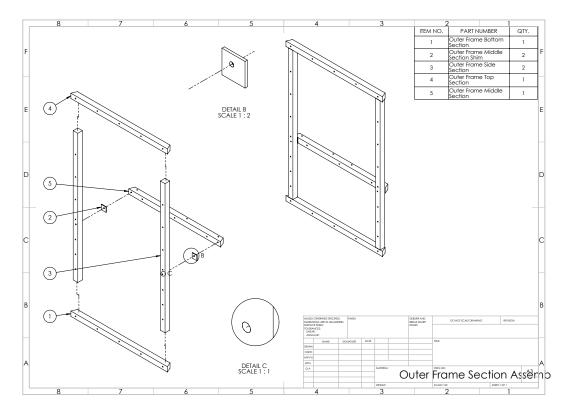
Figure C.1: Displayed here is one of the outer frame sections from the enclosure. There were 3 separate variants of the outer frame sections; one which allowed the installation of the door and viewing with, this section (which was a generic section with no significant features) and the final which allowed the attachment of the lid sections.

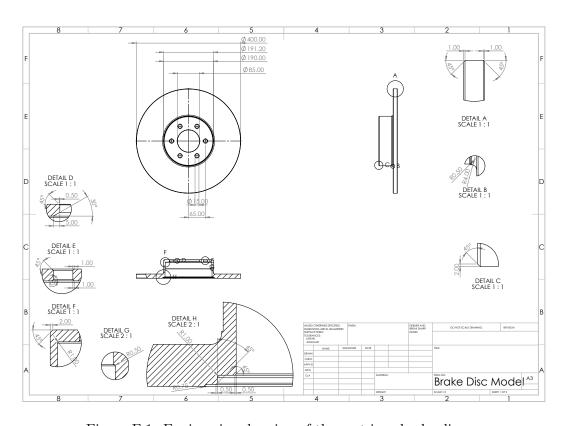
Figure F.1: Engineering drawing of the cast iron brake disc.

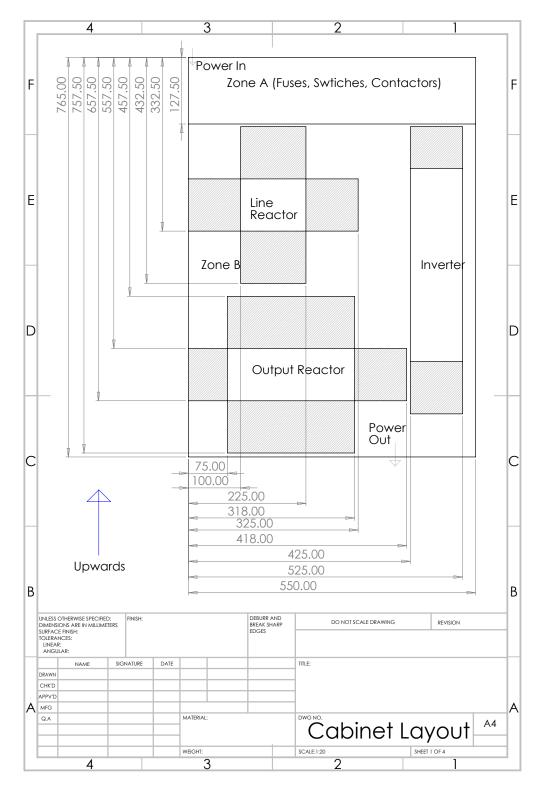
Figure G.1: An engineering drawing of the back plate for the motor cabinet purchased from RS Online. The shaded sections around each of the components indicate ventilation zones for each of the components. \$278

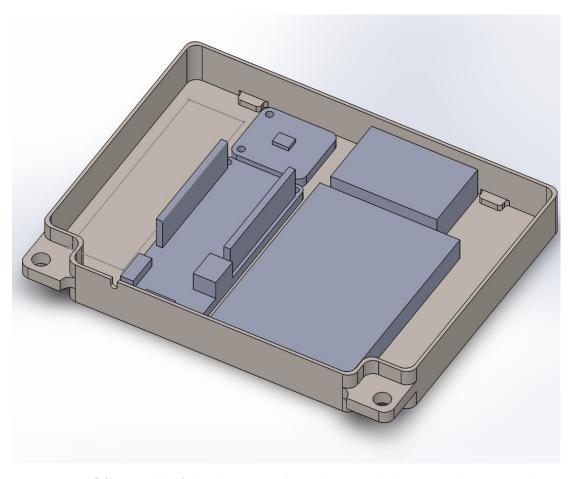
Figure H.1: CAD model of the electronics box, showing the battery, thermocouple amplifier, switch and MKR1010 $\,$
