**An Investigation into the Reliability of
Thermosonics for Aero Engine Turbine
Blade Inspection**

Submitted in May 2013

for the degree of Doctor of Engineering

Centre for Ultrasonic Engineering

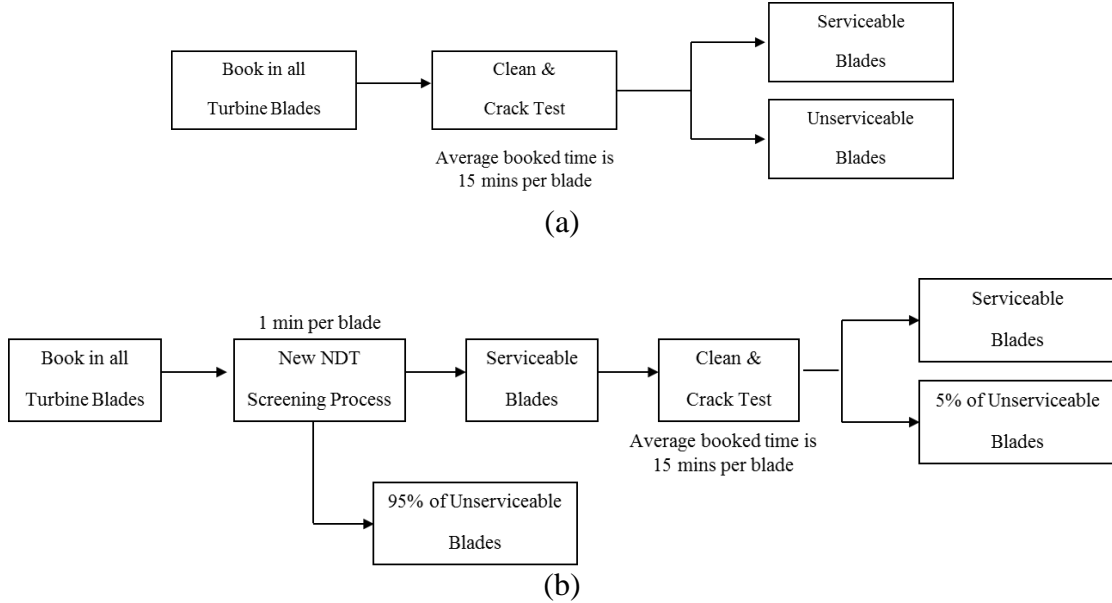
Figure 1-1 (a) Current inspection process (b) proposed inspection process.

Figure 1-1 (a) shows the current inspection process for turbine blades in Rolls-Royce (RR). The blades are first booked in to register their part numbers, after which they go through an extensive chemical cleaning process prior to crack testing with Fluorescent Penetrant Inspection (FPI). FPI is the accepted and mandatory method used to inspect turbine blades for surface-breaking cracks [2, 3]. Surface preparation is important as it removes any contaminant that may hinder the infiltration of penetrant into a crack. However, removal of contaminants such as debris, dirt, corrosion or grease that can accumulate on the surface of a blade while in-service, is not trivial, and in most cases requires a time-consuming and expensive cleaning process.

In the current inspection process shown in Figure 1-1 (a), both serviceable and unserviceable blades go through the clean and crack test process. However, cleaning and inspecting unserviceable blades is a non-value-added process, costing time and money. At present, approximately 11% of RR turbine blades (civil large engine) are classed as unserviceable (due to cracking) after the clean and crack test. Therefore, a reliable and rapid NDT method that can filter unserviceable blades at the pre-cleaning stage is desirable. This will reduce the number of blades going through the mandatory cleaning and FPI process, thereby saving cleaning and inspection costs, and time.

Figure 1-1 (b) shows the proposed inspection process which includes an additional NDT method prior to clean and crack test. However, for this additional NDT method to

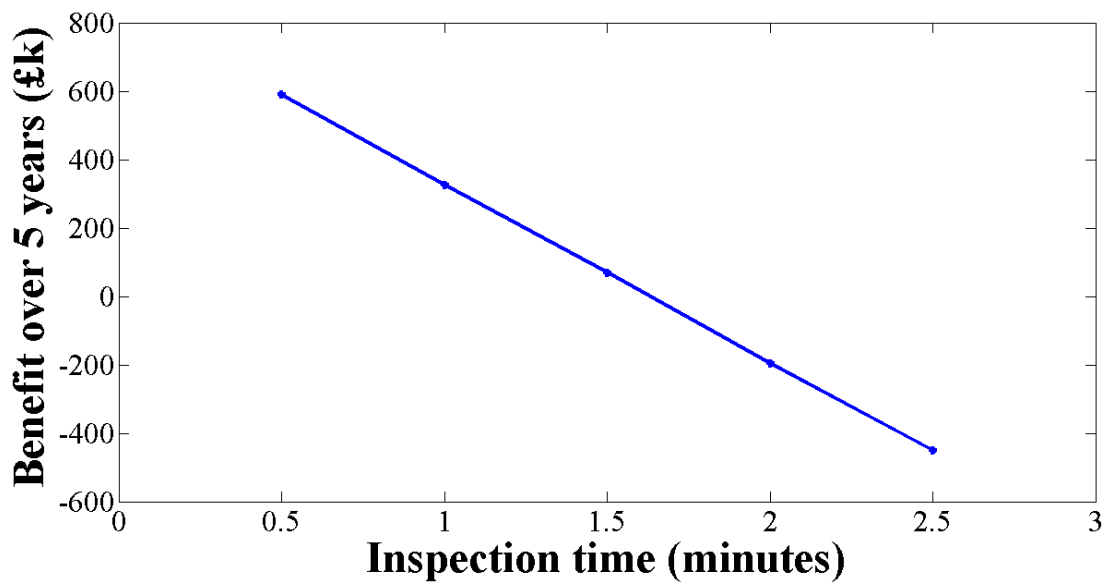
Figure 1-2 Effect of inspection time of additional NDT method on cost benefit over 5 years (Rolls-Royce).

generate meaningful cost savings, the following criterion must be met: reliability of at least 95% in detecting cracks and an inspection time of less than 1 minute. This criterion was established in a business case produced by RR personnel prior to the start of this EngD project. Note that the remaining 5% of cracked blades not detected by the additional NDT method will be later detected at the FPI inspect stage. Figure 1-2 shows the effect of the inspection time of the additional NDT method on the potential cost savings over 5 years. This Figure shows estimated savings of at least £327 k over 5 years with an inspection time of less than 1 minute (and 95% reliability), while an inspection time over 1.6 minutes results in additional costs to the inspection process. Note that Figure 1-2 was produced by RR personnel as part of the business case for this project.

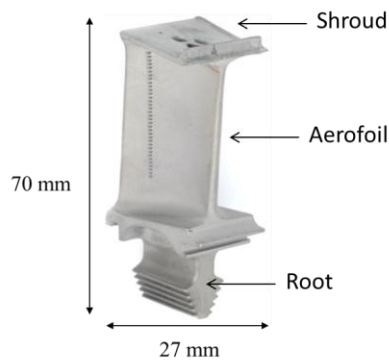
Figure 3-1 Turbine blade used in empirical study.

Figure 3-1 shows a representation of the blades used in this study. This blade is made of high-strength nickel alloy and is approximately 70 mm in height and 27 mm at the widest point. The blades were all in a clean condition having been through the routine cleaning and FPI process, during which cracks were detected at the shroud, as indicated in Figure 3-2. The cracks on all 60 blades were visible and their lengths measured using a calibrated optical microscope/CCD camera (Leica MZ8/ JENOPTIK ProgRes® C12). The crack lengths ranged between 0.3 mm and 6.0 mm. Figure 3-3 shows a frequency distribution of the crack lengths, which shows a relatively consistent distribution of crack lengths between 1 mm and 6 mm. In addition, the accepted minimum detectable crack size (~0.75 mm) using the current method (i.e. FPI) for inspecting these blades is represented in the range of crack lengths set out for this study.

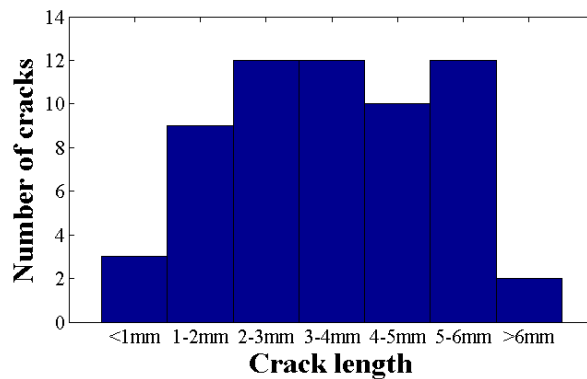
Figure 3-3 Frequency distribution of crack length in set of 60 turbine blades.

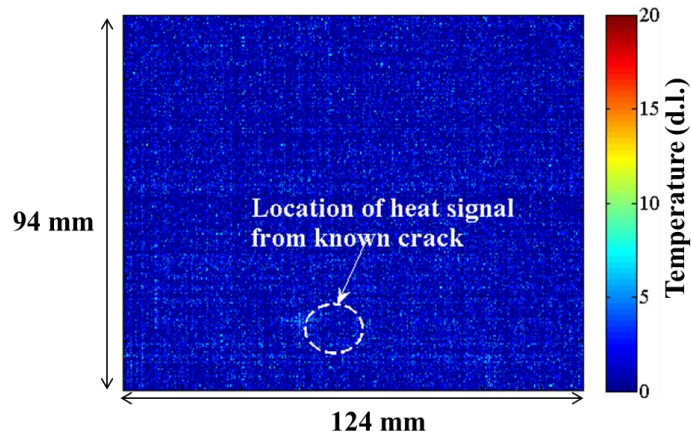
Figure 3-6 Example of a difficult to interpret background subtracted image.

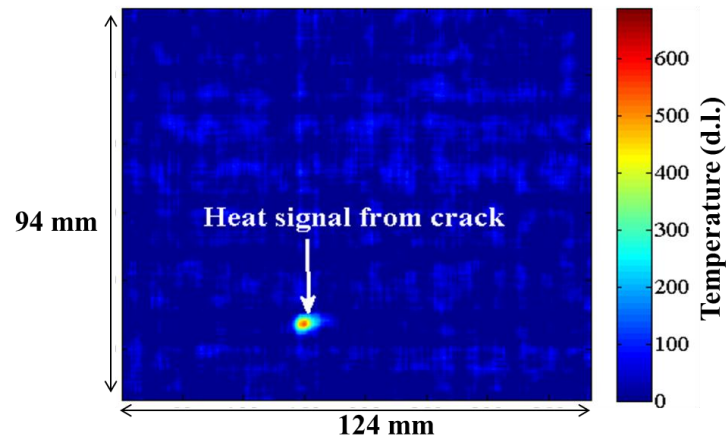
Figure 3-7 Improved imaging result after applying a linear filter to the background subtracted image shown in Figure 3-6.

One drawback of using this type of filter for noise reduction is image blurring [109]. However, this did not adversely influence the interpretation of the imaging results obtained in this work. A 9 x 9 filter mask with a weighting of one in all locations was found to enhance the crack heat signal and allow for easier interpretation. This is illustrated in Figure 3-7 where the heat signal from the crack (red spot) is clearly discernible from the rest of the background. The image in Figure 3-7 was a result of applying a linear filter to the background subtracted image shown in Figure 3-6.

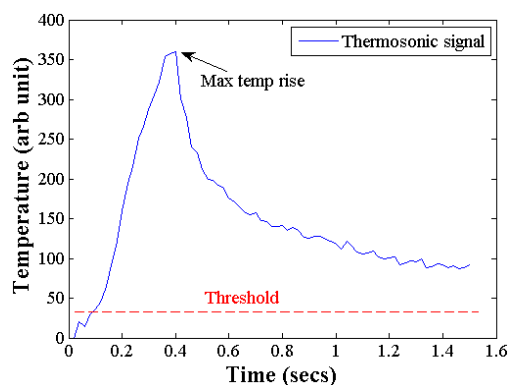
Figure 3-8 Temperature rise profile of a crack heat signal.

represented in digital levels (d.l.), was computed as the contrast between an average pixel intensity of a specified region of interest around the crack and an average of a background area elsewhere in the image. Furthermore, the red dashed line in Figure 3-8 represents the chosen detection threshold, which was set at three times the background noise level. Any heat signal above this threshold was discernible in the final thermosonic image.

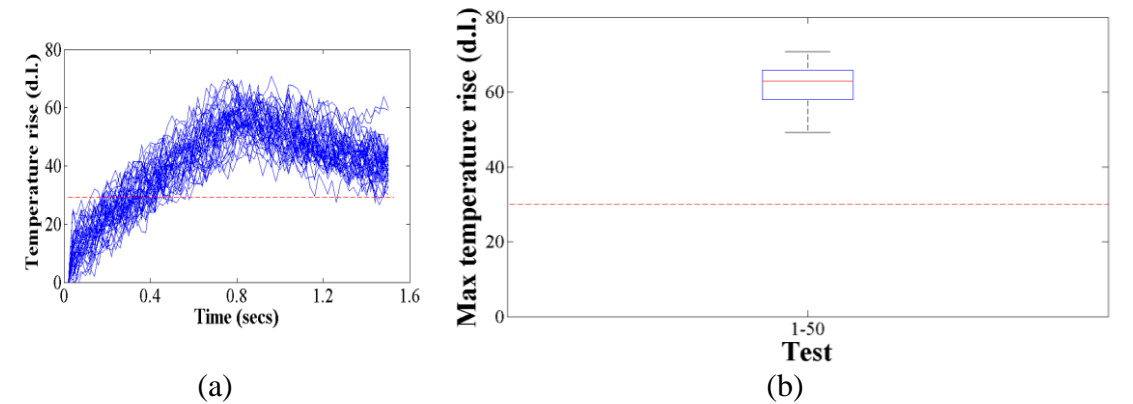
Figure 3-14 Temperature rise profile of 50 inspections for blade B4 with both variations included after one inspection.

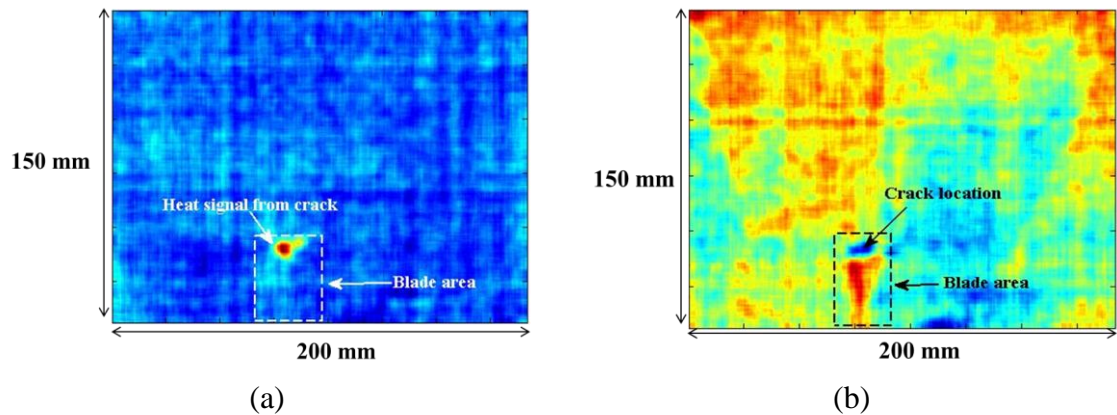
Figure 3-15 Thermosonic image result (a) crack generated a discernible heat signal (b) no heat signal generated by crack.

Figure 3-15 (a) and (b) respectively show images of a positive and negative detection case. This Figure highlights the total area of the image covered by the blade, which is relatively small. The field of view (FOV) of the camera, with the blade in focus, was approximately 200 mm x 150 mm (i.e. Horizontal x Vertical). This FOV was large compared to the size of the blade in the image. Nevertheless, the heat signal generated by the crack was still visible in the image as shown in Figure 3-15 (a). In Figure 3-15 (a), the crack heat signal in red (hotter) is distinguishable from the rest of the blade area, which mostly appear blue (colder). This level of contrast between the known crack location and other parts of the image allowed for easy interpretation of the results, and this was typical of the positive detection cases. However, for the negative detection case shown in Figure 3-15 (b), the heat signal shown in the vicinity of the known crack location appears colder than the rest of the blade which is crack free. This indicates that the crack generated little or no heat. The heat distribution seen across the blade area is simply due to the vibration of the material.

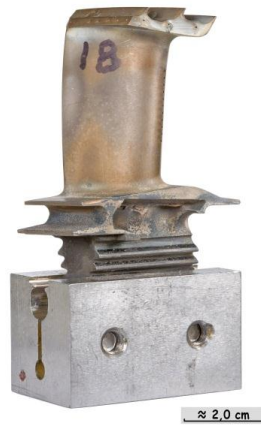
Figure 4-2 Image of turbine blade in blade holder.

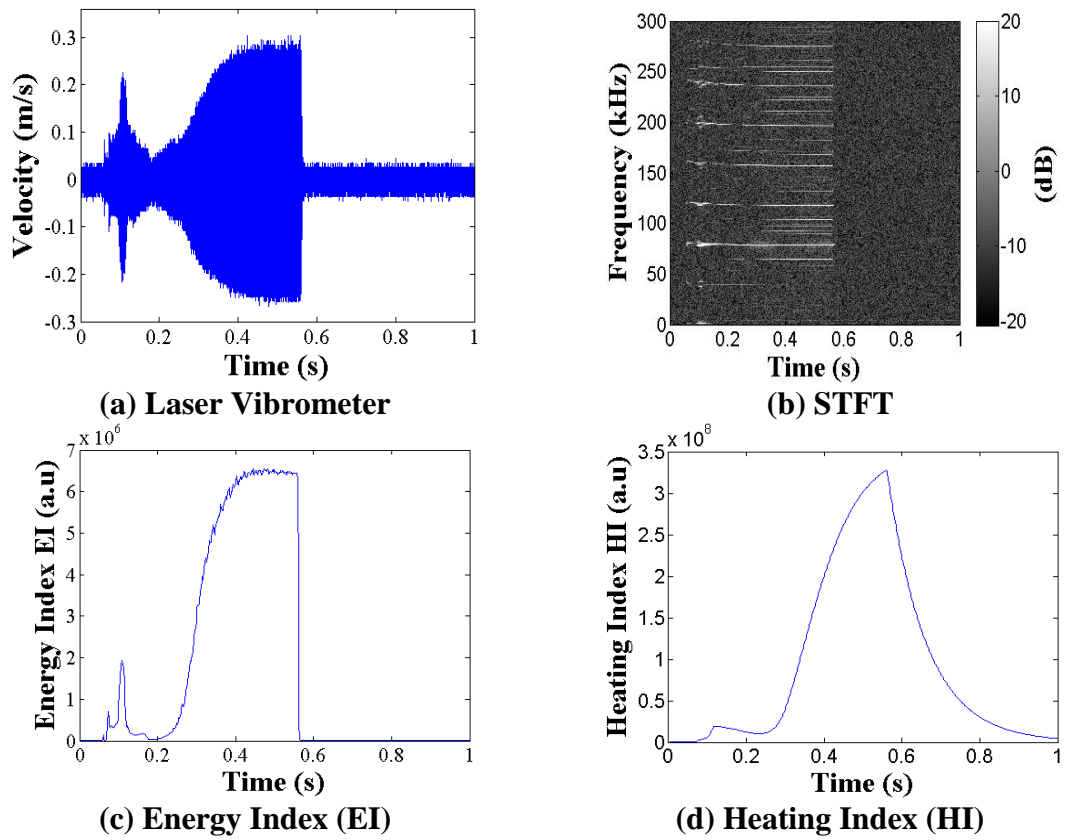
Figure 4-5 Vibration waveform, STFT, EI, and HI for test 8.

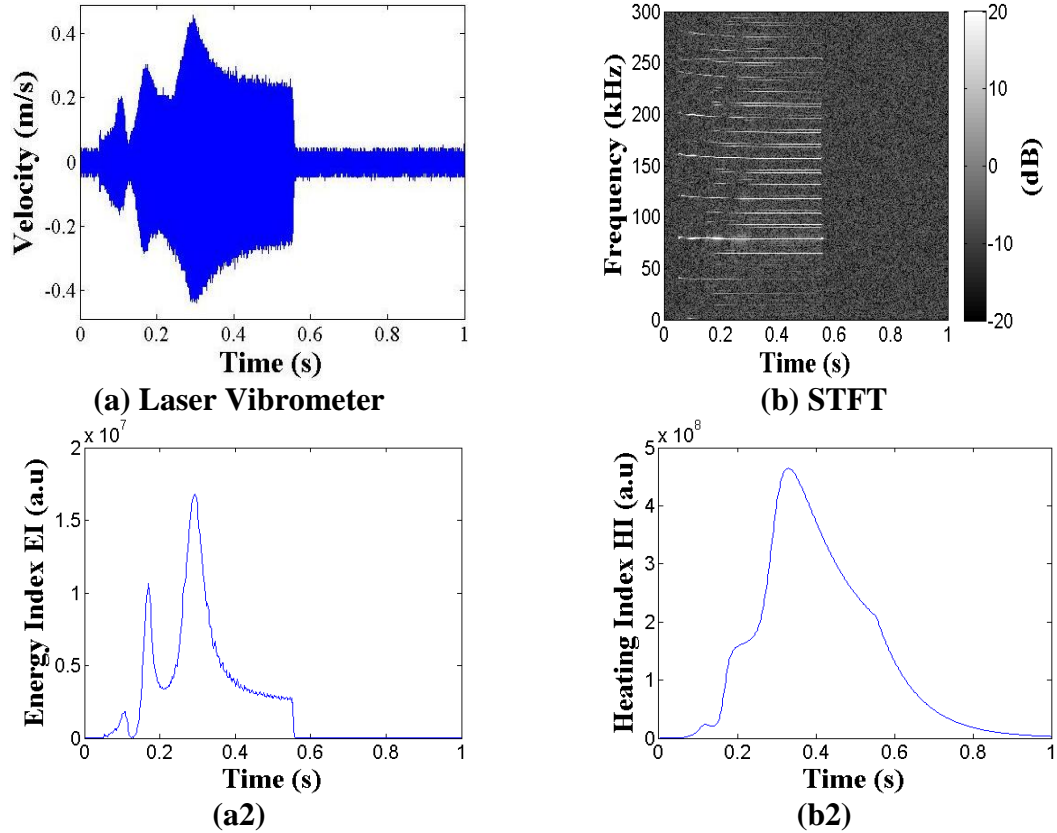
Figure 4-6 Vibration waveform, STFT, EI, and HI for test 23.

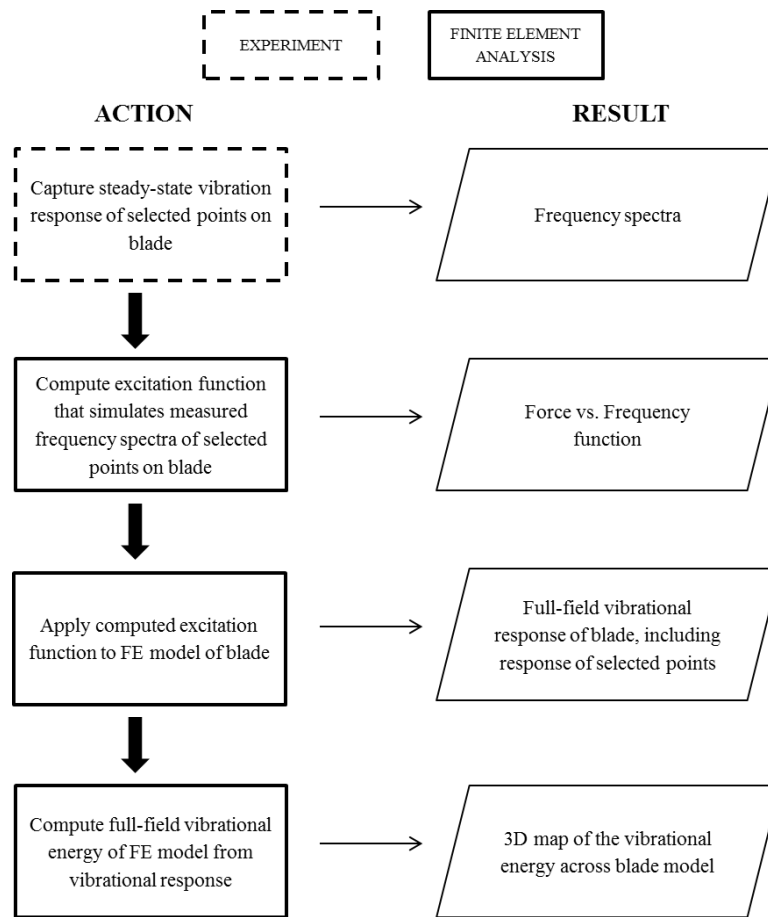
Figure 6-2 Proposed methodology for simulating the full-field vibrational response of a turbine blade under thermosonic excitation.

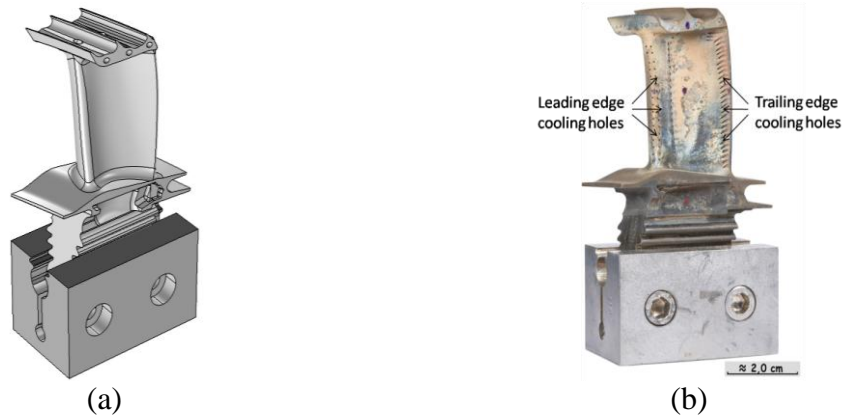
Figure 6-11 Turbine blade representation (a) FE model (b) image of turbine blade.

Figure 6-11 (a) and (b) respectively show the 3D FE blade model and photograph of the blade, both attached to a clamp. The FE model closely resembles the blade and clamp geometry except for the cooling holes at the trailing and leading edge, which could not be easily added to the model. The blade model shown in Figure 6-11 (a) was produced from an X-ray CT scan of a real blade, where both the external and internal structure of the blade was captured, as shown in Figure 6-12. The blade and clamp were modelled as a single geometry as opposed to separate components in contact. This was to avoid contact analysis which introduces non-linearities and a significant increase in computation time and resources [132].
