Tribology Group
Department of Mechanical & Aerospace
University of Strathclyde
Glasgow, UK

Erosion Issues in Tidal Turbine Blades

A thesis submitted in fulfilment of the requirements
for the degree of Doctor of Philosophy

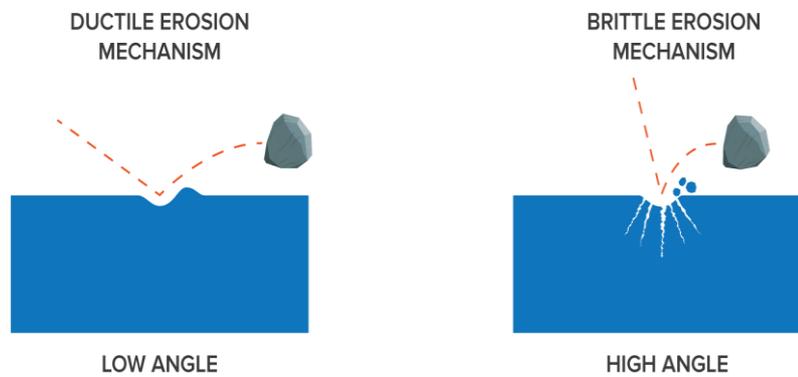
Figure 1. Brittle and Ductile Erosion

Figure. 1 provides a very clear illustration of how the target material reacts differently based on the kind of erosion process that is taking place. The brittle kind of erosion is characterised by a great lot more cracking and flaking of the material, while the ductile type of erosion is characterised by a significantly smoother hollow [80]. Plastic deformations and brittle fractures are responsible for the wear's obvious visible abnormalities, which have occurred over time [33]. In these settings, there are variations in the particle size, the impact's velocity, angle, and direction; nevertheless, the maximum angle of impact during mass loss is extremely varied depending on the kind of erosion [62].

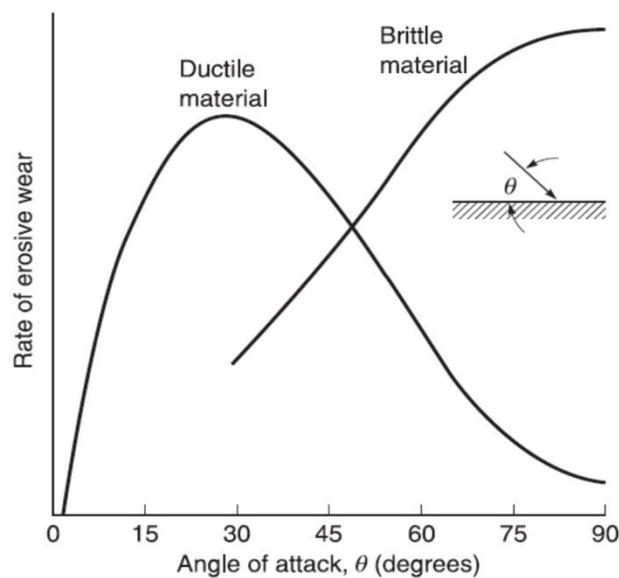
Figure 2. Rate of erosive wear versus angle of impingement [185]

Fig. 2 makes it very clear that the angles of attack that range from 15 to 45° are the most common ones for ductile erosion to take place. As a result, the leading edge of the turbine blade is less vulnerable to this phenomenon than the sides of the blades themselves. The highest value of attack angles for brittle erosion is greater than 90°, which indicates that, in the majority of instances, erosion-initiating particles and slurry are facing each other in a direction that is perpendicular. An illustration of what the typical images of a turbine blade's leading edge, with eroding particles coming in from the opposite direction of the blade's tip and cutting the leading

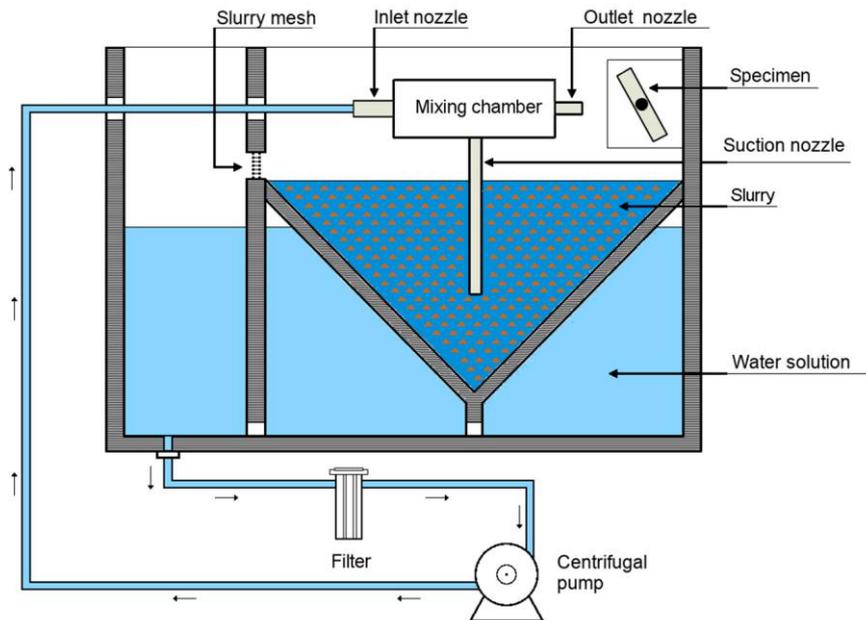
Figure 3. Impingement Rig Test Set-Up

For this kind of simulated testing, a slurry Jet rig is employed. The design principles presented by Hutchings [124] have been followed in the construction of the jet impingement rig. This testing apparatus is convenient for use in the laboratory or at home because it is easy to set up and use, takes little time, and allows for regulation of environmental factors. Fig. 3 shows how the rig is put together and how everything connects to one another.

The experiment conducted to simulate the conditions experienced by tidal turbines used the Jet rig, which is shown in Figure 3 of Chapter 3. The aim was to assess the impact of various factors on the performance of tidal turbines. The study was conducted at various impact angles of 15°, 30°, 45°, 60°, 75°, and 90°, and at an impact velocity of 9.04m/s, the test duration was 30 min for each sample.

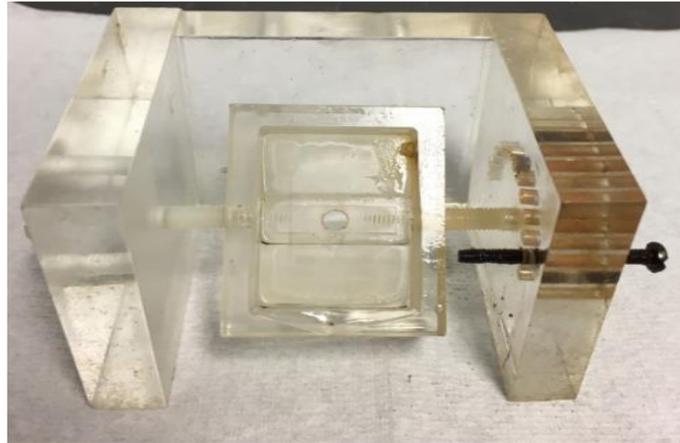
By drilling holes through the test material's holder and positioning the test material in the holder at the desired angle, the impingement angle can be controlled. This allows the holes to be drilled through the holder without affecting the test material. The screw in the holder allows the test material's position to be adjusted. As shown in the following fig. 4, this enables the holding of test material between the angles of 0° and 90° , with the adjustment allowing for 15° increments.

Figure 4. Sample Holder

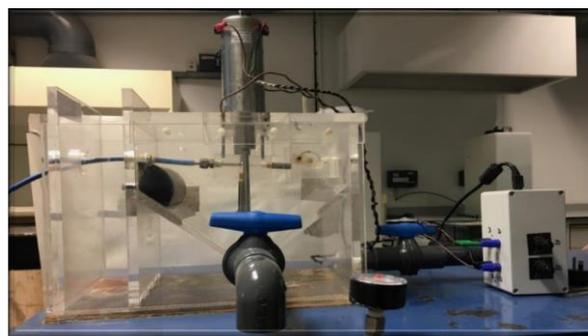
Figure 5. Impinging Jet rig setup

Figure. 5 shows the impinging jet rig's configuration. Sand and salt water are trapped within the chamber by the V-shaped wall sides, which serve as a trap. The rig's top-mounted propellers maintain the flow of the sand-and-seawater mixture from the vertically positioned entrance of the T-piece ejector. The two connected electric motors at the top of the rig power these propellers. Each electric motor has its own speed control, as can be seen in Fig. 5. The position of the filter, which is at the very top of the sloping wall on the left, serves to prevent sand from reaching the pump so that only salt water can pass through it. After that, the sand travels through the slit to the following compartment, which is found on the extreme left side.

The hole acts as a passageway for the seawater flow, which passes through the compartment's bottom, travels to the pump via the pipes, and is then redirected by the blue piping. Figure 5 shows how the blue piping is passing through the compartment's perforations on its way to the T-shaped nozzle. Only 10 litres of water are added to the tank to prevent the mixture from overflowing the compartment openings. This will ensure that the overflowing of the mixture will stop.

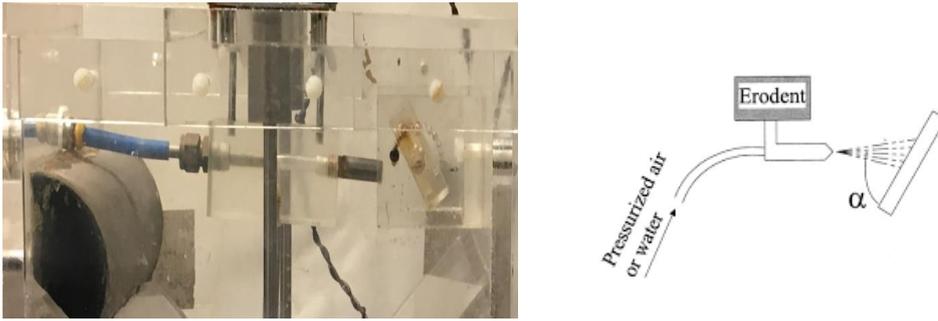
After the testing material has been positioned and secured within the rectangular specimen container, the nozzle will next discharge the slurry that has been thoroughly mixed onto the testing material. The angle of impingement is established by where the screw is positioned within the intended hole in the material. The screw also contributes to the holder's tightness by binding the material together and pressing it up against the holder's wall, preventing it from being pulled free by the force of the slurry. The rig is equipped with two roof parts to ensure that the testing chamber is hermetically sealed. These roof parts hold the T-piece ejector as well as the electric motors and are responsible for hermetically sealing the slurry.

Figure 6. close-up of the sample holder and ejector nozzle

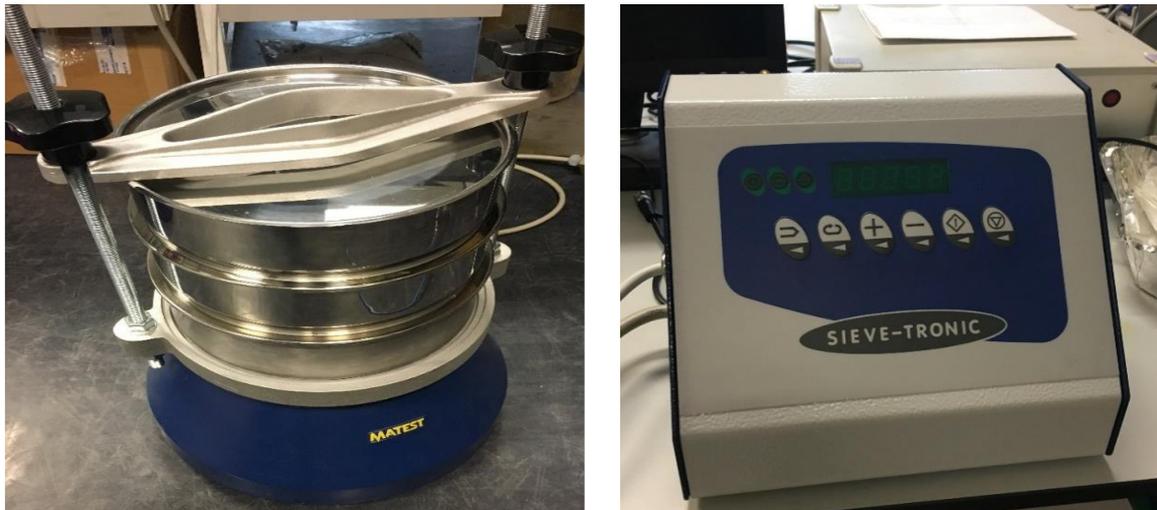
Figure 7. Matest sieve shaker

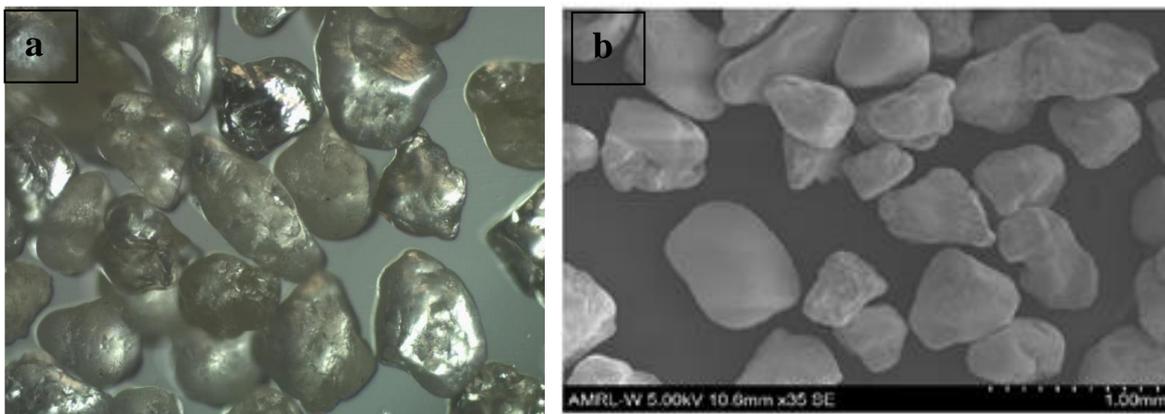
Firstly, it was determined, based on Fig. 8 obtained from the SEM, that the sand particles have an irregular structure with sharp edges. When they come into contact with the surface of the material, these sharp edges cause erosion to occur. The material's surface develops dents and scratches as a result of the constant impact from these pointed and sharp sand particles, as well as the chipping away of material from the surface, which results in the erosion of the blades. In order to carry out the experiment, the sand particles were collected at a concentration of 3%. The pointed corners of the sand particles become rounded off as a result of repeated impact with the surface of the sample. Moreover, the size of the sand particles is often reduced as a

result of collisions that occur between the sand particles themselves. The reduction in the number of sharp edges may be seen in the following Fig. 8 scanning electron micrograph of the sand particles that was taken after the experiment.

Figure 8. (a) Before, (b) After the experiment, image of sand particles

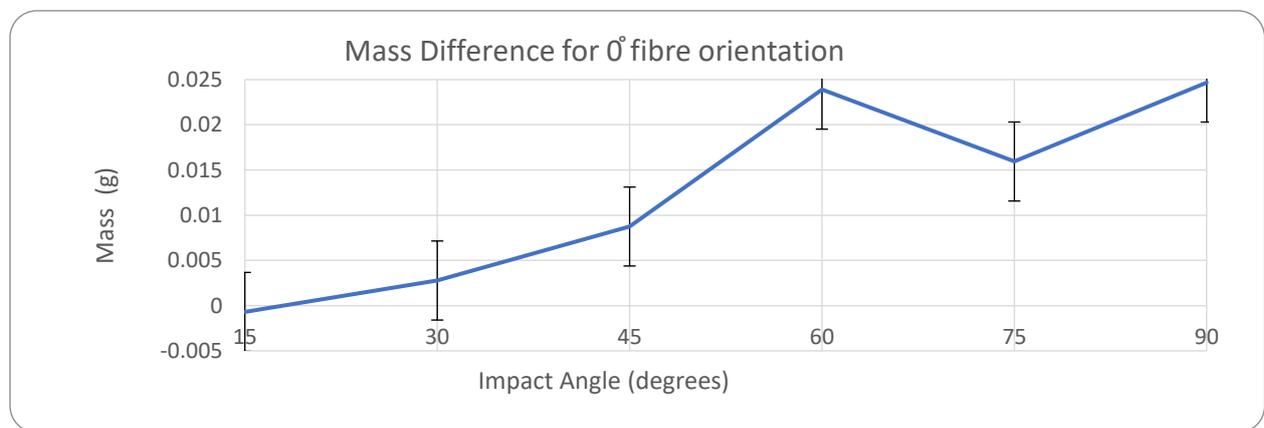
Figure 9. Mass Difference for 0° fibre orientation

The data presented in Fig. 9 reveals that the sample experienced a net increase in mass upon impingement at a 15° . This observation can be assigned to the high velocity of the collision, which resulted in the deposition of salt and other particles onto the surface of the GFRP specimen [10]. Further analysis of the erosion behaviour of 0° fibre oriented GFRP samples revealed that erosion occurred at a relatively slow rate when subjected to impingement at 15° and an impact velocity of 9.04 m/s. It is worth noting that impact velocity plays a crucial role in the phenomenon of erosion [137], [138], as demonstrated by the experimental findings. The preceding fig. 9 indicated the erosion frequency peaked at an impact angle of 60° to 90° . This phenomenon can be explained by both impact angle and surface strike rates. An increase in impact angle for the 0° fibre orientations led to a larger area being hit by particles, making the material more effective [139]. Particles stay on the surface for longer as a result of this increase, which subsequently removed material from the sample.

The data presented in Fig 9 allowed for the conclusion that the rate of volume loss is highest at impingement angles of 60° or 90°, as erosion is the primary cause of volume loss. The impact angle and surface strike rate both contribute to this phenomenon [62]. The larger surface area struck by particles at higher angles leads to a more efficient erosion of the UD-GFRP material. This increased surface area also causes particles to remain on the surface for longer periods, further contributing to the material's removal [62]. Therefore, a larger volume of material is lost while covering a wider surface region.

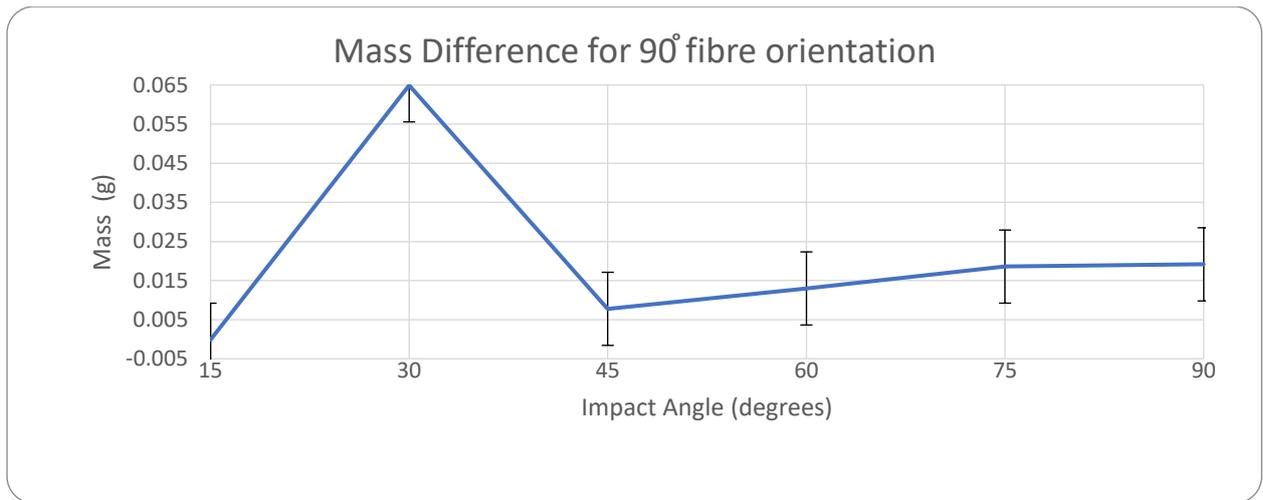
Figure 10. Mass Loss at various impact angles of 90° fibre orientation

From fig 10, it was observed that the sample with a 90° fibre orientation experienced a mass gain at an impingement angle of 15° due to the deposition of particles on its surface. This phenomenon can be attributed to the larger surface area that is struck by particles at this angle. Fig 10 shows that the rate of erosion for the 90° fibre orientation remains relatively constant between impingement angles of 45° and 90°.

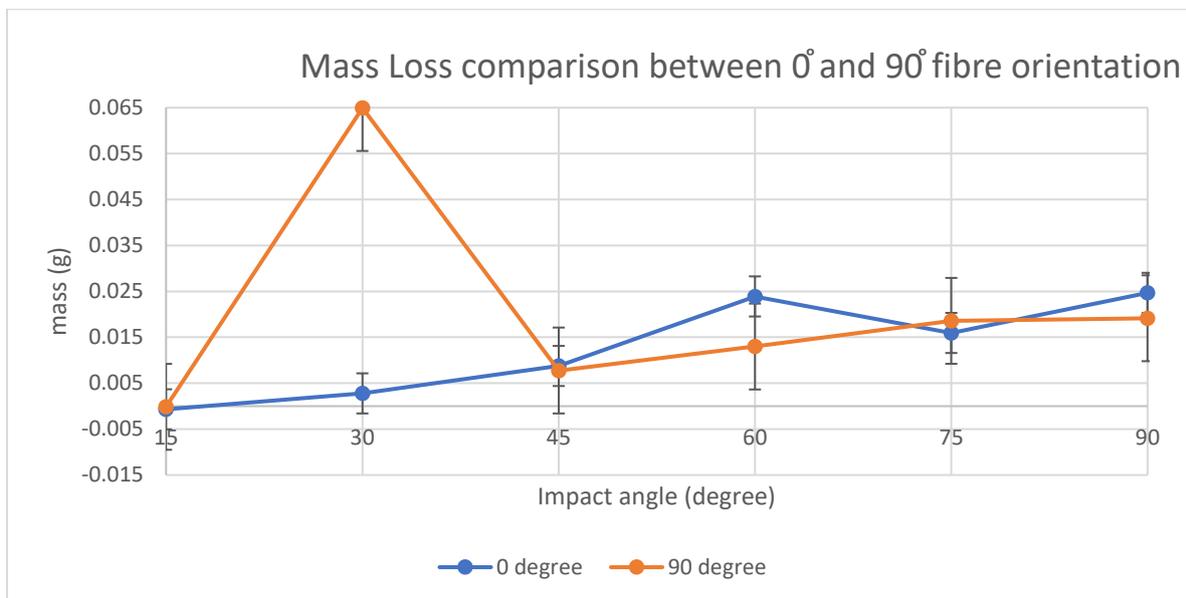
Figure 11. Mass Loss Comparison between 0° and 90° fibre orientation

Fig. 11 illustrates the erosion profile difference in 0° and 90° fibre orientation and compares their respective erosion mechanisms at different impingement angles. At an impingement angle of

Based on the data presented in Fig 11, it was observed that for the 90° fibre orientation, the rate of deviation in volume remained relatively constant between impact angles of 45° and 90°. Therefore, taking into consideration the characteristics of marine environments and the factors that contribute to erosion, it is recommended to use GFRP material in a way that minimises its impact on these environments.

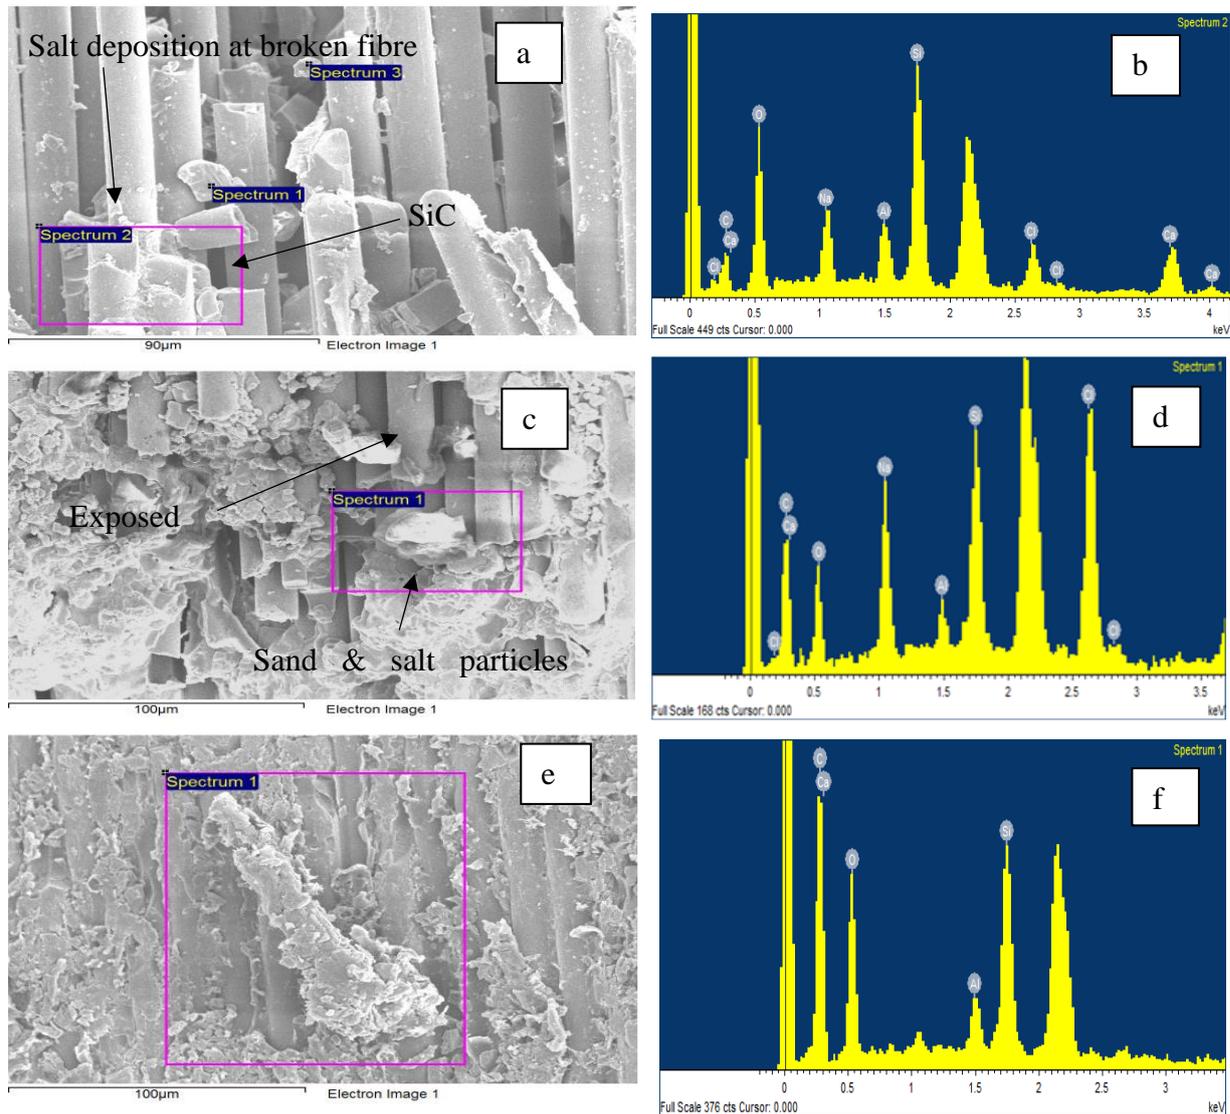
Figure 12. SEM & EDX of 0° fibre orientation at 45° impact angle

Figure 12 (a) provided evidence that the erosion of the 0° fibre orientation was caused by the degradation of the glass fibre matrix, which was established in the previous section. The displaced matrix further contributed to the erosion of the GFRP. The EDX Fig. 12 (b) indicated the presence of Silicon (Si) from silica sand and broken fibres in the fibre matrix interfaces. Additionally, the SEM image presented in fig. 12 (b) displayed the presence of Sodium (Na) and Chlorine (Cl) from Sodium Chloride (NaCl) salt.

Figure 12 (a) provides a clear illustration of the accumulation of salt within the damaged fibre. The image also reveals the presence of (SiC) from sand particles within the fibre matrix.

Figures 12 (c), illustrate the deposition of an external substance on the matrix. Through EDX analysis, it was discovered that sodium and chloride ions from the salt were present on the

fibre-matrix interface, as depicted in fig. 12 (d). The diffraction pattern of EDX confirmed this finding. On the other hand, Figure 12 (c) demonstrates the evidence of the erodent on the exposed matrix fibres due to erosion.

Figure 12 (e) depicts the deposition of silicon carbide (SiC) and a polymeric compound on the surface of the sample. The deterioration of the matrix was found to be a result of erosion, as evidenced by the presence of fine particles and a removed layer on the GFRP surface. The shredded structure of the composite fibres provided a location for the slurry particles to aggregate, which contributed to the deposition of SiC and the polymeric compound. This observation highlights the susceptibility of GFRP materials to erosion, which can lead to significant changes in their physical and mechanical properties.

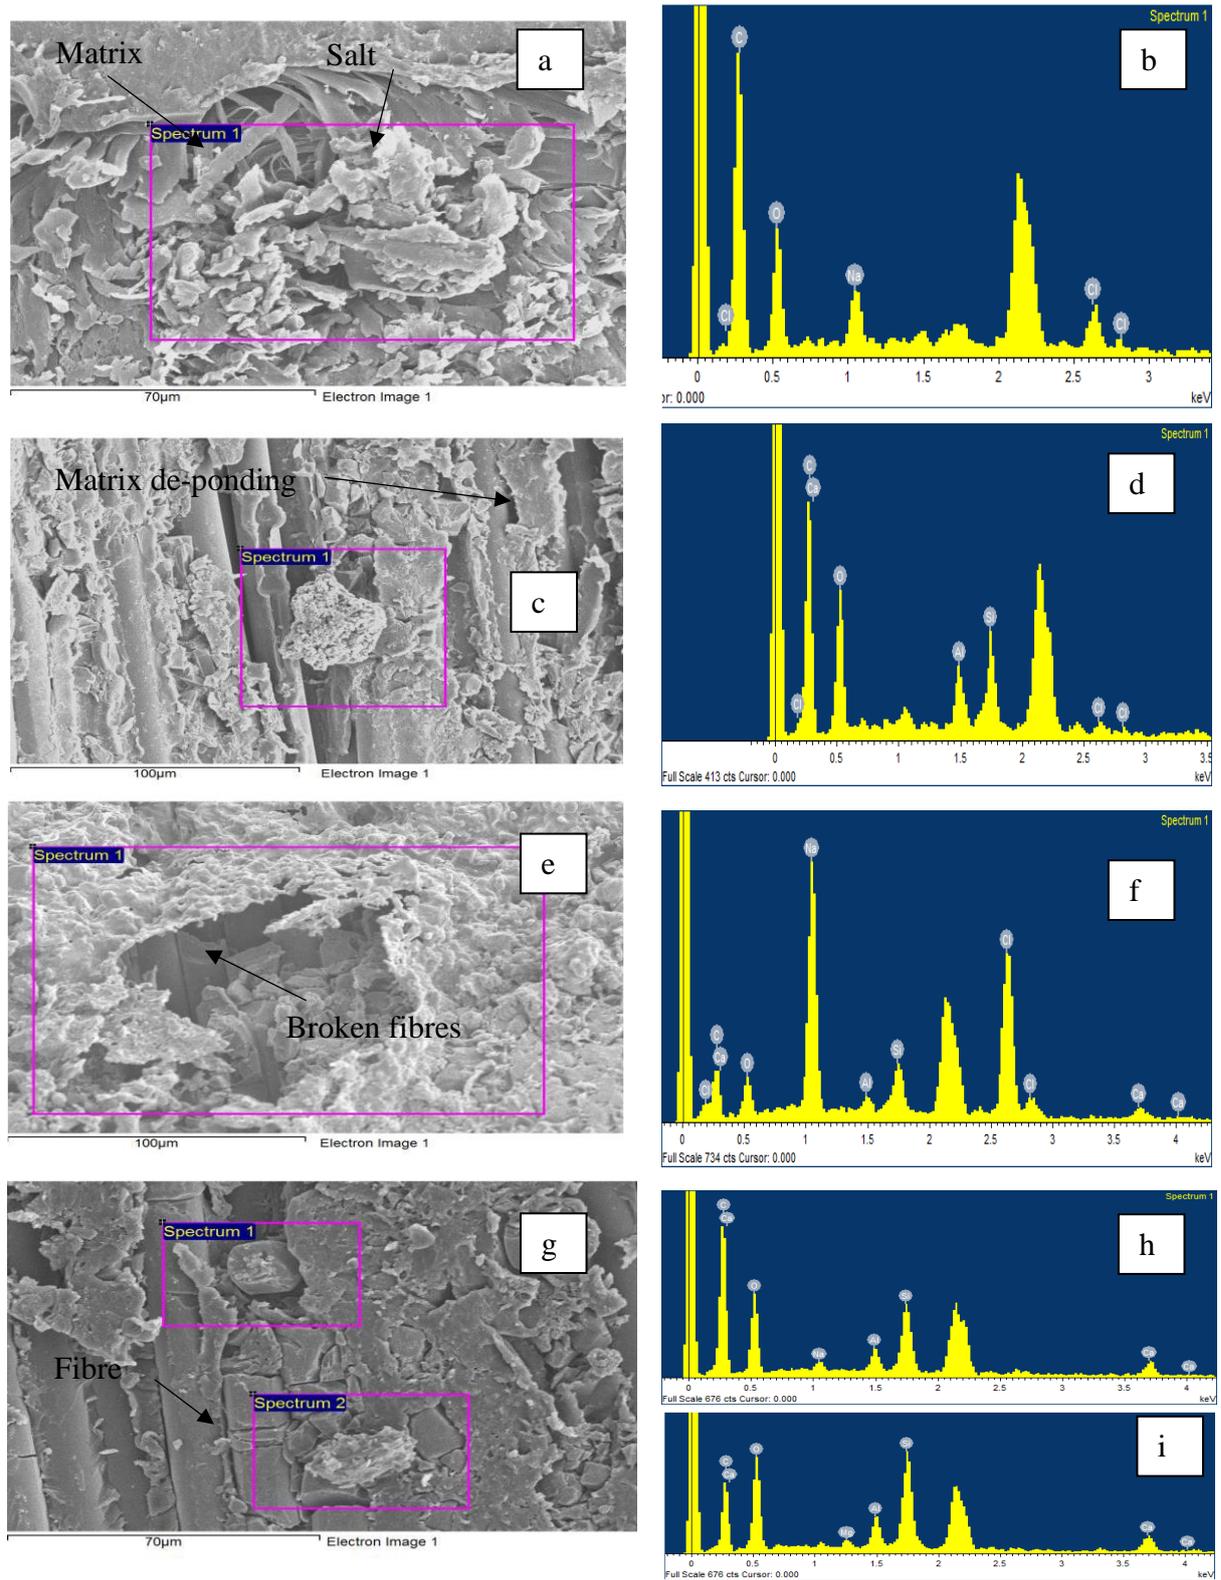
Figure 13. SEM & EDX of 0° fibre orientation at (a)(b) 60°, (c)(d) 45°, (e)(f)(g)(h)(i) 90° impact angle

Figure 13 (a) provides a detailed explanation of the erosion mechanism observed in the 0° fibre orientation sample. It was observed that the erosion caused the composites of the material to fracture, which was attributed to the erosive forces. The surface scraping revealed the inner

Figure 13 (c) showed that the components in the erodent were what caused the glass fibres to scrape and erode laterally. Additionally, the deposition of salt particles on the surface of the (GFRP) composite is shown in Fig. 13 (d). The erosive forces exerted by the particles on the composite surface caused the fibre matrix to be de-boned, resulting in a separation of the fibres from the polymer composite[144]. This debonding effect made the glass fibres and the matrix vulnerable to damage and fracture, which could ultimately lead to a deterioration of the composite material's properties [145].

Figure 13 (e) clearly illustrates the extensive damage caused by solid particles to the surface layer of the UD-GFRP material, resulting in the exposure of its interior fibre matrix. Erosion caused the fibres located within the surface to break, and the protective outer layer of the polymeric composite underwent complete erosion. This, in turn, led to ductile erosion of the matrix layer of glass fibre linked to the surface[146], in the direction of the fibre's transverse axis. The breakdown of the fibres was followed by lateral erosion of the fibre matrix, resulting in the formation of voids and hollows within the matrix. This observation highlights the severe impact of erosion on the mechanical and structural properties of composite materials, which can lead to their deterioration and ultimately impact their performance in various applications [61].

Figure 13 (g) depicts the deposition of erodent particles on the surface of the sample. Fig 13(h) shows the presence of salt particles at the interface, while fig. 13 (i) shows the composition of sand particles. During the erosion process, a fracture was identified on the glass fibres running in a transverse direction. The sharp-edged erodent particles caused the development of the fracture and erosion of the surface of the glass fibre. These cracks could potentially result in faults in the fibre composite material at a later stage, emphasising the need for a better understanding of the mechanisms involved in erosion processes in composite materials.

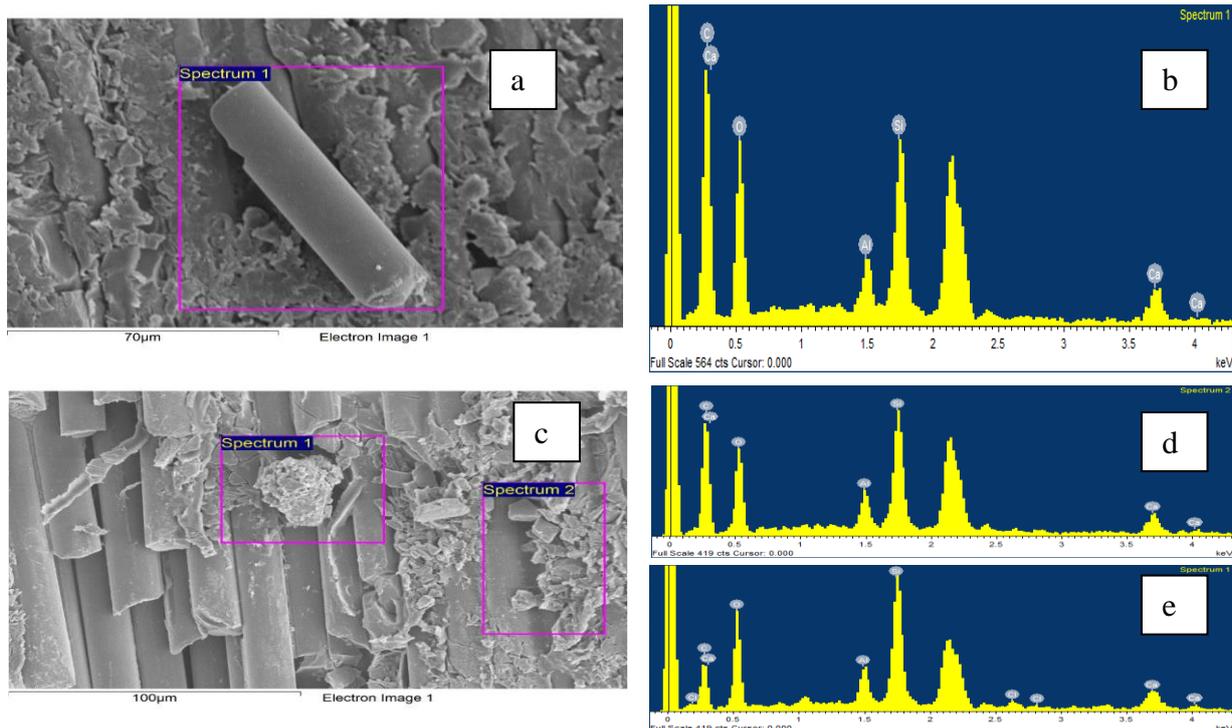
Figure 14. SEM & EDX of 0 fibre orientation at 75° impact angle

Figure 14 (a) illustrates the fragmentation of the fibre resulting from erosion. Figure 14 (b) displays evidence of the SiC particles' presence, which were found to have caused the fracture of fibre on the surface because of impingement on the GFRP.

The results presented in Fig. 14 (c) indicate that the impingement of particles on GFRP caused the complete breakage of the fibre matrix. Figure 14 (d) illustrates the presence of sand particles, while Figure 14 (e) reveals the complete breakage and de-bonding of the glass fibre, along with the presence of Chlorine (Cl).

The findings suggest that the impingement of particles on GFRP can cause significant damage to the fibre matrix, leading to complete breakage and de-bonding of the glass fibre [147]. The detection of Chlorine in Figure 14 (e) indicates the nature of the environment in which the

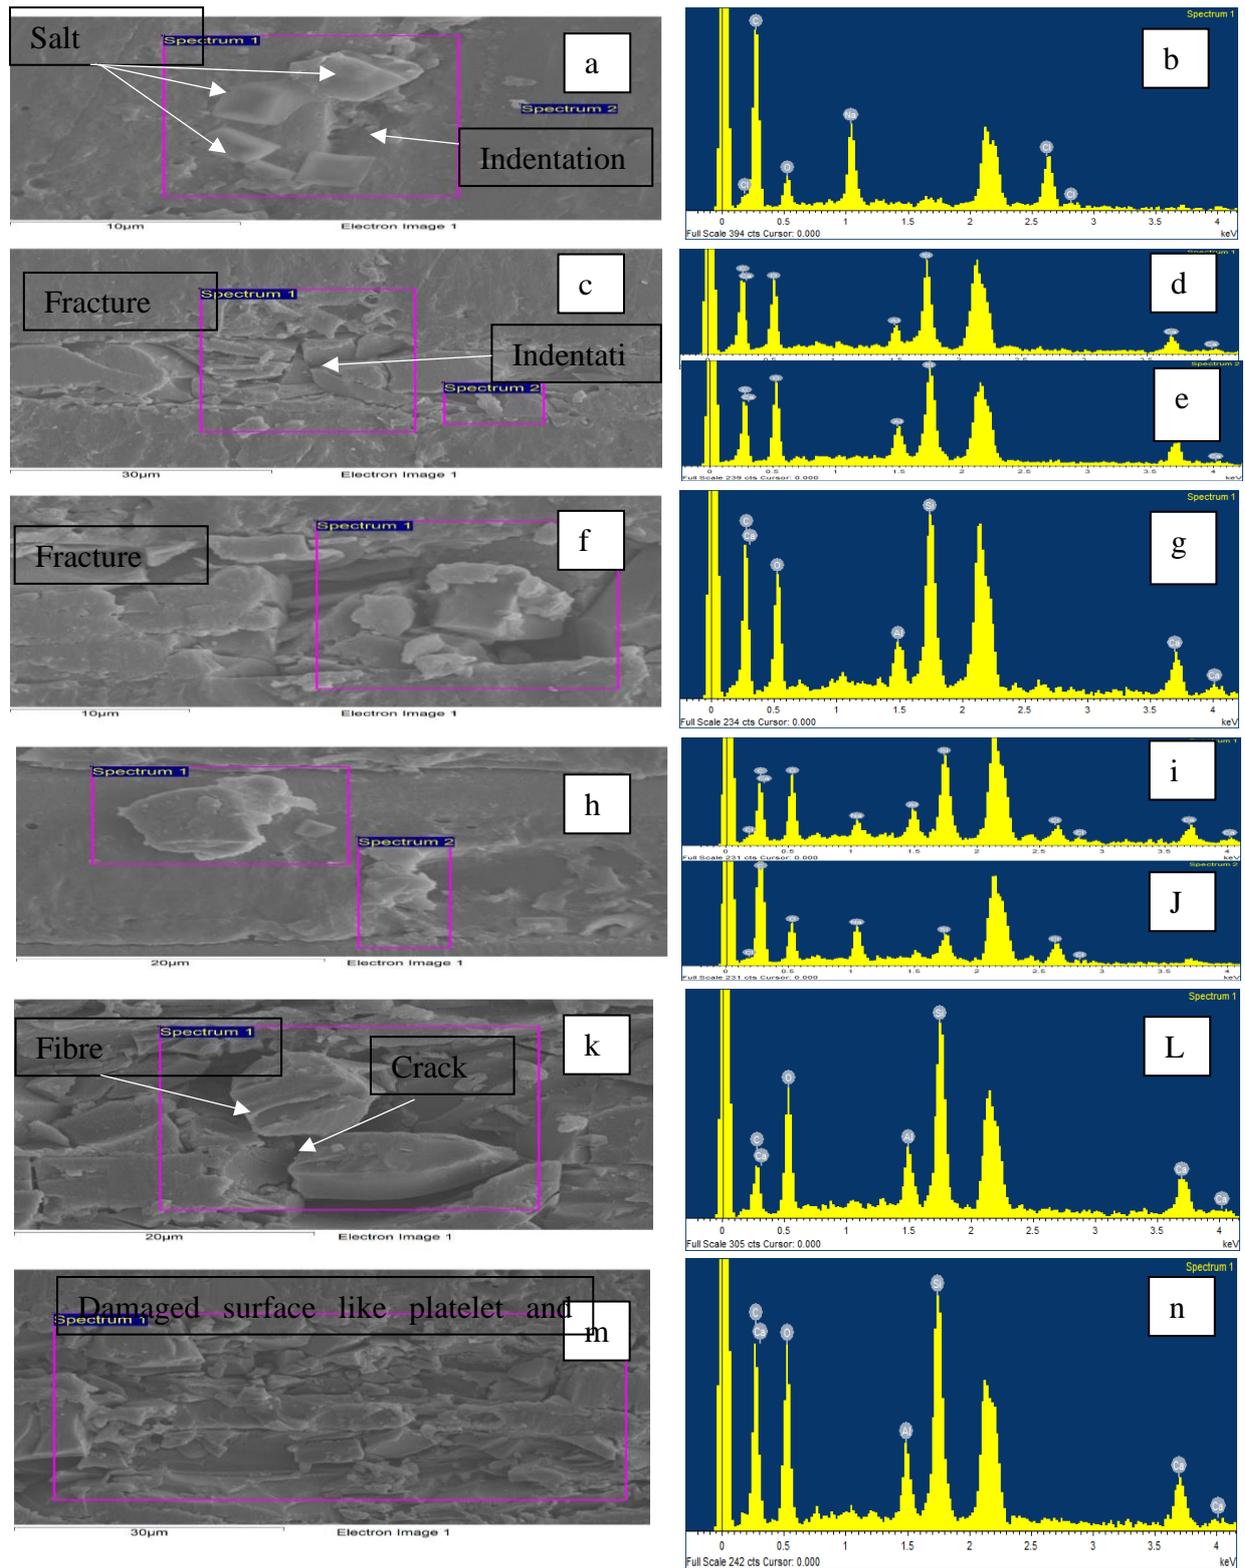
Figure 15. SEM & EDX of 90 fibre orientation, fig 15 (a)(b)(c)(d)(h)(i)(j)(m)(n)15 impact angle; Fig 15 (f)(g) 4; impact angle Fig. 15 (k)(l) 90 at 15 impact angle

Figures 15 (a) and (b) illustrate the accumulation of salt crystals on the surface, let to the increase in the mass of the sample. To validate this occurrence, the test was repeated on two additional samples. These findings suggest that salt crystal deposition on the surface of composite materials could result in an increase in their mass, which may have implications for their performance and durability in various applications.

Figure 15 (m) presents a clear description of the erosion phenomenon in the 90° fibre orientation. The erosion process causes multiple breakdowns of the matrix and the composite constituents. Fig 15 (n) confirmed the presence of sand particles, indicating a gain in mass in the 15° samples. The presence of sand particles is evidence of the erosion process, which causes the breakdown of the material.

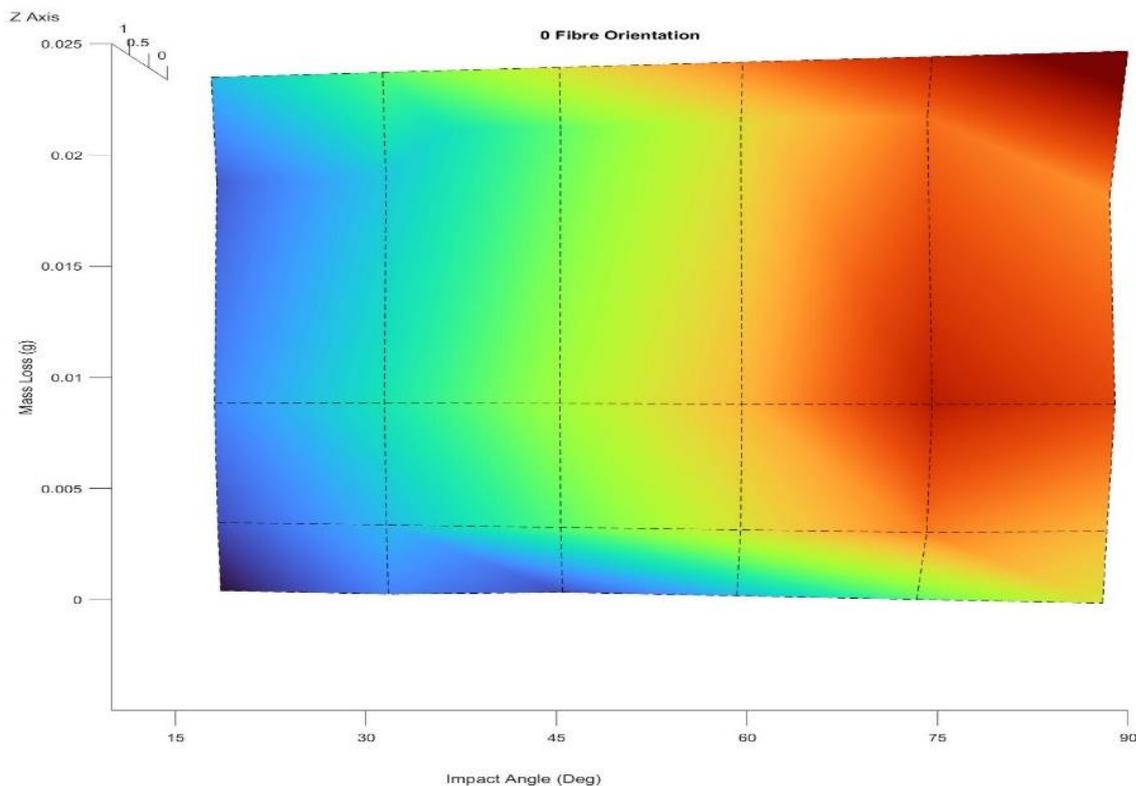
The findings from the erosion map in figure 16 demonstrate that the highest erosion occurs in the composite material when subjected to an impact angle in the range of 45° to 90° at an impact velocity of 9 m/s. This suggests that the UD-GFRP material is particularly vulnerable to erosion at high impingement velocities and angles. The dark blue colour in the image indicates the area that suffered the least amount of material loss during the erosion tests. This suggests that there are areas in the composite material that are less vulnerable to erosion and that these areas could potentially be reinforced to improve the overall erosion resistance of the material [154].

Figure 16. Erosion map of 0 fibre orientation

Additionally, the discovery that the GFRP material suffers the least amount of material loss when subjected to an impact with a velocity of 9.04 m/s and an impingement angle of either 15° , 30° , or 45° is significant because it suggests that there is an angle that can help to minimise erosion damage in the material. This information can be useful in the design of blades that are exposed to erosion, as it can help to identify the conditions under which erosion damage is most likely to occur, and the conditions under which the material is most resistant to erosion.

MATLAB code for erosion map Fig 16

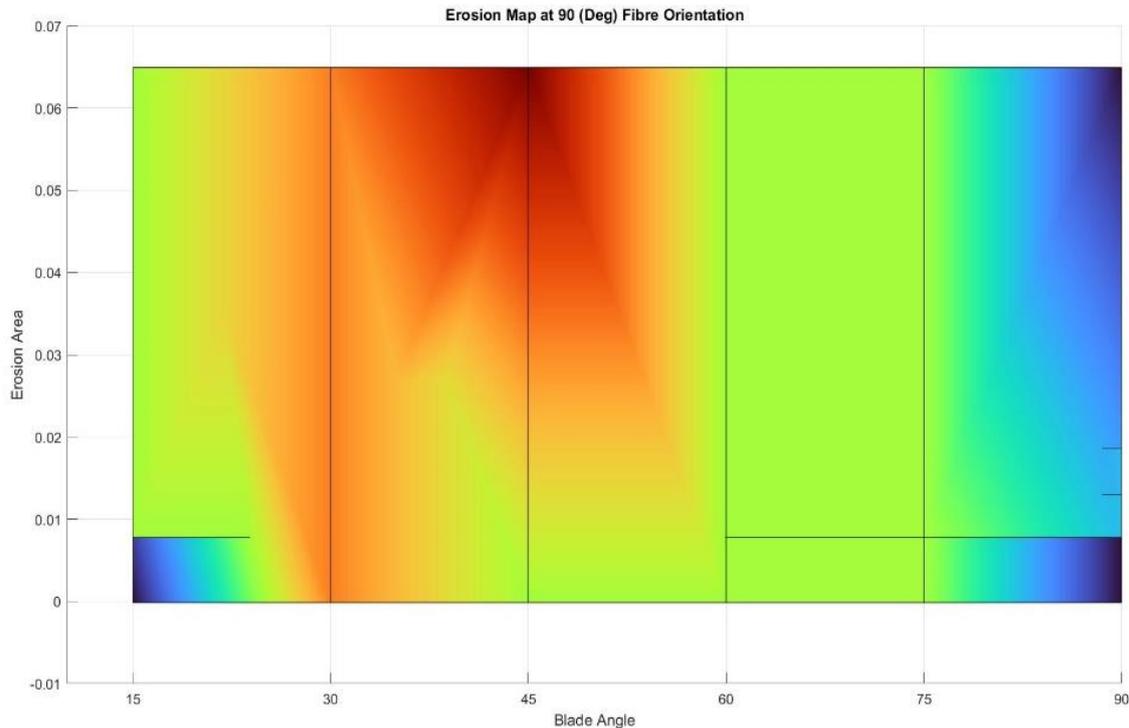
Figure 17. Erosion map of 90 fibre orientation

The finding from figure 17 of the erosion map is a significant result in the study of the erosion behaviour of UD-GFRP material. The maximum erosion observed in the material at the impingement angle range of 15° to 45° and impingement velocity of 9 m/s implies that the material is highly vulnerable to erosion under these conditions. This is an important consideration when designing and implementing structures that are subjected to high-velocity impacts or abrasive environments [155].

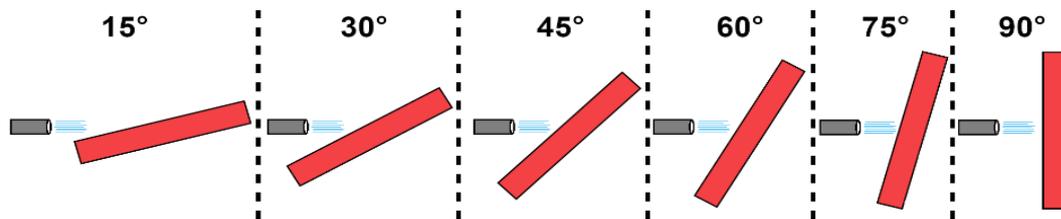
Figure 18. Schematic of the test specimen position in respect to the exit nozzle for the range of impingement angles tested.

The experiments were conducted using an impingement speed of 9.04 m/s and a sand particle concentration of 3%. The flat specimen was mounted on a flexible bracket, allowing testing at different impingement angles ranging from 15° to 90°. Following impingement, the slurry flowed back into the slurry chamber, and surplus water drained into the water chamber, while a mesh trapped the particles in the slurry chamber for reuse over the 30-minute testing period. SEM was used to examine surface defects to obtain a more detailed understanding of the type of erosion occurring in UD-GFRP [142]. Figure 18 Schematic of the test specimen position with respect to the exit nozzle for the range of impingement angles tested.

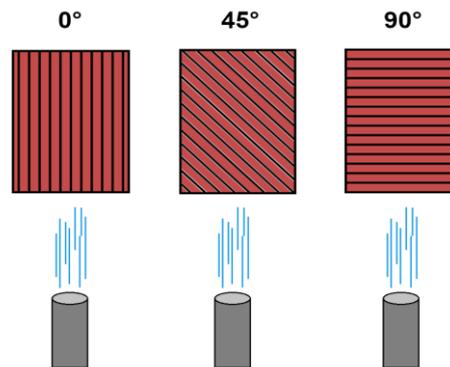
Figure 19. Schematic representation of fibre orientation with respect to the impingement jet

to investigate the impact of fibre angle on erosion behaviour, as shown in Figure 19. The erosion behaviour was evaluated by analysing mass loss using an analytical scale with an accuracy of $\pm 0.01\text{mg}$ and conducting a surface inspection with a Scanning Electron Microscope (SEM).

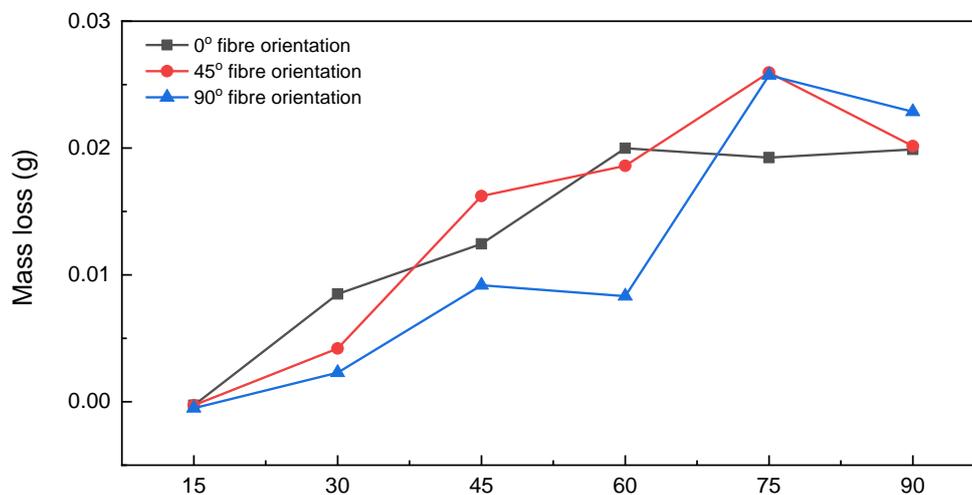
The direction of fibres in unidirectional glass fibre-reinforced plastic (GFRP) has a significant impact on the erosion rate [85], [162], with 90° fibre orientation being more vulnerable to erosion compared to other orientations. Figure 20 shows that when subjected to a 15° impingement angle, all three standard plate specimens exhibited a small increase in weight to a similar degree, while the specimen with 45° fibre orientation experienced weight loss. This weight loss occurred because particles were deposited on the surface of the sample due to the high impingement velocity of 9.04 m/s combined with the acute angle of attack and ductile

Figure 20. Mass loss of GFRP Standard plates with three different surface fibre orientations 0°, 45° and 90° subjected to erosion at 15°, 30°, 45°, 60°, 75° and 90° at 9.04 m/s impact velocity.

nature of the composites. As the impingement angle increased, there was a significant increase in weight loss across all types of specimens.

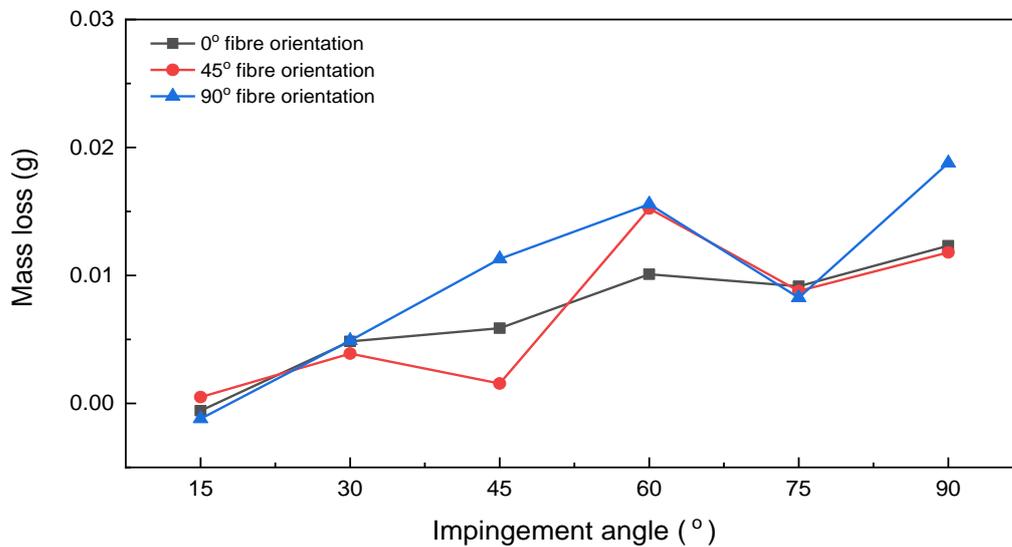
Figure 21. Mass loss of GFRP Gradient plates with three different fibre orientations 0°, 45° and 90° subjected to erosion at 15°, 30°, 45°, 60°, 75° and 90° at 9.04 m/s impact velocity.

their fibre orientation [156]. Grd0 showed a nearly linear increase in mass loss, with the highest mass loss occurring at a 90° impact angle. On the other hand, Grd90 had its maximum mass loss at 90° after a linear increase in mass loss up to 60°, followed by a significant decrease in a mass loss at 75°. Grd45 had a more unpredictable pattern, with mass loss increasing at 30° and then decreasing at 45°, followed by a sharp rise to the highest mass loss at 60°, a decline at 75°, and a small increase at 90°.

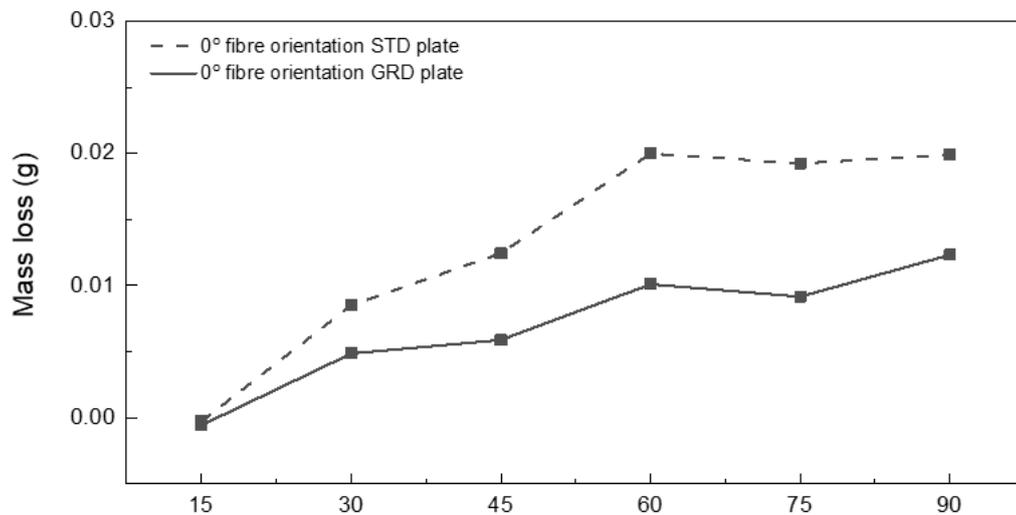
Based on Figure 22, the mass loss of the gradient specimens with 0° fibre orientation is generally lower than that of the standard specimens with 0° fibre orientation for most impingement angles, although both types of GFRP exhibit a similar trend. At an impingement angle of 15°, both types of specimens experience a gain in mass due to the deposition of sand and salt particles, which is supported by SEM analysis in Figure 25(a). Previous research has also reported similar findings of mass gain due to erodent deposition [53]. The sand particles

Figure 22. Mass loss of STD0 and GRD0 subjected to erosion at 15°, 30°, 45°, 60°, 75° and 90° at 9.04 m/s impact velocity.

the salt facilitated the diffusion of saline water through the matrix, which enabled the glass fibres in the composite matrix to de-bond. This phenomenon is visible in Figure 25 (d). As the impingement angle increases, there is a noticeable difference in erosion behaviour between the two GFRP types. At 30°, the Std0 exhibits a 75% higher mass loss than Grd0, and this difference increases to 112%, 98%, and 110% at 45°, 60°, and 75°, respectively. At 90°, the difference decreases to 61%.

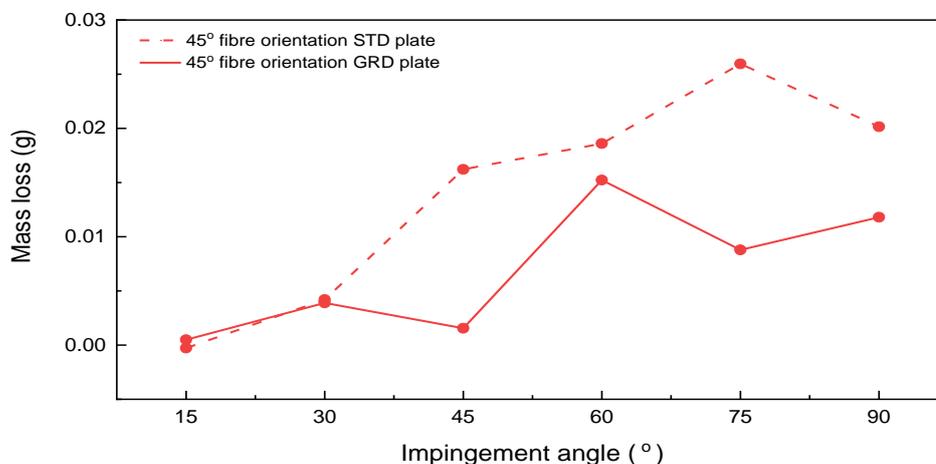
The results presented in Figure 23 show that, similar to Std0, Std45 experiences an increase in mass at an impingement angle of 15°. However, Grd45 only shows a minor mass loss of 0.00049g. This difference in behaviour can be attributed to the denser epoxy used in Grd45, which reduces the amount of sand particle embedding. At an impingement angle of 30°, there is almost no difference in the erosion performance between the two specimens, with Grd45

Figure 23. Mass loss of STD45 and GRD45 subjected to erosion at 15°, 30°, 45°, 60°, 75° and 90° at 9.04 m/s impact velocity

slightly outperforming Std45 by only 7%. However, at 45°, the difference becomes significant, with Std45 showing a much higher mass loss of 945% compared to Grd45. The SEM analysis in Table 6 revealed that the fibres of Std45 were broken away, resulting in significant mass loss, while the damage to Grd45 was mostly on the matrix, indicating some degree of fibre protection by the polymer. At higher impingement angles of 60°, 75°, and 90°, Std45 had mass loss values 22%, 195%, and 70% higher than those of Grd45, respectively. These results suggest that the toughened epoxy used in Grd45 has a better ability to absorb the kinetic energy of the impacting erodent at higher impact angles.

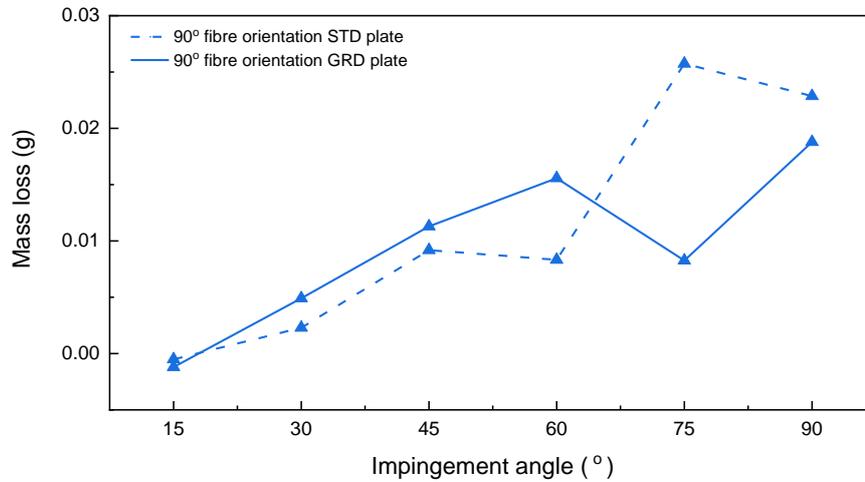
The results shown in Figure 24 indicate that while Grd0 and Grd45 have better erosion resistance than their standard counterparts, the same cannot be said for Grd90. At 15°, both Grd90 and Std90 experience mass gain, while at 30°, 45°, and 60°, Grd90 has higher mass loss than Std90, with differences of 113%, 22%, and 87%, respectively. However, at 75° and 90°, Grd90 outperforms Std90, with mass losses being 68% and 18% lower, respectively. Overall, the best-performing specimen was Grd45, which not only had the lowest average mass loss over the range of impingement angles but also performed best at 15°, 45°, and 90° impingement angles.

Figure 24. Mass loss of STD90 and GRD90 subjected to erosion at 15°, 30°, 45°, 60°, 75° and 90° at 9.04 m/s impact velocity.
