Tribology Group
Department of Mechanical & Aerospace
University of Strathclyde
Glasgow, UK

Erosion Issues in Tidal Turbine Blades

A thesis submitted in fulfilment of the requirements
for the degree of Doctor of Philosophy

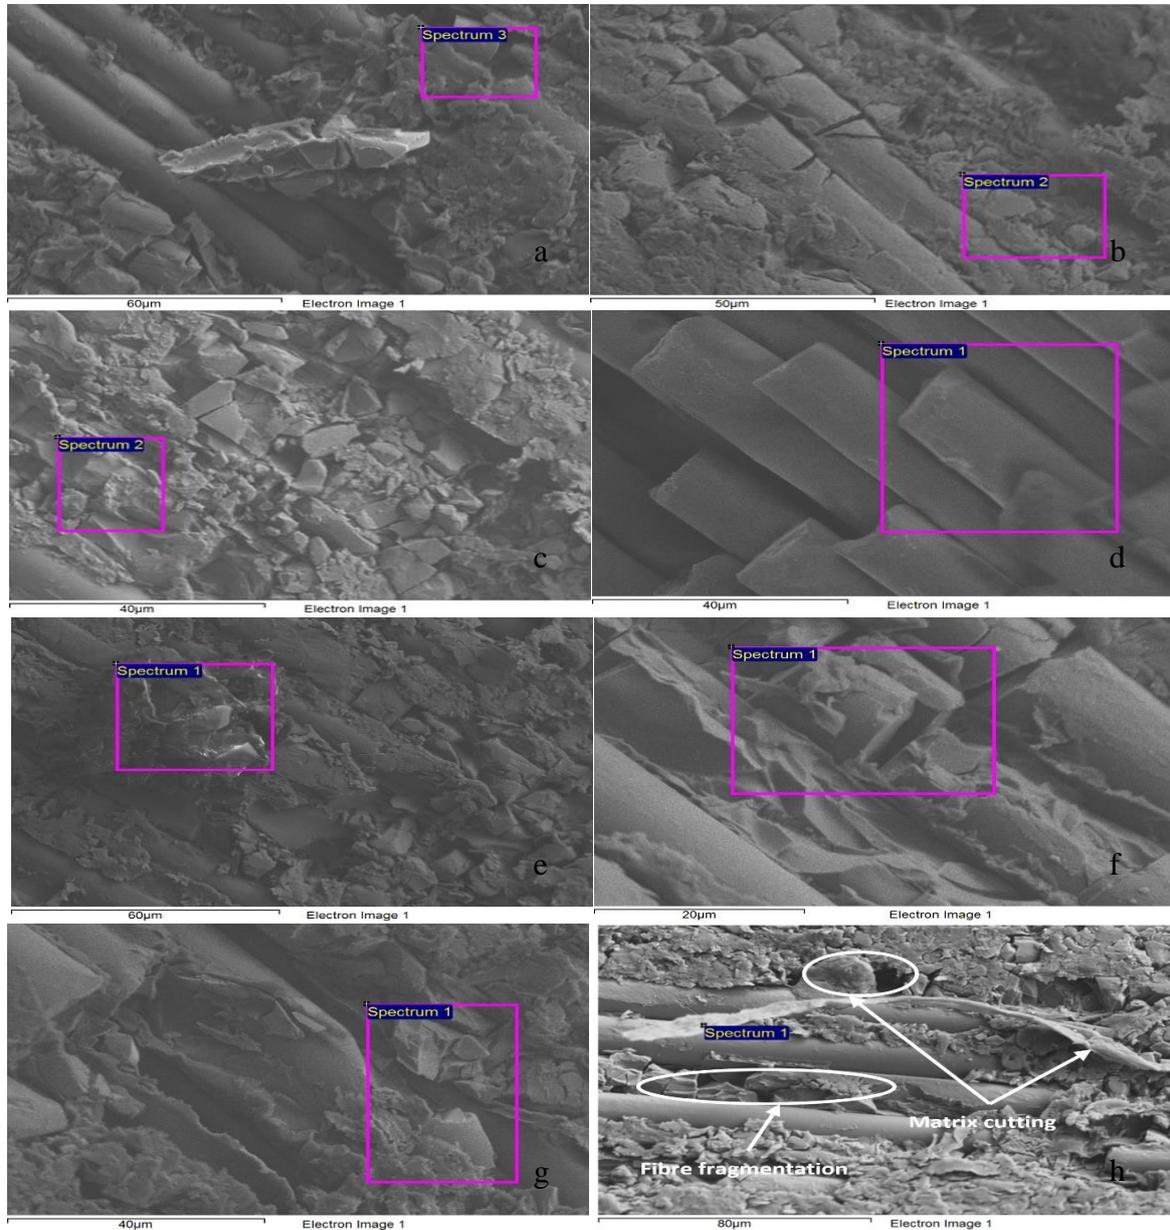
To gain a deeper understanding of the erosion mechanisms involved, surface analysis is required in addition to mass loss measurements. In this study, after being coated with a 5 μm layer of gold to facilitate SEM examination [39], all specimens underwent optical analysis using a (W-SEM). Table 4 identifies and lists the types of surface damage that each specimen experienced. The results show that all GFRP specimens, regardless of fibre orientation or epoxy type, experienced sand particle embedment on their surface when subjected to erosion at 15°, which explains the low mass loss or even mass gain recorded in this scenario [10]. Figure 25a shows an illustration of a particle embedded in a GFRP specimen's surface. The damage process altered as the impingement angle increased. The STD specimens displayed fibre damage in the form of cracking and fracture at 30, while the matrix of the GRD specimens was harmed. At this point, no embedded particles were visible. The damage types and intensities between STD and GRD specimens were remained different at 45, with STD specimens exhibiting fibre breakage and cracking and GRD specimens mostly experiencing matrix

damage. Higher impact angles (60° , 75° , and 90°) resulted in substantial damage for all specimens, with GRD and STD type specimens suffering notable matrix and fibre damage without any discernible pattern separating their erosion behaviour depending on epoxy type or fibre

Figure 25. SEM of GRD45 at 15° impact angle (a), STD45 at 30° impact angle (b), GRD45 at 30° impact angle (c), STD45 at 45° impact angle (d), GRD45 at 45° impact angle (e), GRD45 at 60° impact angle (f), GRD45 at 75° impact angle (g), STD90 at 90° impact angle (h)

the salt facilitated the diffusion of saline water through the matrix, which enabled the glass fibres in the composite matrix to de-bond. This phenomenon is visible in Figure 25 (d). As the impingement angle increases, there is a noticeable difference in erosion behaviour between the two GFRP types. At 30°, the Std0 exhibits a 75% higher mass loss than Grd0, and this difference increases to 112%, 98%, and 110% at 45°, 60°, and 75°, respectively. At 90°, the difference decreases to 61%.

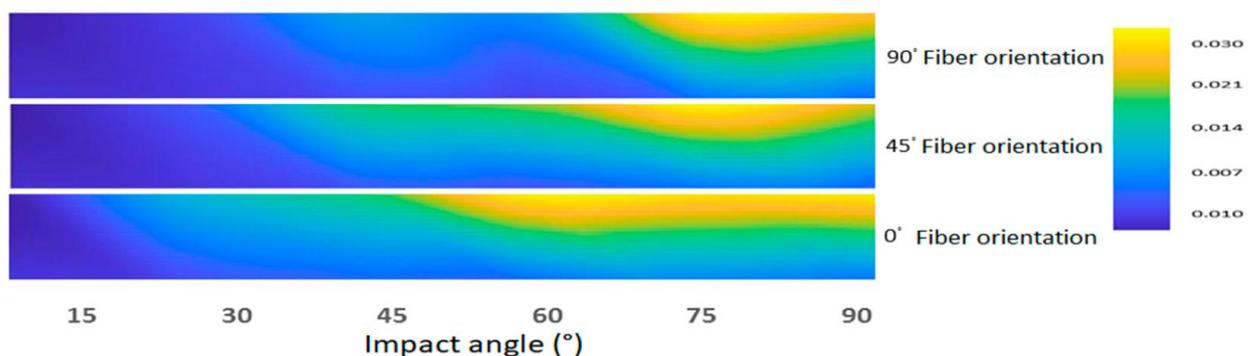
In Figure 26, for instance, the STD plate with a 0° fibre orientation encounters medium waste at 30° and 45° impingement angles, with the amount of wastage rising as the impingement

Figure 26. STD Erosion wastage map

angle rises. For the STD plate with a 45° fibre orientation, there is medium wastage at an impingement angle of around 45°, high wastage at an angle of more than 60°, and maximum wastage at 75°. The STD plate with a 90° fibre orientation, in contrast, exhibits low wastage at impingement angles between 15 and 65°, with a sharp rise at 75 and 90°.

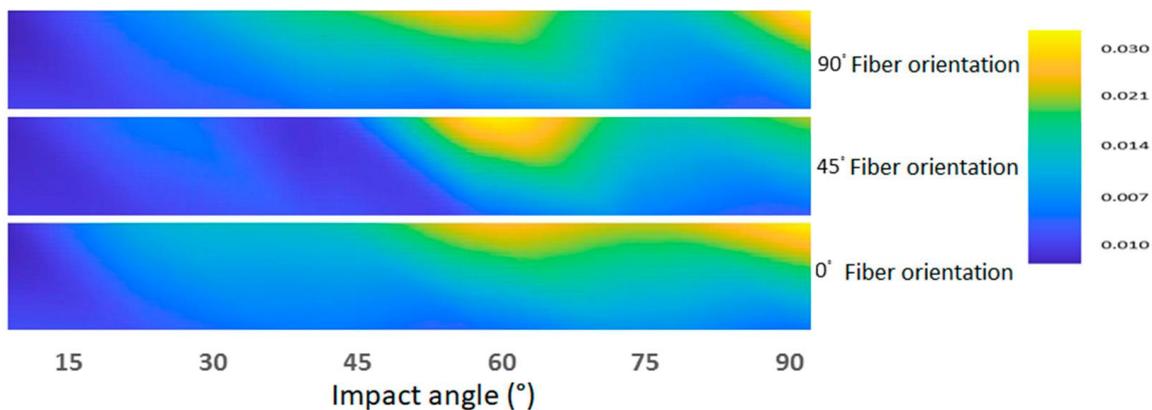
The wastage maps for the GRD plates are notably different from those for the STD plates, as seen in the figure 27. For the GRD plate with a 0° fibre orientation, the wastage rises with the impingement angle, becoming high at 60° and peaking at 90° with a slight decline at 75° . The wastage for the 45° fibre orientation GRD plate is minimal for acute impingement angles, rising to a high level at 60° and then levelling off at higher impingement angles. The wastage is uniformly low for the 90° fibre orientation GRD plate, with occasional peaks of substantial wastage at 60° and 90° impingement angles.

The impingement angle at which the peak erosion occurs varies significantly between the STD and GRD plates. Peak erosion for STD plates occurs at 75° , whereas it occurs at 60° for GRD plates. Additionally, across the range of studied impingement angles, GRD plates demonstrate generally lower wastage and more uniform erosion. Since the GRD plates' erosion is uniform, damage to the blades will also be more predictable, making damage prediction easier.

Figure 27. GRD Erosion wastage map

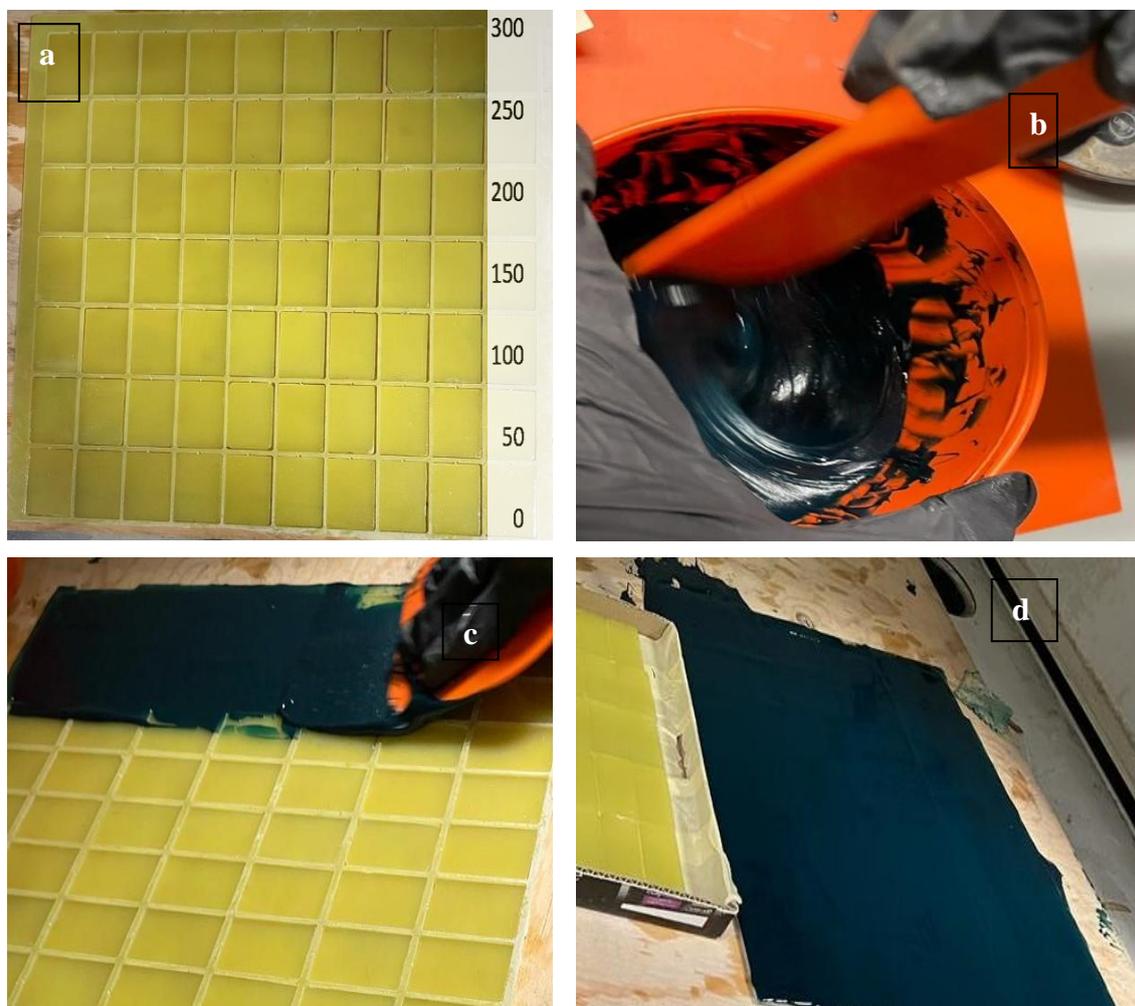
To apply the Belzona 2141 coating to the FR4-G10 GRP samples, the surface of the samples was first prepared using 80-grit sandpaper as in Fig 28 (a), which helps to ensure good adhesion between the coating and the composite material. The Belzona 2911 activator was then mixed with the Belzona 2141 coating to achieve the required polymeric coating form. This mixture was carefully prepared according to the manufacturer's instructions to ensure the correct ratio of components and consistency of the coating [13]as shown in Fig 28 (b).

Once the samples were prepared and the coating mixture was ready, the coating was applied as a one-coat system by brush [11], [13]to achieve the desired thickness as shown in Fig 28 (c,d). The coating application process was carried out under the supervision of Belzona representatives to ensure that it was performed correctly and according to the manufacturer's guidelines [13].

Figure 28 Coating application steps – Fig 28(a) in mm

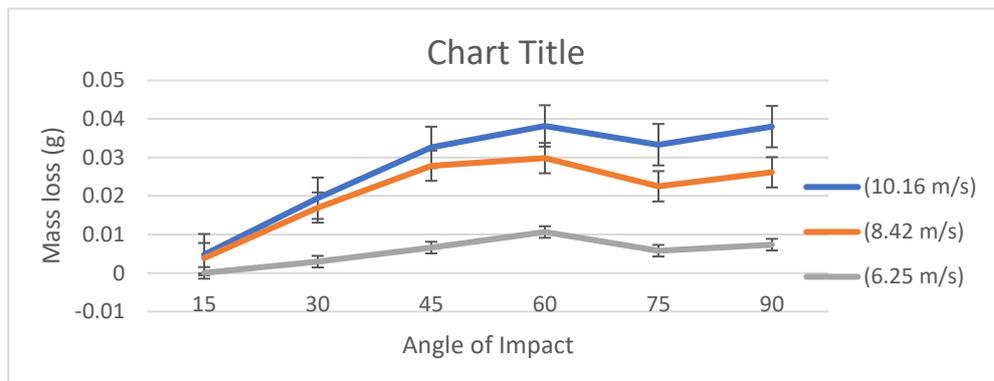
Figure 29 Mass Difference of Coated samples at 6.25m/s, 8.42m/s and

The erosion of the coating material was significantly influenced by the impact angle and water flow velocity, according to Fig. 29 it was noted that the coating experienced higher mass loss at impact angles of 60° and 90°, regardless of the velocity. This suggests that these angles are more critical for the durability of the coating and should be considered in the design and operation of turbines.

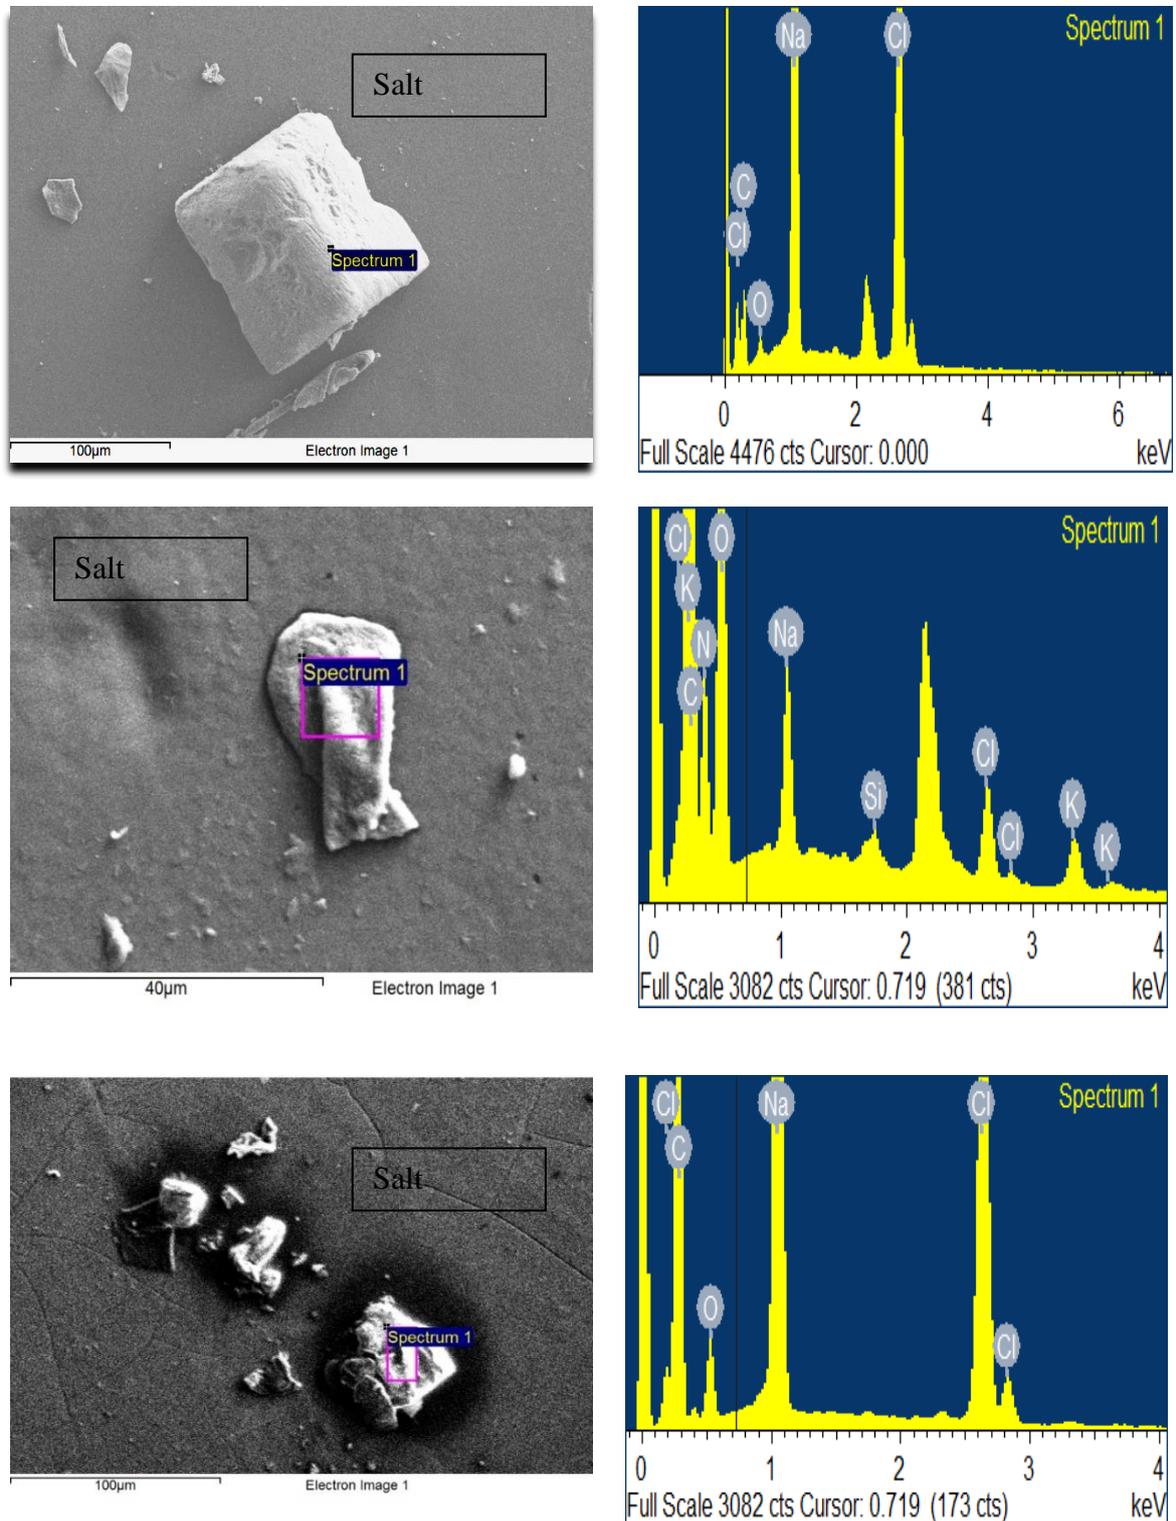
Figure 30 SEM micrograph and EDX coated sample at 15° Impact angle and 6.25 m/s velocity

SEM was used to analyse the surface of an FR4-GRP coated with Belzona 2141. Fig. 30 of the SEM provided evidence of salt deposition on the coating surface, which occurred at an impact angle of 15 and 6.25 m/s velocity.

The combination of the SEM image and the observation of an increase in mass in Fig. 30 provide strong evidence that the impact of the erodent caused salt deposition on the surface of the coating. This finding is important because it can have implications for the performance of the coating in tidal turbine operation, as salt deposition can have detrimental effects on the integrity and durability of coatings [12].

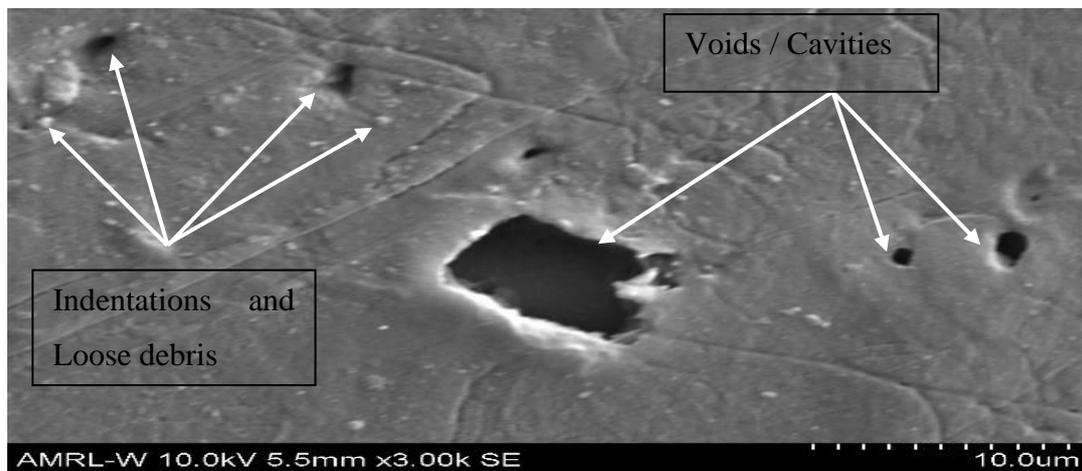
Figure 31 coated sample at 75 Impact angle and 8.42 m/s

Fig. 31 shows the results of an erosion test on a coating surface, specifically at a 75° angle and a velocity of 8.42 m/s. Fig.31 indicates that this impact caused significant damage to the coating, as evidenced by the presence of voids, cavities, and loose debris scattered around the eroded surface.

The presence of loose debris indicates that the impact caused some material to be dislodged or broken apart, similar to what was observed in Fig. 31. The confirmation of loose debris and coating erosion at higher impact conditions suggests that the coating may not be able to withstand high-speed impacts at these conditions. The presence of ductile cutting in the coating further confirms that the coating is a ductile material, as was observed in Fig. 32 at lower impact conditions [146].

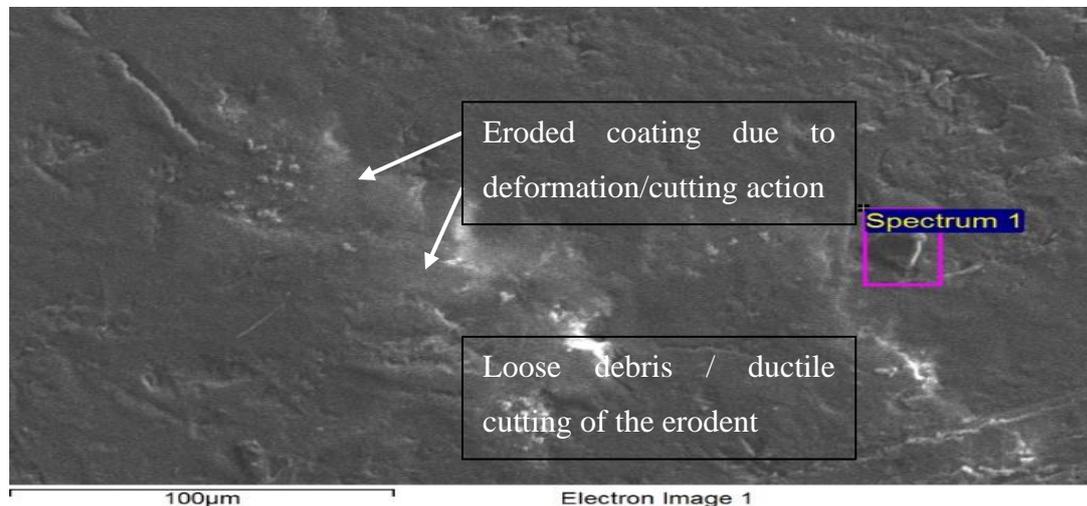
Figure 32 Coated sample at 90 Impact angle and 10.16m/s action at a higher impact velocity of 10.16 m/s and an impact angle of 90°. The figure also confirms the ductile cutting in the coating at these test conditions [134].

The combination of loose debris, coating erosion, and ductile cutting observed in Fig. 32 provides evidence of the extent of damage caused by the impact at these higher impact conditions. The deformation and cutting action caused significant damage to the coating, resulting in the removal of material and the formation of loose debris.

The observation of ductile cutting in Fig. 33 is consistent with the observation in Fig. 32, which suggests that the coating is a ductile material. This information is important for understanding the behaviour of the coating under high-speed impact conditions and for determining the potential applications of the coating in environments with high-velocity impacts [174].

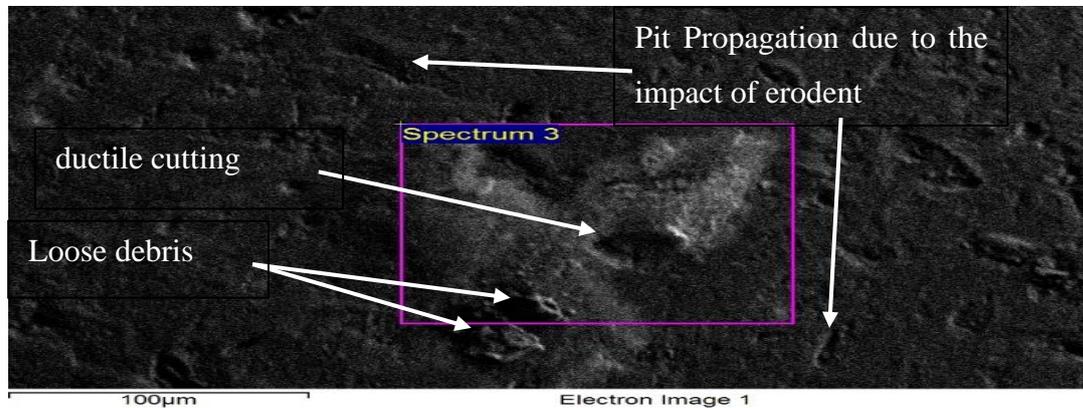
Figure 33 Coated sample at 75° Impact angle and 10.16m/s velocity.

Fig. 33 shows that at an impact angle of 75° and a velocity of 10.16 m/s, the coated surface suffered from pit propagation due to the impact of the erodent. The figure also shows the presence of loose debris and ductile cutting.

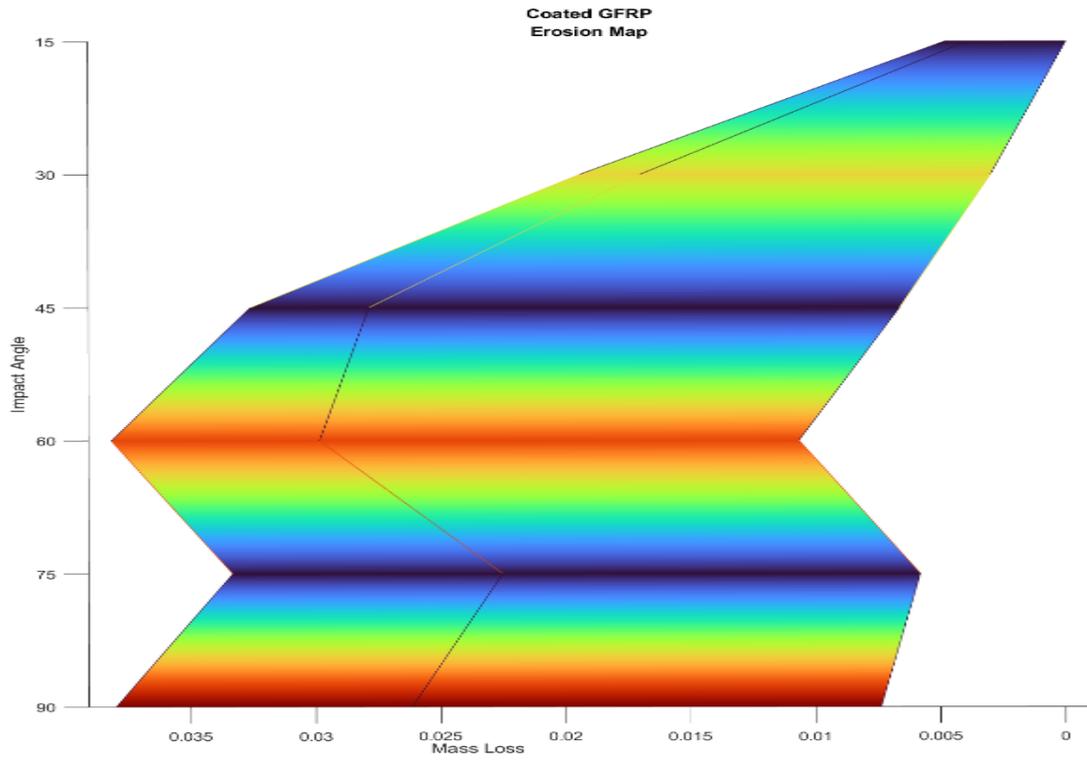
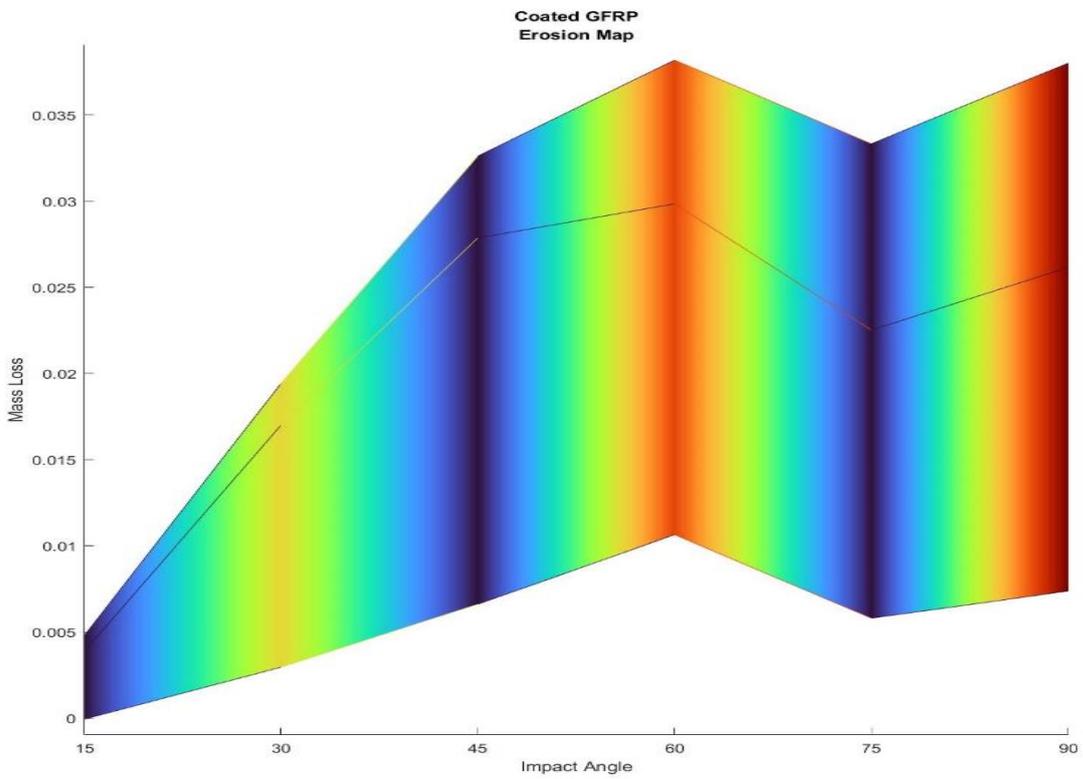
Figure 34 Erosion map of surface coating

The erosion map provides a graphical representation of the level of material loss experienced by the coating under different impact velocities and angles [52]. The map in fig. 34 indicates that the coating is most resistant to erosion when tested at impact angles of 15°, 30°, 45°, and 75° and velocities of 6.25 m/s, 8.42 m/s and 10.16 m/s, suggesting that the coating's design is most effective at deflecting the force of the impacting particles when it is applied at these angles.

Fig 34 revealed that the coating performed best at a velocity of 6.25 m/s compared to velocities of 8.42 m/s and 10.16 m/s. This data can be used to optimise the design of the tidal turbine blades to reduce the impact of ocean currents and tides, potentially reducing erosion and improving the durability of the coating.

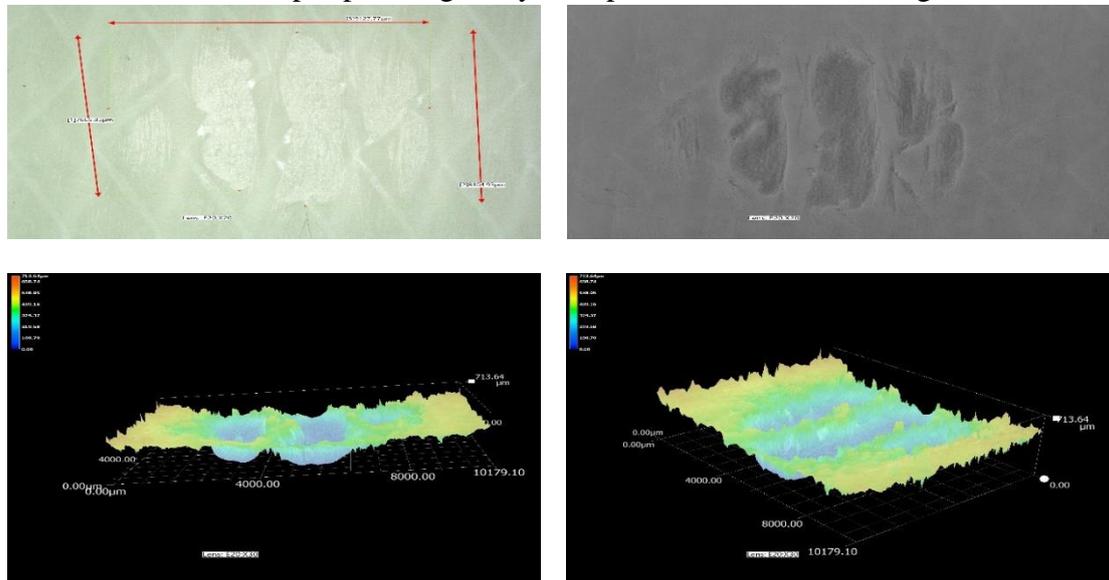
The 3D depth profiling analysis presented in Fig. 35 reveals the extent of erosion damage experienced by a GFRP composite sample tested at an impact angle of 60° and a fibre orientation of 90°. The depth profiling analysis captures the erosion damage across the entire

Figure 35. 3D profile for uncoated GFRP at 60° impact angle and 90° fibre orientation and 9.04 m/s

surface of the sample, allowing for a comprehensive assessment of the damage sustained. The results show that the eroded sample experienced a loss of 713.64 μm in depth, indicating severe erosion damage.

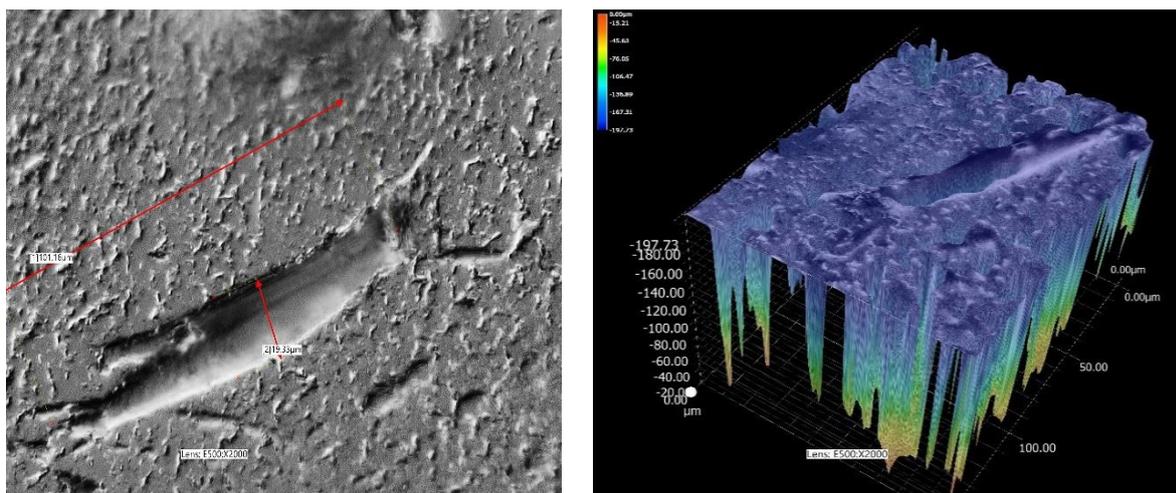
Figure 36. 3D Depth profile of the coated sample at an impact angle of 60° and impact velocity of 10.16 m/s

Figure 36 presents a 3D depth profile analysis of a Belzona 2141 coated sample described in section 4.3, subjected to solid particle erosion at an impact angle of 60° and impact velocity of 10.16 m/s. The results indicate that the material suffered a maximum loss of $197.73 \mu\text{m}$ in depth due to the erosion caused by solid particles. Moreover, the 3D depth analysis clearly shows the formation of voids and cutting of the coating when the silica particle hit the coated surface.

The presence of voids and matrix cutting suggests that the coating has undergone significant deformation during the impact event. Voids can be caused by the detachment of the coating from the substrate or the collapse of the coating due to the force of the impact. Matrix cutting occurs when the coating material is sheared or sliced by the projectile or by the deformation of the coating during the impact event.

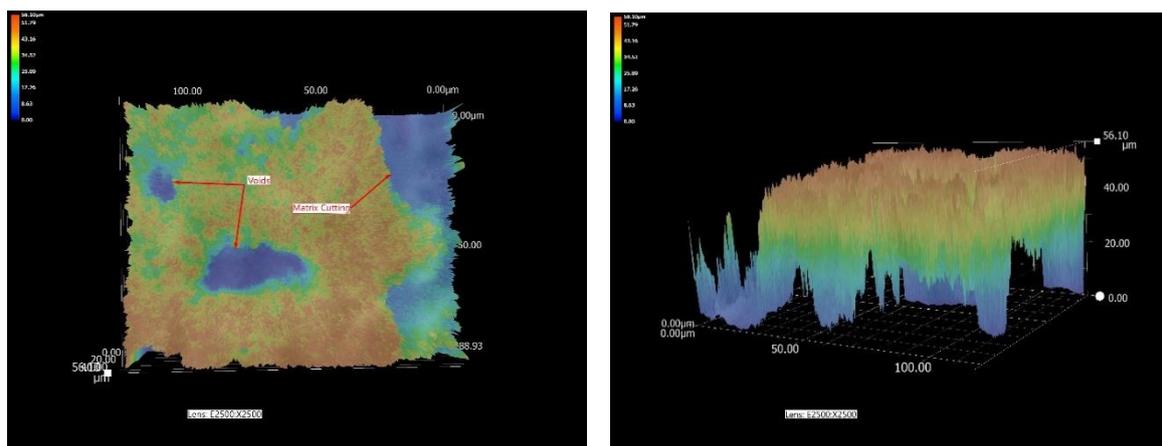
Figure 37. UD-GFRP sample at an impact angle of 75° ; 90° fibre orientation and velocity of 9.04 m/s

Fig. 37 depicts the impact of erosion on a unidirectional glass fibre reinforced polymer (UD-GFRP) sample at an impact angle of 75° and an impact velocity of 8.42 m/s. The analysis of the sample indicates that it has suffered a loss of $56.10 \mu\text{m}$ in depth, with the presence of voids and matrix cutting. The presence of voids and matrix cutting suggests that the erosion process was predominantly ductile. The resin matrix of the composite is a relatively brittle material compared to the glass fibres and is therefore more susceptible to fracture upon impact. The presence of voids and matrix cutting indicates that the resin matrix has fractured or detached from the glass fibres upon impact, resulting in the rapid and removal of material from the composite surface.

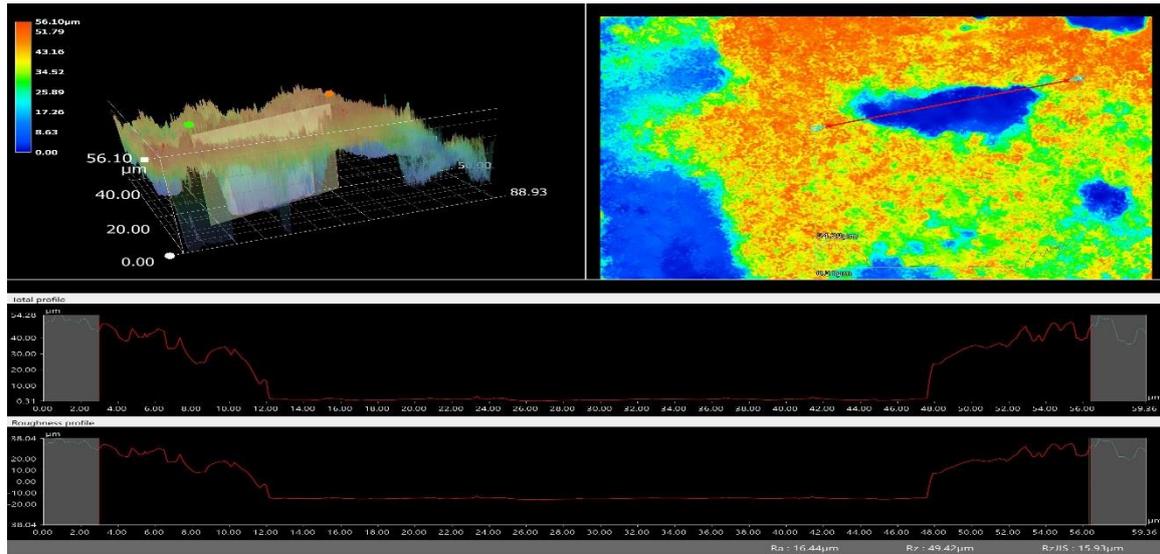
Figure 38 UD-GFRP at 45° impact angle and 45° fibre orientation and 9.04 m/s velocity

Fig. 38 and Fig. 39 show the analyses of the surfaces of eroded UD-GFRP and eroded coated samples, at 45° impact angle respectively, under the influence of solid particle erosion. While both figures depict surfaces that have undergone erosion by solid particles, there are some differences between the results shown in Fig. 38 and Fig. 39.

Fig. 4 shows the analysis of an eroded UD-GFRP sample, indicating an average surface roughness value of 14.44 μm . This suggests that the erosion process has caused a significant

amount of material loss and surface damage, resulting in a rough and irregular surface. The roughness value may be attributed to the detachment of the resin matrix, exposing the glass fibres, and resulting in surface roughness.

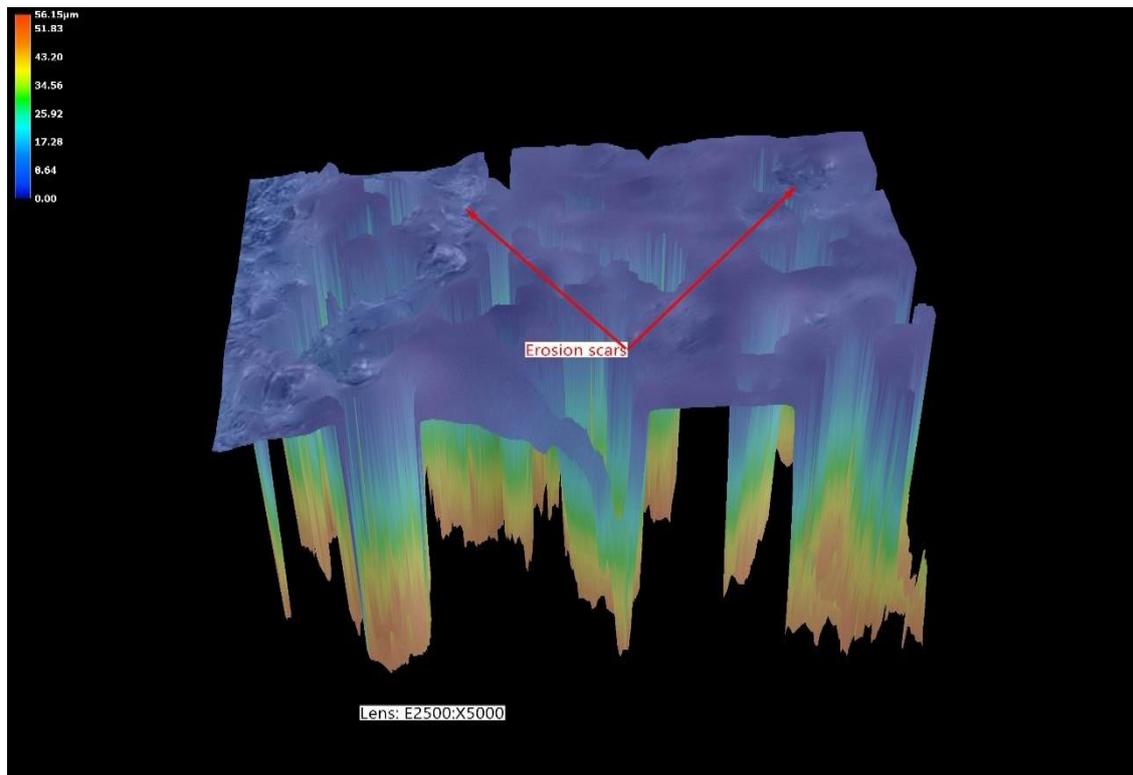
Figure 40.3D depth profiling for coated sample at $6.25\ \text{m/s}$ velocity

Fig. 6 shows the analysis of a coated sample that has undergone solid particle erosion at an impact angle of 60° and a velocity of $6.25\ \text{m/s}$. The analysis reveals that the sample has been exposed to severe erodent hitting, resulting in the formation of scars and voids on the surface. The scars and voids indicate that the coating has been partially removed from the surface, exposing the underlying substrate to further erosion.

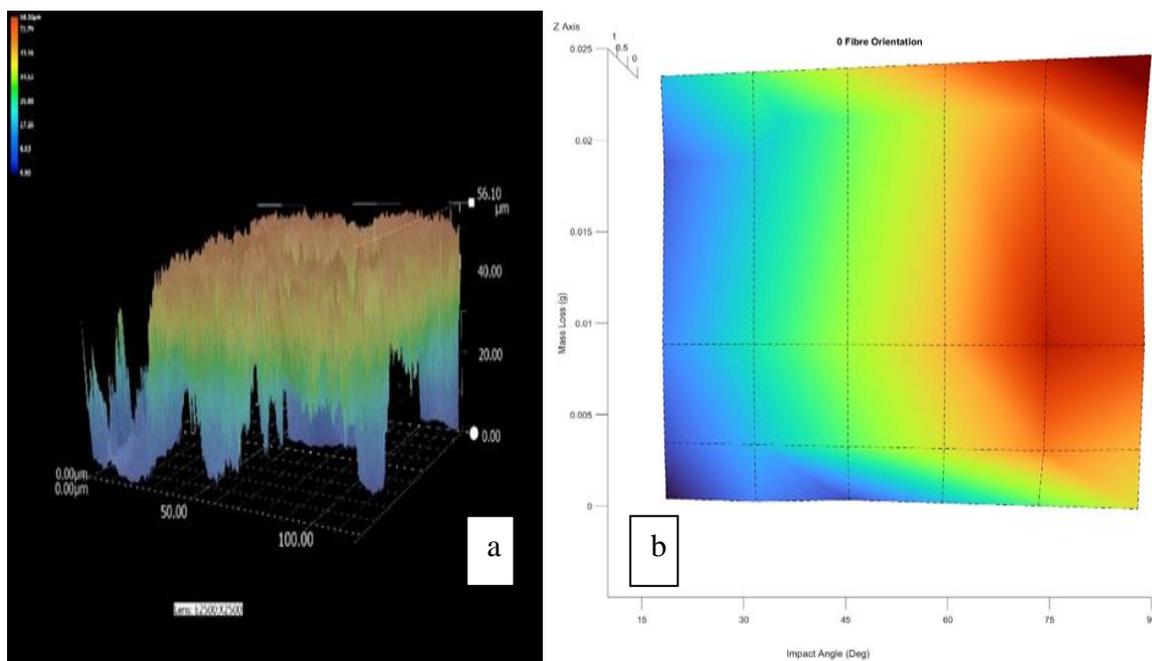
The results presented in Fig. 41 indicated that two distinct techniques were employed to investigate the erosion mechanism resulting from solid particles on turbine blades subjected to an impact angle of 75. One of the techniques involved generating a figure denoted as (a), which demonstrated the depth of the defect incurred from erosion. This figure (a) shows that the erosion caused a loss of 56.20 μm in depth due to the existence of voids on the sample surface. The second technique entailed the creation of an erosion map Fig. 41 (b), which provided concrete evidence of the erosion damage sustained at the same impact angle of 75 degrees. The erosion map revealed the distribution of the eroded material on the blade's surface, thereby enabling to pinpoint areas that are especially vulnerable to erosion. The application of both techniques is critical in comprehending the erosion mechanism resulting from solid particles and its impact on turbine blades. The figure 41(a) furnishes quantifiable data on the depth of the defect attributable to erosion, while the erosion map fig. 41 (b) offers a visual representation of the extent of the erosion damage. Together, these techniques enabled us to identify the contributory factors of erosion and formulate effective strategies for mitigating its impact on turbine blades. The findings reported here provide empirical evidence that erosion resulting from solid particles can significantly affect the efficacy and longevity of turbine blades. A thorough understanding of the erosion mechanism and the development of effective strategies for mitigating its effects are vital for enhancing the efficiency and dependability of tidal turbines.

Figure 41. (a) Depth profiling (b) Erosion maps of UD-GFRP with 90 fibre orientation and 75 impact angle
